**FACTUAL NOTES, ENGINE TEARDOWN INVESTIGATION IN SUPPORT OF ACCIDENT INVESTIGATION OF AIRCRAFT REGISTRATION NO. N4531K PERFORMED FOR NATIONAL TRANSPORTATION SAFETY BOARD (NTSB).**

**NTSB Accident No. Not available at this time P&WC Ref. File No: 17-148**

PWC PT6A-15AG S/N 14144  
Data plate Airforce Turbine indicating PT6A-34AG

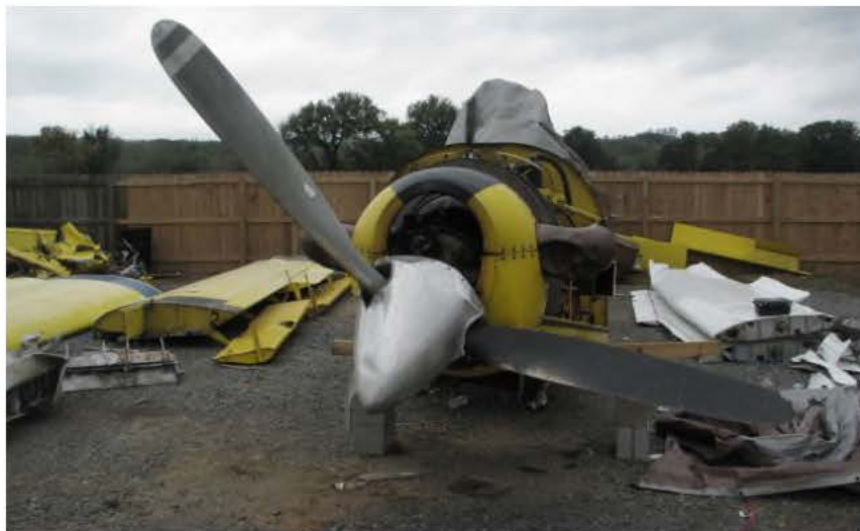
Photo No. 1  
Propeller assembly and left exhaust stack

- 3.1 **External Condition:** The propeller assembly was still attached to the propeller shaft (Photo No. 1). One of the three propellers exhibited mechanical damages (arrow, Photo No. 2). The undamaged propellers were near the feathered position. The propeller shaft was still attached to the reduction gearbox which was separated from the exhaust case at the “B” flange (Photo No. 3). The exhaust duct was crushed on the bottom portion from impact (Photo No. 4). The gas generator case showed no external impact damage (Photo No. 5), however torsional damage was observed in the inner portion of the gas generator (arrow, Photo No. 6). The PWC engine data plate showed the serial number was PCE- 14144 and that the engine is a PT6A-15AG (Photo No. 7). Attached over the bottom of the PWC data plate is another data plate from Airforce Turbine Service (STC SE7677SW) showing the engine is a PT6A-34AG (Photo No. 7).

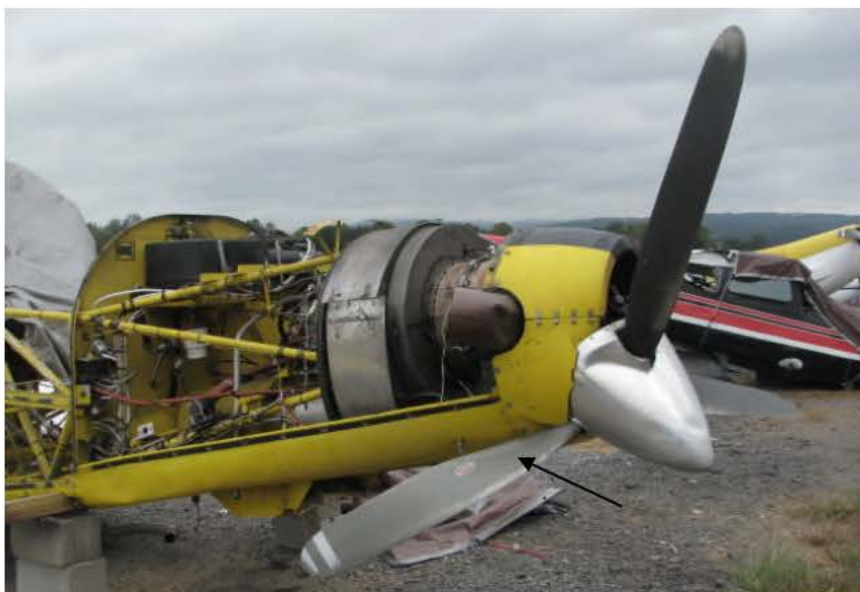
Photo No. 2  
Bent Propeller and right exhaust stack

**Exhaust Duct:** The two exhaust stacks showed mechanical damages (Photo Nos. 1 and 2). The exhaust duct showed mechanical damages (Photo No. 4).

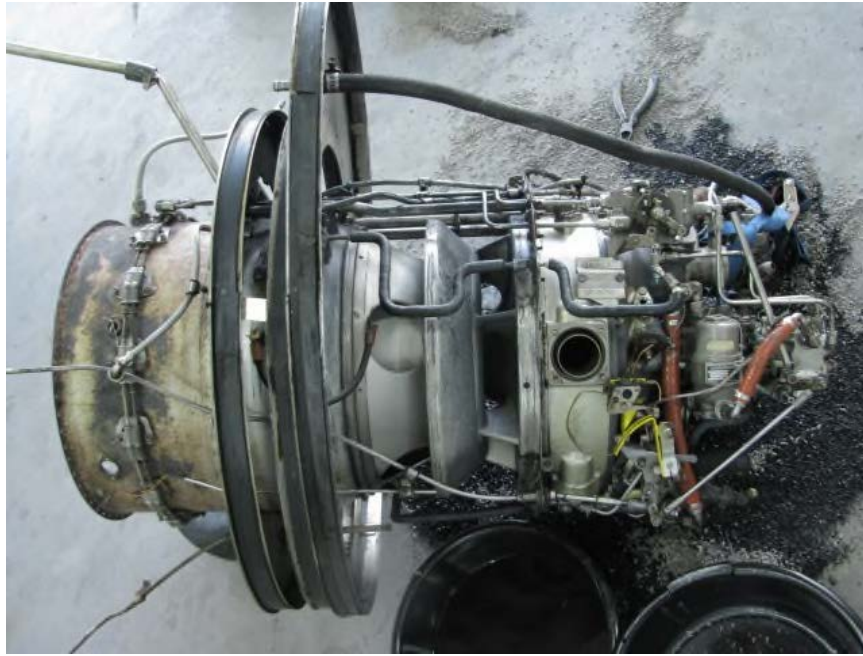
Photo No. 5

**Gas Generator Case:** The gas generator case showed no external damages (Photo No. 5), however torsional damage was observed in the inner portion of the gas generator (Photo No. 6).

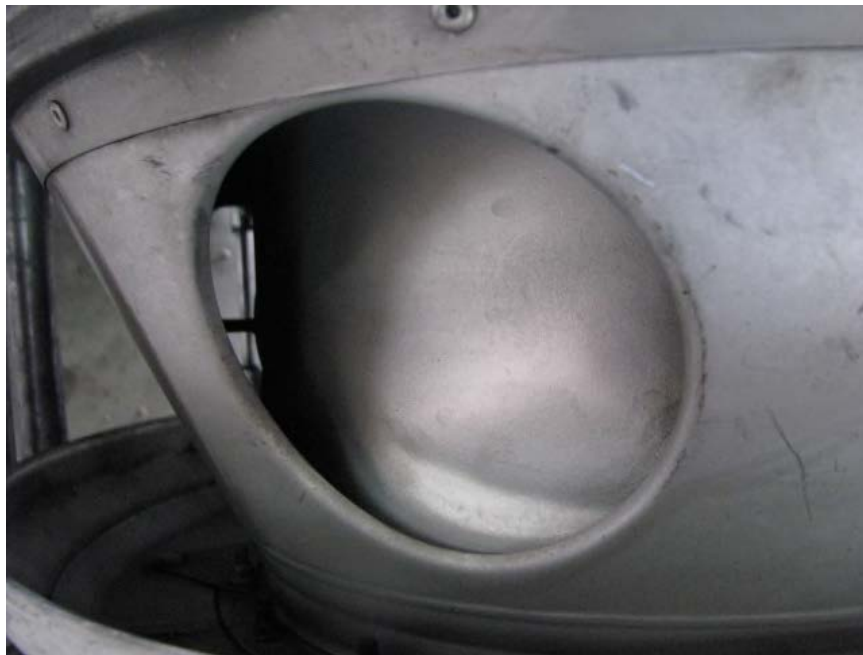
Photo No. 6

Gas generator case torsional deformation

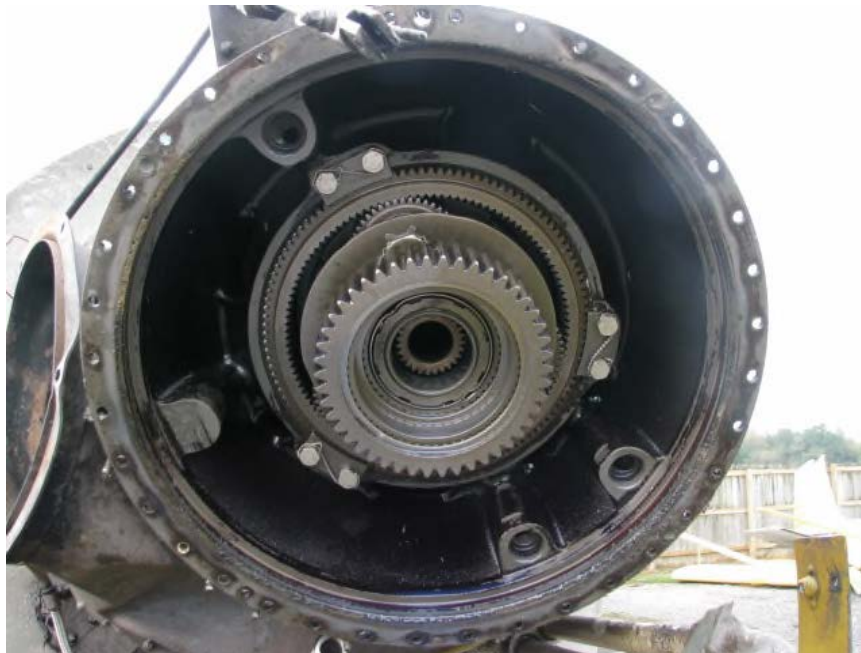
Photo No. 8

**Reduction Gearbox:** The reduction gearbox front housing could be partially rotated. The scavenge and pressure lines were deformed from impact damages. No evidence of oil starvation or distress was observed on the first and second stage planet gear assemblies, which were exposed during engine removal from the airframe (Photo Nos. 8 and 9 respectively).

First stage planet gear carrier assembly

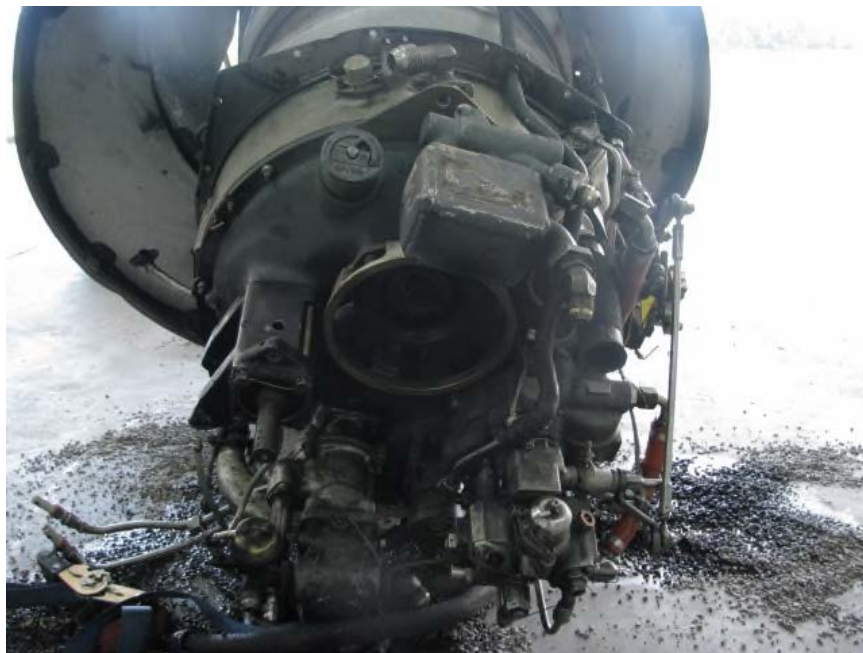
Photo No. 10  
Accessories gearbox

**Accessory Gearbox:** The accessory gearbox showed no damages and could be rotated by hand, continuity was observed with the compressor turbine (Photo No. 10).

**3.2.5 Accessory Gearbox:** The accessories gearbox showed no damages (Photo No. 10). The accessories gearbox was not accessed further for the purposes of this investigation.

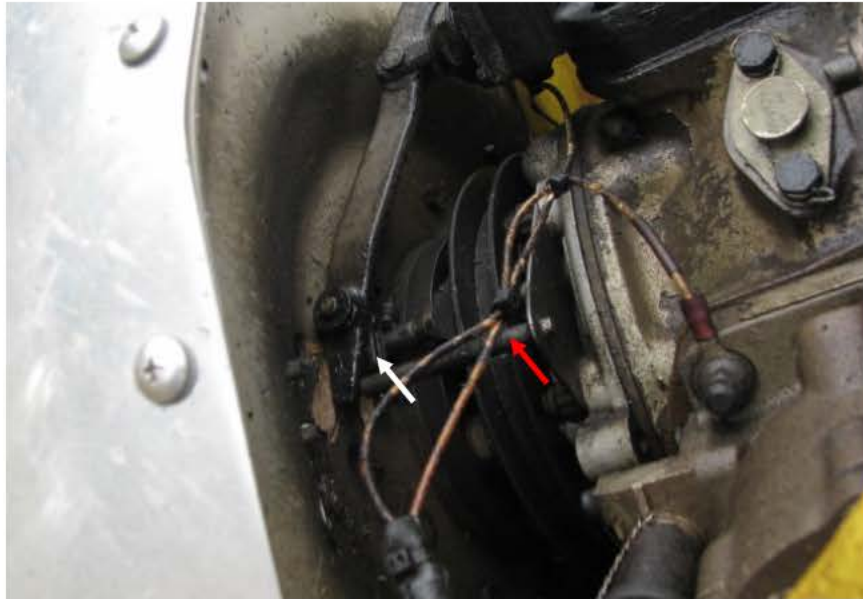
Photo No. 11

3.1.2 **Power Control and Reversing Linkage:** The beta lever guide pin was in place (red arrow, Photo No. 11). The propeller reversing lever was displaced at the carbon block outside of the slip ring (white arrow, Photo No. 11). The propeller reversing linkage was in place (red arrow, Photo No. 12). The propeller speed control lever was fractured from the propeller governor (black arrow, Photo No. 12). The reset interconnect rod was complete and secure (white arrow, Photo No. 12). The input lever, reversing cable, and airframe power lever cable linkage was attached and secure on the CAM box (red circle), (white, red and black arrows respectively, Photo No. 13). The start valve to the fuel condition lever was connected (yellow arrow, Photo No. 13).

Beta guide pin and the propeller reversing lever

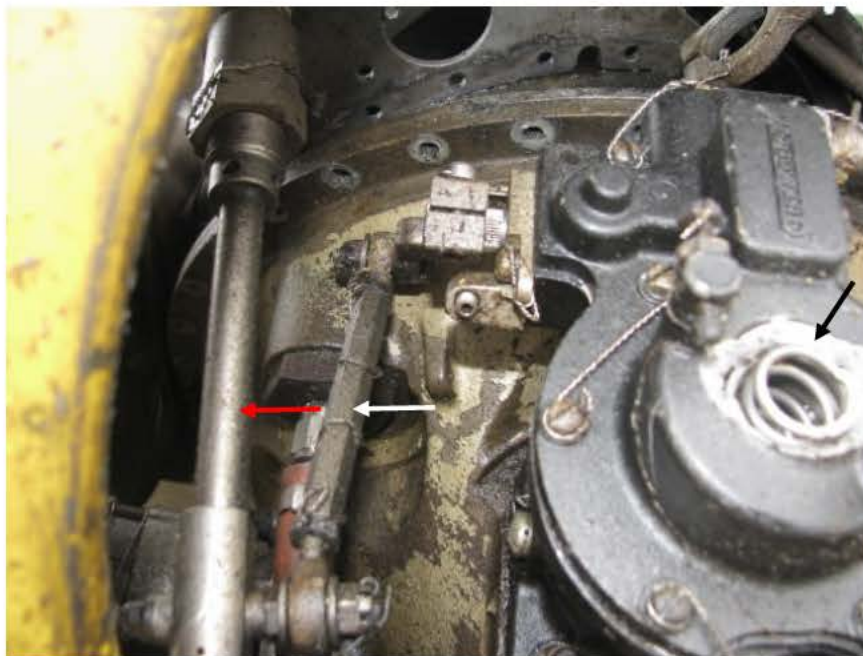
Photo No. 12

Reversing linkage and fractured propeller governor speed control lever

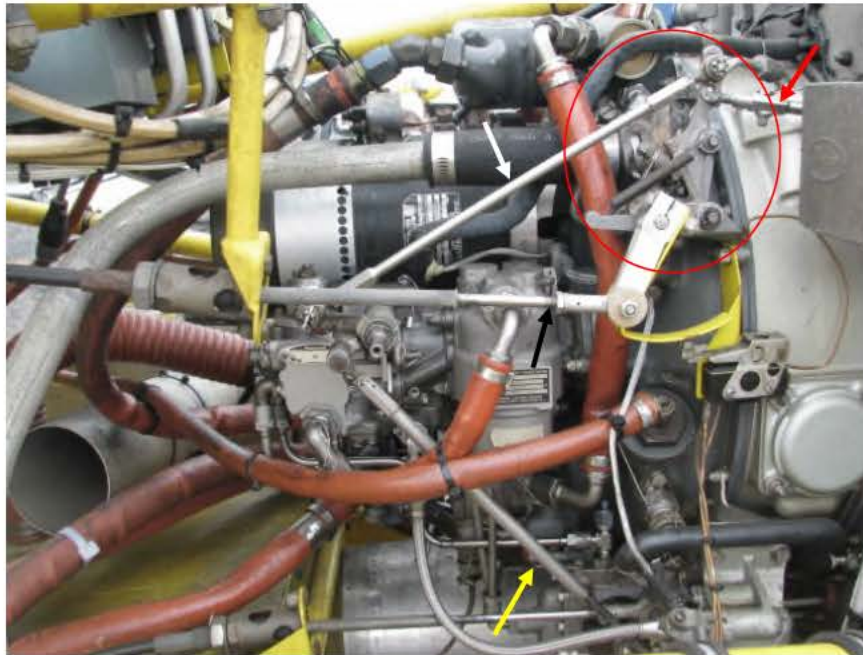
Photo No. 13

CAM box, input lever and airframe power lever cable

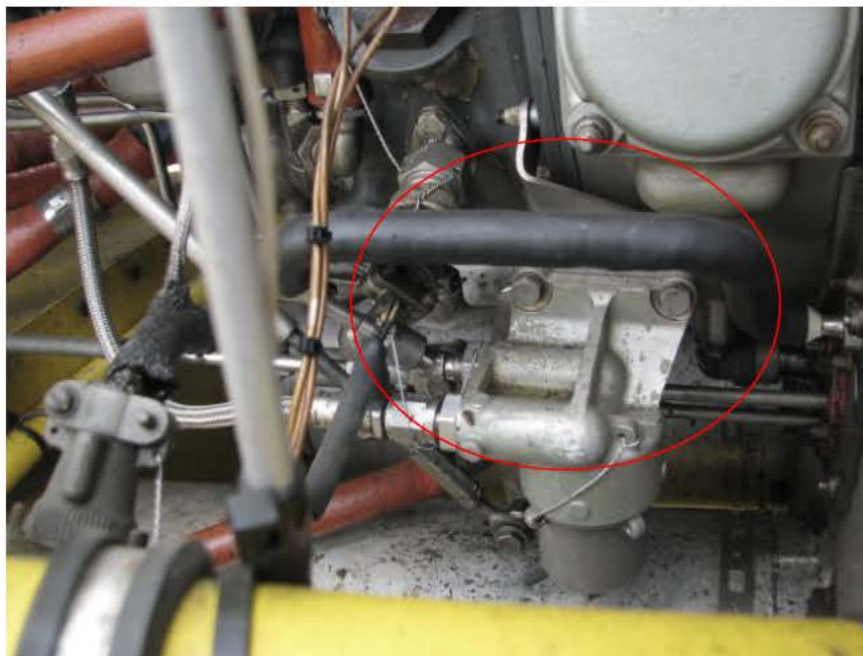
Photo No. 14

**Compressor Discharge Air (P3):** The P3 lines connectors were found tight and secure from the fuel control unit to the P3 bowl to the gas generator (circled, Photo No. 14). The P3 filter and bowl were dry (Photo No.15).

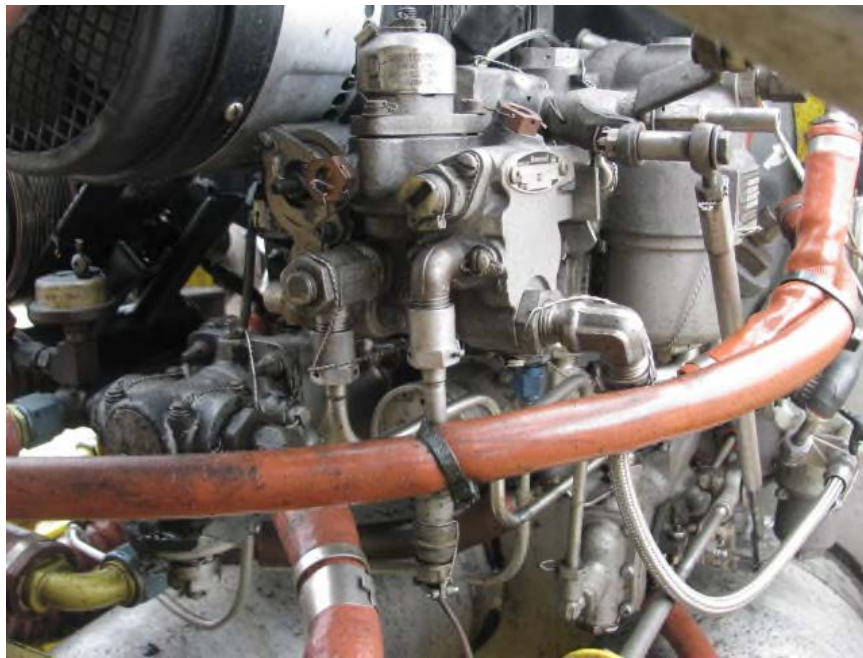
**Power Turbine Control (Py):** The Py line was found connected and secure from the fuel control unit to the propeller governor (Photo Nos.16 and 17).

Photo No. 16  
Py line at the fuel control unit

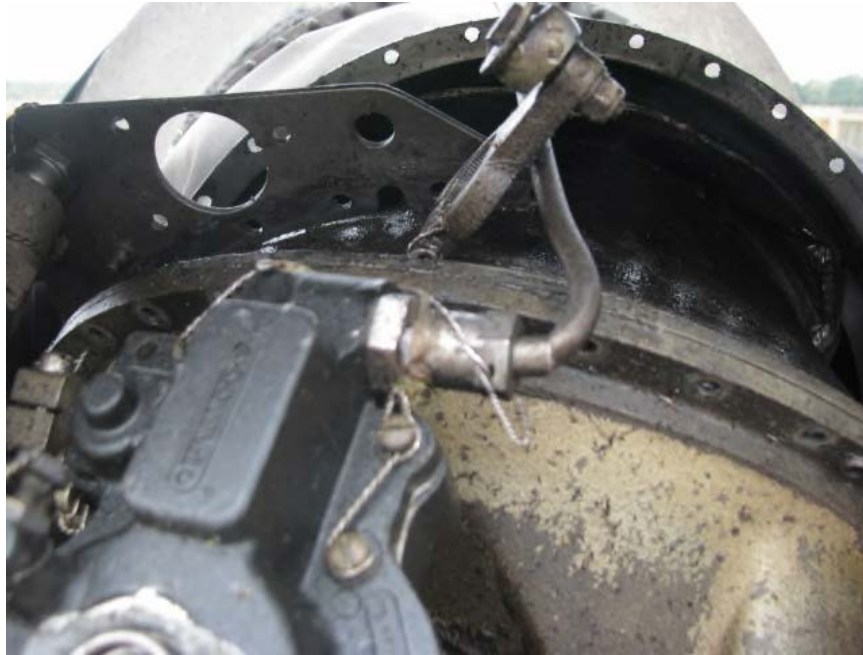
Photo No. 17  
Py line at the propeller governor

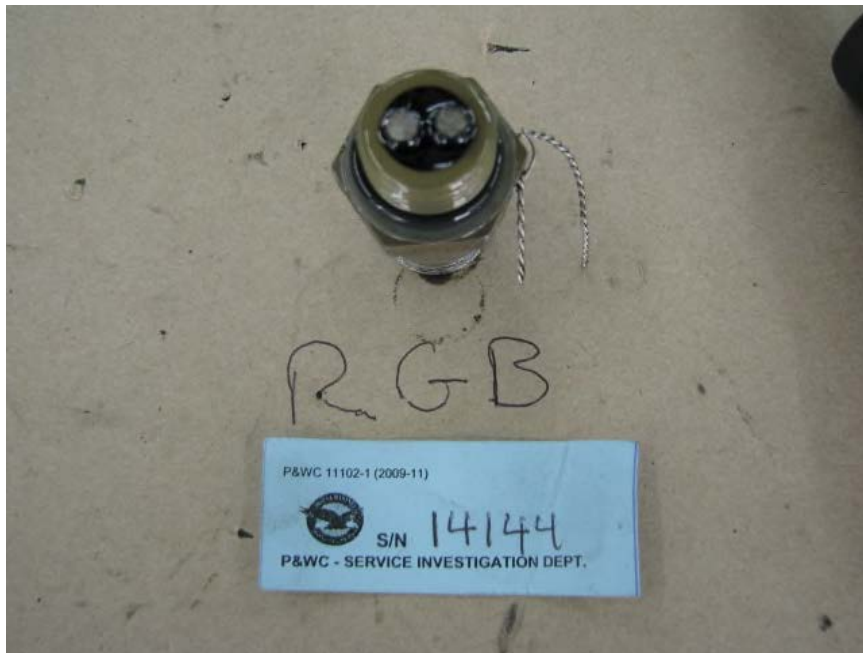
Photo No. 18  
Reduction gearbox magnetic chip detector

**Reduction Gearbox Chip Detector:** The reduction gearbox magnetic chip detector showed no significant metal debris accumulation (Photo No. 18).

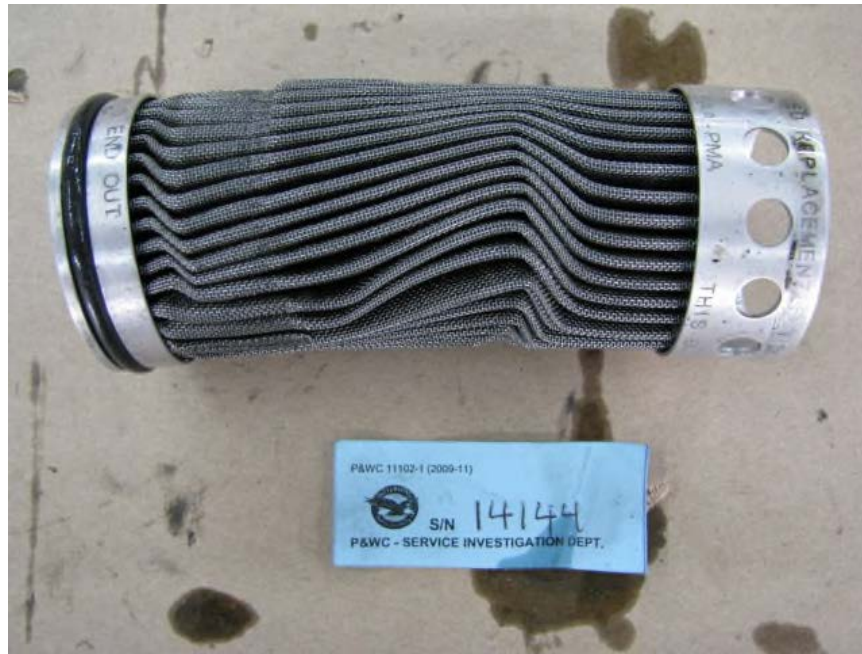
Photo No. 19  
Oil filter

**Oil Filter:** The oil filter was removed and found to show no metal debris contamination (Photo No. 19).

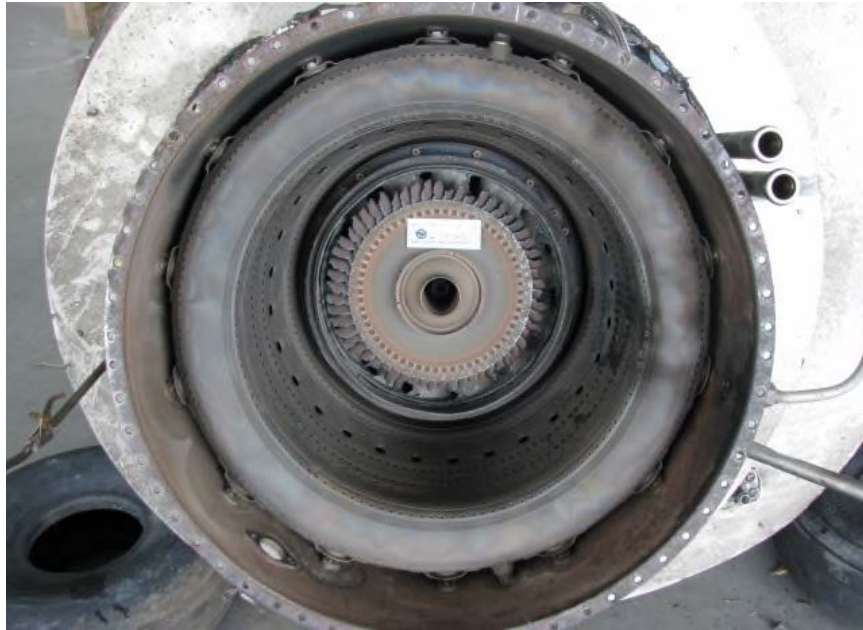
Photo No. 20  
Outer combustion liner

**Combustion Chamber Liner:** The outer surface of the liner showed no distress and exhibited normal in-service condition (Photo No. 20). The fuel nozzles were not accessed for the purposes of this investigation.

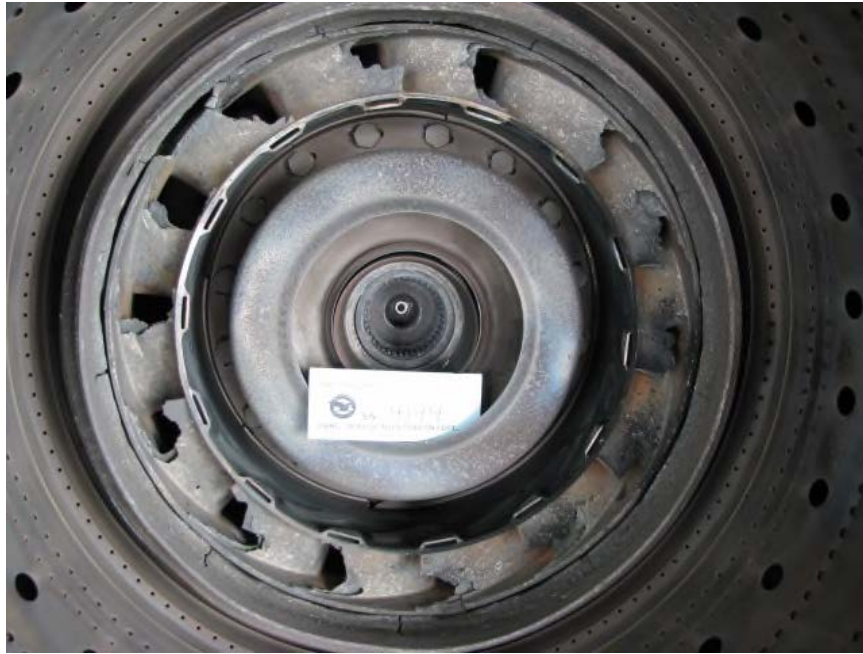
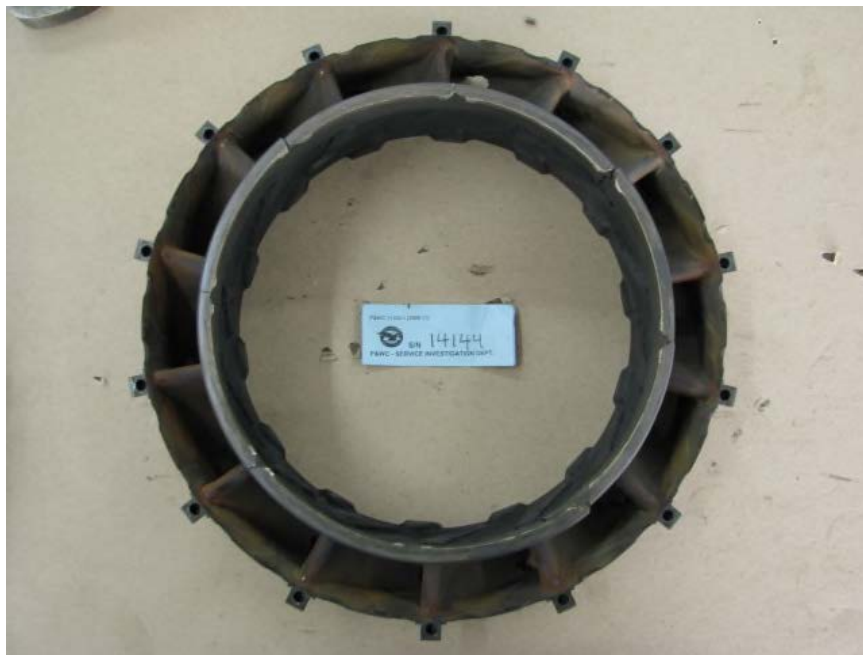
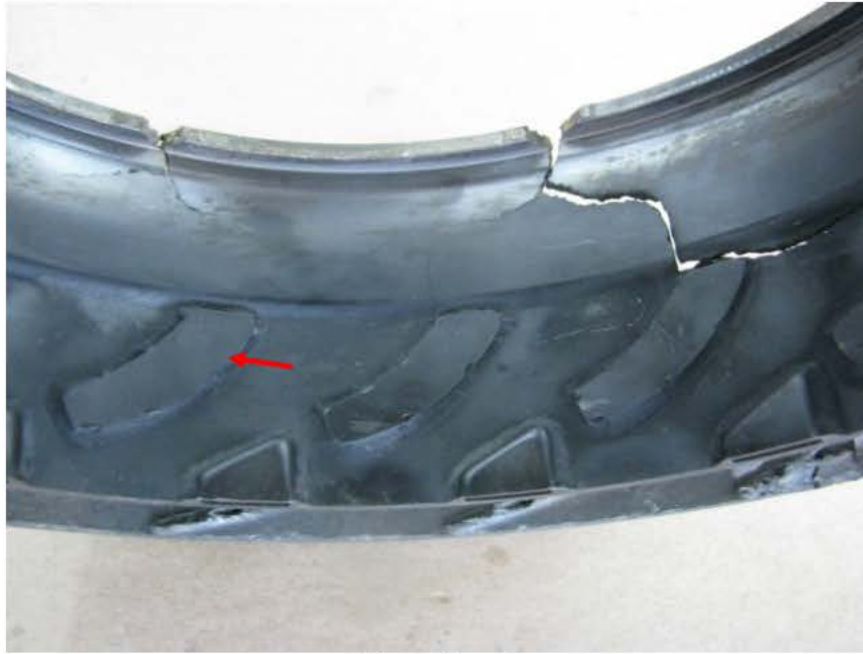
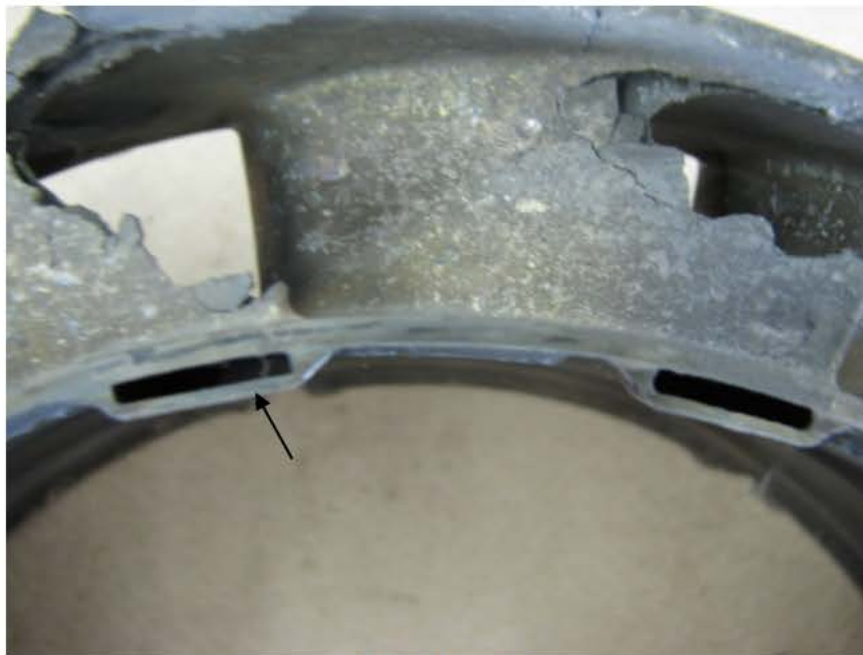
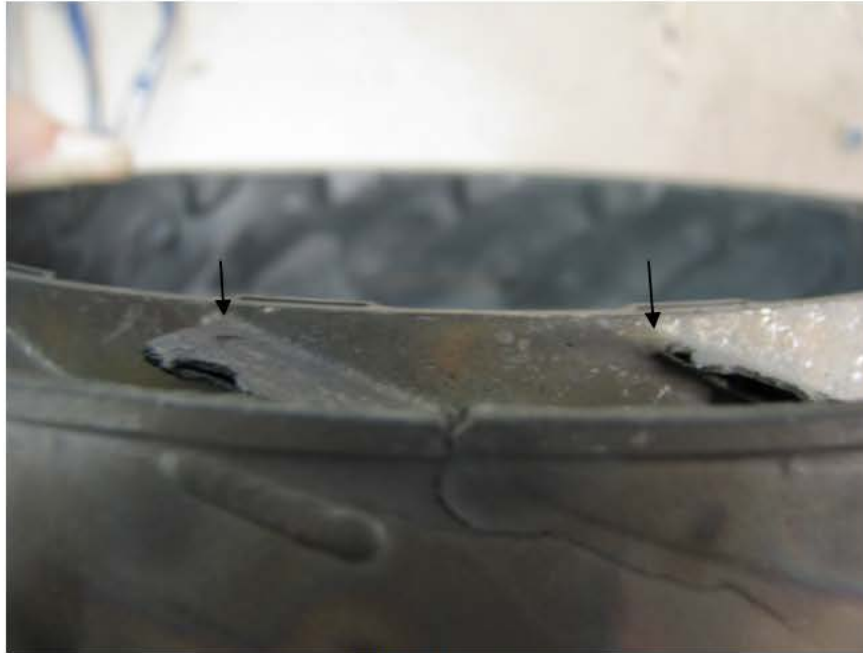
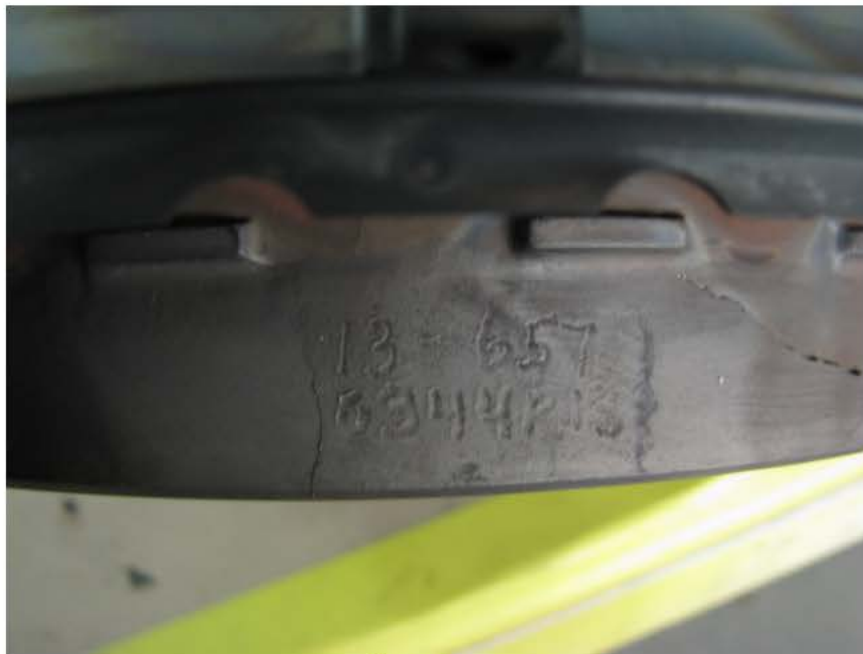
**Compressor Turbine Vane Ring:** The compressor turbine vane ring downstream showed impact damages to the vanes (Photo No. 21). The compressor turbine vane ring showed no upstream damages to the leading edge of the vanes (Photo No. 22). The inner shroud was cracked in several locations (Photo No. 23). The inner shroud welds and the air slots' shapes were different than those observed on similar application PWC stators (red arrow, Photo No. 23 and black arrow, Photo No. 24 respectively). The trailing edge distances to the end face of the inner shroud also visually appeared to vary from vane to vane (arrows, Photo No. 25). Limited markings on the stator showed 0344R13 and 13-657 (Photo No. 26). Records showed that the CT stator was installed after overhaul repair by Southwest Turbines at engine TSN11959.2. Their repair is not a PWC approved repair.

Photo No. 21  
Compressor turbine stator downstream view

Photo No. 22  
Compressor turbine stator upstream view

Photo No. 23  
Compressor turbine inner shroud side welds

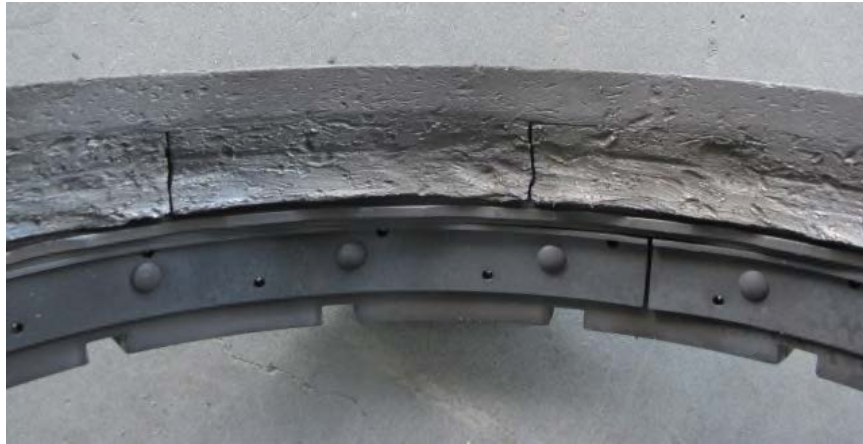
Photo No. 27  
Compressor turbine shroud segments

**Compressor Turbine Shroud:** The compressor turbine shroud segments showed impact damages from the release of the compressor turbine blades fragments (arrow, Photo No. 27).

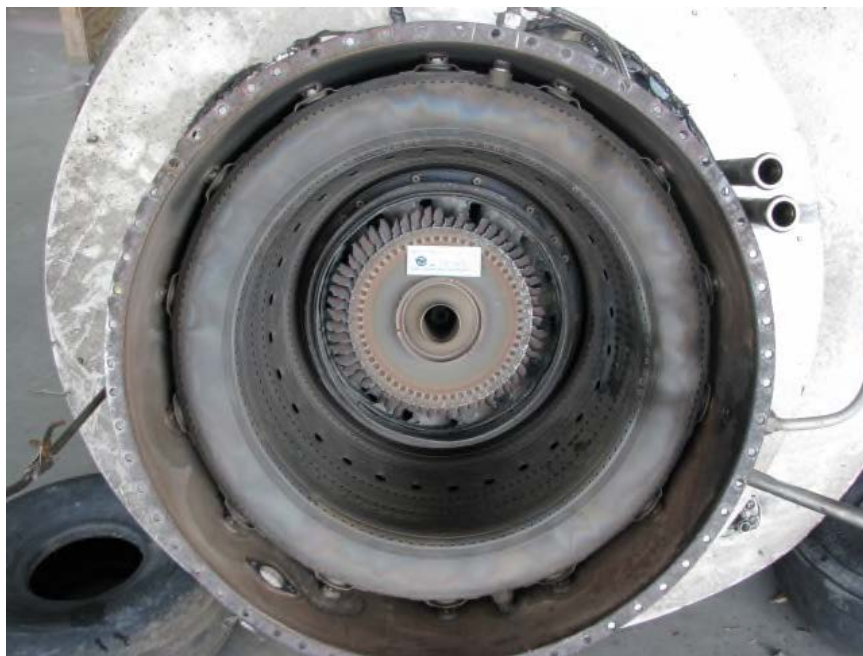
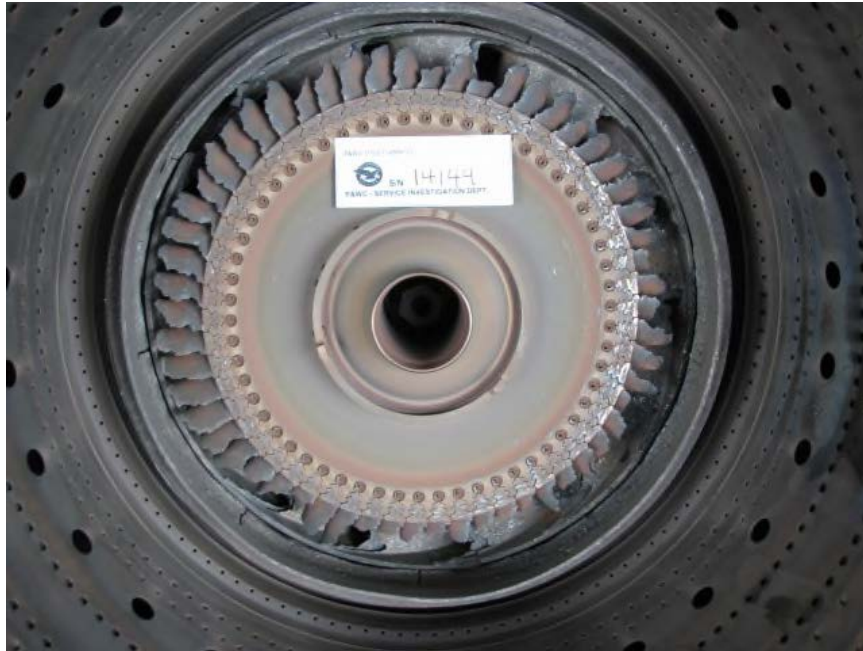
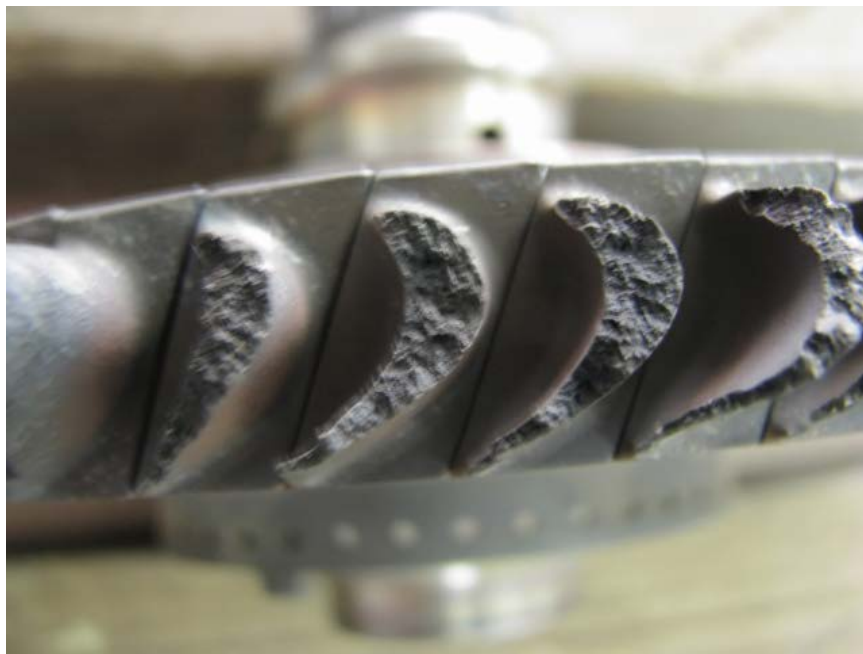
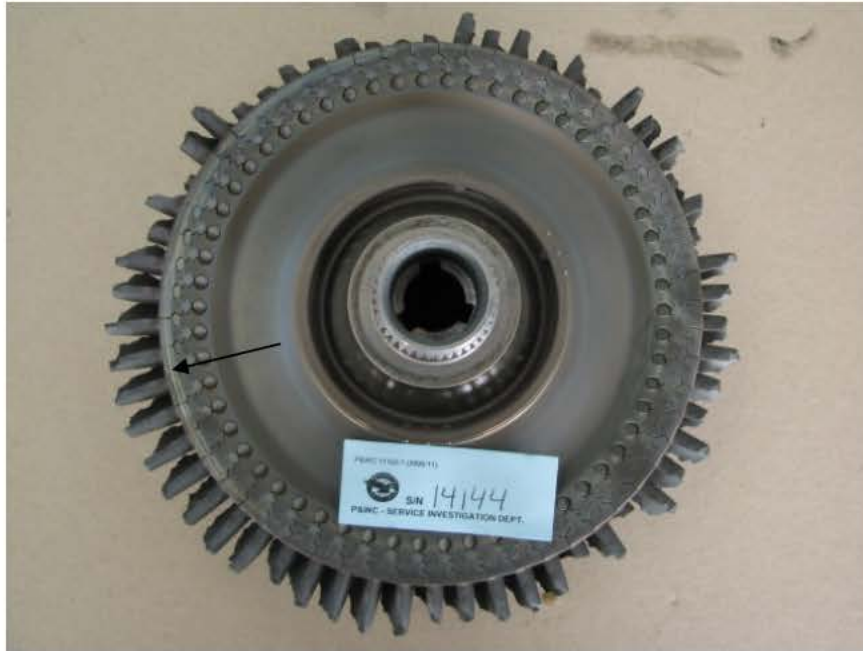
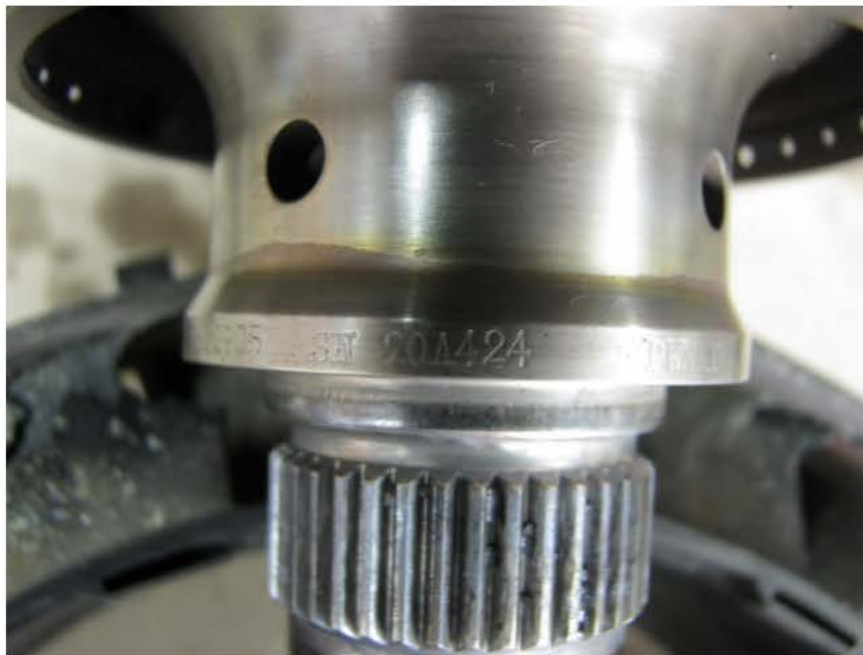
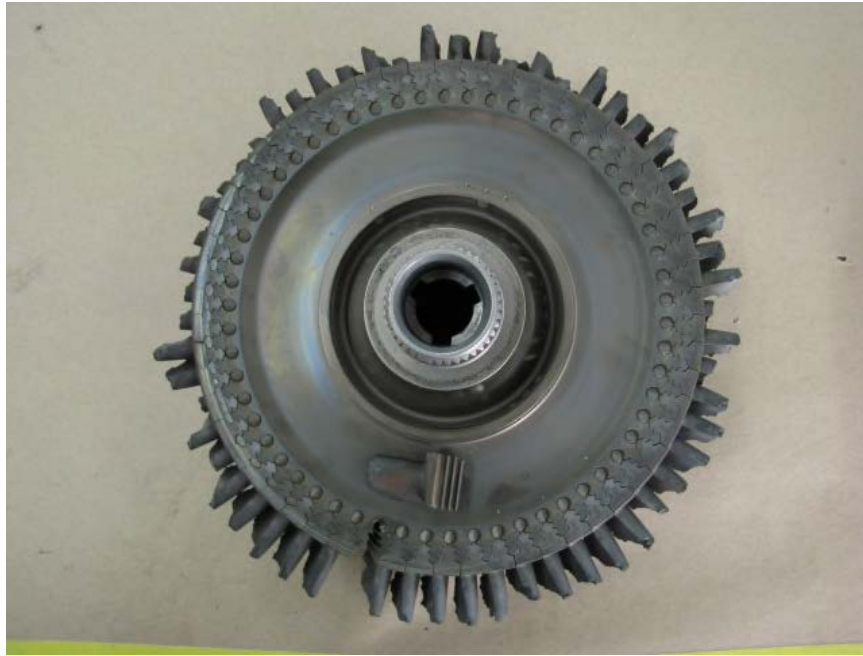
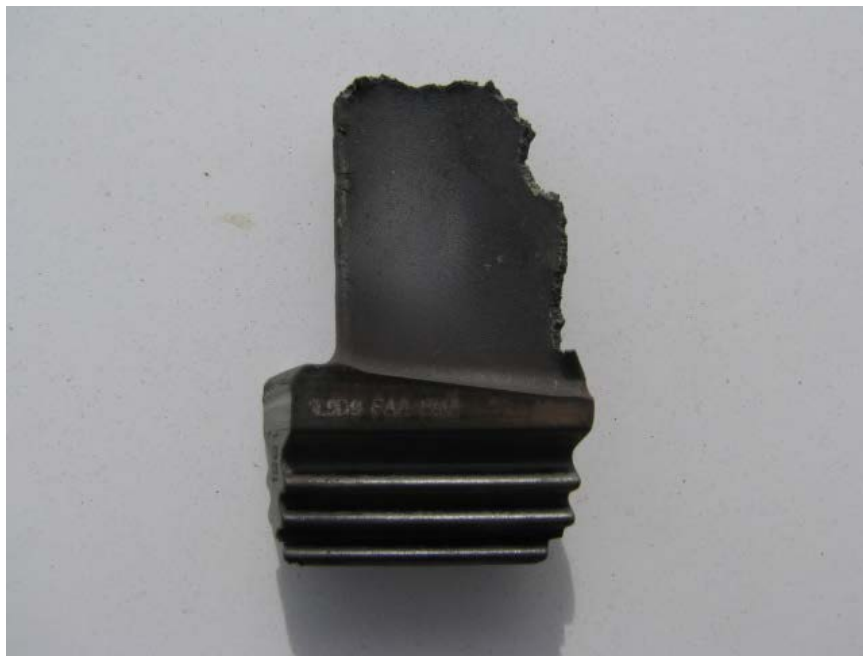
**Compressor Turbine:** The compressor turbine blades were all observed to have fractured (Photo Nos. 28 and 29). Visual examination of all the compressor blade fractures showed no obvious primary blade fracture. All the blades had an appearance of a rough fracture morphology indicative of tensile overload type fractures (Photo No. 30). The compressor disc retaining bolt was properly secured, however during removal it was noted that the bolt was easily untorqued. The upstream view of the compressor disc is shown in Photo No.31. Circumferential rubbing contact with the compressor turbine stator inner shroud was observed for an arc of approximately 120° on the upstream face of the compressor turbine blades (arrow, Photo No. 31). The compressor turbine disc at engine TSN in the records indicated P/N 3013411 S/N 29A424 with part CSN 14,807. The installed disc was P/N 3013411 S/N 20A424 (Photo No. 32). One compressor turbine blade was removed revealing a non PWC manufactured compressor turbine blade, P/N 1L9D9 FAA-PMA (Photo Nos. 33 and 34).

Photo No. 29  
Closer view of compressor turbine blades damages

Photo No. 30  
View of typical fracture surfaces observed on the compressor turbine blades

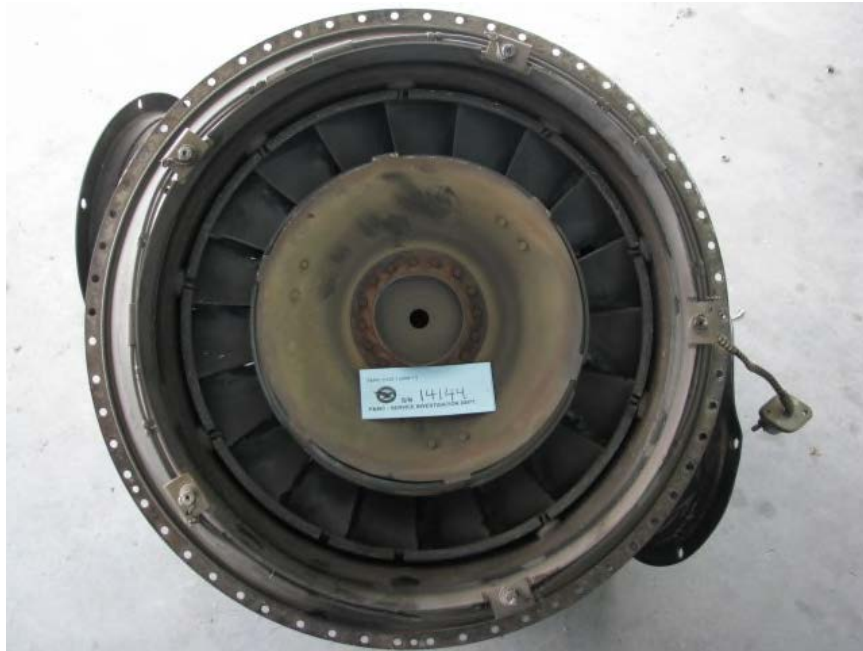
Photo No. 35

**ITT Probes, Busbar, and Harness:** The inter turbine temperature probes were all fractured (Photo No. 35). The harness and busbar were intact (Photo No. 36).

Power turbine housing, inter turbine temperature probes and upstream view of first stage power turbine stator

**Power Turbine Stator Housing:** The power turbine stator housing was intact (Photo No. 35).

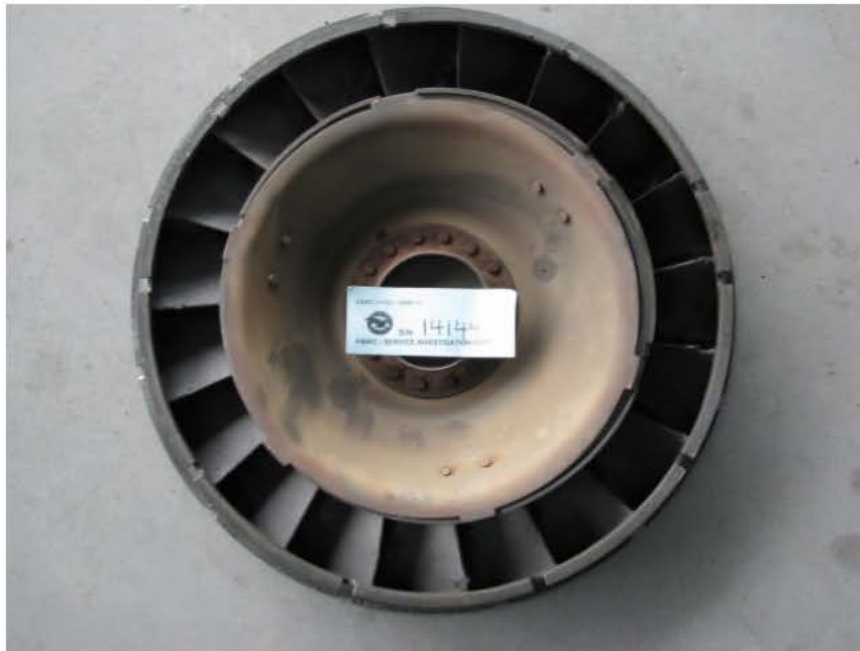
Photo No. 37  
Upstream view of the power turbine stator

**Power Turbine Vane Ring:** The upstream view of the power turbine vane ring showed impact damages to the leading edge of several vanes and the vane ring baffle was displaced (Photo No. 37). The downstream view of the power turbine vane ring showed impact damages to all the vanes and a static crush mark in the vane baffle from contact with the displaced power turbine disc hub (Photo No. 38).

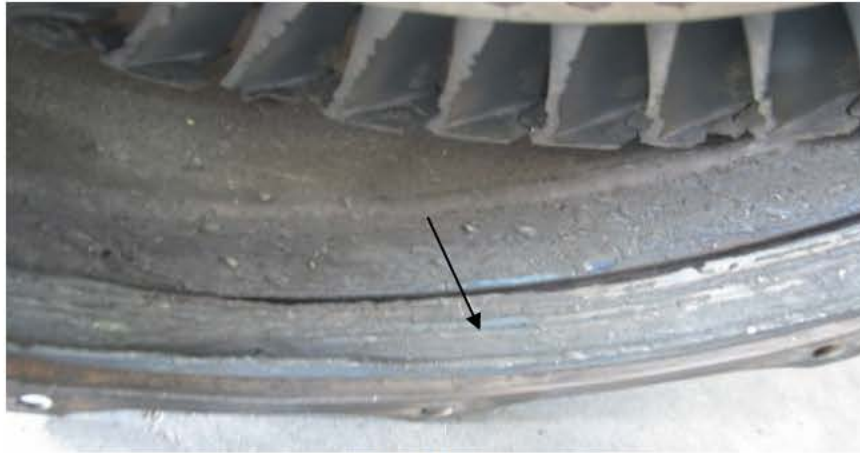
Photo No. 39  
Power Turbine Shroud

**Power Turbine Shroud:** The power turbine shroud contact surface was almost completely obliterated by mechanical damages (arrow, Photo No. 39).

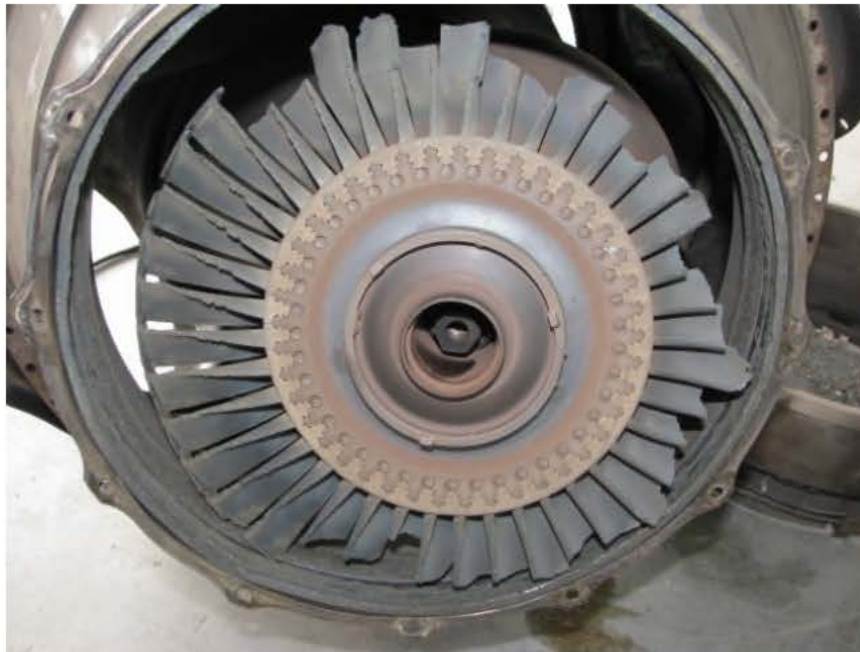
Photo No. 40  
Power turbine

**Power Turbine:** The power turbine assembly which was displaced due to impact damages to the exhaust case showed several of the blades to be fractured (Photo No. 40). The power turbine could be rotated with some difficulty. The retaining bolt retaining bolt was found secure with noticeable undo torque required, however at some point during the untorque process the bolt seized and could not be removed. Examination of the fracture surfaces of the PT blades insitu showed a fracture morphology indicative of tensile overload (Photo No. 41).

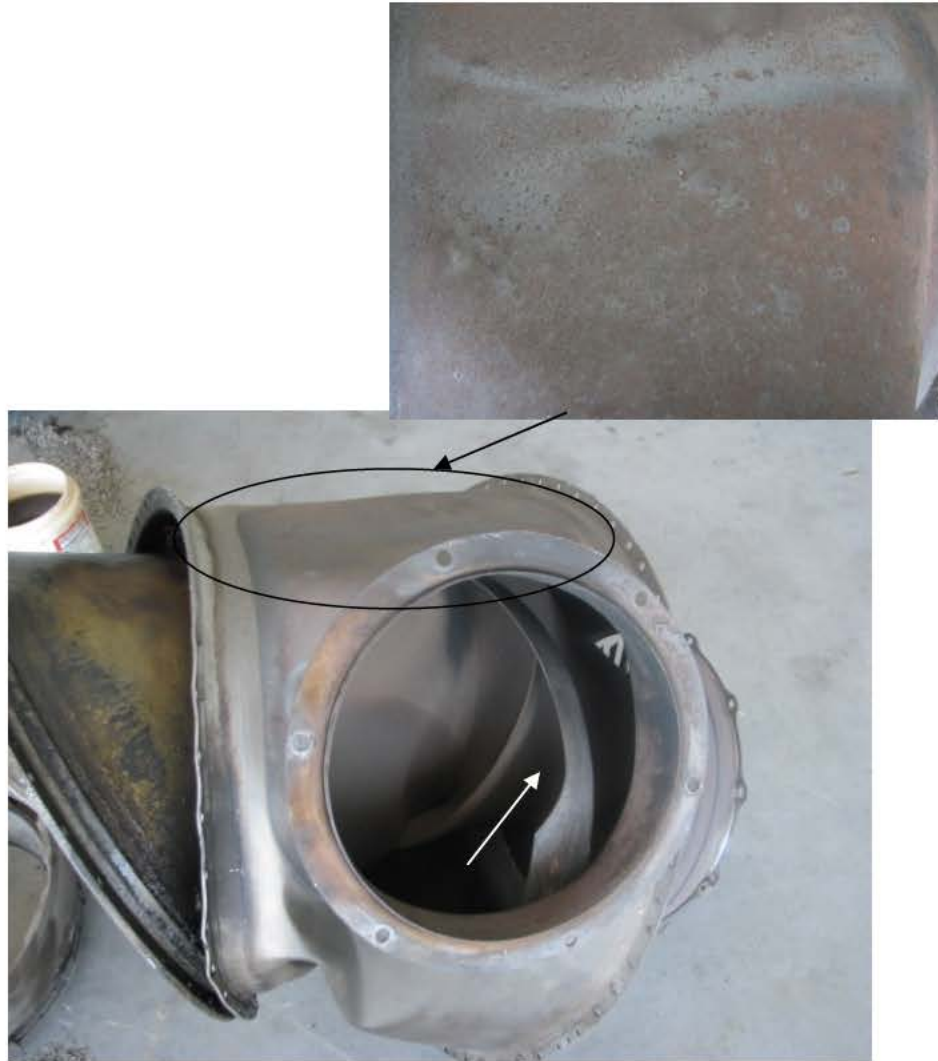
Photo No. 42

**Power Turbine Shaft and Shaft Housing:** The power turbine housing was deformed due to deformation of the exhaust duct during impact (arrow, Photo No. 42, note the “pock marks from debris impact on the inside of the exhaust case (inset)). A loss in continuity was observed between the power turbine and first stage reduction gearbox assembly. The power turbine shaft and shaft housing was not accessed for the purposes of this investigation.

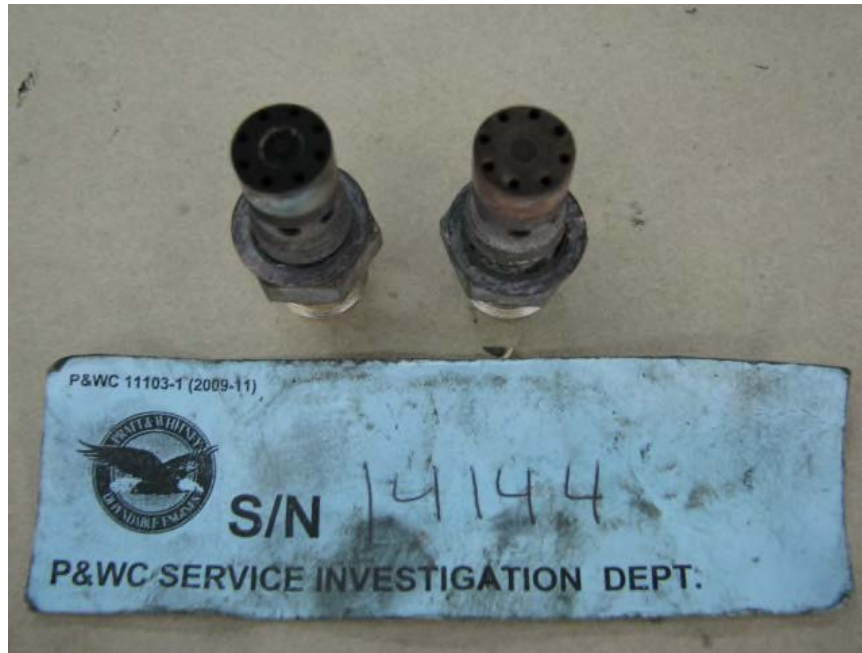
Photo No. 47  
Intact ignitor plugs

**Ignition Plugs:** Both plugs were in place, secure and intact. The ignitors removed showed no distress (Photo No. 47).

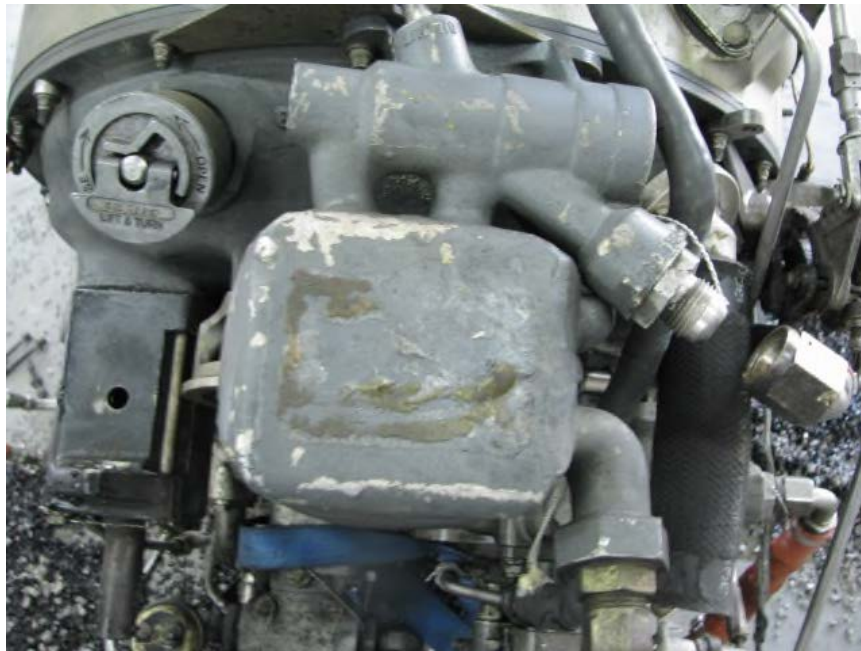
Photo No. 48  
Fuel heater

**Fuel Heater:** The fuel heater was intact and in place (Photo No. 48).
