**FACTUAL NOTES, ENGINE TEARDOWN INVESTIGATION IN SUPPORT OF ACCIDENT INVESTIGATION OF AIRCRAFT REGISTRATION NO. N4531K PERFORMED FOR NATIONAL TRANSPORTATION SAFETY BOARD (NTSB).**

**NTSB Accident No. Not available at this time P&WC Ref. File No: 17-148**

PWC PT6A-15AG S/N 14144  
Data plate Airforce Turbine indicating PT6A-34AG

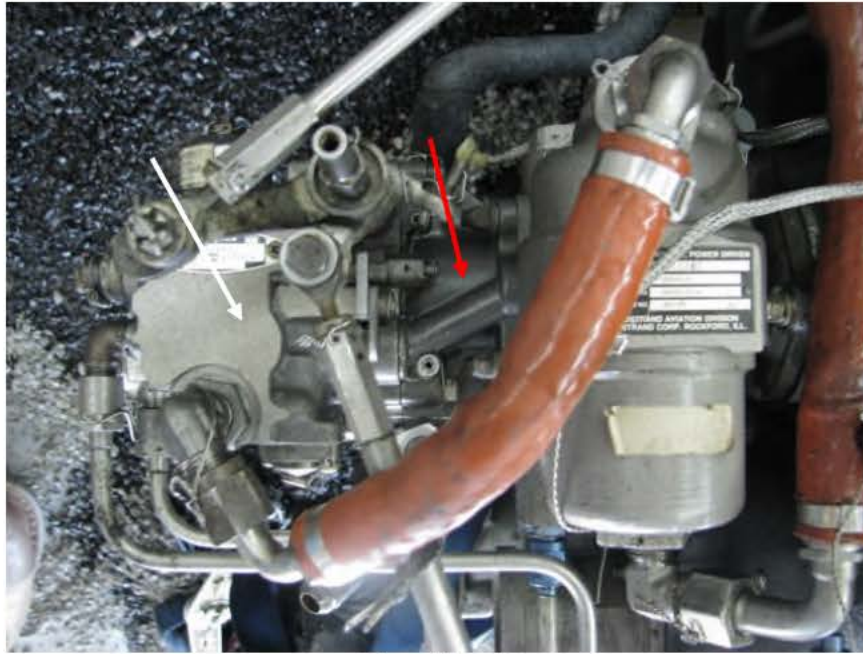
Photo No. 49  
Fuel pump

**Fuel Pump:** The fuel pump was not accessed for purpose of this investigation (red arrow, Photo No. 49).

**Fuel Control Unit:** The fuel control unit was not accessed for purpose of this investigation. The unit was in place and secure (white arrow, Photo No. 49).

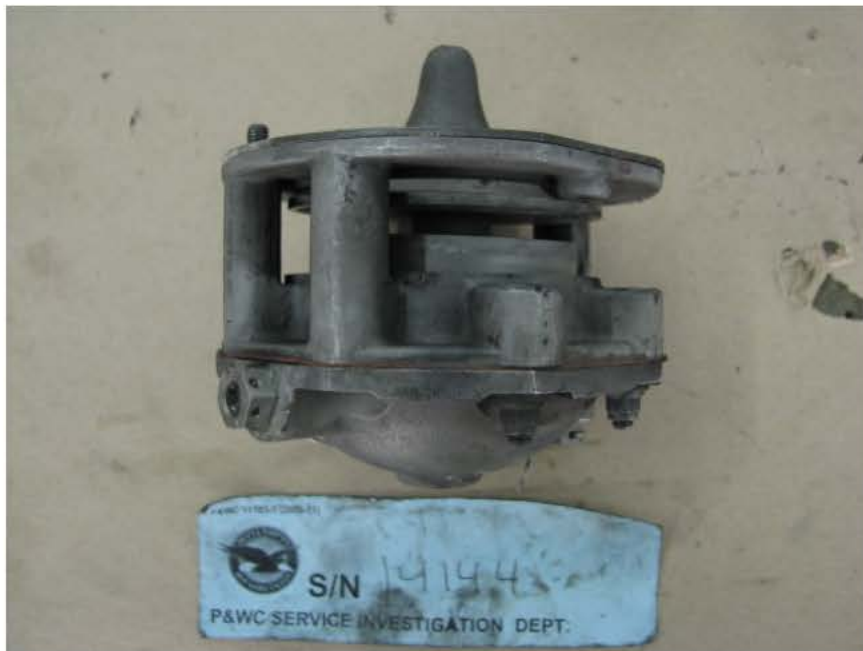
Photo No. 50  
Bleed off valve

**Compressor Bleed Valve:** The compressor bleed valve was in place and secure. The bleed valve was removed and could be easily moved by hand (Photo No. 50).

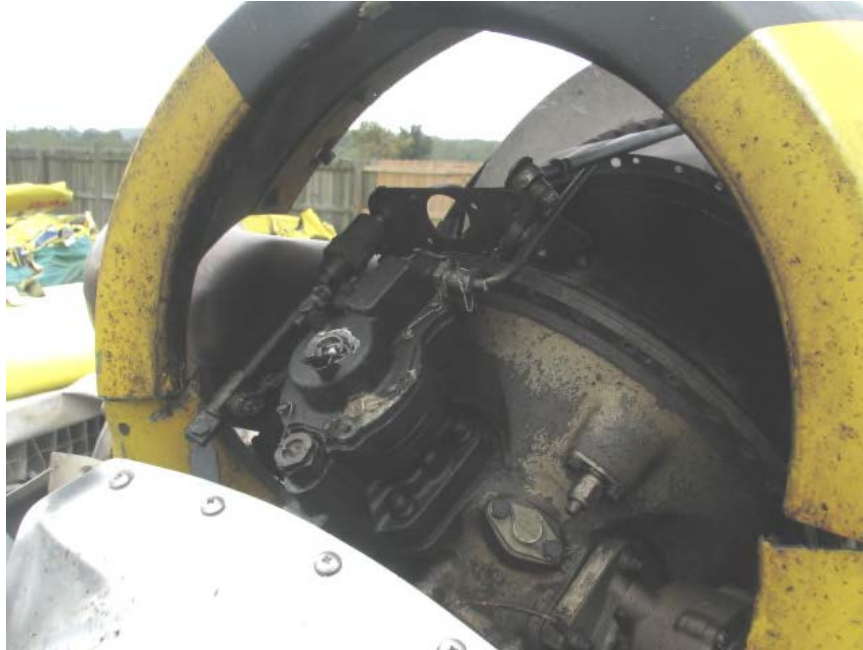
Photo No. 51  
Propeller governor

**Propeller Governor:** The propeller governor was damaged during impact (Photo No. 51)

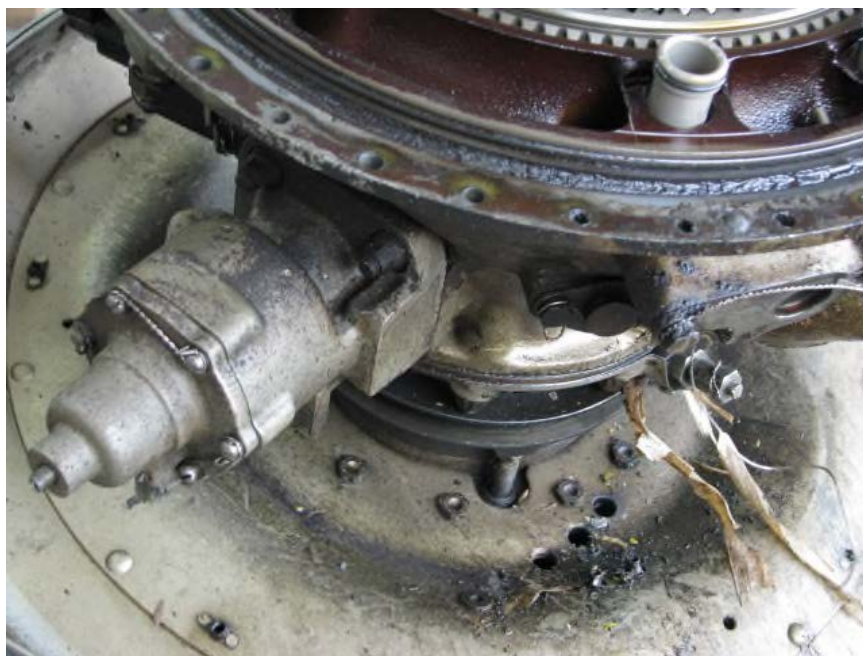
Photo No. 52  
Overspeed governor

**Overspeed Governor:** The overspeed governor was in place and showed no damages (Photo No. 52).
