## RECORD OF CONVERSATION

**Date: August 5, 2019**  
**Person Contacted: Conference Call**  
**NTSB Accident Number: ERA17LA329**

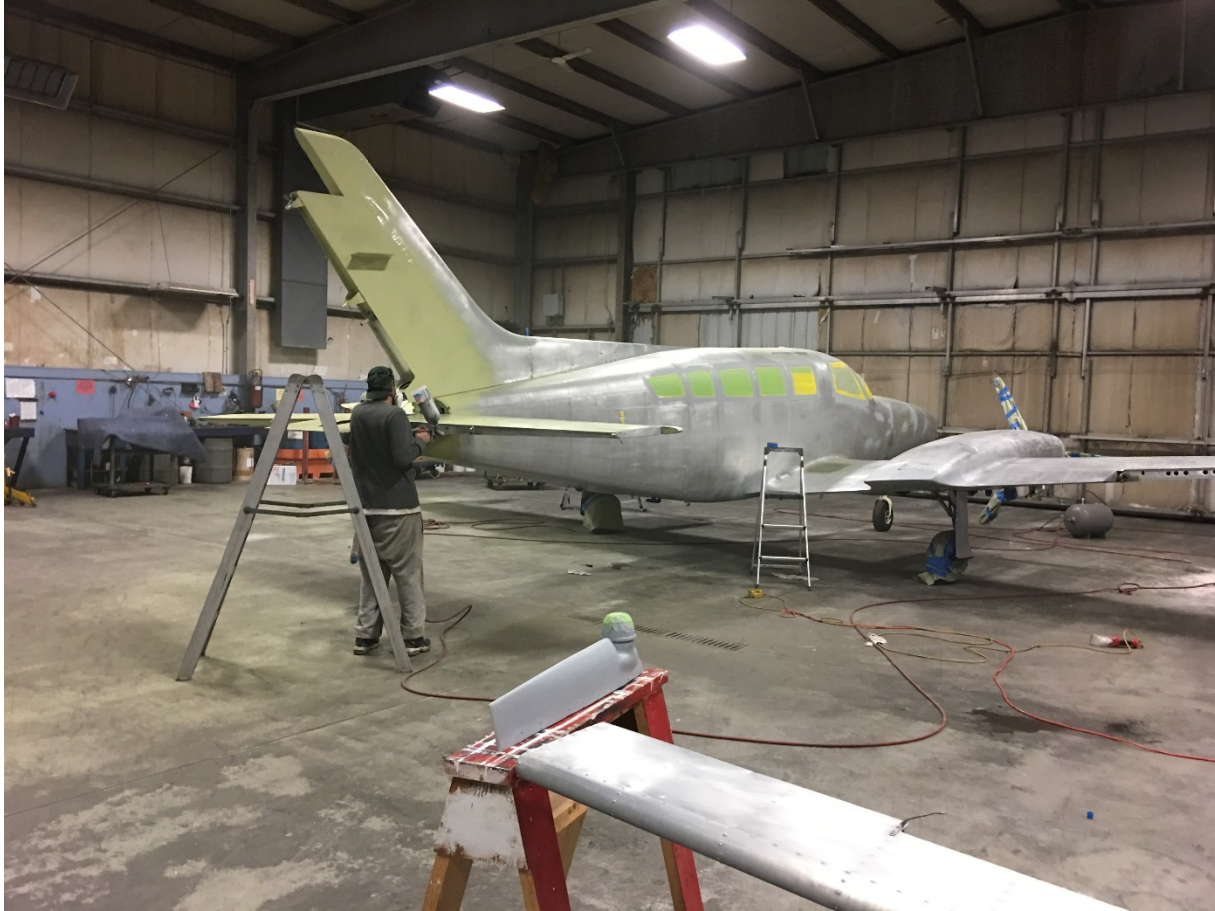
Inspector Giron reviewed his previous interview notes with Messrs. Araujo and Gurner where they indicated they did not remove the push rod from the elevator trim tab actuator during their work on the airplane. Inspector Giron showed 2 pictures of N836GW that were taken by the owner of the airplane. The pictures were identified as IMG\_0038 and IMG\_0042. Picture IMG\_0038 is the right rear quartering view of the airplane fully stripped of paint, with both elevators removed, and a person behind the right horizontal stabilizer just inboard of the center elevator hinge in the process of applying zinc chromate to the airplane. Picture IMG\_0042 is a left rear quartering view depicting the airplane with both elevators removed, both elevators in the background, and zinc chromate fully apply to the airplane. Both pictures were enlarged to enhance detail in an effort to determine whether the pushrod remained connected to the elevator trim tab actuator, as was reported by them.

Figure 1: Photograph IMG\_0038 Provided By Airplane Owner. It was taken by iPhone 6S Plus on December 20, 2016 at 2029:35.

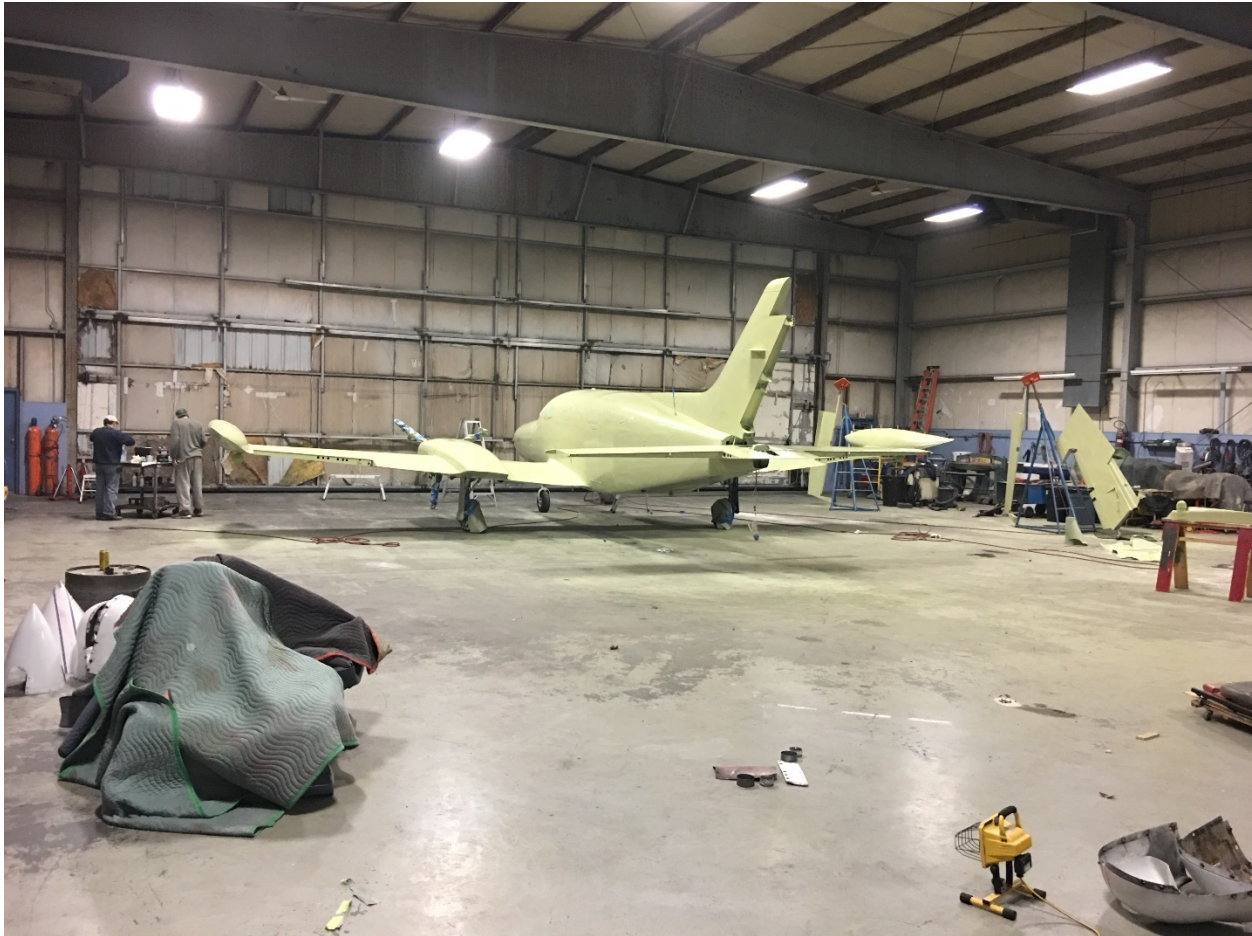
Figure 2: Photograph IMG\_0042 Provided By Airplane Owner. It was taken by iPhone 6S Plus on December 20, 2016 at 2233:38.

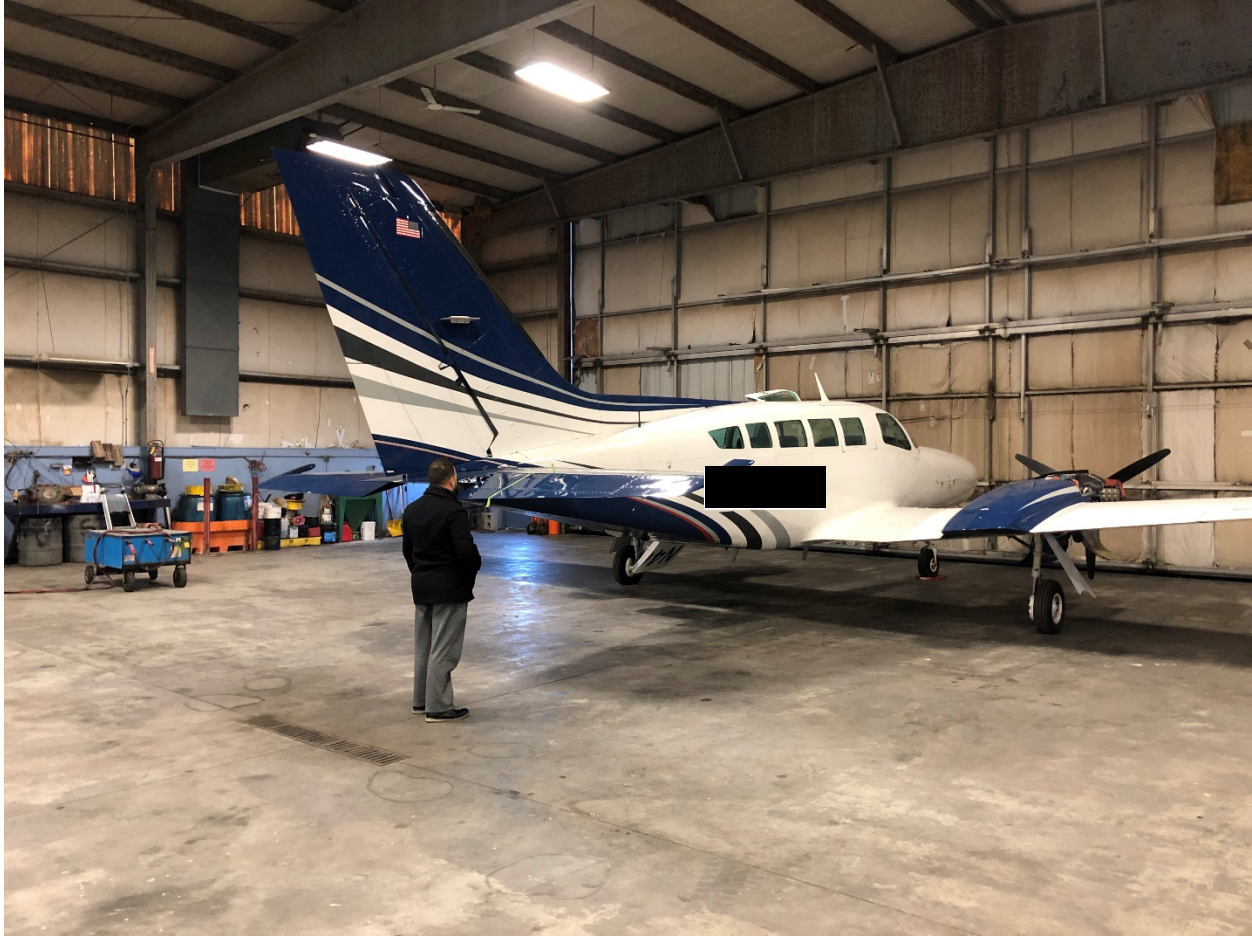
Mr. Araujo indicated that he has access to a Cessna 402C, N404JD that they can use for a comparative inspection. He also confirmed that it has the same dimension for the horizontal stabilizer. Inspector Giron was asked to take pictures which duplicated the angle and orientation of the owner provided pictures and an effort to determine if the pushrod was installed at the elevator trim tab actuator. The location of the elevator trim tab actuator was depicted with colored tape. The center hinge was located about 12 inches outboard of the elevator trim tab actuator position. It was agreed by all that in the owner provided picture IMG\_0038, the push rod was not in place, but the location of the elevator trim tab actuator was visible. Since Mr. Araujo had indicated that he did not remove the push rod at the actuator as part of the right elevator removal, it could not be determined who removed or reinstalled the push rod at the elevator trim tab actuator.

Figure 3: FAA Photograph of a Cessna 402C from same Orientation as Owner Provided Photo. Tape on Elevator depicts the location of the elevator trim tab actuator location.
