# NATIONAL TRANSPORTATION SAFETY BOARD

## MATERIALS LABORATORY FACTUAL REPORT

Report No. 18-047

Place : Nantucket, MA  
Date : September 13, 2017  
Vehicle : Cessna 402B, N836GW  
NTSB No. : ERA17LA329  
Investigator : Timothy Monville

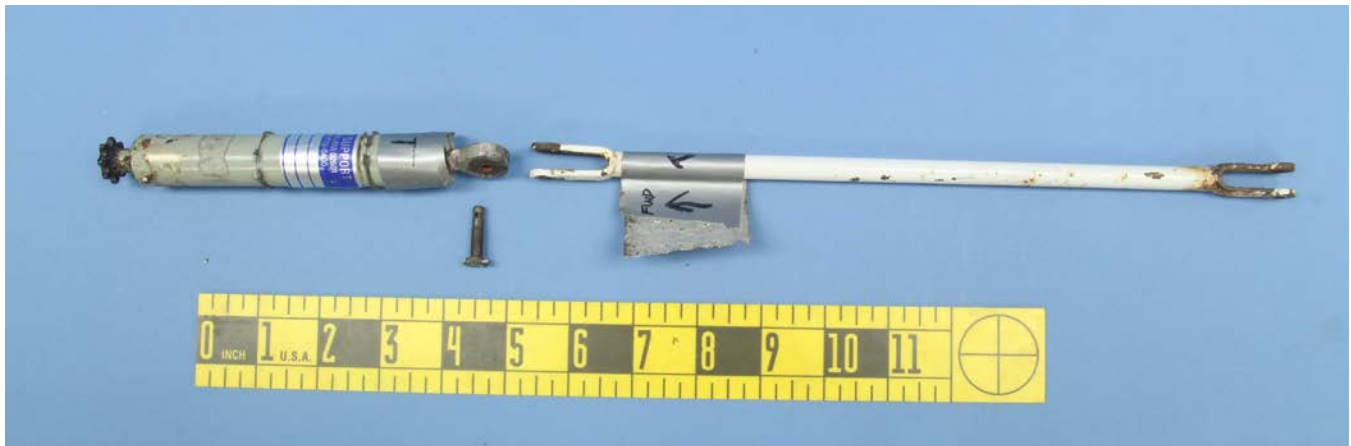
An elevator trim tab actuator, a push pull rod and a cross drilled bolt (figure 1)

Figure 1: Trim tab actuator, push-pull rod and cross drilled bolt as received.

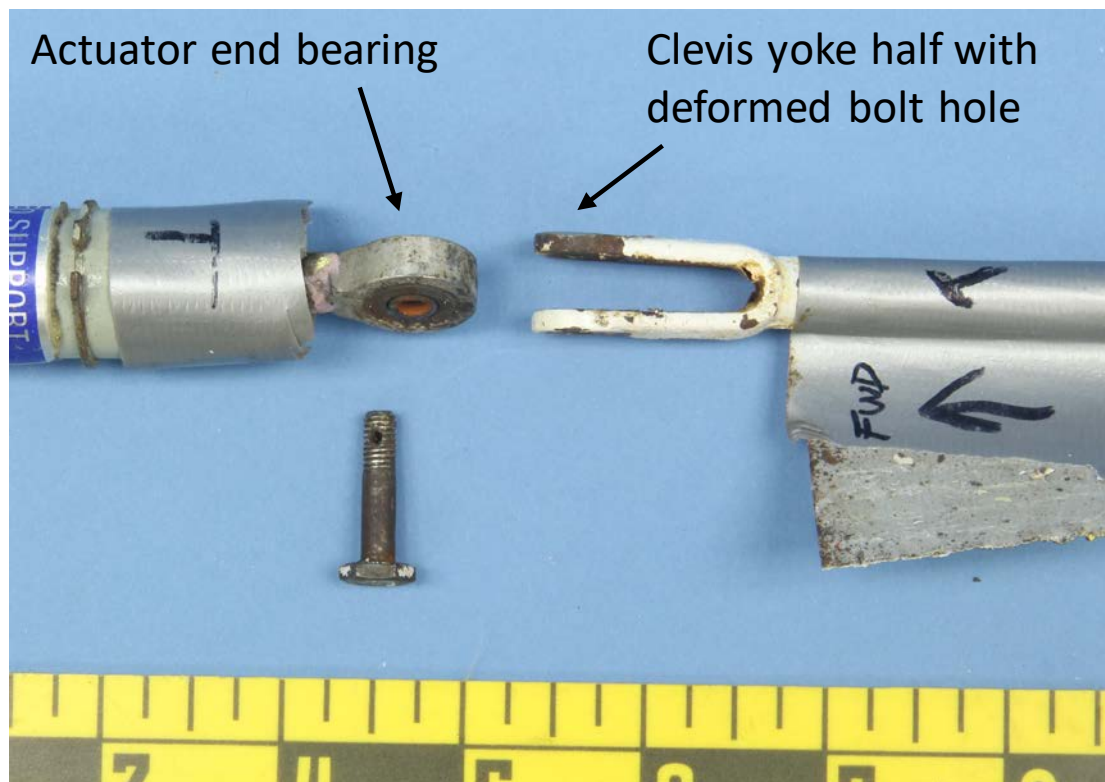
Examination of the actuator end of the push-pull rod revealed deformation of the bolt hole on one of the clevis yoke halves (figure 2) as well as an impression from rubbing between the clevis yoke and the actuator end bearing. The deformation is characterized by a rounding of the bolt hole edge and raised burr (figures 3, 4). The bolt hole bores of the clevis were smooth and did not exhibit thread impressions.

Figure 2: Clevis yoke half with deformed bolt hole.

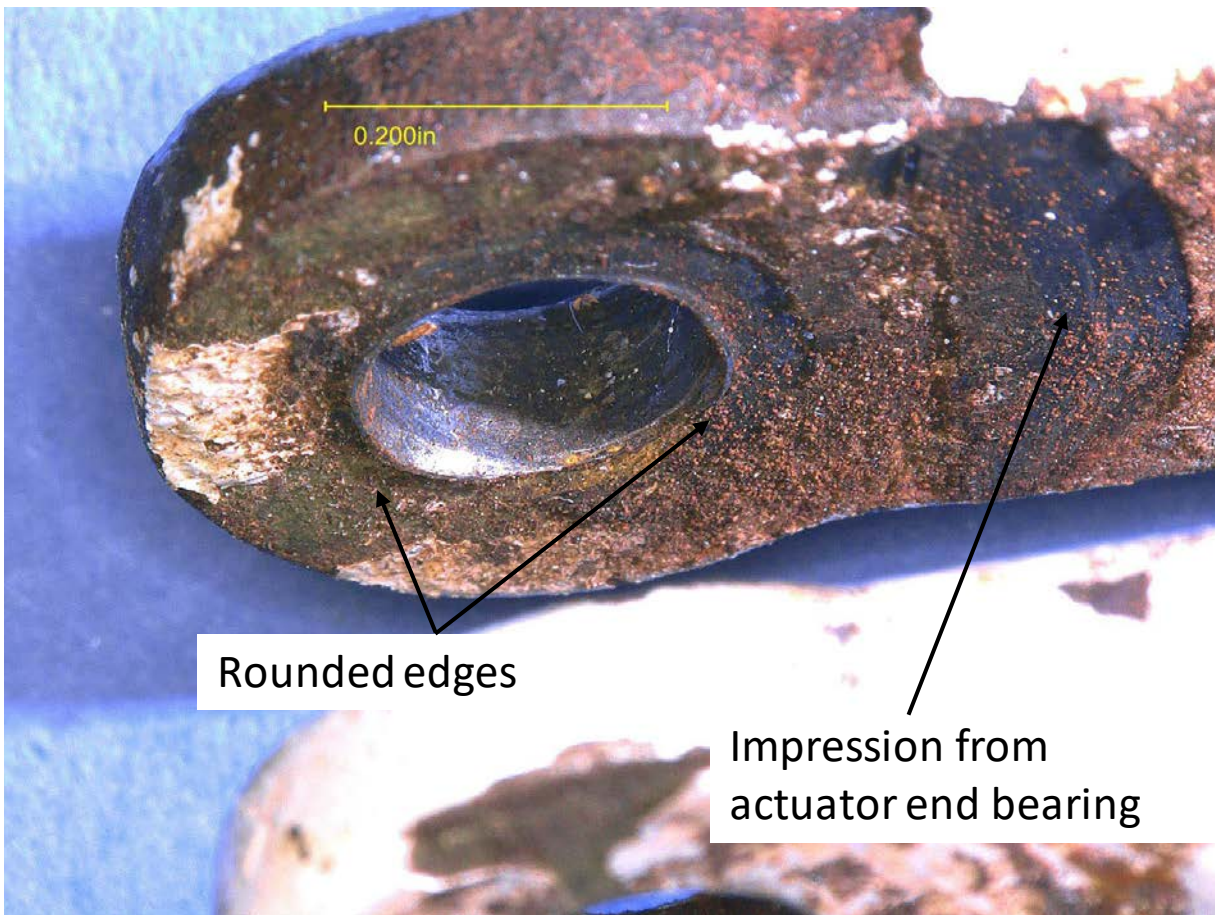
Figure 3: Deformed yoke bolt hole and impression from actuator end bearing.

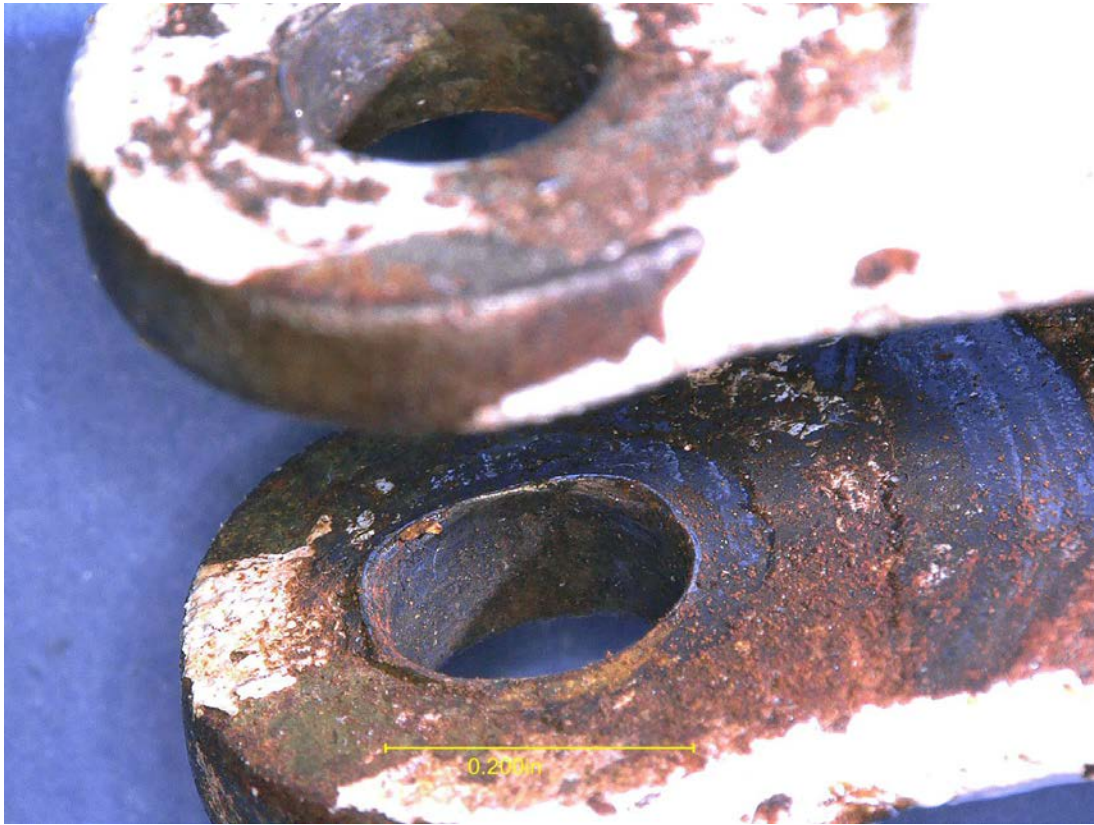
Figure 4: Deformed yoke bolt hole exhibiting a raised burr.

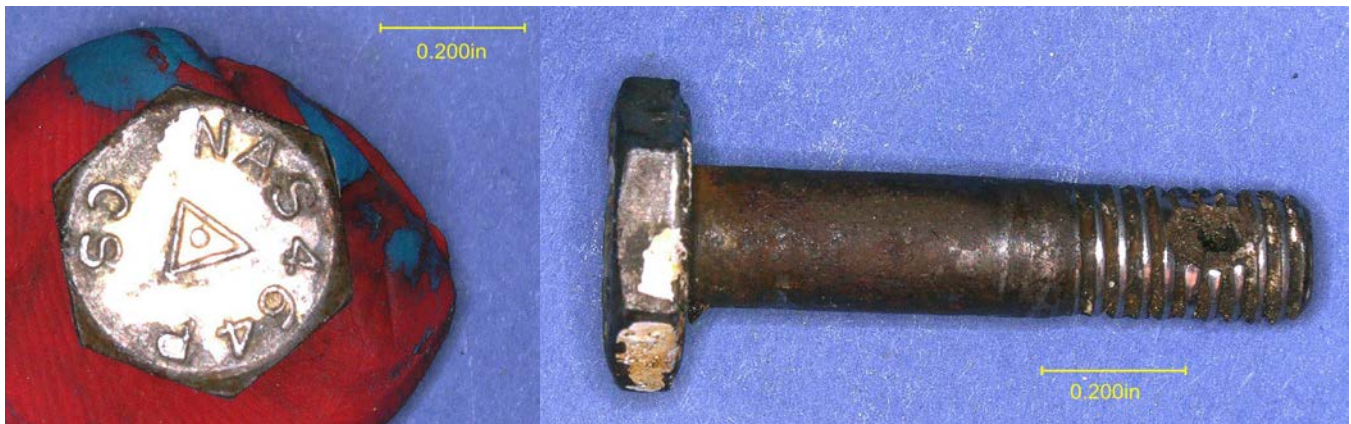
The cross drilled bolt was consistent with a NAS464P3-8 bolt (figure 5). The threads on the end of the bolt had a flattened and polished appearance (figure 6). The cross drilled hole had debris inside. The bolt had remnants of paint on the head and did not appear to have been a replacement.

Figure 5: Bolt consistent with NAS464P3-8.

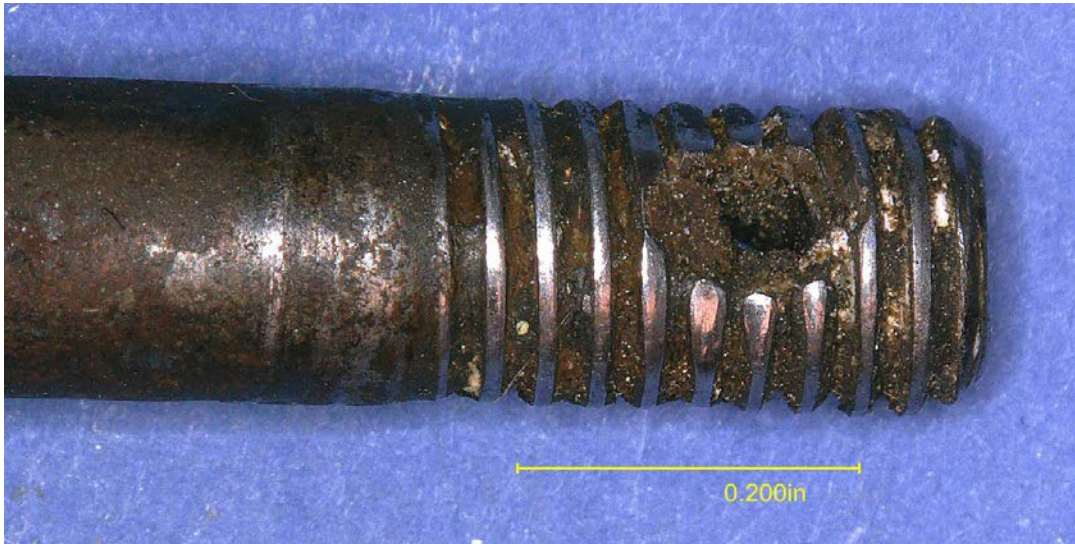
Figure 6: Flattened and polished bolt threads.
