## **N146DU Accident Investigation Findings & Analyses**

(SafranHE ref. RA 2017/238)

22 Sept. 2020

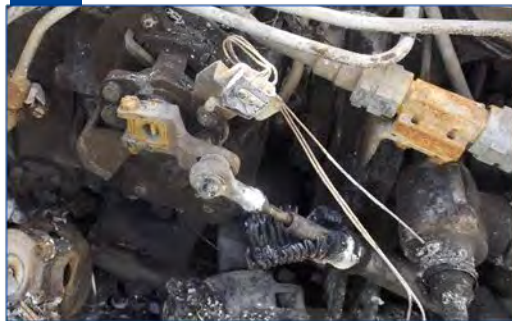
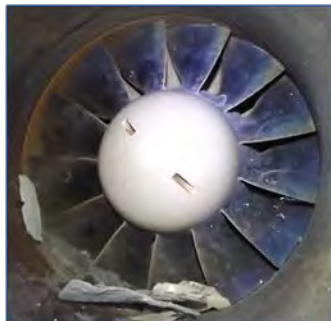
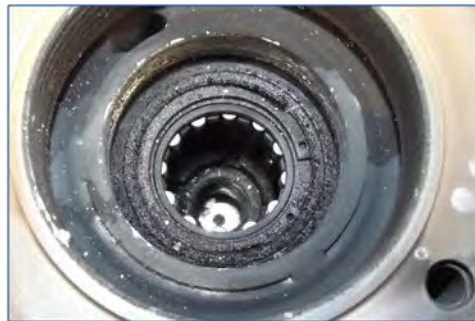
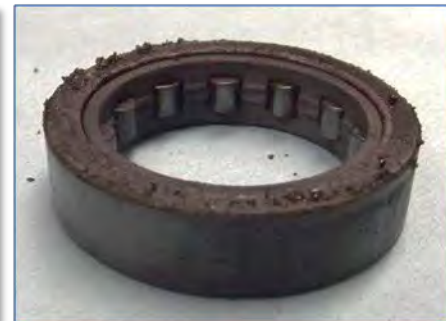
- No FOD damage to compressor
- Fuel control lever on FCU was in closed position, consistent with twist grip in stop position
- Gas Generator could be rotated manually
- Engine tear-down : nothing remarkable found
- Coke was present in the rear bearing housing. Bearing was in good condition, rotated smoothly.
- 3-way union (deck fitting, AHD supply) of vent line found clogged.
- Rear bearing's scavenge line was clear (nominal condition).

- Findings were consistent with the engine 1 being at stand-still at the time of impact
- Reason for fuel control in stop position (0°) not determined

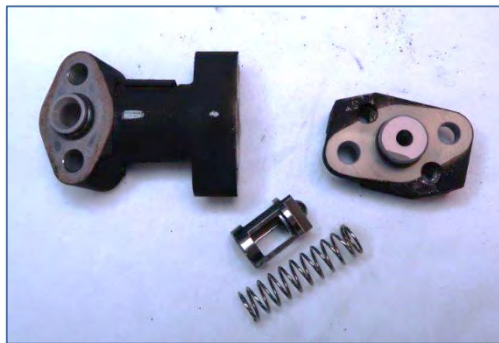
- Fuel ejector covered with soot externally and otherwise in good condition
- Internal holes clear with no foreign object
- Jet in place within ejector
- Astatic valve in good condition

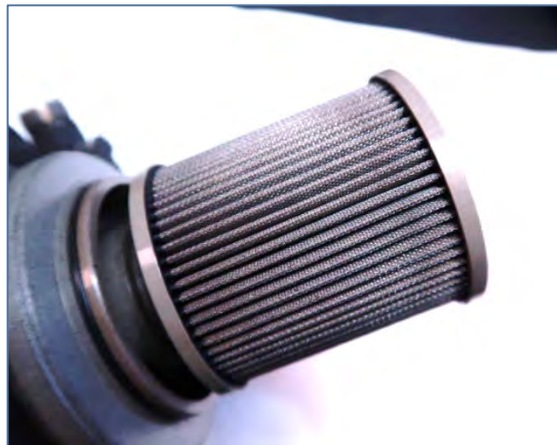
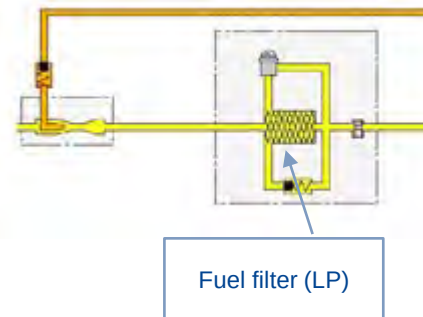
- The fuel filter (LP) was in good condition

→ No findings to report for fuel filter

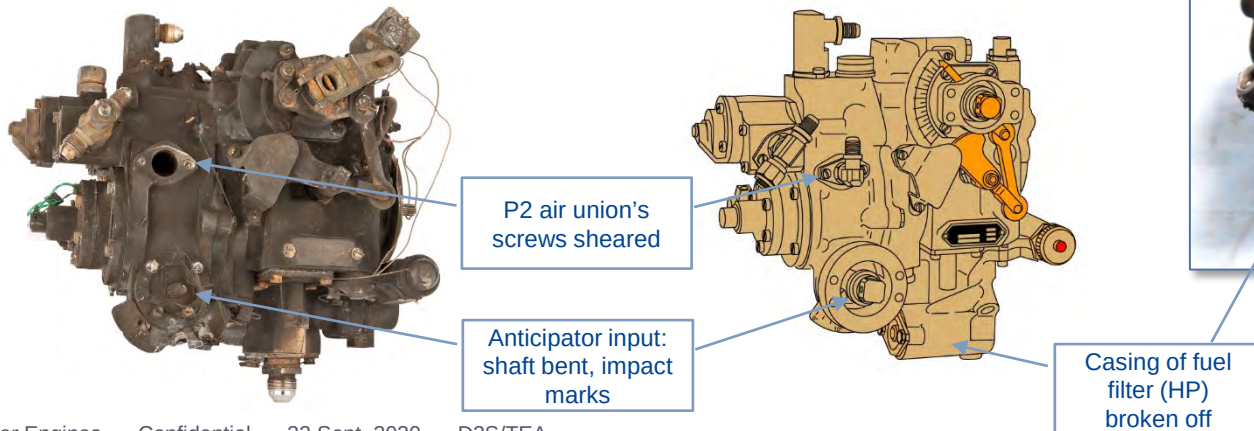
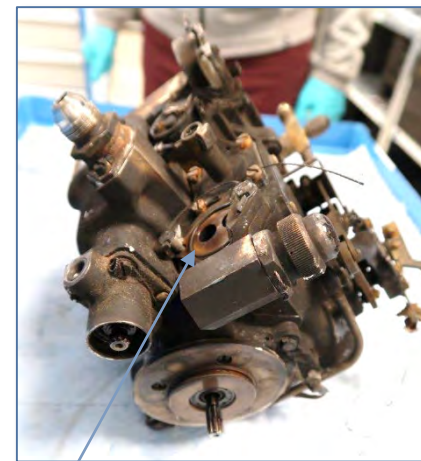
- According to maintenance records, the FCU was checked at TSN 2674 hrs (38hrs before accident).
- Fuel control unit was externally covered with soot
- Drive shafts could not rotate manually
- Several impact damages associated with the accident and/or the wreckage recovery effort : anticipator input shaft bent, impact marks on its fixing ring, P2 air union's screws sheared, fuel filter (HP) casing broken off (found attached on site).
- Due to its condition it could not be tested on a test bench

→ **Damages extremely likely due to the crash** (engine could not operate like this)

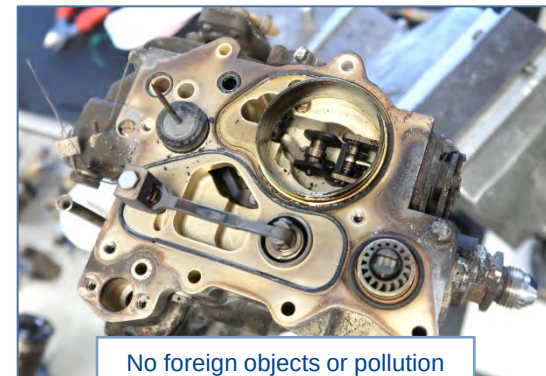
- Internal fuel system was bone dry
- No presence of foreign objects or pollution found in internal fuel system
- All elastomers were caked and crumbled on contact or during disassembly (little black debris as can be seen on photo)

→ **No findings to report for FCU's internal components**

No foreign objects or pollution  
in internal fuel system

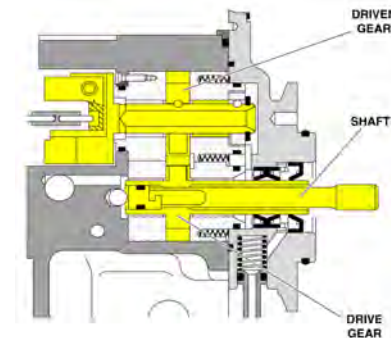
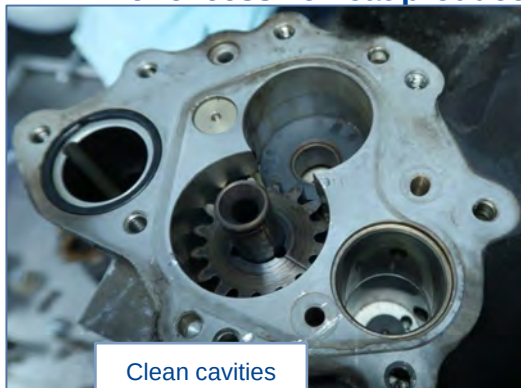
- The HP fuel pump was seized
- Gears were in good condition with no findings to report. No scratches on gears' faces nor on adjacent plates. Cavities were clean.
- The gears left an imprint of their shapes in the adjacent plates. This imprint resulted from dried layer of fuel after the engine shut-down which acted as glue thus explaining the impossibility to rotate the gears manually  
→ the seizure was due to the post-crash fire heat
- The drive shaft was in good condition  
→ **No significant findings to report for the HP fuel pump other than signs of excessive heat produced by the post-crash fire**

Clean cavities

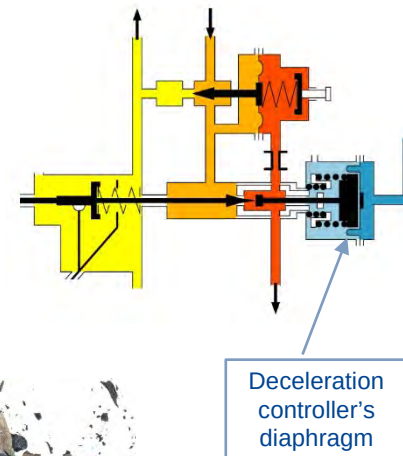
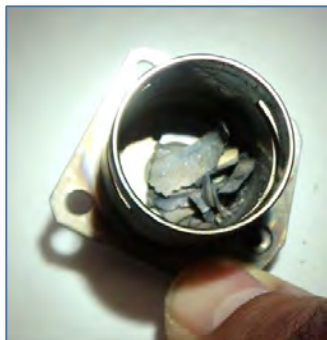
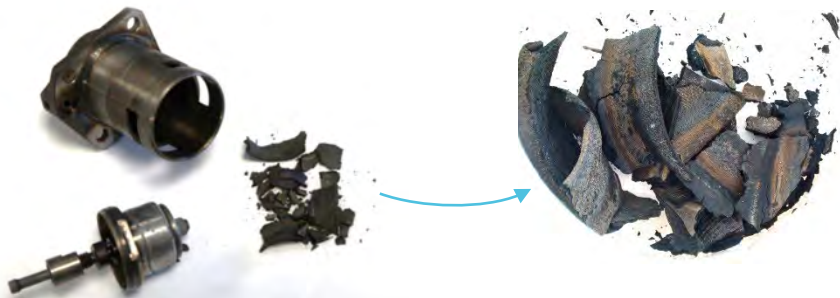
- The deceleration controller's diaphragm was found ruptured in small pieces in its casing. Was very brittle and snapped like glass (normally very soft and flexible).
- Elastomer cooked. Condition consistent with that of the other elastomers in the FCU. Material deteriorated due to post-crash fire heat producing a hard carbon product.
  - **No other known case of similar fracture feature**
  - **Rupture consistent with exposure to the heat of the post-crash fire**
- During operation, the diaphragm rupture leads to the engine slowing down to idle.

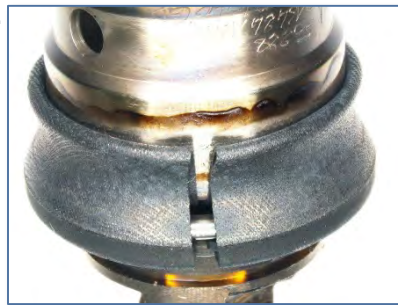
- Diaphragm slit lengthwise. Not consistent with normal working section along folding.
- Diaphragm of Engine 1 was very brittle and snapped like glass. No movement possible without breaking it. Its material is normally very soft.

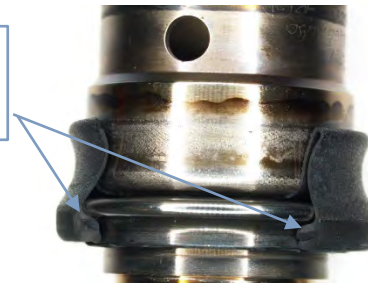
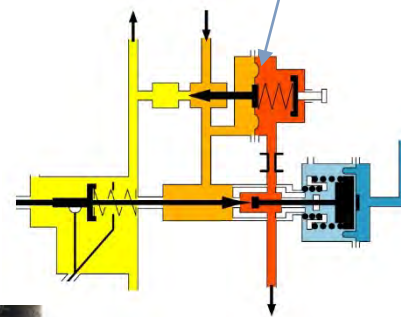
- Feature of fractured surface highly similar to that found when a portion of the diaphragm was snapped off for examination.

- No other known case of similar fracture feature
- Fracture surface consistent with sudden rupture during post-solidification cooling

Section removed  
in lab.  
→ Highly similar  
fracture surfaces

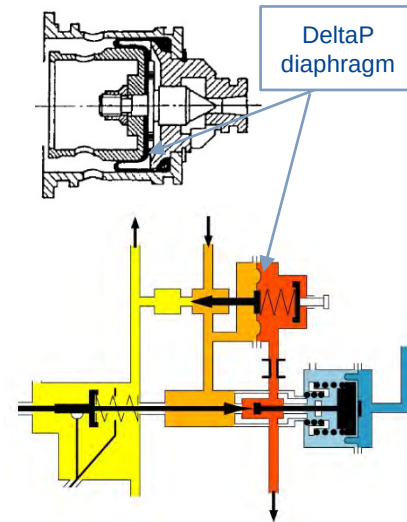
- Only one case of deltaP diaphragm rupture in service on Arriel 1 in June 2003 (2000-2017 period, 23 million flight hours). It had been installed the wrong way around. TU337 modification validated in Nov. 2003 introduced a fool-proofing on the bottom surface. FCU of Engine 1 was fitted with TU337.
- Does not correspond to other known cases of deltaP diaphragm ruptures (Arriel 1, Arrius 1 or Arriel 2 engines).
- Elastomer cooked and brittle. Consistent with other elastomers on FCU. Material deteriorated due to the post-crash fire's heat and resulted in a hard carbon product.
- No operation recorded in the FCU log card. This FCU was installed on engine 1 since new and was operated for 2711 hours without incident.
- Control of the engine's operation (including engine start) would only be possible in manual mode.

- **Diaphragm's elastomer deteriorated into a hard carbon product due to the heat of the post-crash fire**
- **Diaphragm's rupture was due to hardening and shrinkage during the post-solidification cooling**

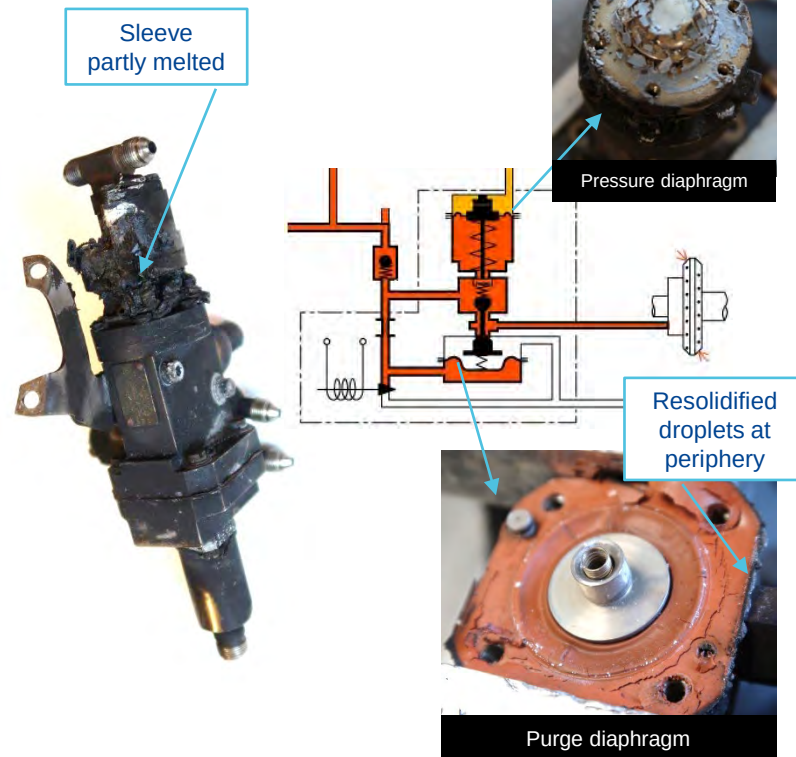
- The assembly was covered with soot
- The upper part was partly covered with the remnants of the partly melted sleeve indicative of the implementation of covered drain valve assembly SB A292 73 0853. The diaphragm was shattered in small rigid fragments consistent with exposure to the post-crash fire heat.
- Maintenance records showed that SB was implemented since June 2017 (157hrs before accident). Daily checks records indicate no leak at the top diaphragm (pressure) level.
- The bottom diaphragm (purge) showed signs of delamination and local radial tears consistent with expansion and contraction during and after exposure to abnormal heat. Droplets of resolidified elastomer visible at the periphery. No signs of circular tears in the circular folds and no signs of holes in the diaphragm.

→ **The condition of the assembly and of both diaphragms was consistent with exposure to the heat of the post-crash fire.**

→ **No signs of tears or holes in the purge diaphragm**

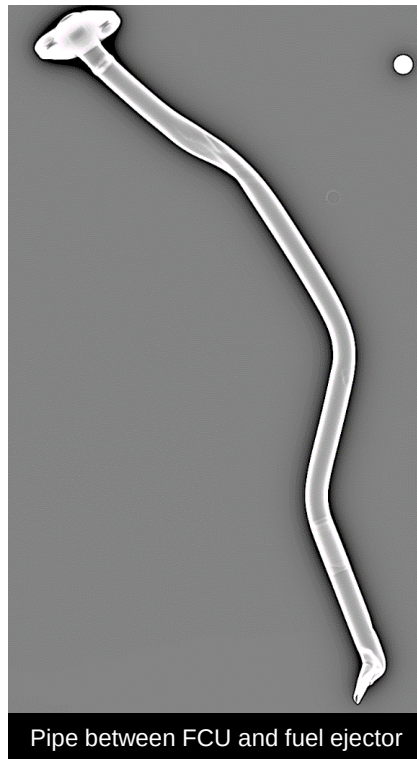
Pipe between FCU and fuel ejector

- **Fuel supply pipes** : X-Ray examination  
→ **No deposits nor particles inside**
- Note : the pipe was ruptured and deformed either during the crash or the wreckage recovery.

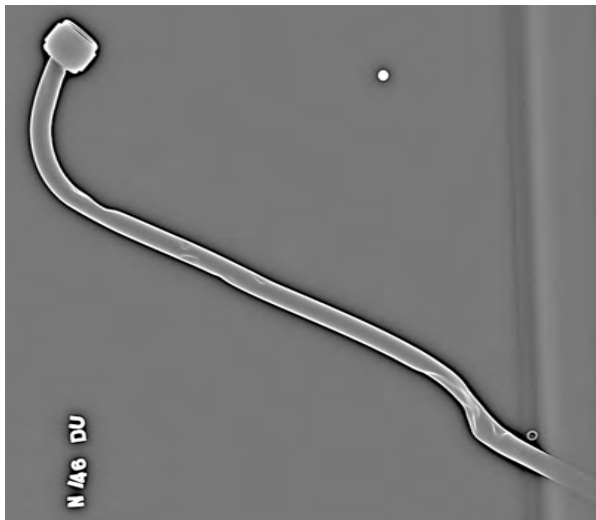
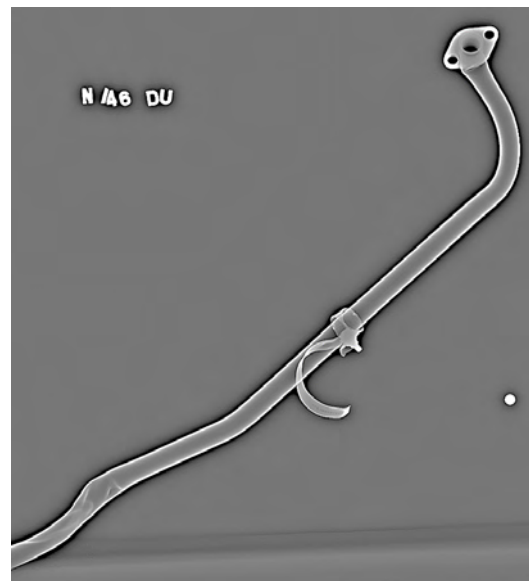
Pipe between fuel filter (LP) and FCU

- **Fuel supply pipes** : X-Ray examination  
→ **No deposits nor particles inside**
- Note : the pipes were ruptured and deformed either during the crash or the wreckage recovery

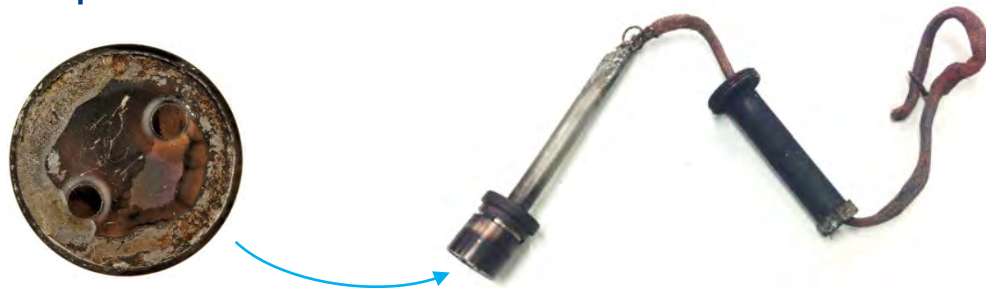
- No contact between the sensor and the phonic wheel
- Head of sensor intact
- O-ring caked due to hot temperature consistent with post-crash fire
- Sheath of harness missing consistent with post-crash fire
- Back of tube damaged during disassembly from Module 4
- Due to its condition, the sensor could not be tested

→ **Damages to overspeed sensor associated with post-crash fire or removal from engine**

→ **No other findings to report**

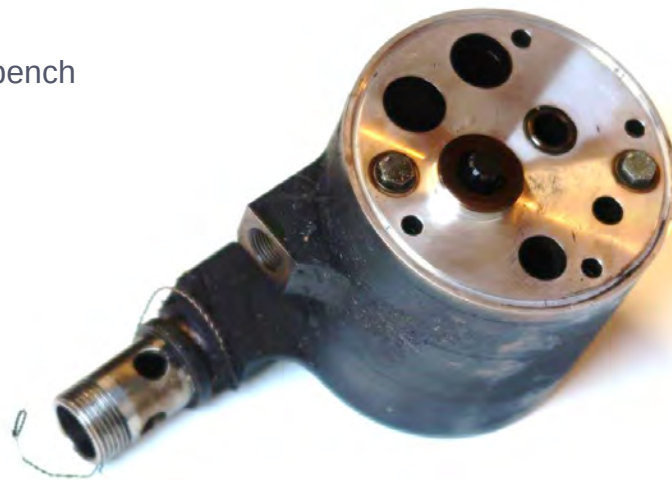
- The pump was found seized
- The drive shaft was in place and in good condition
- Due to its condition it could not be tested on a test bench

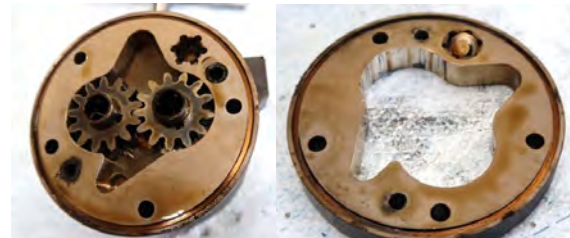
- The pump was oily as normal
- All elastomers (O-rings and lip seals) were stiffer than normal and broke easily indicative of exposure to abnormal heat.
- The gears left an imprint of their shapes in the adjacent plates. This imprint resulted from a dried layer of oil after the engine shut-down which acted as glue thus explaining the impossibility to rotate the gears manually → the seizure is due to the post-crash fire heat
- The overpressure valve was in place. Its spring was tested and found conform to the specification.
- Oil supply stage : gears in good condition, no scratches.
- All scavenge stages (accessories gearbox, reduction gearbox and rear bearing) : no significant scoring at periphery and on adjacent plates.

→ **Oil pump in good condition. Was exposed to heat from post-crash fire. No other findings to report**

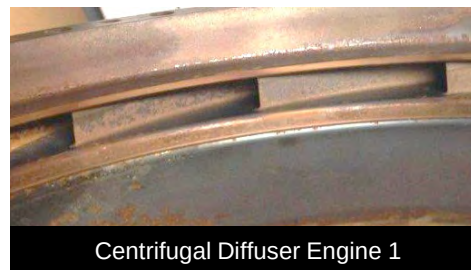
Centrifugal Diffuser Engine 1

- Vanes in good condition. No erosion, no FOD impacts.

→ **Small impacts due to homogenous grit-like ingestion**

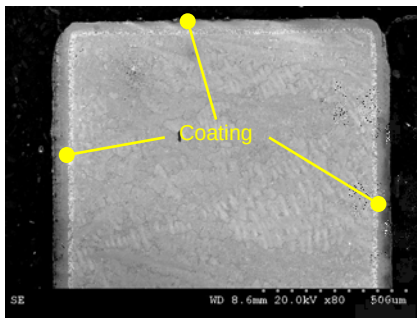
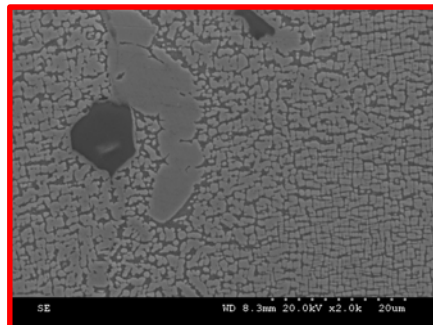
- Coating present all round and in good condition
- Slight evolution of the metallographic structure from blade foot to tip in line with experience

→ **HPT1 blades' condition in line with experience**

→ **No signs of overtemperature**

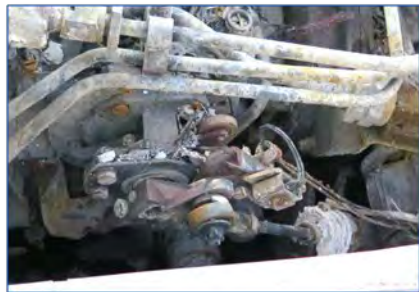
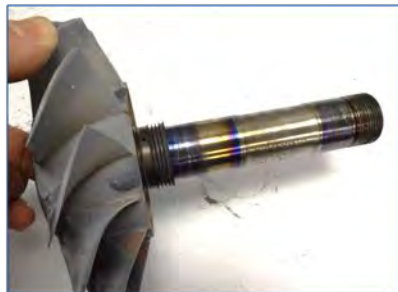
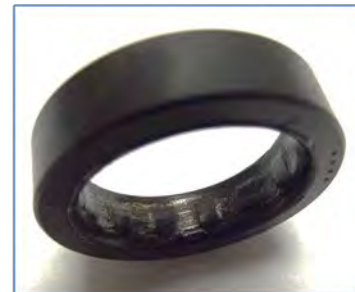
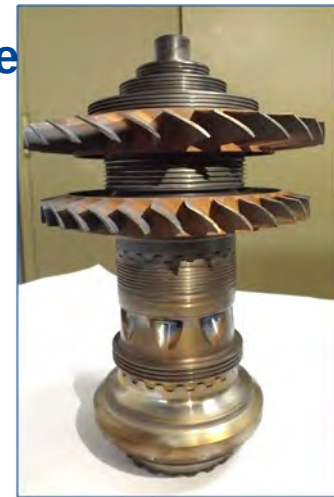
- No FOD damage to compressor
- Fuel control lever on FCU was in full-open position
- Rear bearing damage due to seizure. No evidence of coking.
- Metallic (magnetic) debris found on rear bearing's magnetic plug
- 3-way union (deck fitting, AHD supply) of vent line found clear, unobstructed
- Blue stains on axial compressor's shaft at bearings' and bevel gear locations
- Contact marks on Gas Generator's components consistent with bearing's seizure
- Imprints by NPT's blades on NGV consistent with no PT rotation at time of crash

- Findings were consistent with the engine 2 being at stand-still at the time of impact
- Origin of rear bearing seizure not determined

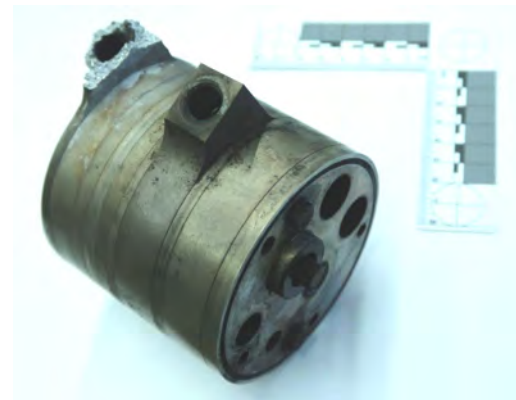
- The oil supply inlet boss on the back plate was broken.  
No dirty (no soot) static fracture surface  
→ probably happened during recovery effort
- The pump was found seized
- The drive shaft was in place and in good condition
- Due to its condition it could not be tested on a test bench

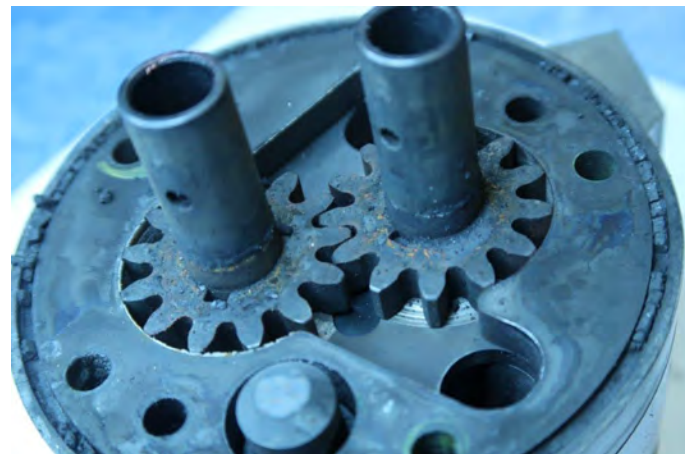
Rear bearing scavenge stage

→ Condition of rear bearing scavenge stage consistent with rear bearing deterioration

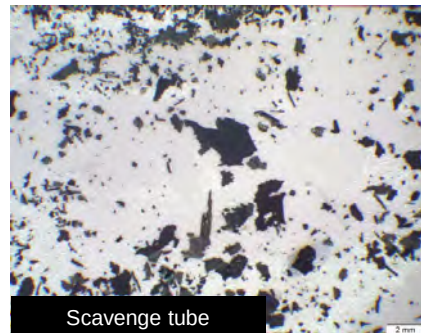
Fe-F-Cr-Mn-Al-Ni-Mo-Ti-Si /  
Fe-Cr-Zn-F-Cu-Ni-Al-S-Mn /  
Fe-Cr-F-Zn-Ag-Si-Ti-Al-Mn-S

- The metallic debris could not be identified. They could be the result of the final deterioration in the rear bearing chamber with different components involved.
- **All metallic components indigenous to the rear bearing assembly and oil**
- **Numerous debris show that oil flowed through the rear bearing chamber and the scavenge system (duct, pipe, mag plug assembly, strainer and pump)**
- The pieces found in the Module 5 could originate from an O-ring and many particles found in the oil pump originate from the elastomer lip seals separating the pressure stage from the scavenge stages.

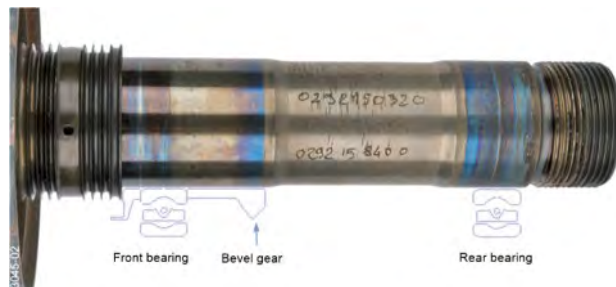
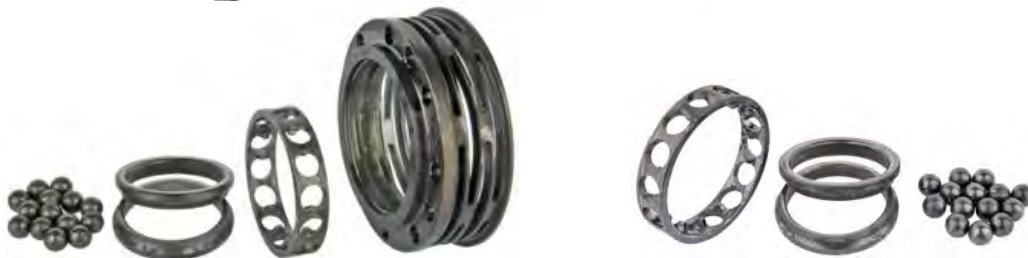
- Blue marks on shaft below bearings and bevel gear
- Bearings' components bear dark coloration
- Bearings in good condition
- No rotation of the rings on the shaft

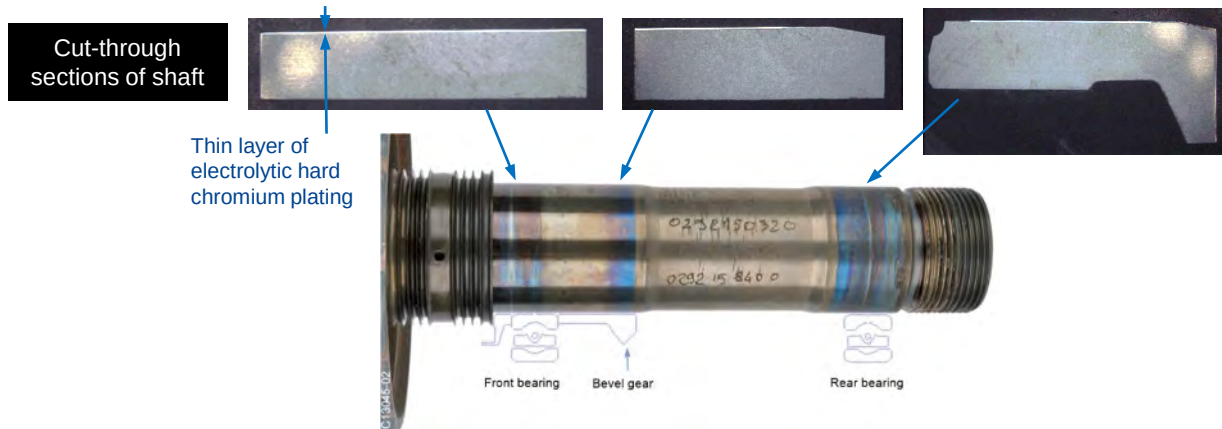
→ **Blue stains = coloration of chromium plating under heat**

Electrolytic hard chromium plating

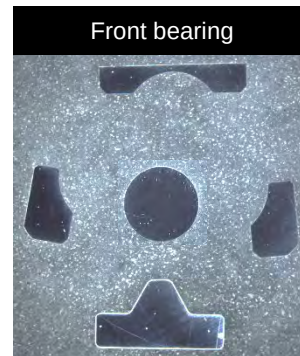
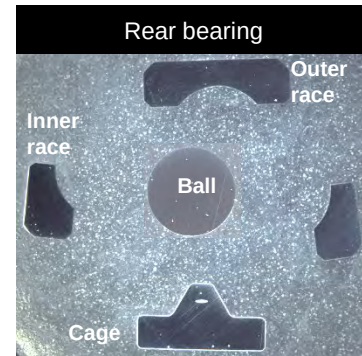
→ **The bearings' condition indicate operation with high temperature**

→ **High temperature not associated with unsatisfactory lubrication**

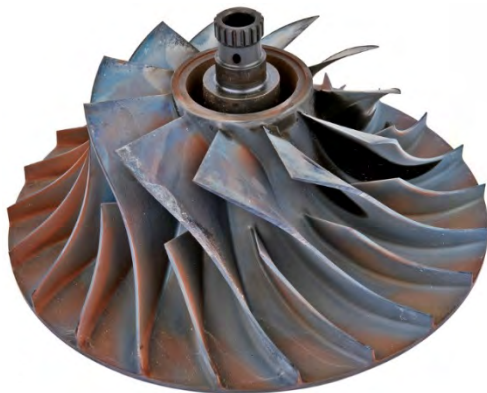
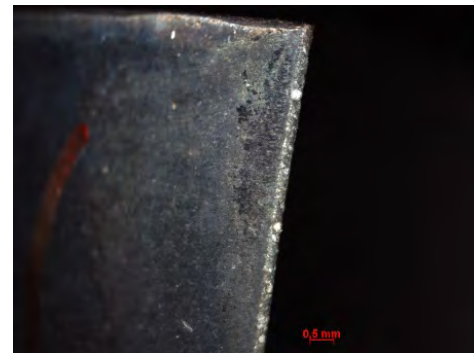
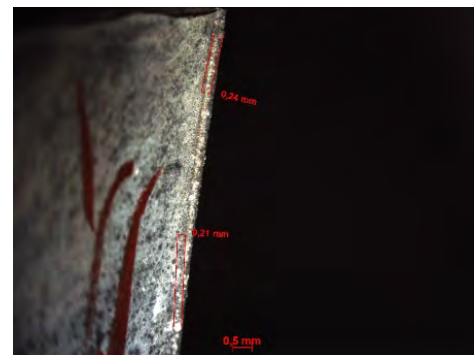
- Rubs at blade tips due to contacts with cover consistent with rear bearing deterioration
  - All leading edges rough with numerous small impacts
  - All blades affected the same way
  - Consistent with the axial wheel's condition
  - No significant erosion
- **Impacts due to homogenous grit-like ingestion**

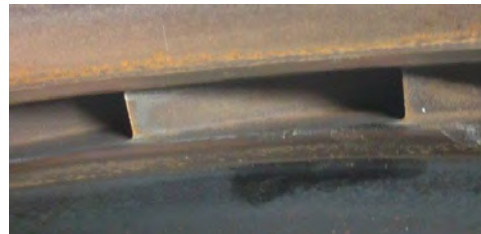
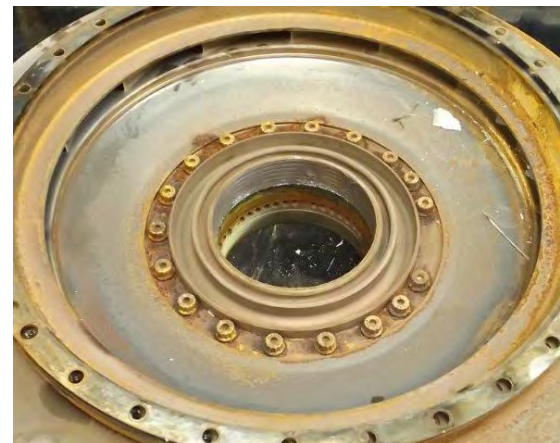
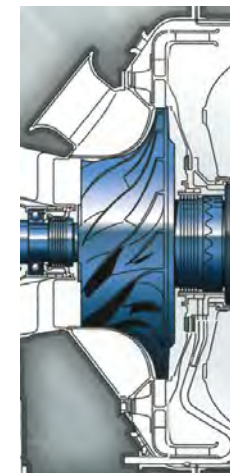
- Leading edges in good condition
- No erosion
- No FOD impact marks

→ **No findings to report for the centrifugal diffuser**

→ **Grit ingestion exceptional and not sustained**

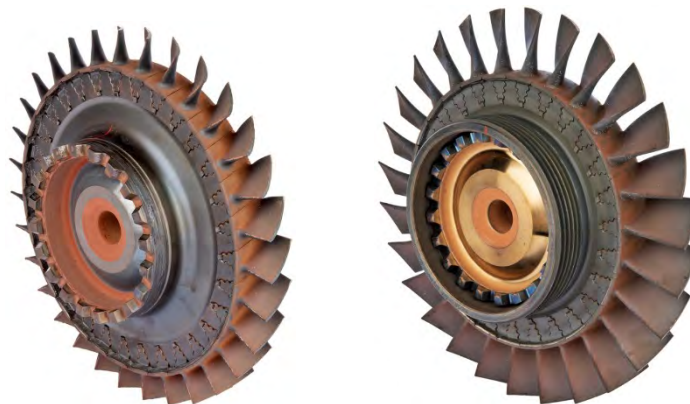
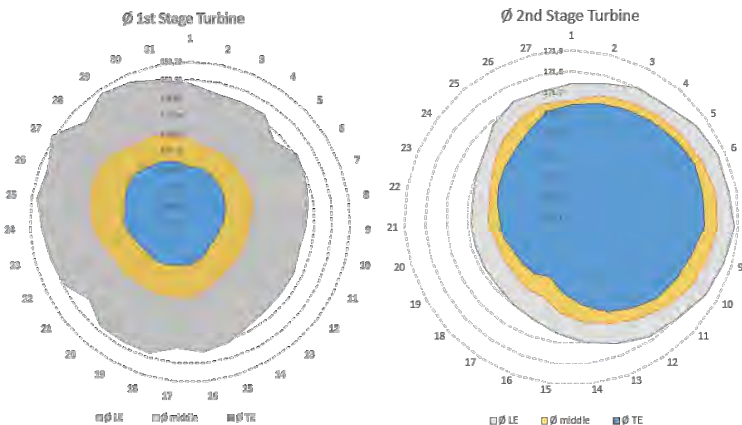
→ Even wear at HPT1&2 blades' tips due to light contact with shrouds

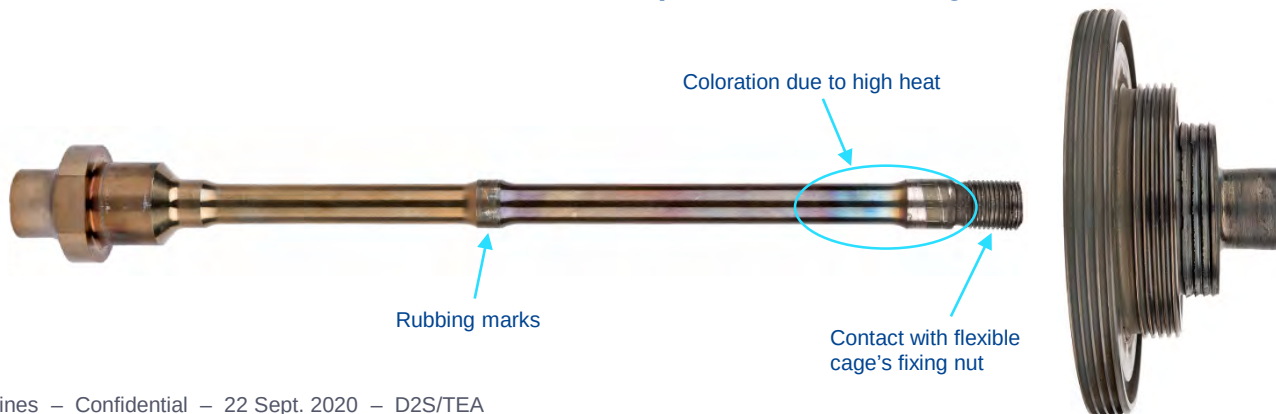
→ **Signs of deterioration and wear are indicative of operation without high unbalance and with seized bearing**

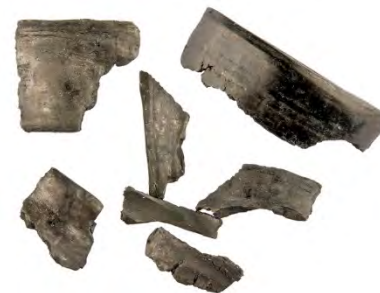
→ **Final condition of the inner race indicative of sustained rubbing with seized rollers**

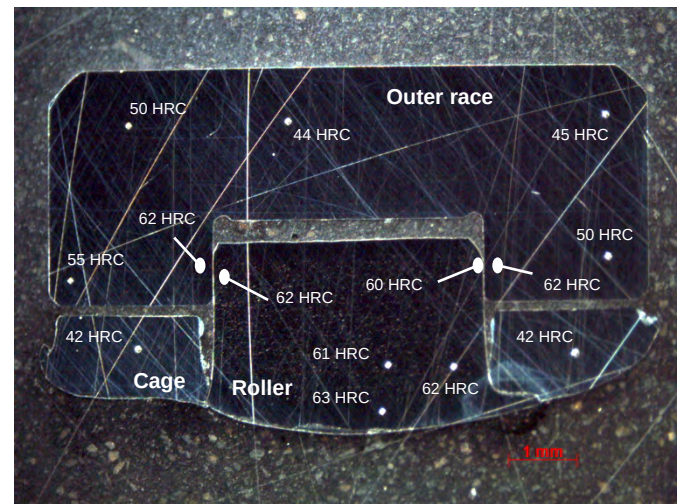
→ The hardness levels found are consistent with the friction with the inner race

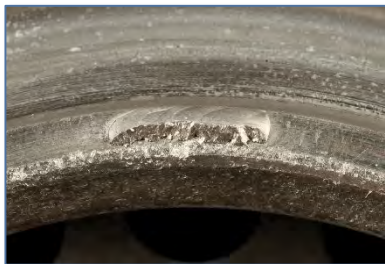
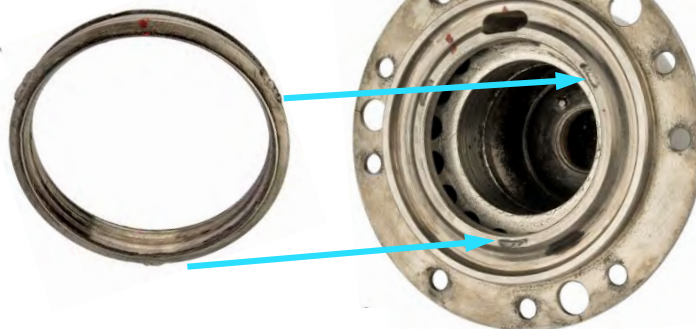
- **Small labyrinth and ring** (note : photos taken after cleaning of components)
  - Even circular grooves inside the ring due to radial penetration of the labyrinth's lips
  - No rupture of and no cracks in the ring
  - No colour change of the ring indicative of no sustained operation with light contact of lips' tips with ring
  - Three welding points ruptured straight through  
→ Sudden static rupture

- At engine shut-down, the Gas Generator runs through resonance modes when slowing down
- The deteriorated rear bearing allowed for abnormal radial play thus allowing contact between labyrinth and ring

→ **It is very likely that the labyrinth's ring separated due to sudden contact with the piston shaft's small labyrinth when the Gas Generator experienced resonance modes when slowing down after engine shut-down**

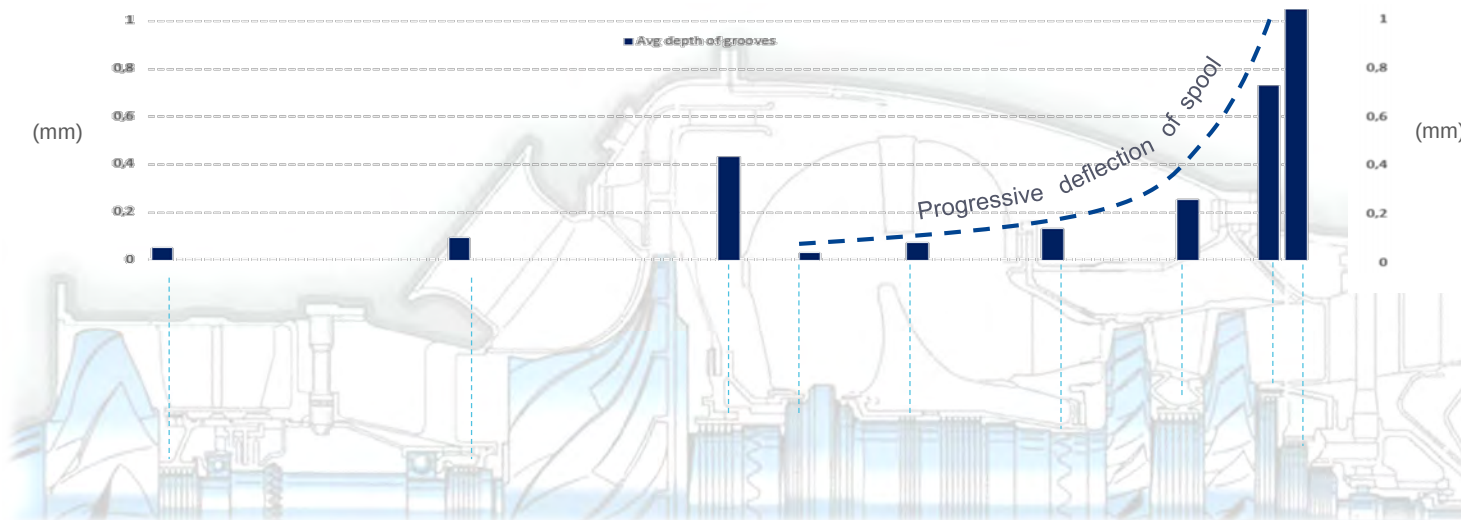
- Circular wear of the labyrinths along the Gas Generator spool → **no significant unbalance has occurred**
- Labyrinths' seals cut grooves in their respective rings with progressive increase of grooves' depth when progressing towards the back → **Progressive deflection of the Gas Generator spool consistent with rear bearing deterioration**

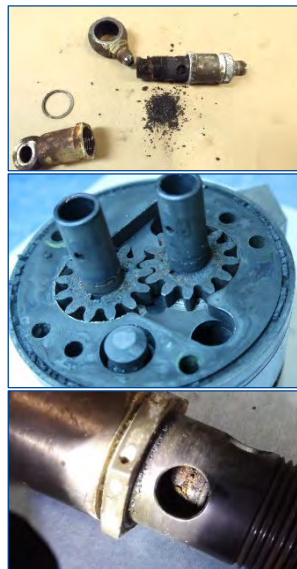
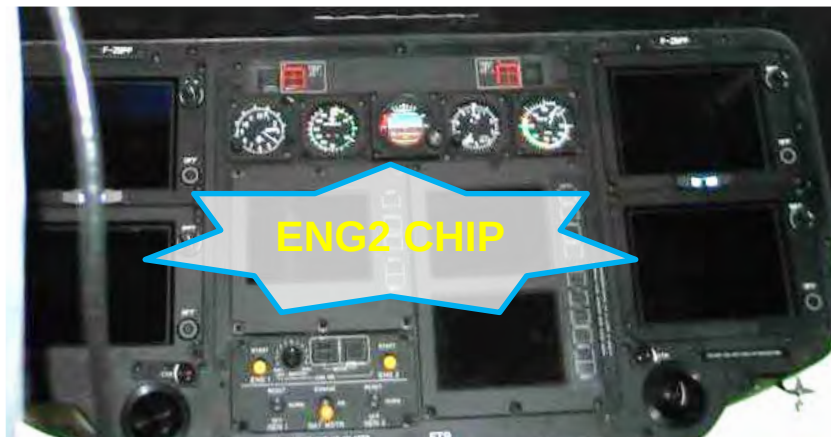
- Numerous metallic particles found on the electric magnetic plug for the Gas Generator rear bearing and scavenge stage of the oil pump
- Normally, the activation of the electric magnetic plug leads to an “ENG CHIP” caution in the cockpit

→ **Metallic particles on electric magnetic plug should have led to “ENG CHIP” caution in cockpit**

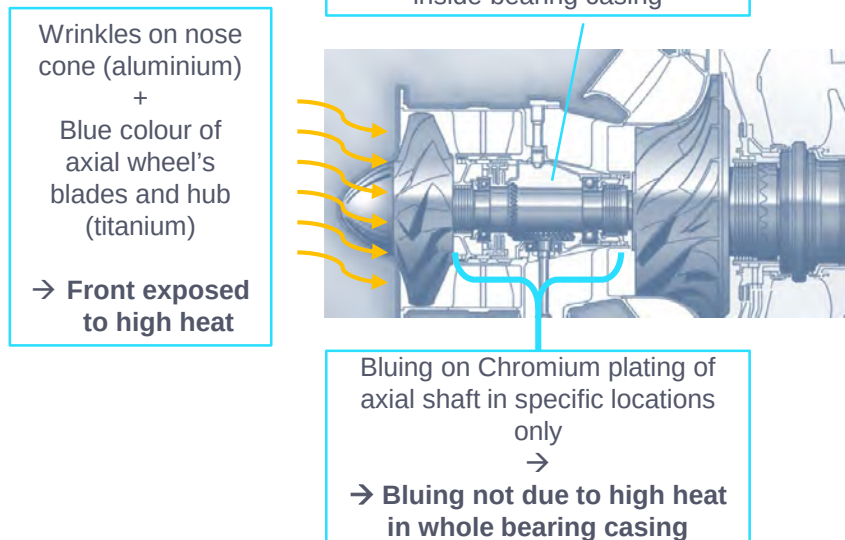
- Engine 2 : axial compressor

→ No indications of fire originating from inside the compressor bearing casing

→ Heat damage at front due to the post-crash fire
