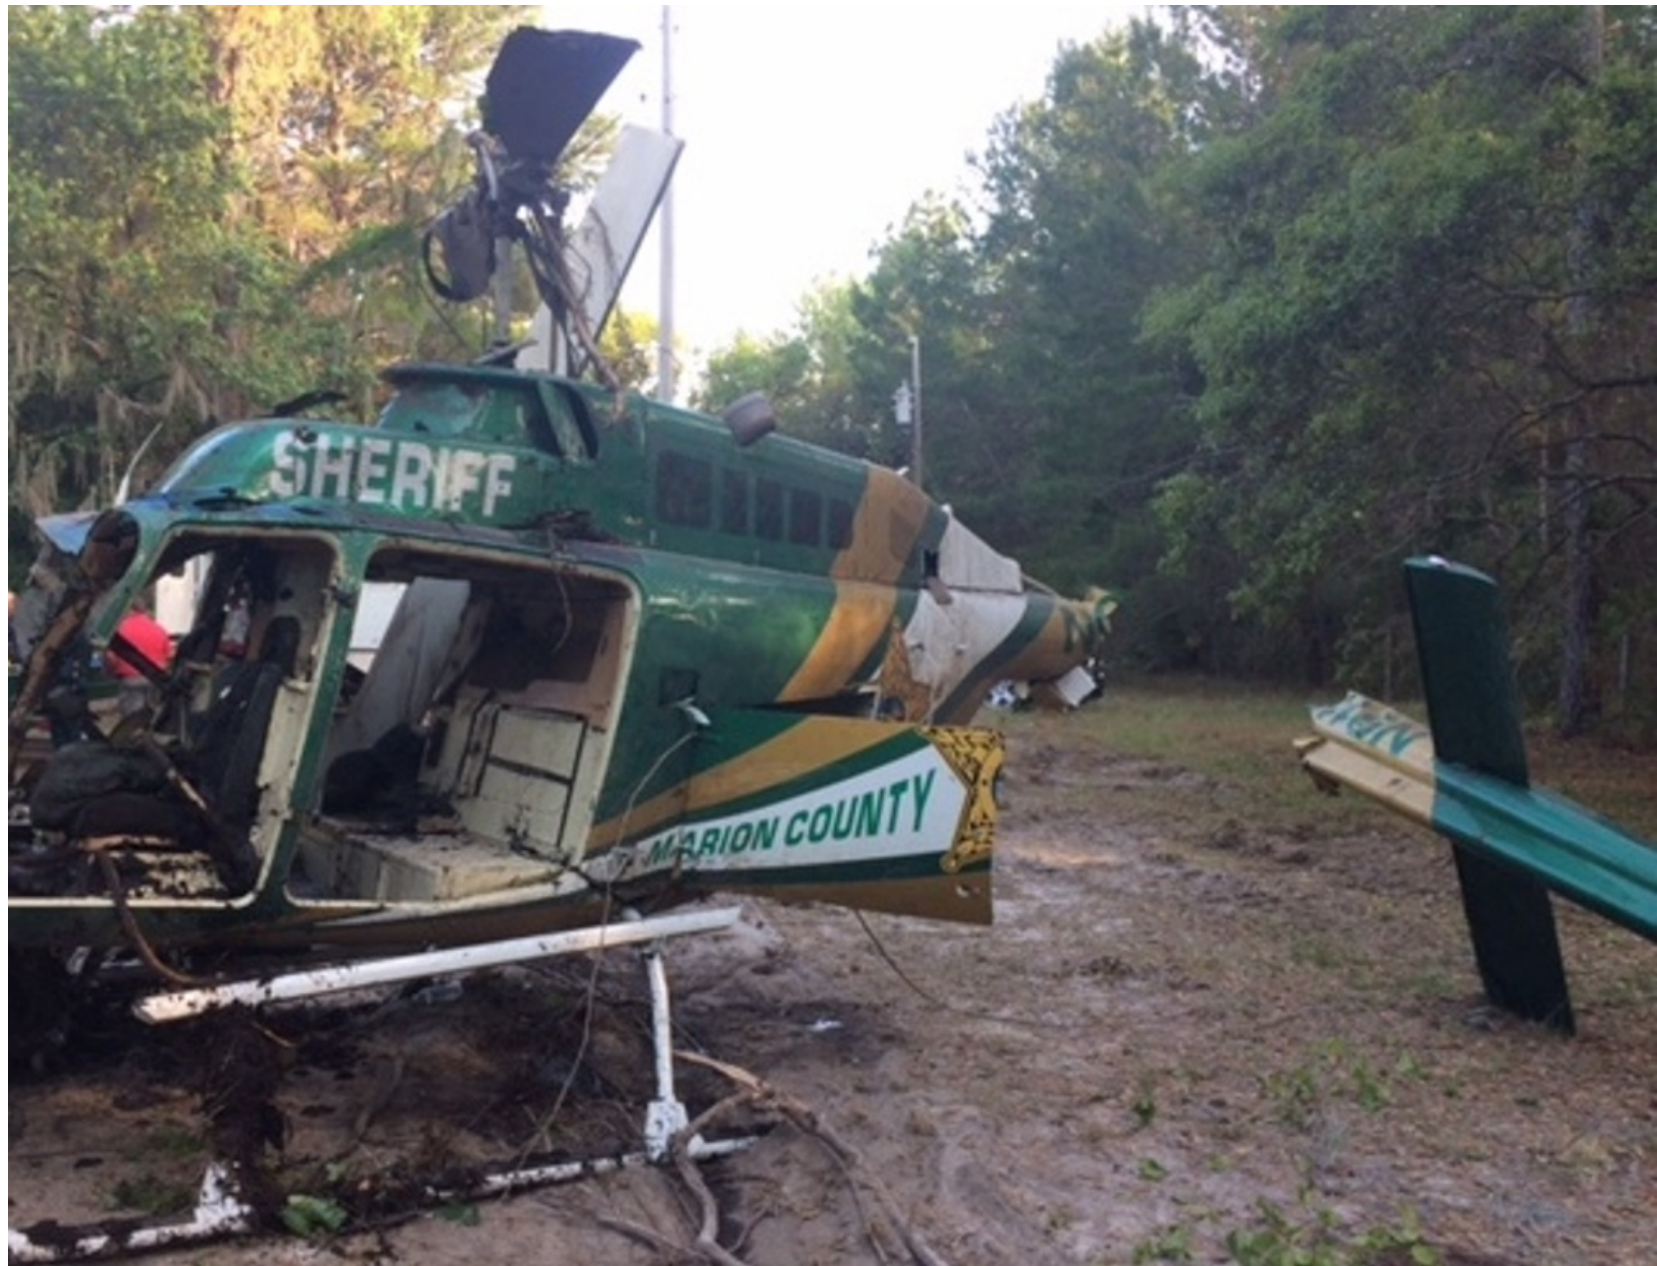
**Photo 1 – Main Wreckage (Marion County Sheriff Photo)**

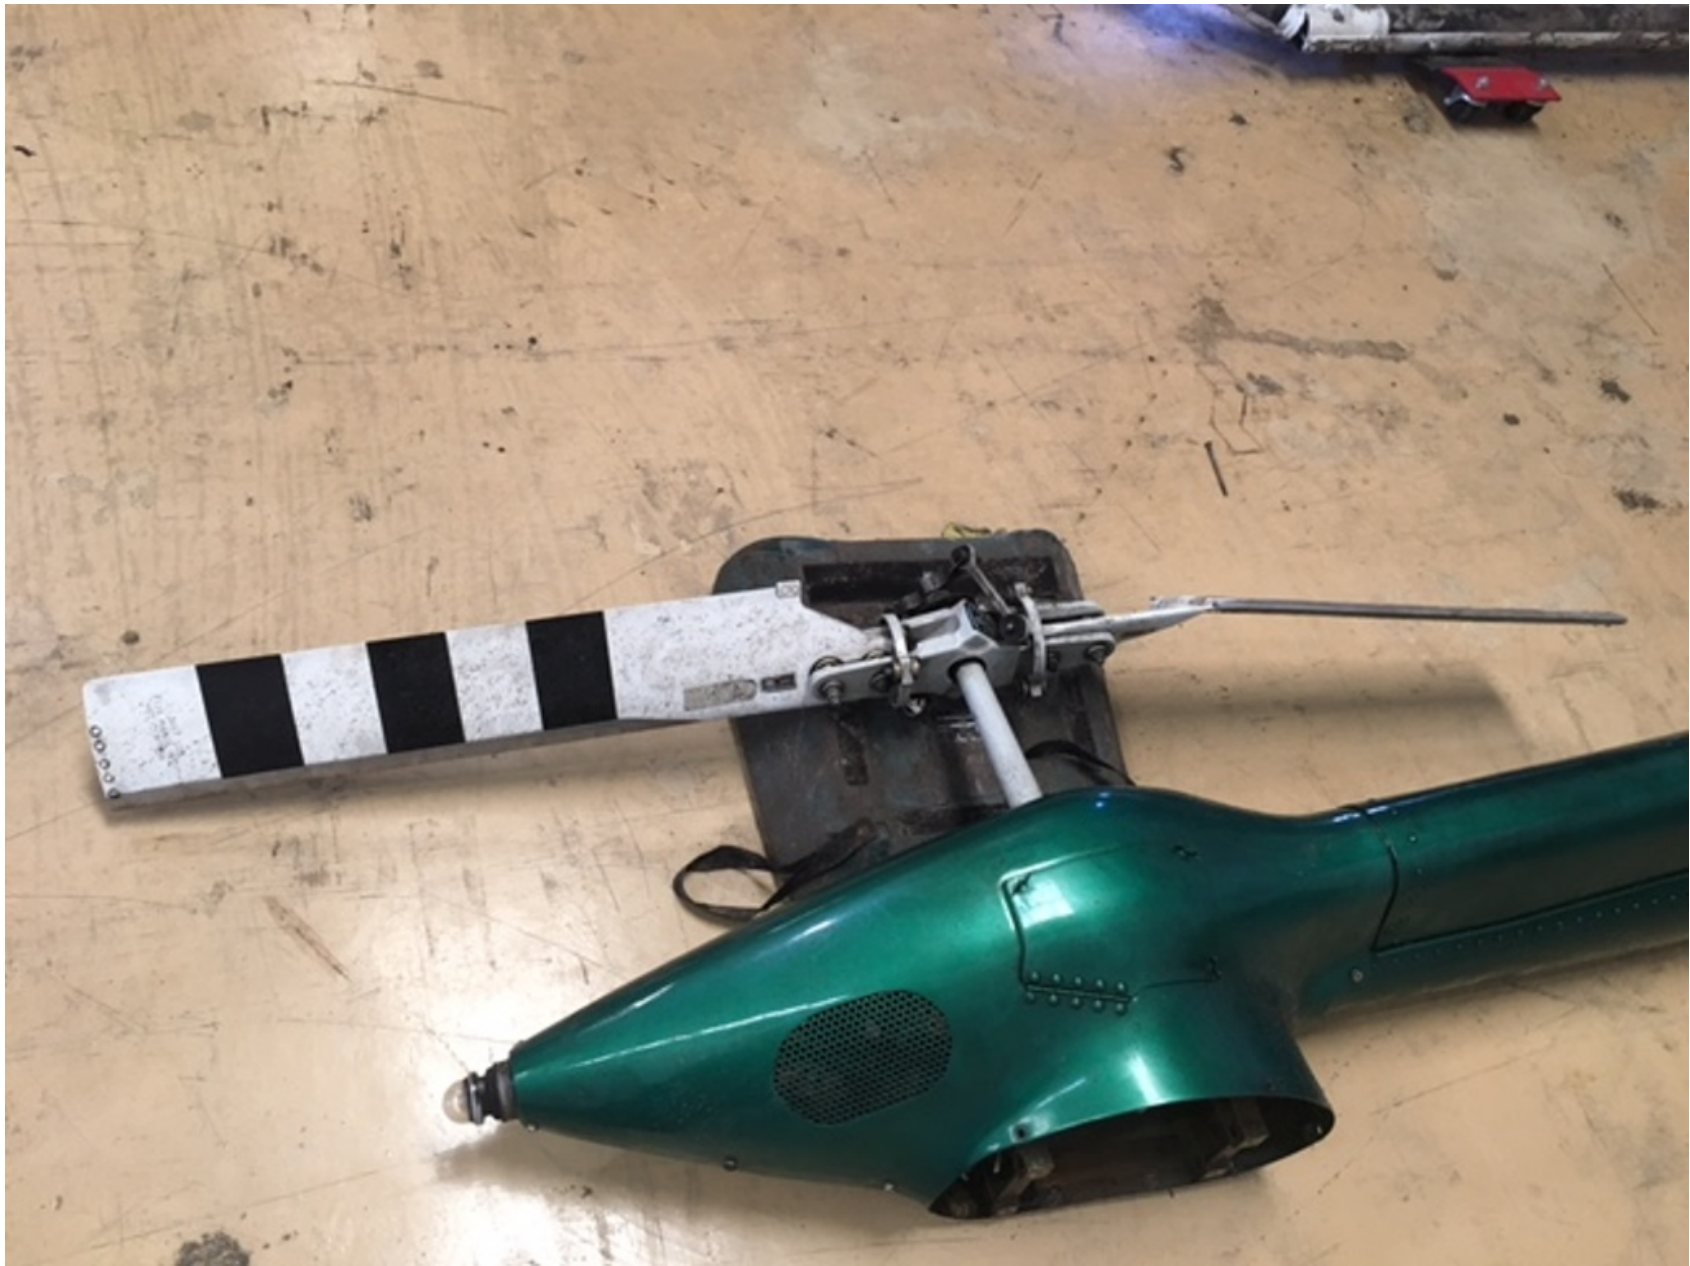
**Photo 2 – Tail Rotor (Marion County Sheriff Photo)**

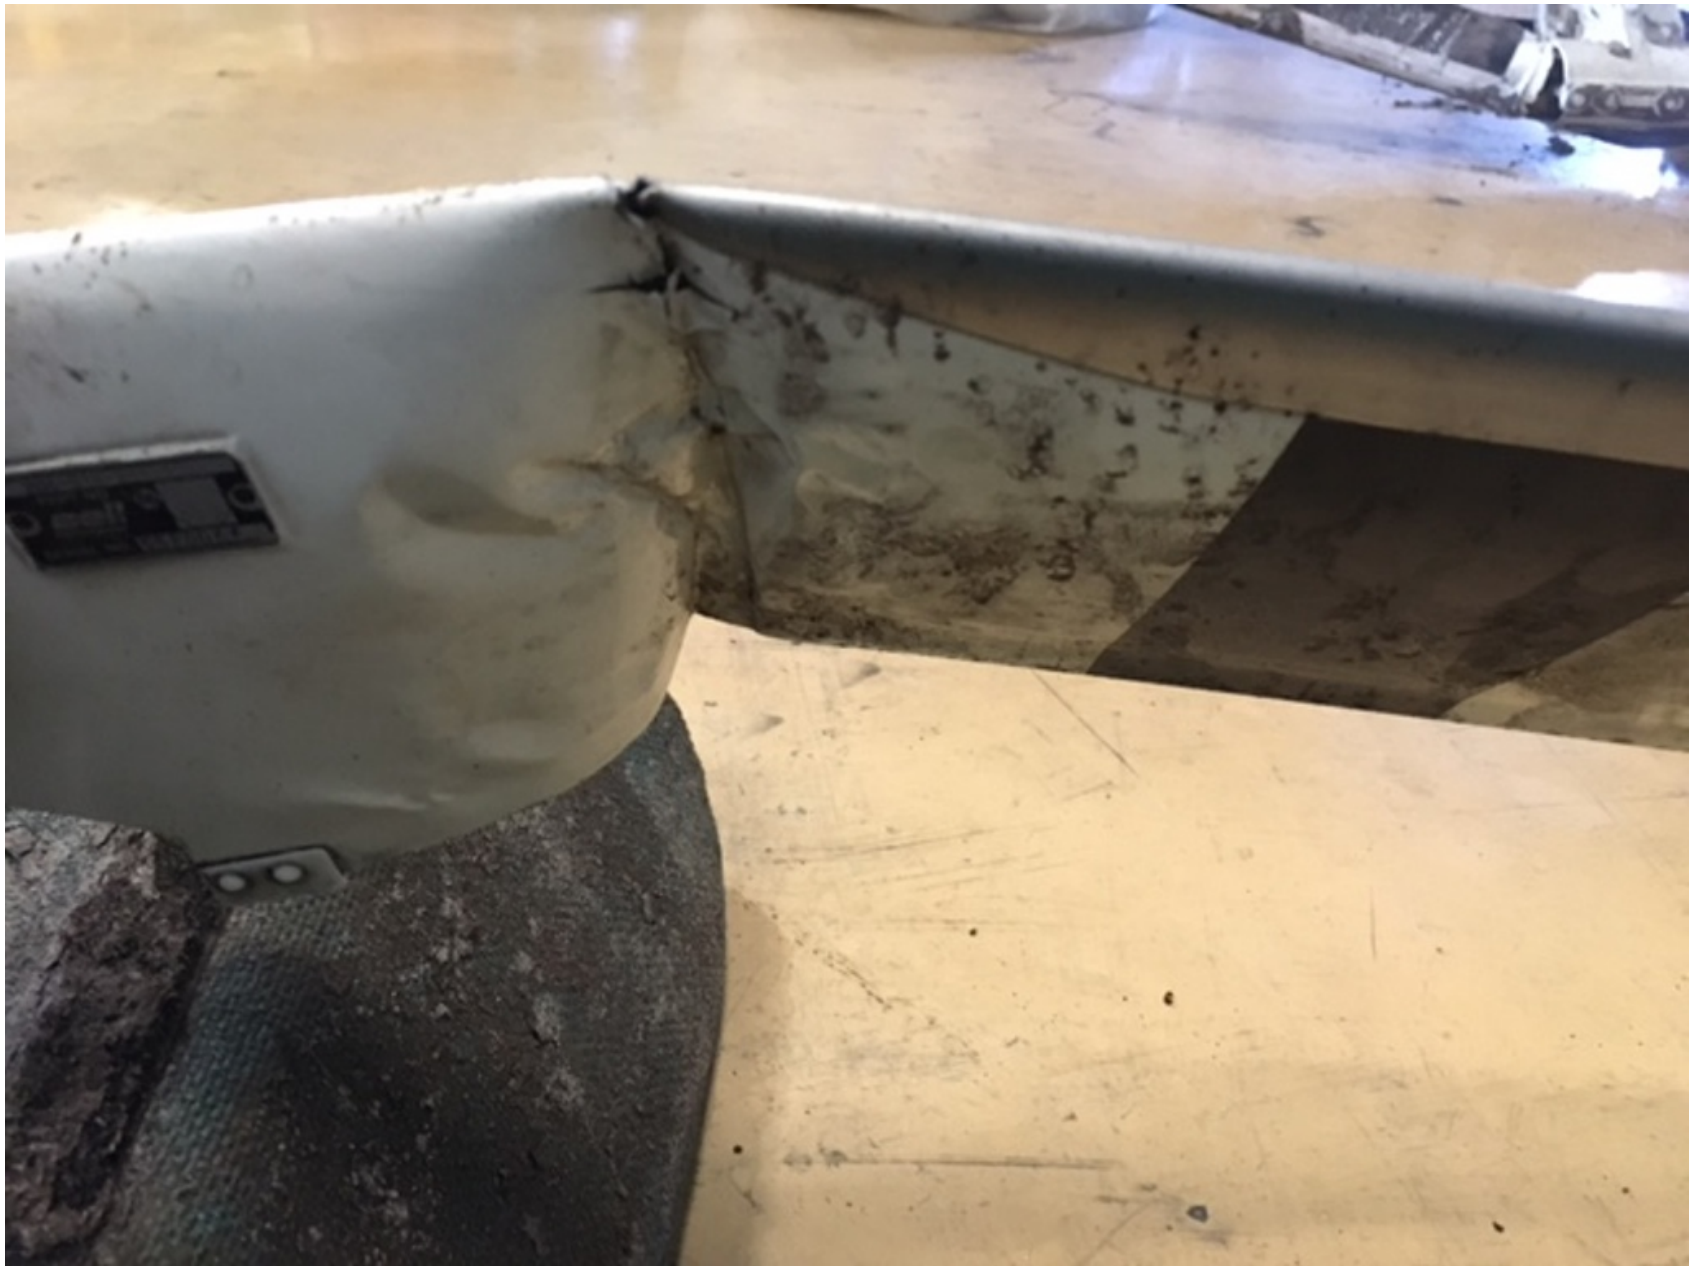
**Photo 3 - Tail Rotor Blade Damage (Marion County Sheriff Photo)**

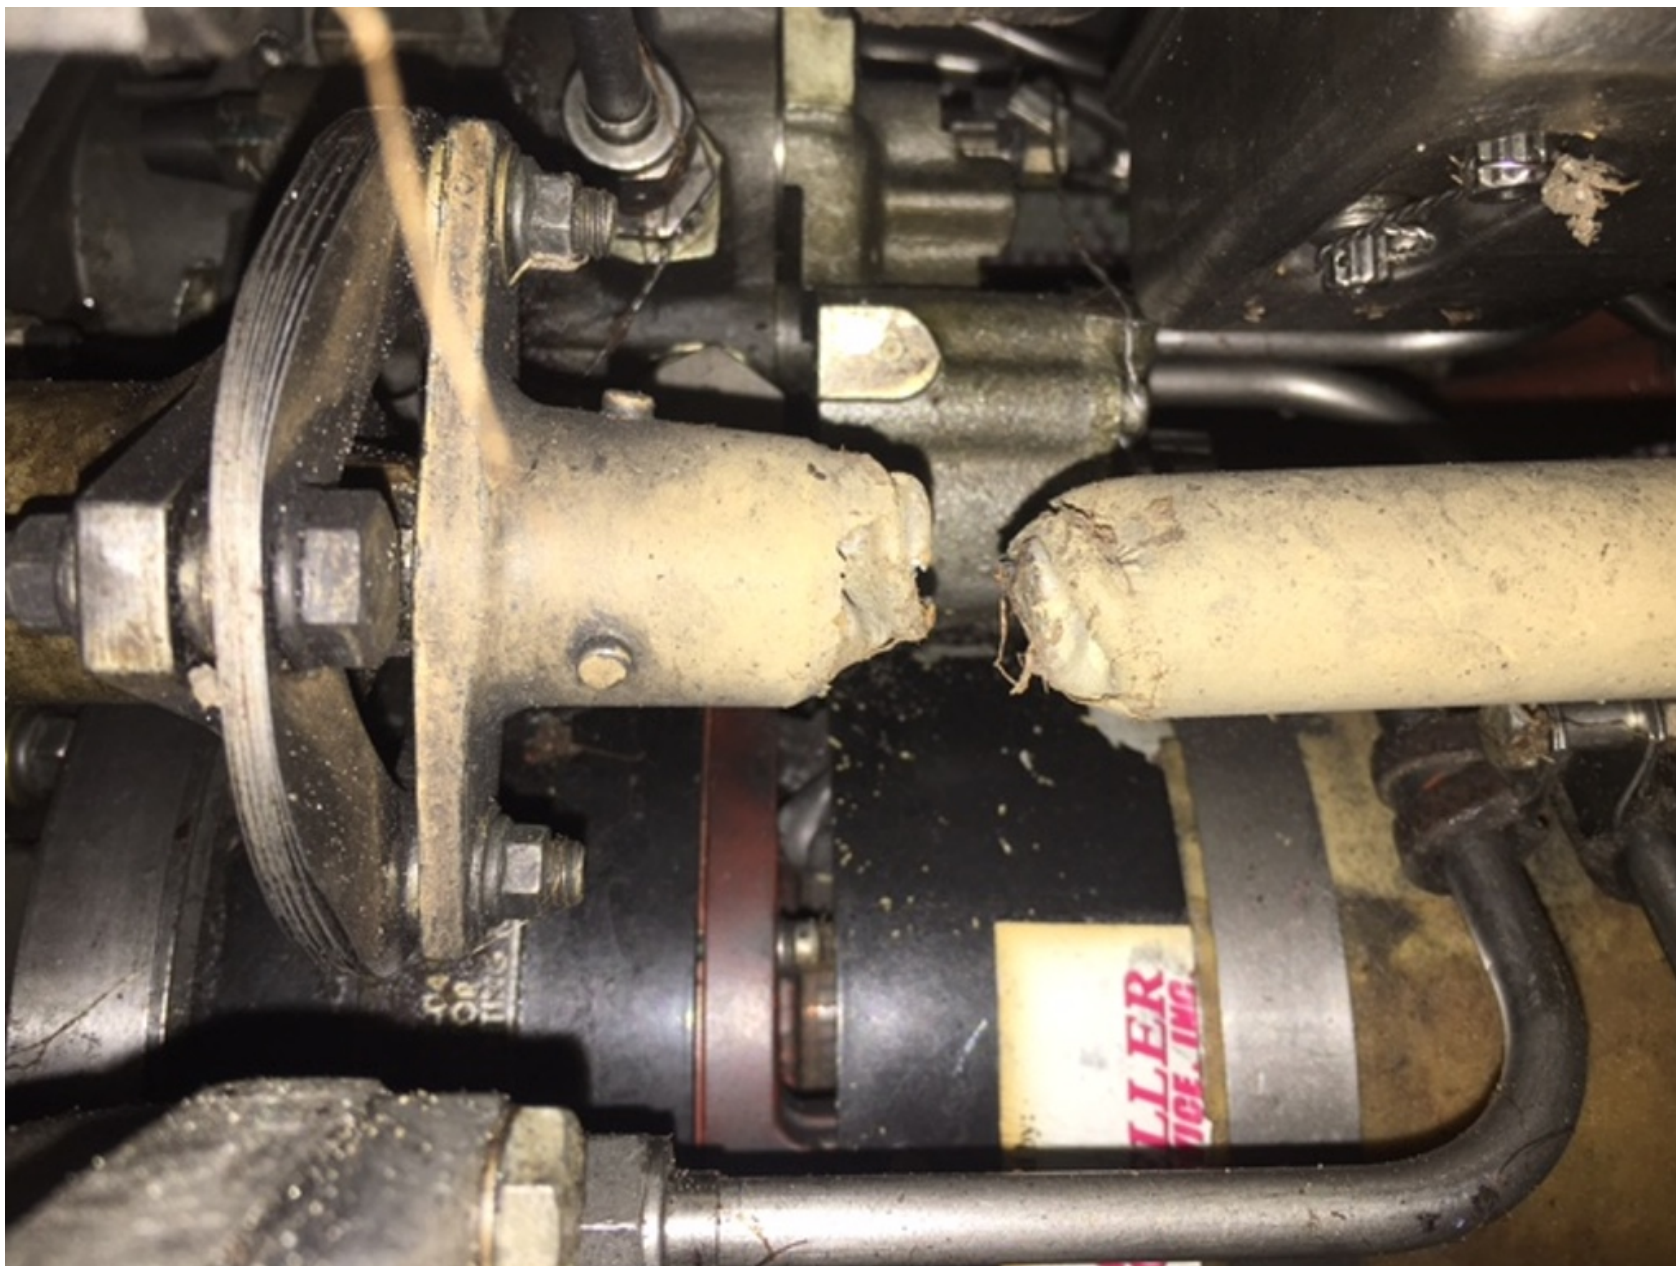
**Photo 4 - Tail Rotor Short Shaft Fracture (Marion County Sheriff Photo)**

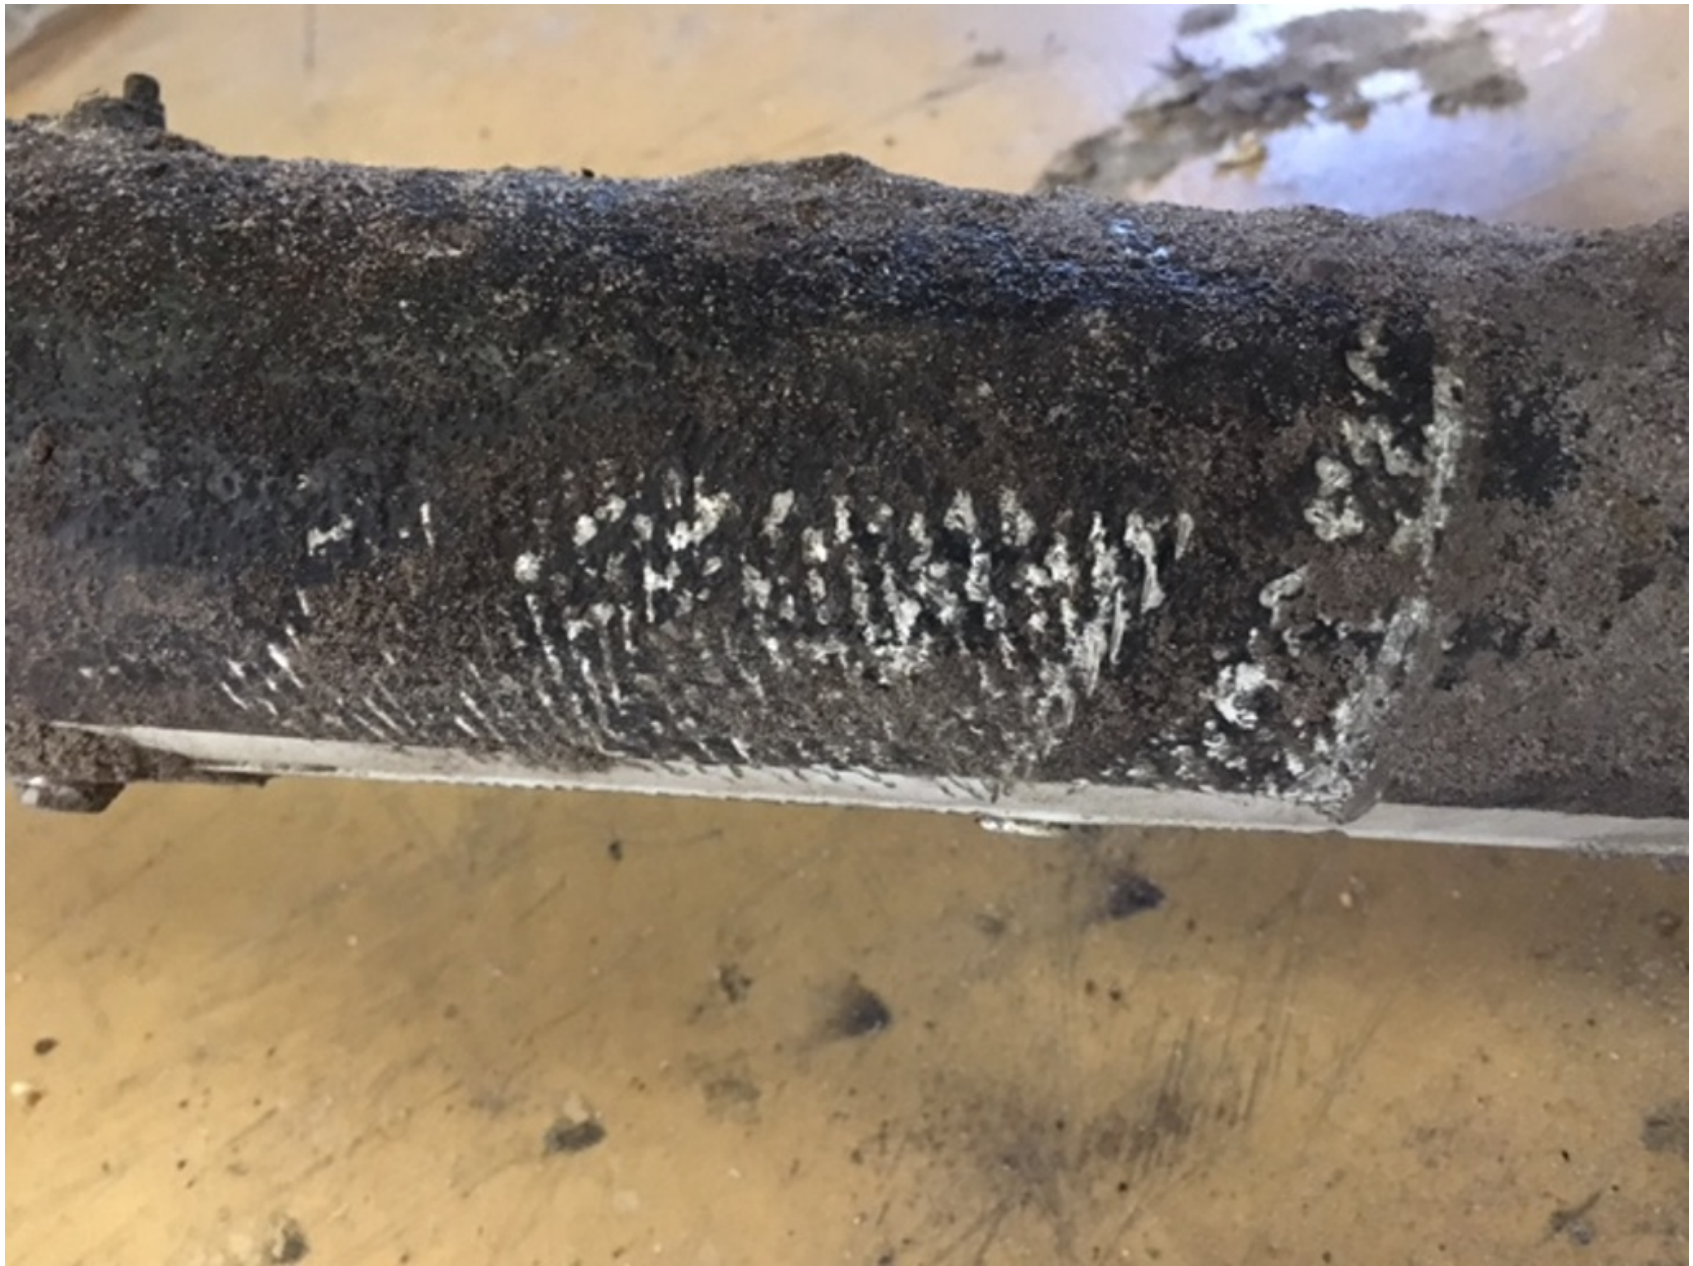
**Photo 5 – Right Rear Skid Tube (Marion County Sheriff Photo)**
