**Photo 1 – View of Main Wreckage as Found (Lycoming)**

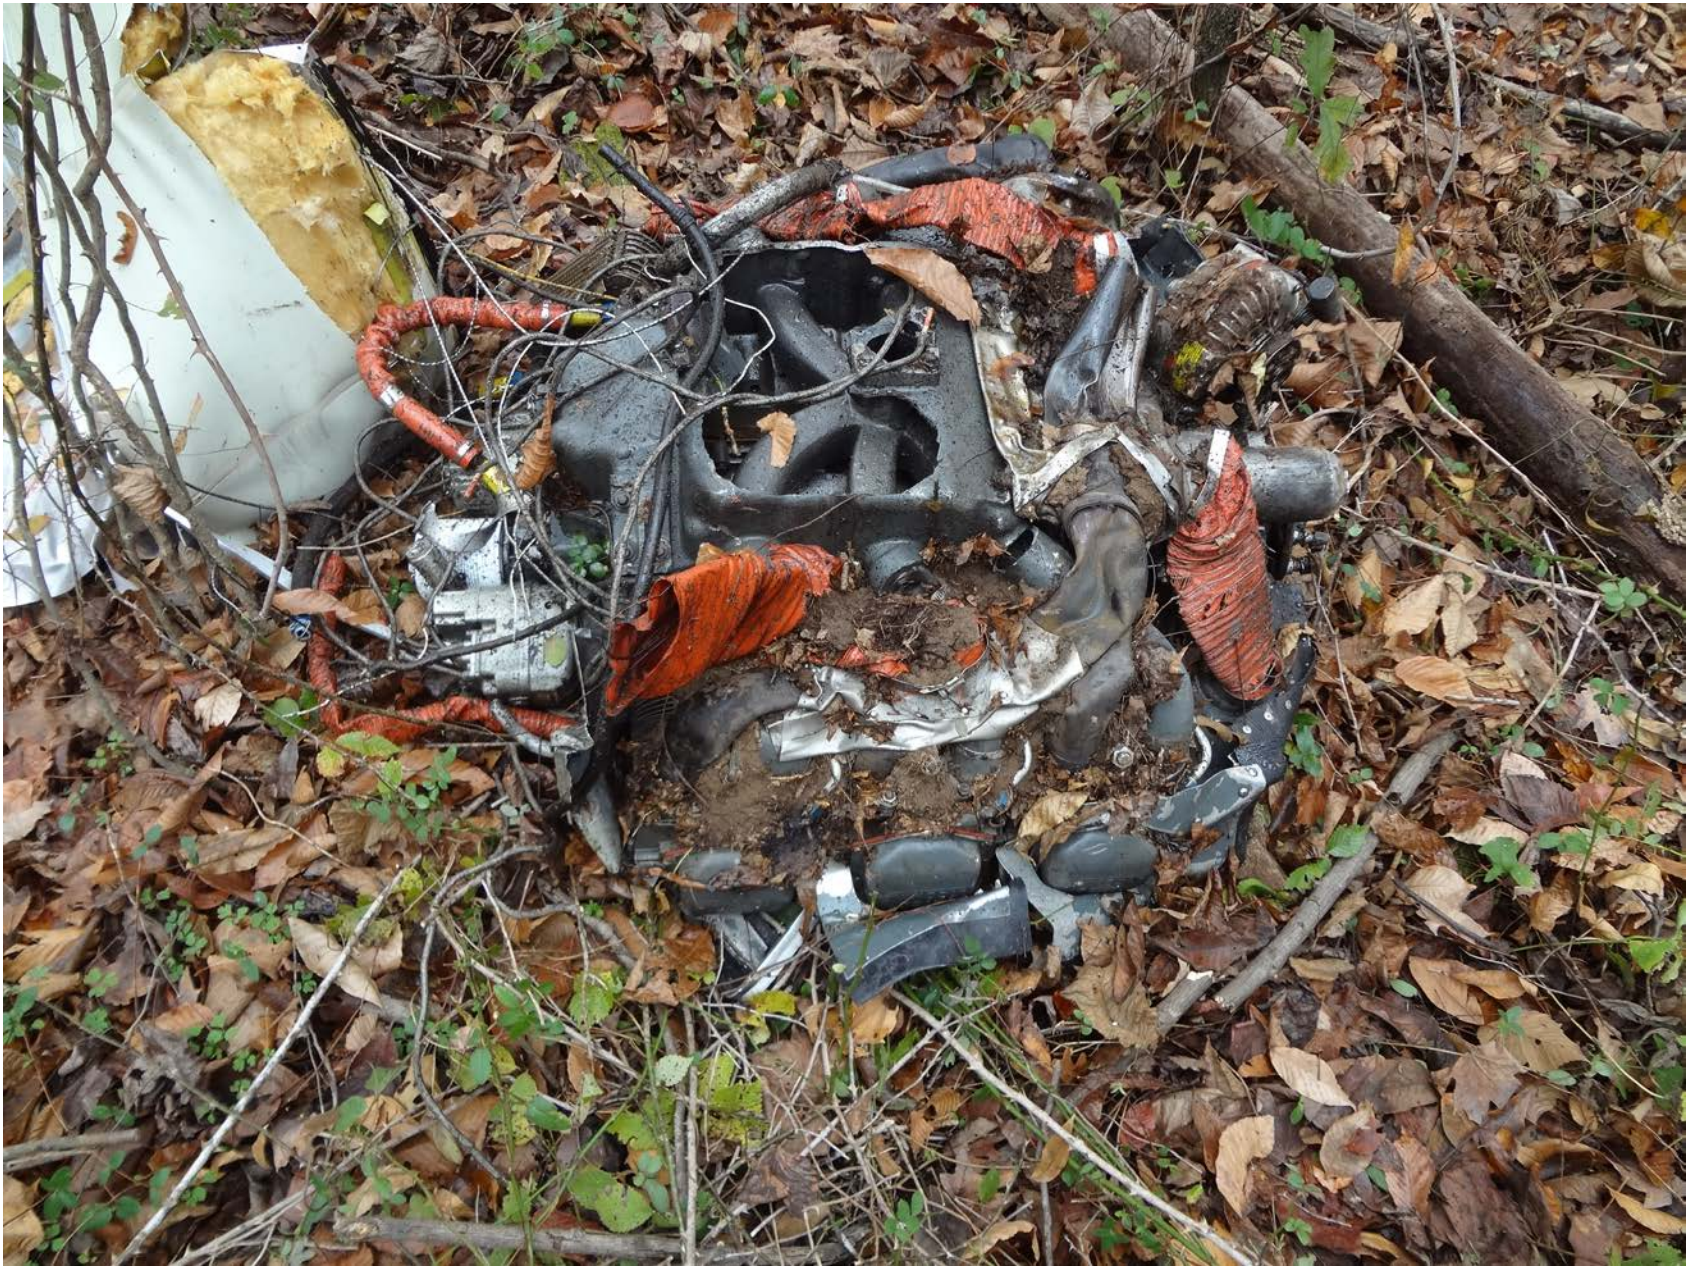
**Photo 2 – View of Engine as Found (Lycoming)**

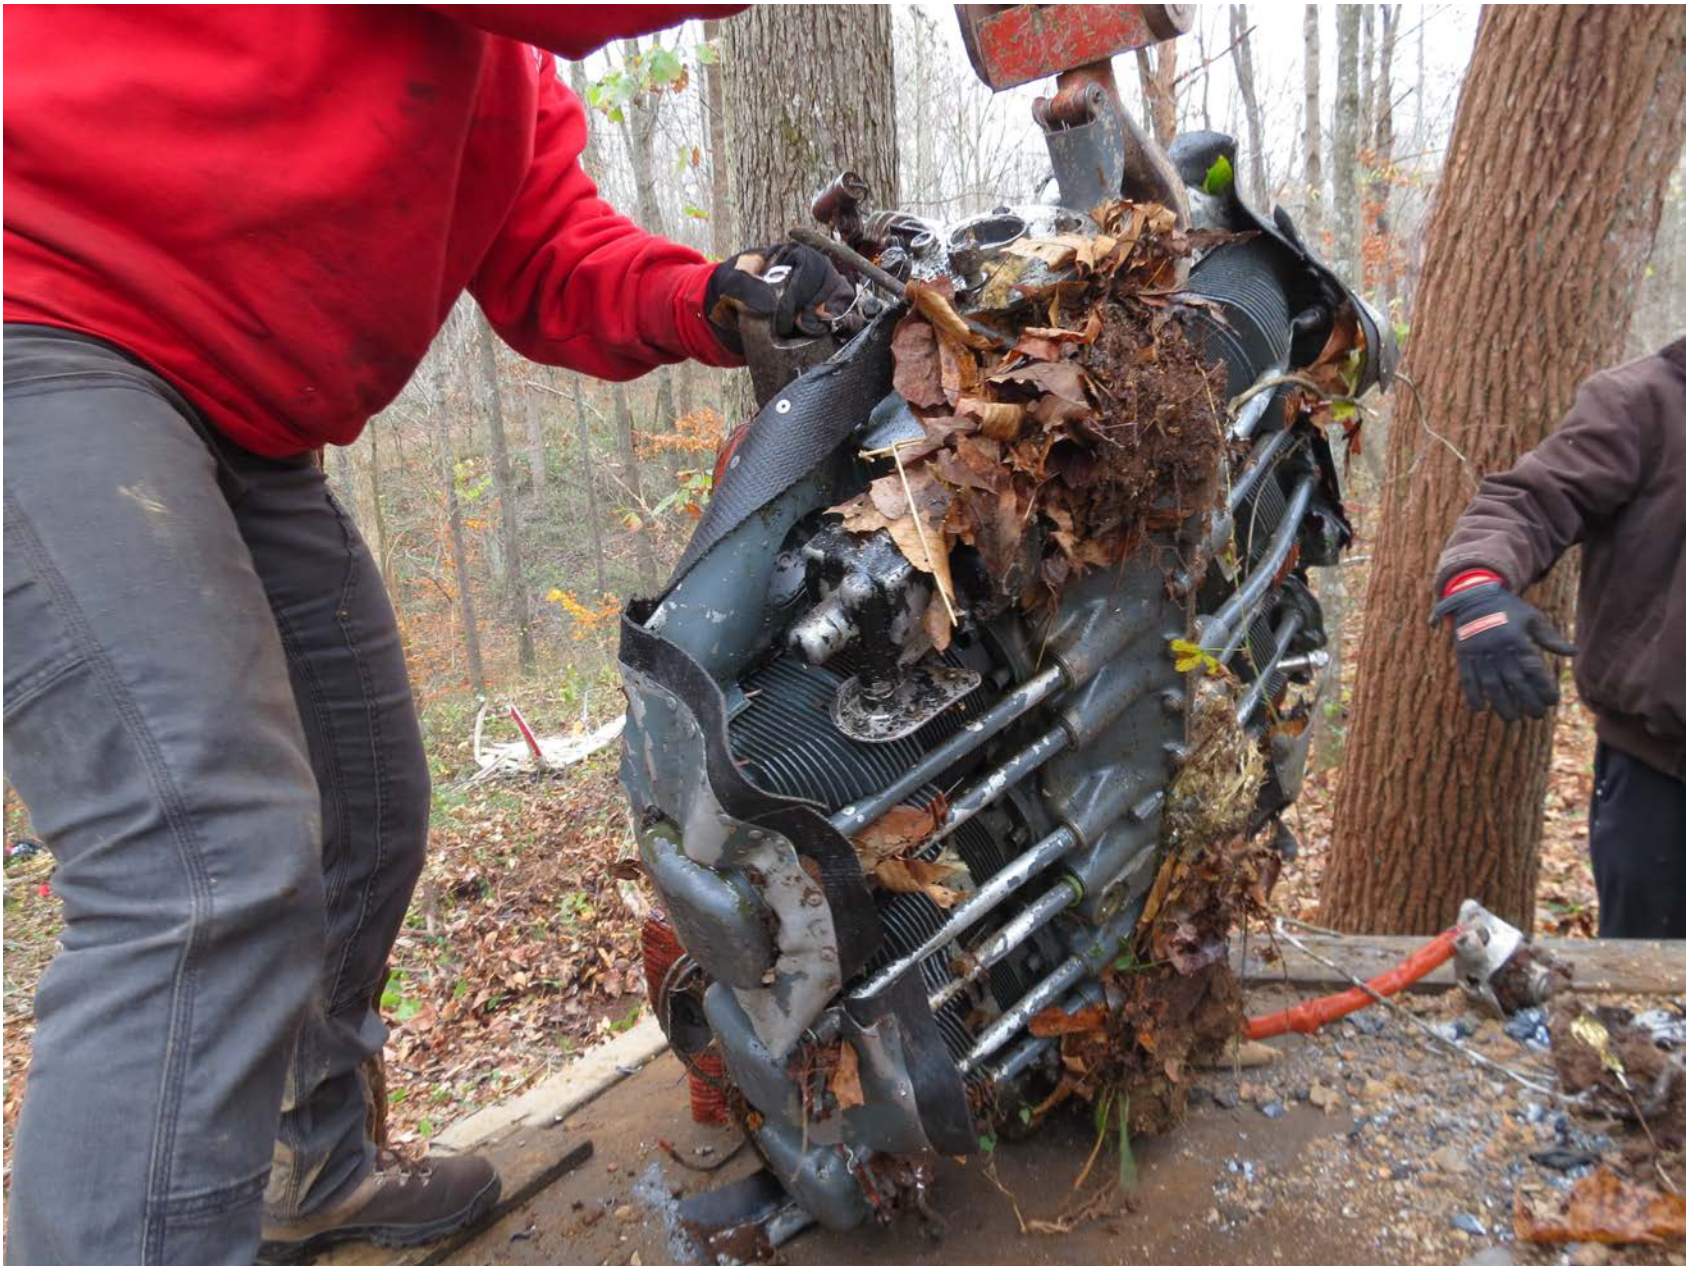
**Photo 3 – View of Engine During Recovery (Lycoming)**

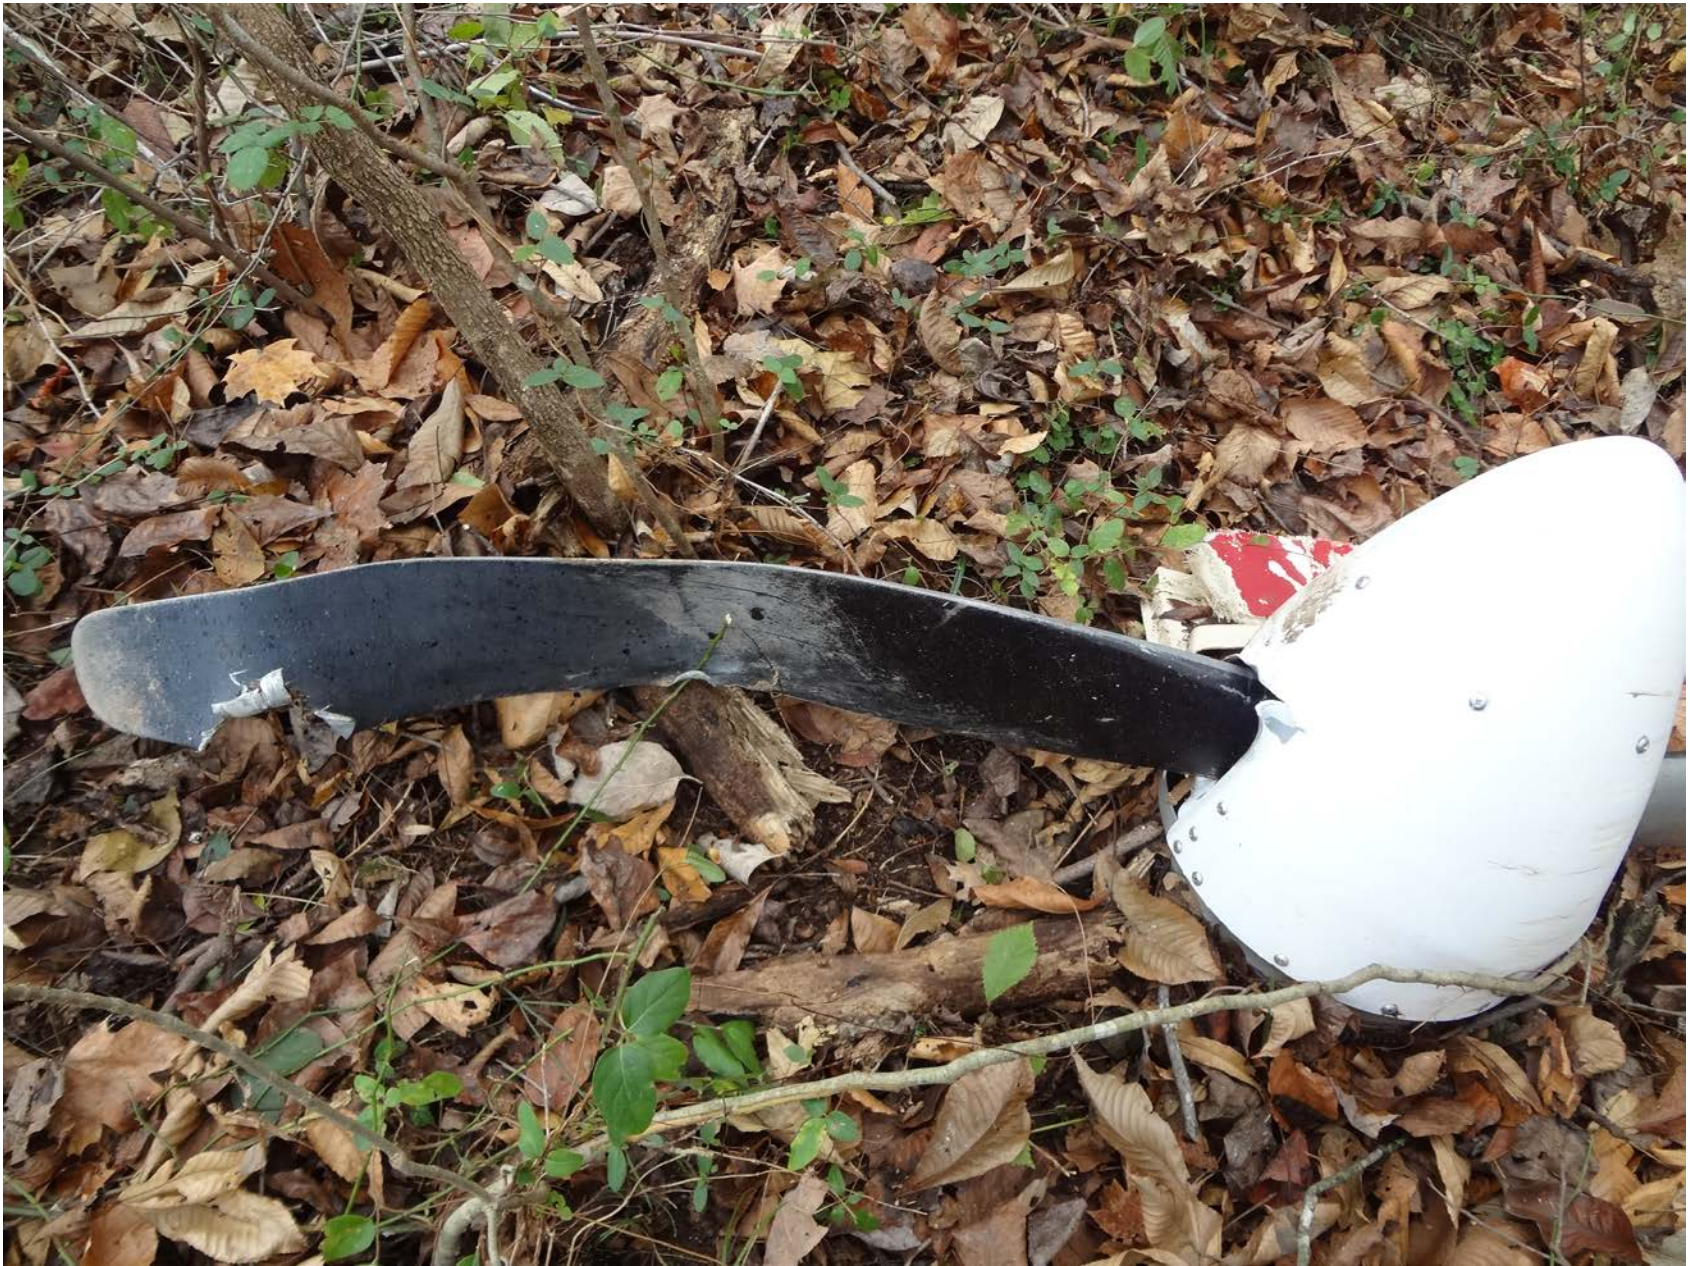
**Photo 4 – View of Propeller as Found (Lycoming)**

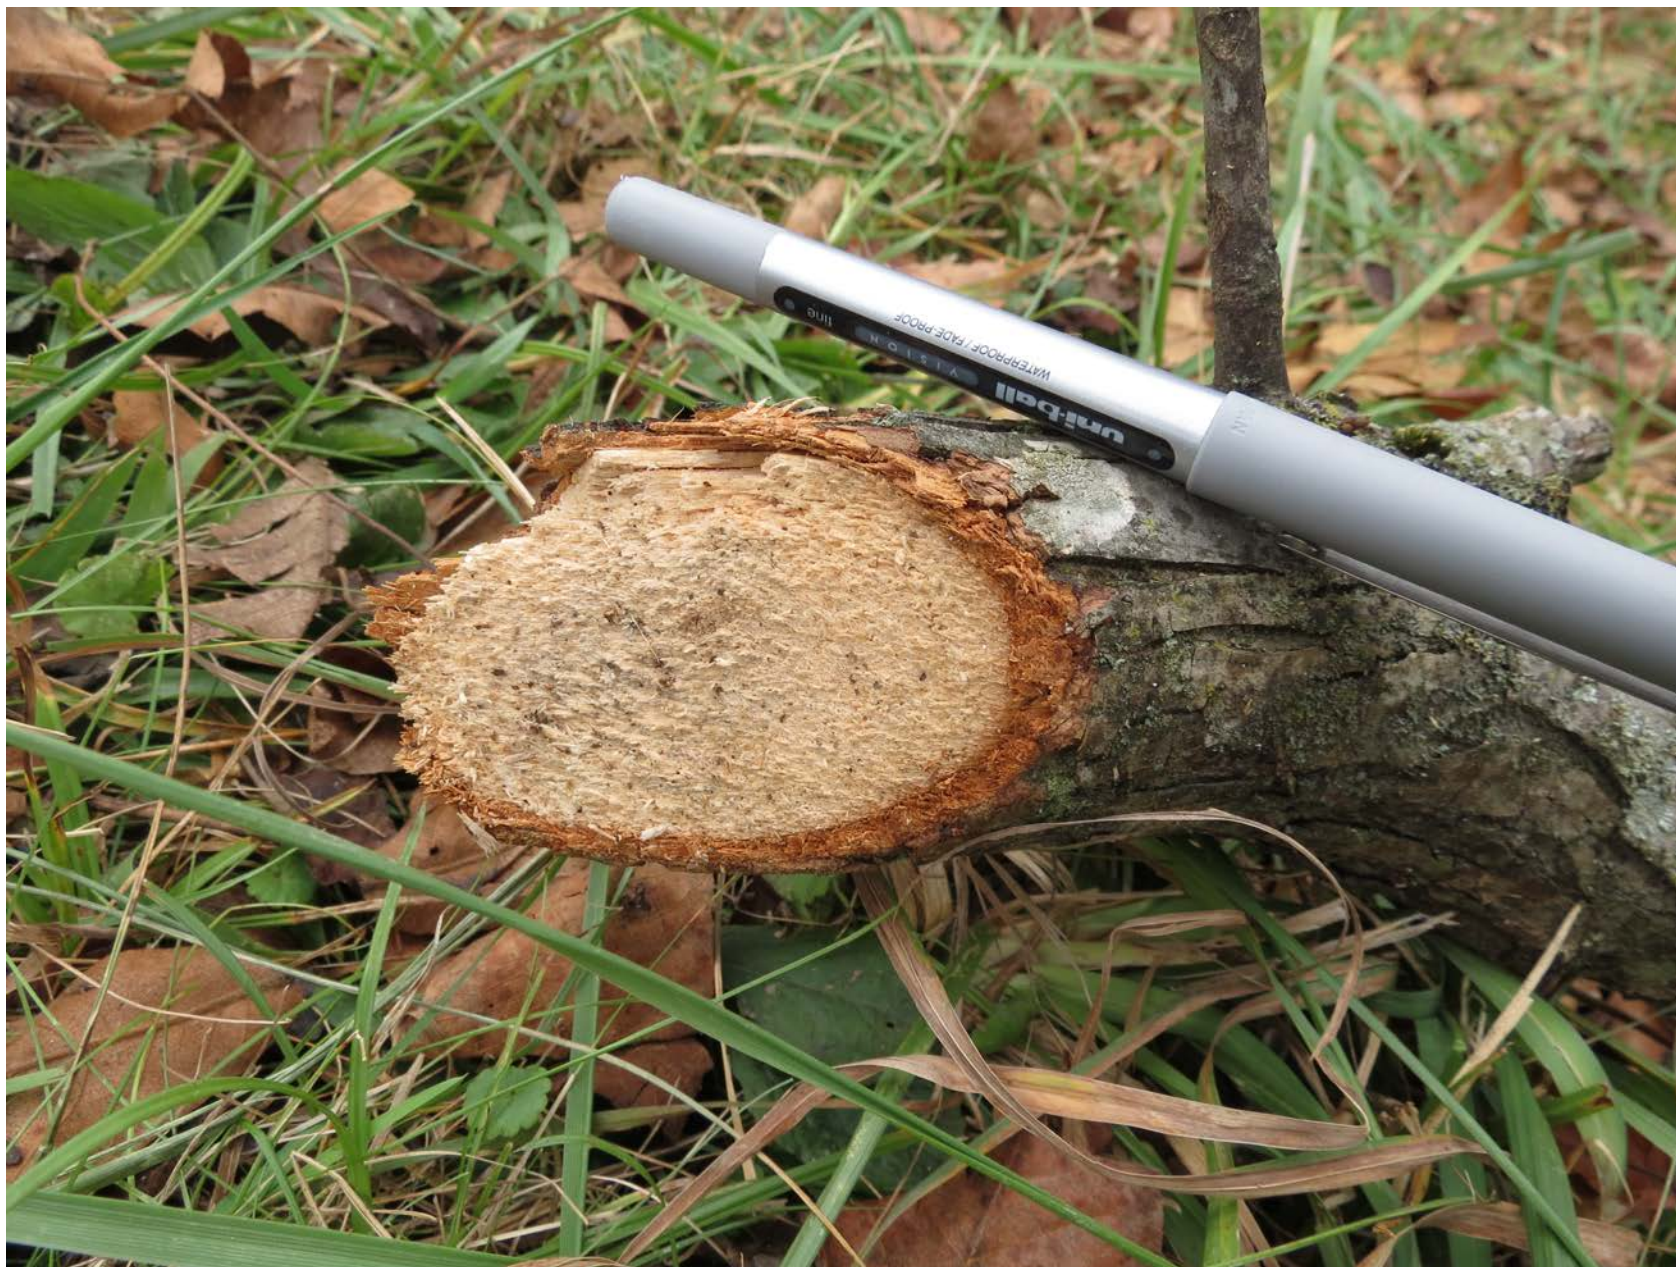
**Photo 5 – View of Angularly Cut Wood at Accident Site (Lycoming)**

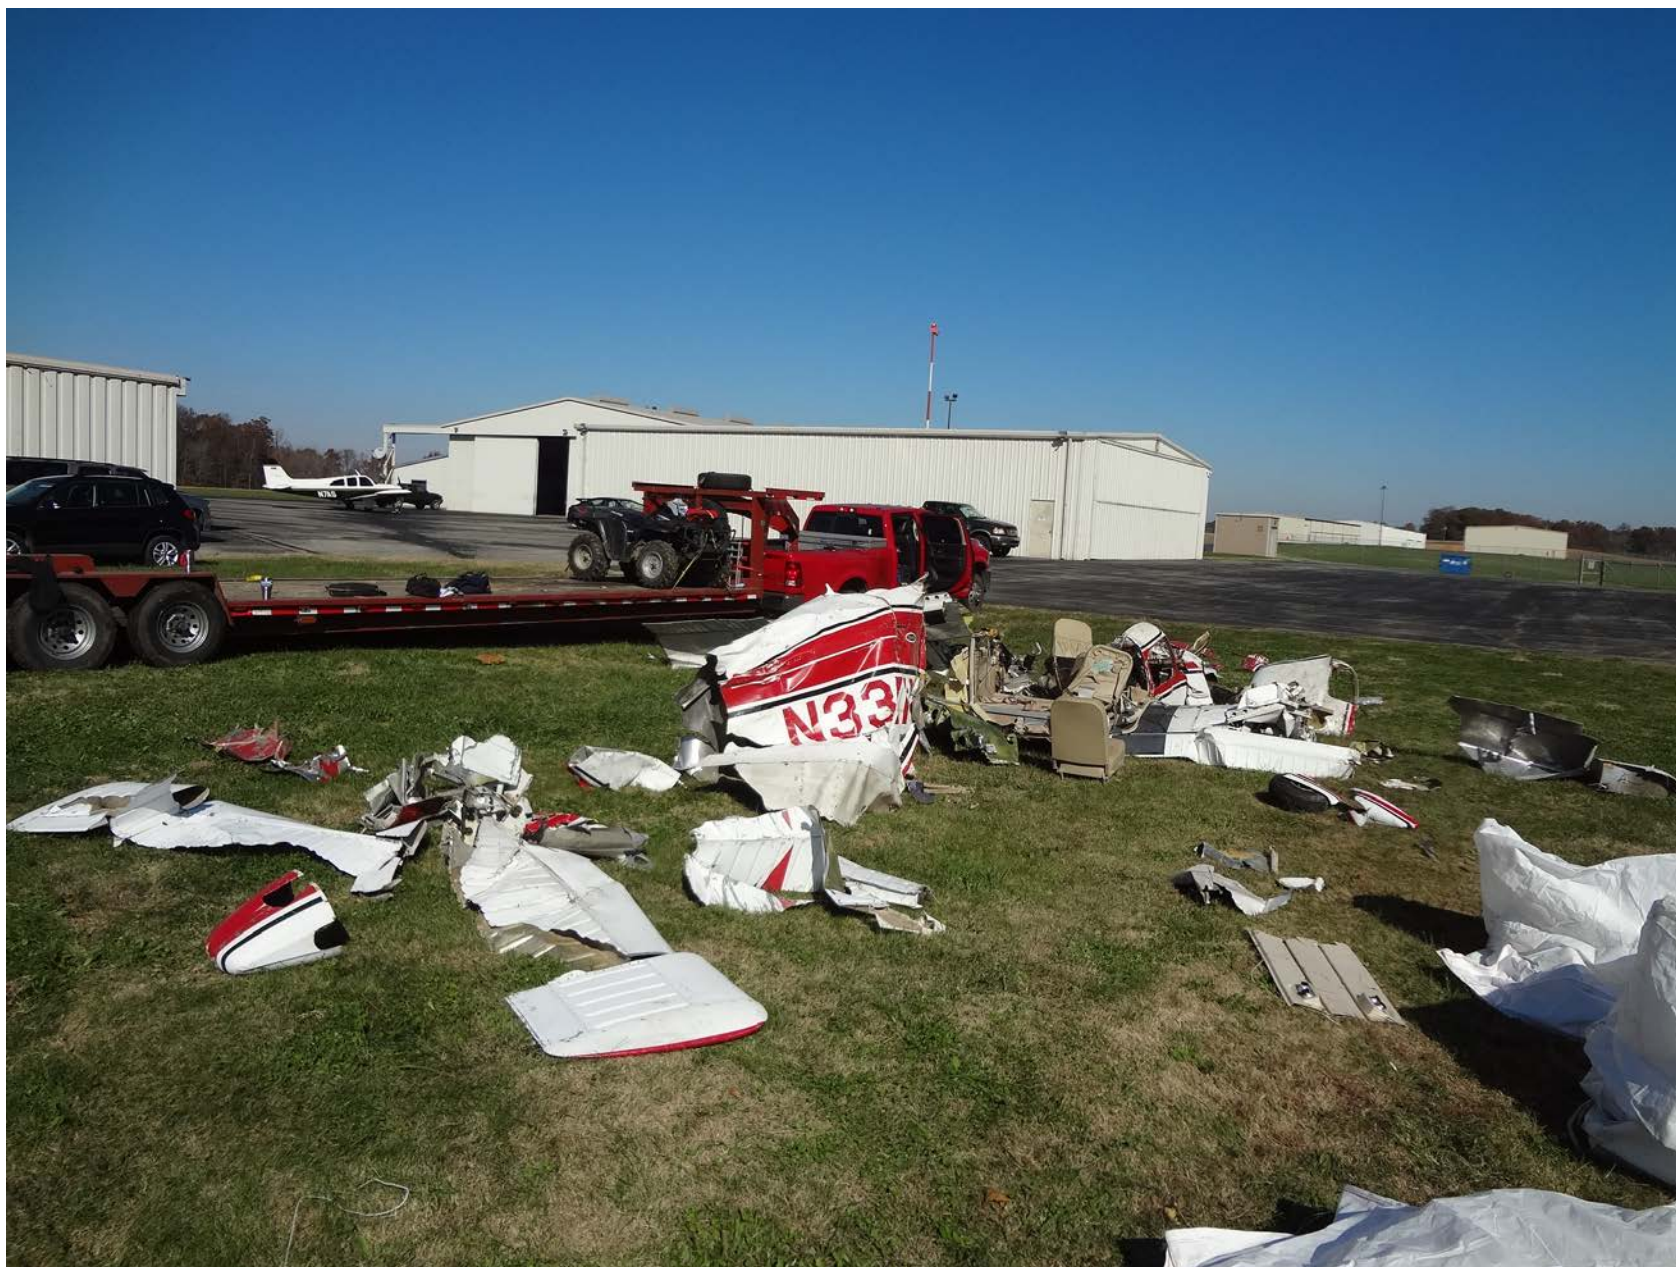
**Photo 6 – View of Wreckage Layout at Recovery Facility (Piper)**
