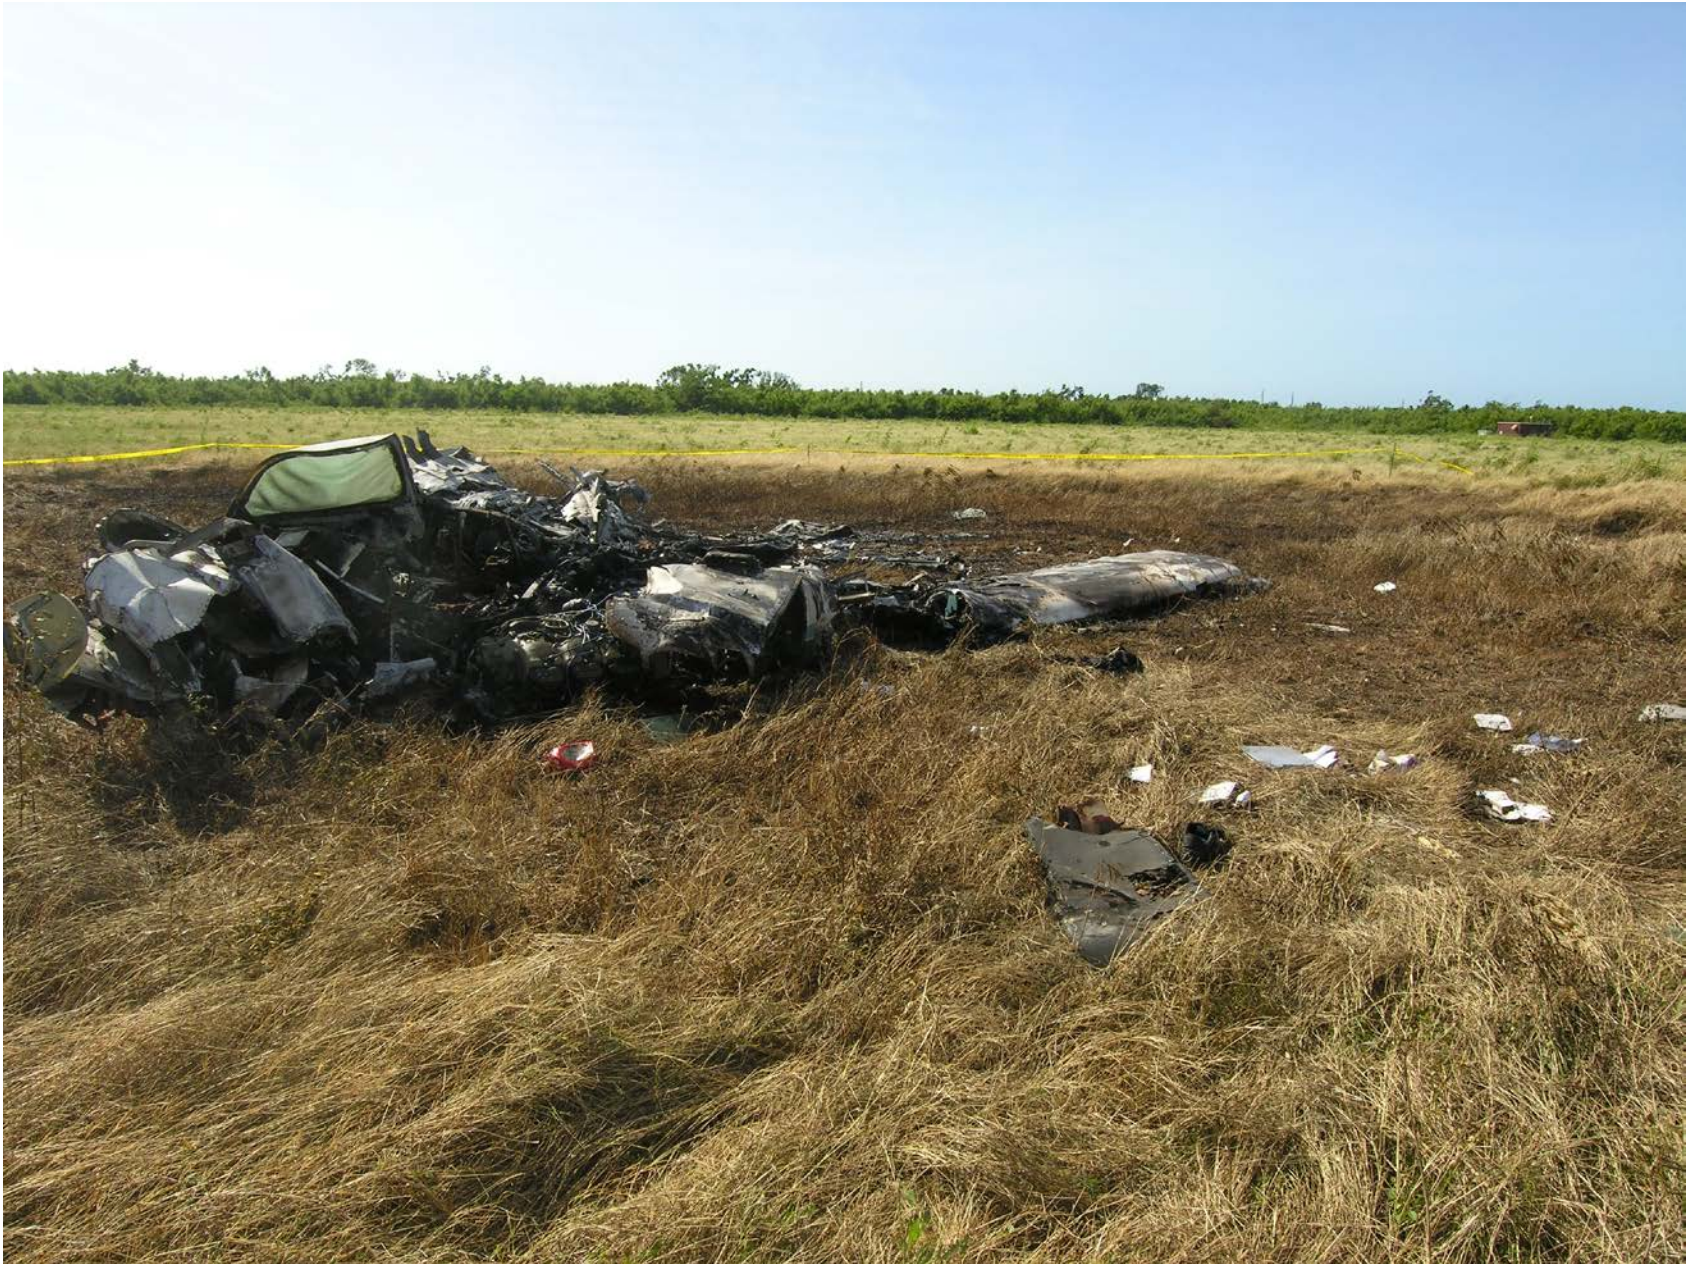
**Photo 1 – View of the main wreckage.**

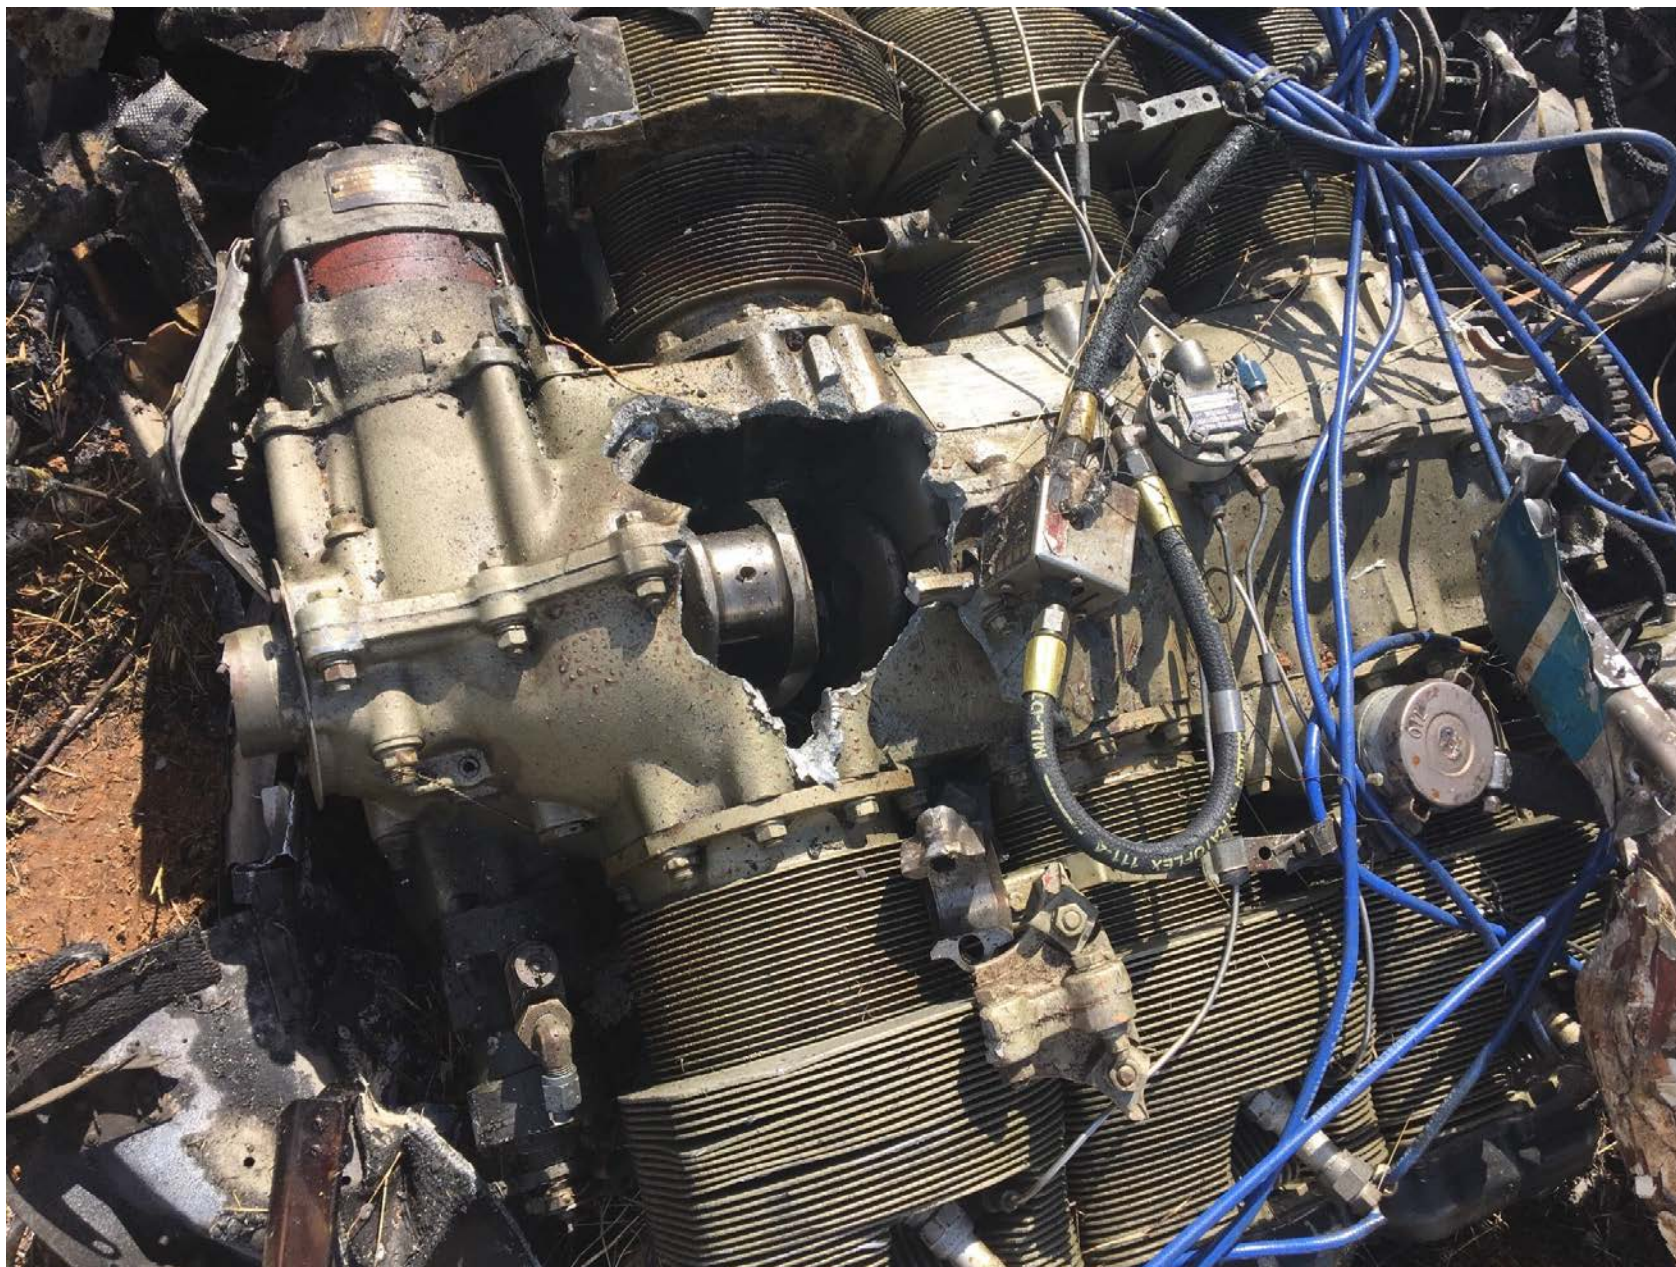
**Photo 2 – View of the hole in the top of the left engine crankcase.**

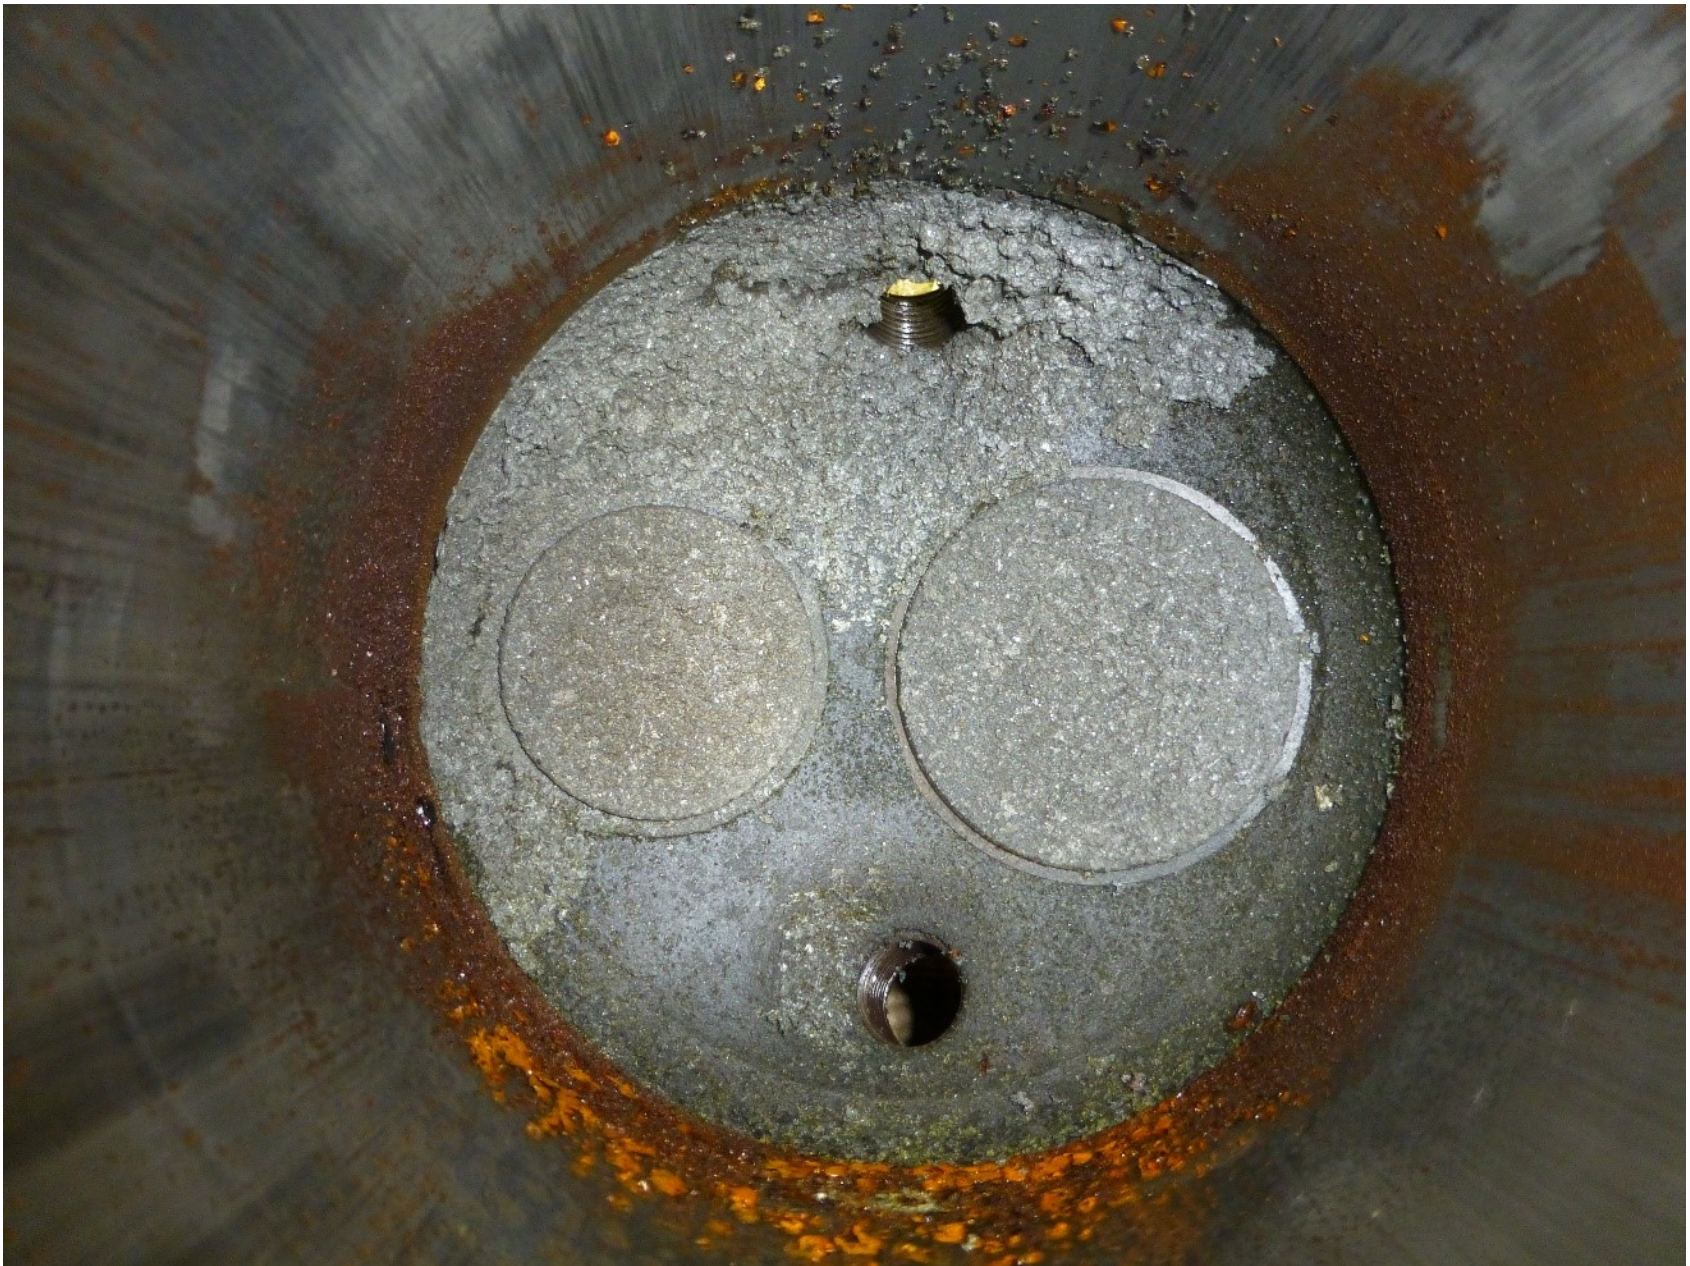
**Photo 3 – Deposits in the No. 2 cylinder.**

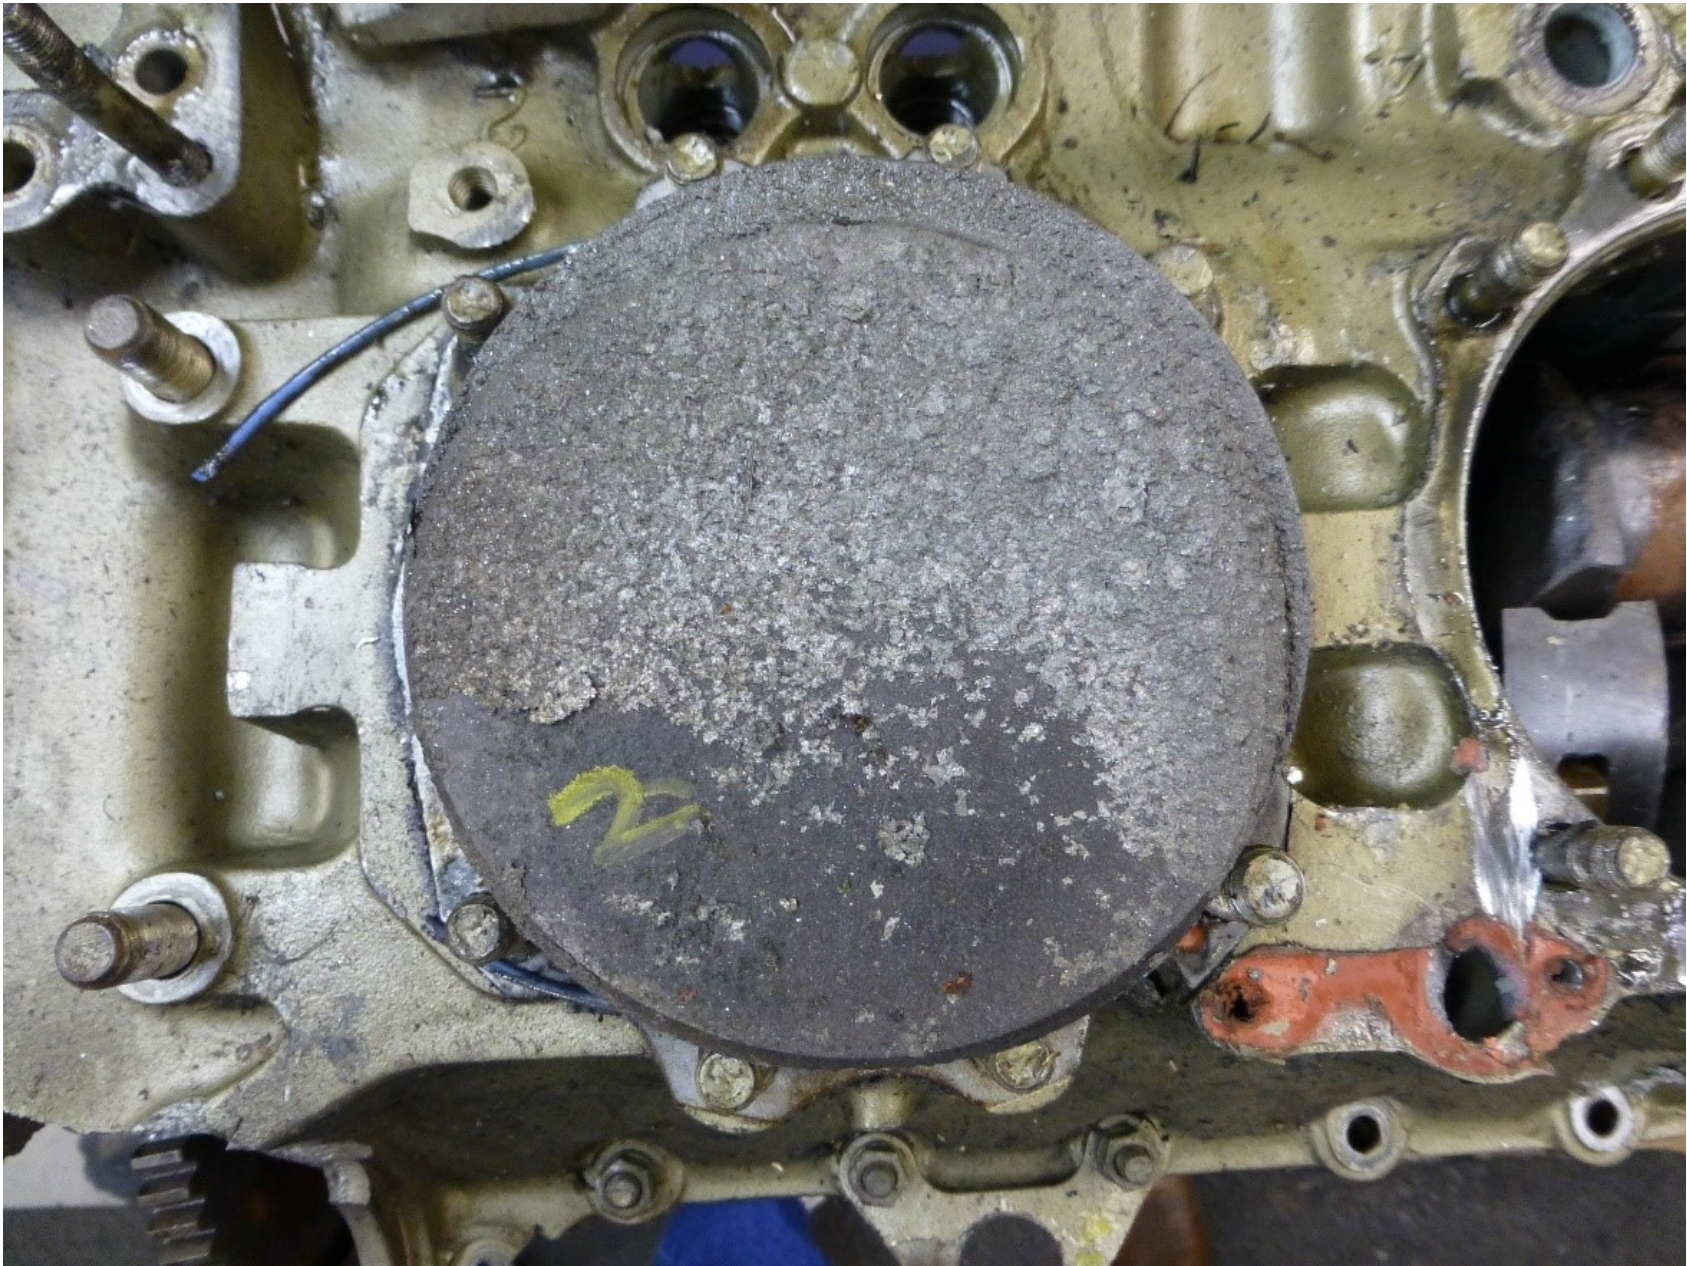
**Photo 4 – Detonation damage to the crown of the piston.**

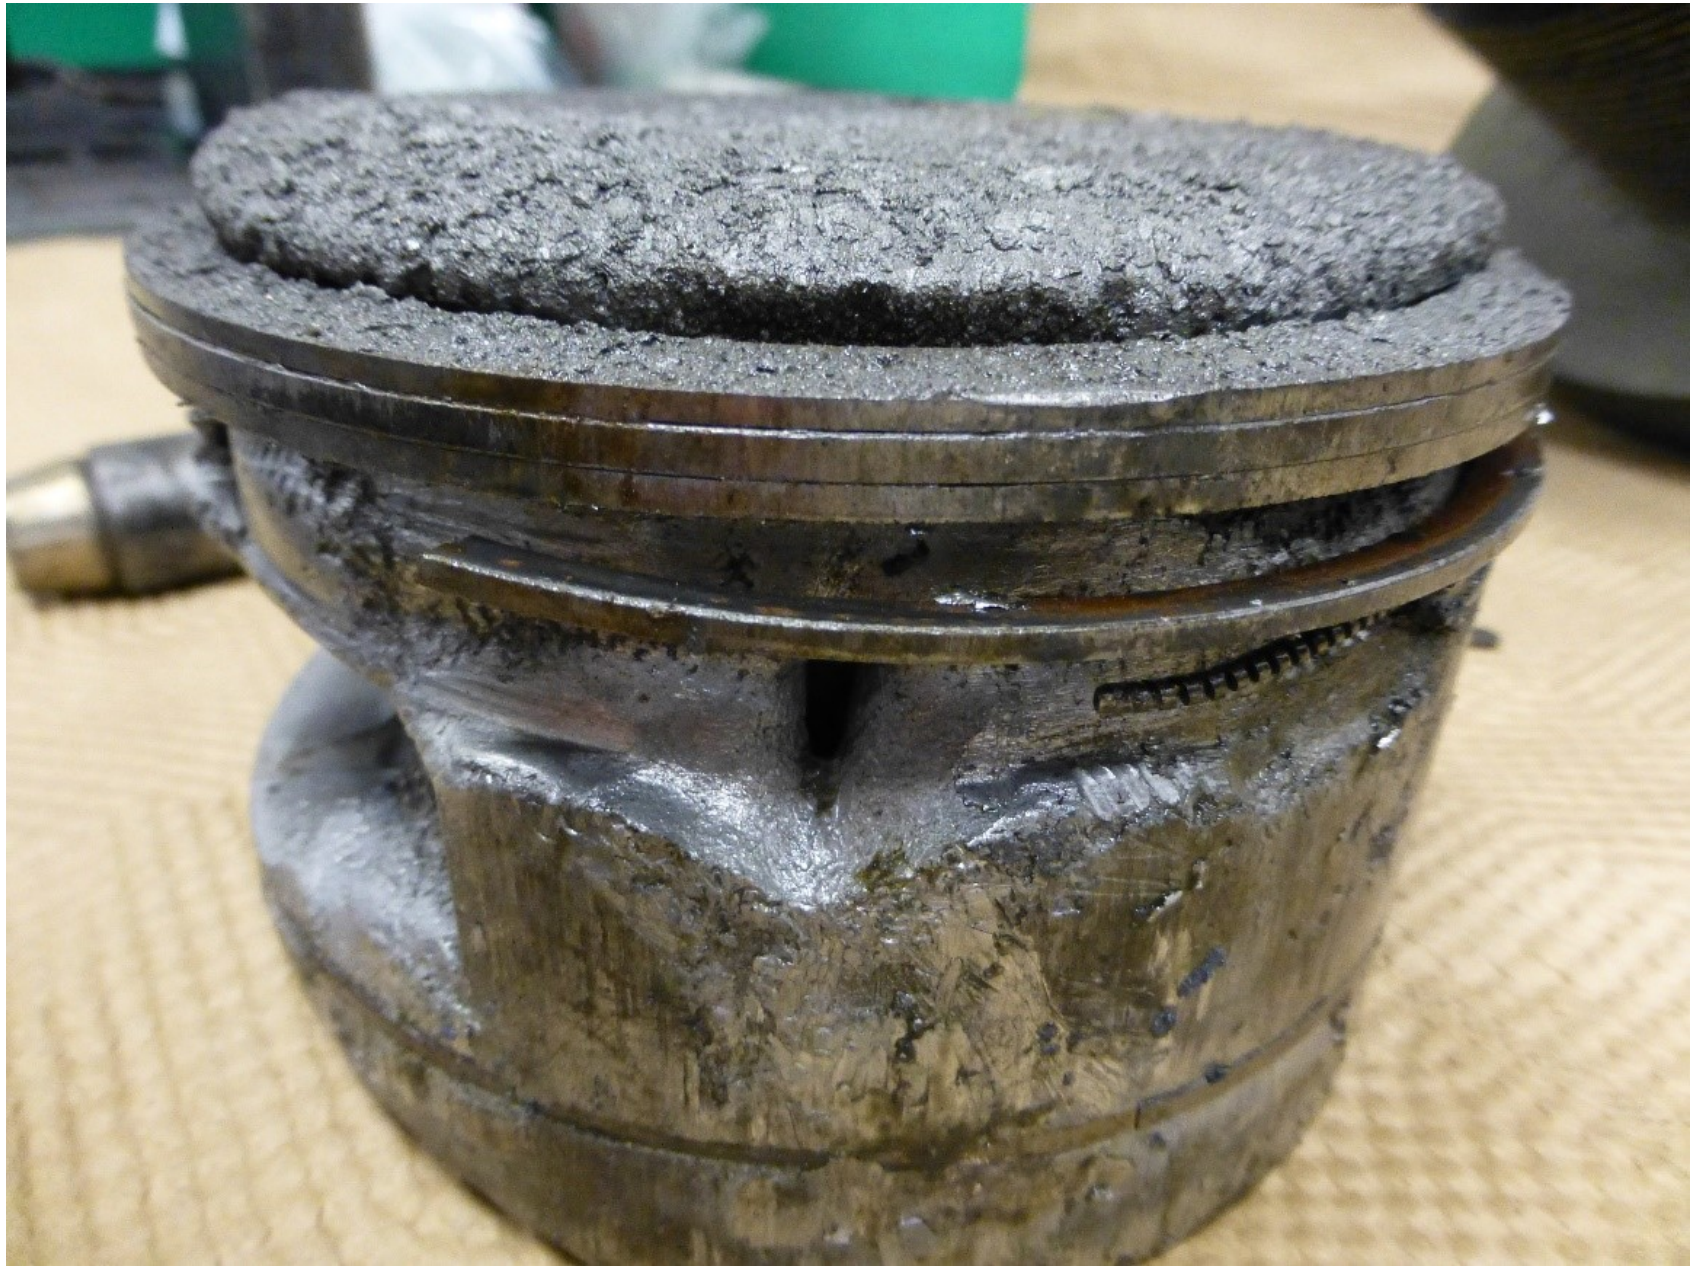
**Photo 5 – Side view of the piston, damage to the oil control ring grooves.**

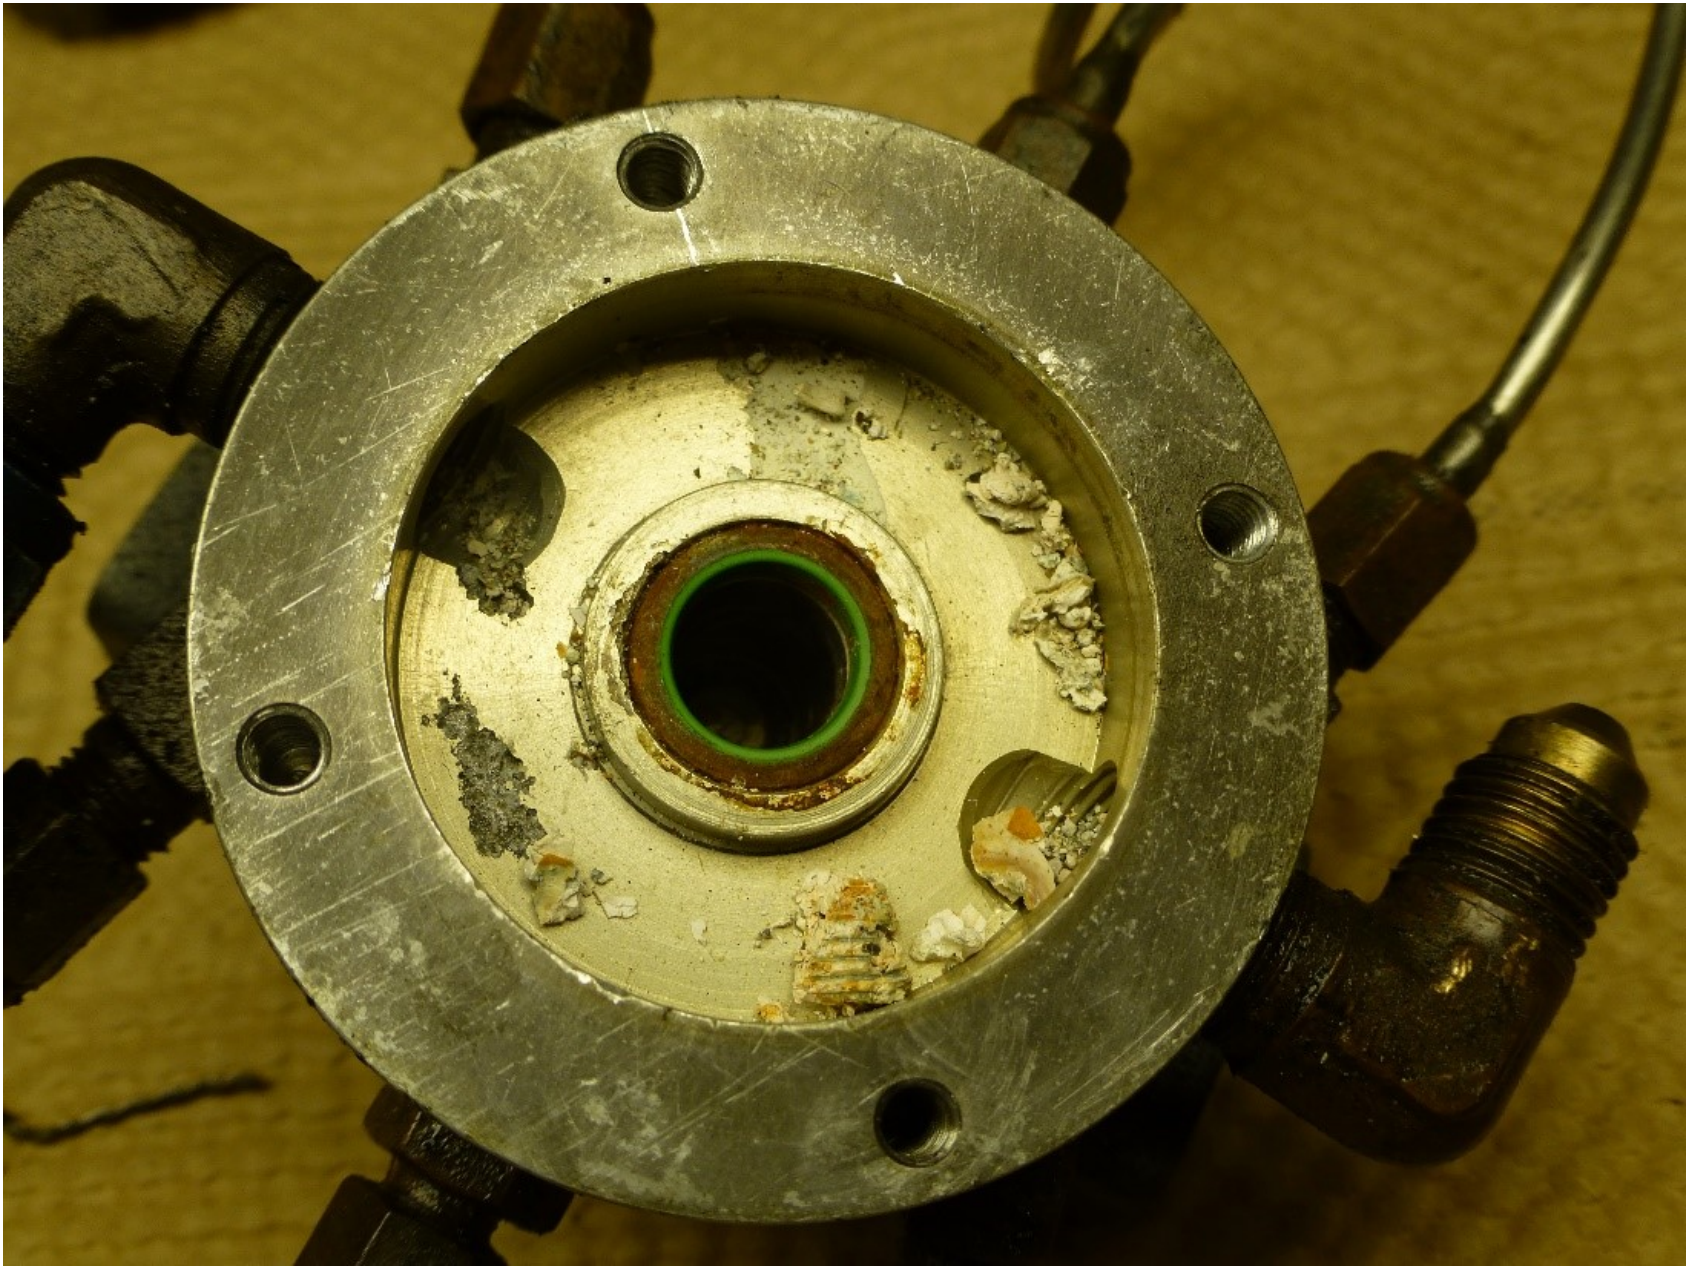
**Photo 6 – Aluminum oxide in the fuel manifold.**

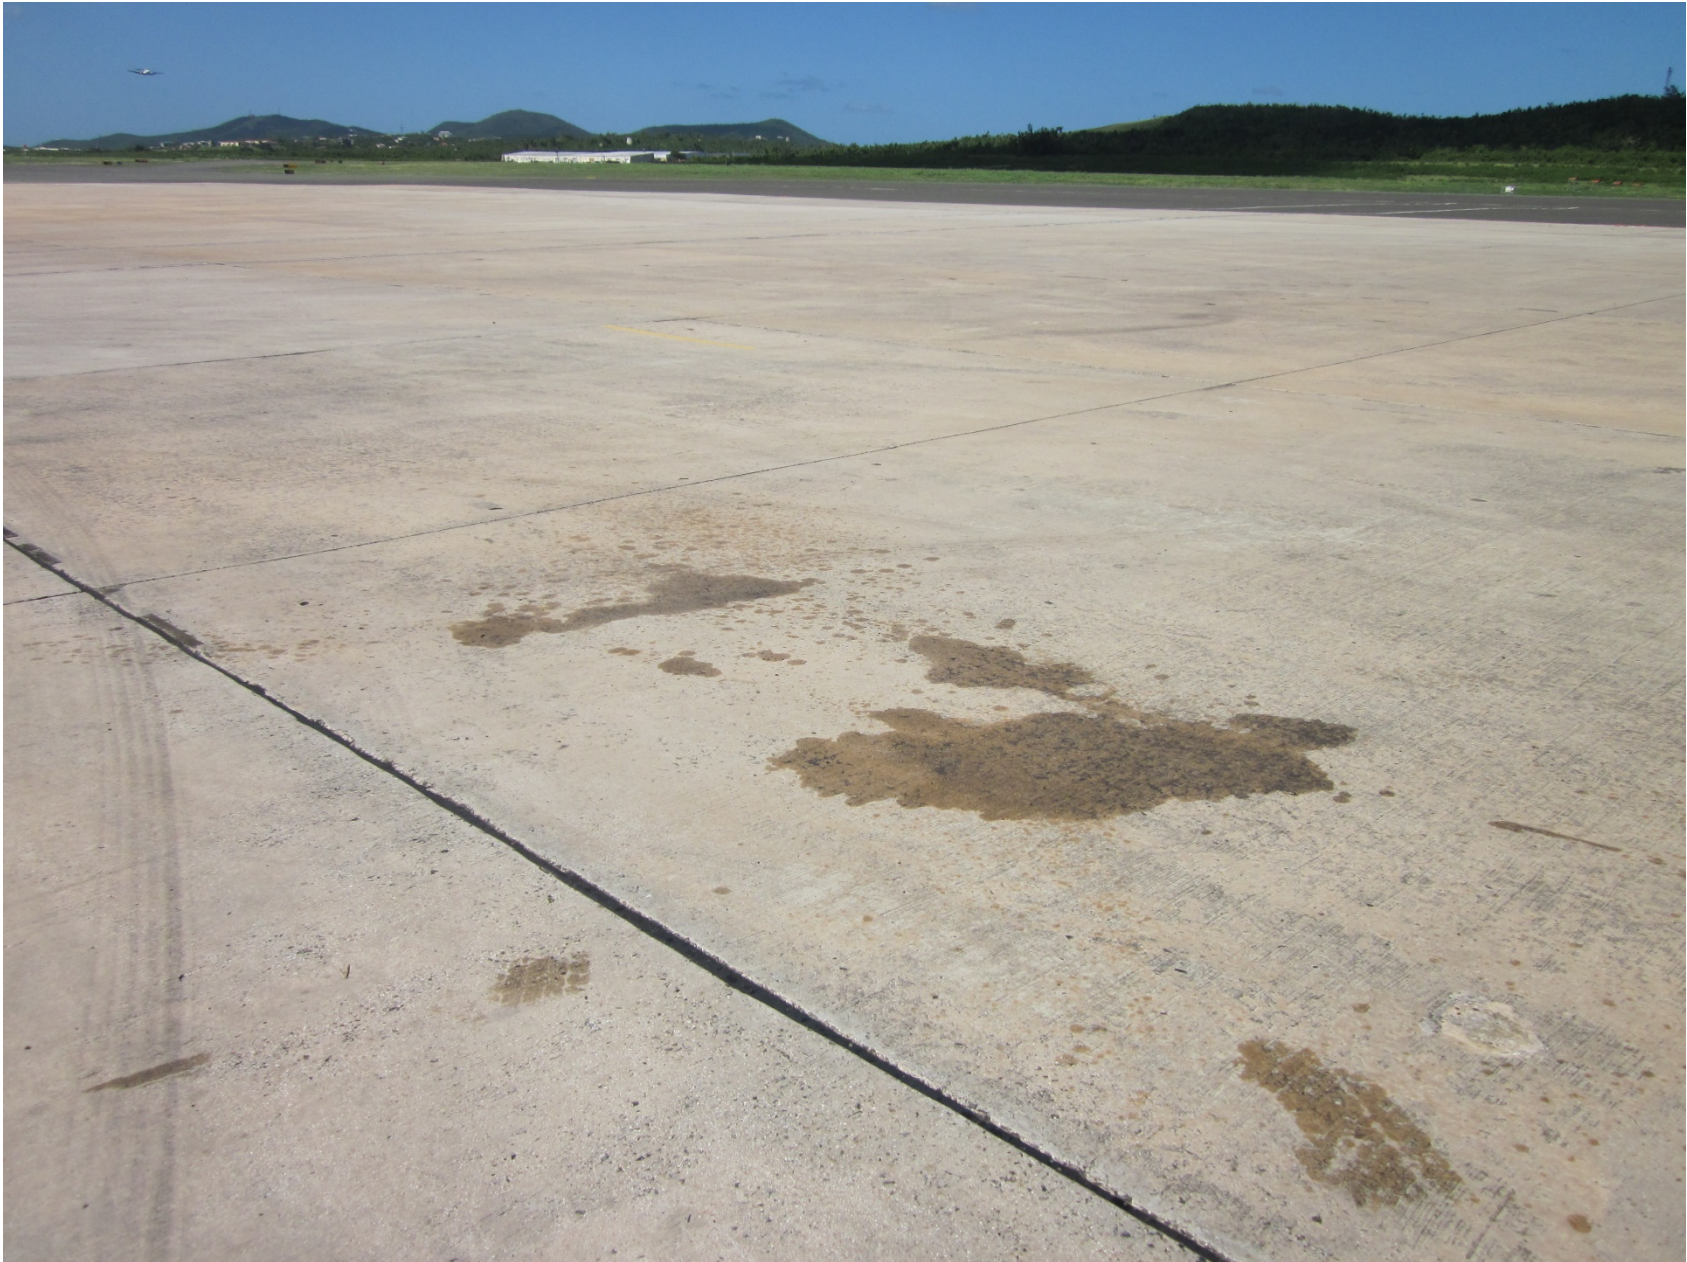
**Photo 7 – Stain on the ramp where N4484A was parked. (Photo courtesy of the FAA)**
