# NATIONAL TRANSPORTATION SAFETY BOARD

## MATERIALS LABORATORY FACTUAL REPORT

Report No. 18-068

Place : St. Croix, United States Virgin Islands  
Date : December 7, 2017  
Vehicle : Beech BE-58, N4494A  
NTSB No. : ERA18FA046  
Investigator : Millicent Hill, AS-ERA

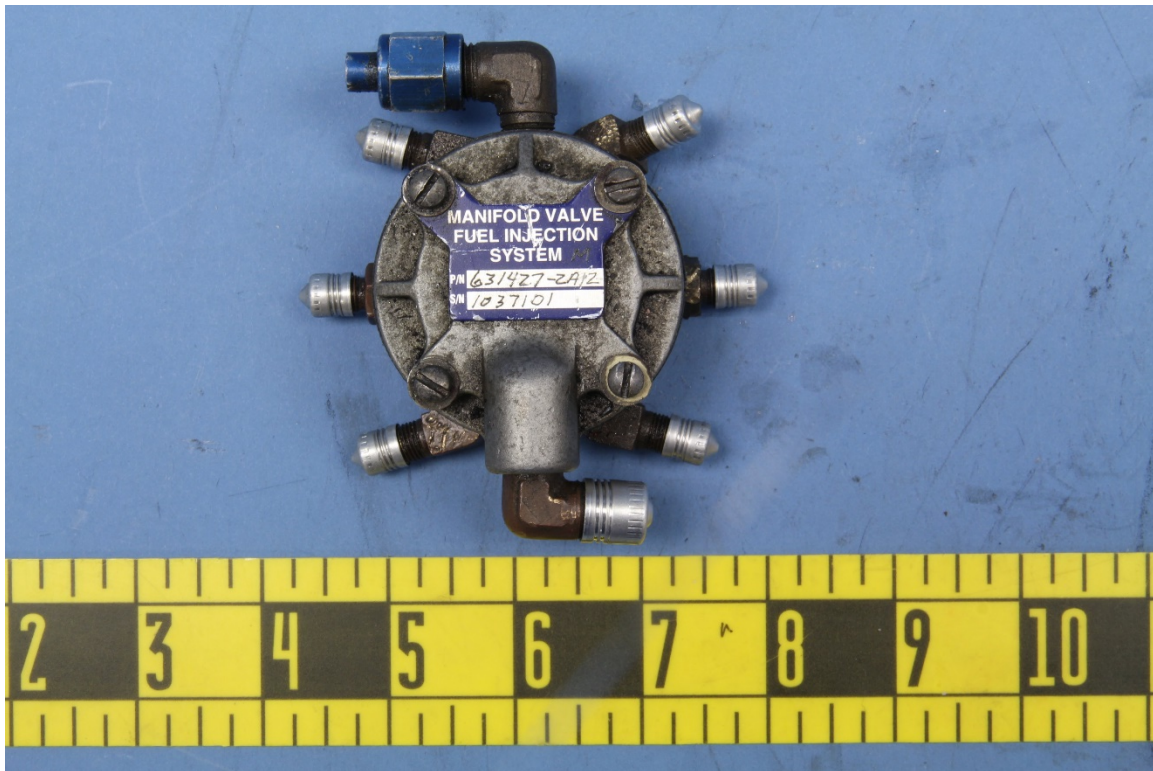
Figure 1 and Figure 2 show the fuel system manifold from the front (labeled) side and the reverse side, as received. The front sticker stated, "Manifold Valve, Fuel Injection System, P/N 631427-2A12, S/N 1037101." The reverse side exhibited a vibroetched serial number. In addition, the valve fittings were labeled using permanent marker 1 through 6, as shown in Figure 2. These positions were labeled prior to receipt by the NTSB Materials Laboratory.

Figure 1 – The fuel manifold assembly, as received, viewed from the front side.

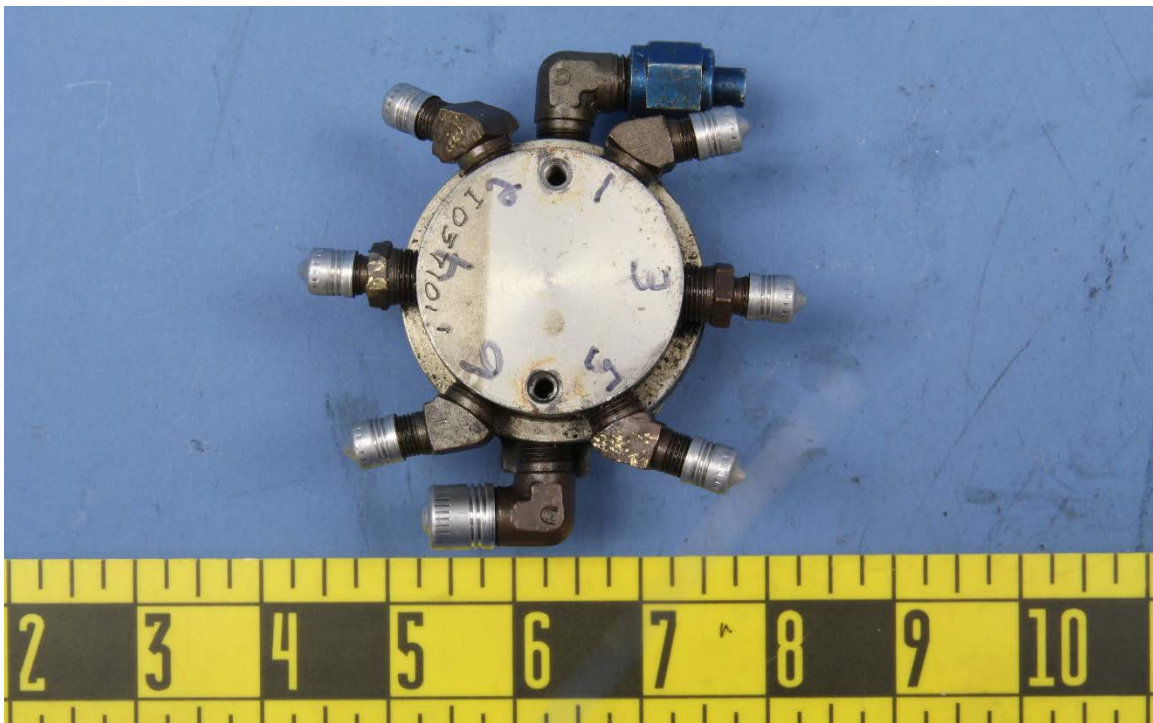
Figure 2 – The fuel manifold assembly, viewed from the reverse side, with labeled fitting locations.

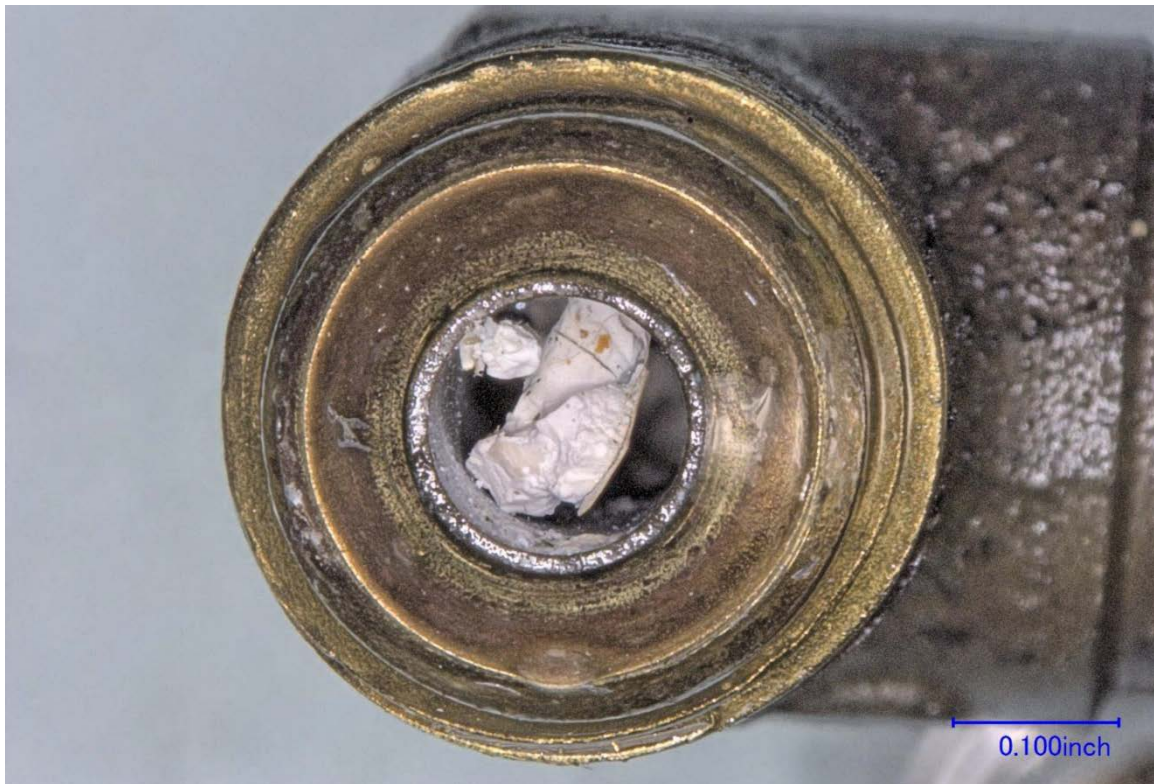
The backside valve fittings were examined and none contained any evidence of foreign material or contamination. However, the forward valve fittings (labeled positions 1.5 and 5.5 for the purposes of this report) did exhibit material in the internal channels. As

shown in Figure 3 and Figure 4, this material appeared dull white in color, with a general blocky and jagged morphology.

Figure 3 – Closer view of the 1.5 fitting orifice, showing white-colored material inside.

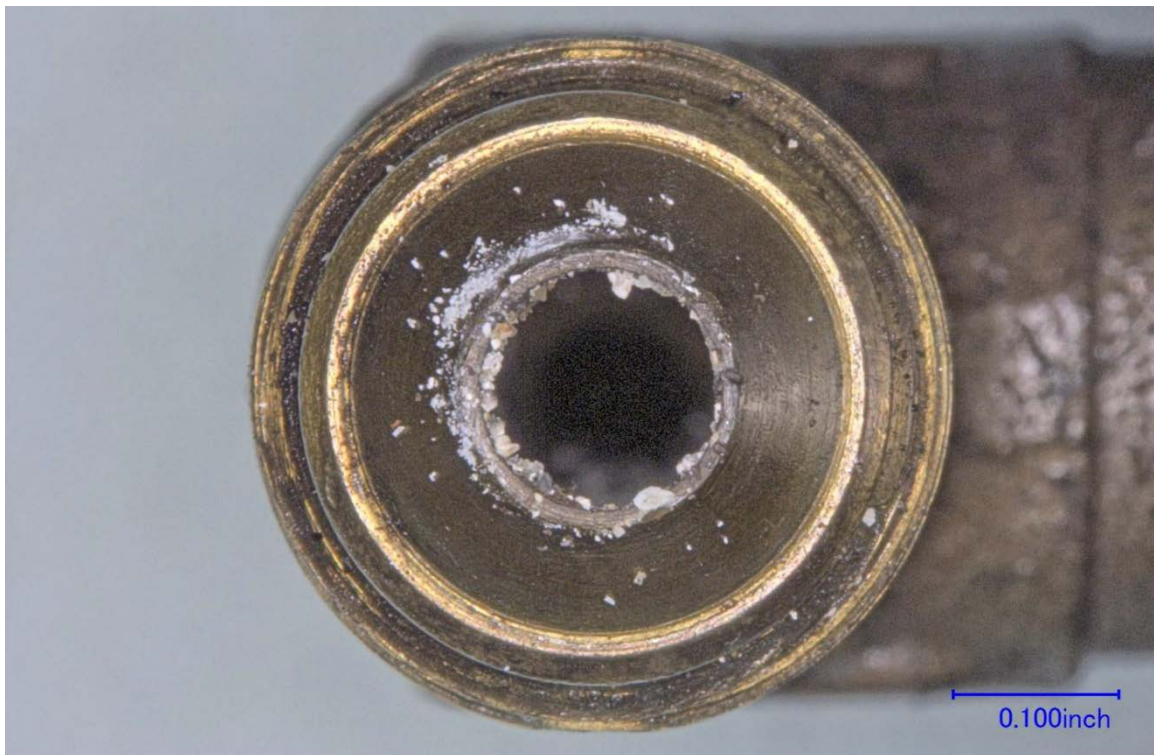
Figure 4 – Closer view of the 5.5 fitting orifice, showing white-colored material inside.

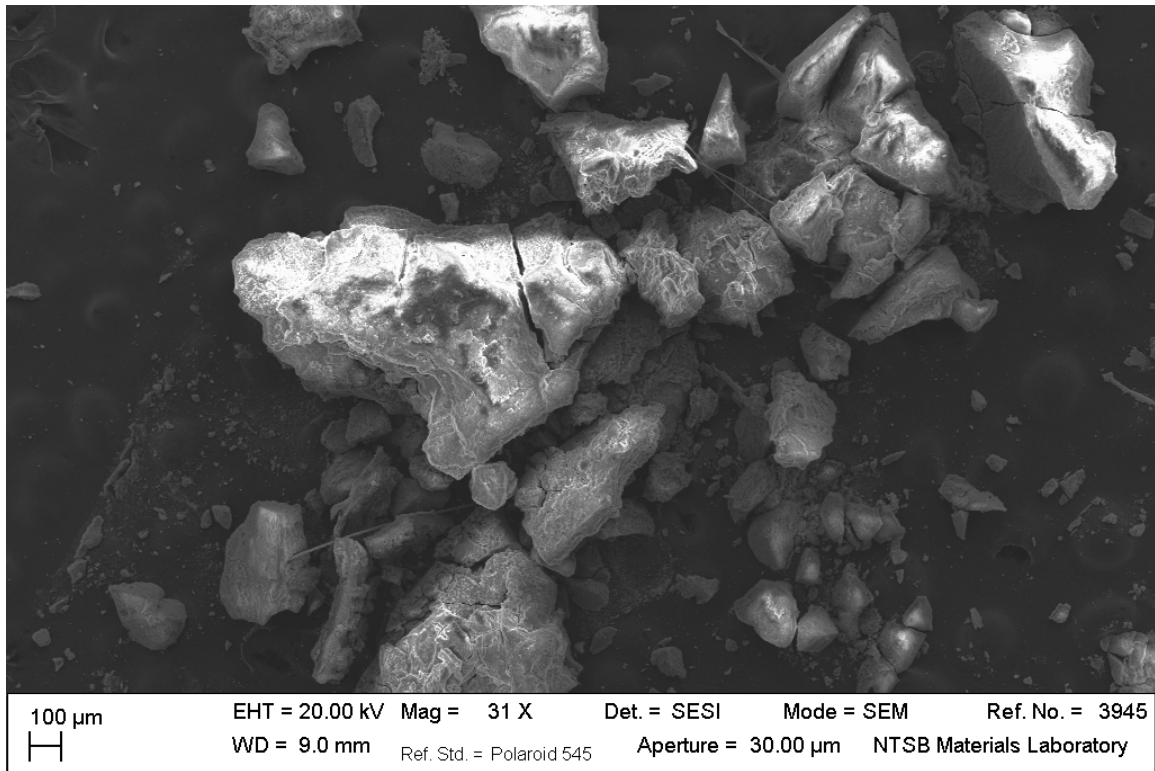
Some of this material was removed from the 1.5 valve fitting. The material fractured readily, consistent with a brittle material. Figure 5 shows some of this material as viewed using a scanning electron microscope (SEM). The material exhibited electron charging effects, consistent with the behavior of non-conductive materials examined using an electron beam. Figure 6 shows a closer view of a typical surface of this material. The surface (also exhibiting electron charging) exhibited a needle-like texture when viewed at high magnification.

Figure 5 – Secondary electron (SE) micrograph of the material removed from the 1.5 fitting.

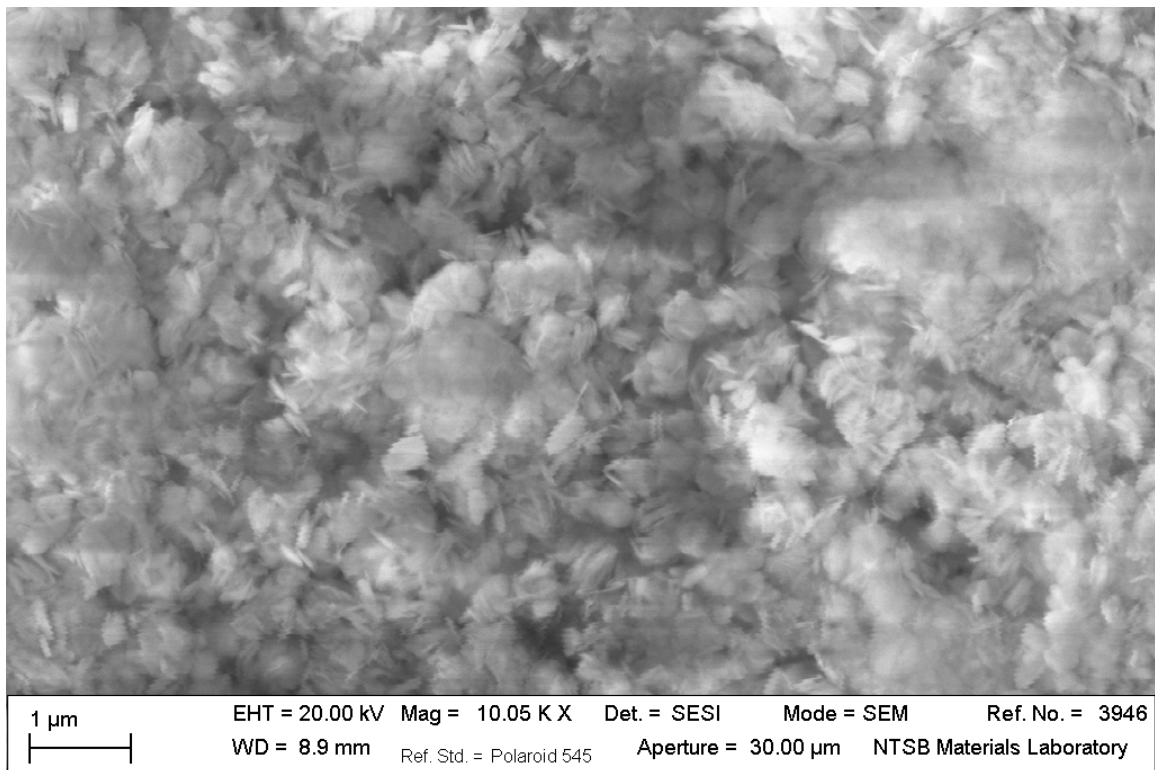
Figure 6 – SE micrograph of a closer view of the surface of the material from Figure 5.

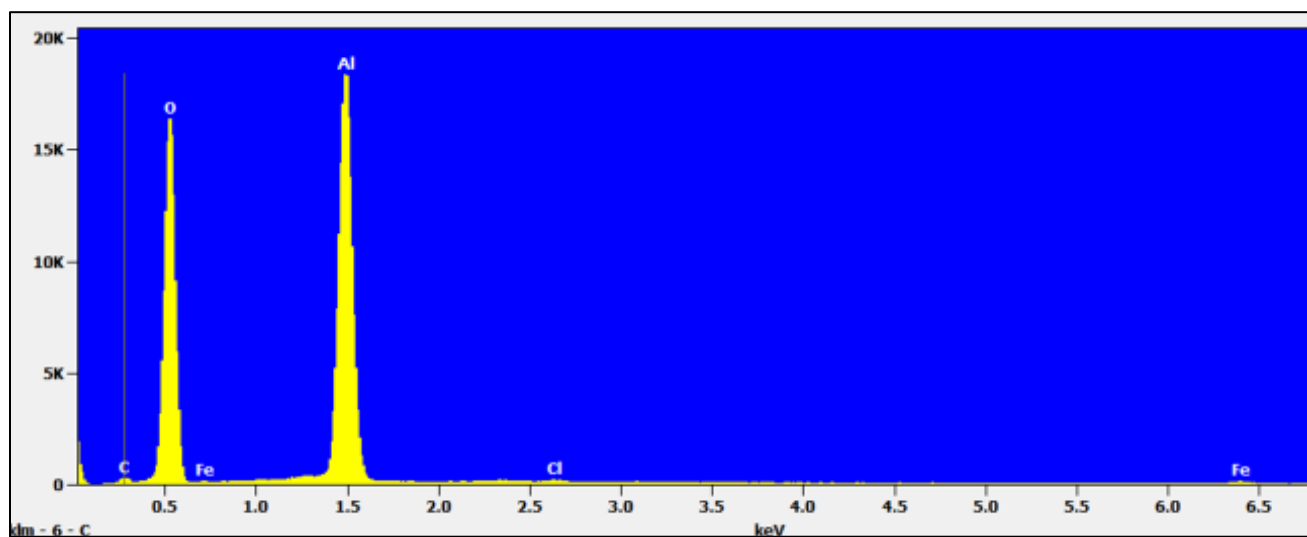
The material chemical composition was examined using energy dispersive x-ray spectroscopy (EDS). A typical spectrum is illustrated in Figure 7. As shown in the spectrum, the material exhibited high amounts of aluminum (Al) and oxygen (O), as well as detectable minor amounts of iron, chlorine, and carbon. The amount and proportion of these elements was consistent with aluminum oxide ( $\text{Al}_2\text{O}_3$ ). The other observed properties of the material found manifold valve fittings would be consistent with those of aluminum oxide.

Figure 7 – EDS spectrum of the area in Figure 6, showing high levels of aluminum and oxygen.
