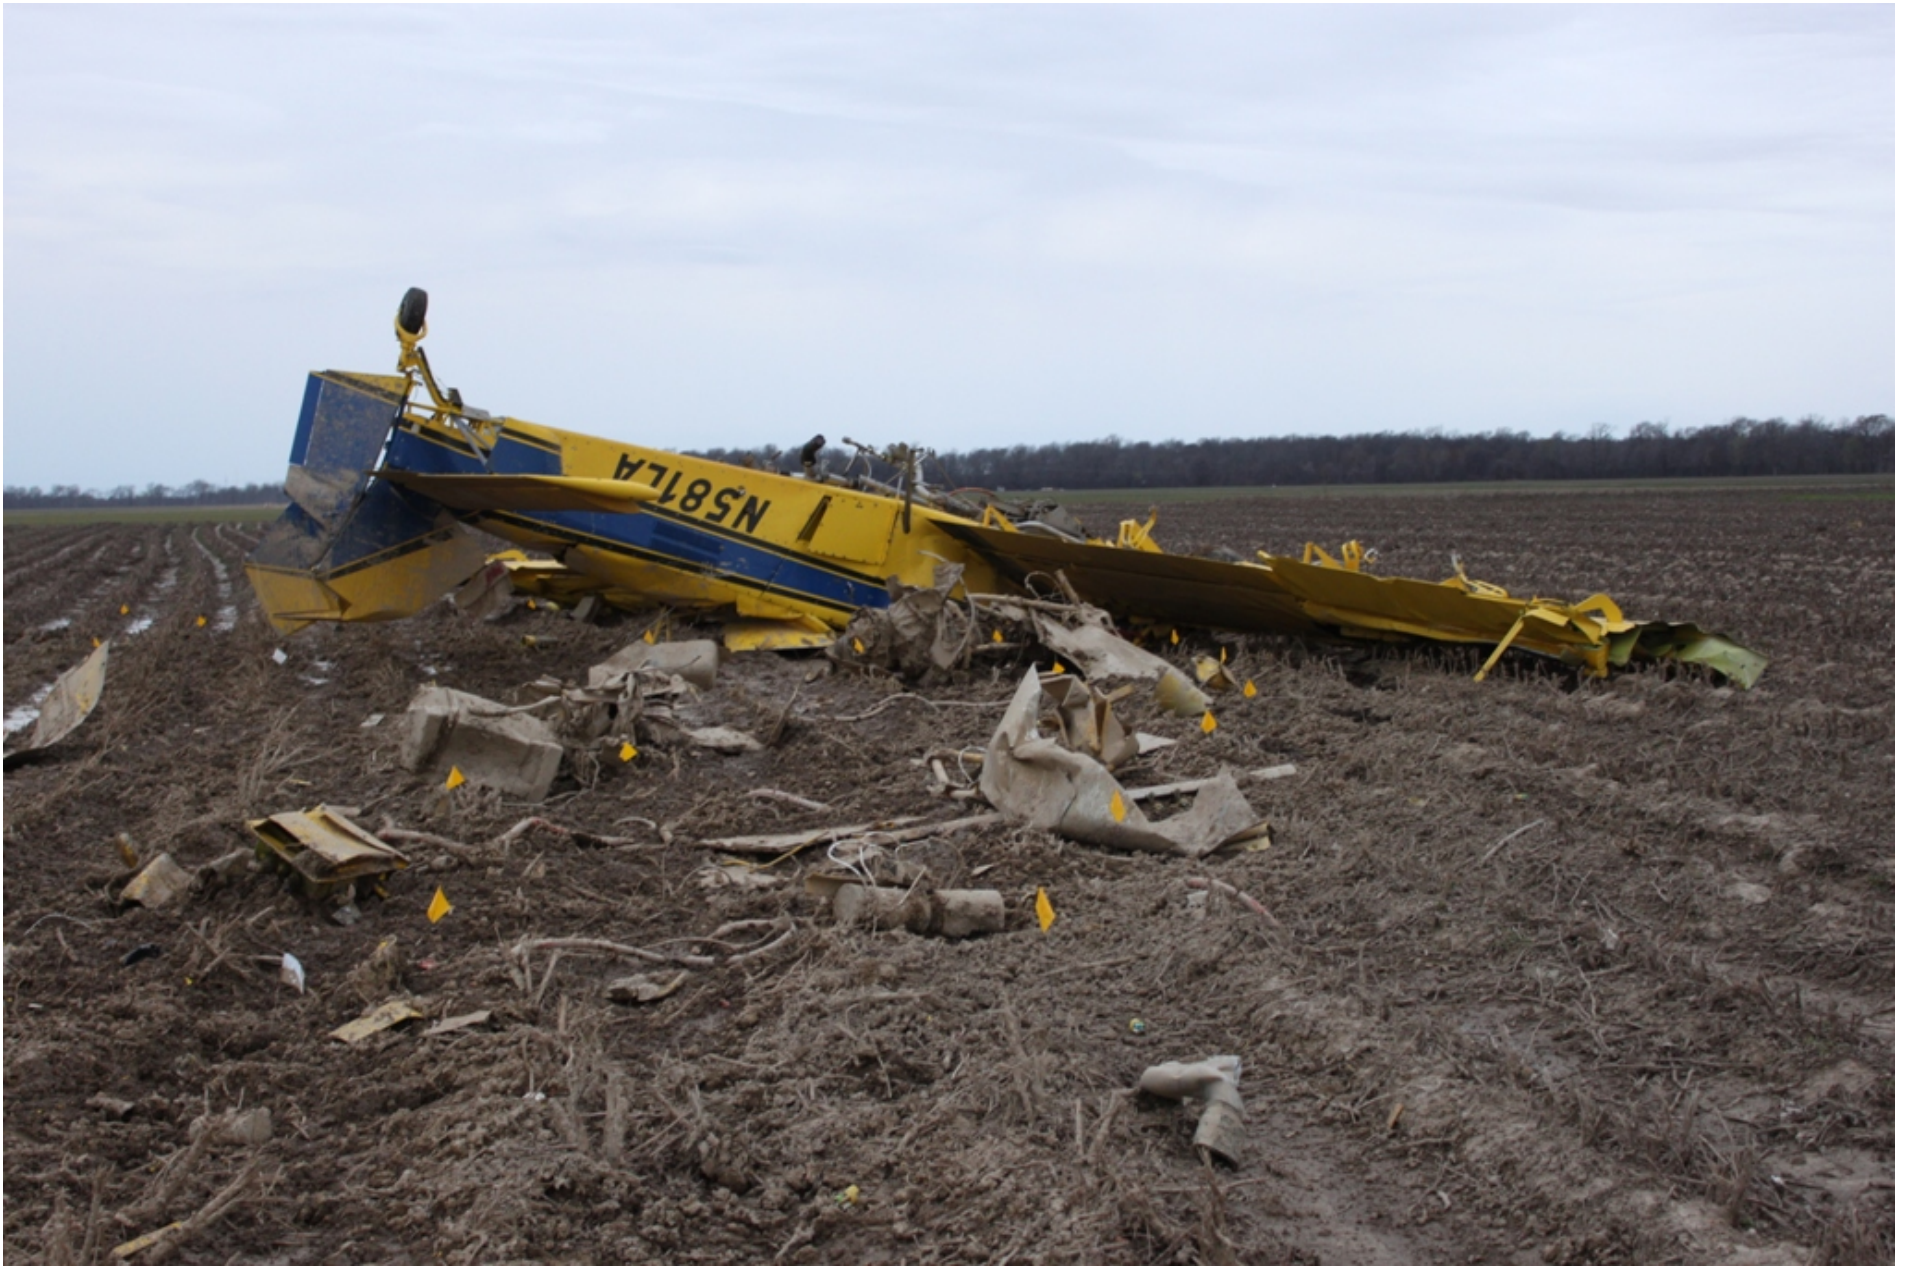
**Photo 1 – NTSB Digital Photograph. Left Side View of the Inverted Airplane at the Accident Site.**

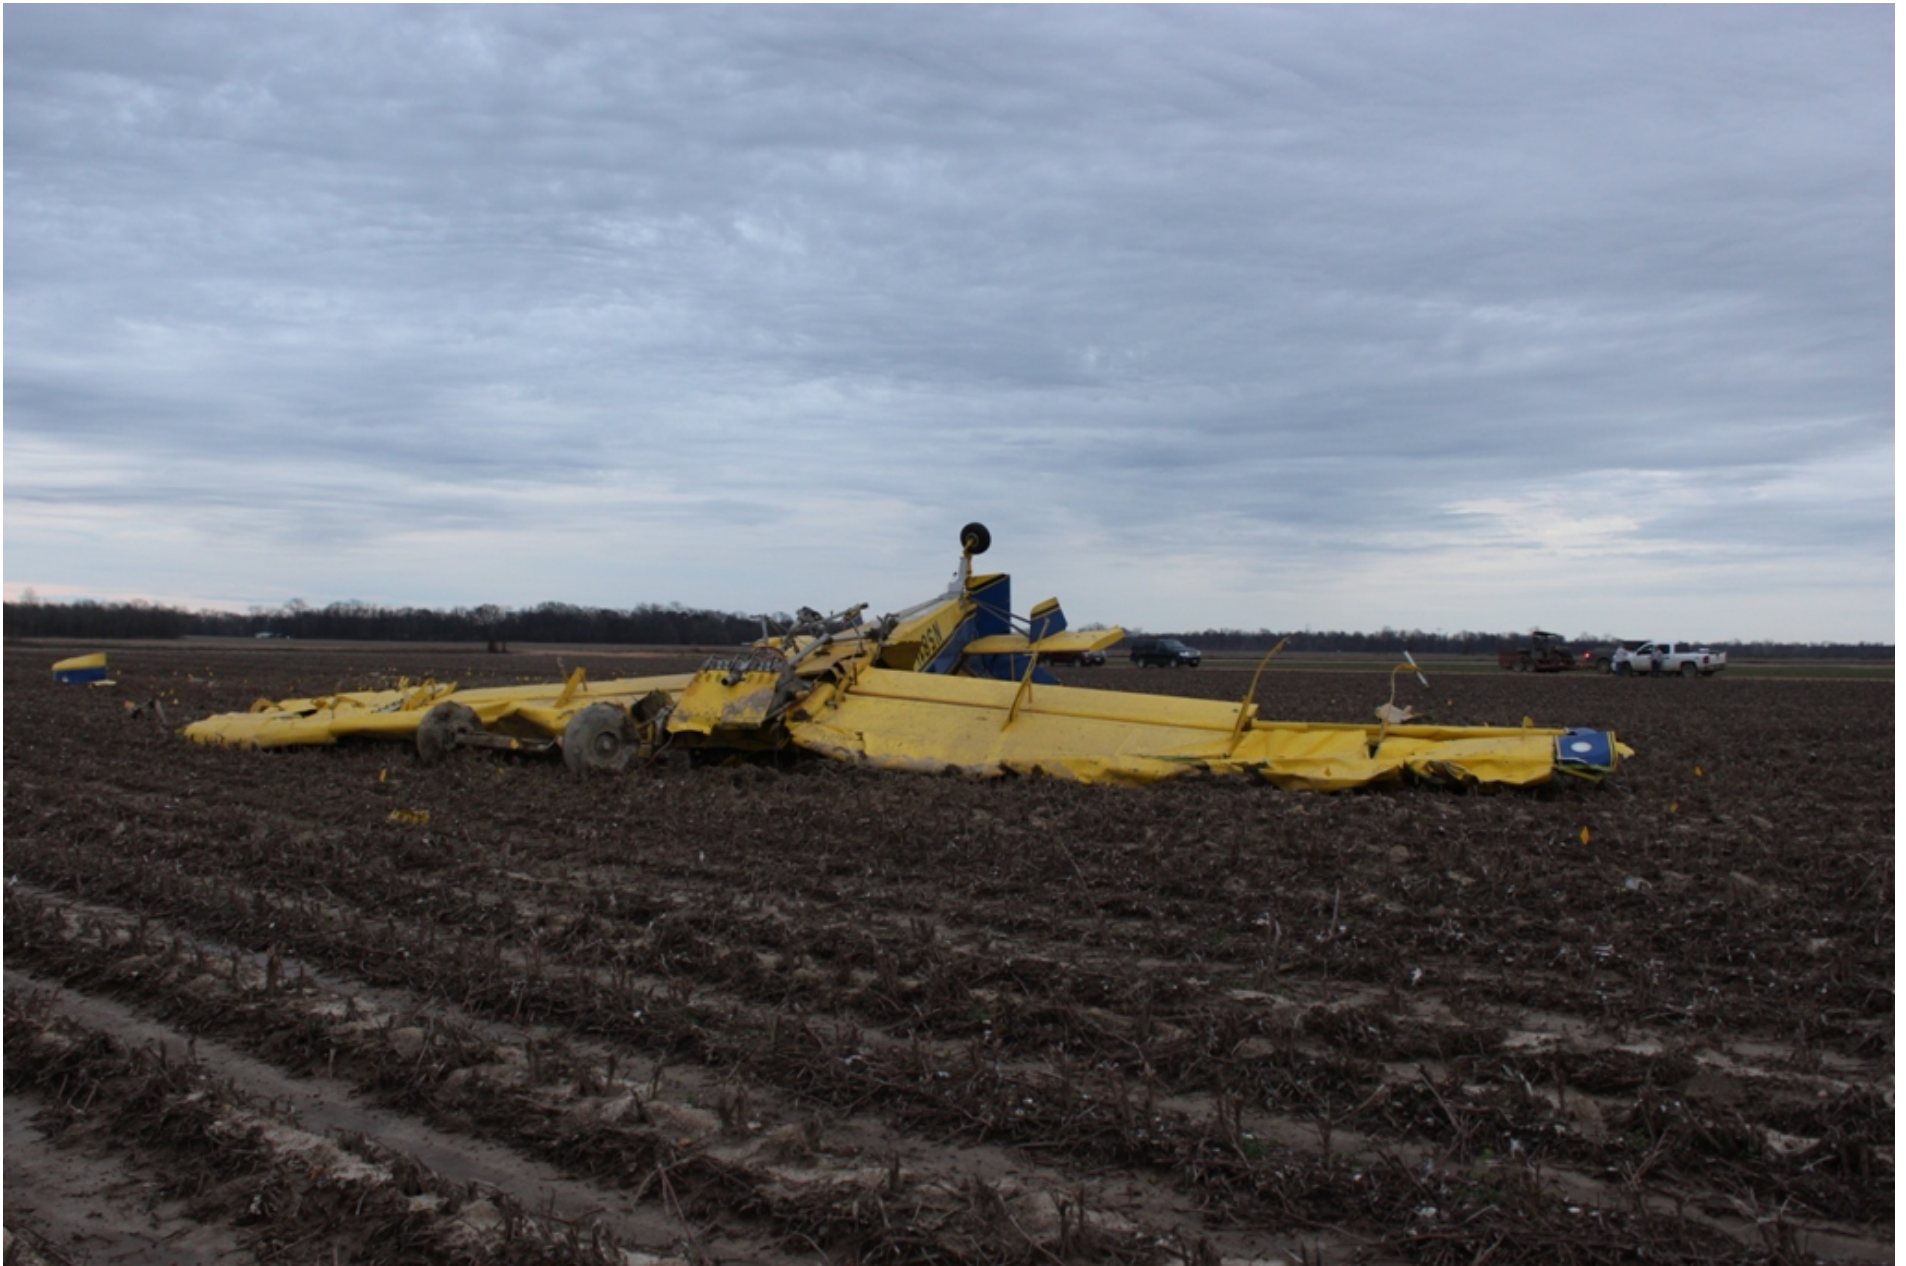
**Photo 2 – NTSB Digital Photograph. Forward View of the Inverted Airplane at the Accident Site. Note the damage to the Leading Edge's of Both Wings.**

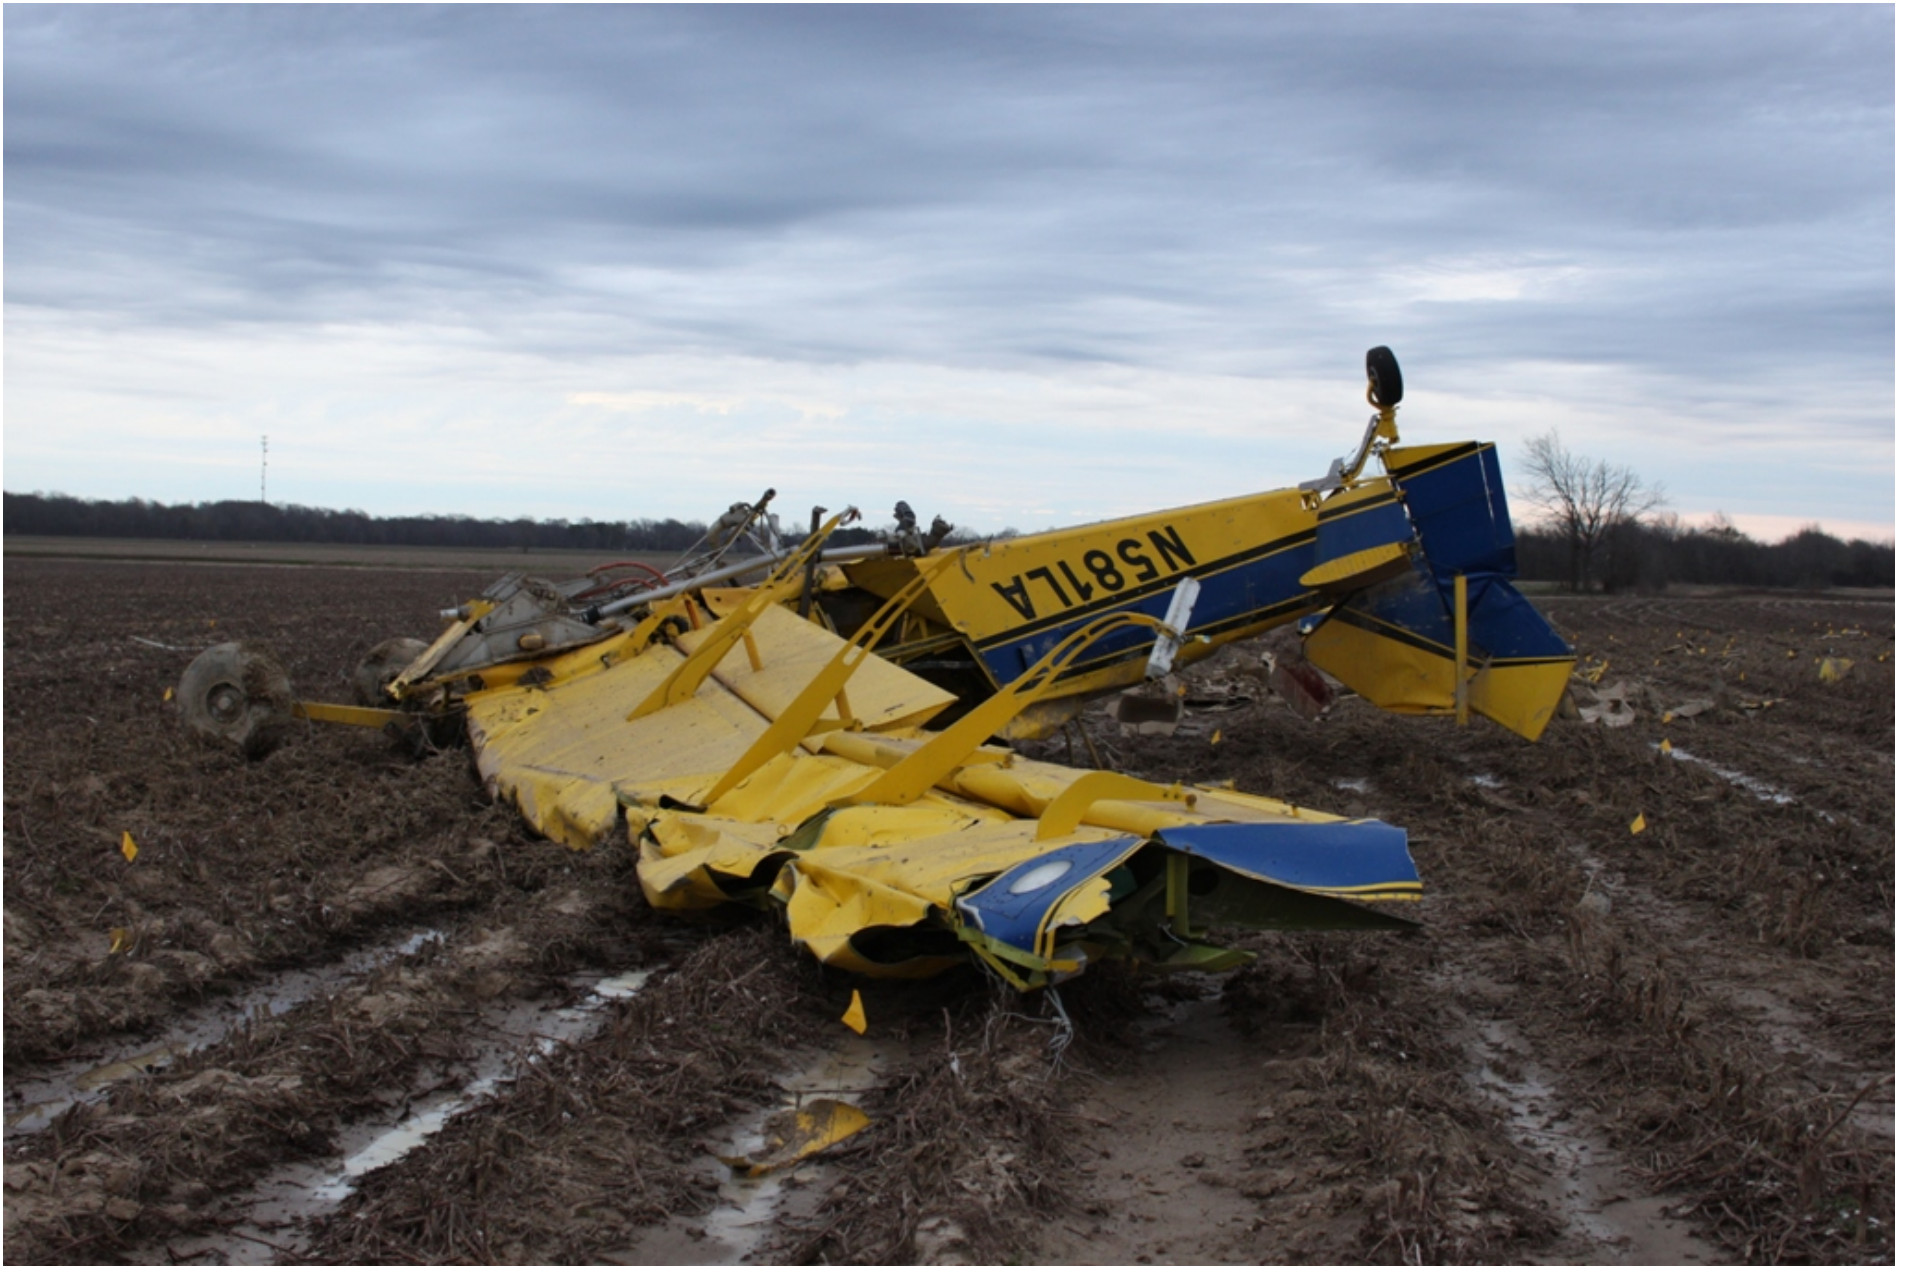
**Photo 3 - NTSB Digital Photograph. Close-Up View of the Right Wing and Right Side of the Inverted Airplane at the Accident Site. Note the Damage to the Leading Edge of the Right Wing.**

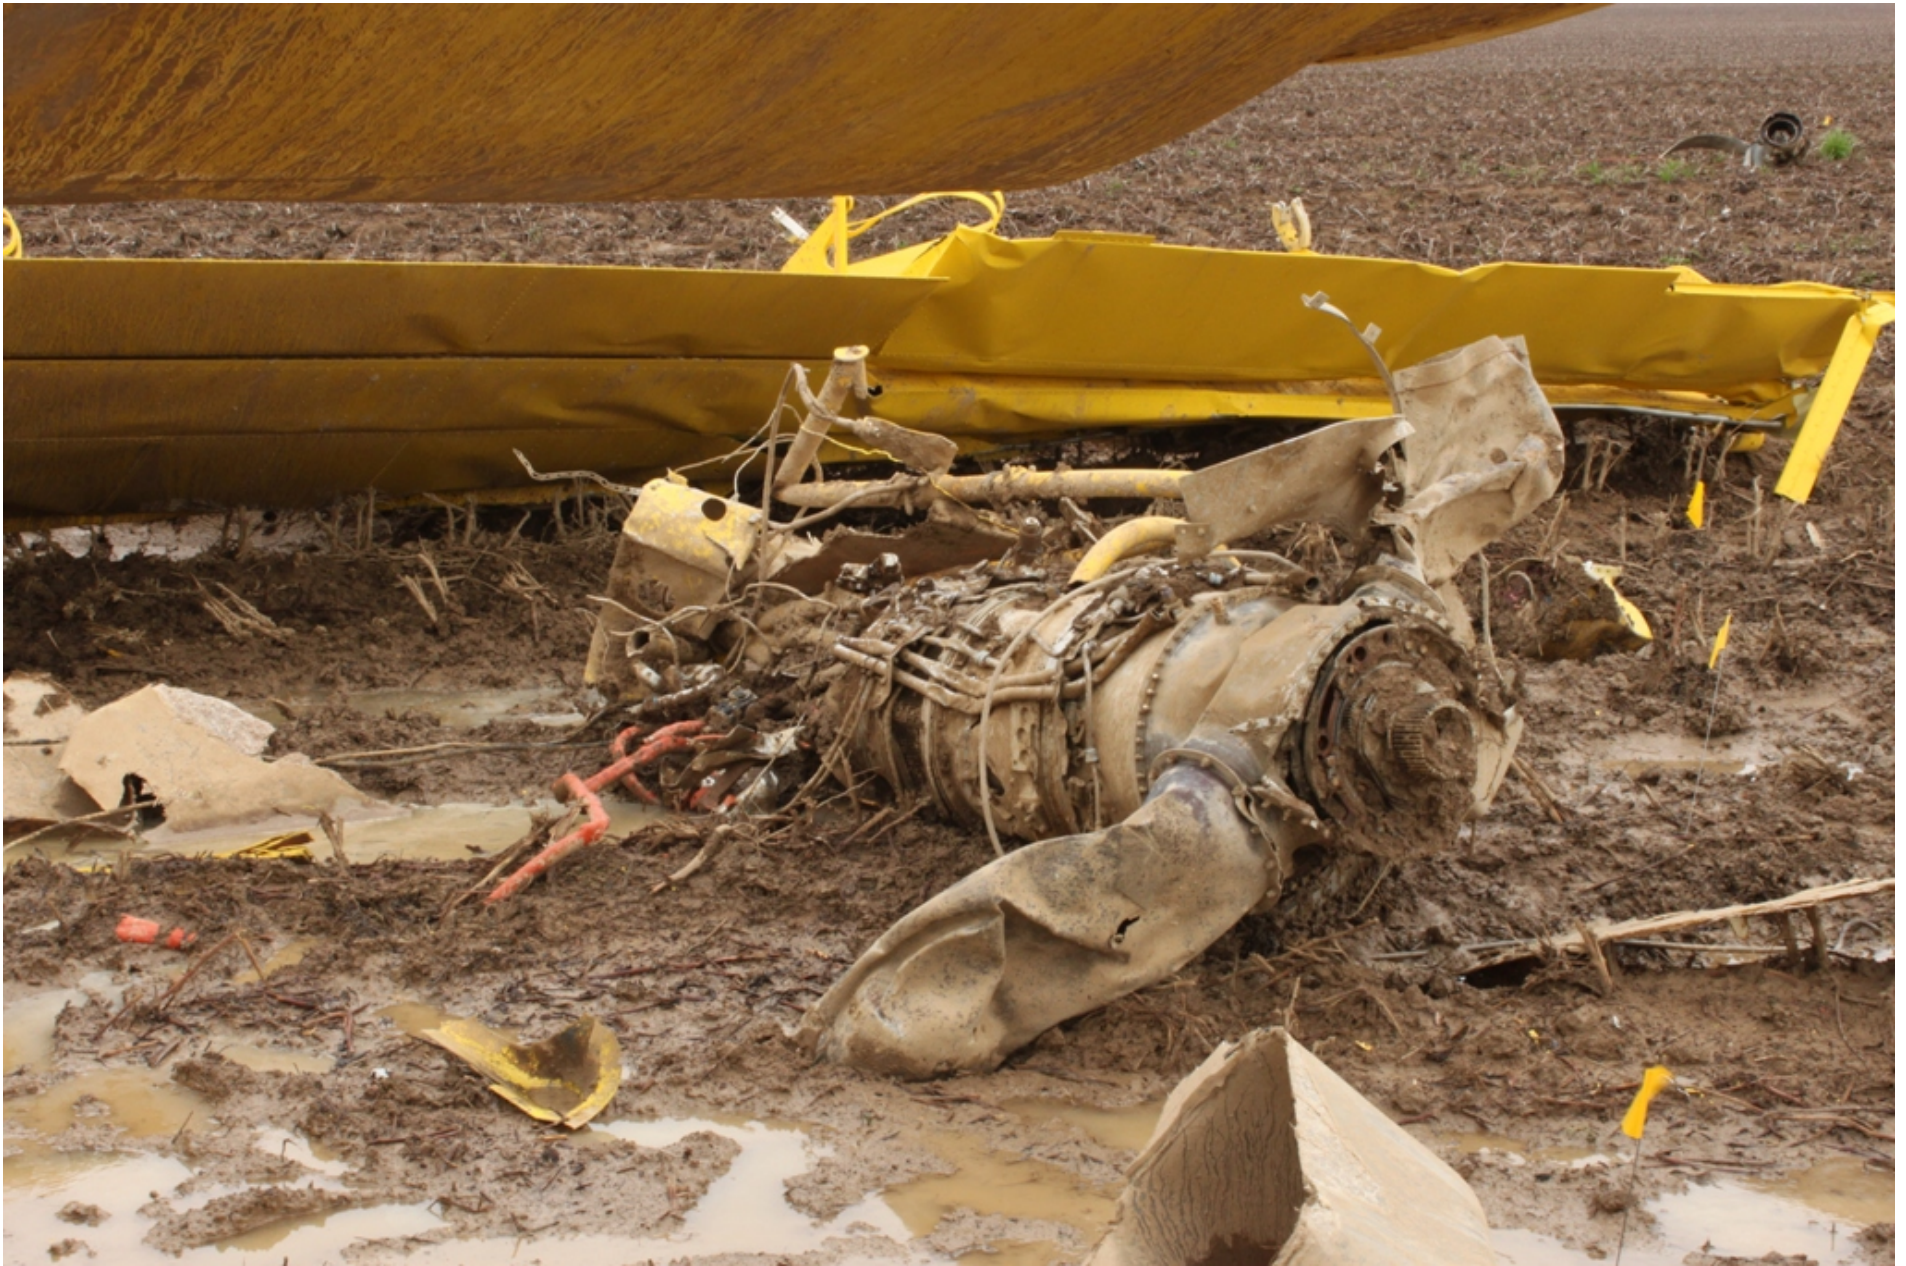
**Photo 4 - NTSB Digital Photograph. Close-Up View of the Separated Engine Assembly behind Left Wing of Inverted Airplane at the Accident Site.**

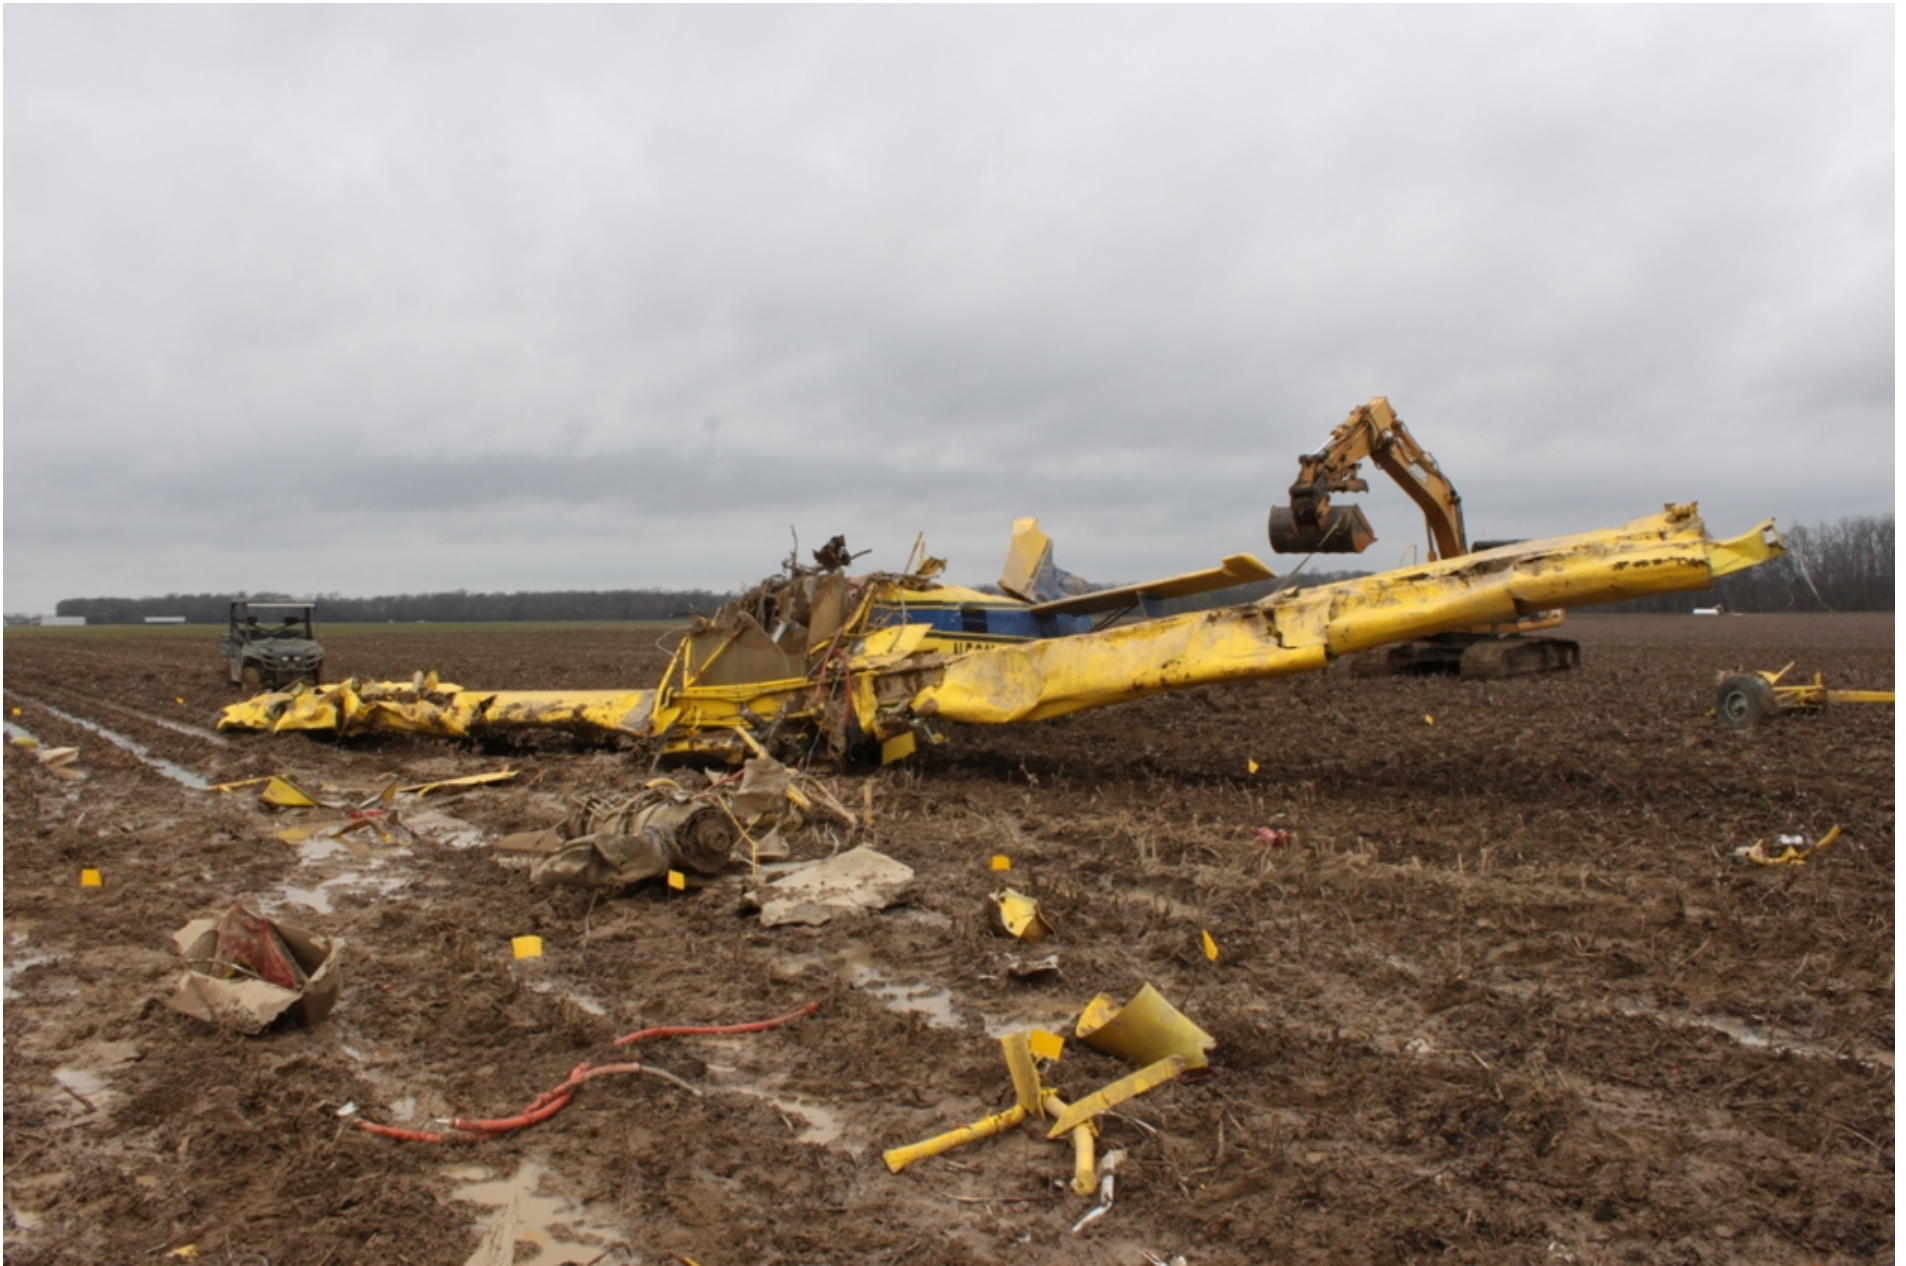
**Photo 5 - NTSB Digital Photograph. View of the Airplane at the Accident Site Following Being Uprighted. Note the damage to the Leading Edge's of Both Wings.**

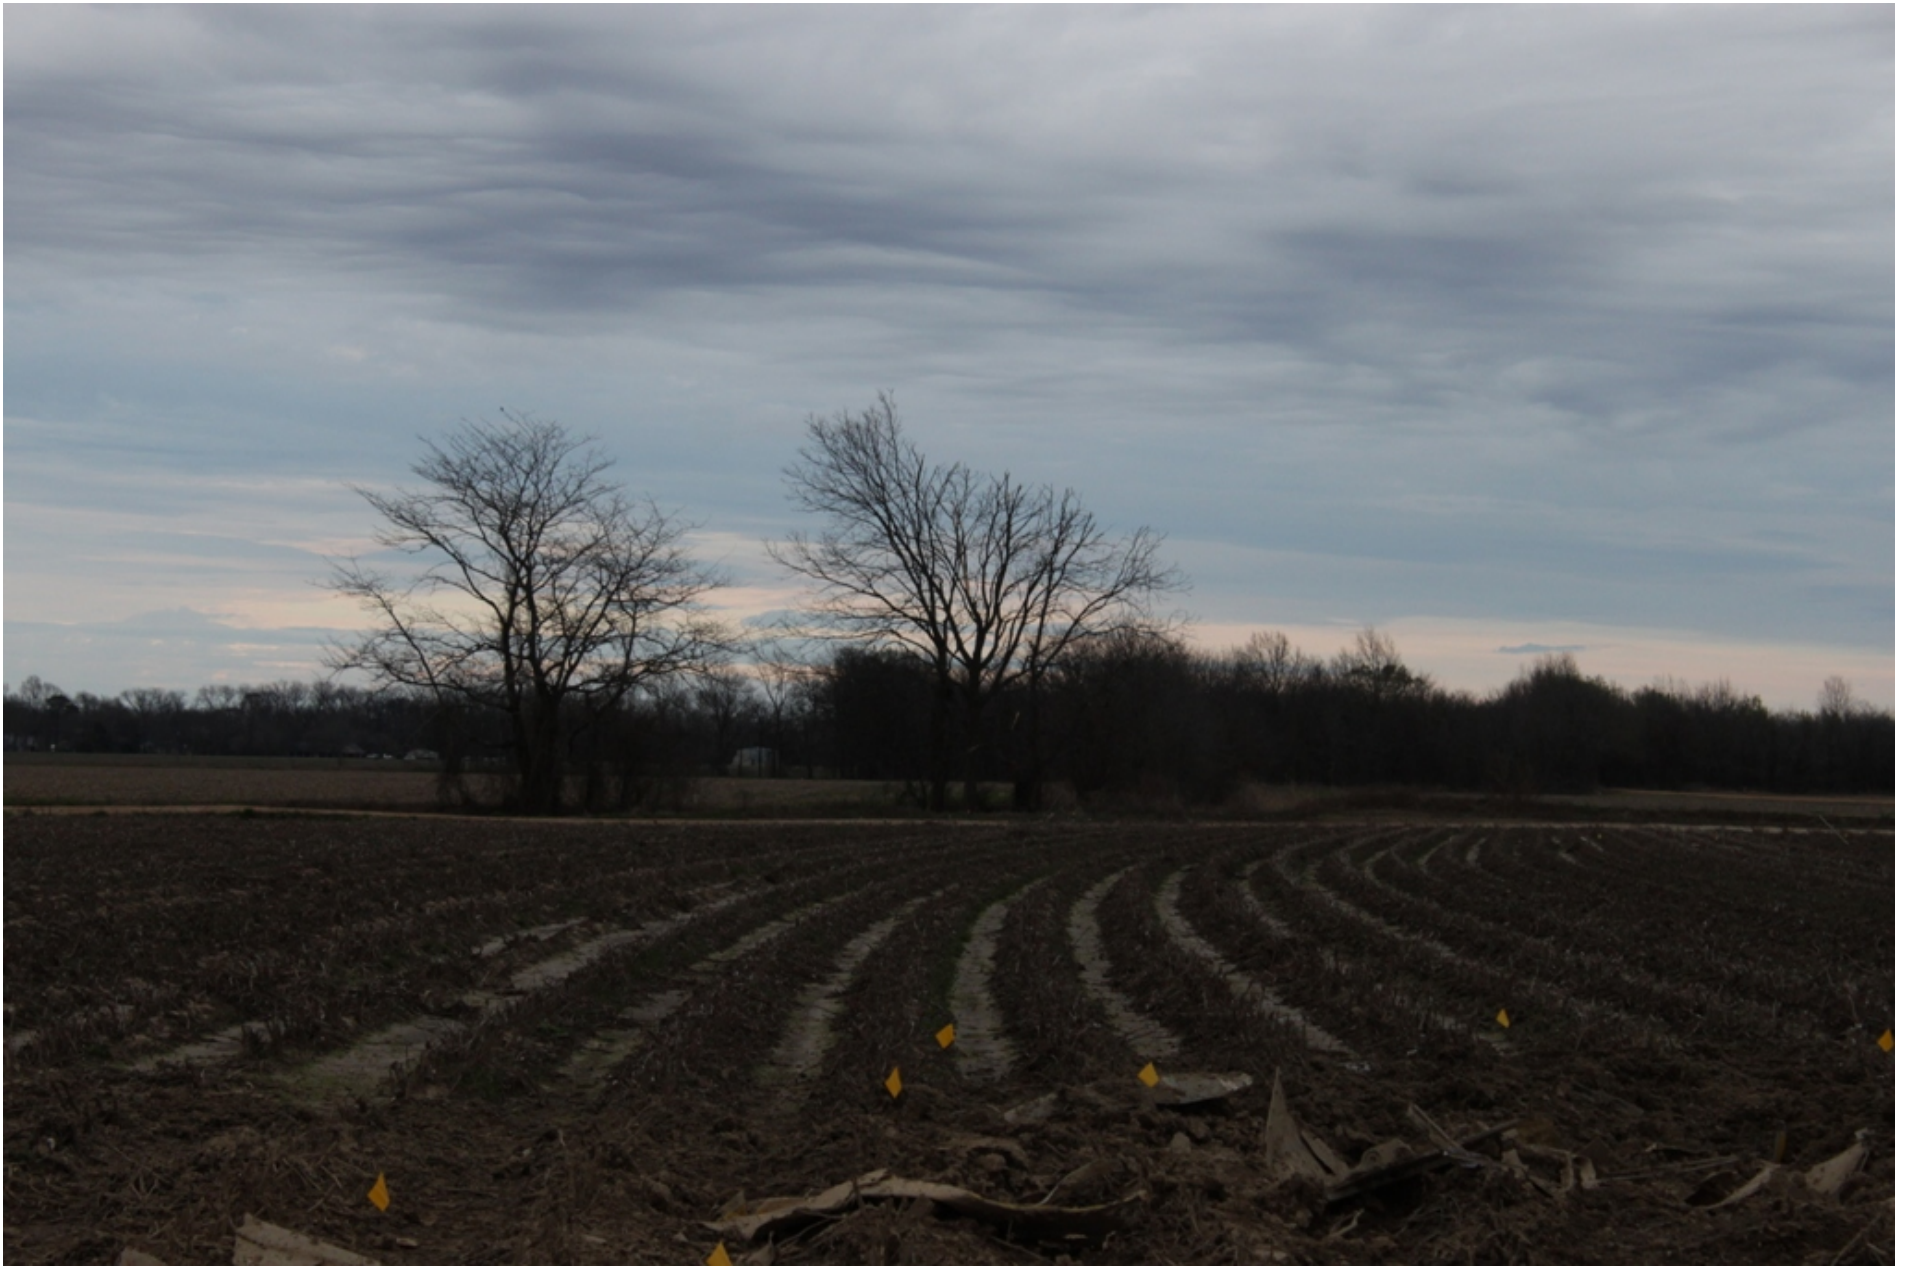
**Photo 6 - NTSB Digital Photograph. View taken from the Initial Ground Impact Looking to the East Depicting the Impacted Tree to the Right. Note the Angle of the Cut Limbs/Branches.**

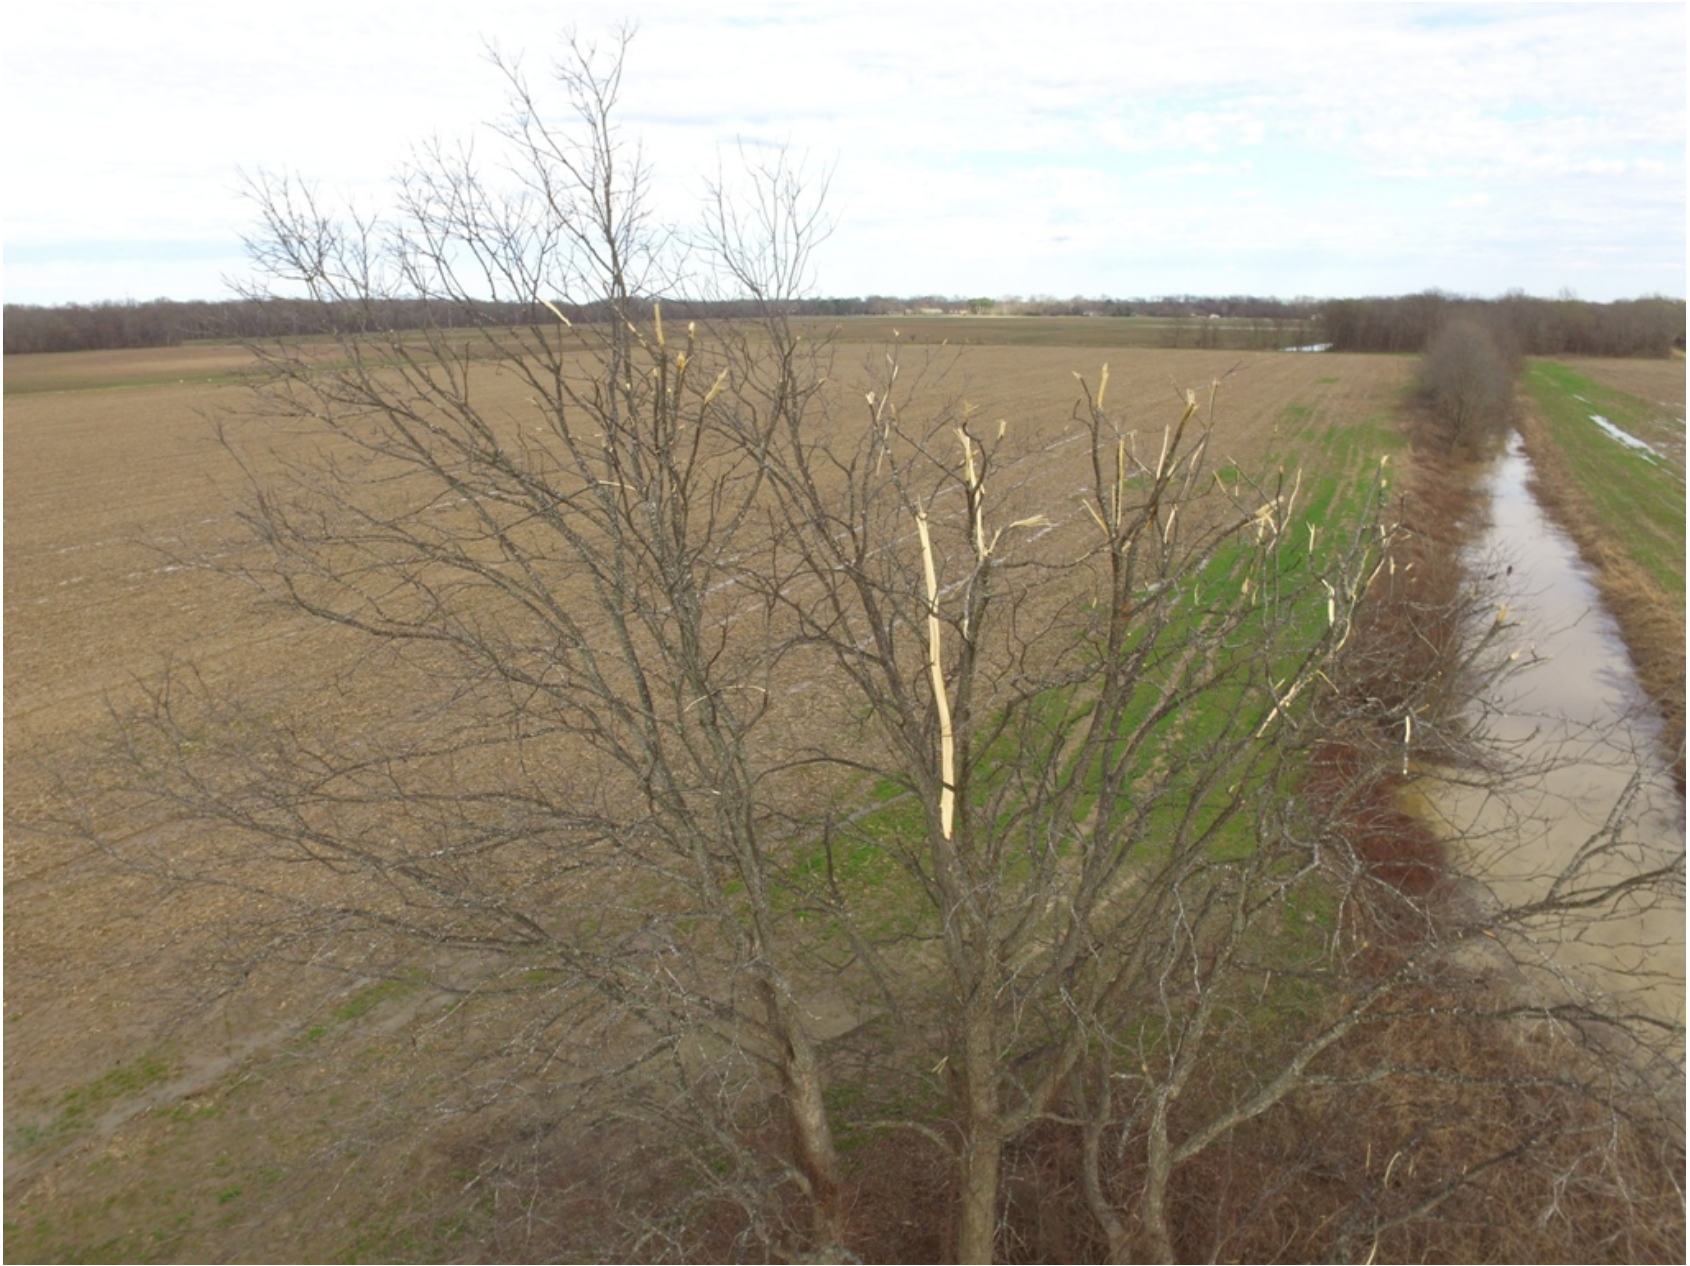
**Photo 7 – Drone Image Provided by Doug Clark. View Looking to the Northwest Depicting the Cut and Broken Tree Branches/Limbs.**

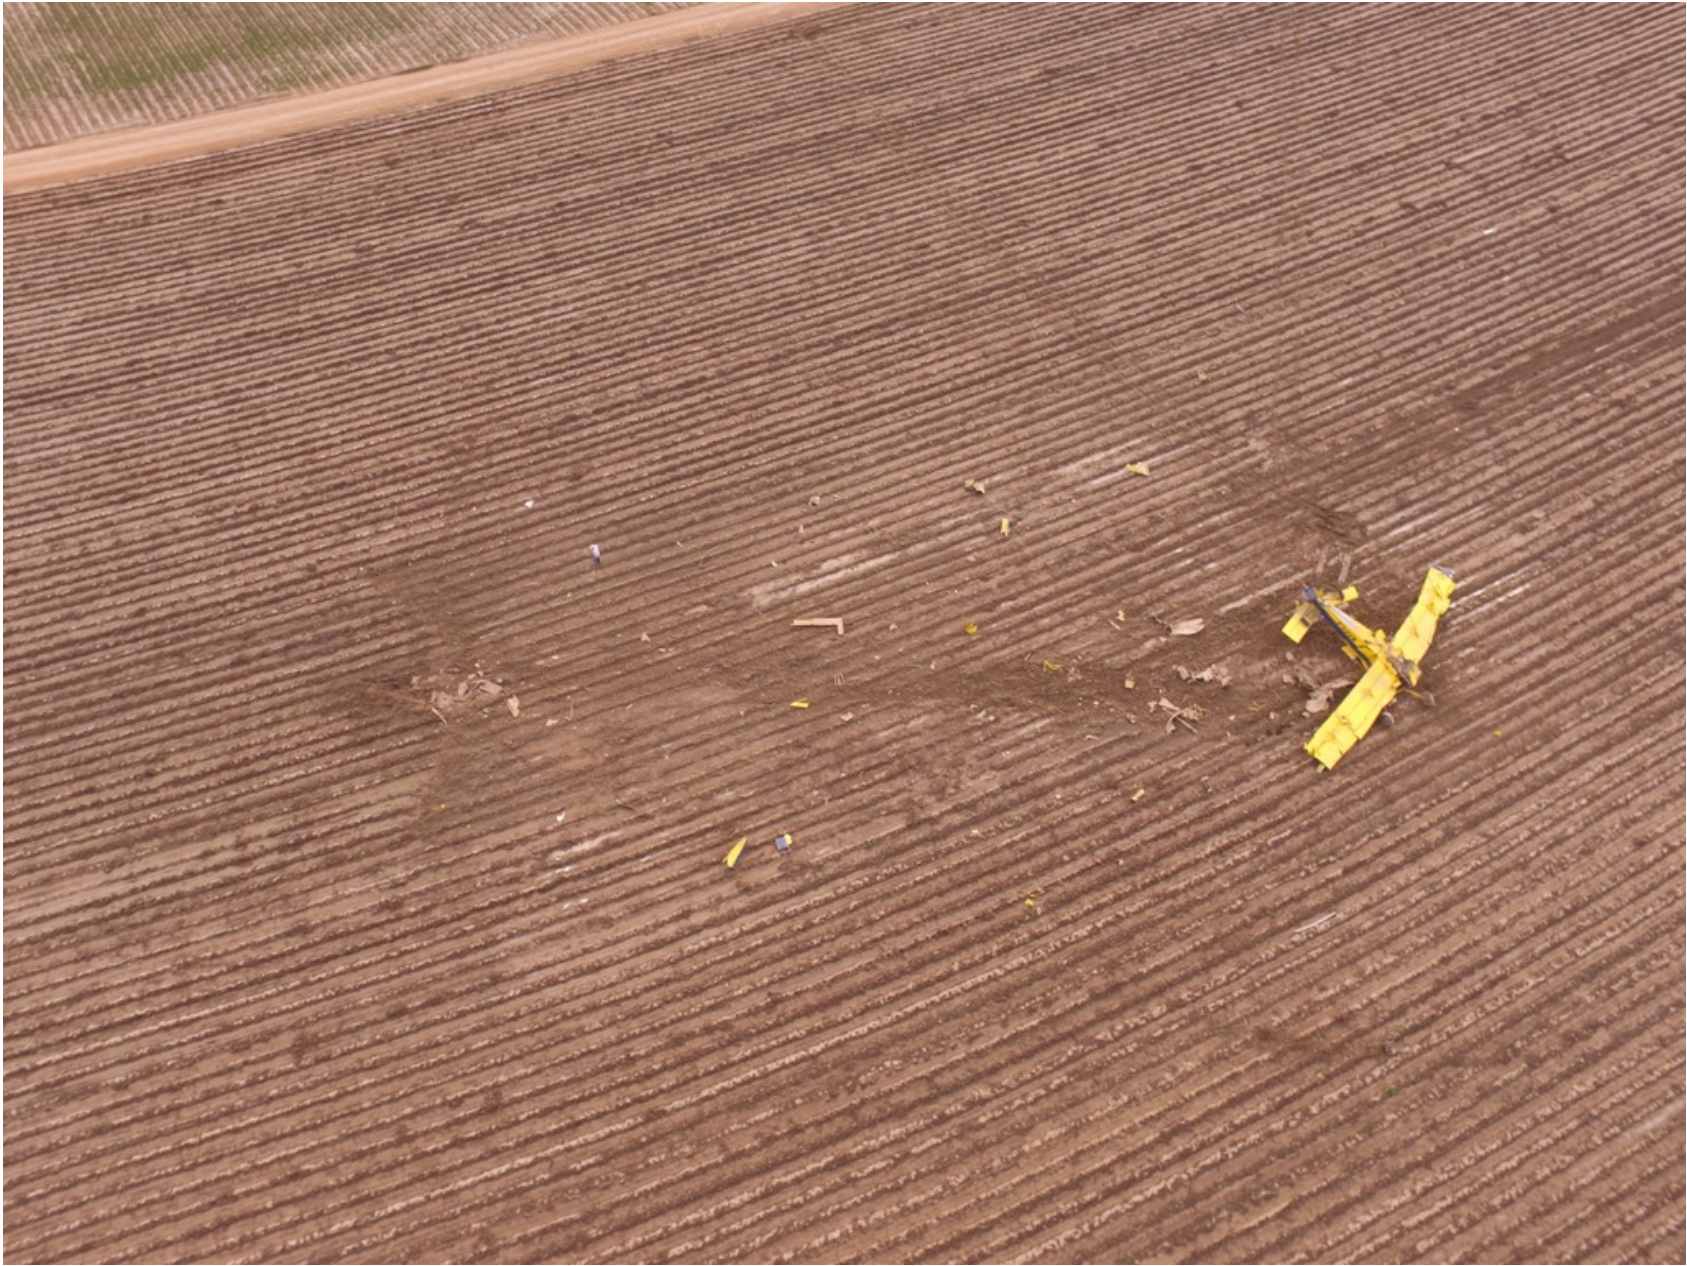
**Photo 8 - Drone Image Provided by Doug Clark. View Depicting the Initial Impact Crater, Ground Scar, and Inverted Airplane at the Accident Site.**

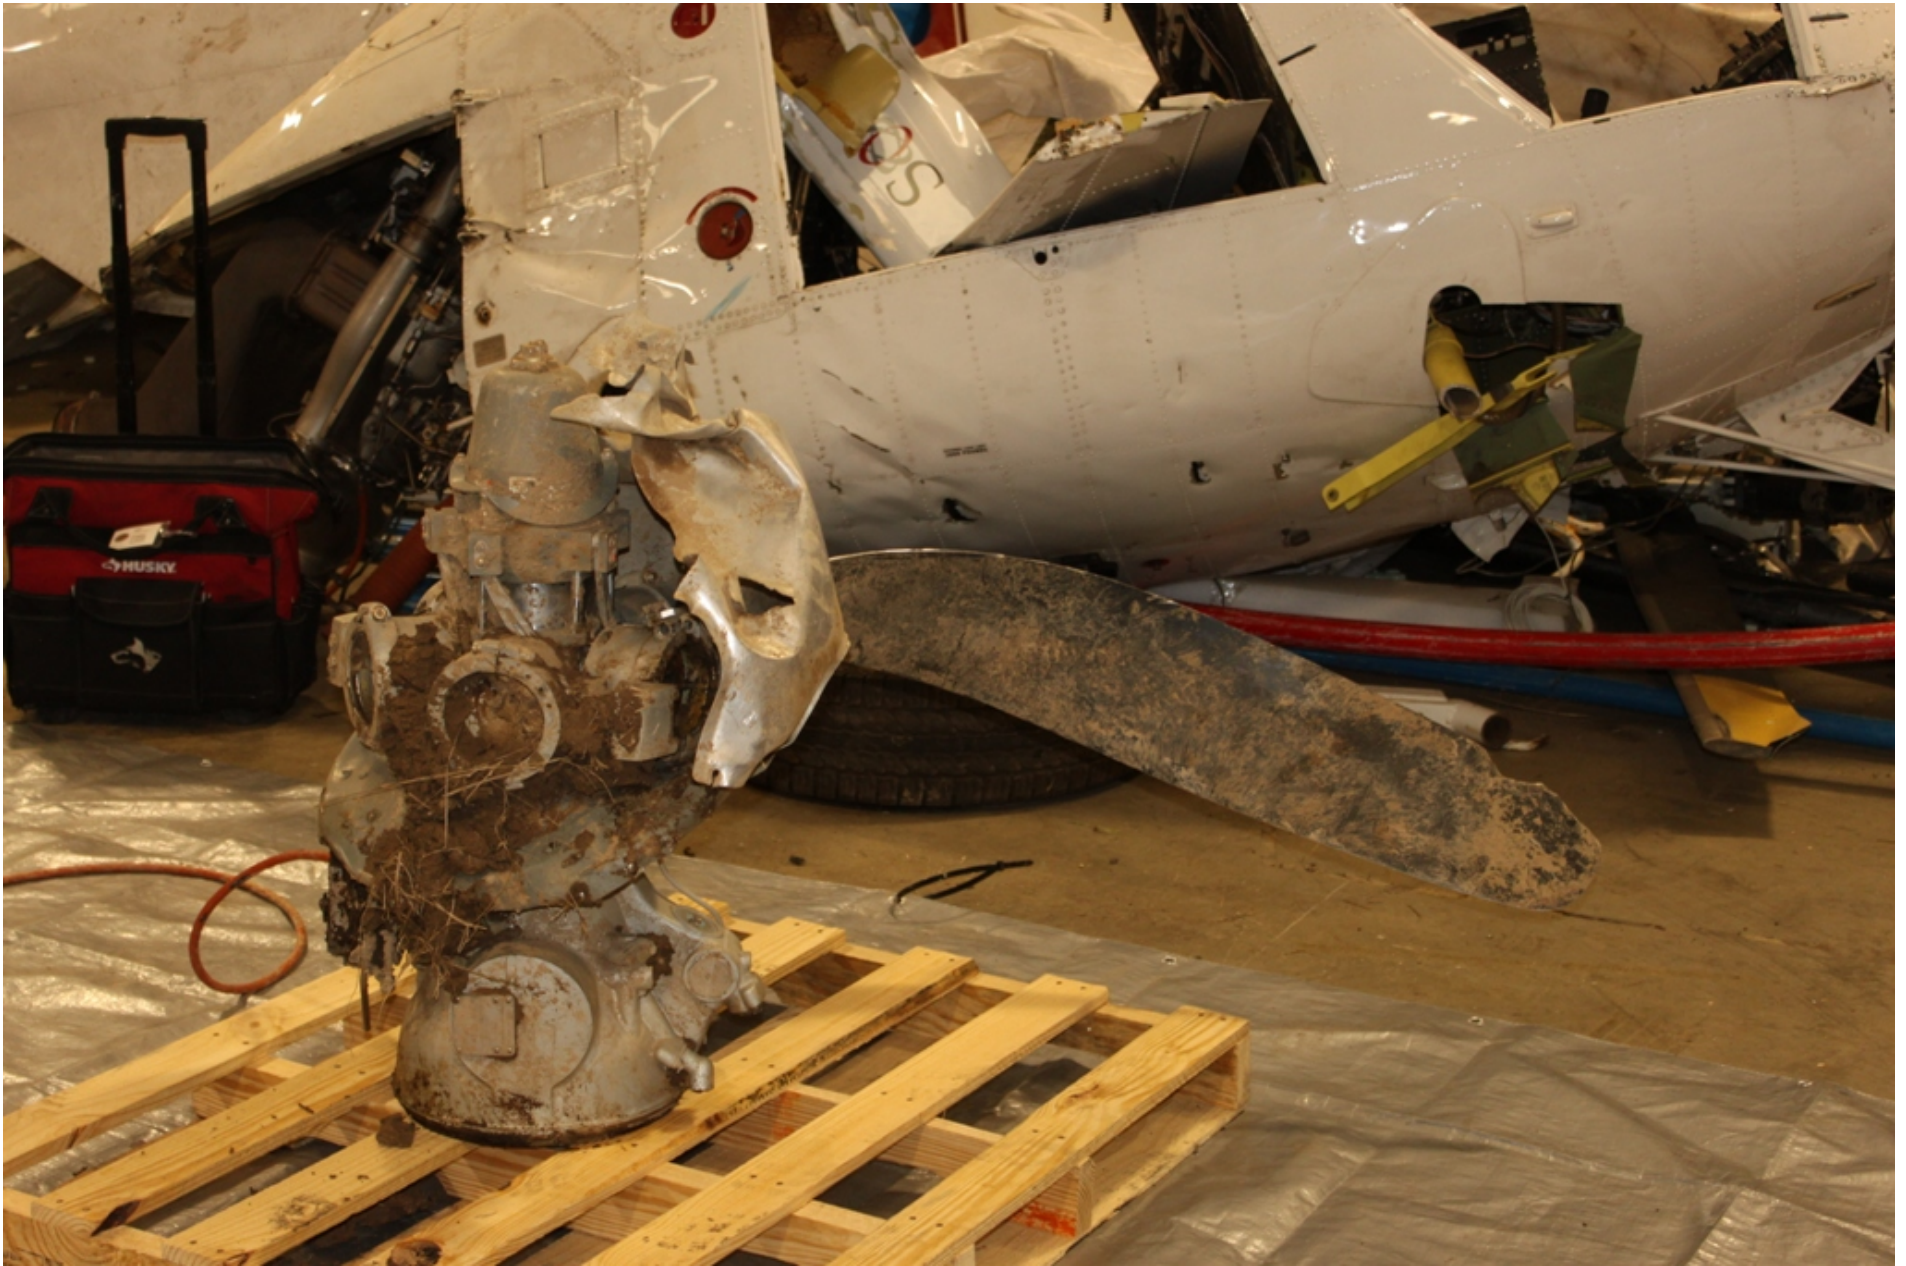
**Photo 9 - NTSB Digital Photograph. View of the Propeller Assembly and Reduction Gearbox. Only 1 Propeller Blade remained Secured.**
