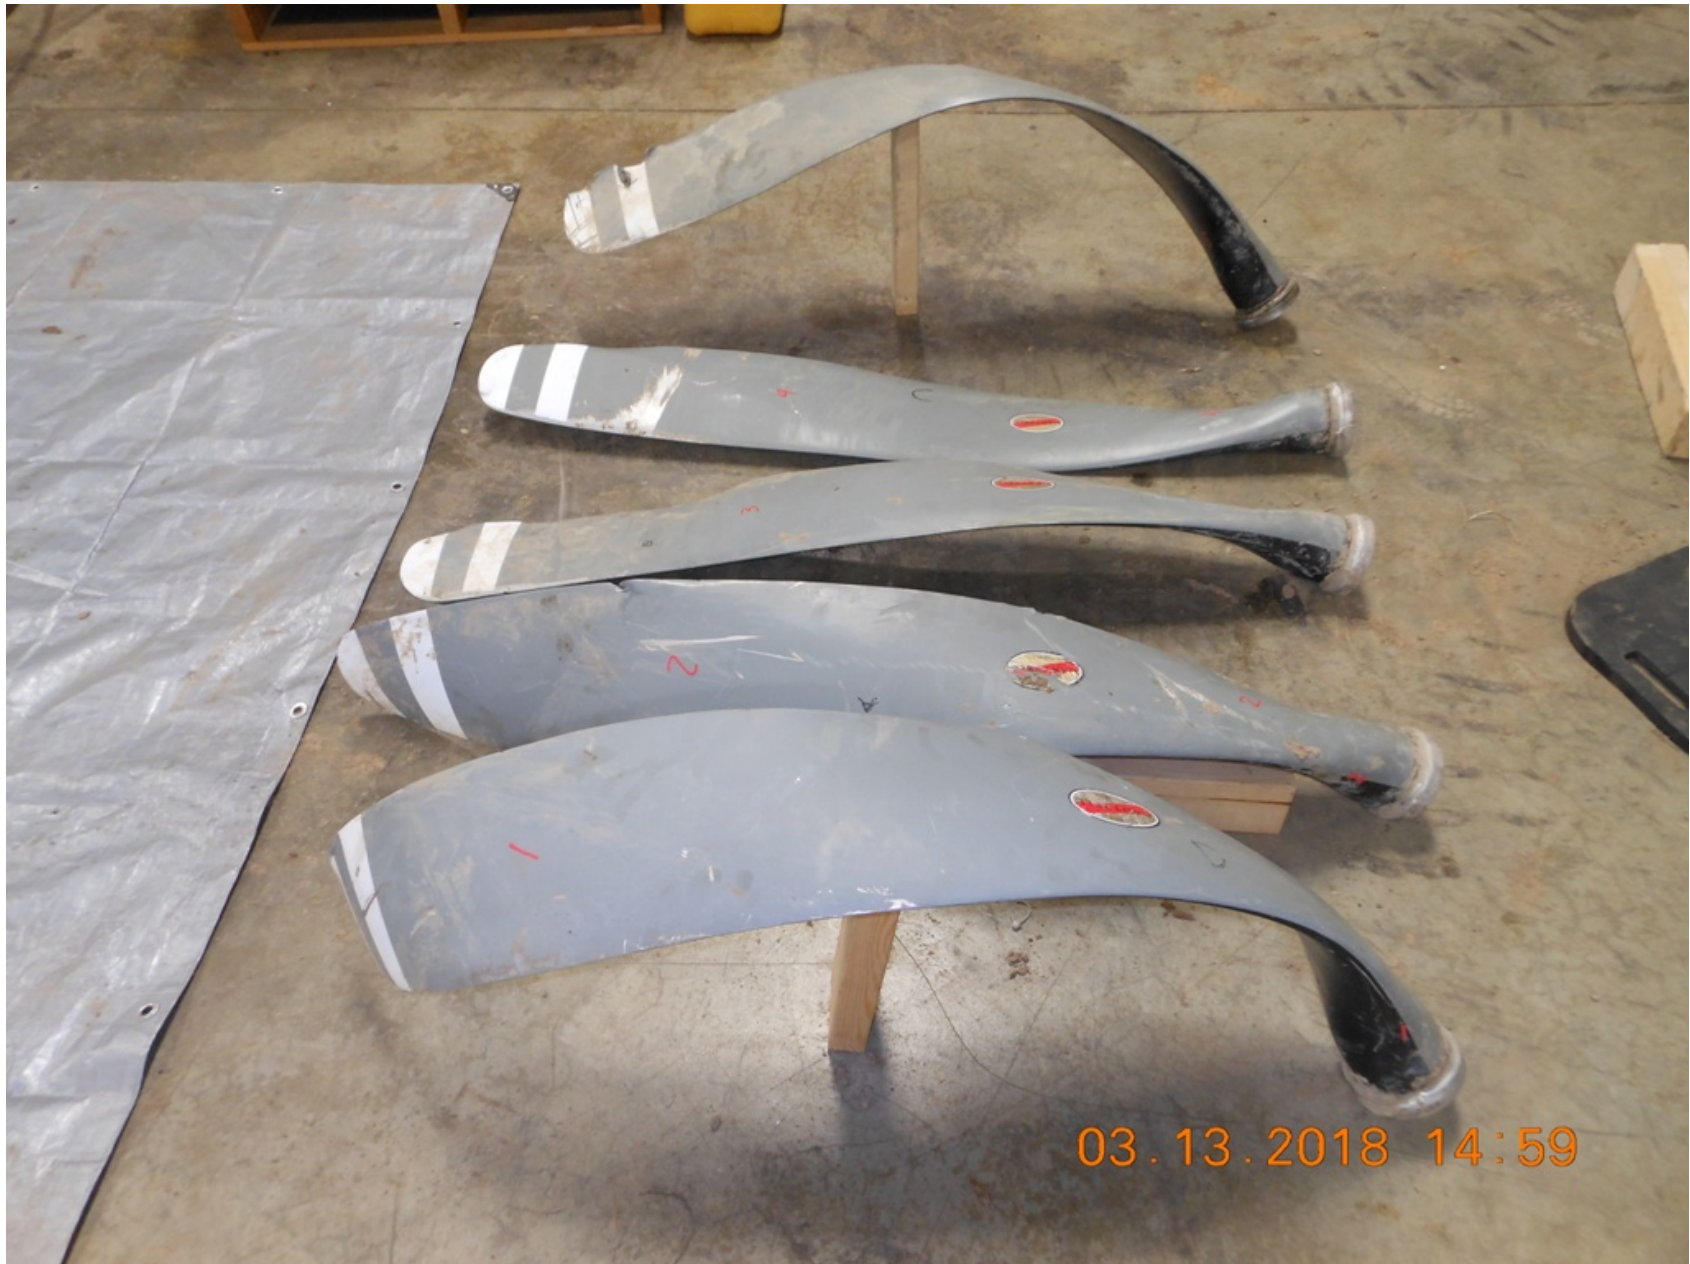
**Photo 10 – Hartzell Digital Photograph. View of the Propeller Blades After Cleaning. Note the Varying Amount of Bending.**
