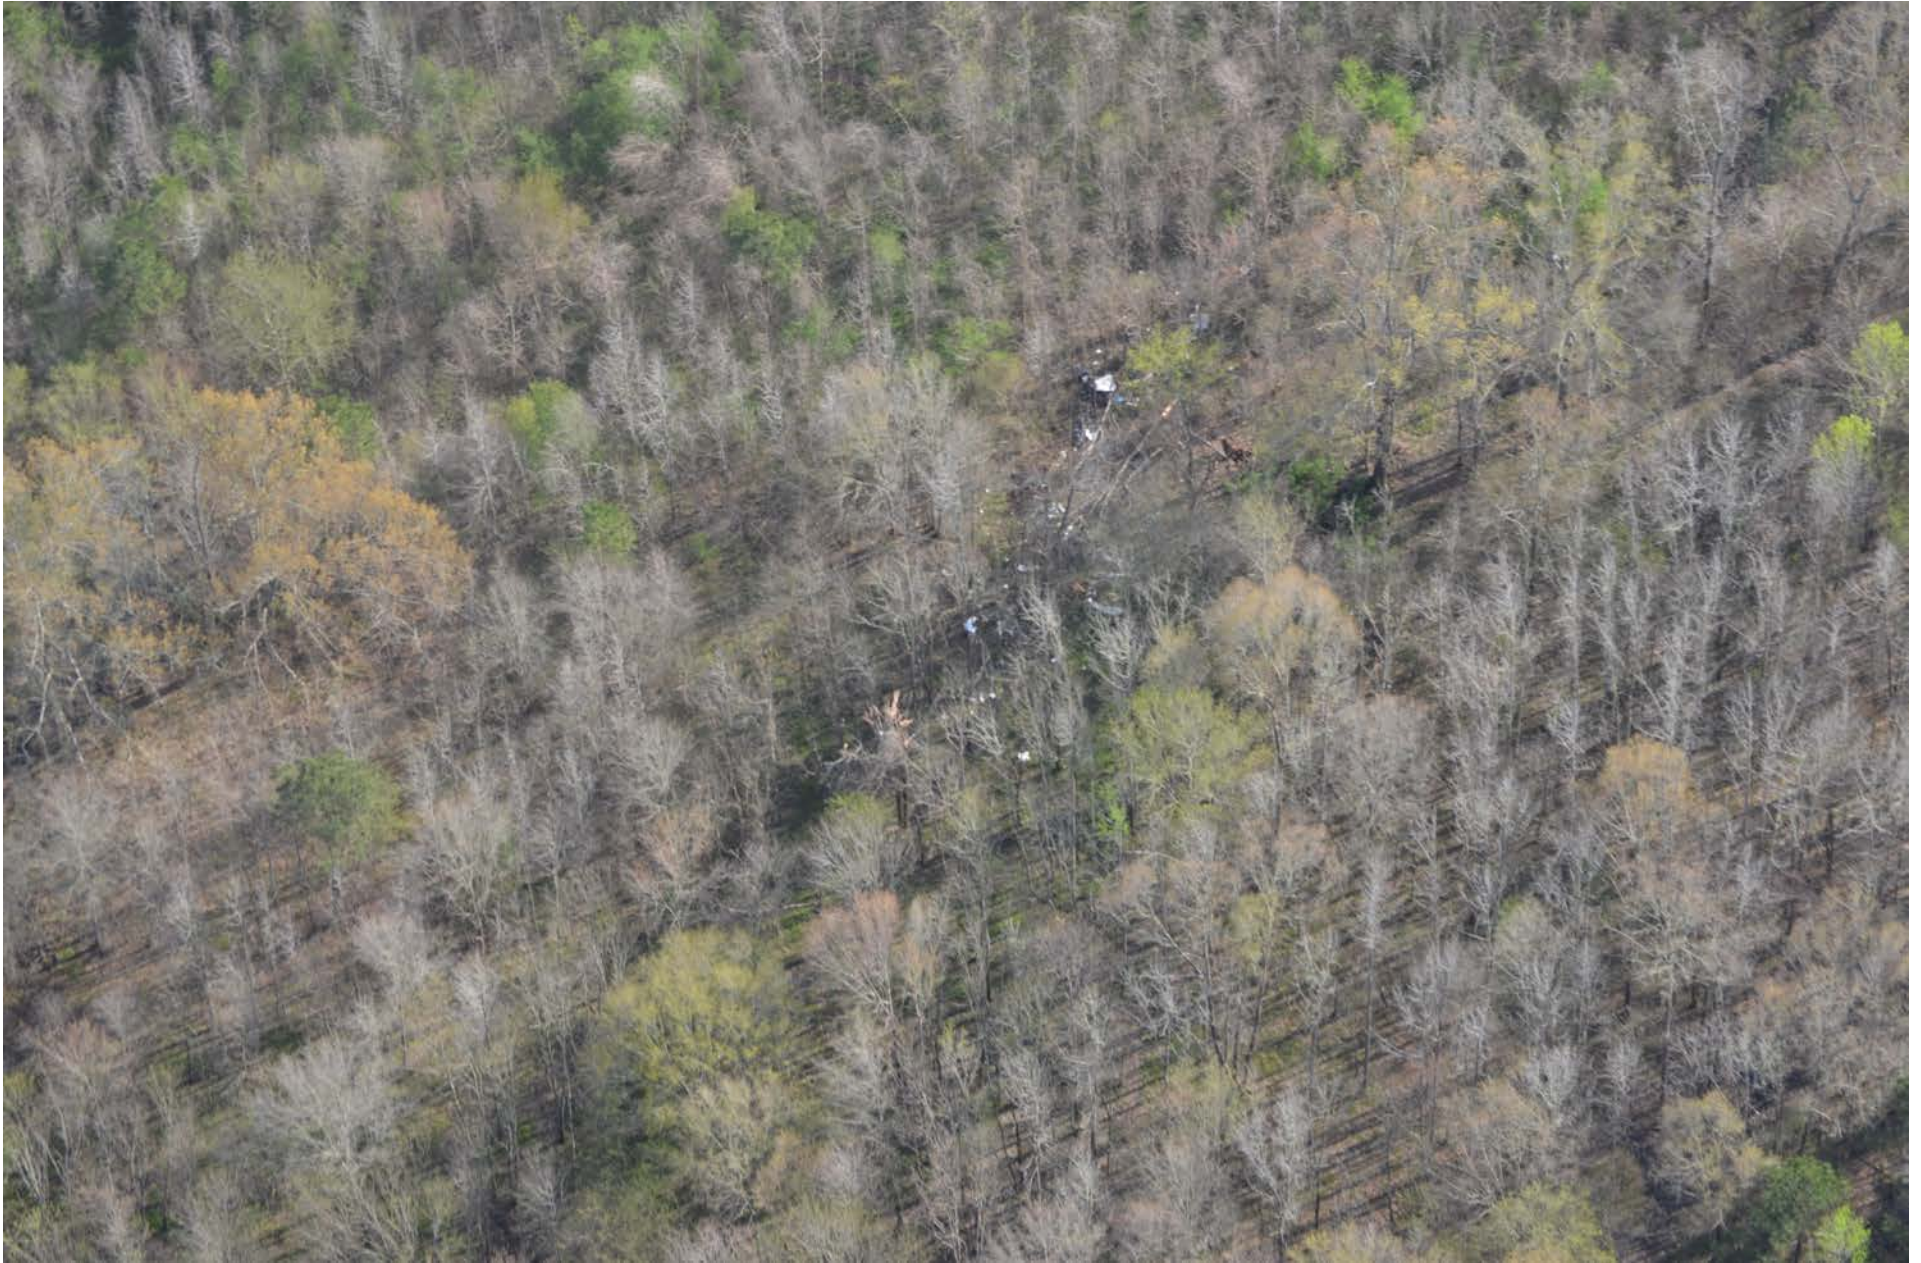
**Photo 1 – Aerial view of the wreckage. (Photo courtesy of the Civil Air Patrol)**

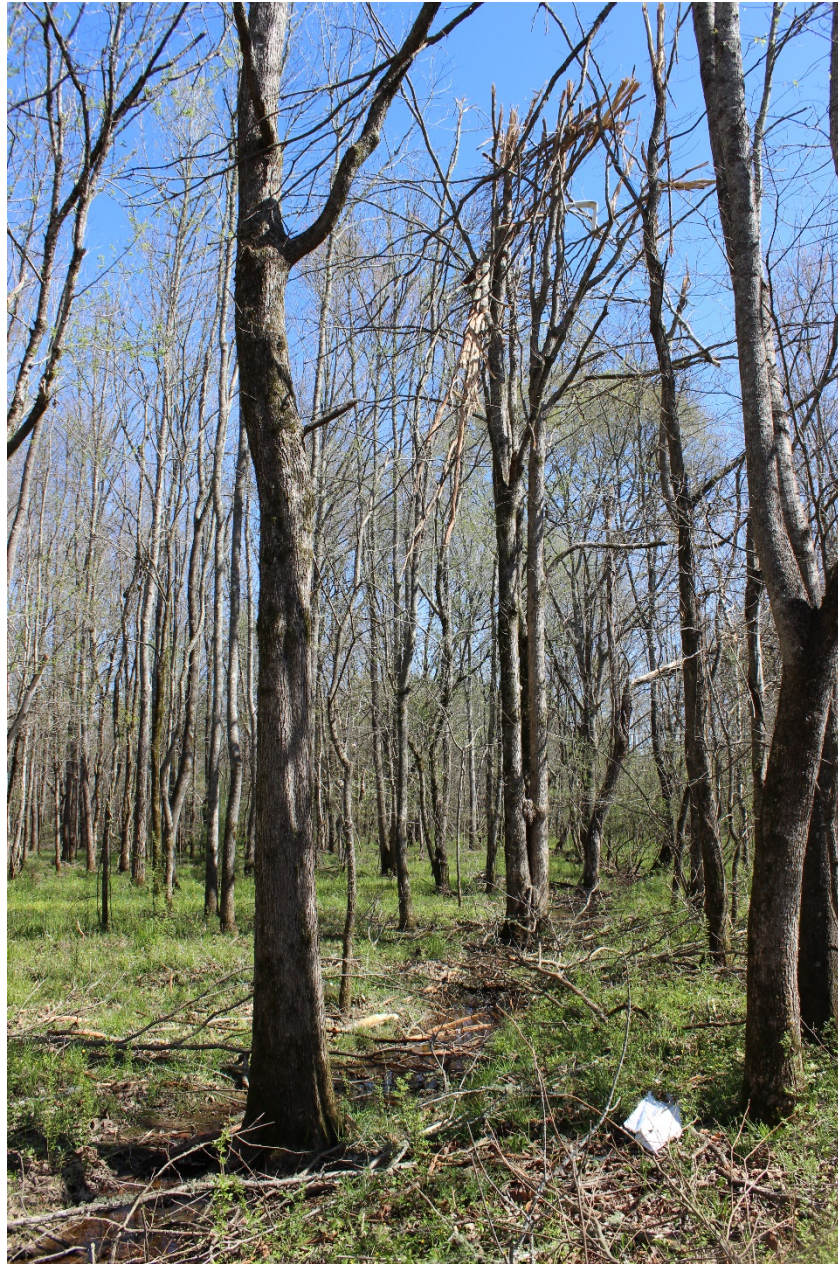
**Photo 2 – Initial tree strike and fragments of airframe.**

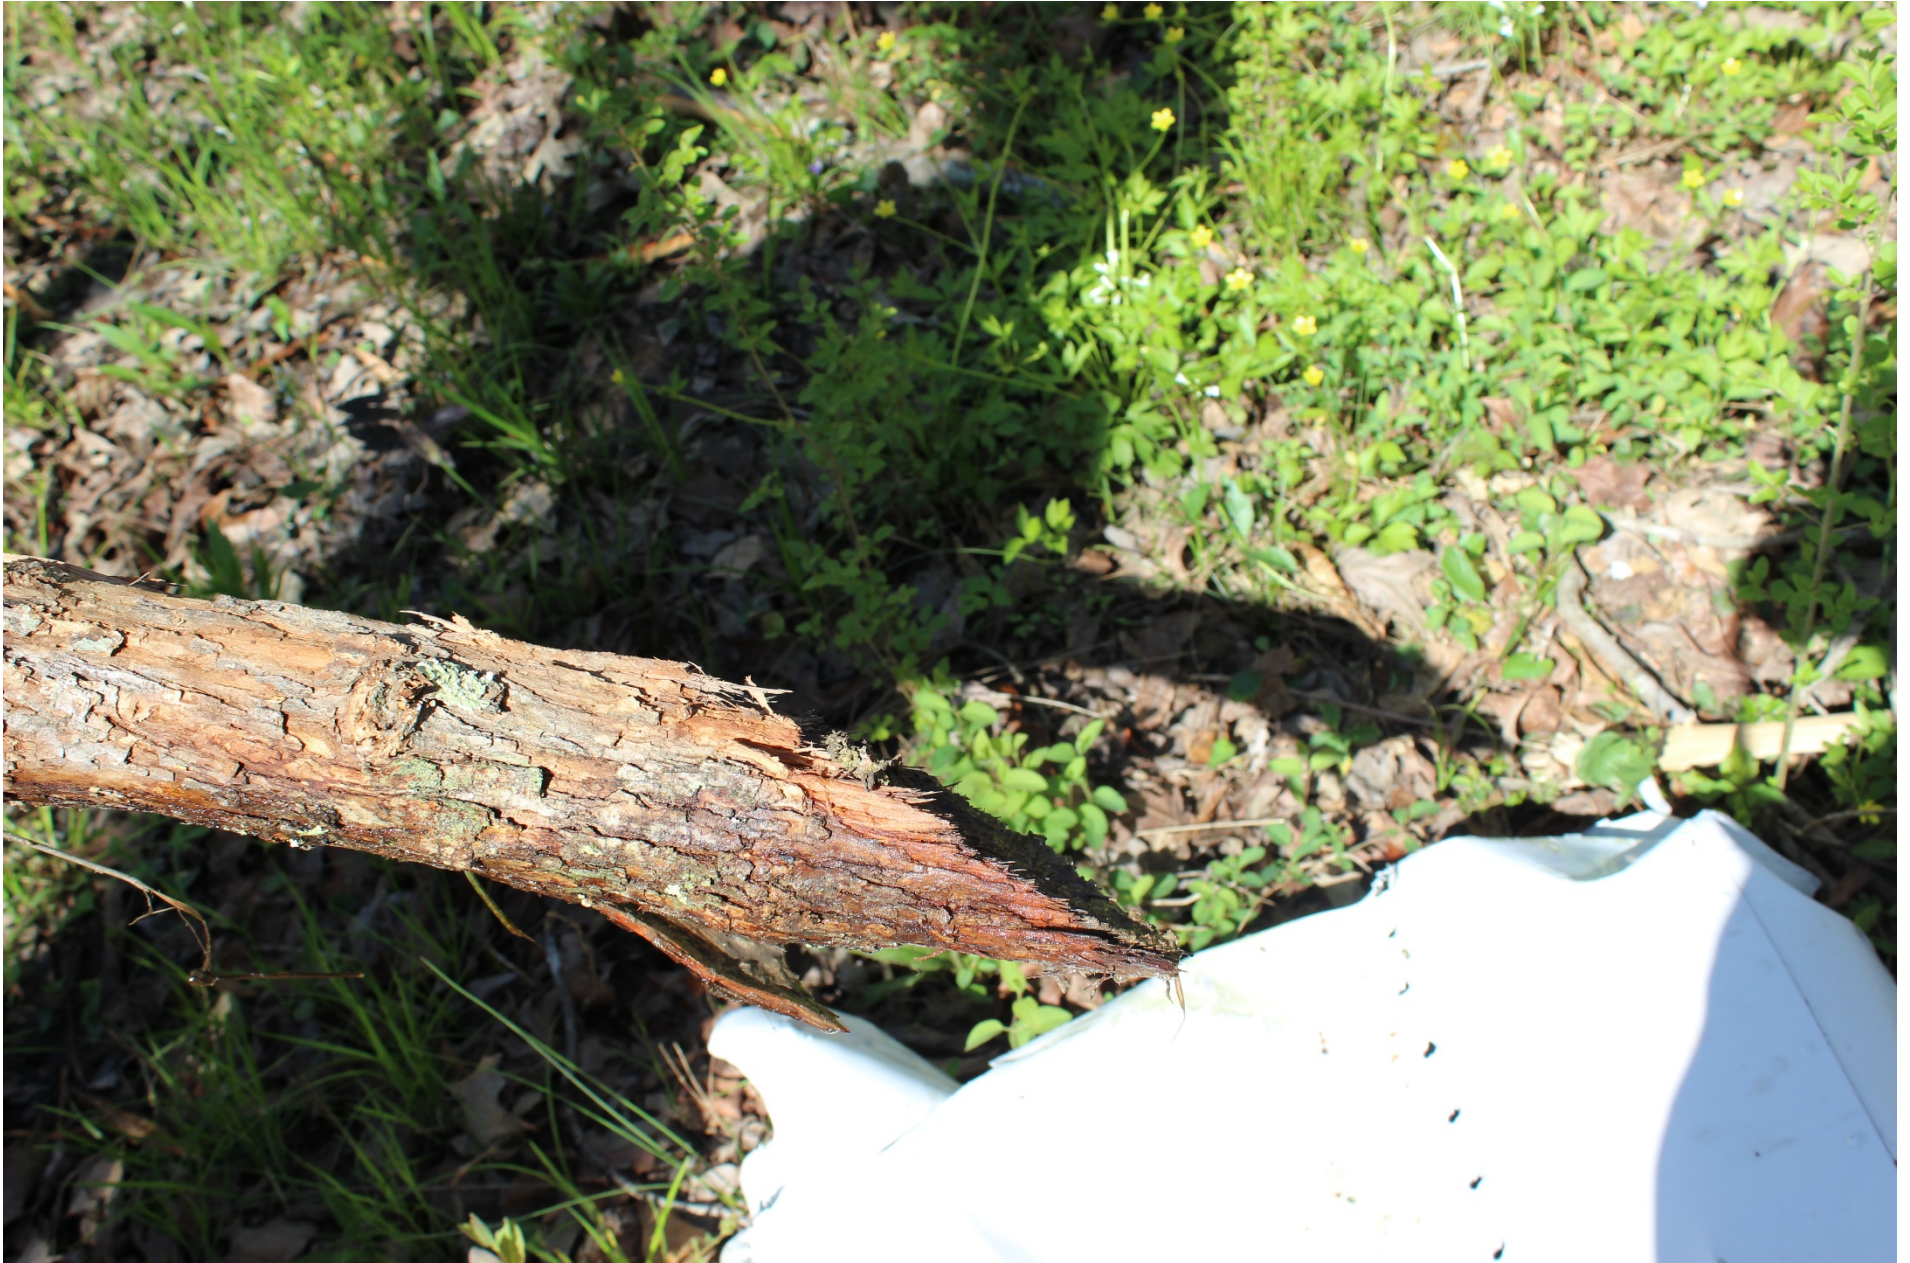
**Photo 3 – Tree branch cut at a 45° angle.**

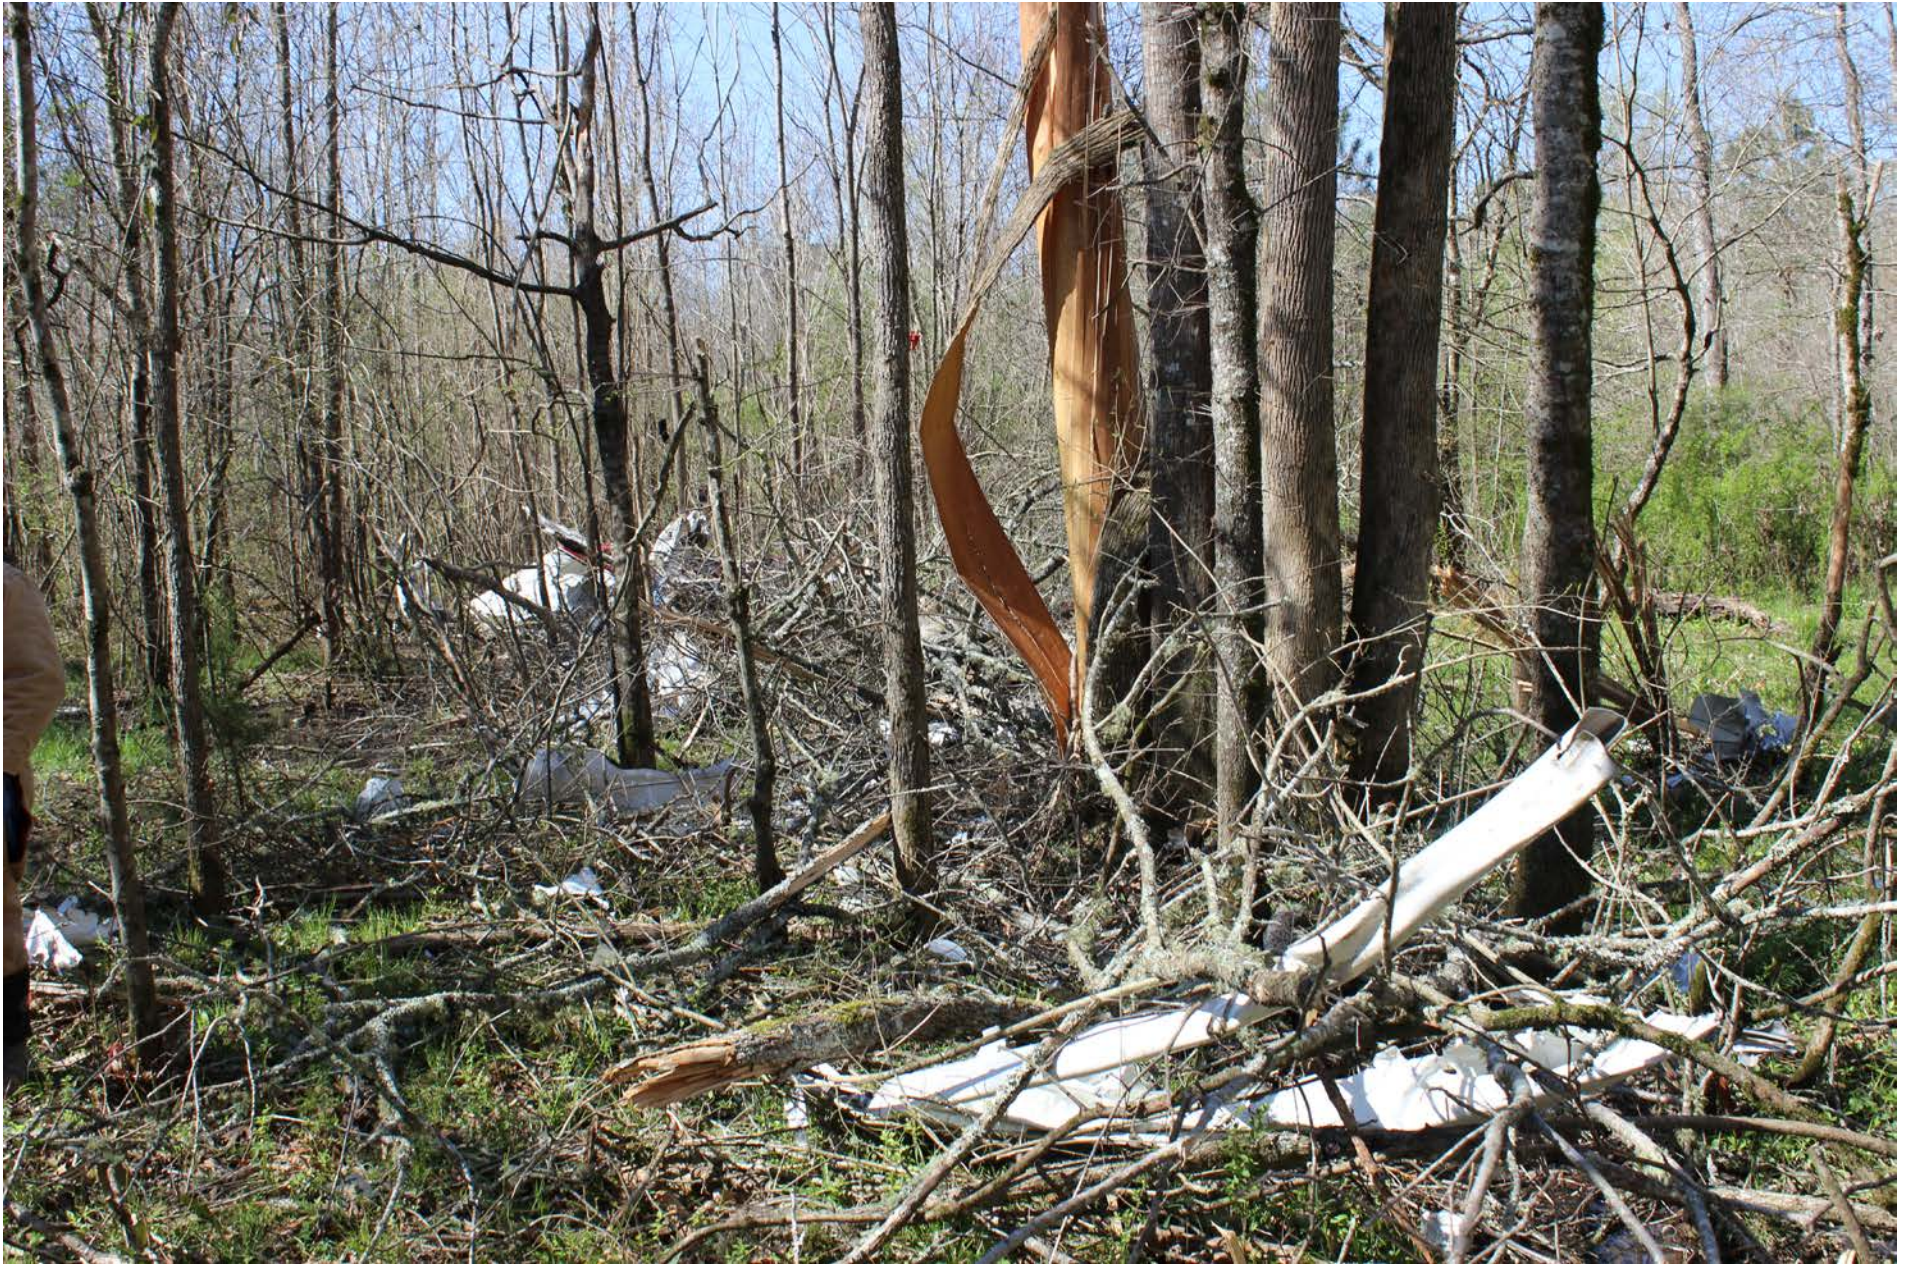
**Photo 4 - Beginning of the wreckage path, looking forward towards the engine.**

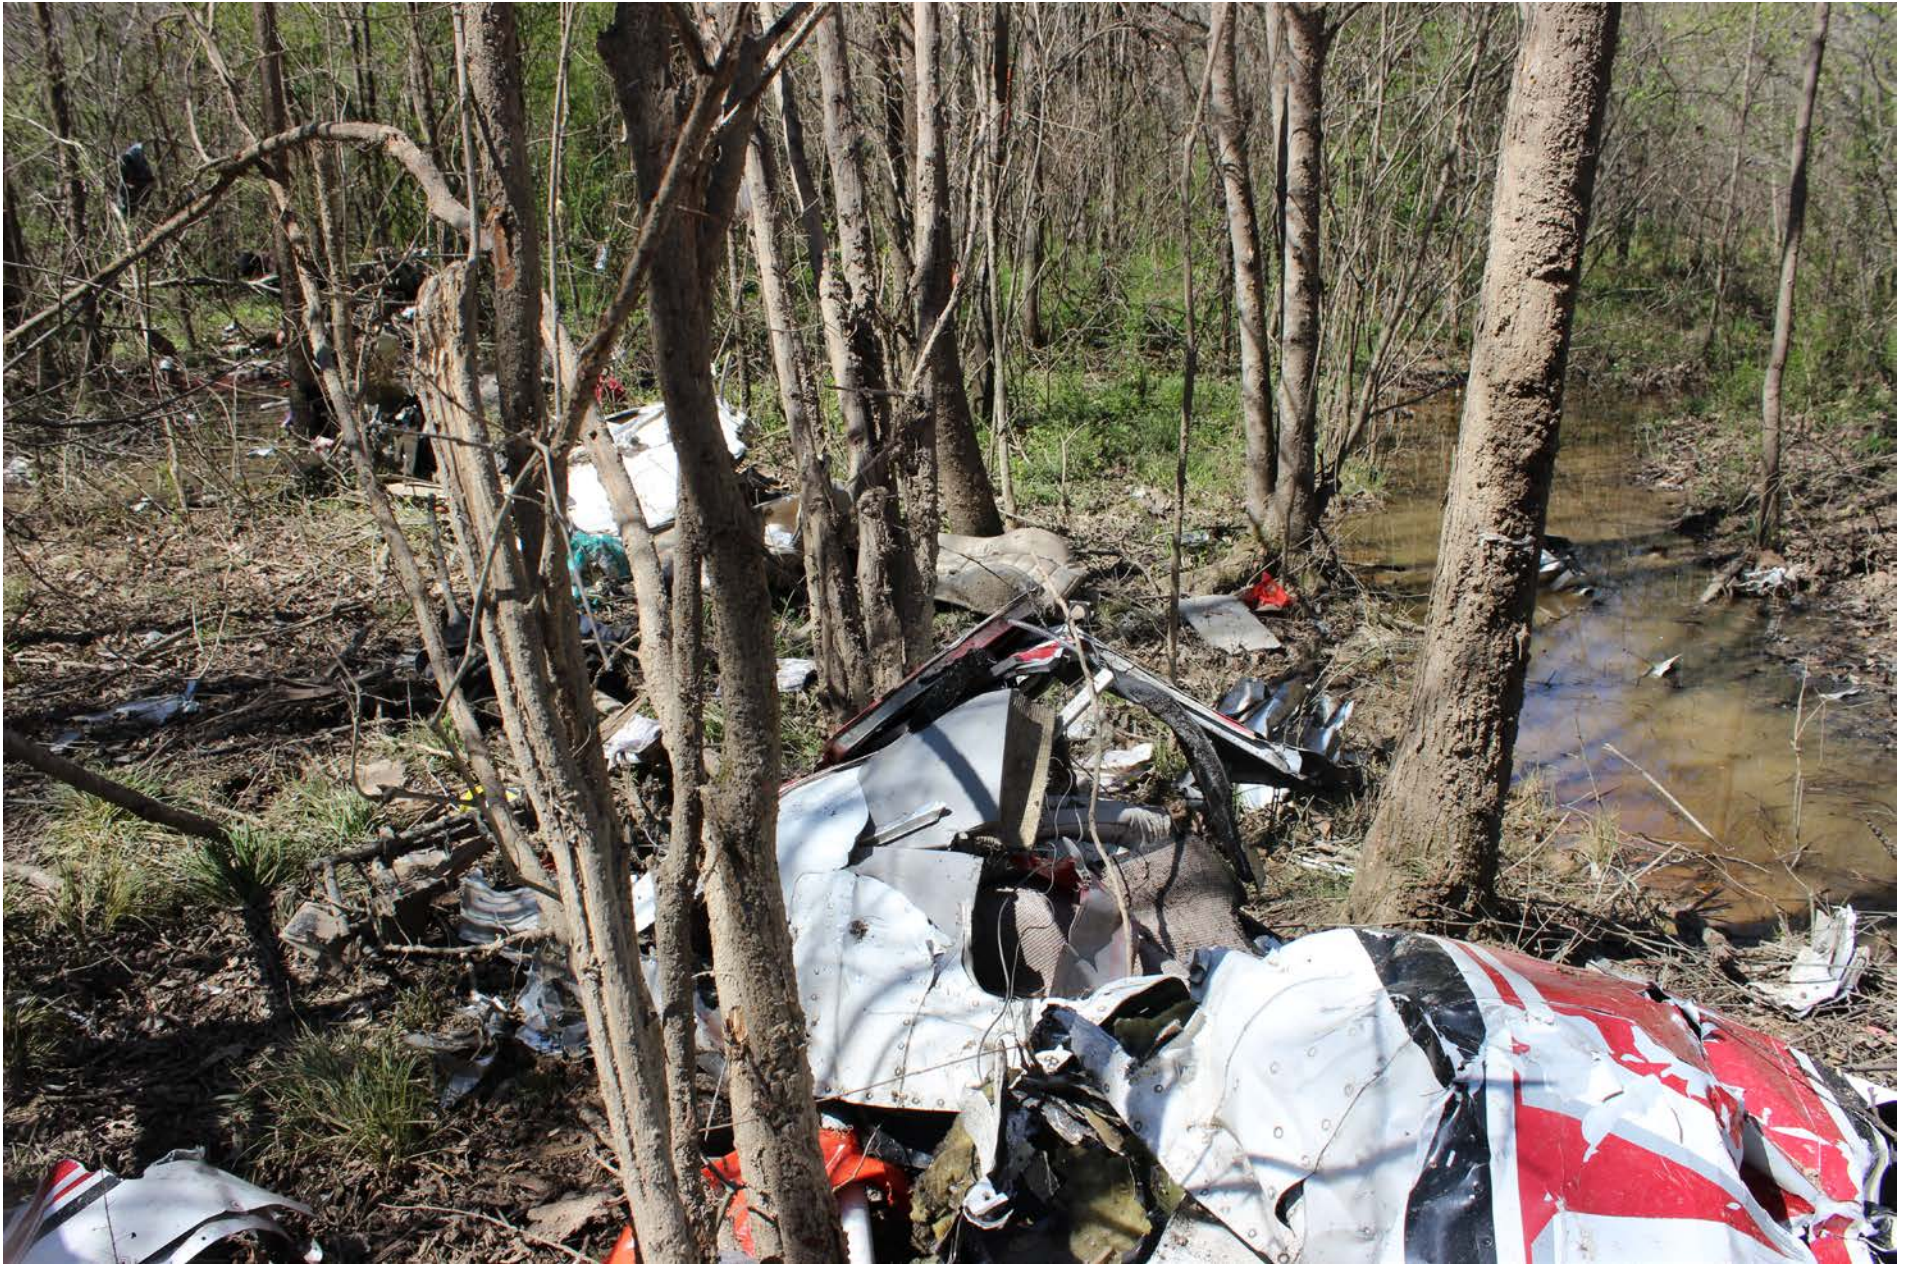
**Photo 5 – View of the fuselage, the engine in the background.**

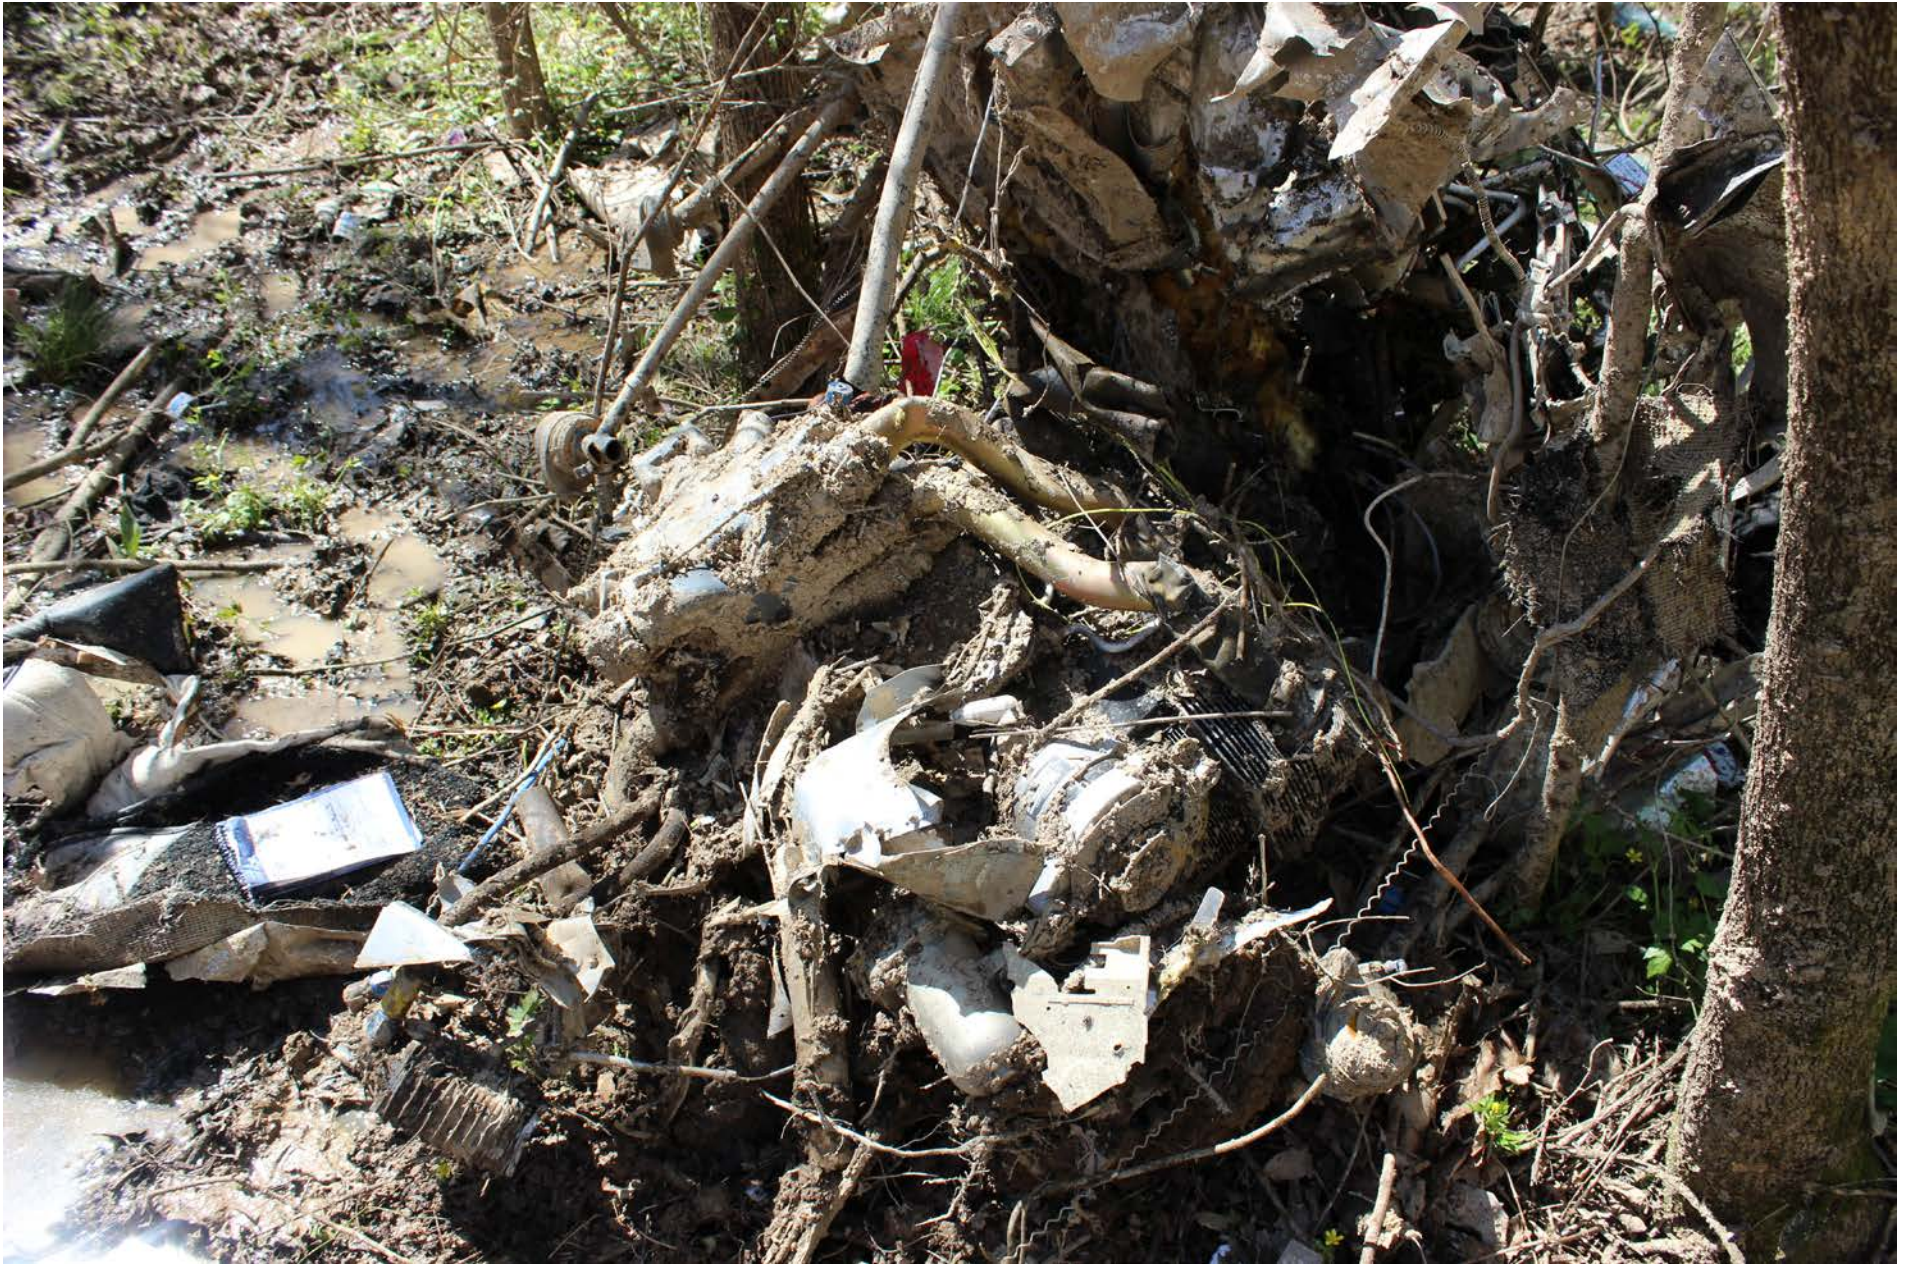
**Photo 6 – Main section of the engine.**

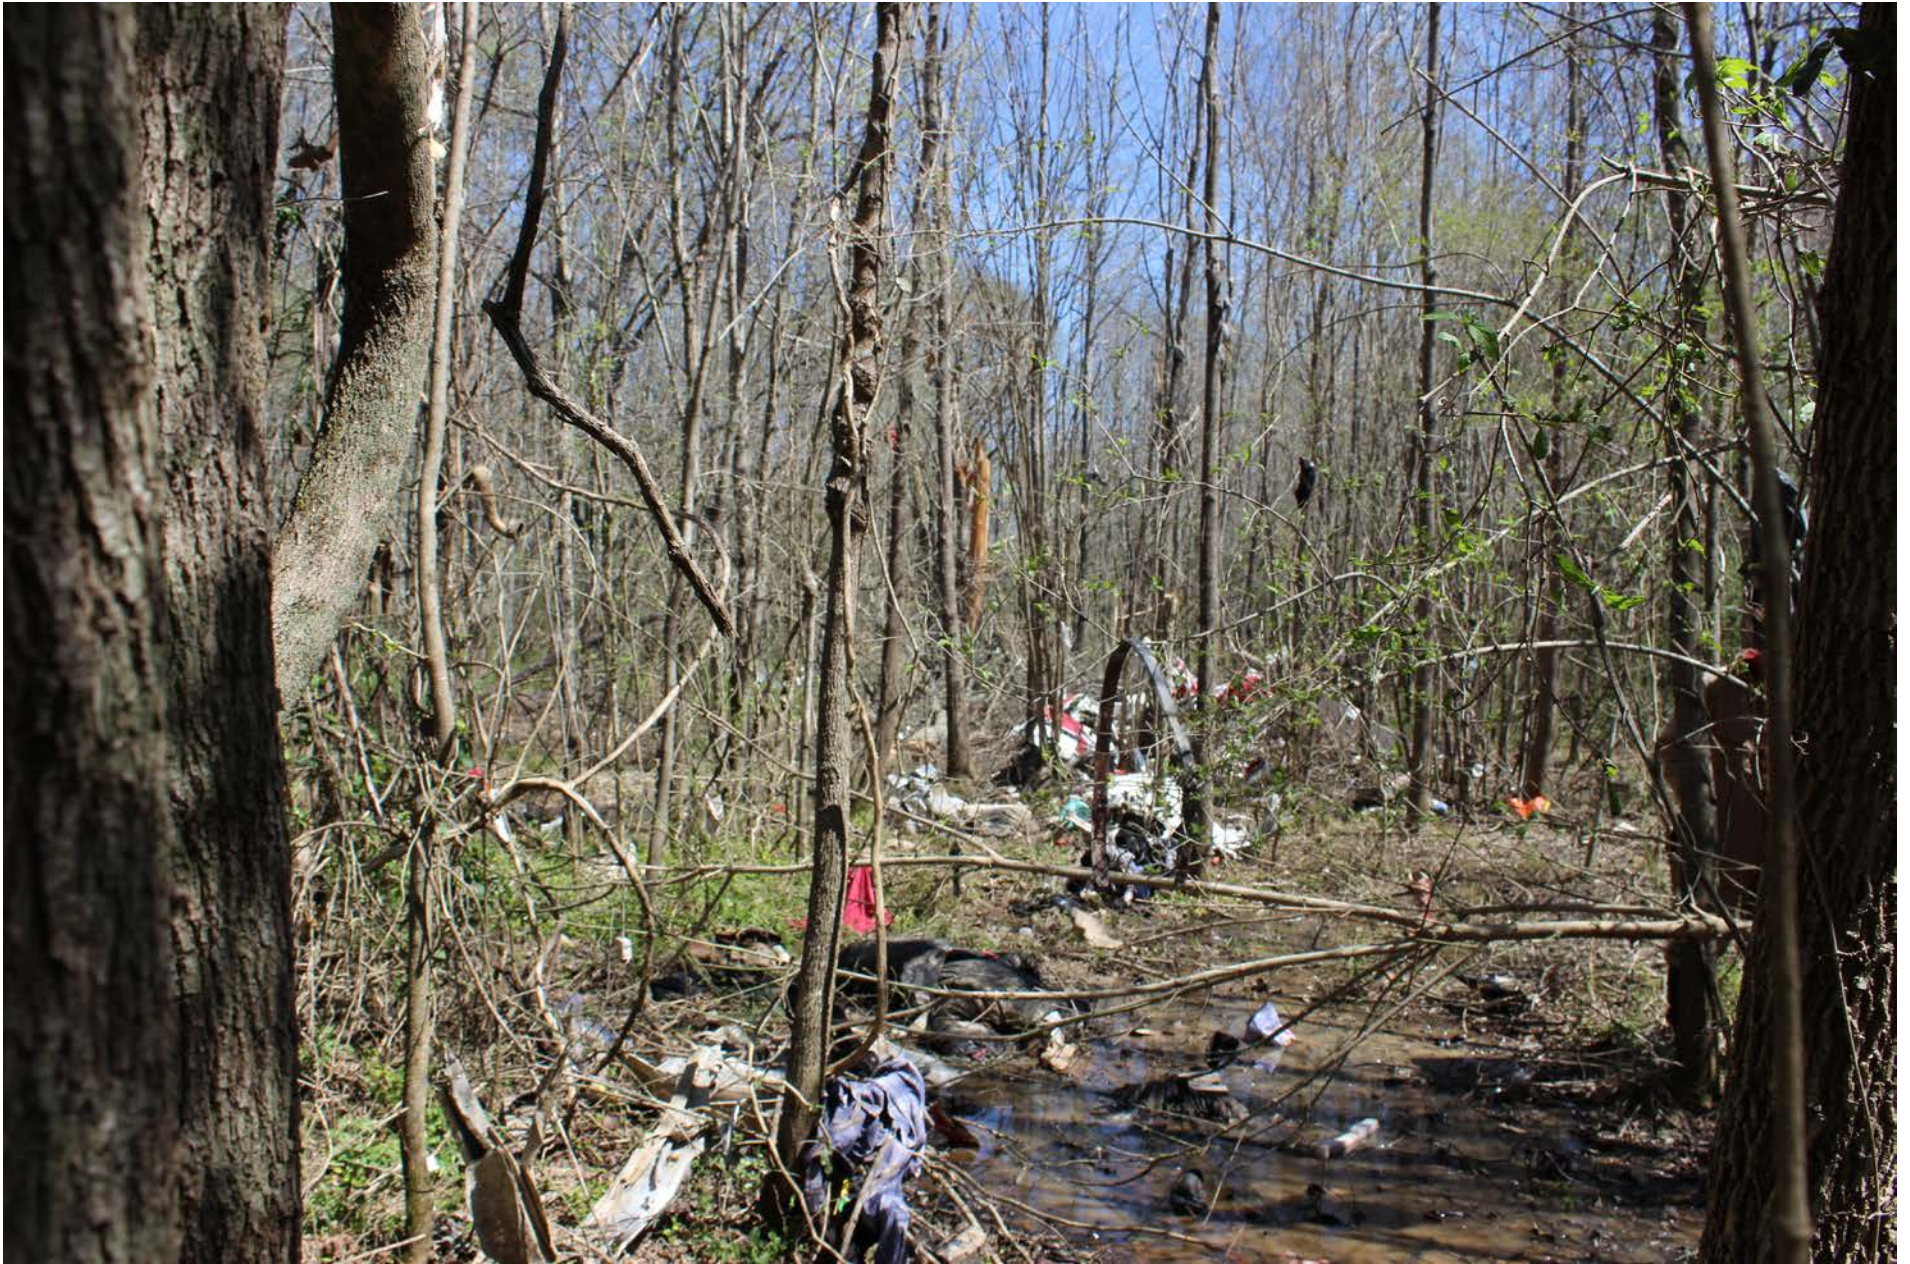
**Photo 7 – View of the wreckage path from the engine looking back.**
