NATIONAL TRANSPORTATION SAFETY BOARD  
Bureau of Technology  
Washington, D. C.

Materials Laboratory  
Report No. 87-89

METALLURGIST'S FACTUAL REPORT

Place : Marlin, Texas  
Date : March 30, 1987  
Vehicle : Piper PA-28-181, N8191U  
NTSB No. : FTW 87-F-A087  
Investigator: Warren V. Wandel (FTW-ASI)

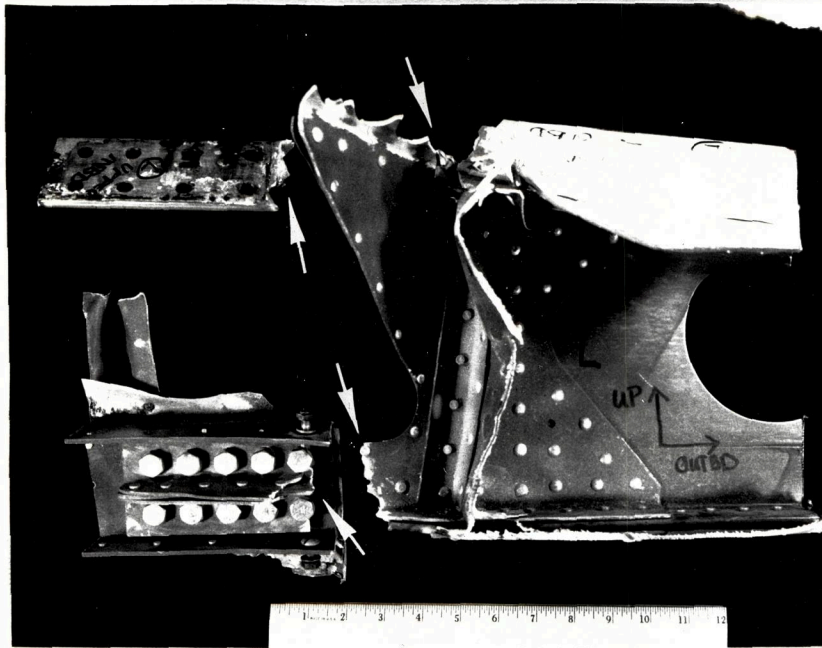
The left wing main spar assembly pieces are shown in figure 1. The spar had separated through the upper and lower spar caps and through the forward and aft sheet metal gusset webs. The locations of these fractures are denoted by arrows in figure 1.

Figure 1. An overall view of the as-received left wing spar pieces with the fracture locations denoted by arrows.

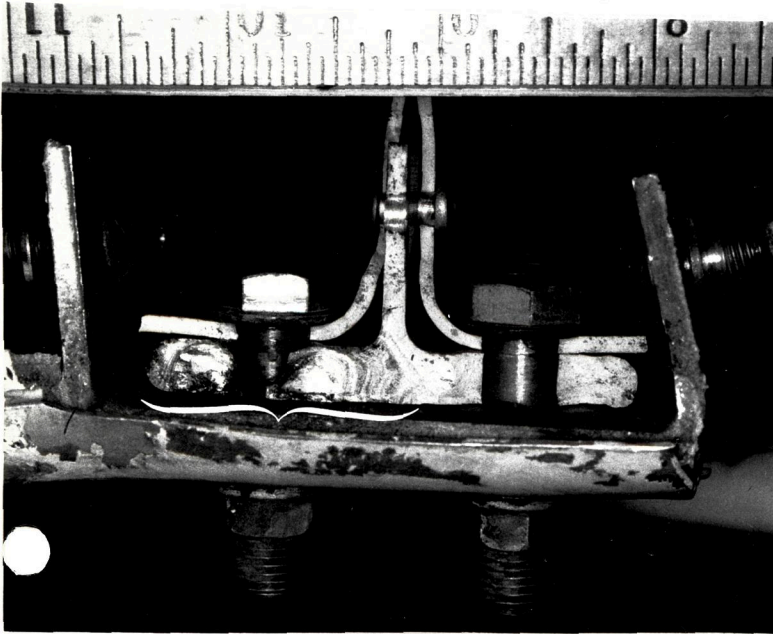
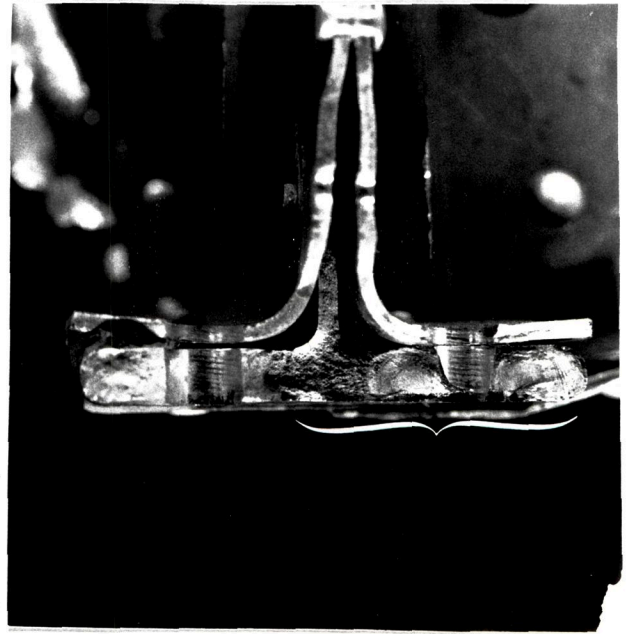
Initial examination of the lower spar cap fracture faces detected the fracture characteristics of fatigue cracks emanating from two areas near the outboard attach hole in the forward flange of the spar cap. Figure 2 displays photographs of both the inboard and outboard spar fracture faces, with the fatigue areas denoted by white brackets.

Figure 2. Inboard (left) and outboard (right) views of the lower spar cap fracture with the fatigue zones denoted by white brackets. Left view also shows fuselage carry through and attachment fasteners.

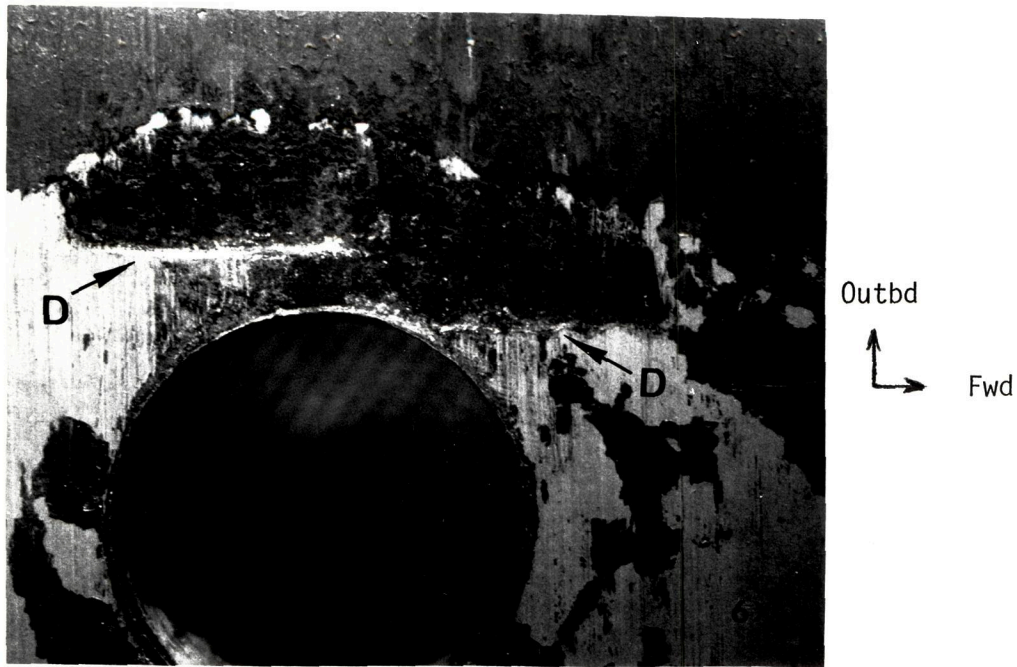
The ten lower spar fasteners were removed and the bolt loosening torques were measured. The measured removal torques are listed in Table A. During disassembly of the inboard spar cap section a fretting pattern was noted on the carry through structure outboard of the spar fatigue area. Removal of the spar section from the carry through revealed a prominent demarcation line between the fretted and unfretted surface, as denoted by arrows "D" in figure 3. This demarcation line corresponded to the location and the profile of the fatigue zone in the spar cap. A matching fret pattern was found on the lower surface of the outboard spar

Figure 3. A view looking at the upper surface of the carry through at the forward outboard bolt hole (forward at right, outboard at top) showing the fretting demarkation lines which correspond to the spar fatigue planes.

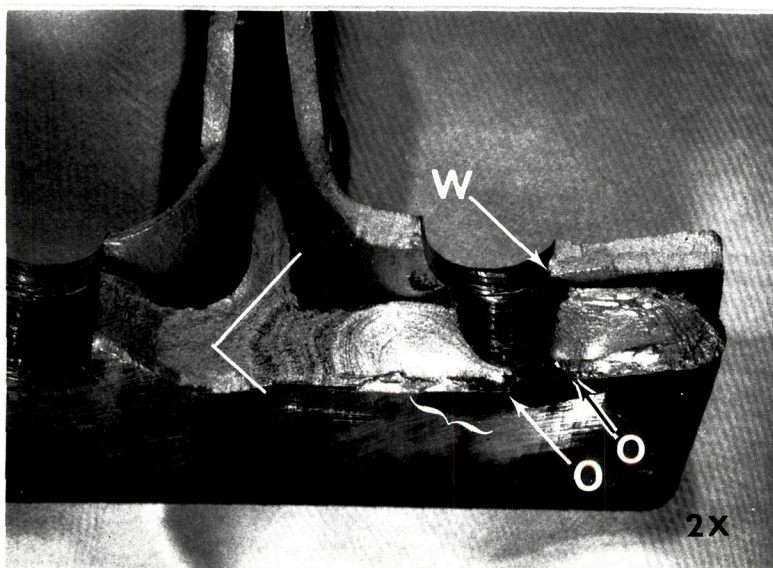
piece, white bracket in figure 4. Inspection of the lower surface of the inboard spar section immediately inboard of the fatigue zone did not detect any evidence of fretting damage, see figure 5.

Further examination identified a single point of fatigue initiation on each fatigue plane. Both fatigue origins were on the lower surface of the spar cap slightly away from the bolt hole. The fatigue origins are denoted by arrows "O" in figures 4 and 5. The origin on the forward (most inboard) fatigue plane was just inboard of the outboard edge of the bolt hole and about 0.14 inch forward of the spanwise centerline of the bolt hole. The aft (most outboard) fatigue plane origin was offset about 0.06 inch outboard of the hole edge and the forward fatigue plane and approximately 0.07 inch aft of the bolt hole centerline.

Fatigue growth in the forward fatigue plane was generally upward and forward and entirely penetrated the portion of the spar flange between the bolt hole and the forward edge of the spar cap. The aft fatigue plane extended upward through the flange thickness and aft, terminating at a position slightly aft of the spar web as denoted by the white line in figure 4.

Figure 4. View looking outboard at the outboard spar fracture face with forward at right. The fatigue origins, arrows "O", and terminus white line, are denoted along with the lower surface fretting, white bracket, and location of web fatigue crack arrow "W".

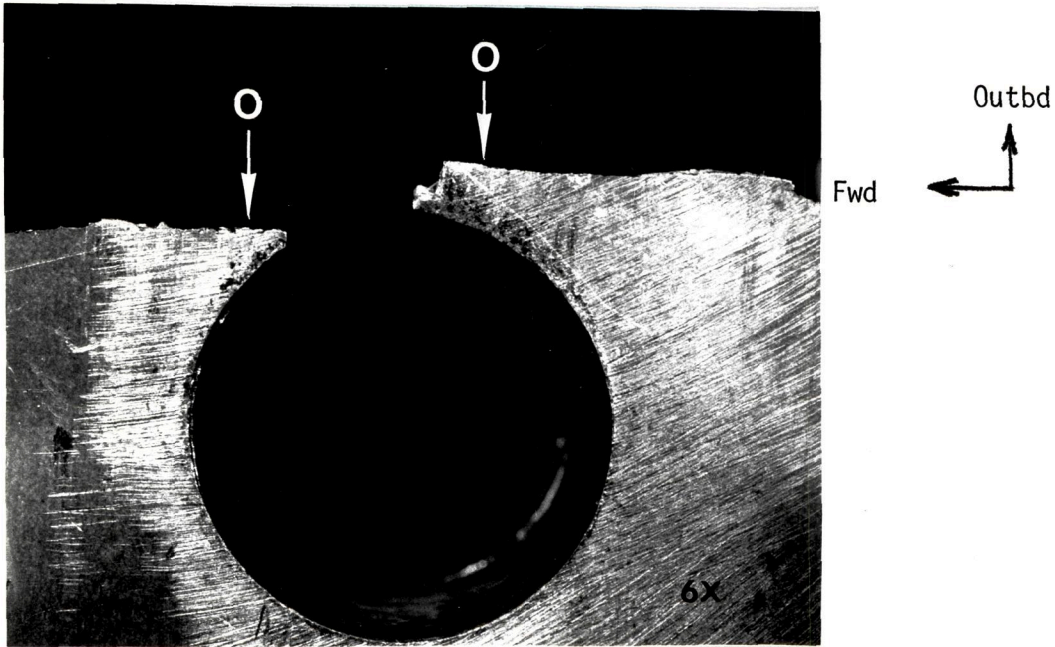
With the inboard spar section removed from carry through structure, both fracture faces were cleaned with a mild detergent solution in water and repeated applications and stripping of replication tape. The cleaned fatigue zone of the outboard fracture half is shown in figure 4. Magnified examination of the spar fracture established that the fatigue region was composed of two independent fatigue planes that were slightly offset to each other in the spanwise direction. Both fatigue planes had intersected the forward outboard attachment bolt hole near the outboard edge of the hole. Figure 5 illustrates the orientation and relationship of the two fatigue planes and the bolt hole.

Figure 5. Photograph displaying the lower spar surface adjacent to the fatigue zones showing the relative positions of fatigue origins, planes and bolt holes. Forward at left, outboard at top.

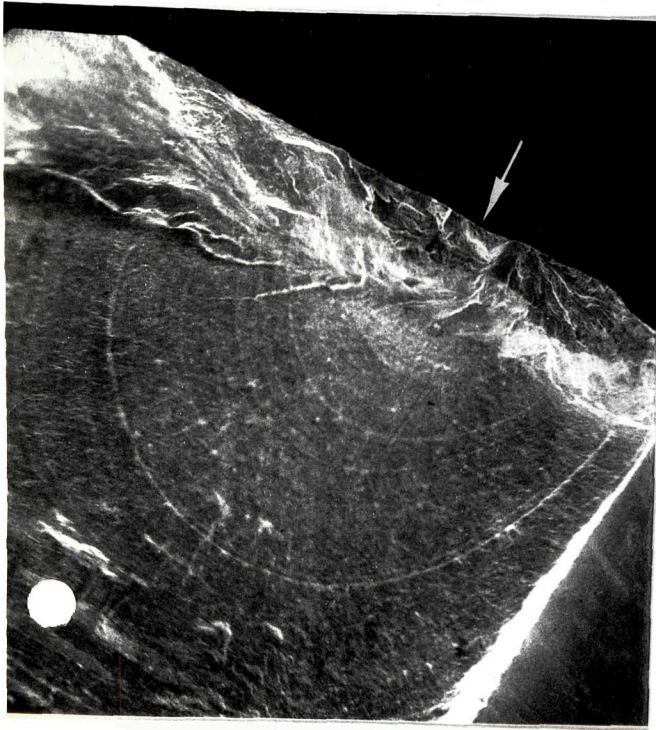
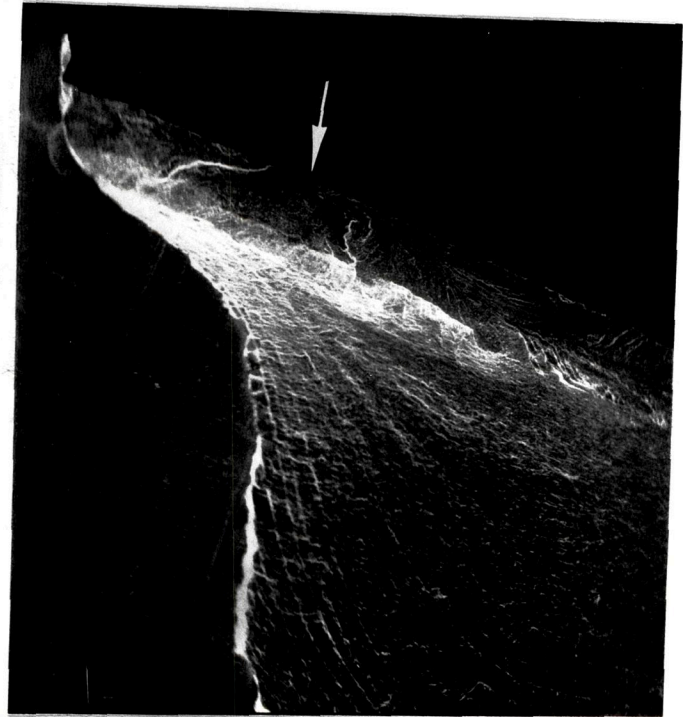
The forward flange (containing the two fatigue planes) of the outboard fracture spar cap piece was saw cut from the remainder and prepared for scanning electron microscope (SEM) viewing. SEM examination confirmed the initial mode of fracture as fatigue by revealing striations consistent with fatigue cracking. The fatigue striations emanated from a

single location for each fatigue plane on the lower spar cap surface also confirming the previous visual observations. The two fatigue origin areas, arrows "O" are shown in the SEM macrographs of figure 6.

Figure 6. SEM macrographs (10X) of the two fatigue origins, forward fatigue plane at left, aft fatigue plane at right.

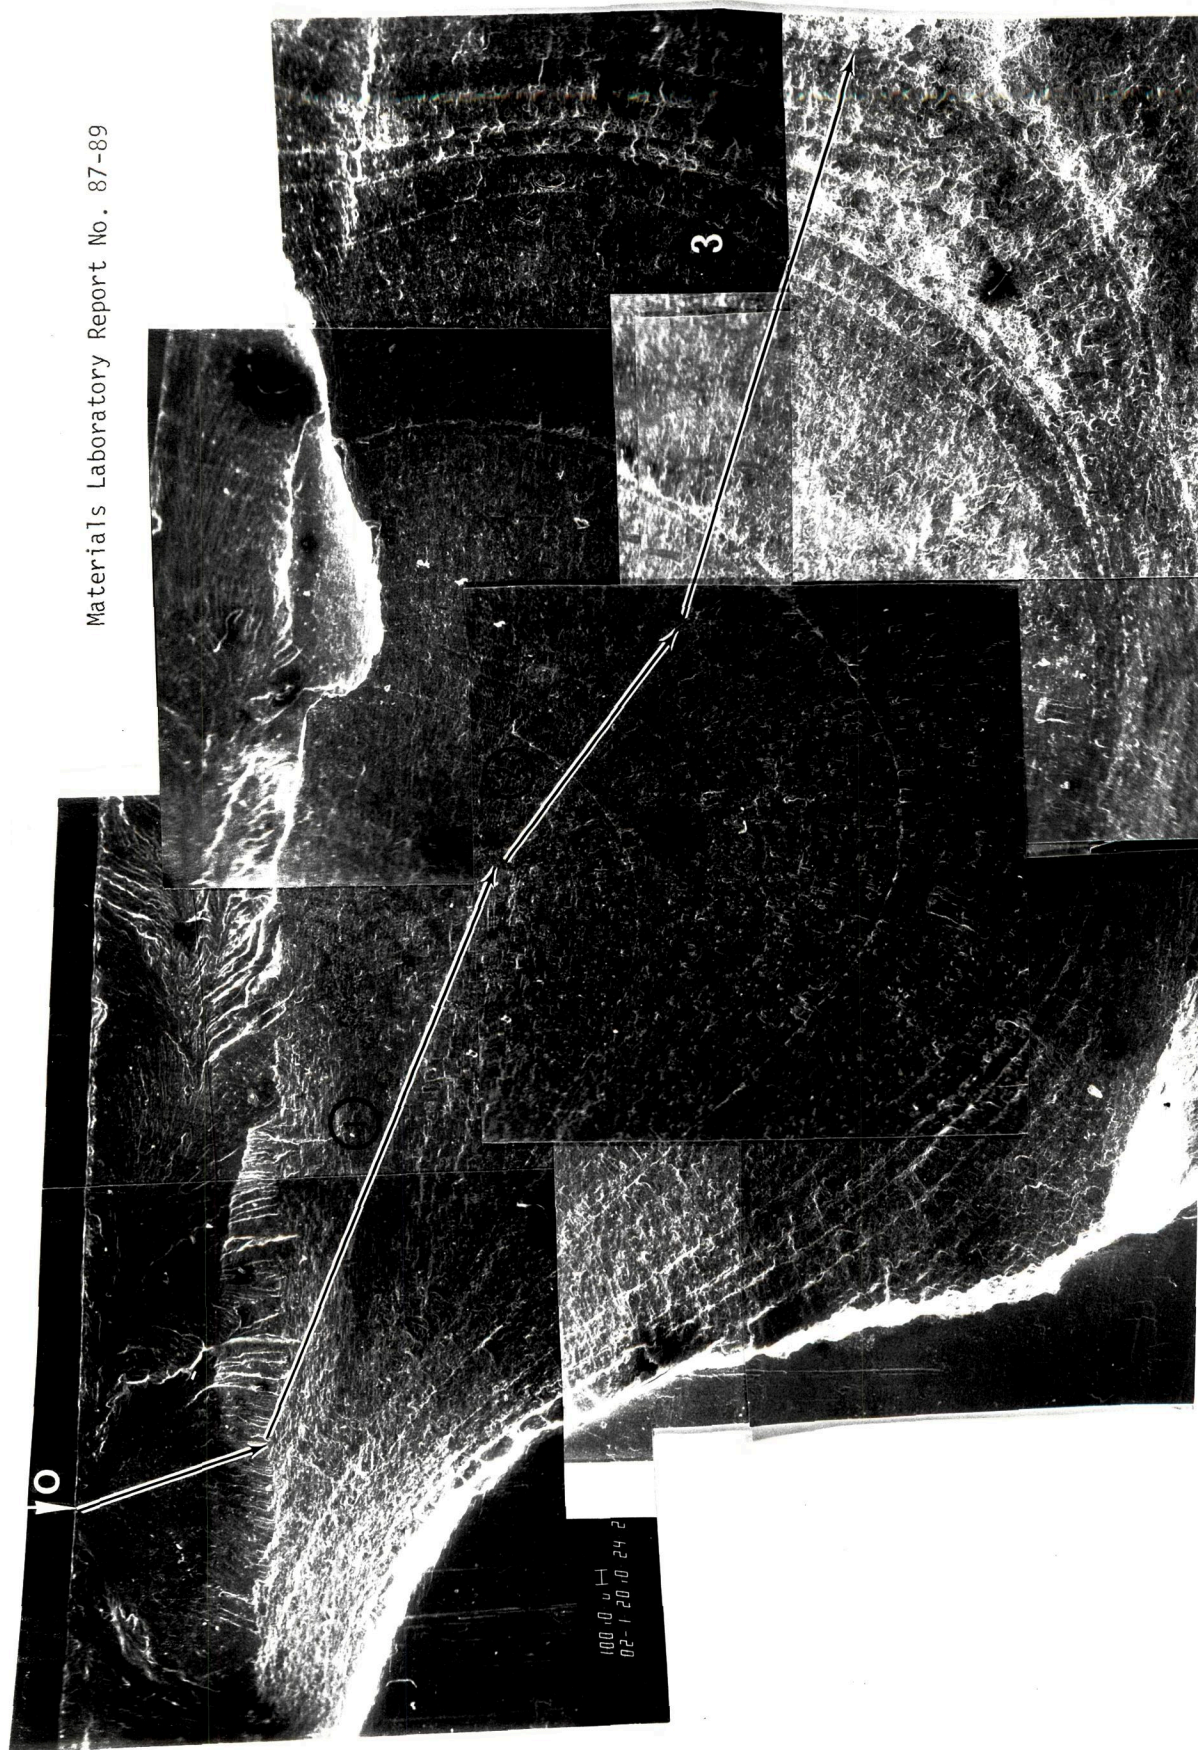
A fatigue striation count was undertaken along the centroid line of the fatigue propagation directions on the aft fatigue plane. Fatigue striation spacing, expressed as striations per inch (S/I), was determined at three positions along the centroid of propagation. These spacings were then linearly integrated over the distance to the previous measurement position. Adding the three integrated spacing measurements, in this manner, results in a conservative estimate of the total fatigue striations for a given length of propagation. For the aft fatigue plane, a minimum of 30,265 fatigue striations were present in the initial 0.49 inch of measured fatigue propagation. The propagation centroid line, fatigue origin, and three measurement points are located on the SEM montage in figure 7. The measurement data at the three points are listed in Table B.

Figure 7. SEM fractograph montage of the aft fatigue plane showing the origin (Arrow "0") and centroid of progression (black/white lines). Circled number indicates approximate locations of striation spacing measurements.

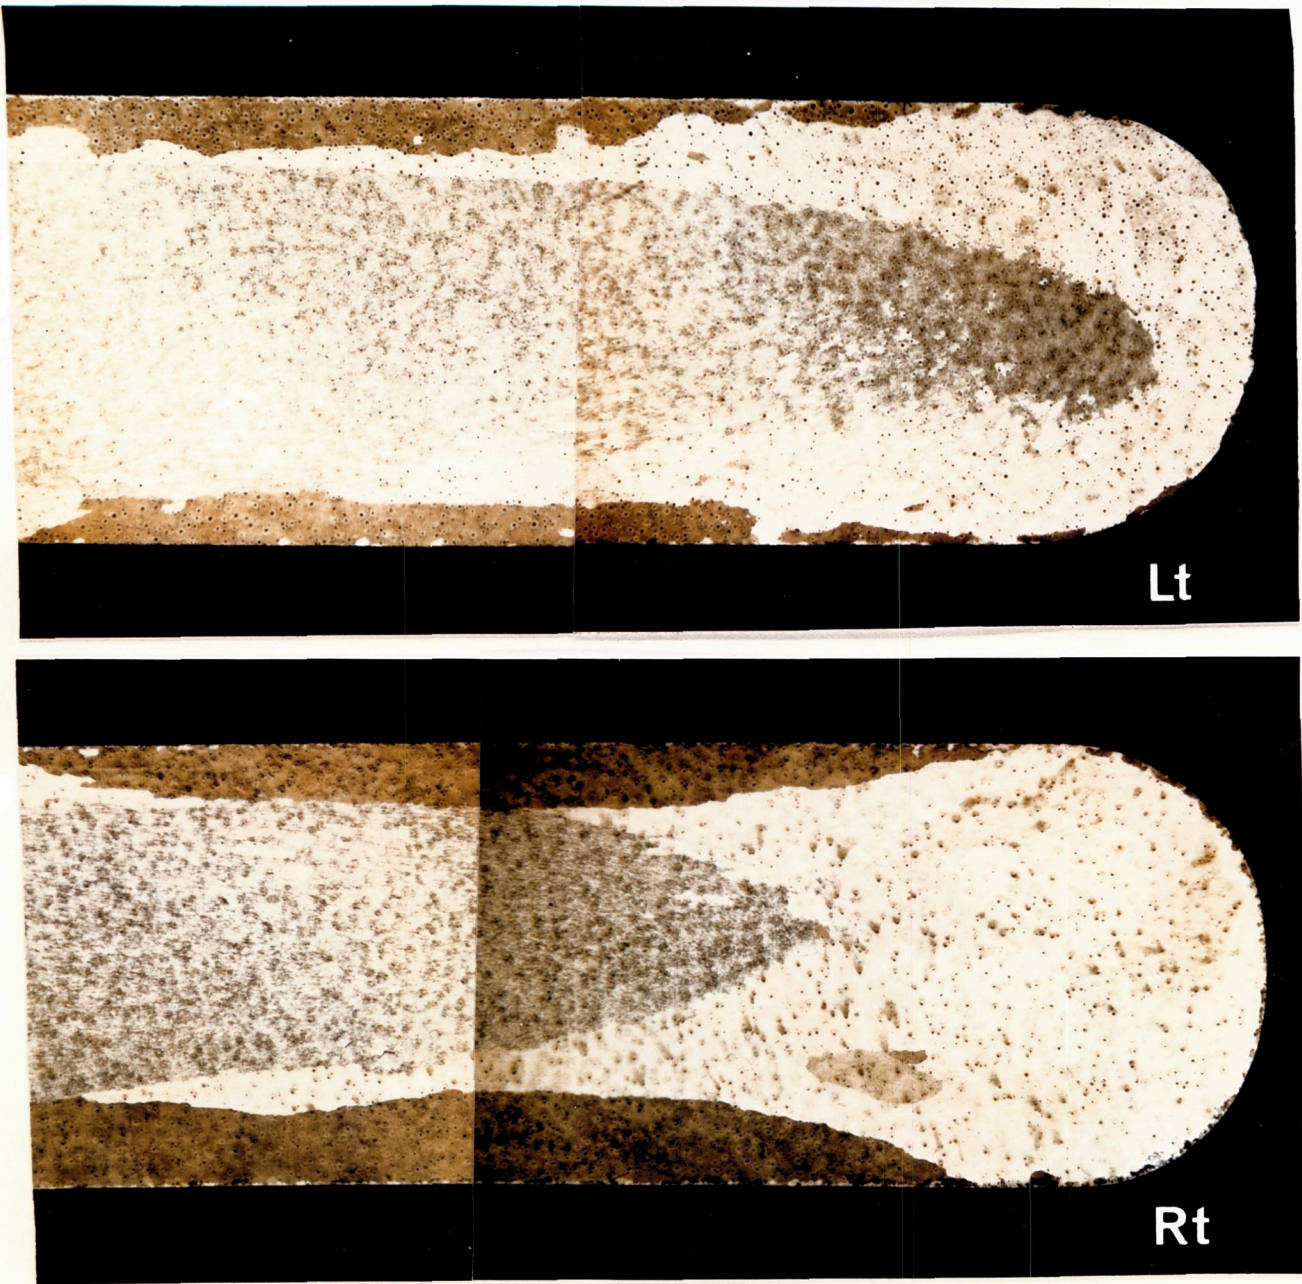
Additional metallographic specimens were prepared from the inboard portions of the left and right wing lower spar caps for microstructure examination. The microstructures shown in figure 8 are from the forward flanges of the spar caps approximately 1.25 inches inboard of the respective fractures. Again, these specimens exhibited a microstructure typical of an aluminum alloy extrusion. Further, the microstructures appeared to be consistent with the specified material and temper, 2024-T3511.

Figure 8. Micrographs of the left and right lower spar caps showing the typical microstructure. Keller's Reagent etch. (6.4X mag.)

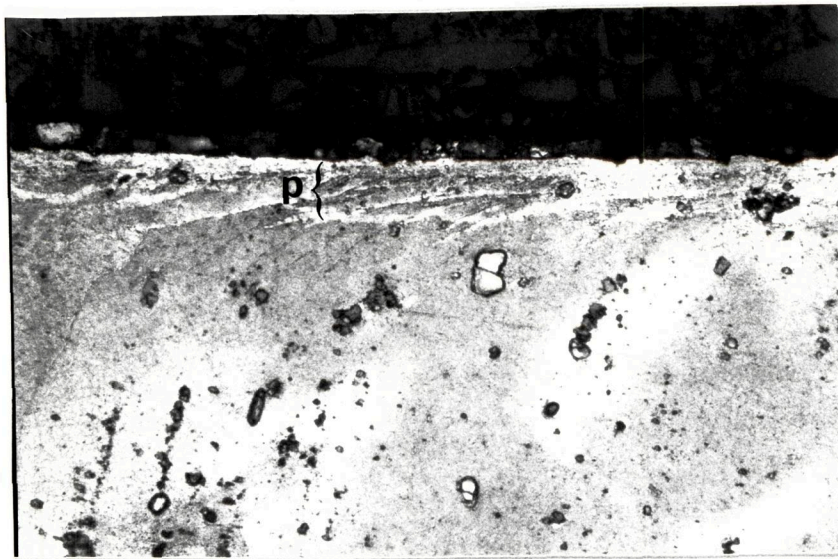
A microsection was also prepared through the left wing lower spar cap aft outboard bolt hole at the fracture plane. This section revealed a layer of plastic deformation adjacent to the bolt hole surface, as denoted by brackets "P" as in figure 9.

Figure 9. Micrograph showing the metal flow layer, bracket "P" adjacent the left wing spar outboard aft attachment bolt hole.

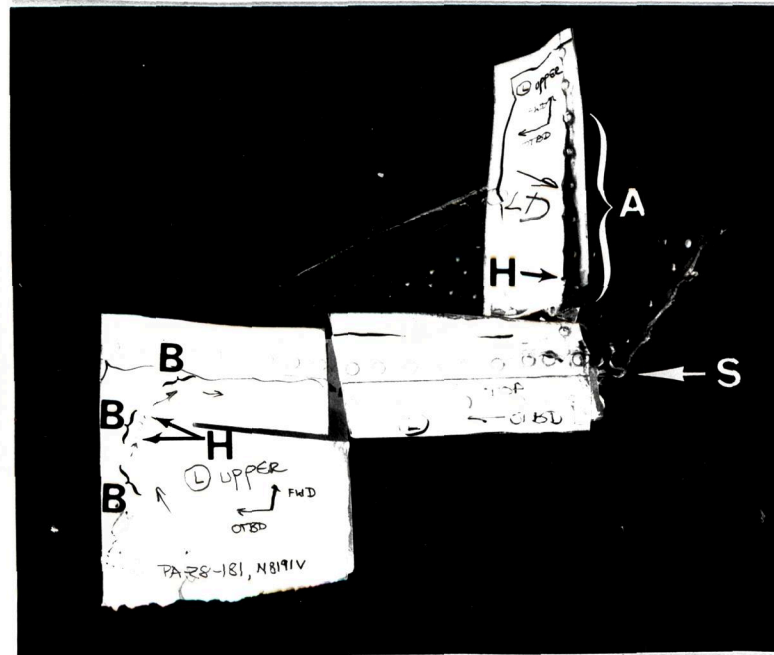
Two portions of the left wing upper skin were received separate from the spar assembly section. Figure 10 shows the location of the two skin pieces in relation to the spar. The skin piece forward of the spar at the wing root area contained a 5.6 inch long crack (see bracket "A", figure 10) between 6 rivets attaching the upper skin to the most inboard wing rib. The outboard aft wing skin section was cracked at three locations adjacent to three skin to second inboard wing rib rivets. These cracks are identified in figure 10 by brackets "B".

At both cracking locations, there were non-original manufacture holes drilled through the skins at the locations of the cracks, as if the cracks had been "stop drilled" (see arrows "D" in figure 10).

Both sets of skin cracks were opened by making appropriate saw cuts through the skins to the crack ends and removing one face from each crack. Optical examination of the crack faces, after cleaning, revealed heavy rubbing damage to large areas of the forward inboard crack faces (bracket "A"). However, sufficient crack face details remained to identify fatigue progression features in the undamaged areas. The directions of the fatigue progression and the presence of slight offsets

along the crack plane indicate the overall crack was formed by the intersections of six independent fatigue cracks. The independent cracks appeared to have initiated on the upper surface of the skin under the edges of the rivet heads.

Examinations of the crack faces from the outboard aft skin cracks (brackets "B") also identified fatigue progressions features. As with the inboard cracks, the fatigue cracks were determined to have initiated on the upper surface of the skin under the manufactured heads of the rivets.

Figure 10. View of the additional upper skin pieces with the cracks at brackets "A" and "B". Stop drill holes at arrows "H" and spar at arrow "S".
