**From:** russell williams <[REDACTED]>  
**Sent:** Tuesday, May 01, 2018 5:07 PM  
**To:** John Romanowski  
**Subject:** statement

To the investigator with the FAA and other concerned person(s). My name is Russell Williams. I am an employee with J.W. Didado. On Sunday April 8th 2018 while working for JWD I witnessed a helicopter crash that resulted in two fatalities and serious life threatening injuries to a third person. My duties for the day were to stand watch at a distribution and road crossing where we had a temporary guard crane set up. I was at structure 15877 with this equipment. My section of the right of way included structure 15878. Between structure 15878 and structure 15879 there is a river. Structure 15879 is in a field where the helicopter would land to refuel and for the linemen to resupply. The line continues to structure 15880 being in the same field. Then structures 15881 and structure 15882 are in a cow pasture. After a road and distribution crossing the line travels up hill to a steel pole structure 15883. The next structure up the hill is the double wood pole structure 15884 where the incident occurred. Structure 15885 being worked prior to the incident see

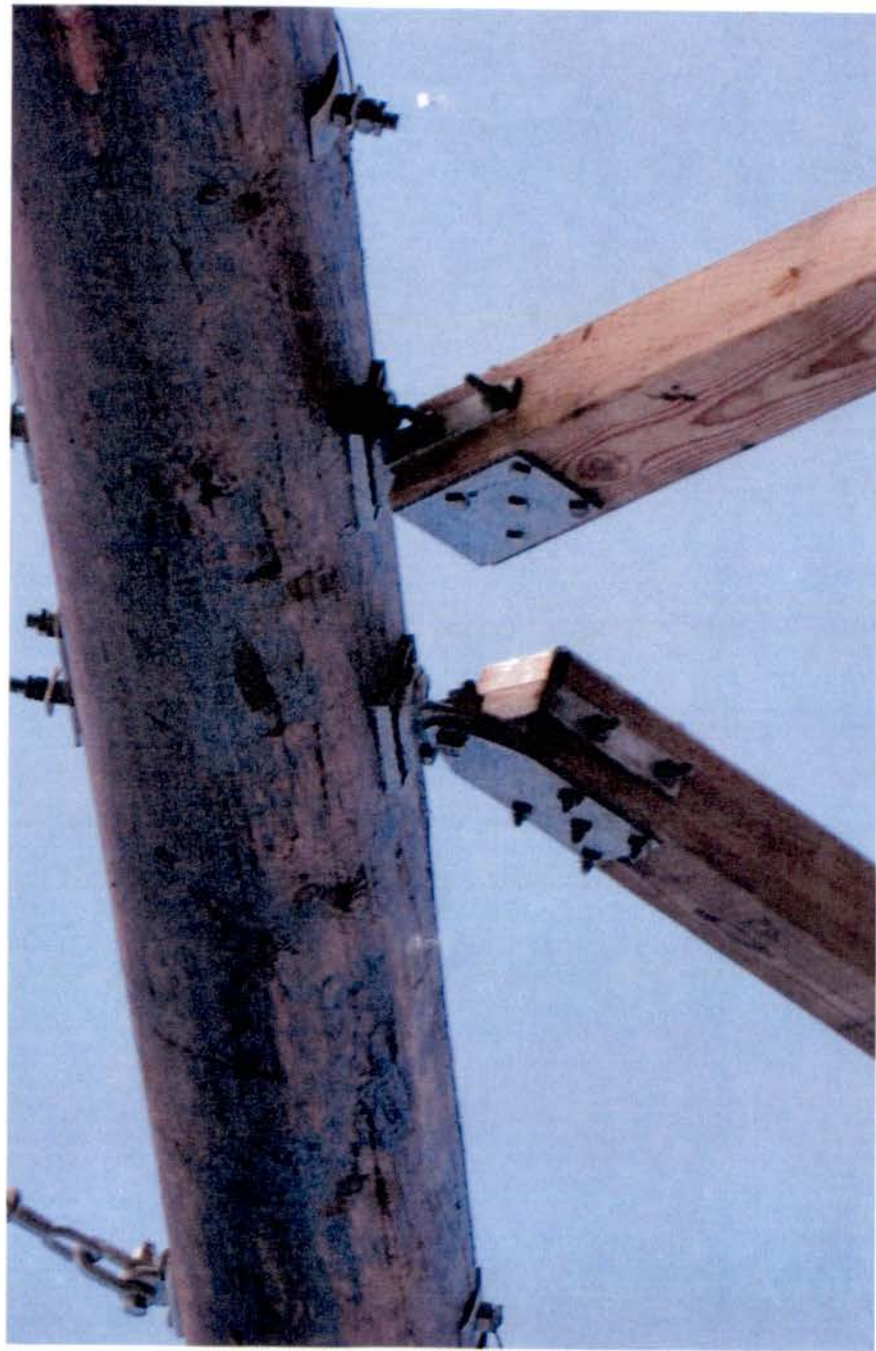
20 A Pole Structure # 15884 with Broken Guy Wire still attached

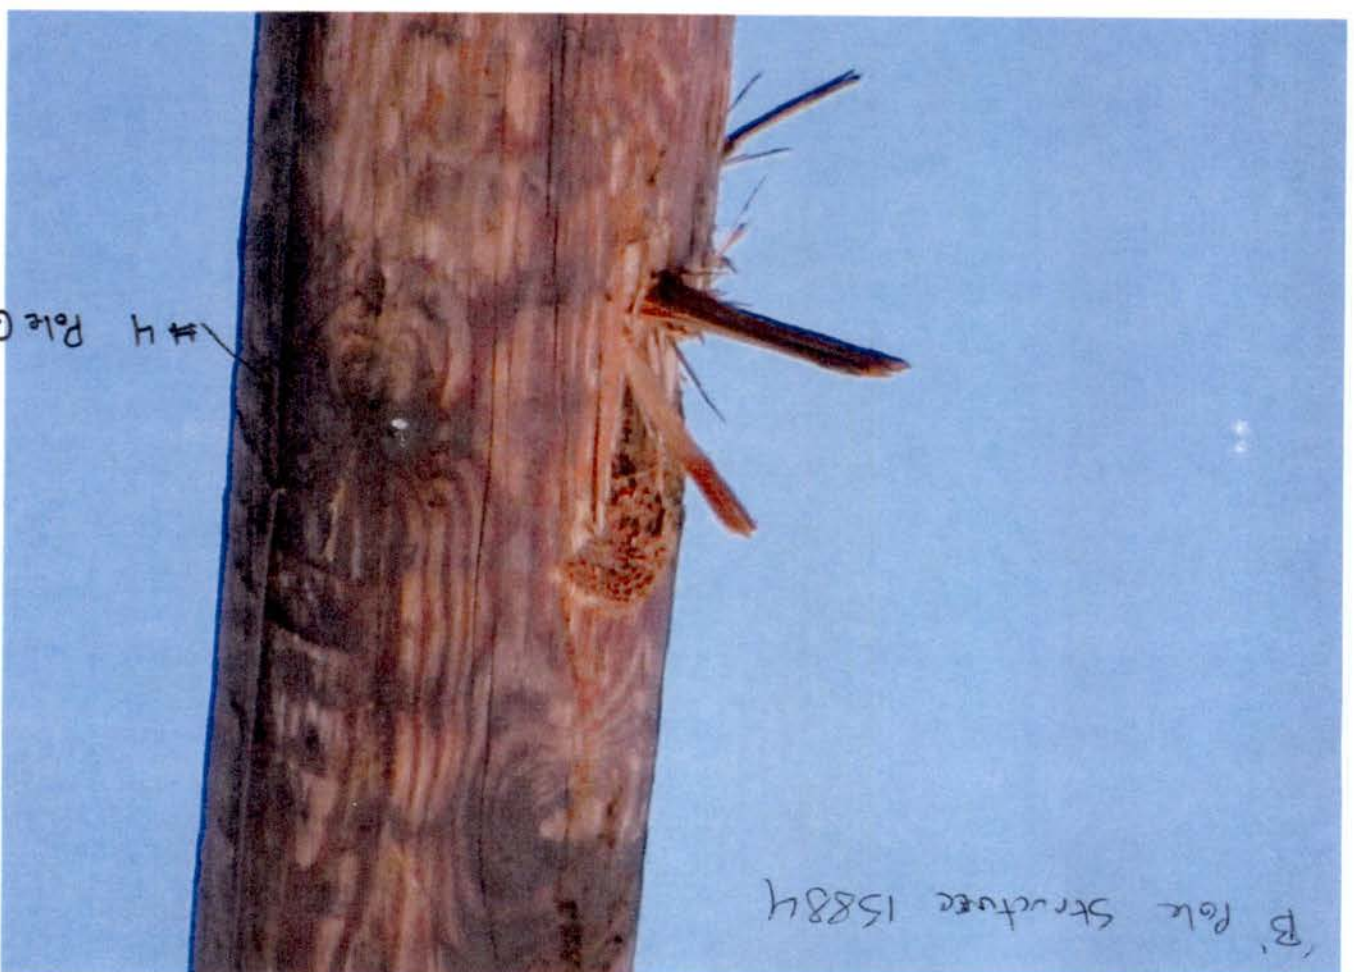
Damage to B Pole Structure 15884

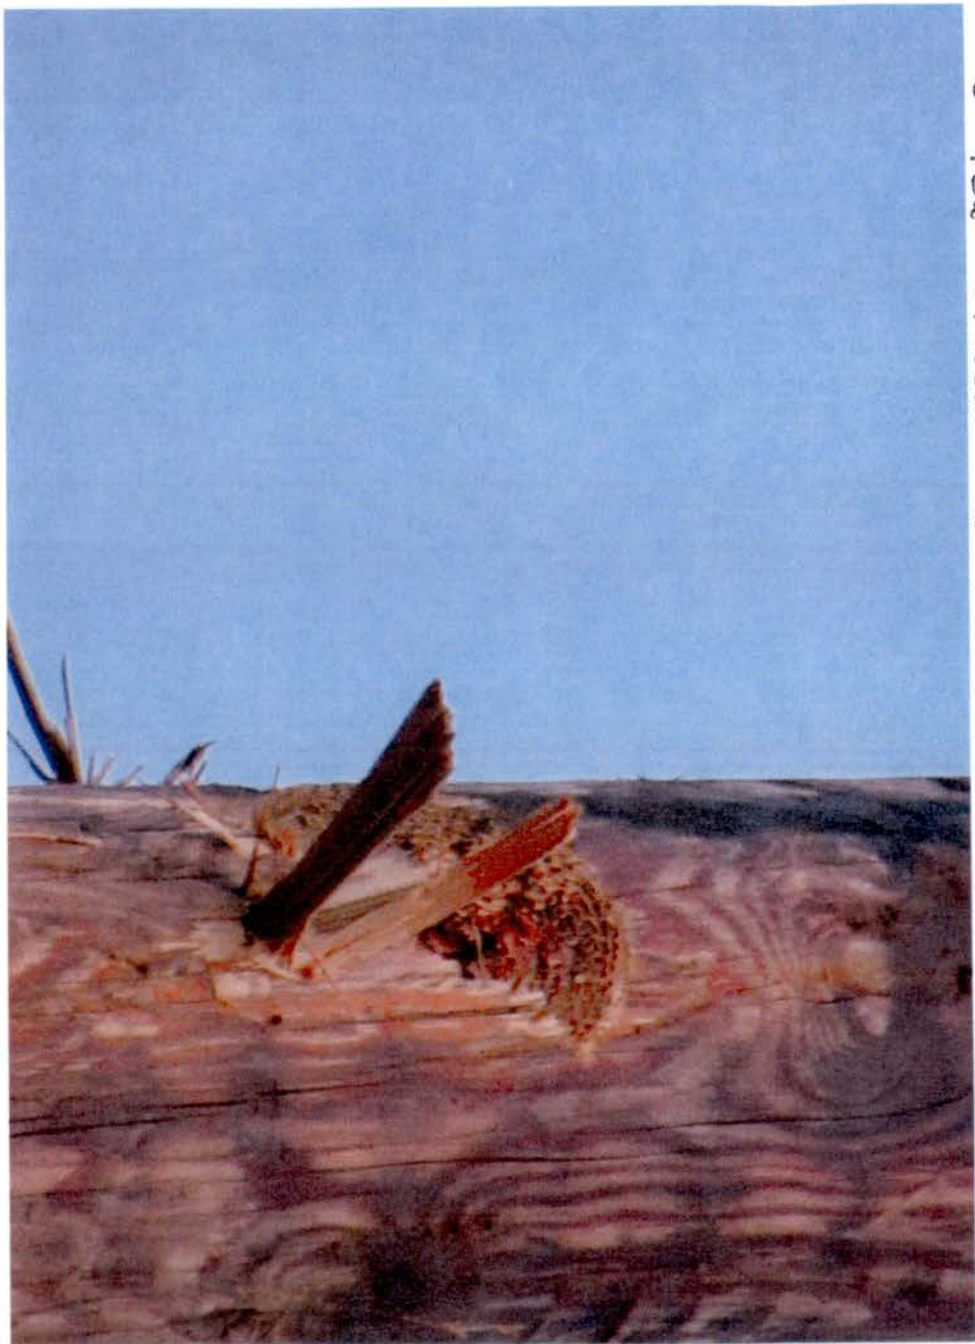
B pole and  
top X Brace  
from lower side of  
Structure 15884

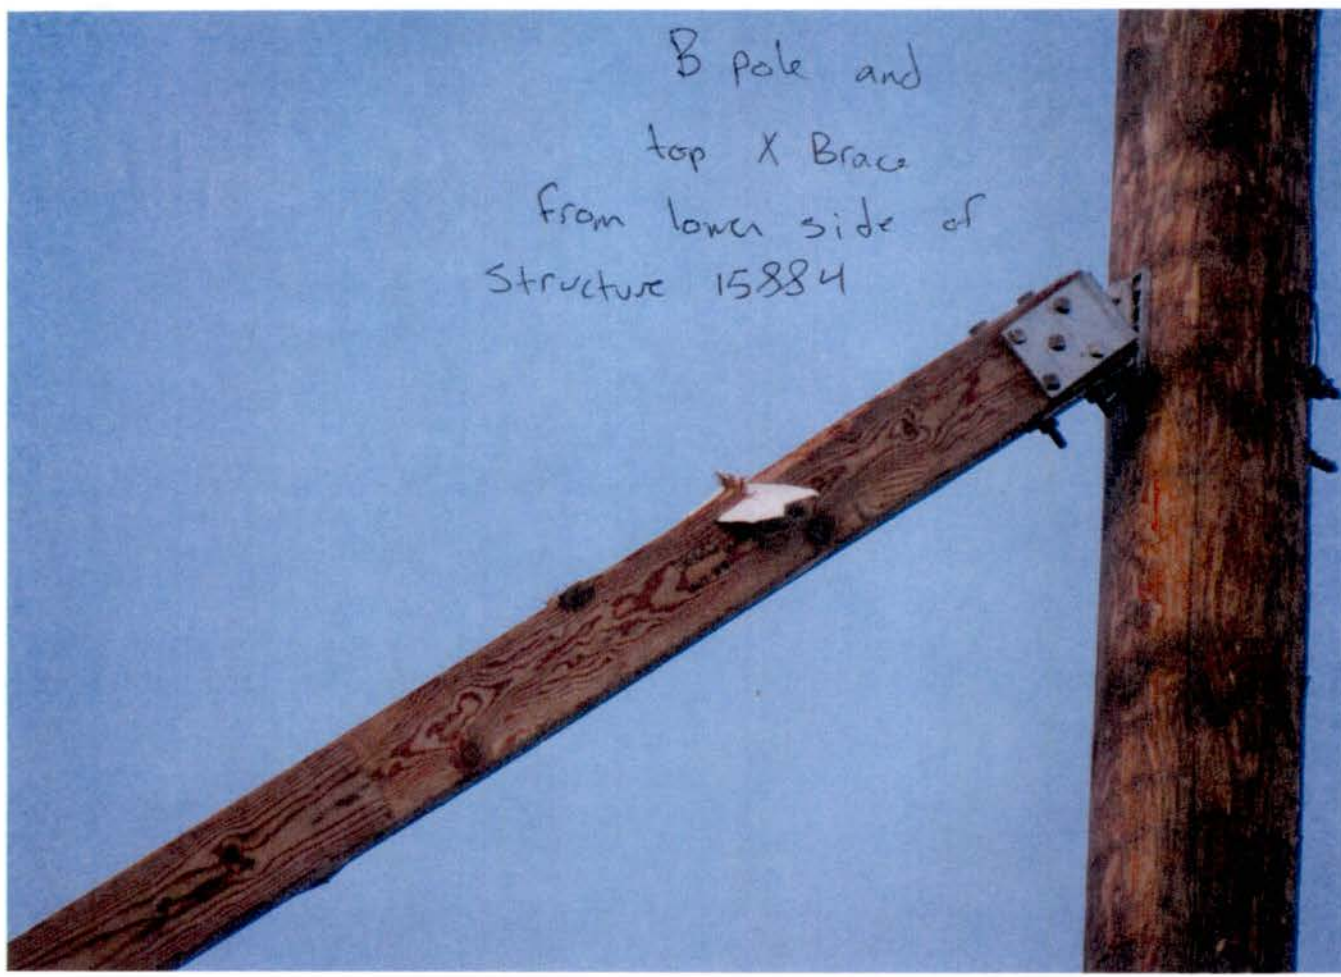
Guy Wire Attachment Pt.

Damage to Pole

Damage to top

X-Brace

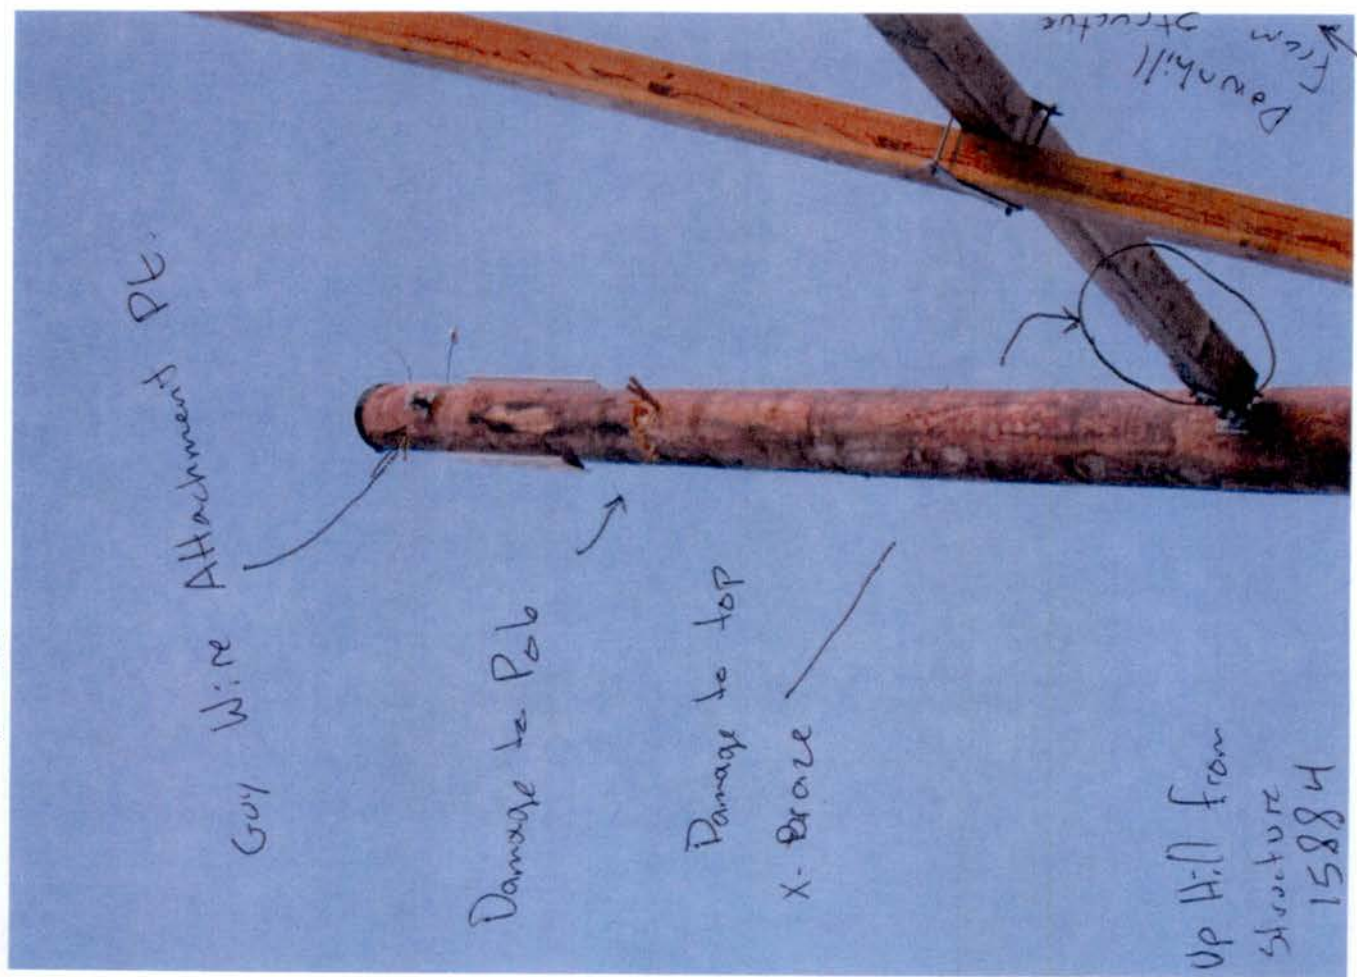
Damage to top X Brace Structure #15884  
taken from uphill side near Base of structure
