# NATIONAL TRANSPORTATION SAFETY BOARD

## MATERIALS LABORATORY FACTUAL REPORT

Report No. 18-084

Place : Smethport, Pennsylvania  
Date : April 8, 2018  
Vehicle : McDonnell Douglas MD 600N, N602BP  
NTSB No. : ERA18FA122  
Investigator : Brian Rayner, AS-ERA

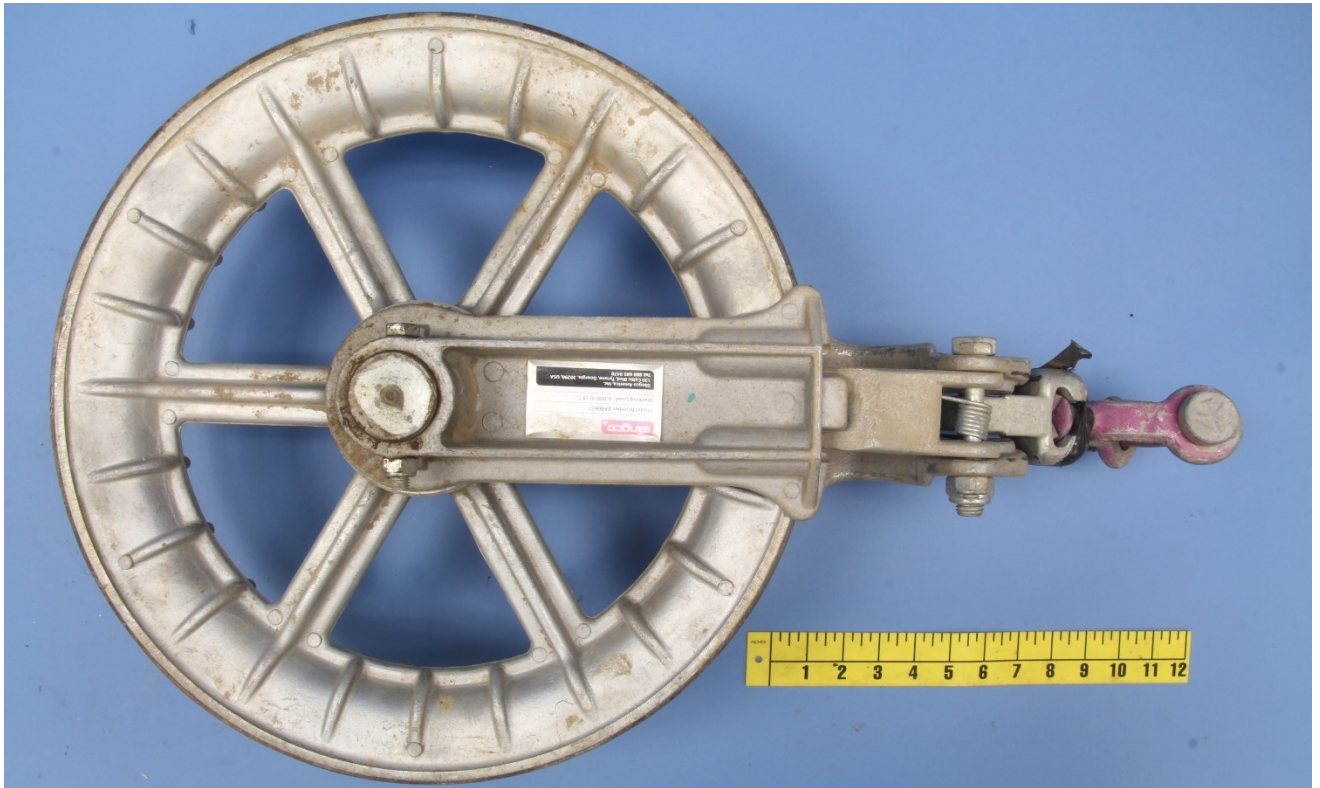
Figures 1 through 4 illustrate the exemplar pulley assembly, or dolly, as received. The assembly consisted of a circular pulley wheel with a U-shape groove for holding a cable, surrounded by a block with a locking gate (Figure 2). This locking gate latch was

Figure 1 – The exemplar pulley assembly, as received.

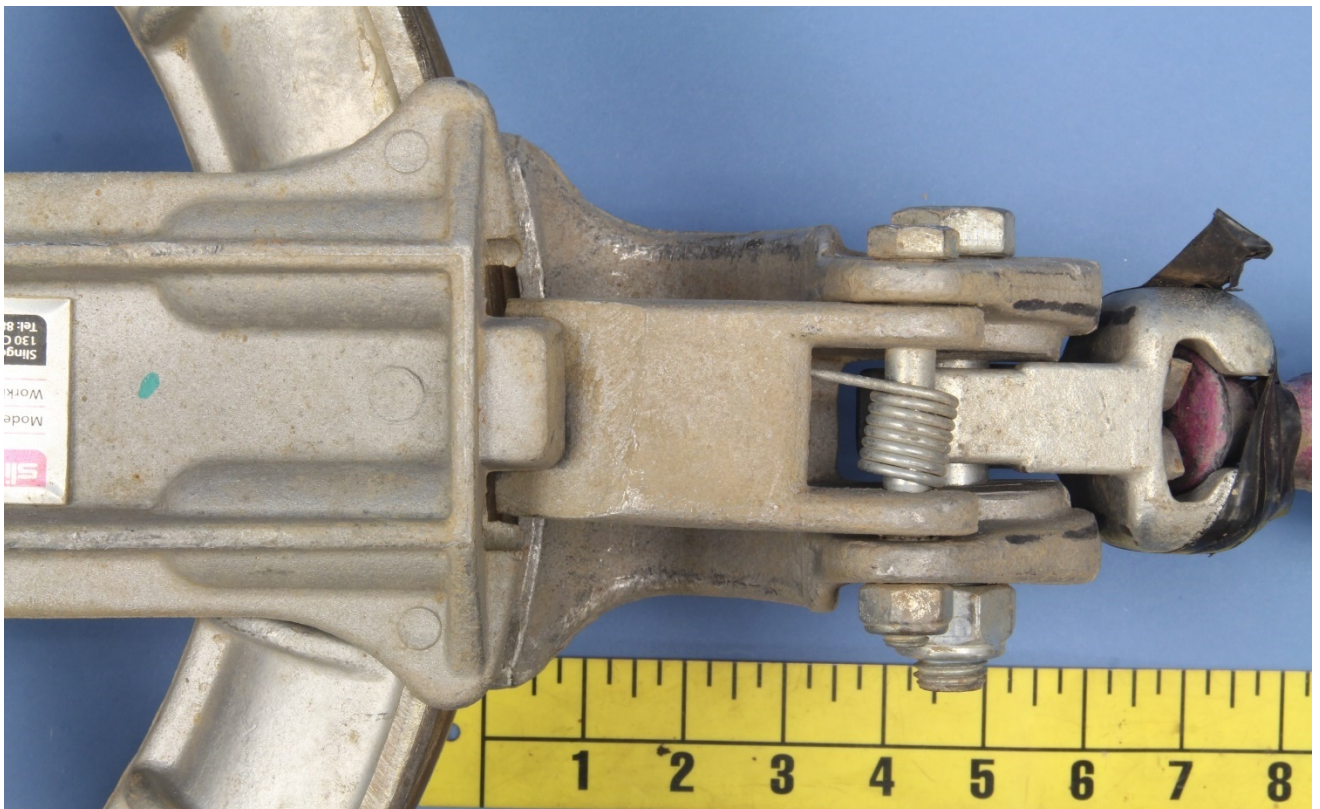
Figure 2 – The locking gate of the exemplar pulley assembly, shown as received.

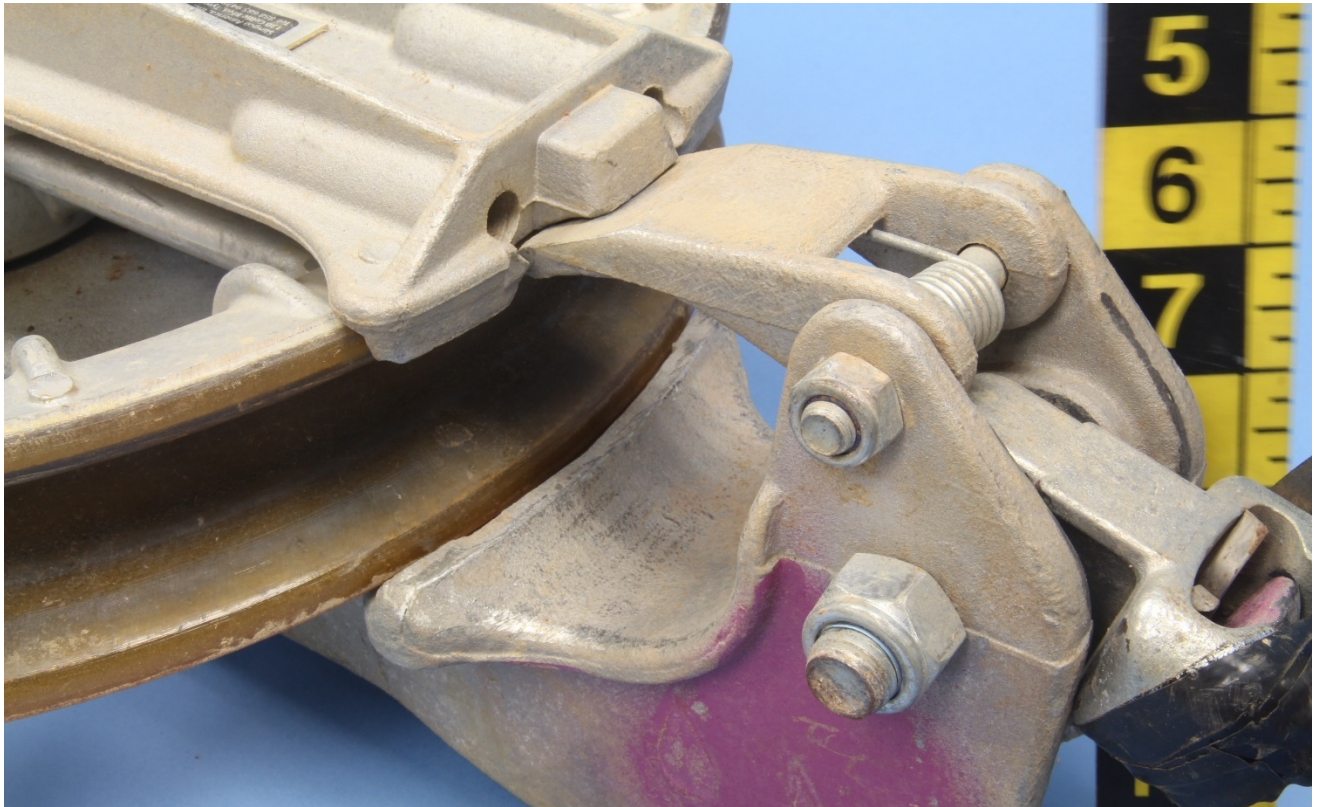
spring loaded to stay in the closed position against a tab on the block when not being actuated (Figure 3). In this position resting against the tab, the latch would be under a bending force, with the tension side being on the outward face (upward, facing the reader in Figure 3), with the compression side facing inward.

Figure 3 – The locking gate from Figure 2, shown from the side in the latch closed position.

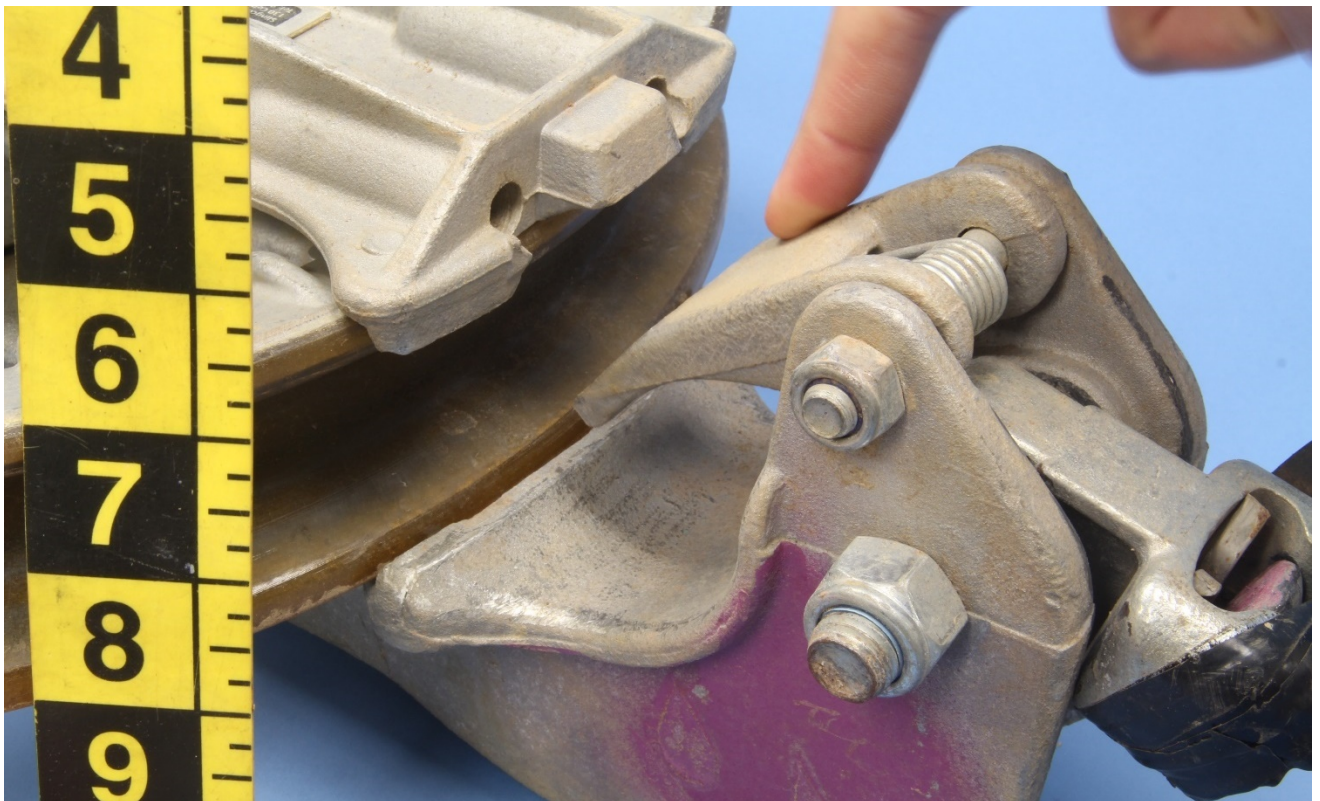
As demonstrated in Figure 4, when actuated by pushing inward, the locking gate latch would rotate inward to allow a cable to be moved inward or outward. In the closed position, the latch would prevent the cable from leaving the groove on the pulley wheel.

Figure 4 – The locking gate from Figure 2, shown from the side in the latch open position.

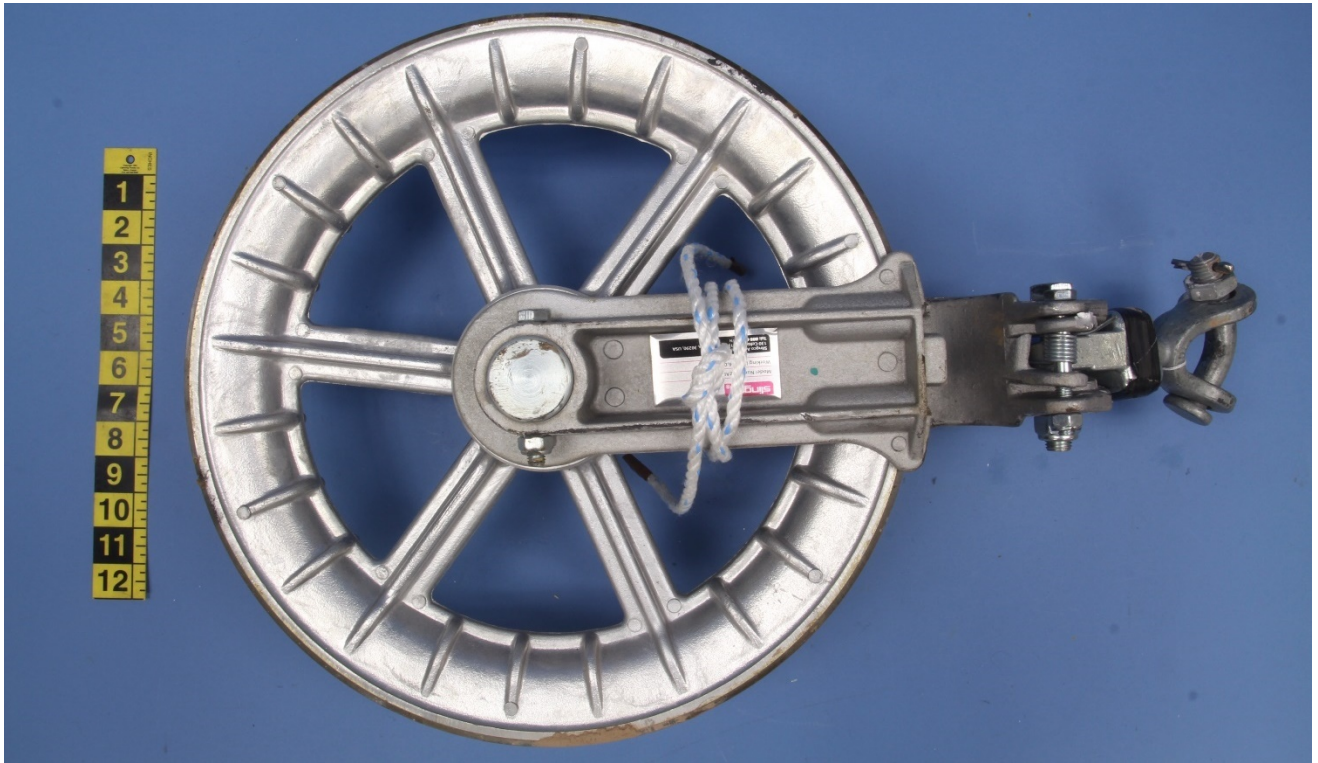
Figure 5 shows the accident pulley assembly, as received. Rope was tied around one of the pulley wheel spokes and the block arms to prevent rotation of the pulley wheel. The markings on a block arm stated "slingco®", "Model Number: ZAB6651", and "Working Load 6,000 lb (3:1)".

Figure 5 – The accident pulley assembly, as received.

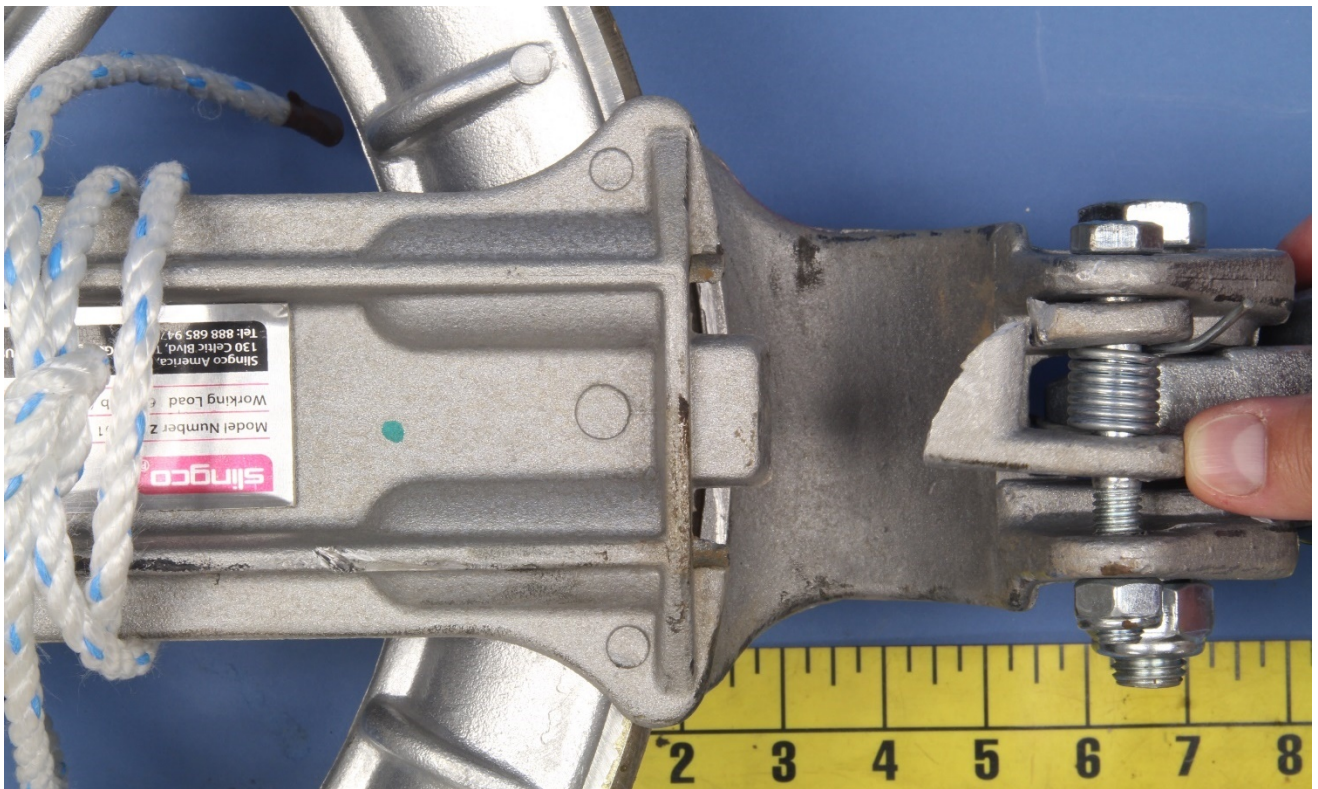
Of note was the locking gate latch that had fractured, shown in Figure 6. The fracture was oriented at a general 45° angle. The gate had fractured in a manner such that two separate fragments of the latch remained affixed to the attachment bolt.

Figure 6 – The locking gate part of the accident pulley assembly, as received and oriented to show the fractured latch as it would be arranged in the closed position.

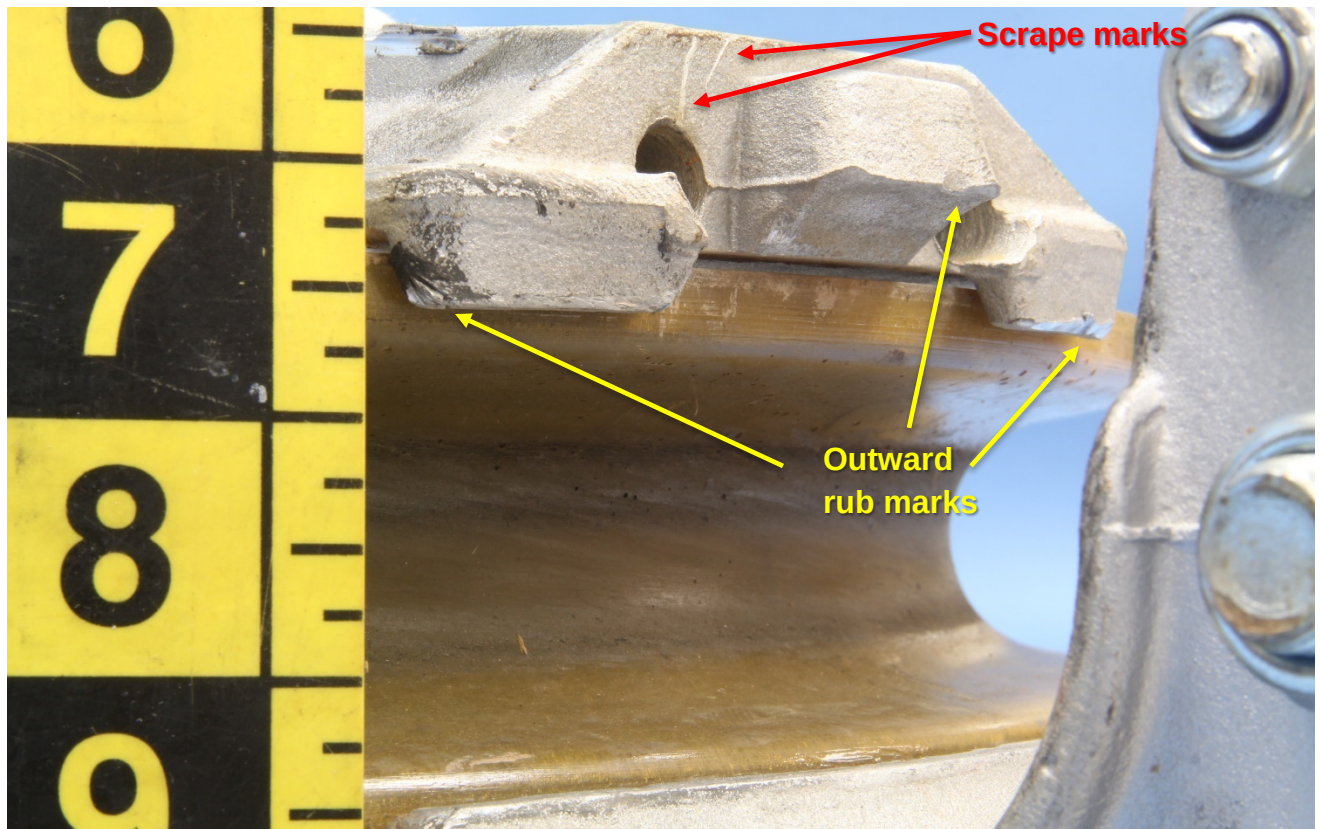
Figure 7 shows a view of the block arm with the tab that held the locking gate. As annotated in the figure, there were several witness marks present consistent with rubbing or gouging from contact with a metallic part. This was most exemplified in the pulley wheel guide outer corners. Each corner exhibited smearing of material in the outward (upward in Figure 7) direction. This smearing orientation was consistent with a part moving outward and sliding against the guide corners.

In addition, the block tab exhibited smearing marks oriented in an outward direction, consistent with a part moving outward and sliding against the tab. On the upper flat face of the block arm were two scrape marks, highlighted in Figure 7. The marks exhibited material being pushed outward, consistent with contact from a part moving outward.

Figure 7 – A view of the tabs for the locking gate from the accident dolly block arm, viewed from the side and below. Witness marks are labeled on the tabs and surface.

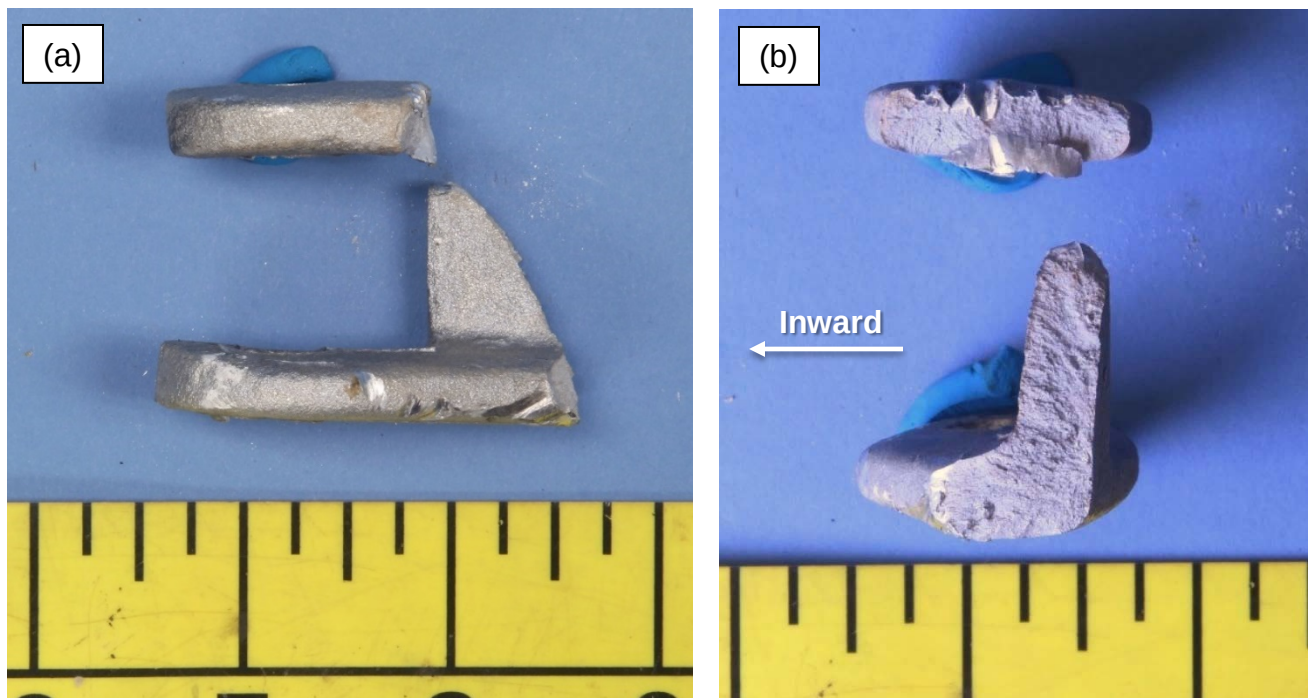
Figure 8 shows the remnants of the latch after disassembly of the restraining bolt that held the locking gate in place. As shown in Figure 8, the only remnants remaining were the clevis portions. Figure 8b shows the fracture surfaces of the latch remnants, using oblique lighting to shadow and enhance the fracture features. Figure 9 and Figure 10 show closer views of the two fracture surfaces. Both fracture surfaces exhibited chevron marks and river patterns, consistent with overstress fracture.

Figure 8 – The fractured latch pieces, after disassembly from the dolly viewed (a) from the side and (b) from the fracture surfaces with oblique lighting to highlight features.

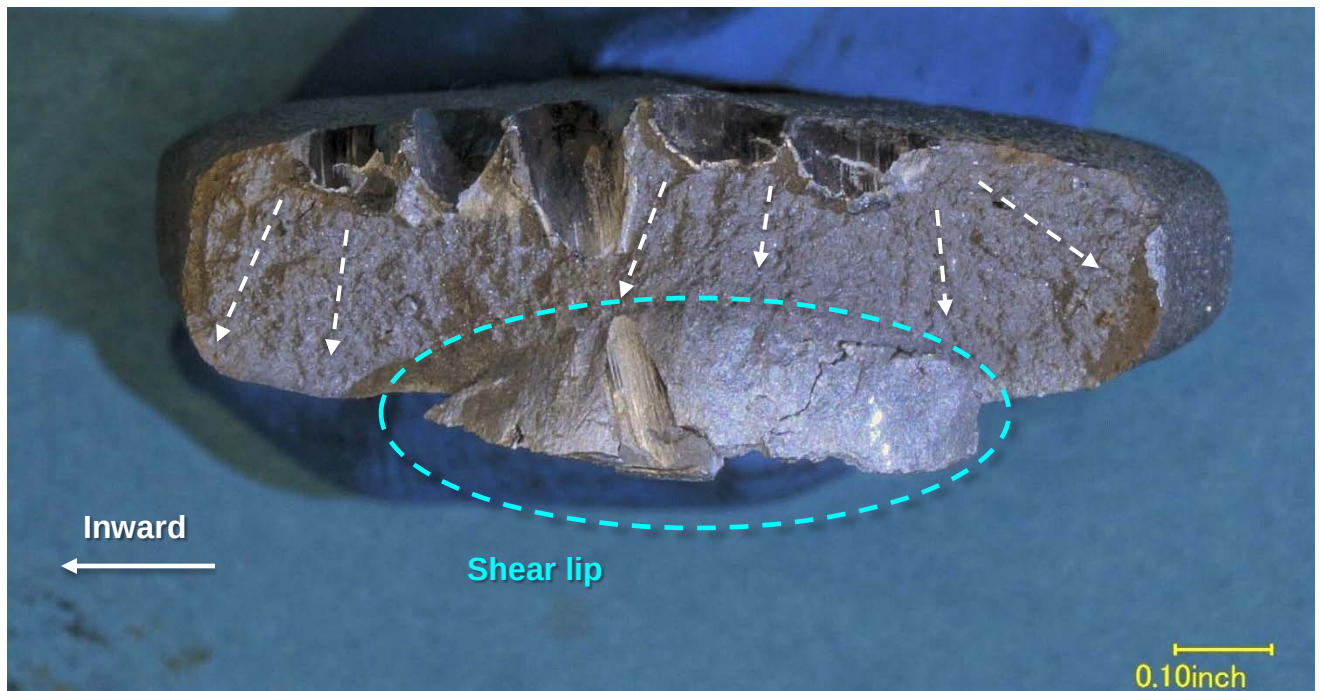
Figure 9 shows the smaller latch fragment fracture surface. As annotated in the figure, the general direction of the fracture features was from the outward to inward in an angled direction. One side exhibited a large shear lip that faced the reader. These features were consistent with fracture from overstress in a bending direction. The five features on the opposite edge of the shear lip were consistent with smearing marks from the top to the bottom of the figure. These smearing marks were consistent with subsequent impact or rubbing damage to the fracture surface after the latch had fractured.

Figure 9 – The smaller latch fragment fracture surface, under oblique lighting.

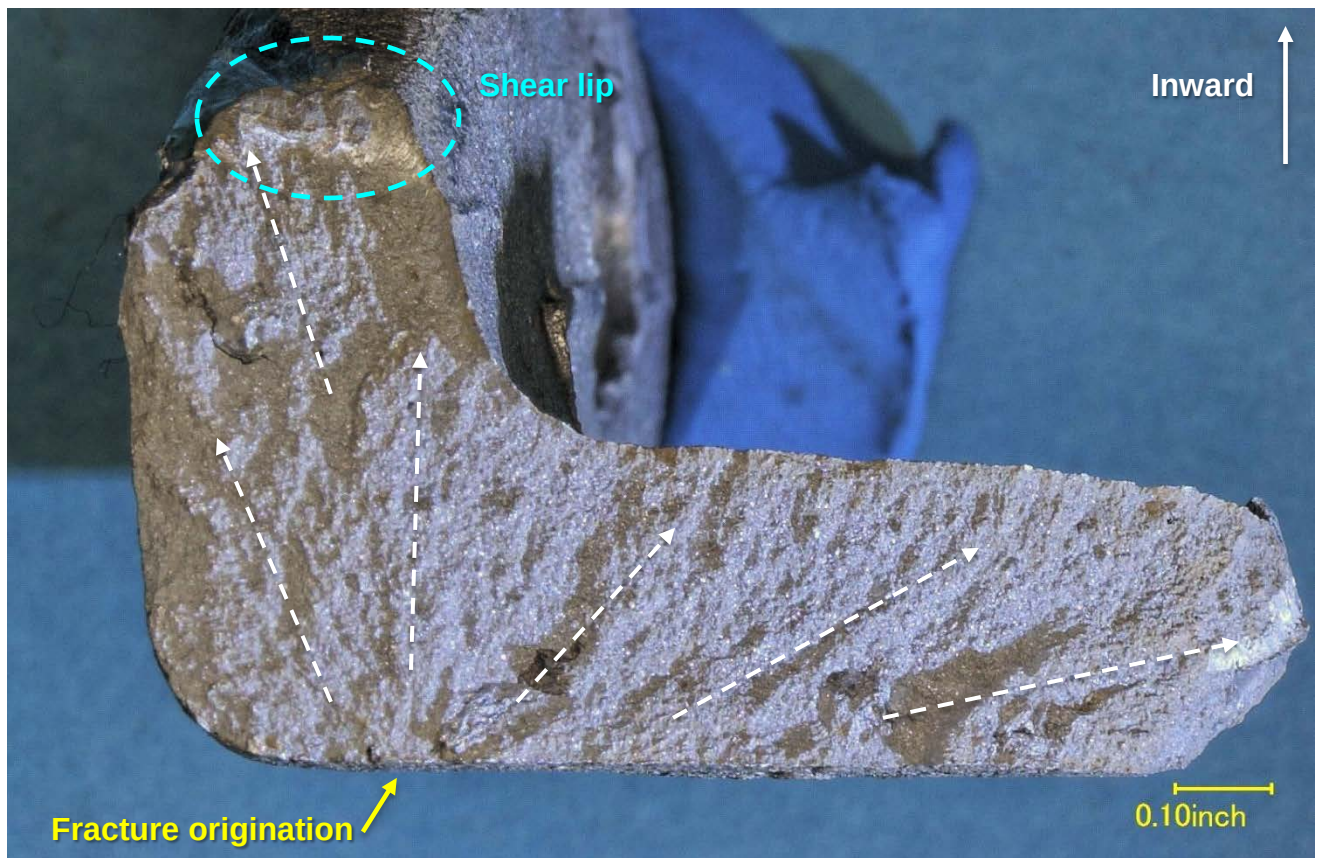
Figure 10 shows the larger L-shaped latch fracture surface. The river patterns and chevron marks were consistent with having emanated from an outward edge toward the inward side, as annotated in the figure. The opposite side exhibited a small shear lip, which faced the reader in the figure. These features were consistent with fracture from overstress in bending, with the tension side located on the outward face of the latch. No particular features were observed at the fracture origination consistent with a pre-existing defect such as a crack, pore, or inclusion (see Figure 11).

Figure 10 – The larger L-shaped latch fragment fracture surface, under oblique lighting. Arrows indicate the fracture direction and fracture origination.

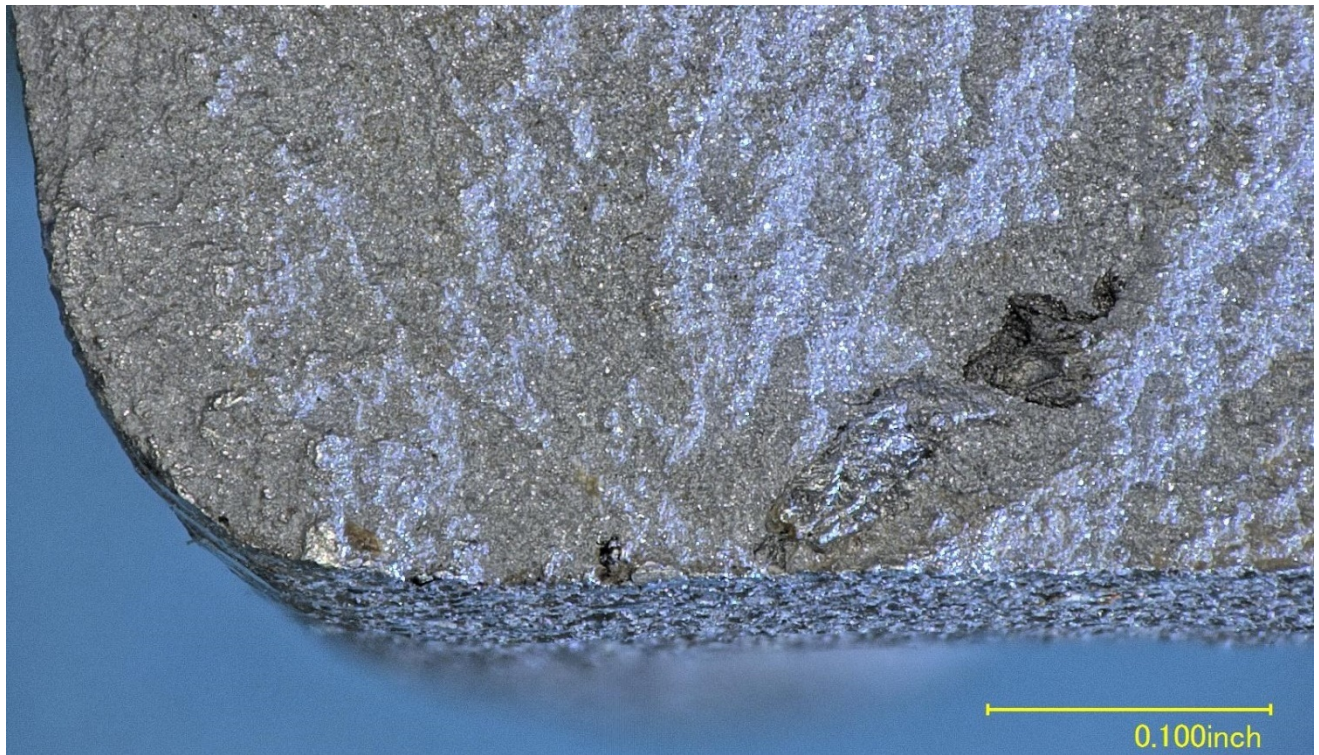
Figure 11 – Closer view of the fracture origination site, under oblique lighting.

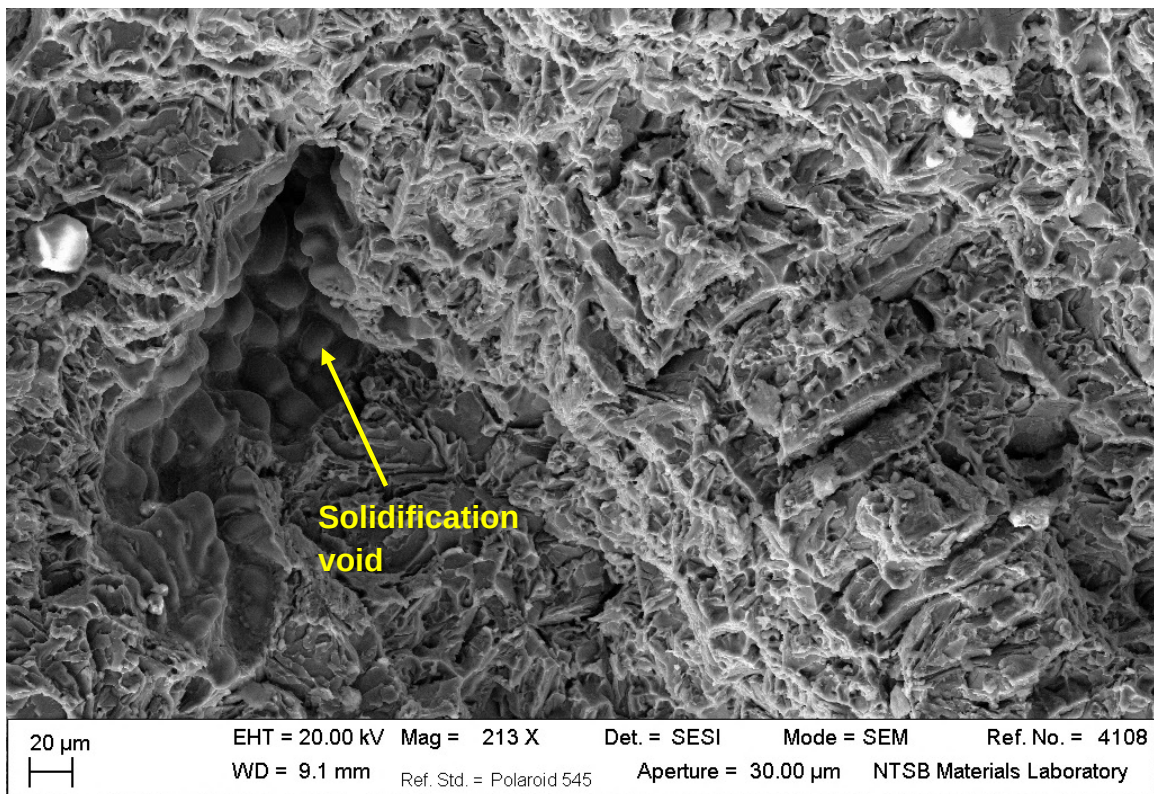
The fracture surfaces were examined using a scanning electron microscope (SEM). Figure 12 shows a typical area of the fracture surface. There were solidification voids sporadically located on the fracture surfaces, but they were typically less than 100  $\mu\text{m}$  in size. The fracture surface exhibited some lamellar-oriented features, particularly at lower magnification. Closer examination, as shown in Figure 13 and 14 show dimple rupture features, consistent with overstress fracture. The clustering of the dimple rupture features was consistent with those typically observed in casting fractures.

Figure 12 – Secondary electron (SE) micrograph of a typical area of the latch fracture surface.

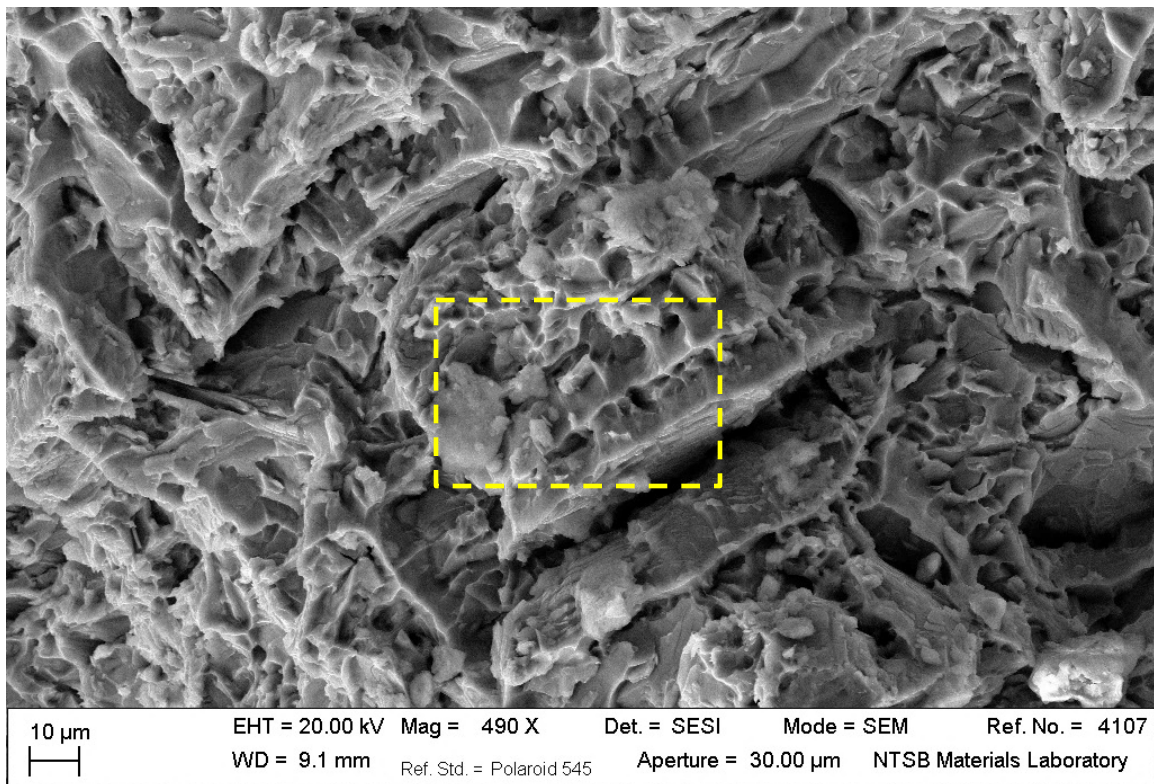
Figure 13 – SE micrograph of lamellar areas of the latch fracture surface. The boxed area is shown in Figure 14.

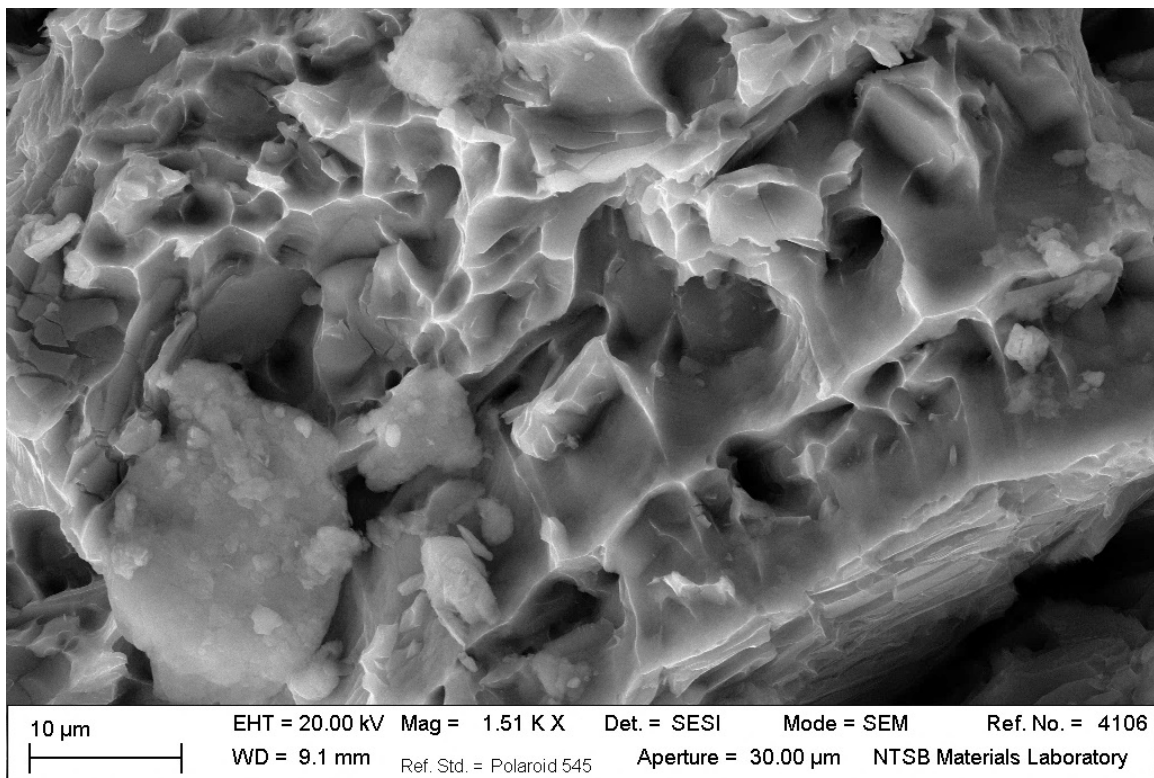
Figure 14 – SE micrograph of the boxed area in Figure 13, showing dimple rupture.

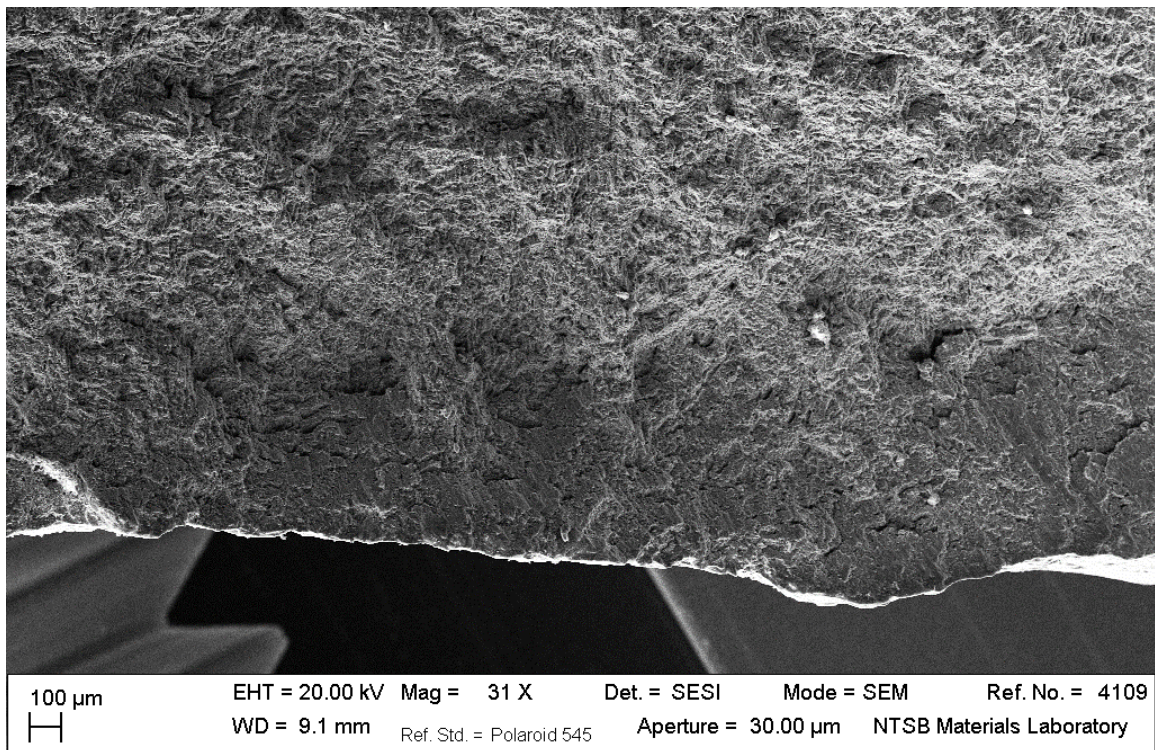
Areas of the fracture surface near the start of the fracture (edge) exhibited a generally flatter surface roughness (see Figure 15). However, closer examination of these areas revealed dimple rupture in shear orientations as well as material tearing, illustrated in Figure 16. No features consistent with other fracture modes were observed on the fracture surfaces.

Figure 15 – SE micrograph of an edge of the latch fracture surface.

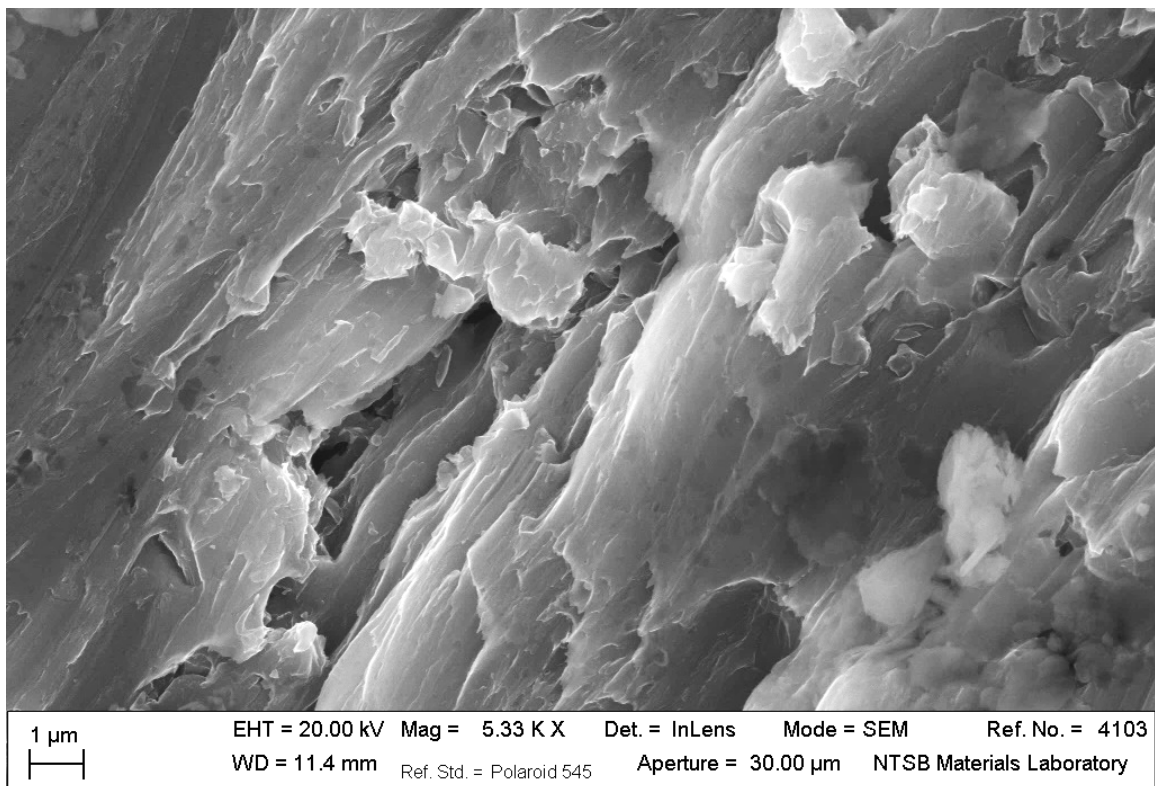
Figure 16 – SE micrograph showing tearing and dimple rupture on the flat area near the edge of Figure 15.

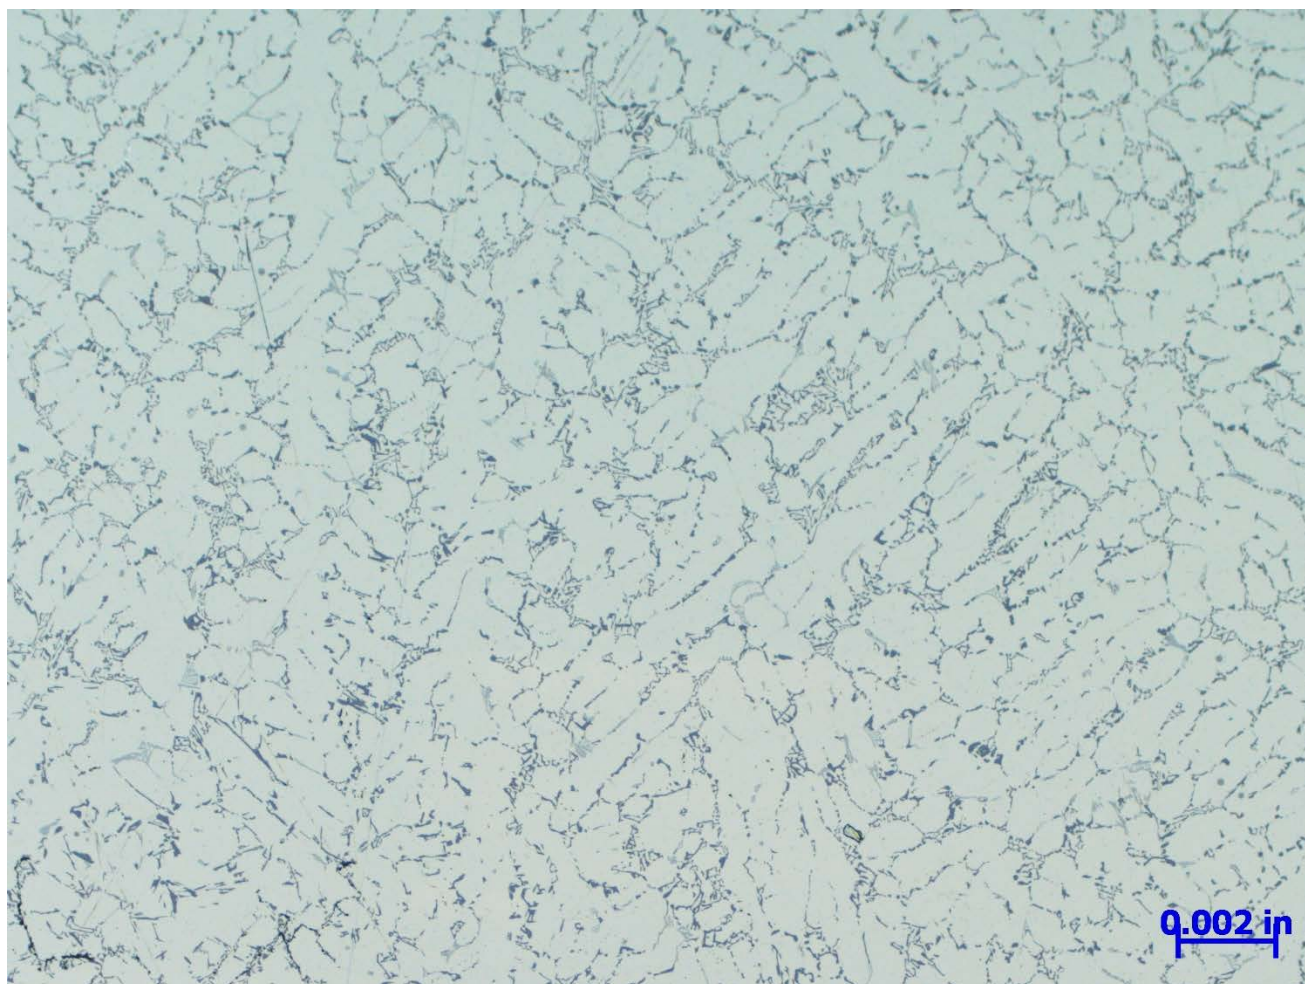
A section of the fractured gate near the fracture surface was mounted and polished. Figure 17 shows a typical area of the gate microstructure, which exhibited a dendritic morphology consistent with a cast material. The chemical composition of the gate was inspected using energy dispersive x-ray spectroscopy (EDS). The composition was consistent with an AA 400-series aluminum casting alloy. The electrical conductivity and hardness were inspected per ASTM E1004 and ASTM E18, respectively.<sup>1,2</sup> The conductivity averaged 31.0% IACS, and the hardness averaged 68 HRE.<sup>3</sup> These data were consistent with those typical of this alloy in the as fabricated condition.

Figure 17 – Bright field (BF) micrograph of a typical area of the latch microstructure (~200X, as polished).
