## **Engine Investigation Report**

**Rolls-Royce Corporation  
Model 250-C47M  
Engine CAE-847837**

**High Line Helicopters, LLC  
Smethport, Pennsylvania**

**Accident date: 8 April 2018  
Wreckage exam date: 17-18 May 2018  
Report date: 20 June 2018**

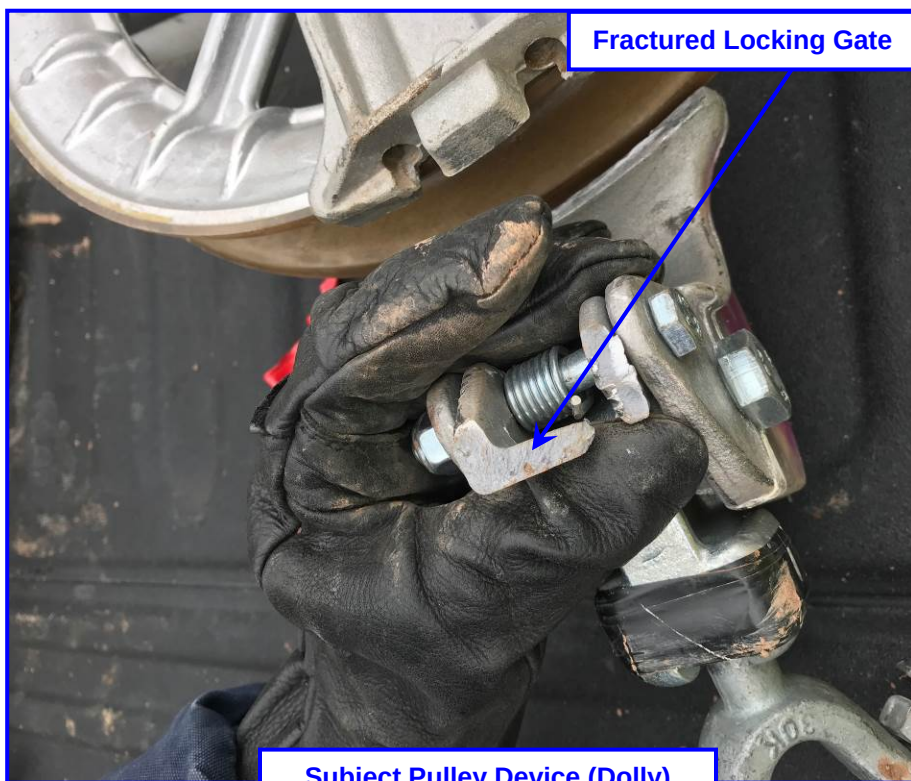
Subject Pulley Device (Dolly)

The safety strap was suspended from a cross-brace of the H-structure, and the hoist was found next to the fuselage; each appeared undamaged. Examination of the structure poles and the static line revealed signatures consistent with main rotor blade strikes. The dolly was in its swiveling mount and facing 180° from its operational position. Damage signatures to the pole above its mounting matched the dimensions of the dolly. The dolly was recovered from the top of the structure, and examination revealed it was intact except for the locking gate, which was fractured. The fracture surface displayed features consistent with overload. The dolly was retained for further examination at the NTSB Materials Laboratory.

Fractured Locking Gate

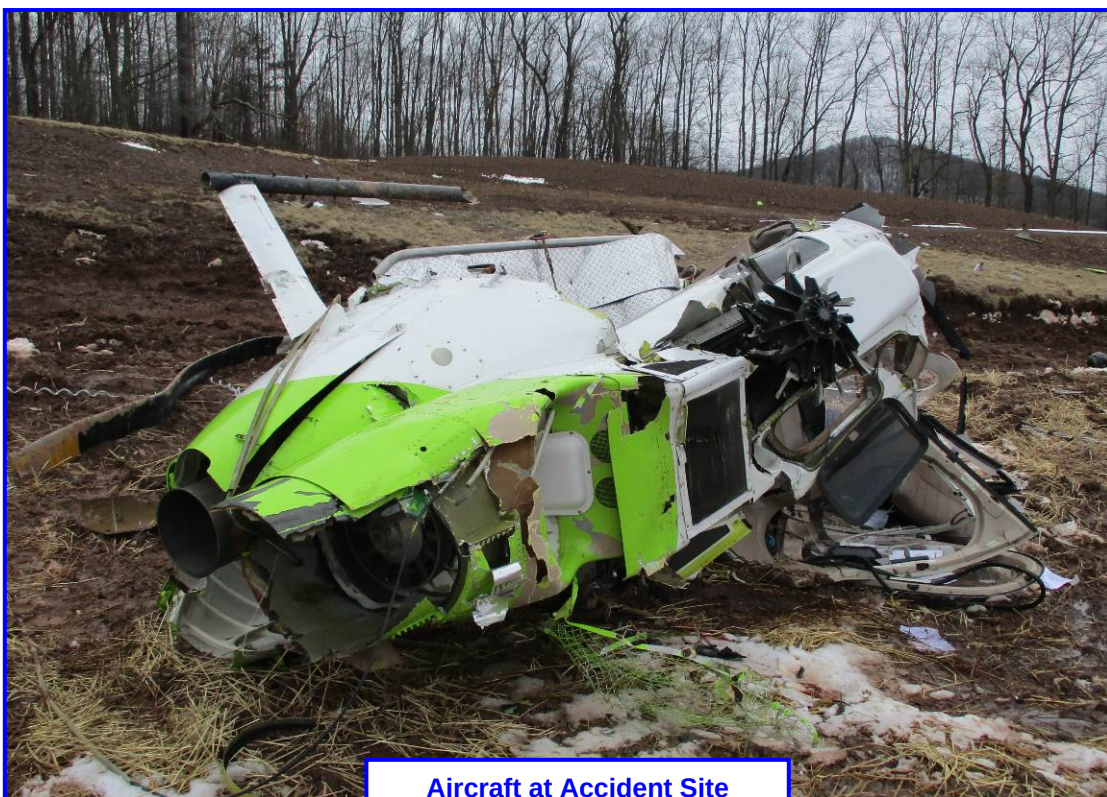
Aircraft at Accident Site

The helicopter was examined at the accident site about 1,600 ft elevation, and all major components were accounted for at the scene. The wreckage was contained largely at the bottom of the wooden H-structure that was struck, with the six rotor blades separated at the hub and scattered at various distances on the south side of the power lines. One rotor blade travelled approximately 300' down the hill (west) of the structure. The tailboom separated and was about 70' west of the structure. Striation marks consistent with wire contact were visible on top of the left skid forward of the front cross tube.

The airframe was resting on its right side. The forward lower fuselage and cockpit structure was extensively damaged. The cabin section lower fuselage was extensively crushed. The NOTAR tailboom was separated from the main fuselage aft of the attachment fitting. The composite tailboom was fragmented mid-span. The aft end of the tailboom contained the direct jet thruster, horizontal and vertical stabilizers. The horizontal and vertical stabilizers were impact damaged. The NOTAR fan shroud was crushed and deformed. There were multiple fractures of the flight controls.

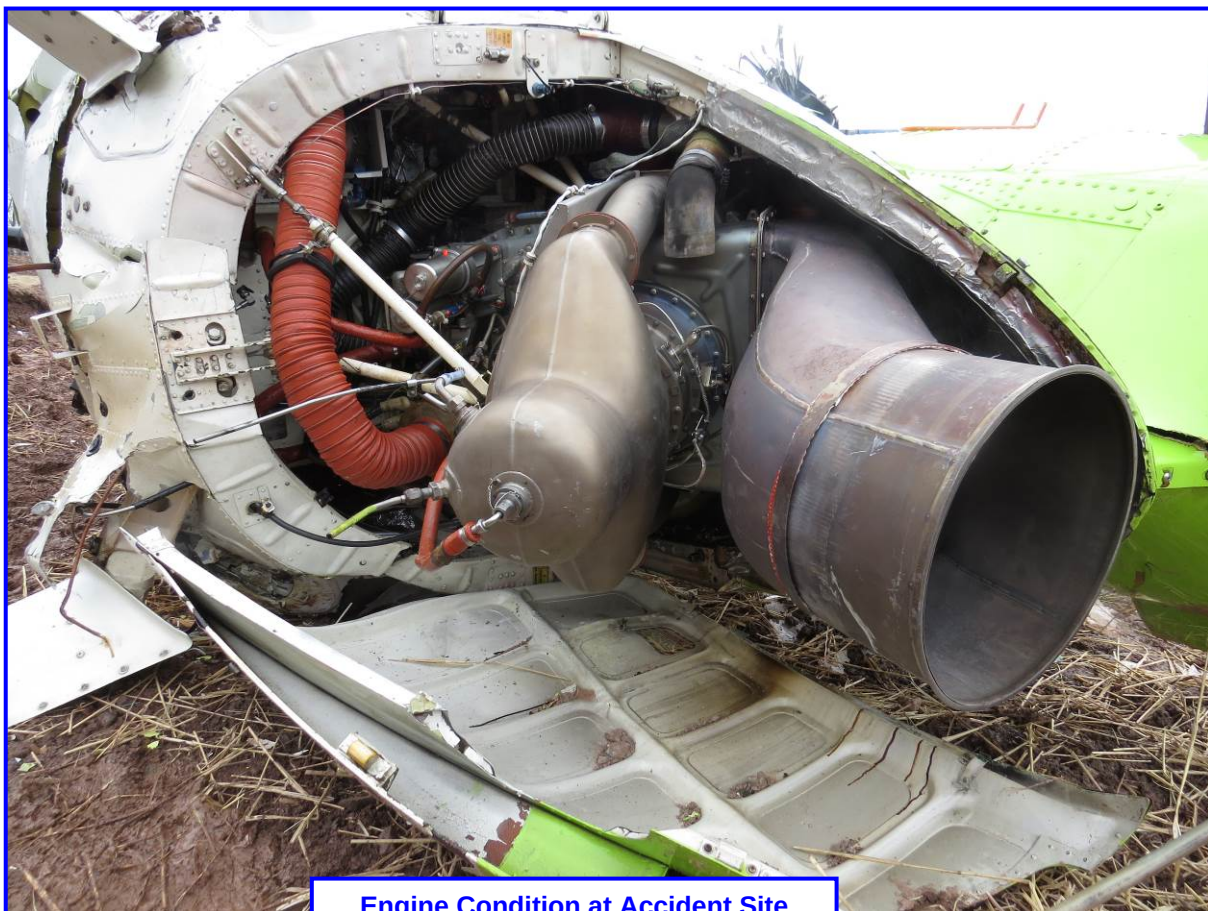
Engine Condition at Accident Site

Access to the right side of the helicopter and engine compartment was limited due to the positioning of the aircraft. Therefore, a complete visual assessment of the entire engine, particularly the right hand side, could not be achieved. Based on what was visible of the engine it appeared to be properly secured within the engine bay with no immediate evidence of external damage. The NTSB stated that the engine was still running when the first responders arrived on scene nearly 20 minutes after the accident occurrence.

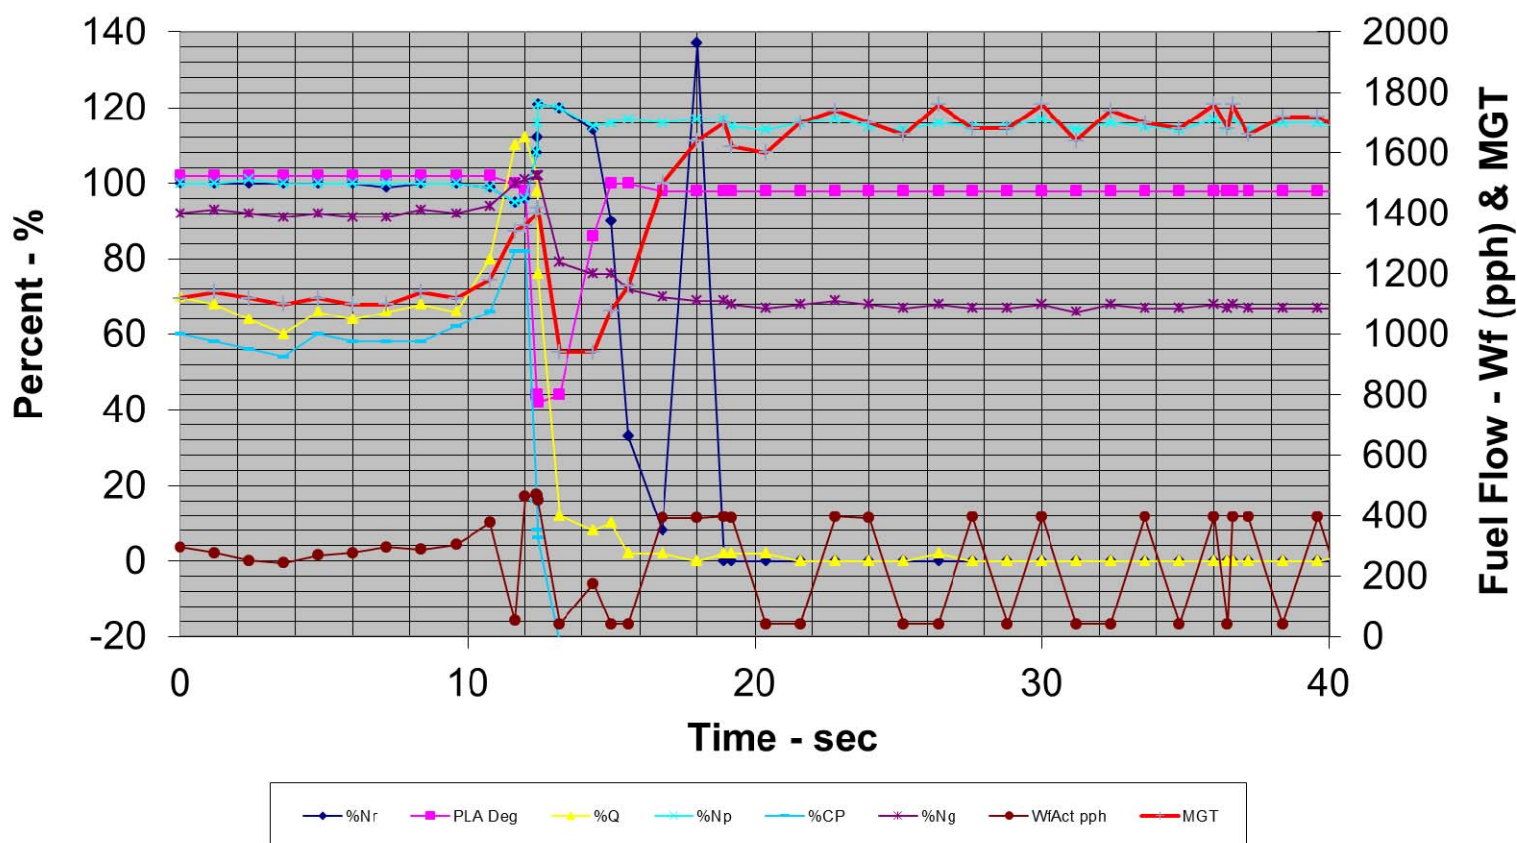
Incident Recorder Data Plot

It was connected to a Rolls-Royce computer for downloading and examination of the ECU's memory. Data download was completed and a cursory review showed primary exceedance messages for Torque, followed almost immediately by Np (power turbine) & Nr (main rotor) speed exceedances. The control system responded by initiating Overspeed Activation sensing the overspeed of Np. The torque spike tracks along with a rapid rise in collective pitch.

Immediately following, the data shows a steep drop off in torque presumably from the loss of drive shaft connection between the engine and main rotor transmission resulting from the main rotor blades impacting static structure (power lines and/or utility stanchions).

The ECU data also showed drastic changes in throttle (PLA – power lever angle) position and at the same time a change in ECU control mode from Auto to Manual. The MD600N has an ECU AUTO/MANUAL switch on the collective pitch control. Although not confirmed, it's possible that the pilot's reactions to the helicopter's violent behavior were reactionary at that moment. This may also explain the abrupt drop in collective pitch at the same time the control mode was switched and the torque bottoming out.

Following impact with the ground the engine continued to run at a slightly higher than idle speed throughout the remainder of the incident data capture and beyond. The Np overspeed activation system controlled the engine during this period as indicated by the repeated spikes in fuel flow and MGT. This is also consistent with the 1st responders stating that the engine was still running nearly 20 minutes prior to their arrival at the accident site. It is unclear as to how the engine was eventually shut down since the fuel cutoff control was still in the engaged (ON) position during the on-site examination.

The ECU data indicated the engine was performing normally prior to the accident sequence. All relevant engine parameters (torque, Ng/Np speeds, fuel flow, and temperature) were normal prior to the sequence and responded as expected during the accident sequence.

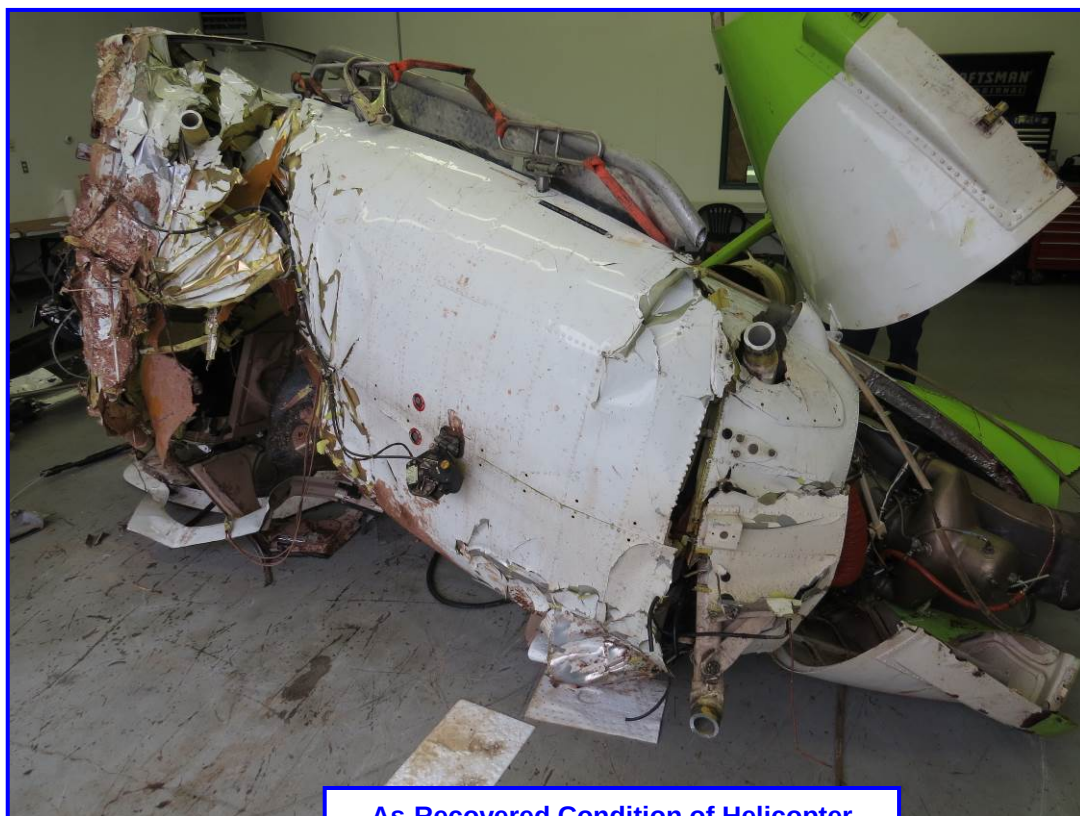
As-Recovered Condition of Helicopter

The helicopter was positioned on its right side in the same manner as the accident site. Therefore, only limited access to the engine was available. The engine remained within the engine compartment and the engine mounts showed no immediate signs of damage. Initial inspection of the engine exterior did not reveal any obvious signs of damage from impact forces, internal engine failure, or evidence of fire. All accessible B-nuts were found to be at least hand tight and were orange torque stripe painted.

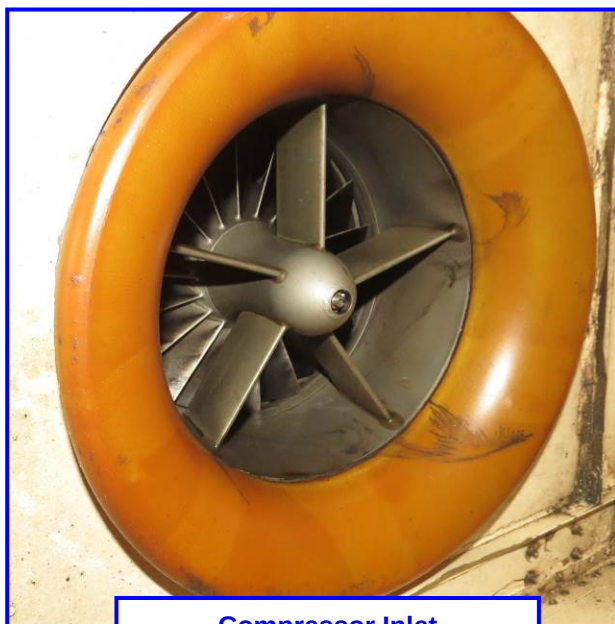
Compressor Inlet

Examination of the compressor inlet revealed the impeller blades to be normal with no evidence of foreign object (FOD) type damage.

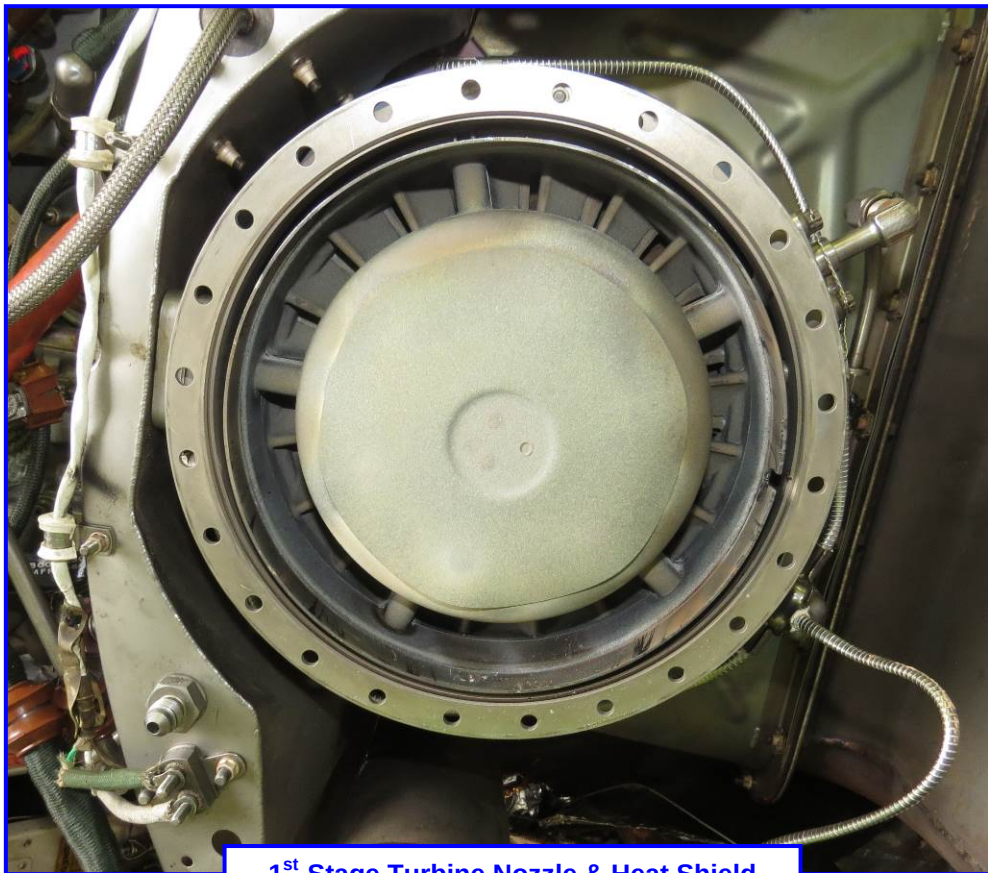
1<sup>st</sup>-Stage Turbine Nozzle & Heat Shield

The Outer Combustion Case (OCC) was removed to facilitate visual access and assessment of the 1st-stage nozzle and wheel. Both appeared to be in good condition with no sign of missing material, impact damage, or heat related distress.

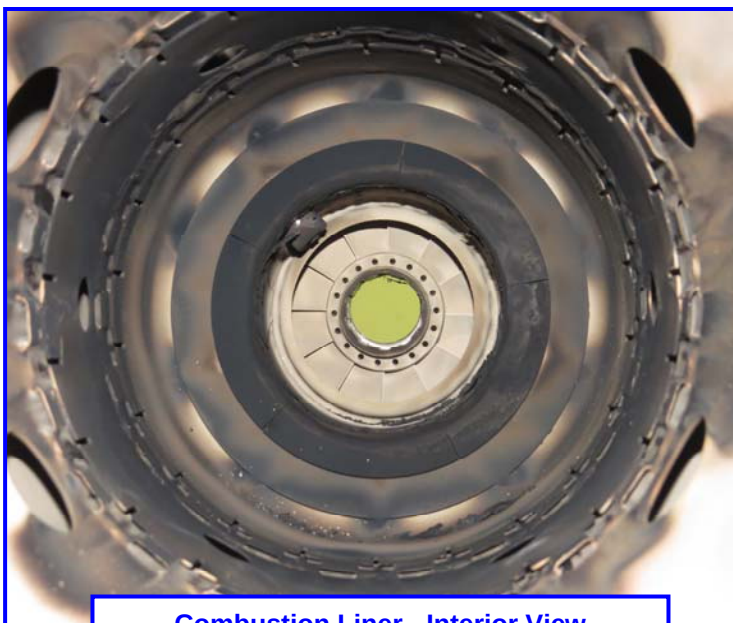
Combustion Liner - Interior View

Following removal of the OCC, the combustion liner was removed for examination. The liner showed no evidence of abnormal combustion patterns or streaking. The entire OCC was visually unremarkable.
