# **NATIONAL TRANSPORTATION SAFETY BOARD**

## **UAS Aerial Imagery Report and Positional Study**

### **A. ACCIDENT ERA18FA122**

Location: Smethport, Pennsylvania  
Date: April 8, 2018

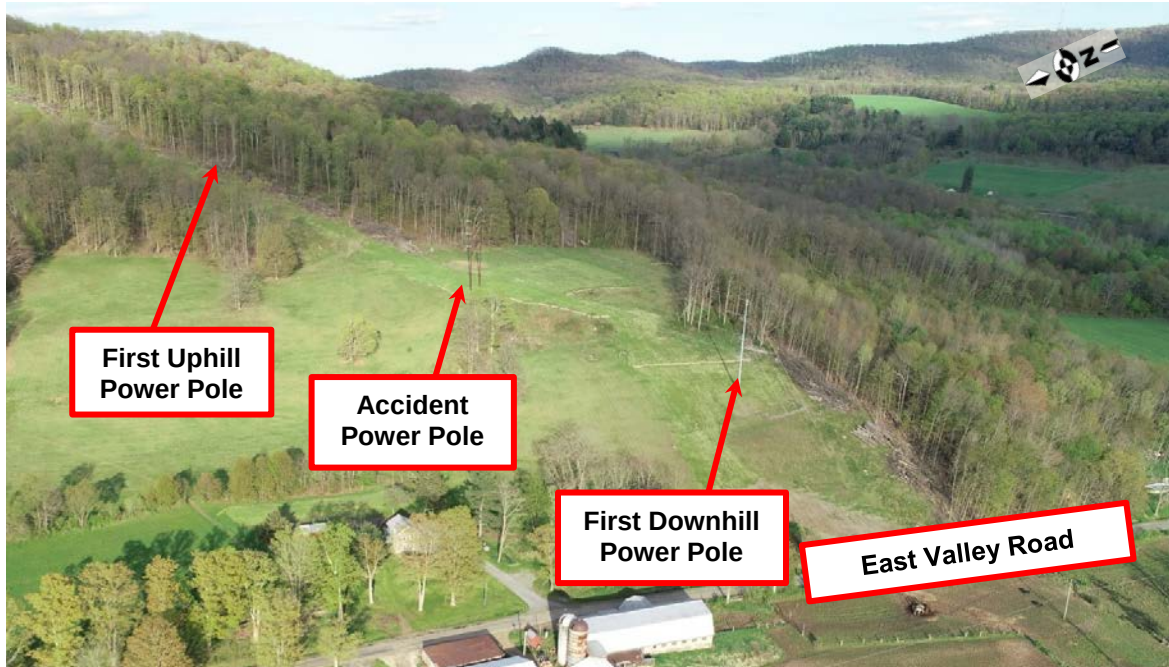
Figure 1 contains a still image taken from across East Valley Road looking towards the accident site power pole and surrounding power poles.

**Figure 1 - Accident site overview, cropped (positional arrow approximate)**

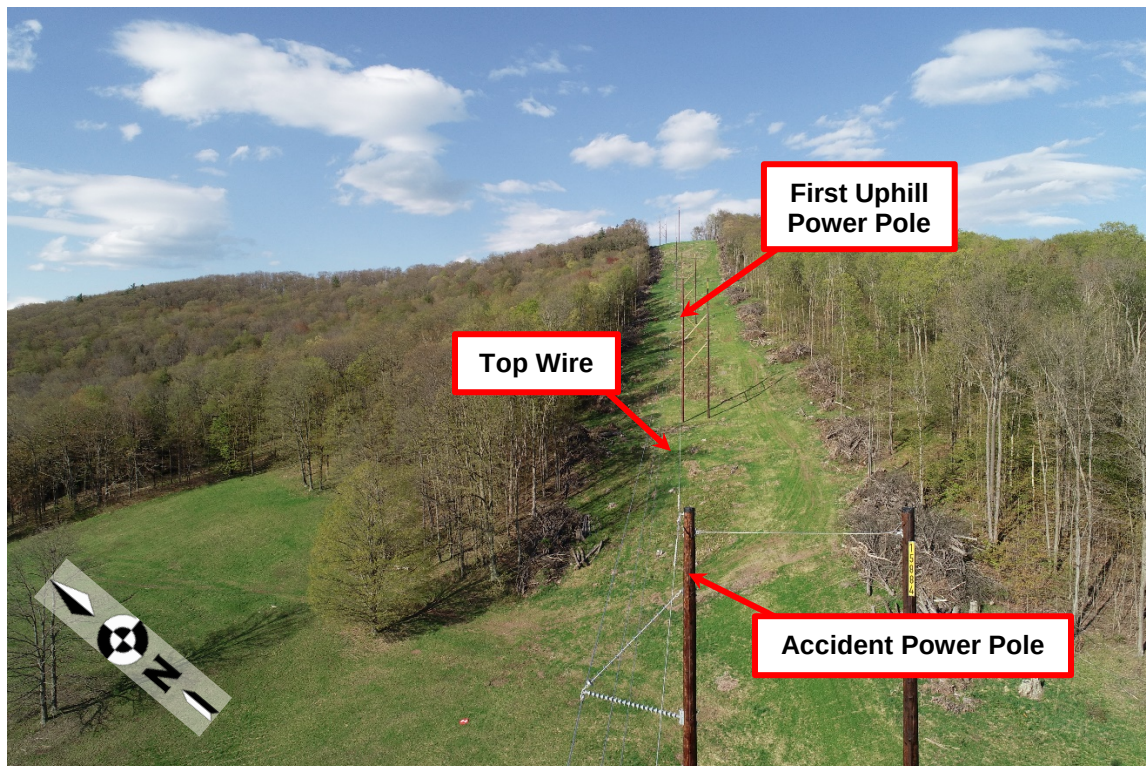
Figure 2 contains a still image taken from slightly below the accident power pole and is looking along the top wire towards the first uphill (and subsequent) power pole.

**Figure 2 – View from below accident power pole looking uphill along wires (positional arrow approximate)**

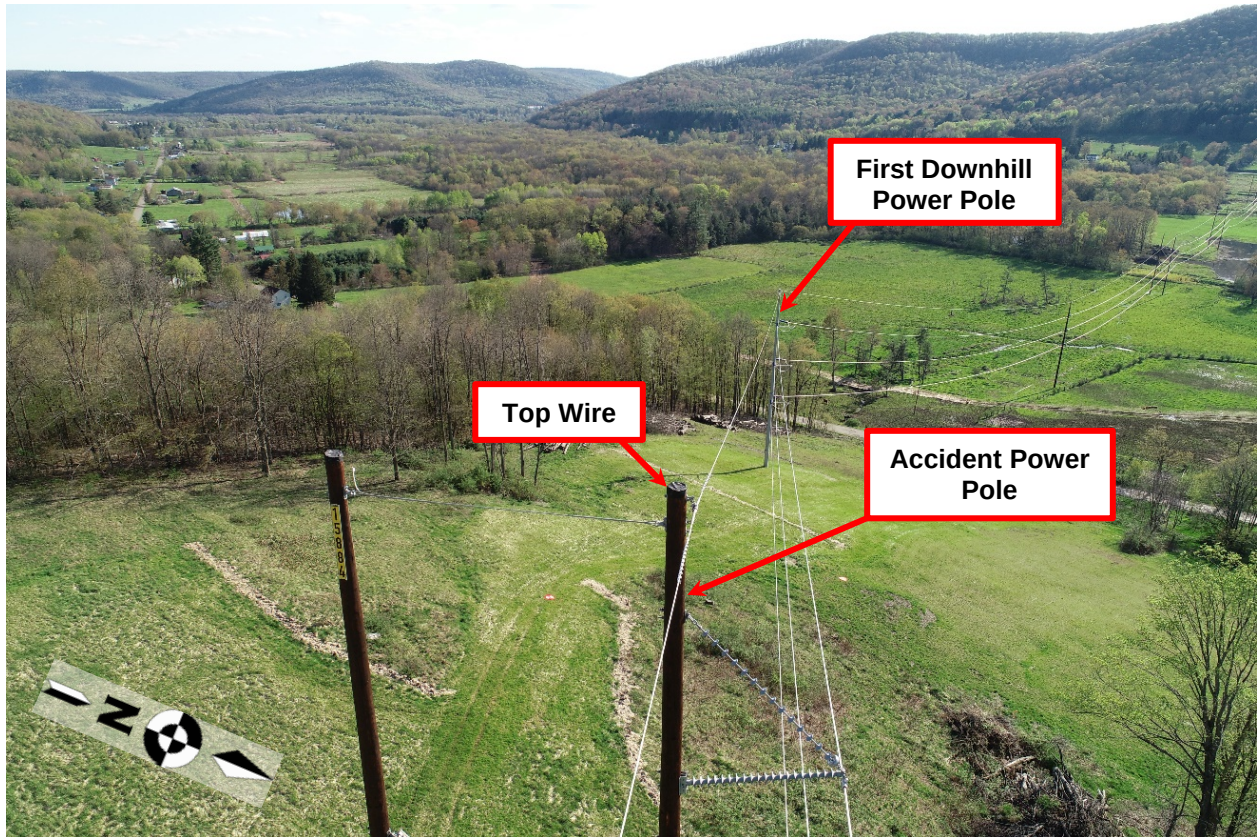
Figure 3 contains a still image taken from slightly above the accident power pole and is looking along the top wire towards the first downhill (and subsequent) power pole.

**Figure 3 – View from above accident power pole looking downhill along wires (positional arrow approximate)**

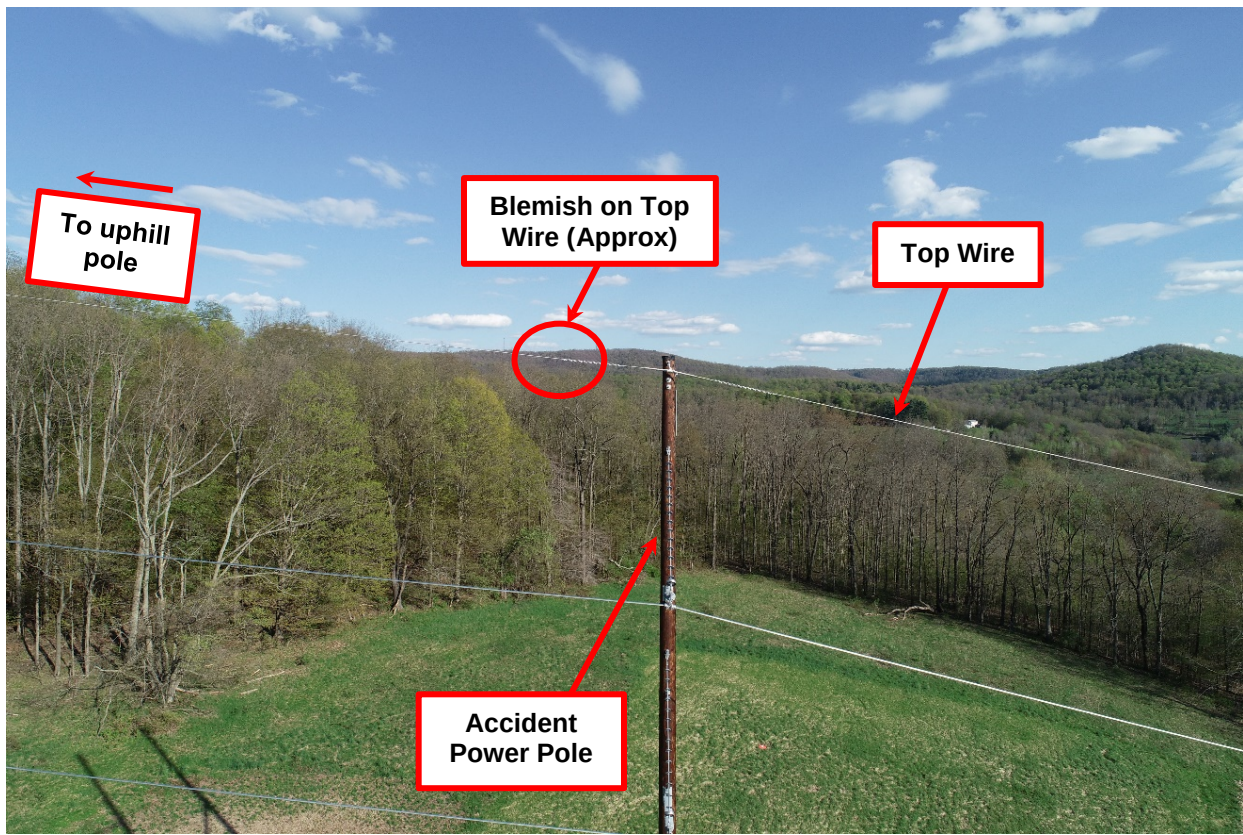
Figure 4 contains a still image of a side view of the accident power pole. The power company indicated that the top wire was not replaced after the accident. The top wire is in view, and a slight blemish in the direction of the uphill power pole can be seen.

**Figure 4 – Side view of accident power pole**

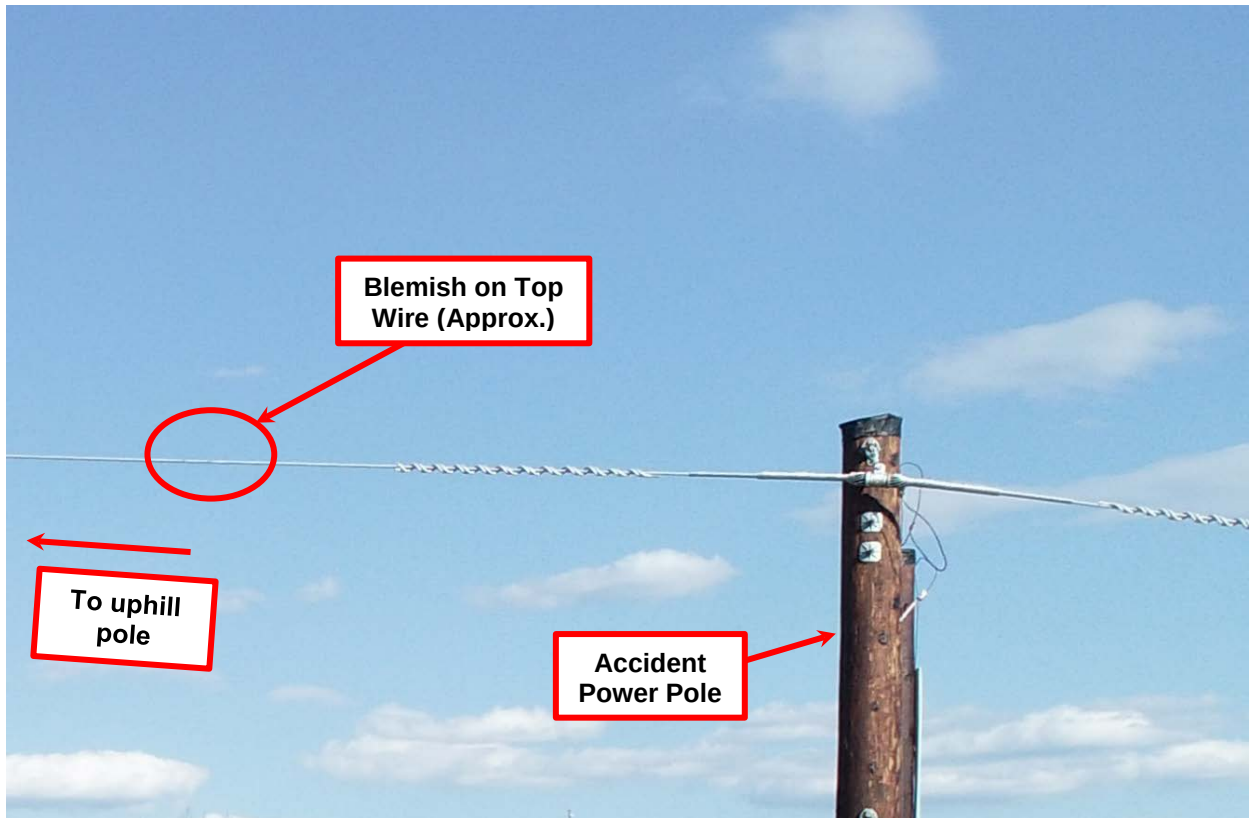
Figure 5 contains a still image, which was zoomed and cropped, of a side view of the accident power pole. The slight blemish in the direction of the uphill power pole can be seen.

**Figure 5 – Zoomed and cropped view of wire blemish (positional arrow approximate)**

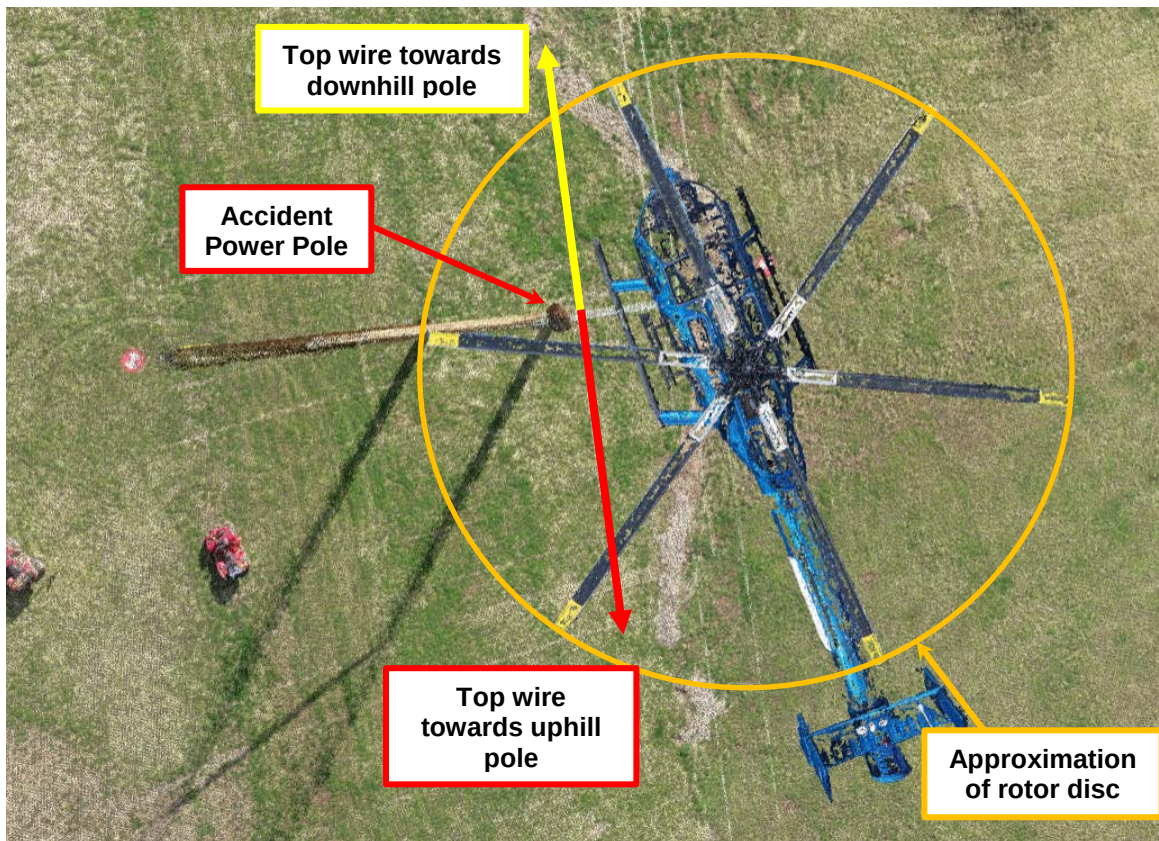
Figure 8 - Screen shot of rotorcraft and terrain visualization (view looking down)

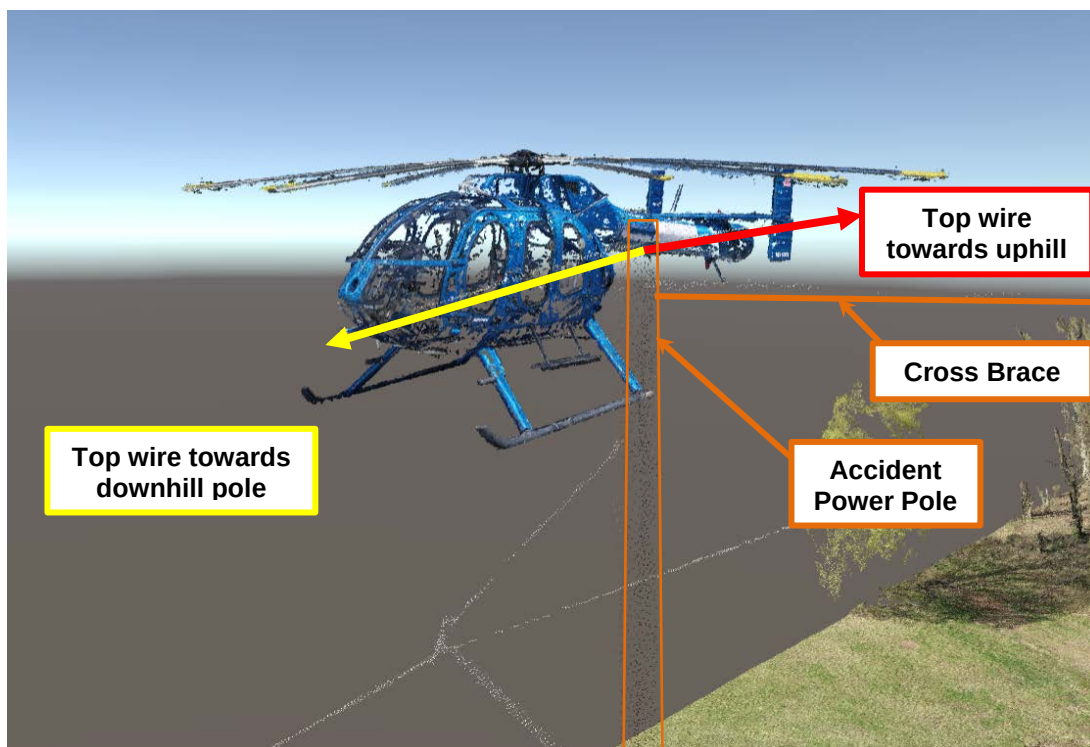
Figure 9 - Screen shot of rotorcraft and terrain visualization (view looking from side at nose of rotorcraft)

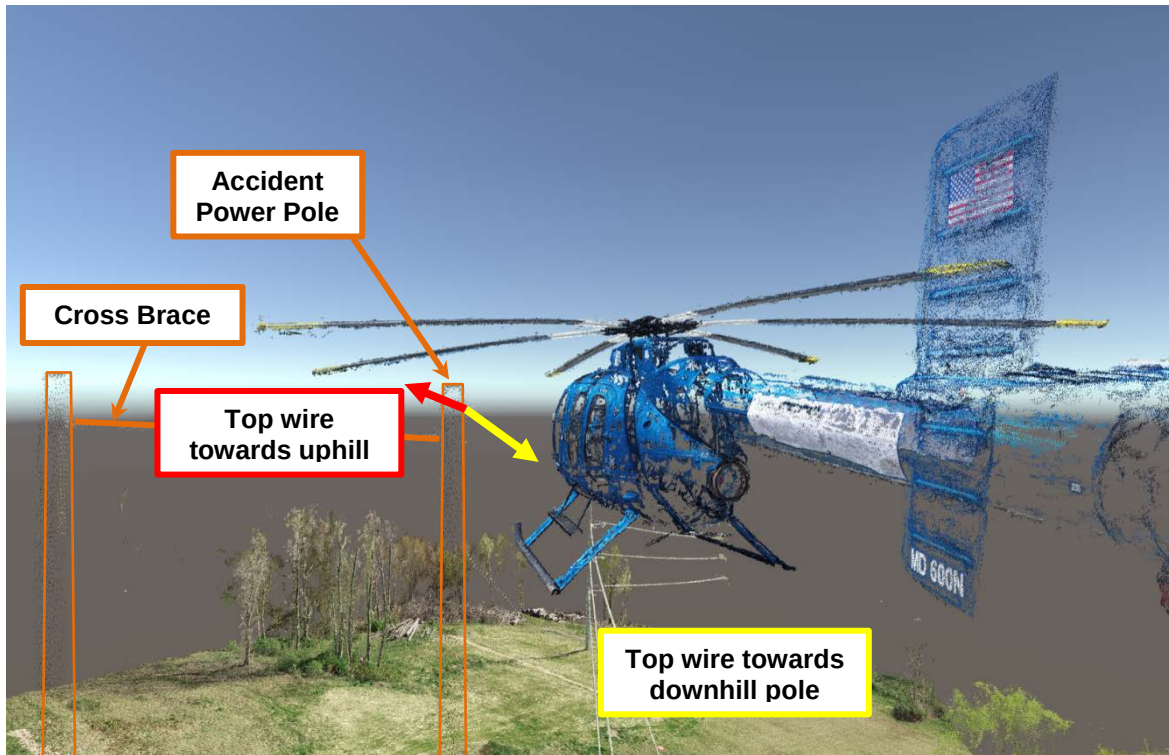
**Figure 10 - Screen shot of rotorcraft and terrain visualization (view looking toward accident power pole from aft of rotorcraft)**

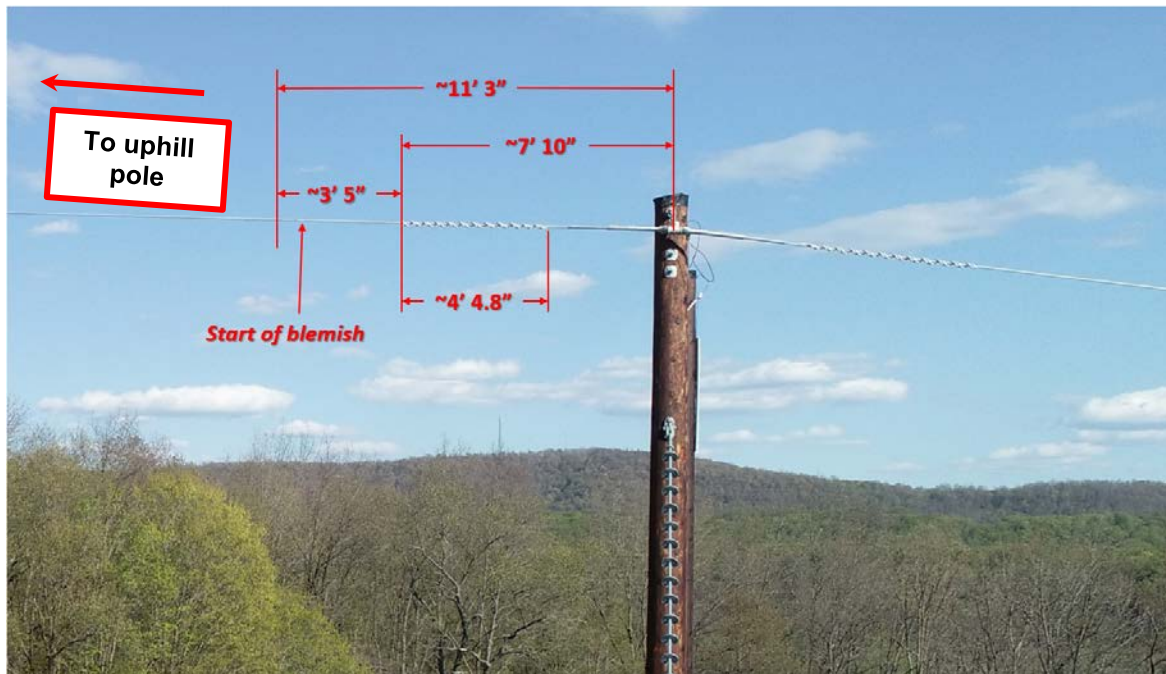
Additionally, using Pix4D, measurements of the top wire were approximated. Figure 11 contains dimensions taken from the top wire tie point on the accident power pole. Distances in feet and inches are to various features on the top wire. Figure 12 contains angles as the wire leaves from the top wire tie point toward the uphill and downhill power poles.

Figure 11 - Distances (in feet and inches) from top wire tie point to various features.

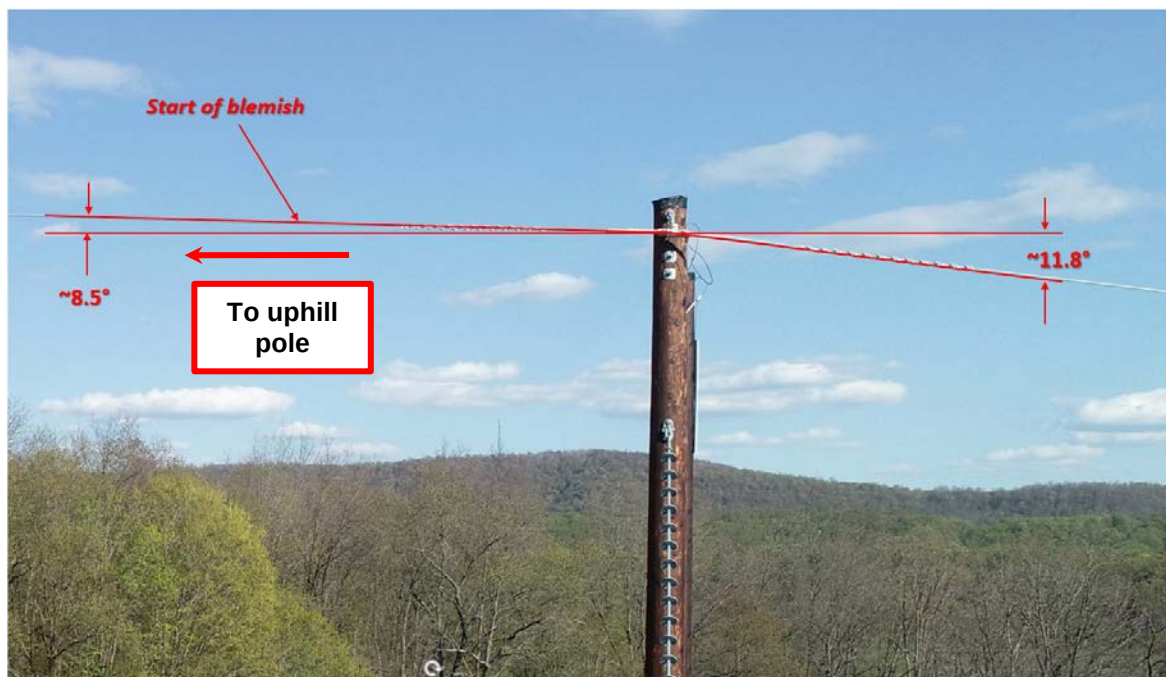
Figure 12 - Approximate wire angles
