# **NATIONAL TRANSPORTATION SAFETY BOARD**

## **UAS Aerial Imagery Report**

### **A. ACCIDENT ERA18FA127**

Location: Crozet, VA  
Date: April 15, 2018

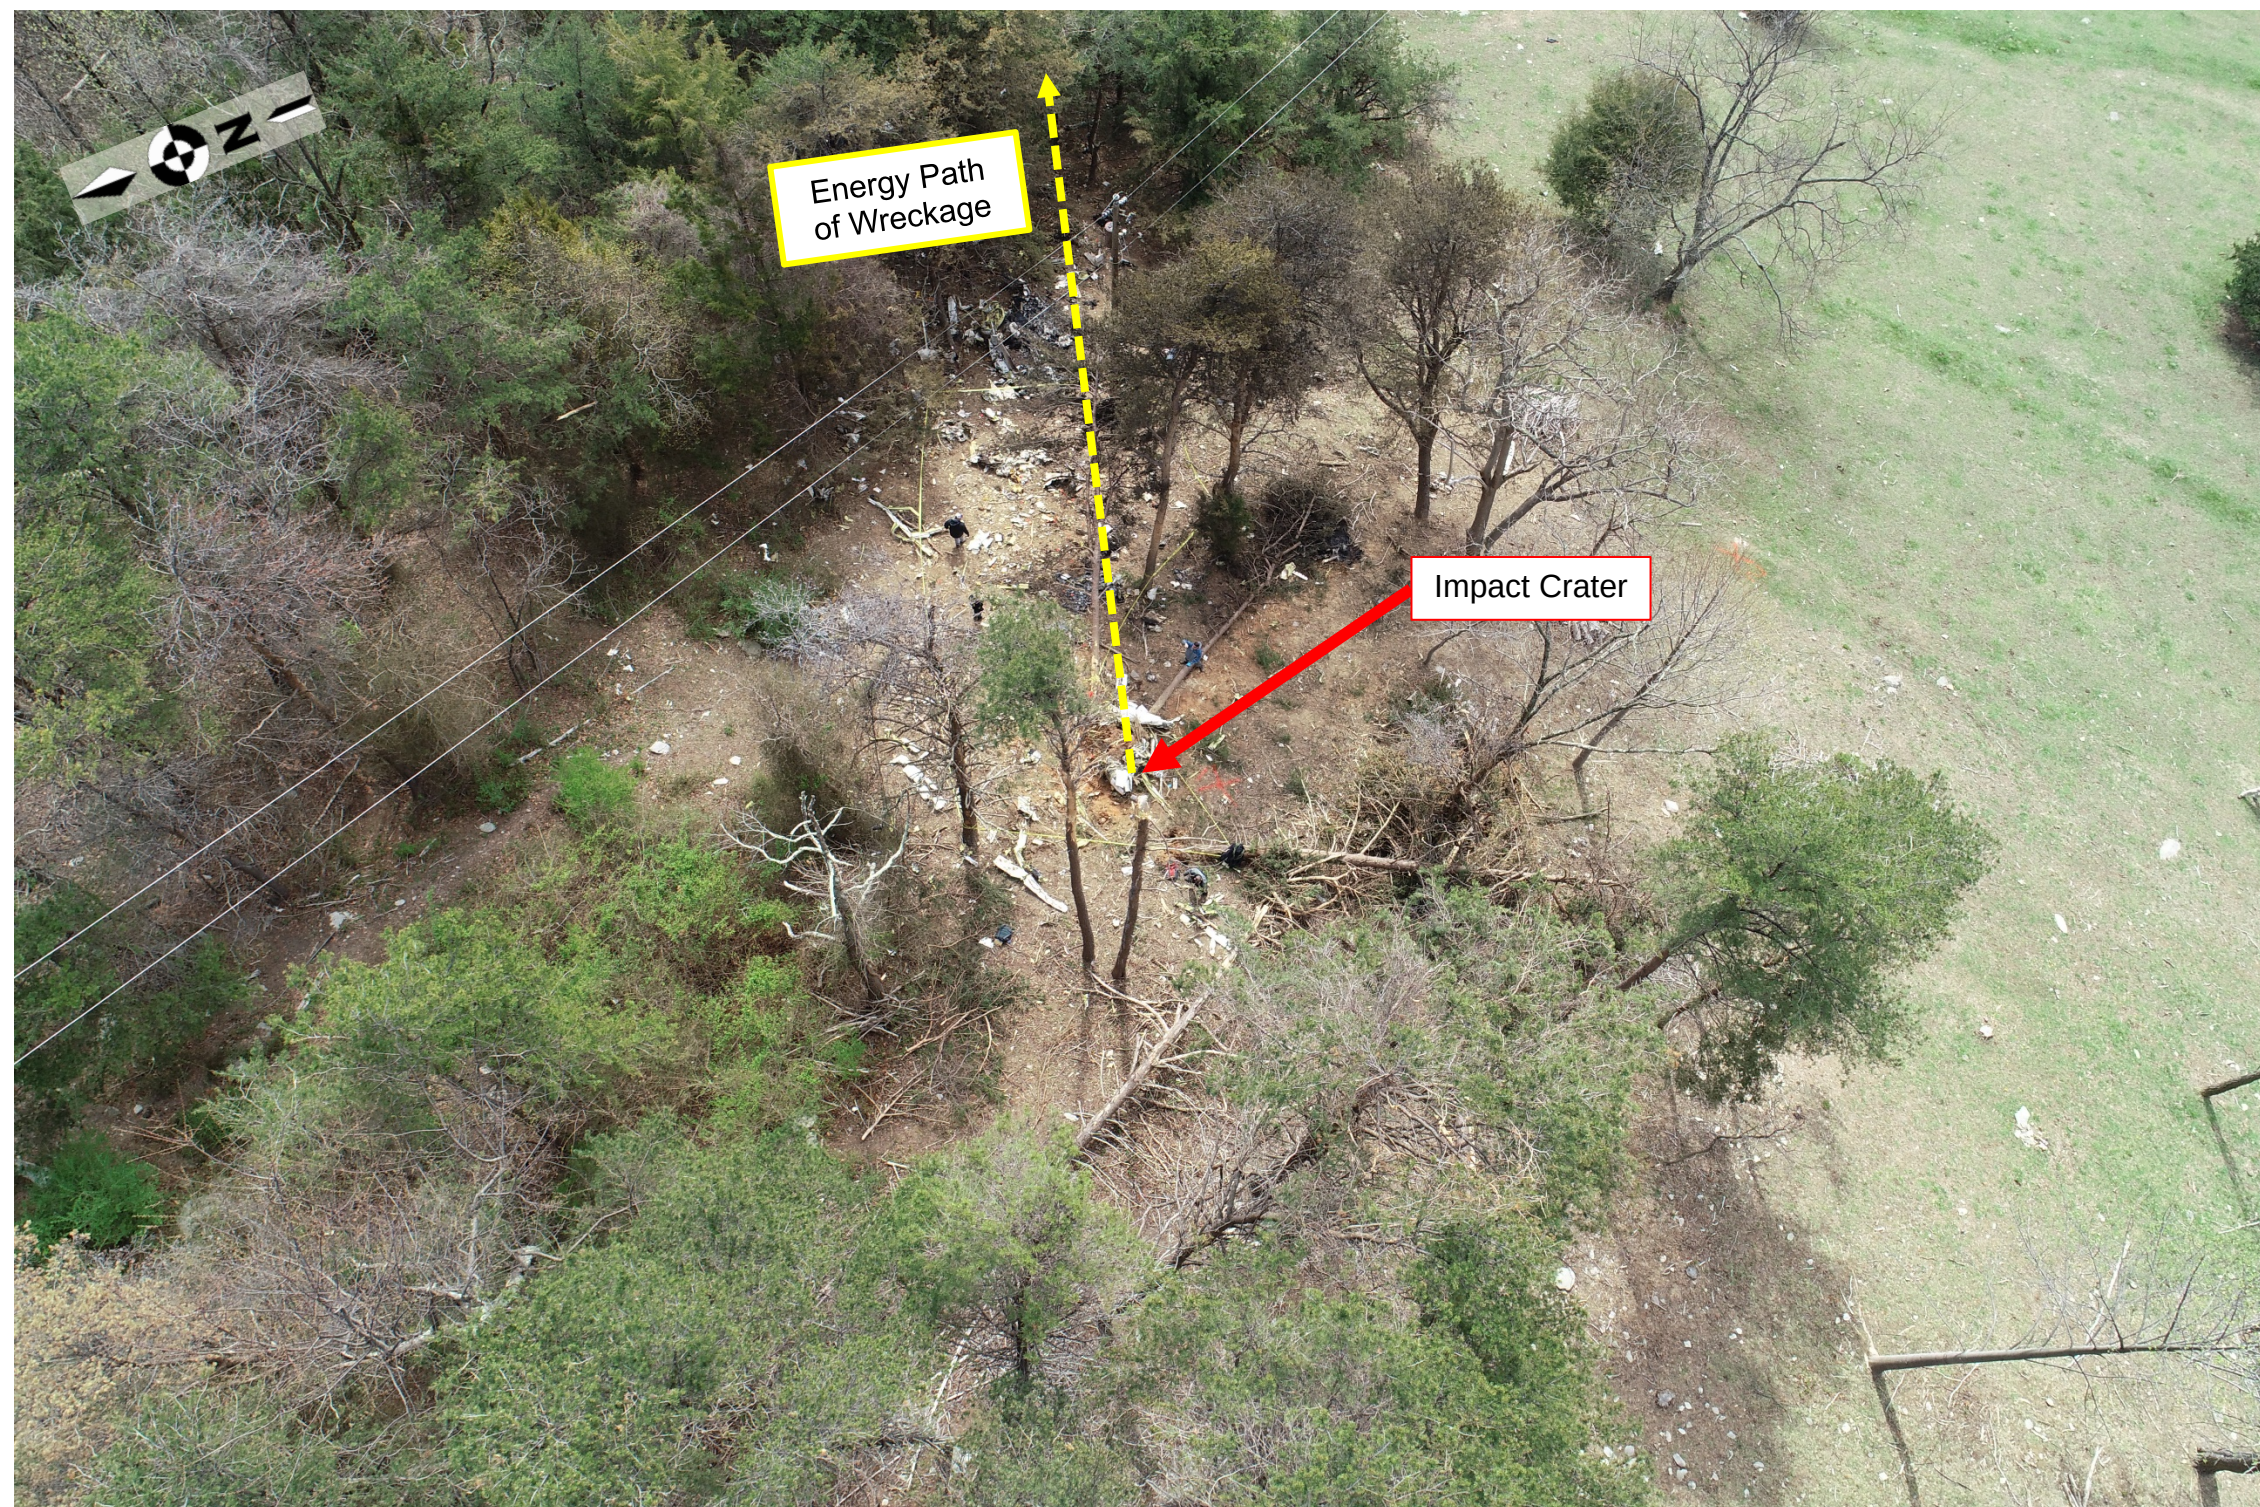
Figure 1 and Figure 2 are still images showing a general overview of the main wreckage area at the accident scene. Multiple damage trees are highlighted around the area of the main impact crater. The energy path of the wreckage was estimated to be on a 106° heading from the Google Earth Mosaic. Although not shown in the imagery, the farthest piece of wreckage visible in the sUAS imagery from the main impact site was measured in Pix4D to be approximately 351 ft (107 m) away from the impact crater.

Figure 1 – Photo – Aerial view of main wreckage area, energy path towards top of page (directional arrow approximated)

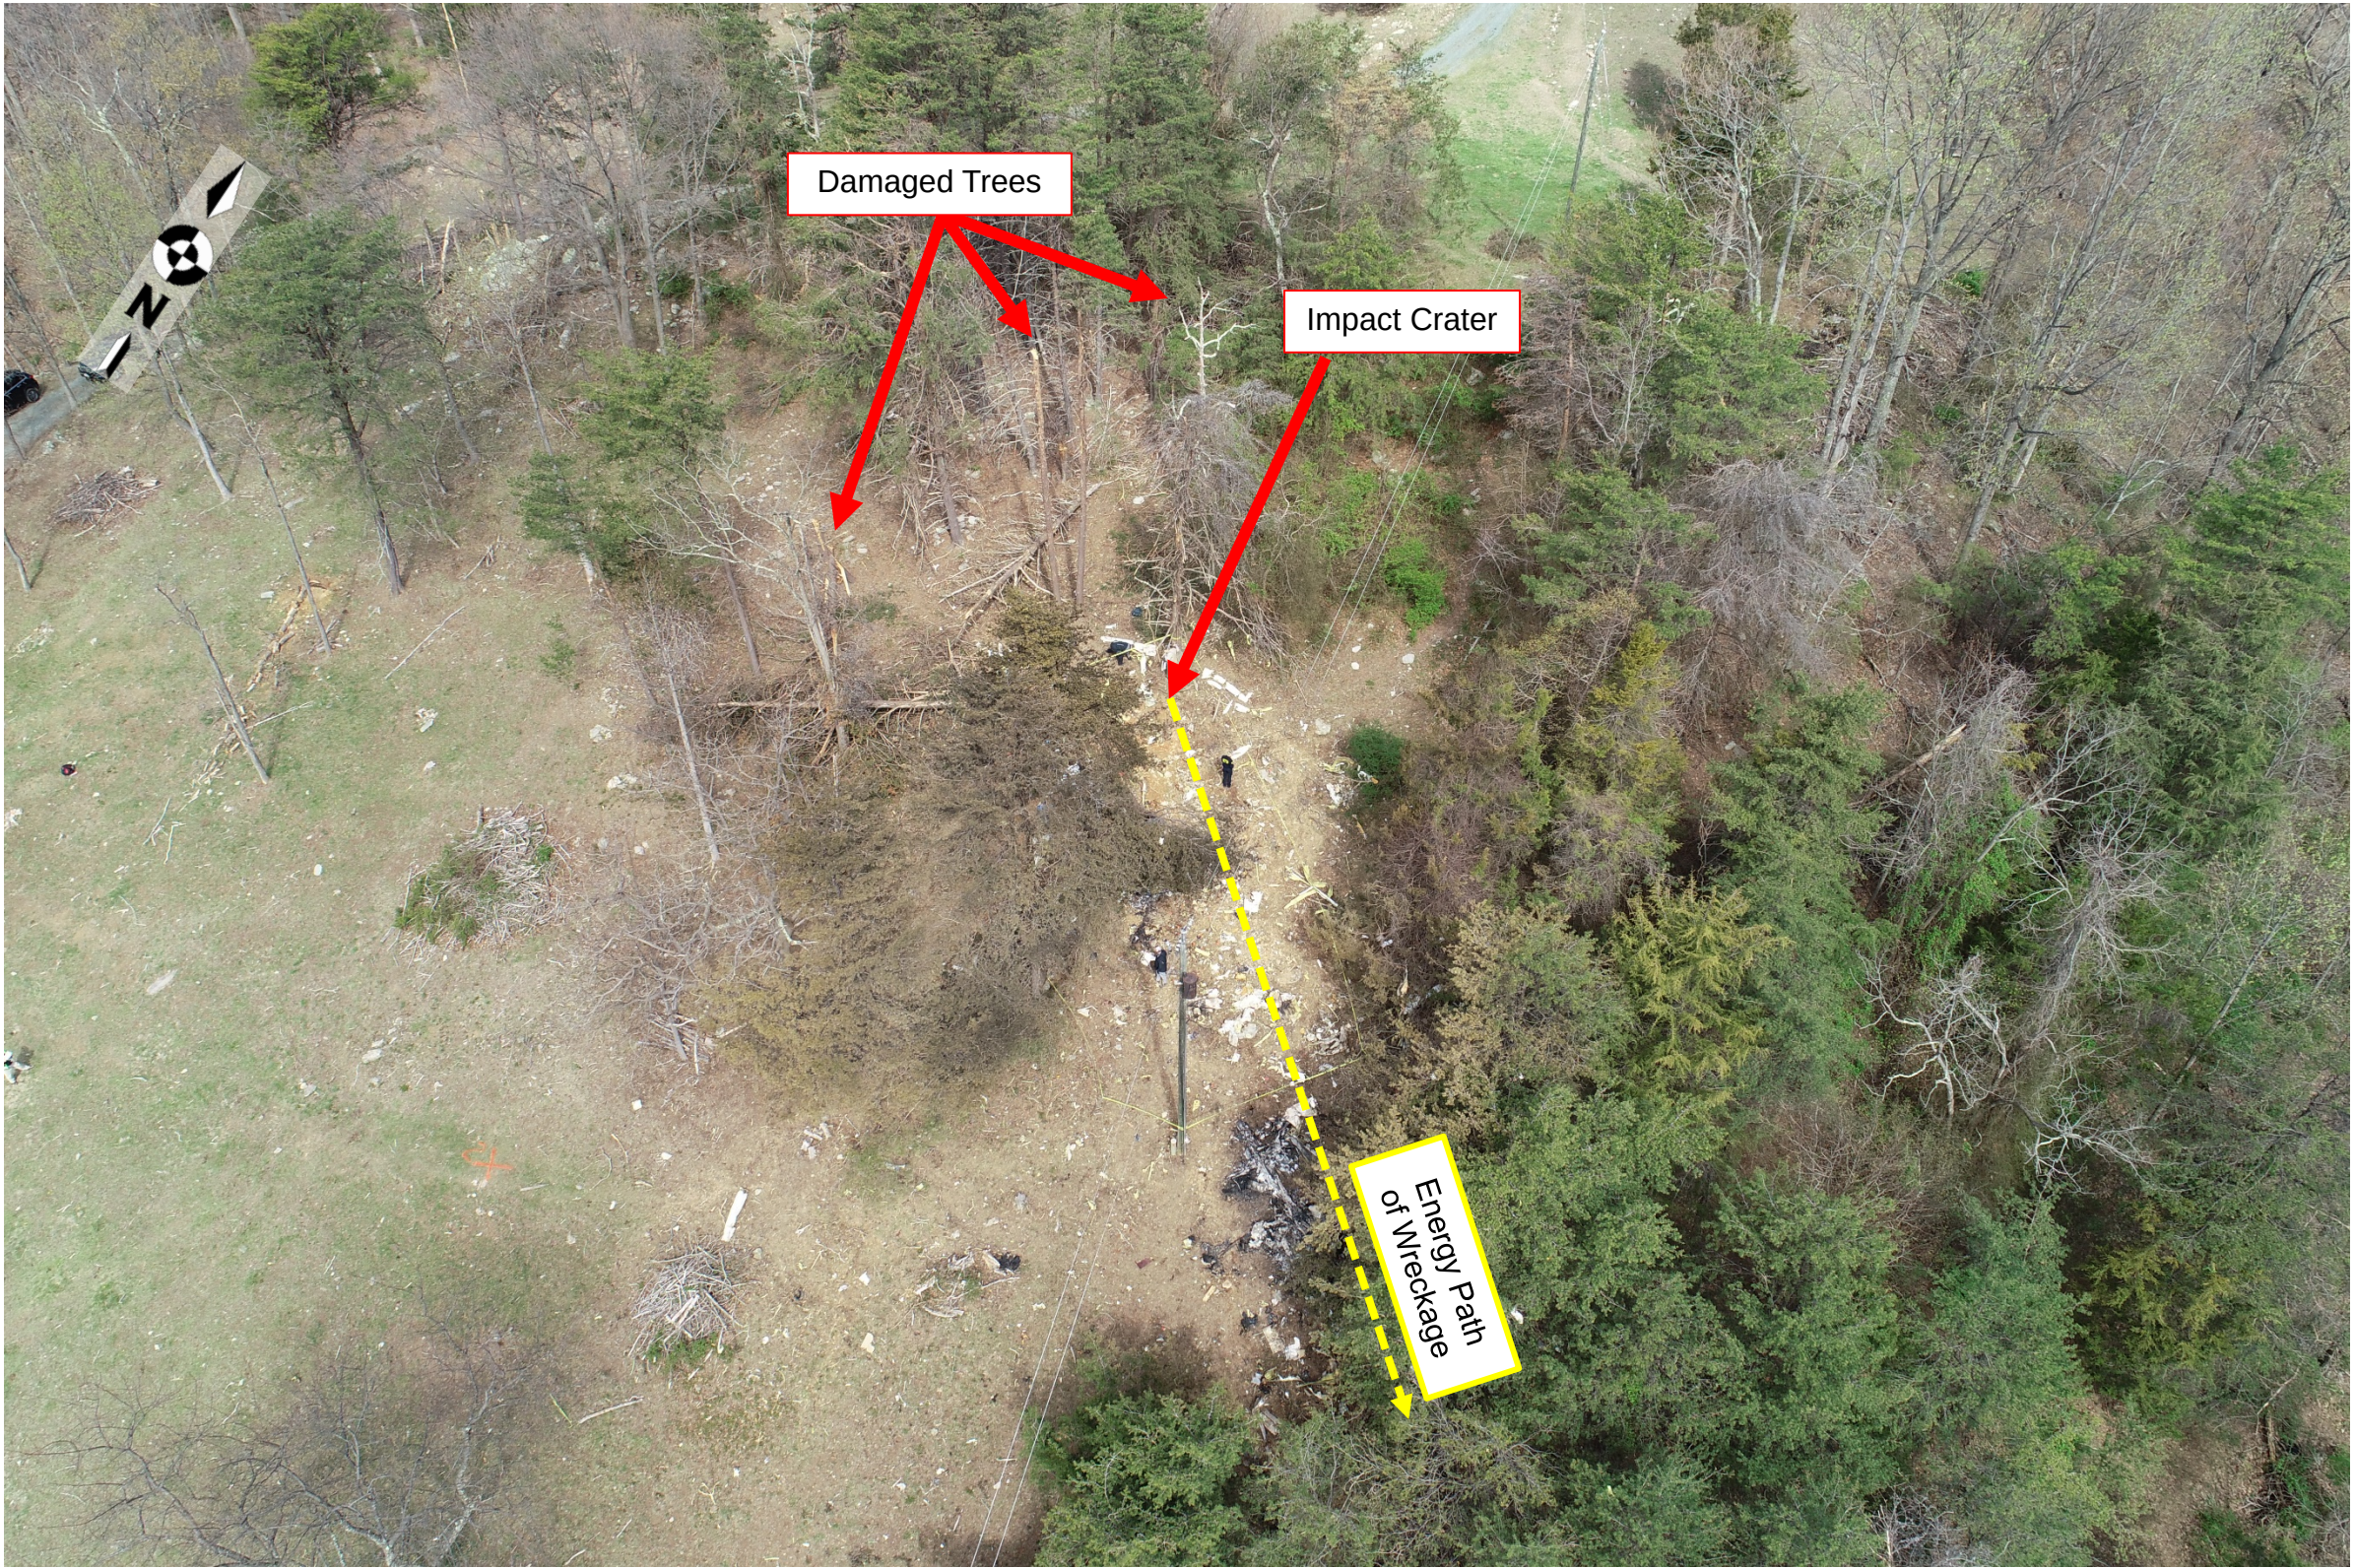
Figure 2 – Photo - Aerial view of main wreckage area, energy path towards bottom of page (directional arrow approximated)

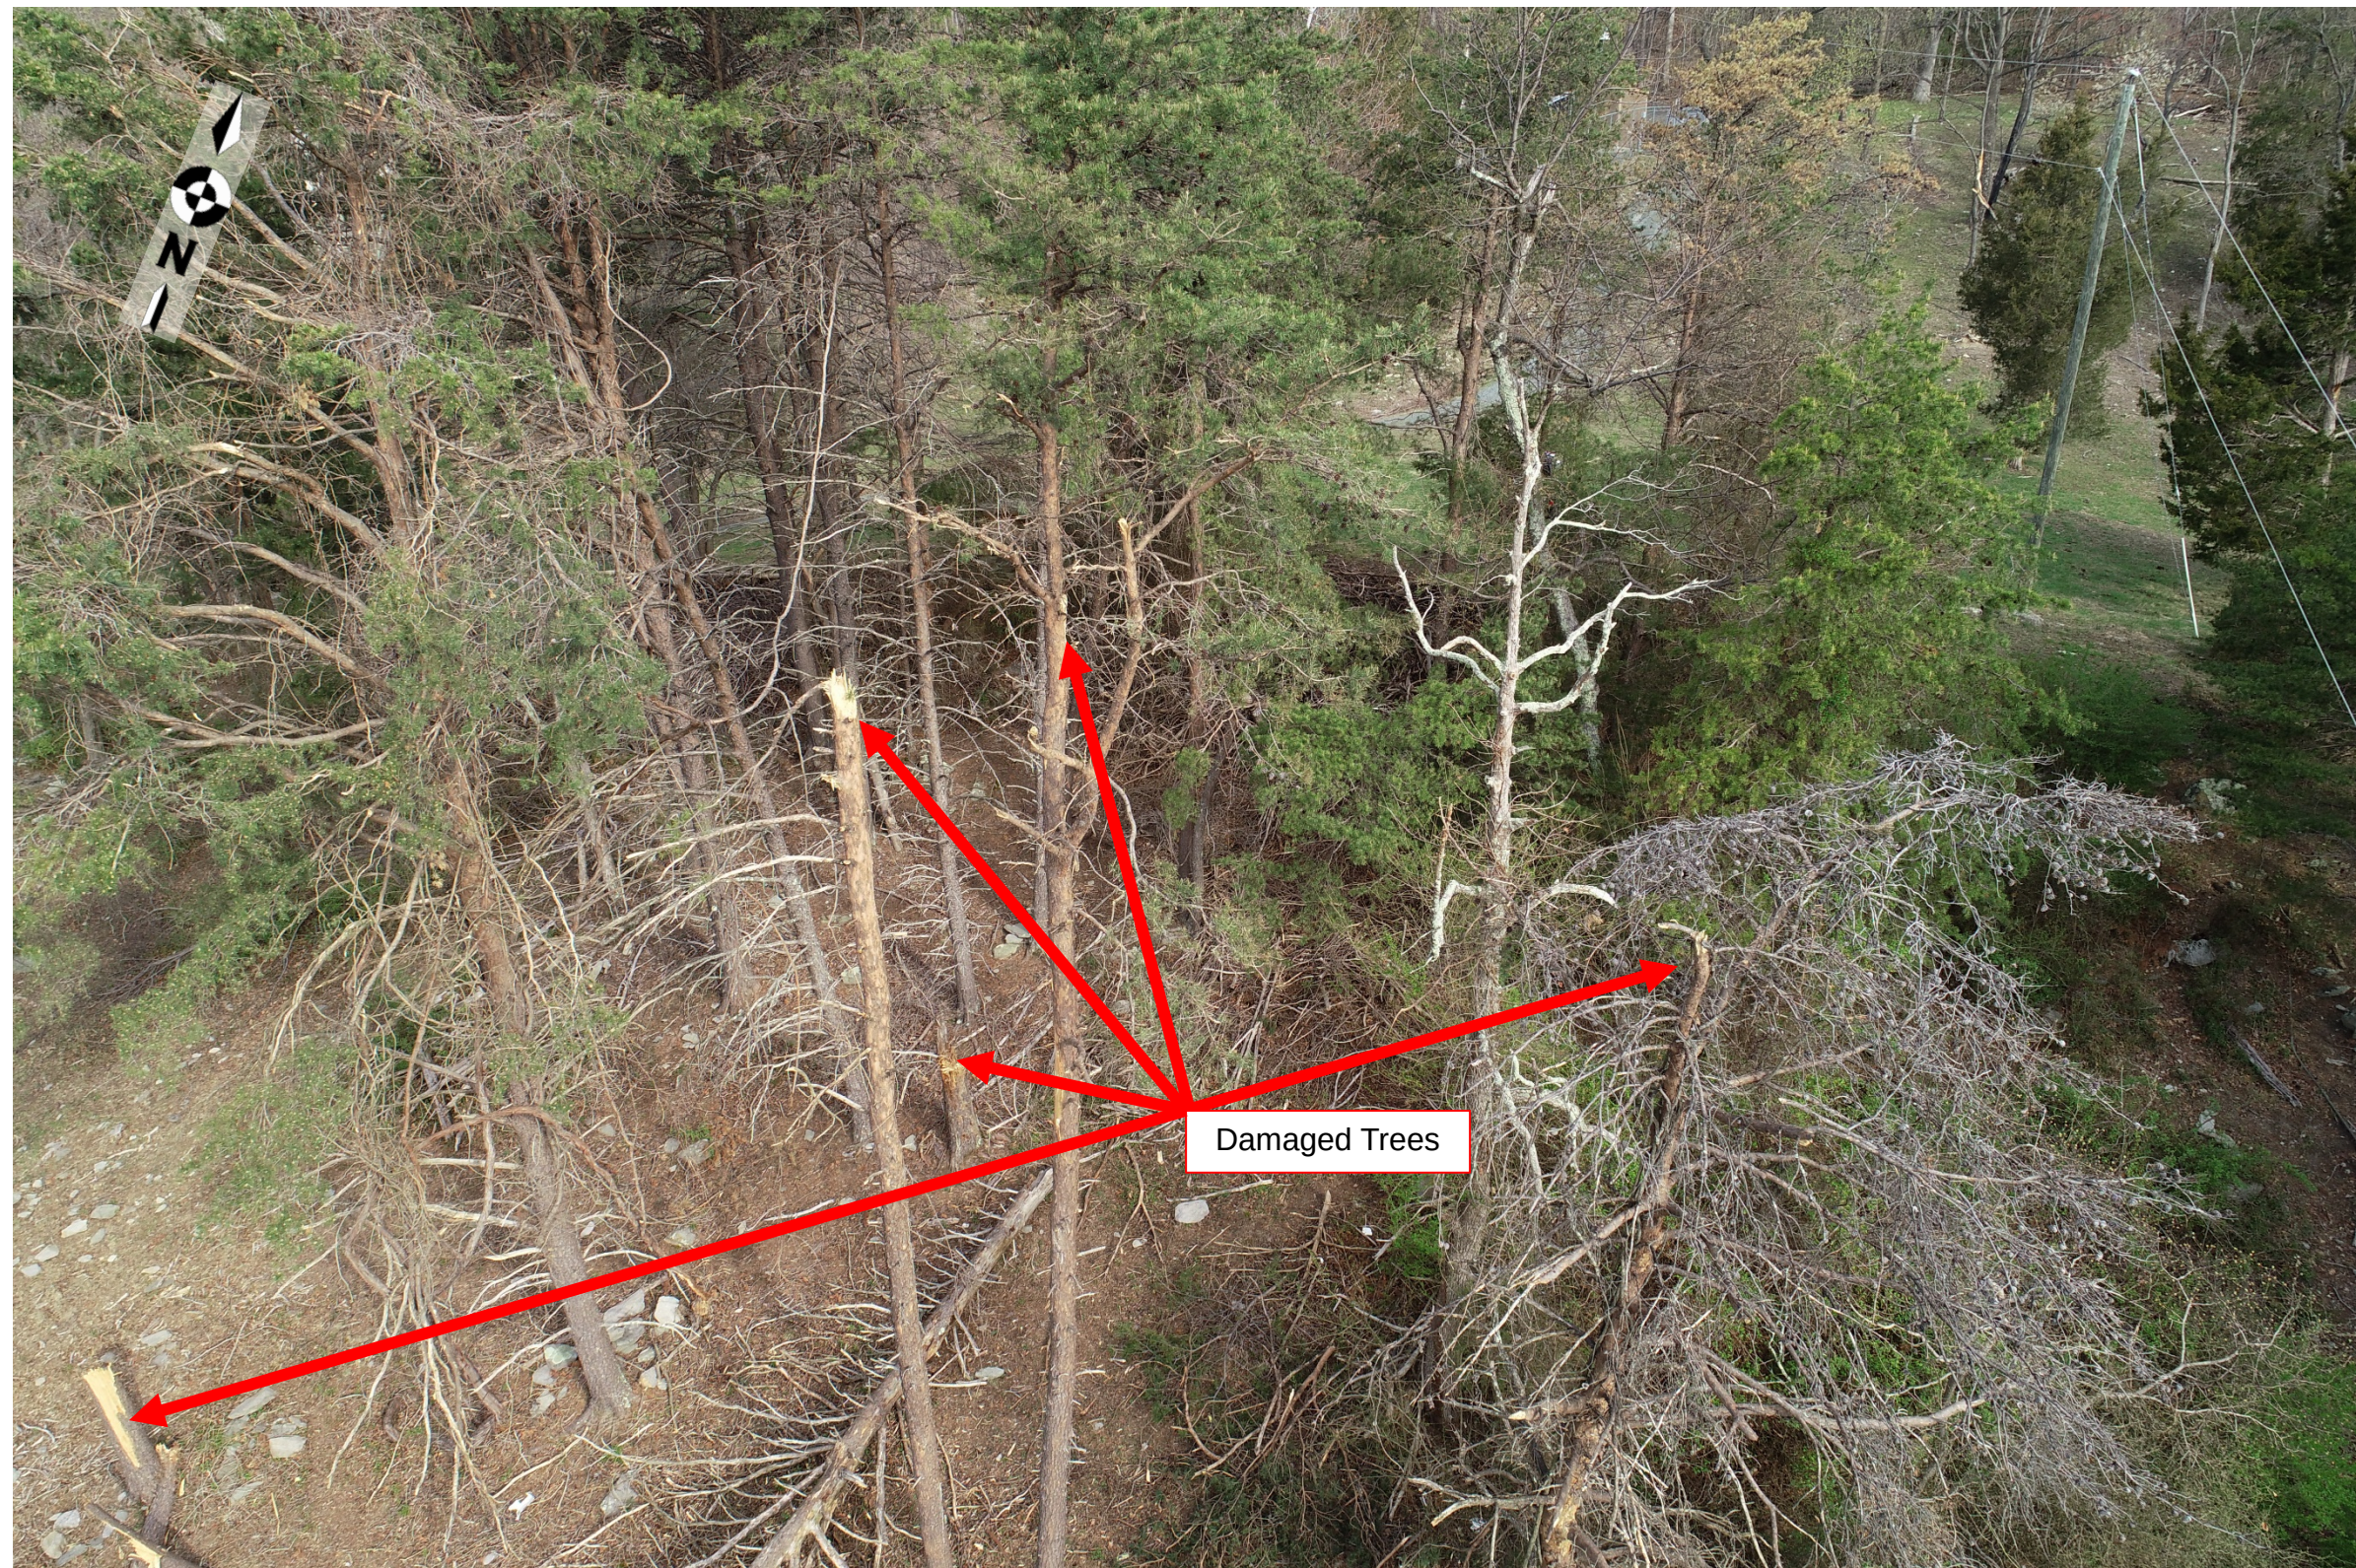
Figure 3 is a still image showing the trees that had trunk and branches separated during the aircrafts' descent. Multiple severed branch locations are noted. Utilizing data from the point cloud, the aircrafts' angle of descent was approximately 71° relative to the horizon.

Figure 3 – Photo - Aerial view of damaged trees around main wreckage site, impact crater and energy path off the bottom of page and is not shown (directional arrow approximated)

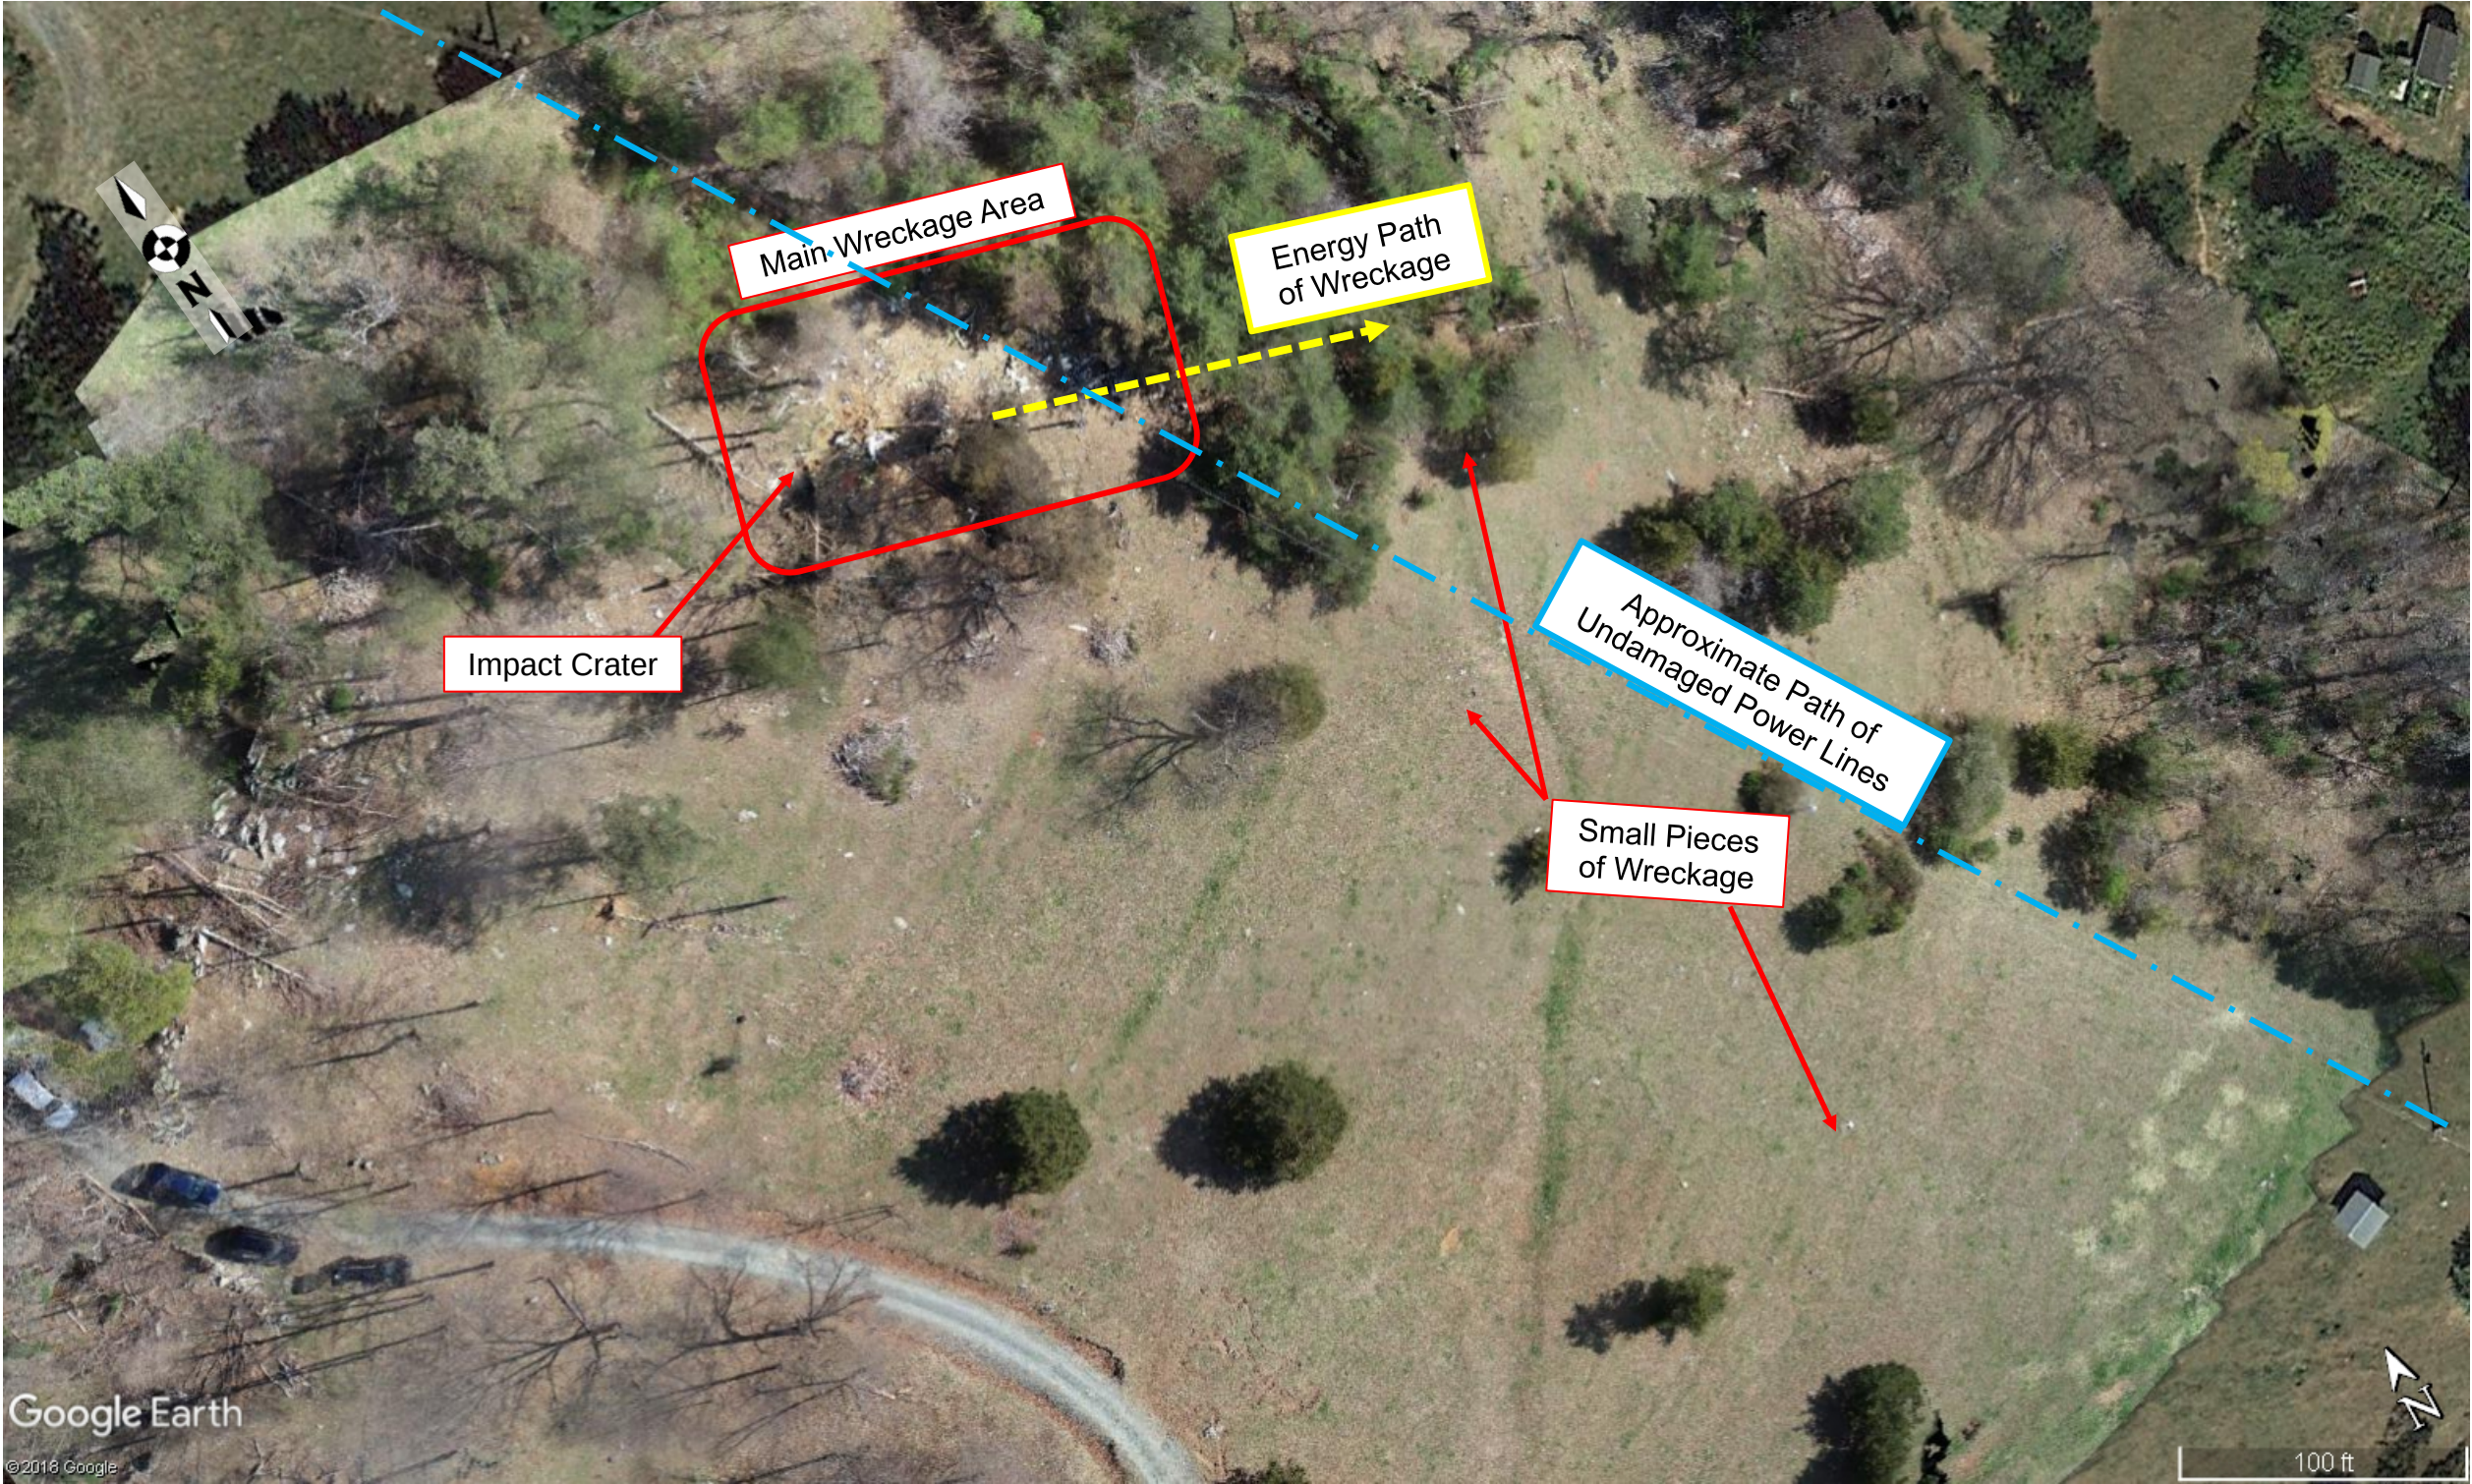
Figure 4 and Figure 5 contain screenshots of the orthomosaic map in Google Earth .kmz format. Figure 4 shows the overall accident site with showing the general direction of the energy path and the extent of smaller wreckage pieces. Figure 5 is an enlarged image around the main wreckage area.

Figure 4 – Orthomosaic of accident site overlaid on Google Earth

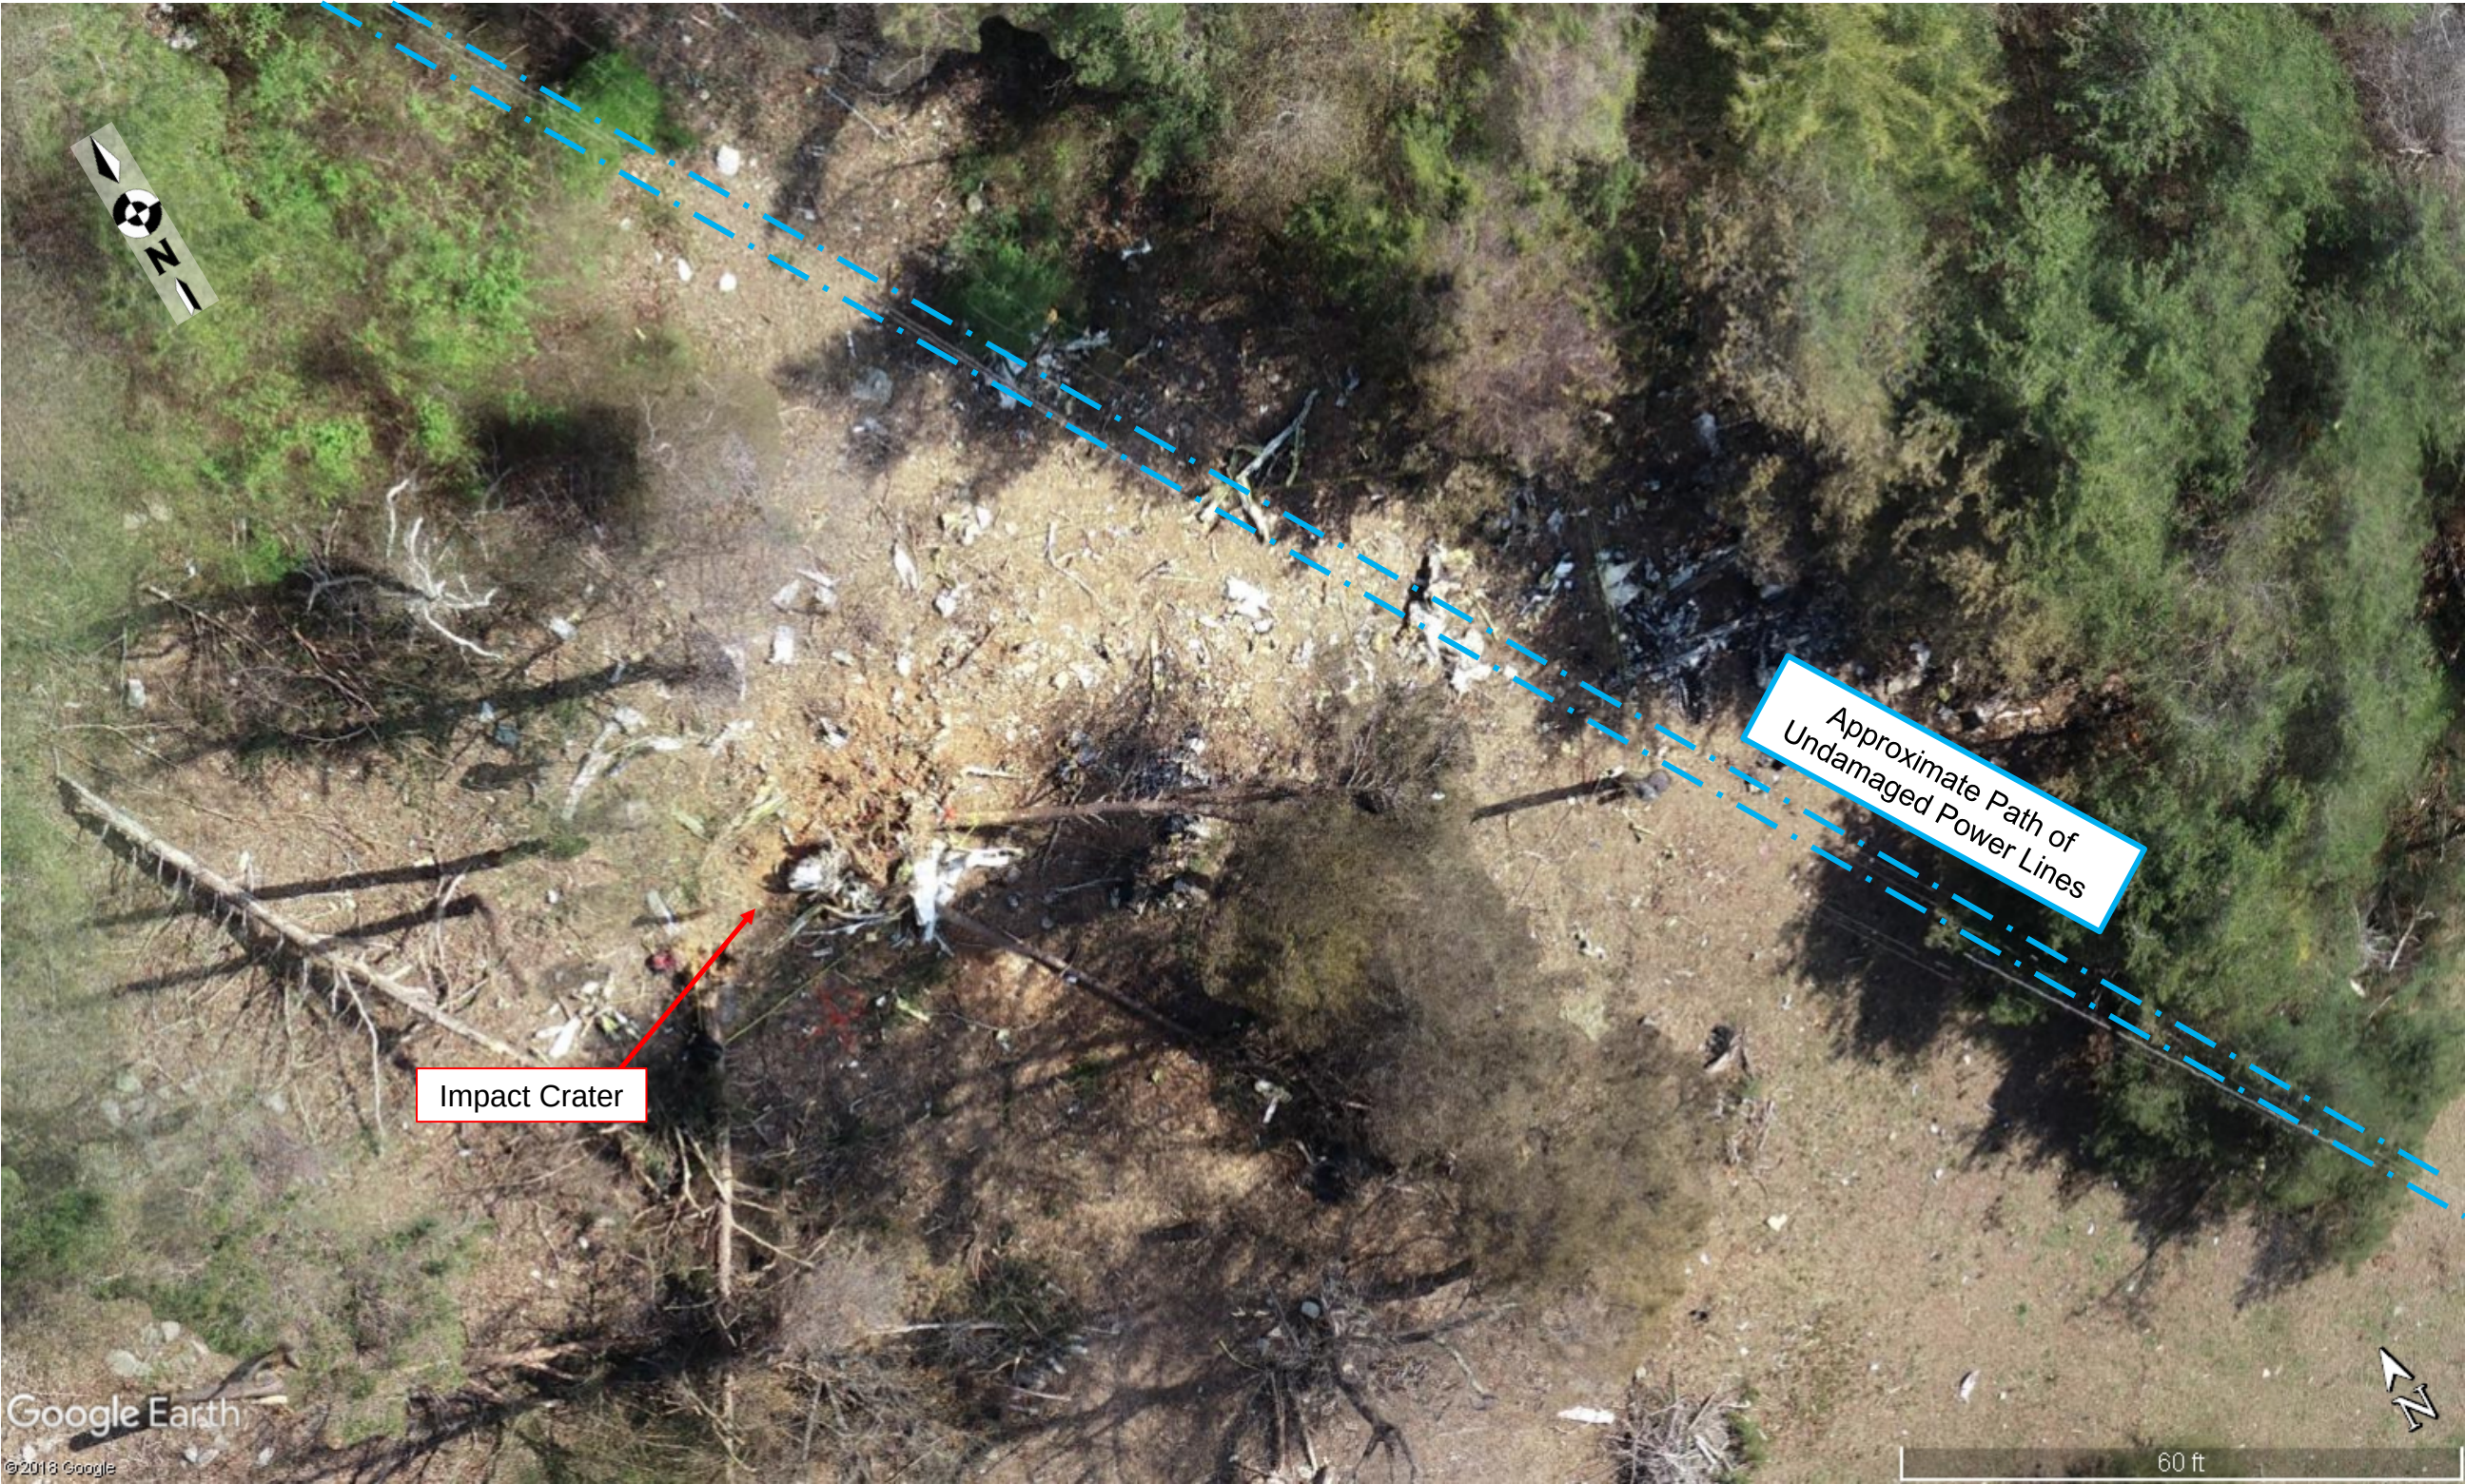
Figure 5 – Orthomosaic of accident site overlaid on Google Earth zoomed in to show main wreckage area.
