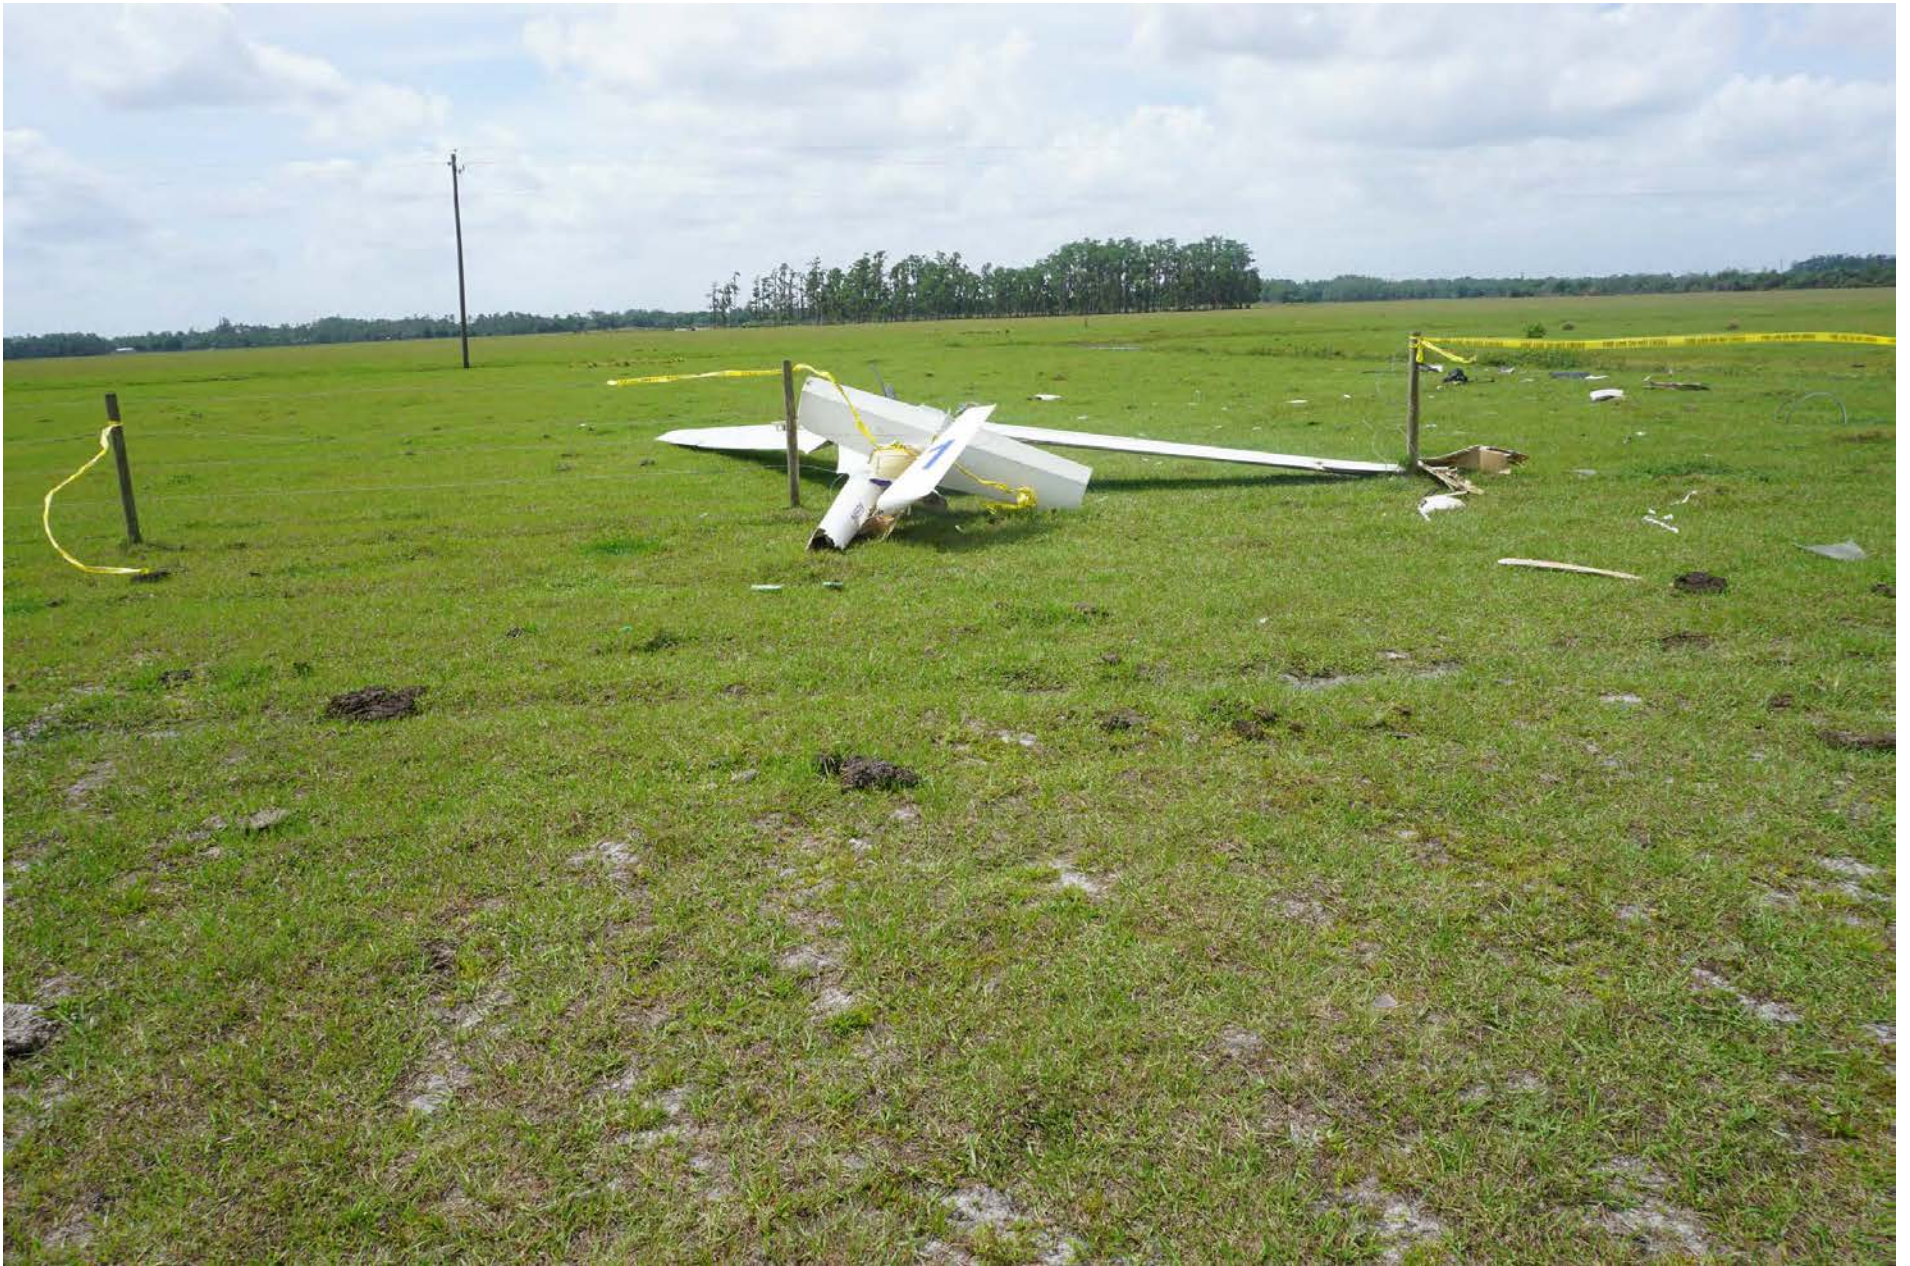
**Photo 1 – Aft view of wreckage showing damaged vertical and horizontal stabilizers**

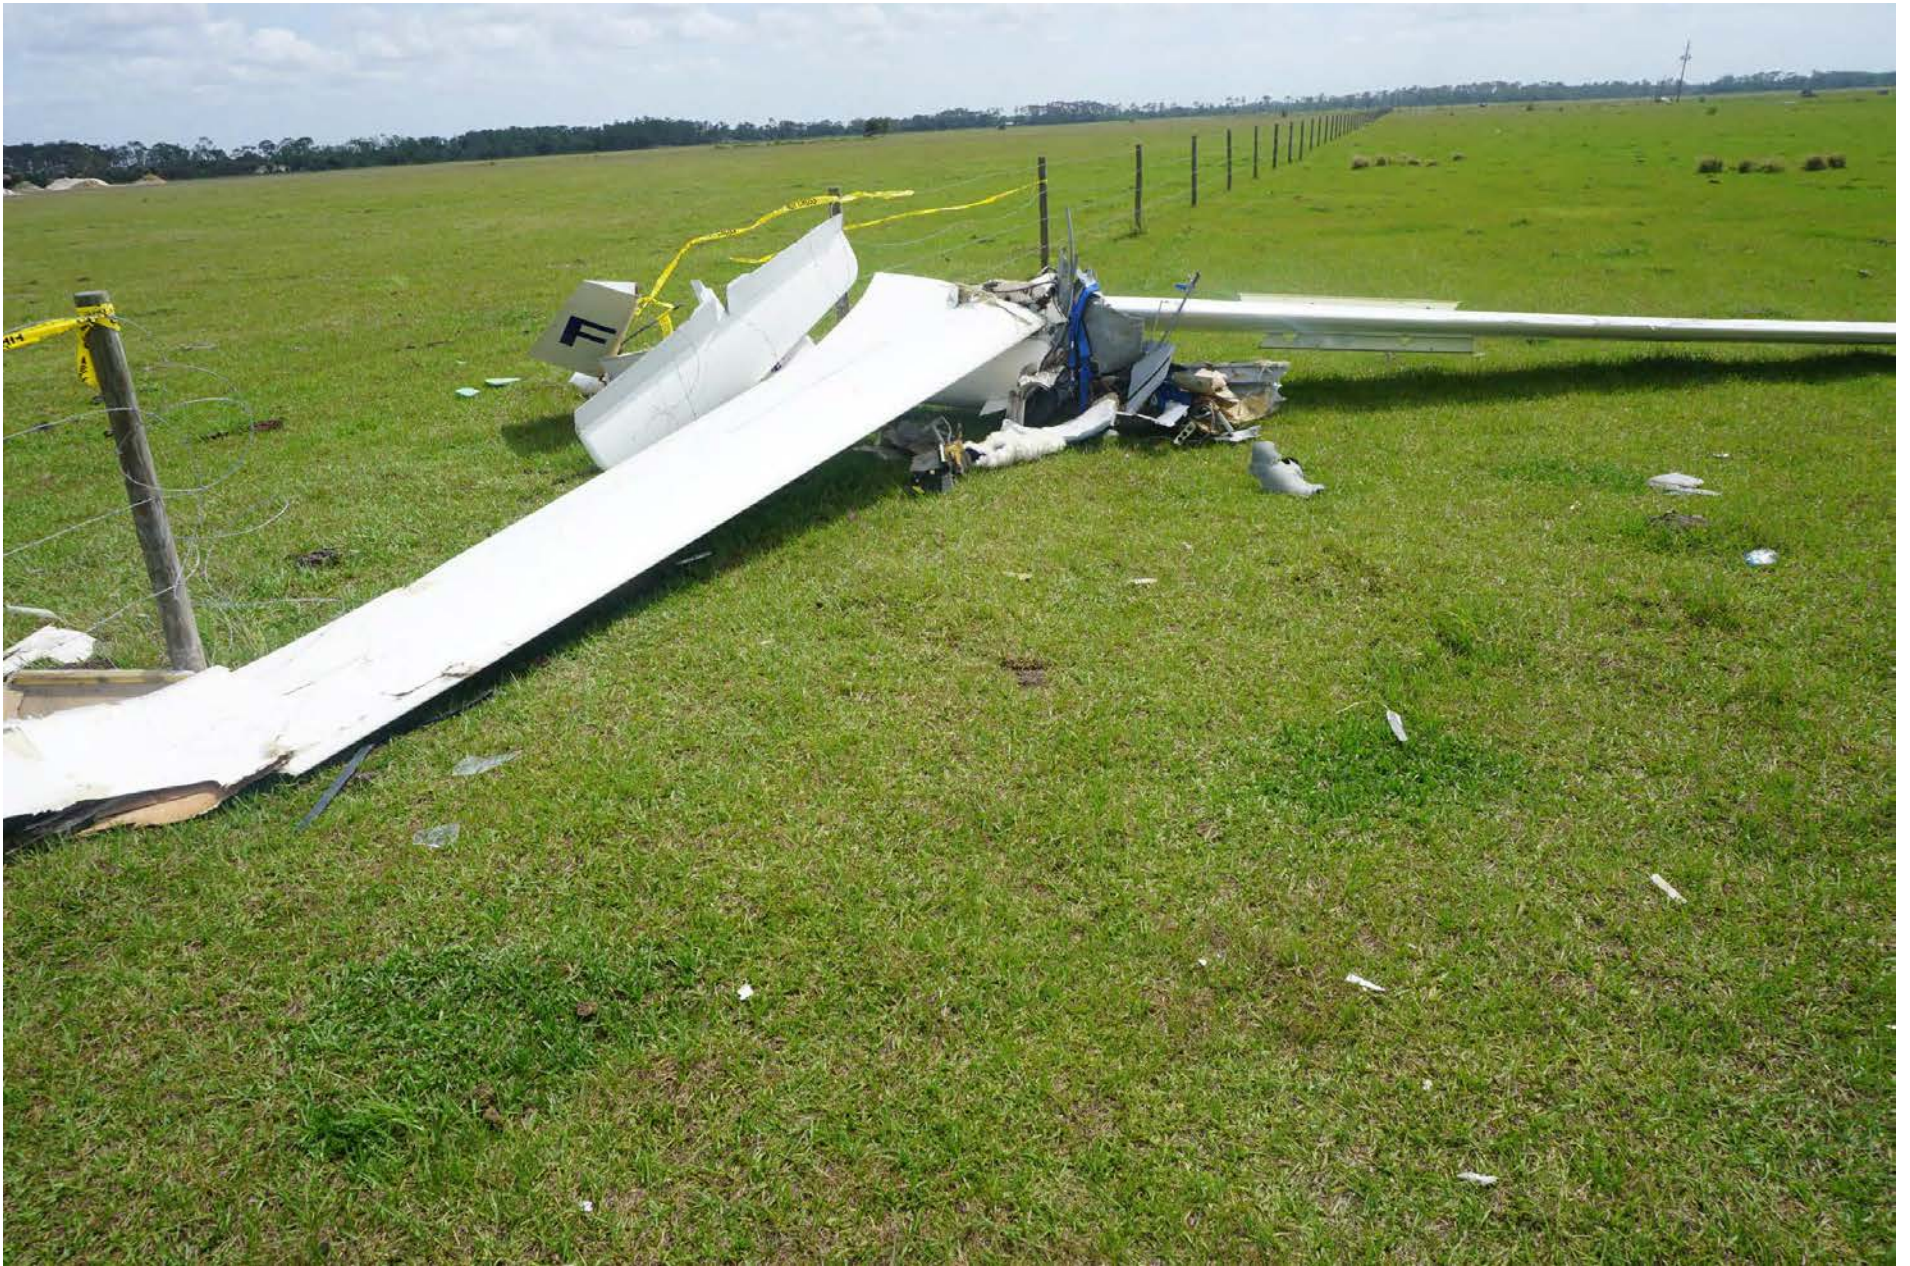
**Photo 2 – Right-side view of wreckage showing damaged right wing and crushed cockpit**

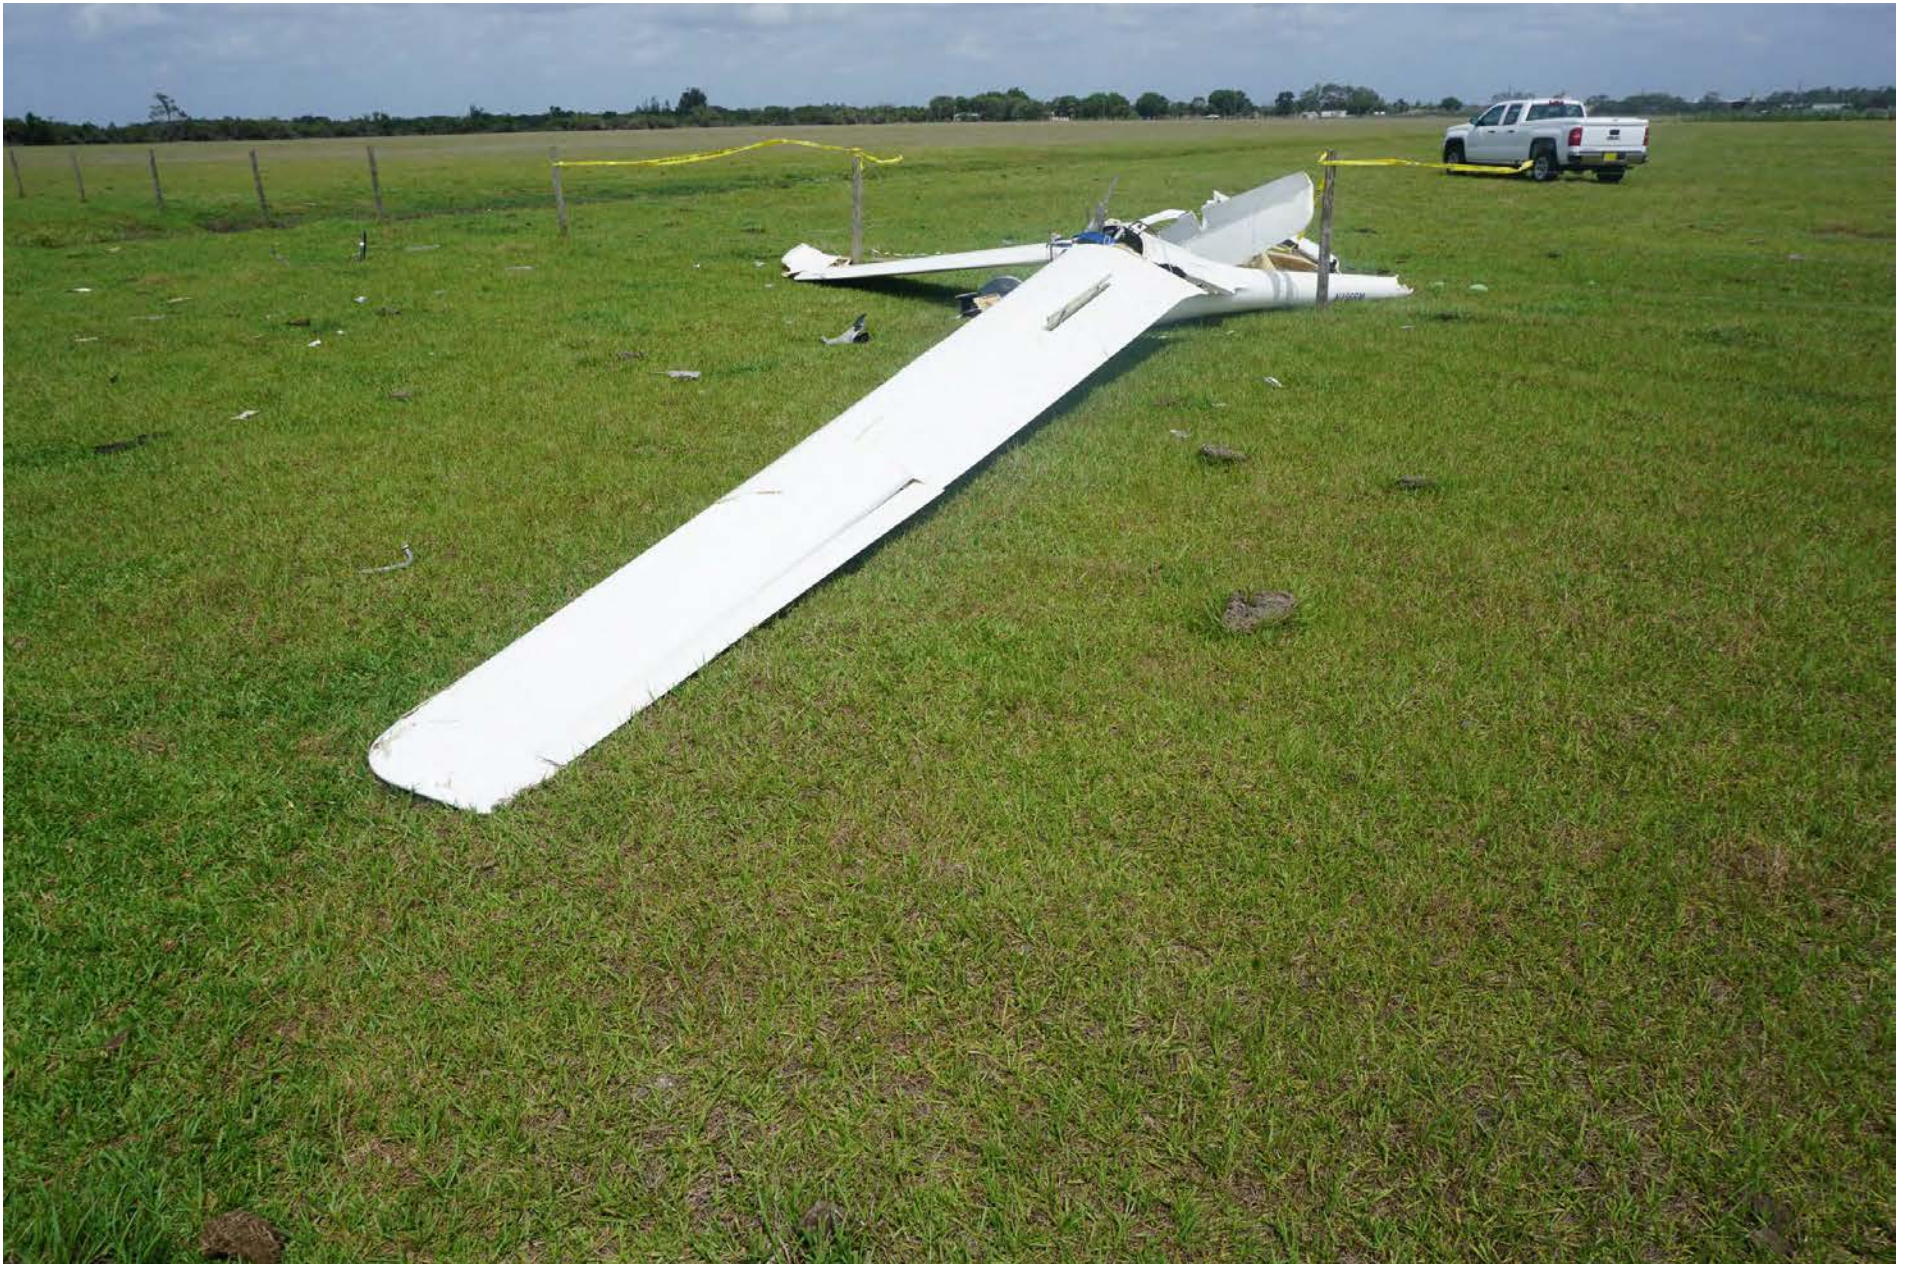
**Photo 3 – Left-side view of wreckage showing damaged left wing**

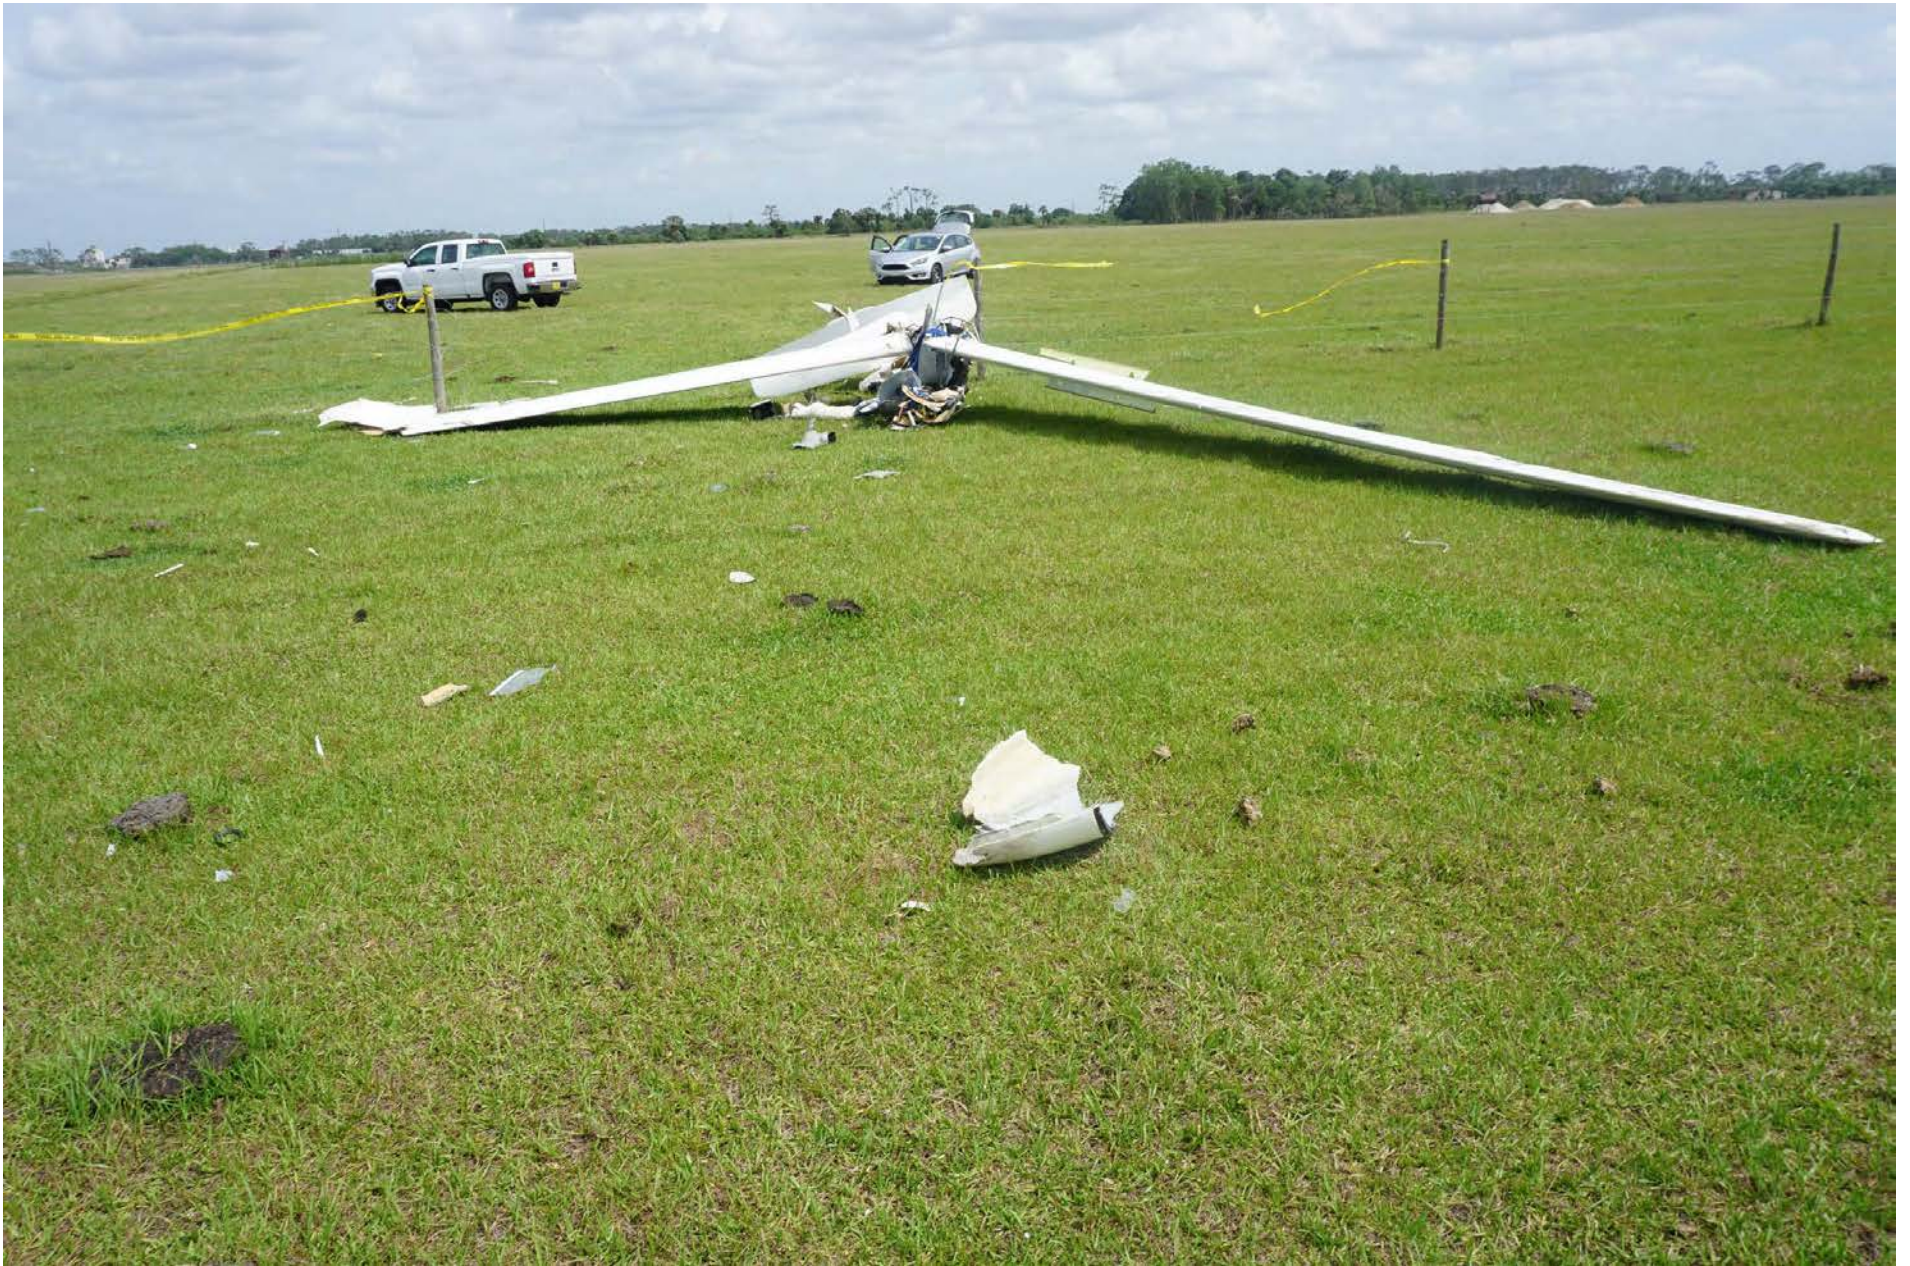
**Photo 4 – Front view of wreckage showing the crushed cockpit**

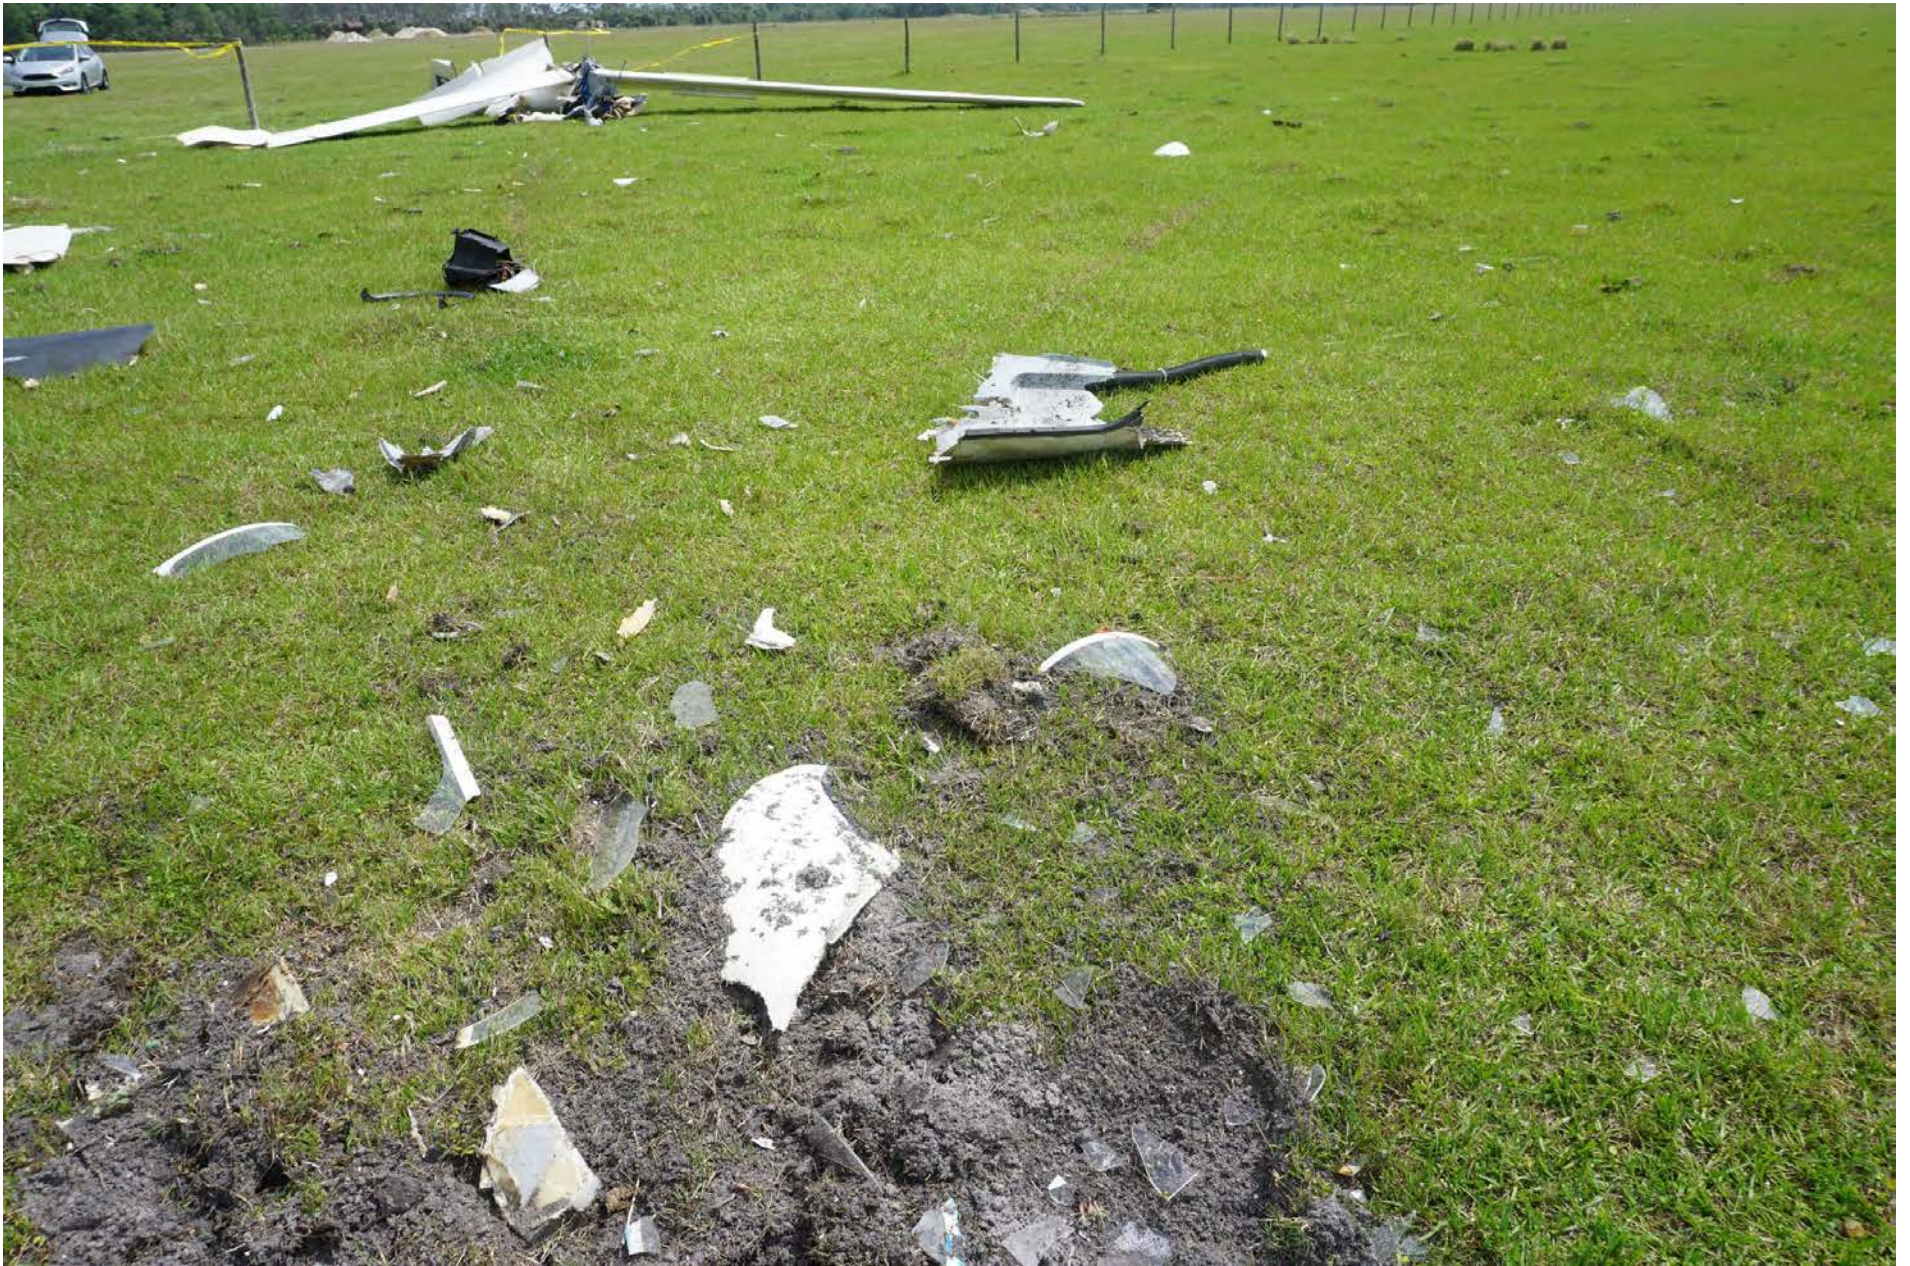
**Photo 5 – Forward view of wreckage showing fragmented cockpit parts and instrument panel**

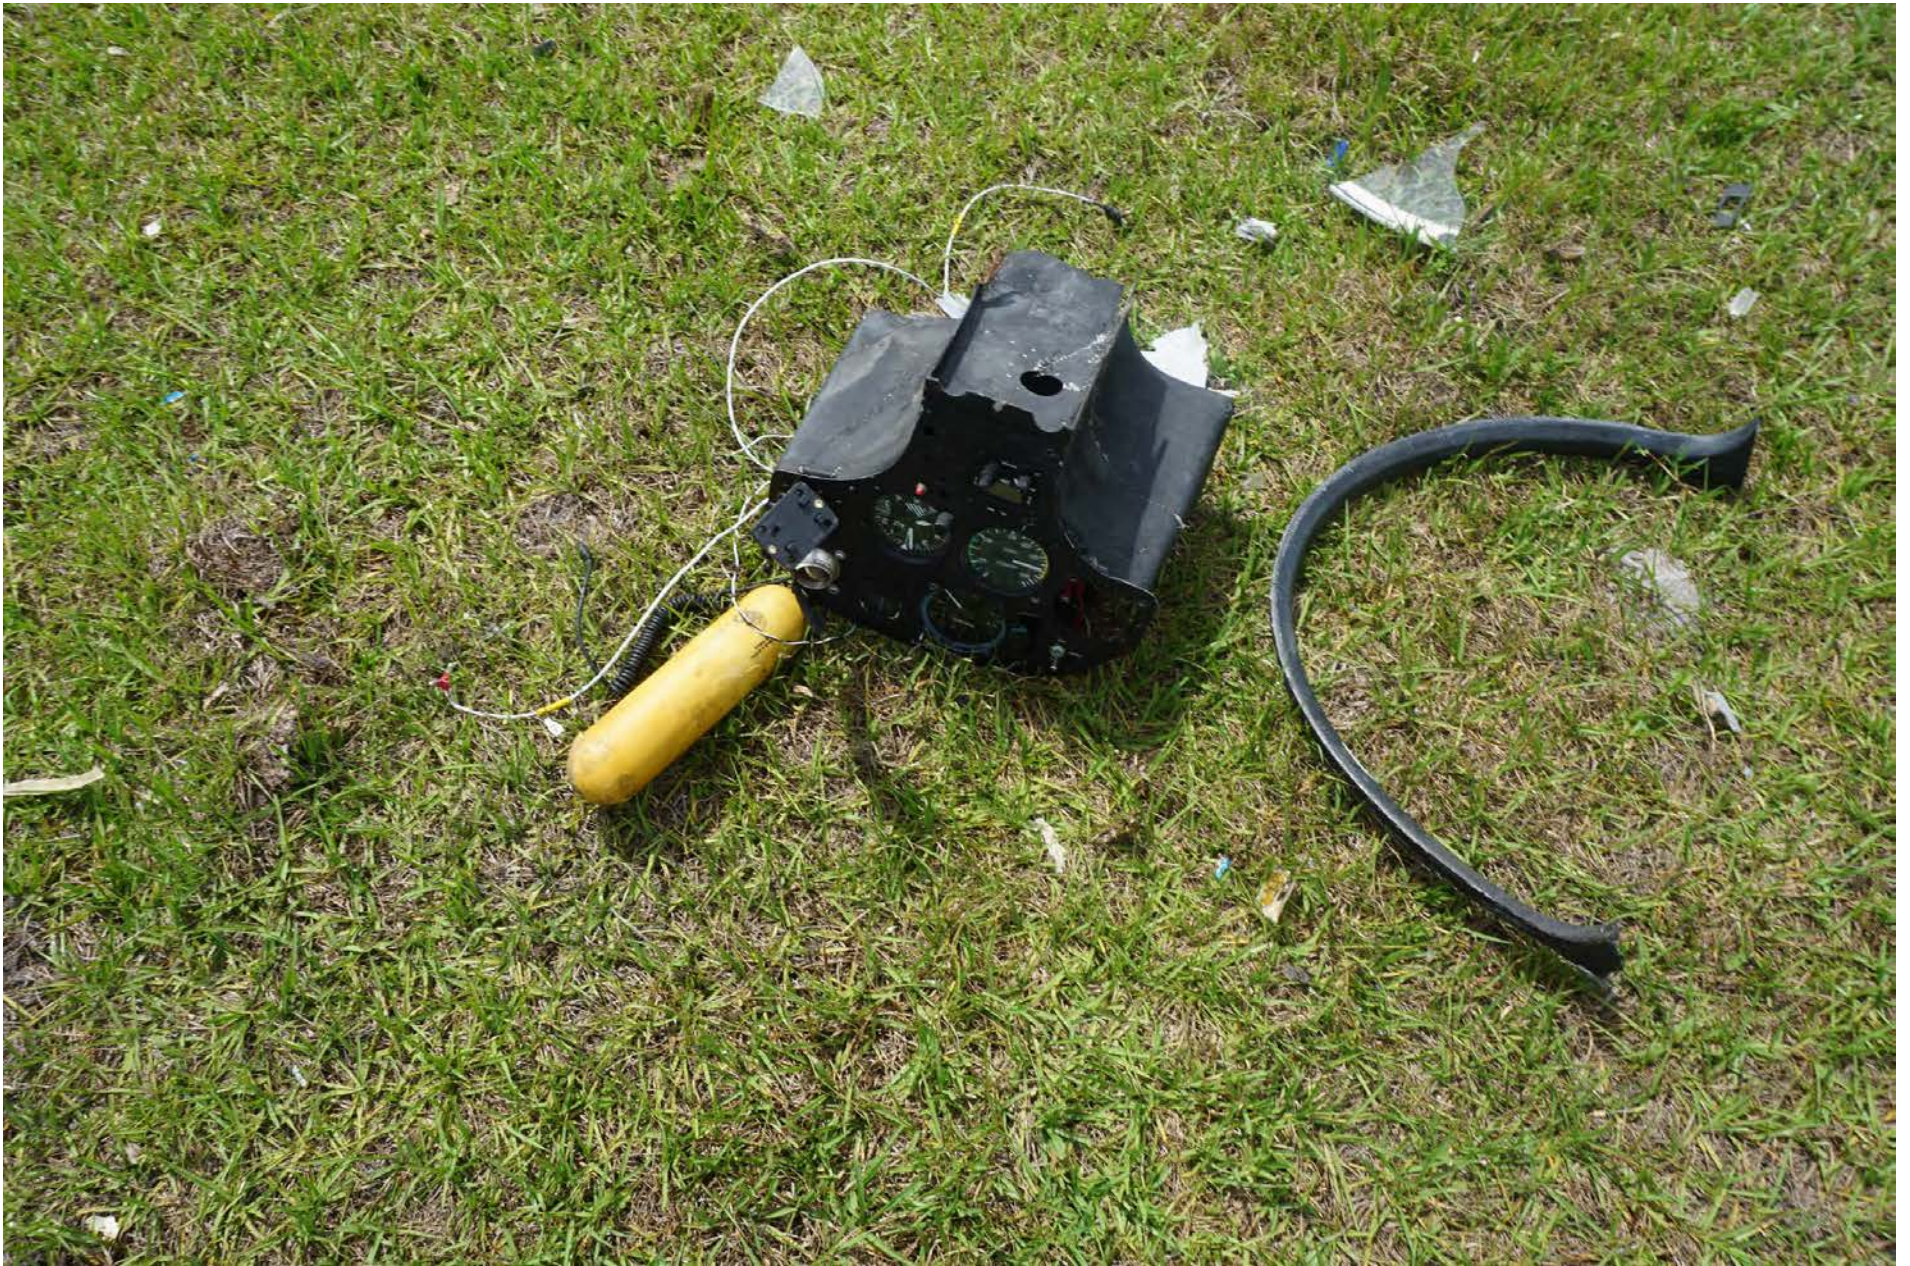
**Photo 6 – View of damaged instrument panel within the debris path**
