# NATIONAL TRANSPORTATION SAFETY BOARD

## MATERIALS LABORATORY FACTUAL REPORT

Report No. 19-065

Place : La Belle, Florida  
Date : April 14, 2018  
Vehicle : S.Z.D. SZD-48 JANTAR STD 2, N456RM  
NTSB No. : ERA18FA128  
Investigator : Eric Alleyne, ASI-ERA

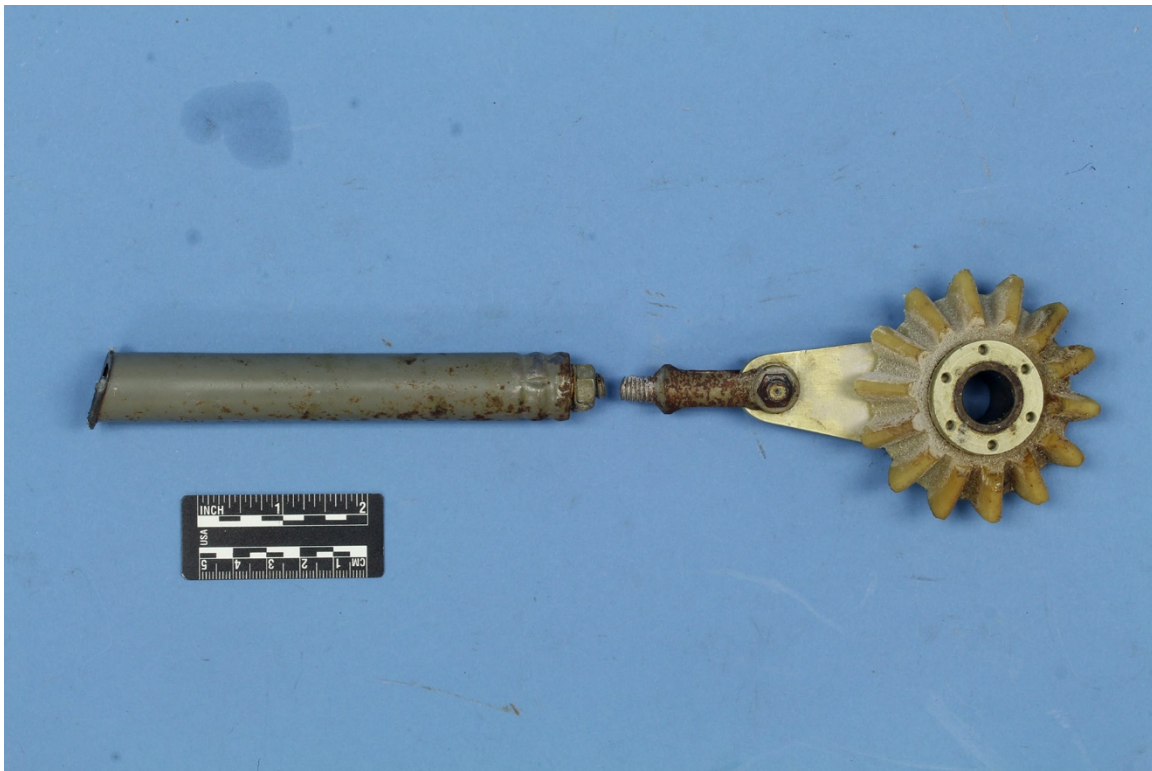
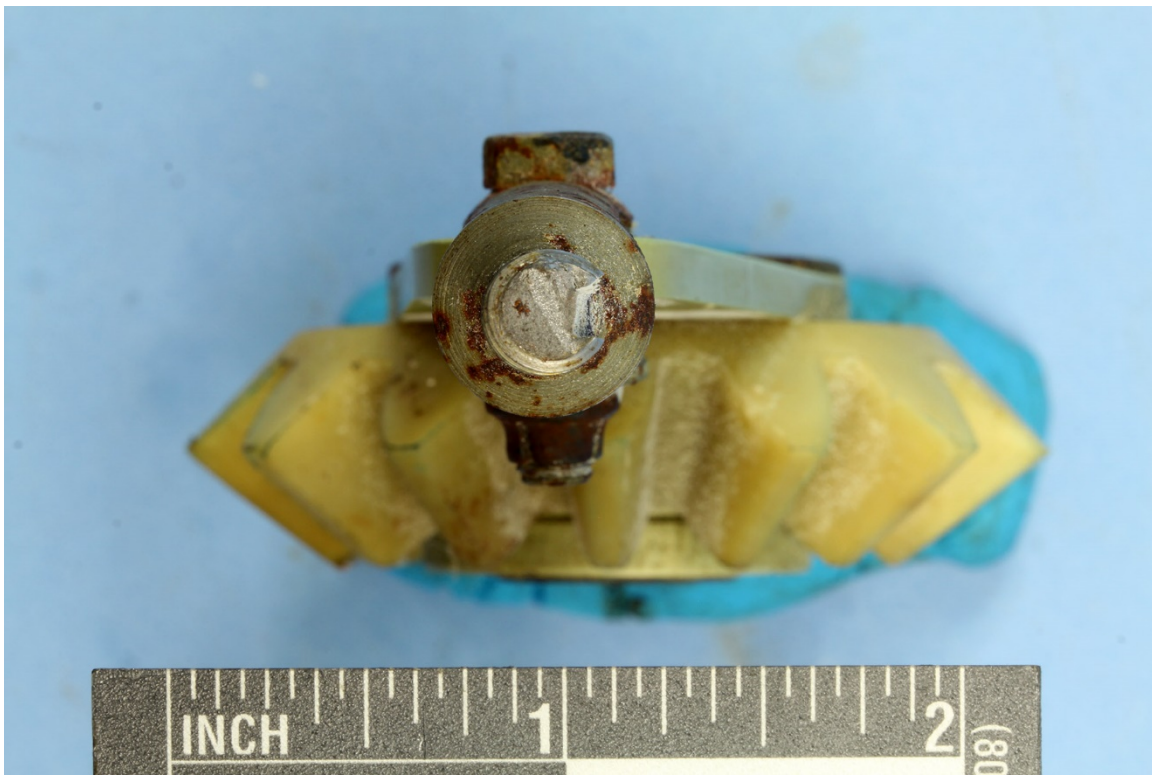
Two pieces of a right-wing speed brake connecting rod assembly were submitted to the NTSB Materials Lab for examination as shown in figure 1a. The assembly consisted of a connecting rod that was coupled to a beveled gear by means of a rod end. The rod end consisted of a threaded portion on one side and a clevis on the other side. The rod end was fractured through the threaded portion as shown in figures 1a and 1b.

**Figure 1:** Images of the speed brake connecting rod assembly as received: a) side view and b) threaded rod axial view.

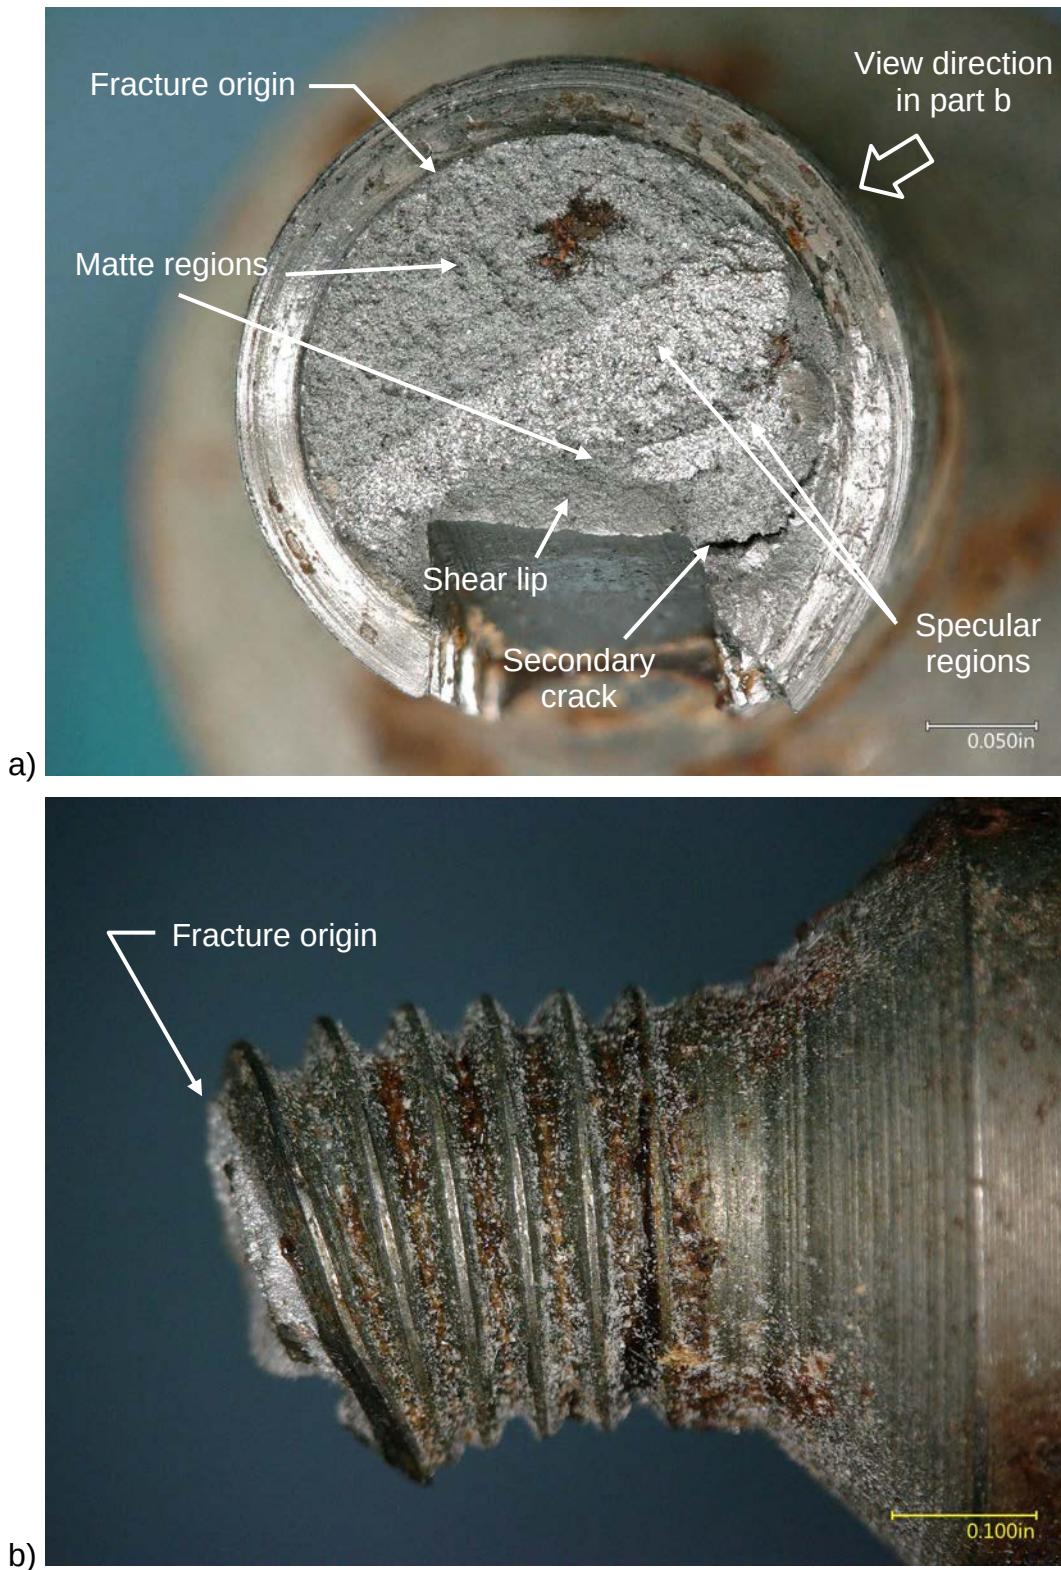
The bolt that connected the clevis to the beveled gear was removed and the rod end piece was cleaned using an alkaline detergent solution, a nylon bristle brush, and a sonicating bath. An image of the fracture surface after cleaning is shown in figure 2a. The fracture surface exhibited two distinct visual morphologies. Several regions exhibited a rough/matte appearance, while other regions exhibited a comparatively reflective or specular appearance, as indicated in figure 2a. A shear lip was observed adjacent to a keyway in the threaded section of the rod and a secondary crack was observed near an internal edge of the keyway.

The threaded section of the rod end was visually bent. The rod end piece was rotated about the axial direction to determine the direction of maximum bend. That orientation, shown in figure 2b was at an angle of approximate 35° to the rotation axis of the beveled gear.

**Figure 2:** a) Image of the threaded rod fracture surface and b) side view of the threaded section at an angle of approximately 35° to the clevis and beveled gear rotation axis.

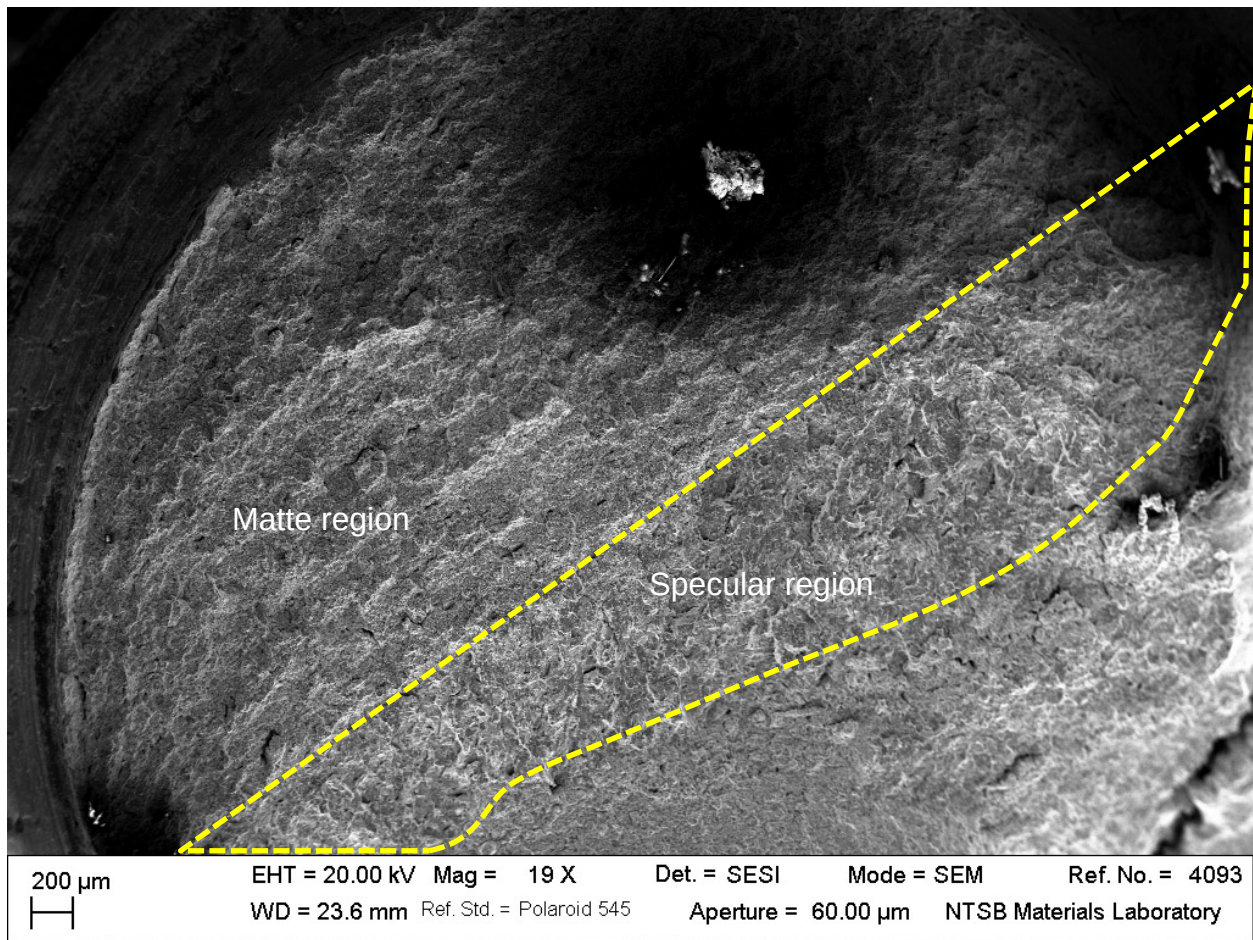
The fracture surface was examined using a scanning electron microscope (SEM) to examine the rough/matte and specular fracture regions. An overview SEM image of the fracture is shown in figure 3. One of the specular fracture regions is indicated and enclosed by a yellow dashed line and one of the matte regions is also indicated. Representative images taken from each region are shown in figures 4a and 4b for the

The fracture surface on the tensile side of the bend was examined visually and determined to exhibit a matte appearance. Based on the SEM observations, this appearance was consistent with the crack initiating by ductile overstress.

**Figure 3:** Overview SEM image of the fracture surface.

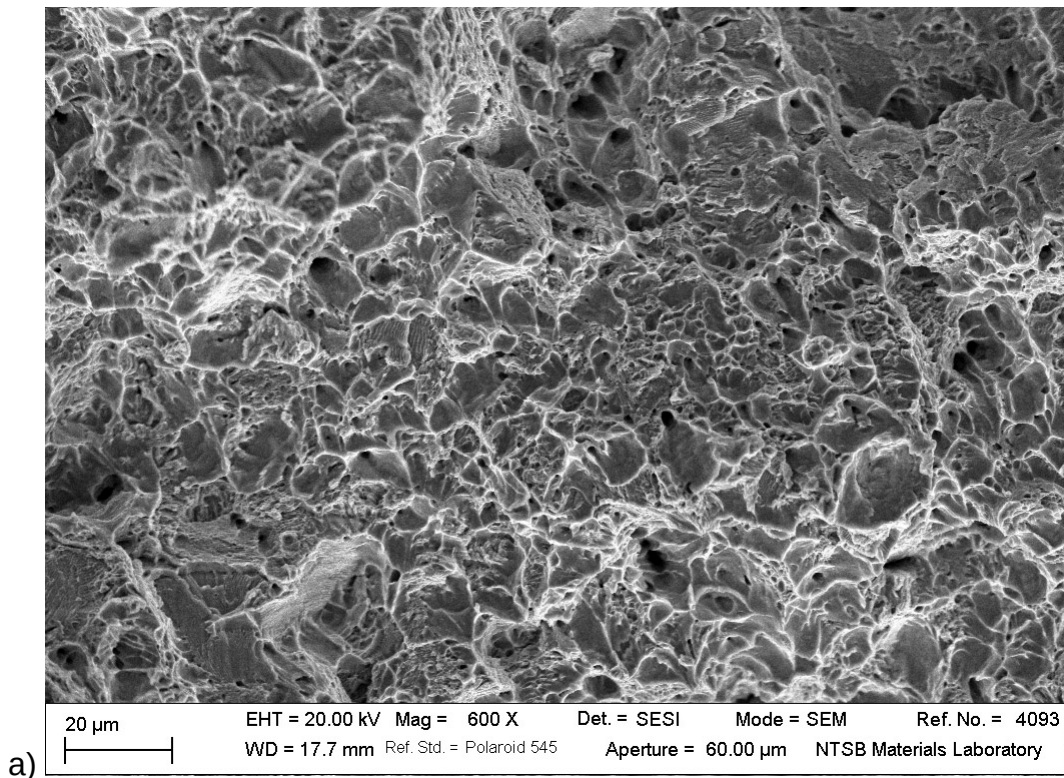
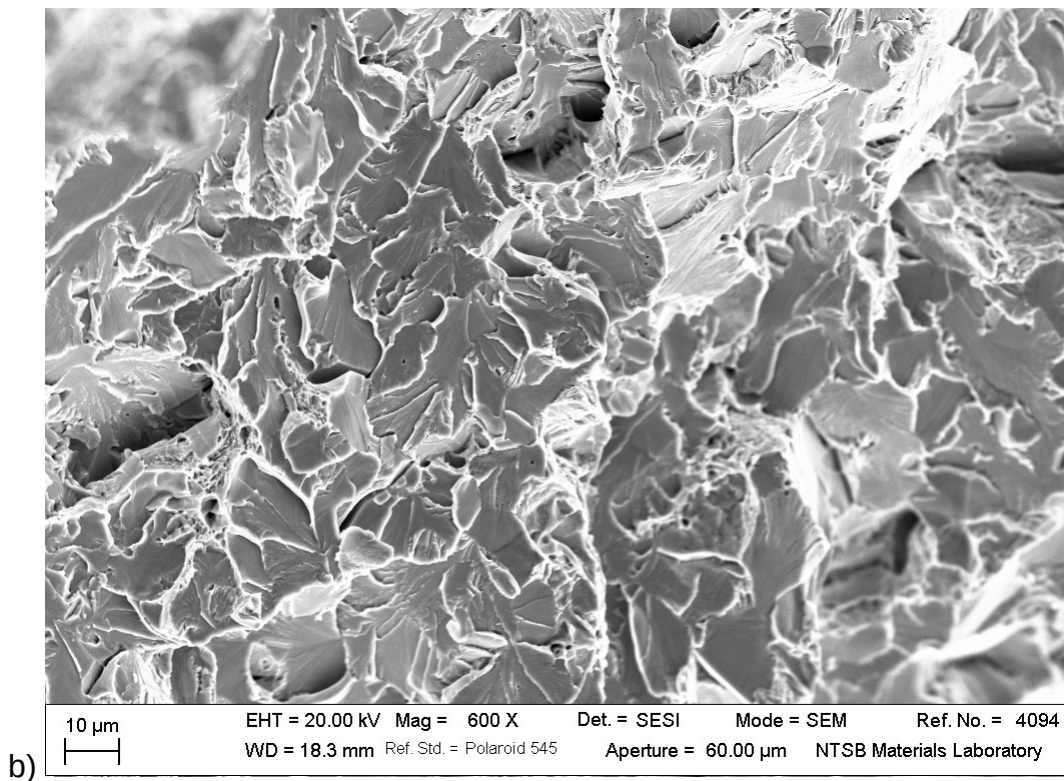
matte and specular regions respectively. The matte region exhibited a dimpled appearance consistent with a ductile overstress fracture. The specular region exhibited a flat faceted appearance consistent with a brittle cleave fracture.

In conclusion, the deformation and fracture features were consistent with a ductile bending overstress fracture that started in a thread root with the bending axis at an angle of approximately 35° to the rotation axis of the beveled gear. The fracture mode subsequently transitioned between brittle and ductile overstress with the point of final fracture near the keyway.

**Figure 4:** SEM images of typical fracture surface features from regions indicated in figure 3: a) ductile dimple morphology in matte region and b) flat faceted fracture in specular region.
