# NATIONAL TRANSPORTATION SAFETY BOARD

## MATERIALS LABORATORY FACTUAL REPORT

Report No. 18-054

Place : Gainesville, Georgia  
Date : April 28, 2018  
Vehicle : Piper PA-28R-200, N4363F  
NTSB No. : ERA18FA137  
Investigator : Leah D. Yeager, AS-ERA

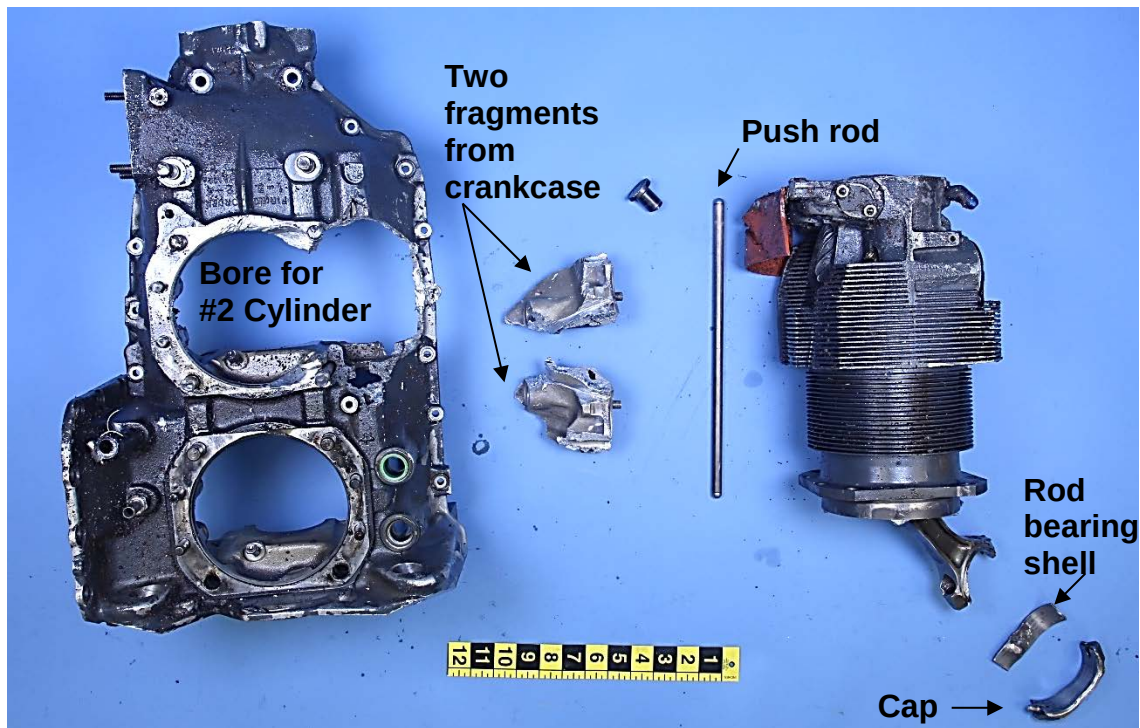
Figure 1 shows a photograph of the as-received left-hand portion of the crankcase and the #2 cylinder that separated from the crankcase. The piston and connection rod arm remained attached to the cylinder. The end cap separated from the connecting rod arm. One of the attachment bolts for the cap was fractured at the shank portion and the other attachment bolt was not submitted (presumed missing). One half of the rod bearing shell was intact and the other half portion of the rod bearing shell was not submitted (presumed missing). The push rod for the #2 cylinder was intact and showed no evidence of damage. The bore for the #2 cylinder contained eight stud-bolts. The stud-bolts were arbitrarily labelled "1" through "8" in figure 2. The eight stud-bolts for the #2 cylinder were fractured at the thread portion.

Figure 1. As-received left-hand section of the crankcase with two fragments of the crankcase (left and center of page); and #2 cylinder that separated from the crankcase (right side of page).

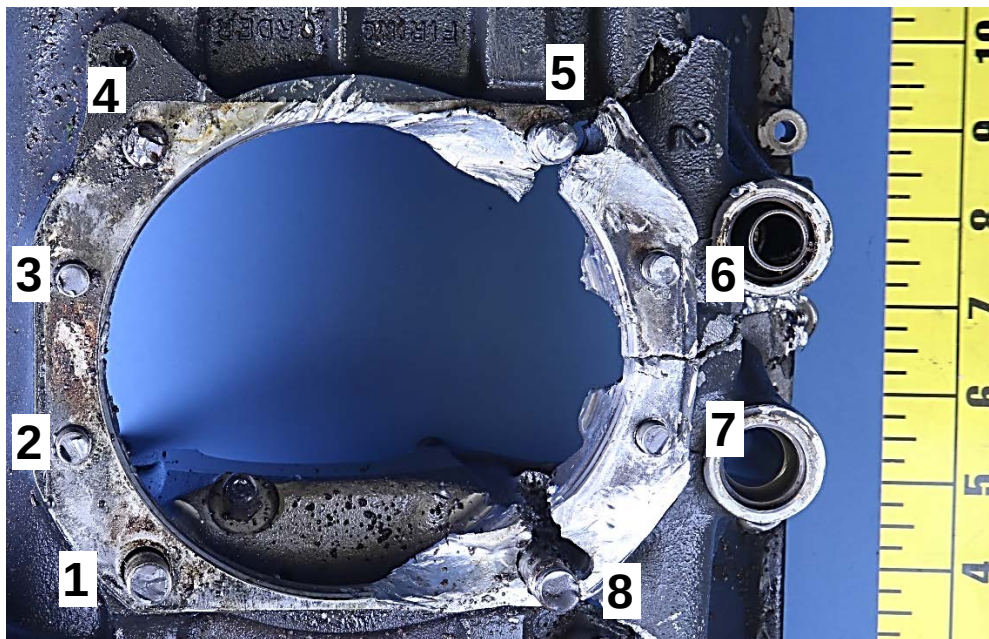
Figure 2. Close-up photograph of the crankcase bore for the #2 cylinder after the two fractured fragments of the wall were inserted into the bore as if intact. The stud-bolts arbitrarily labelled "1" through "8" were fractured at the thread portion.

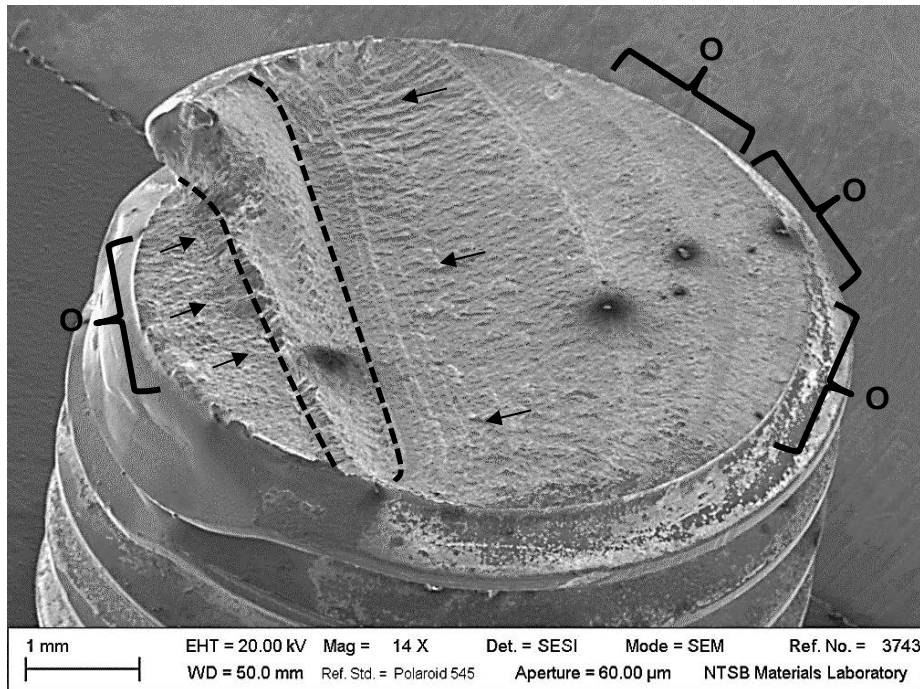
The fractured ends of the eight stud bolts for the #2 cylinder were saw cut from the crankcase to facilitate examination and cleaning of the fracture faces. The fractured ends of the stud bolts were ultrasonically cleaned with acetone. Scanning electron microscope (SEM) examination of the excised stud-bolts revealed the fracture faces of all the stud-bolts contained evidence of crack arrest marks consistent with fatigue cracking. Fatigue cracking initiated at multiple origins along the root portion of the threads. For stud-bolts "1" through "7", fatigue cracking extended between 75% and 90% of the bolt cross section. For stud-bolt "8", fatigue propagation was through approximately 30% of the cross section. Figures 3 and 4 show examples of fatigue cracking on the fracture face of stud-bolt 6. On this bolt, fatigue cracking emanated from multiple origins at the root of the threads on diametrically opposite sides of the bolt. Fatigue propagation was in the general direction indicated by arrows in figure 3 and terminated in the areas indicated by dashed lines. The areas between the dashed lines contained microvoid coalescence features typical of overstress separation.

Figure 3. SEM image of the fracture face from stud-bolt 6 showing fatigue cracks that emanated from multiple origins at the root of the threads on diametrically opposite sides of the bolt in the areas indicated by bracket "O". The fatigue cracks terminated in the areas indicated by dashed lines.

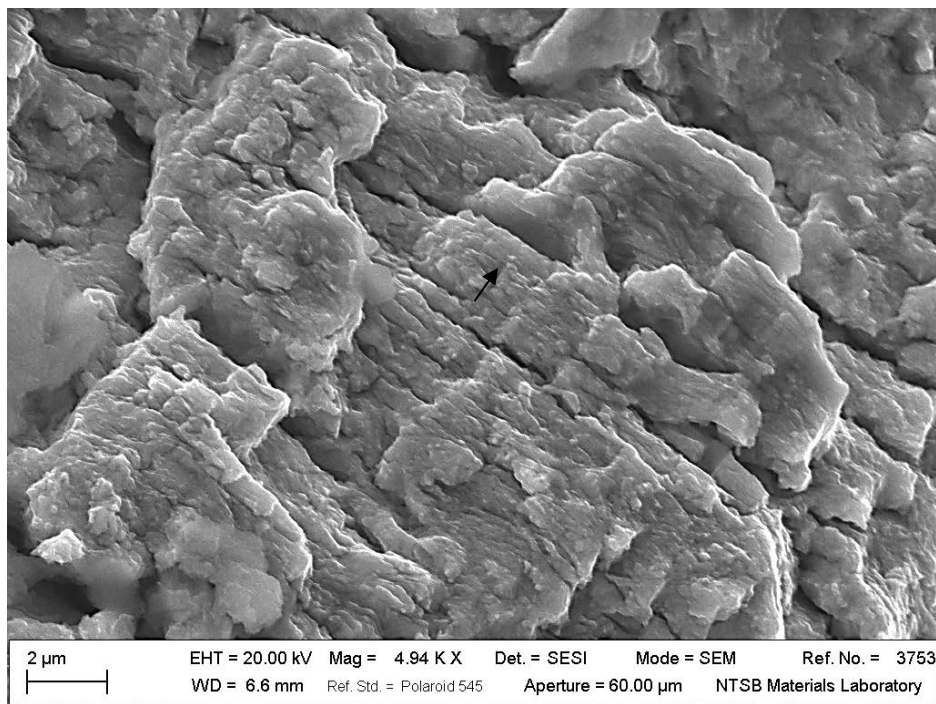
Figure 4. SEM image of typical fatigue striations with arrow showing general direction of fatigue crack propagation.
