# Continental Motors

## ENGINE EXAMINATION REPORT

| ENGINE MODEL | A65 |
| FILE NUMBER | 17-532 |

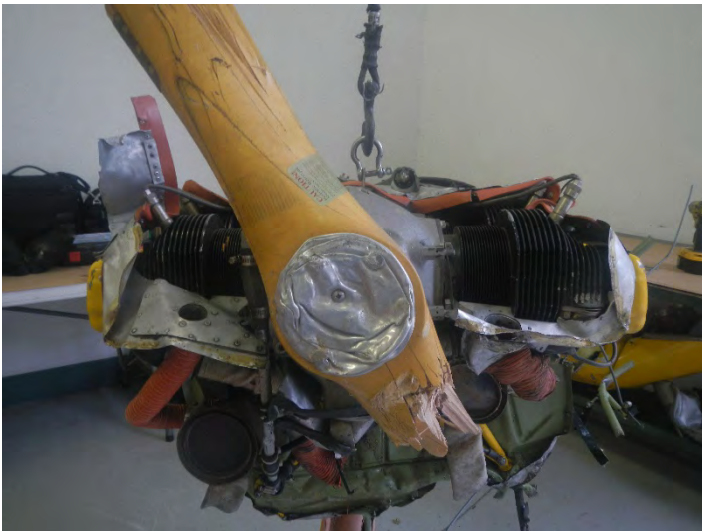
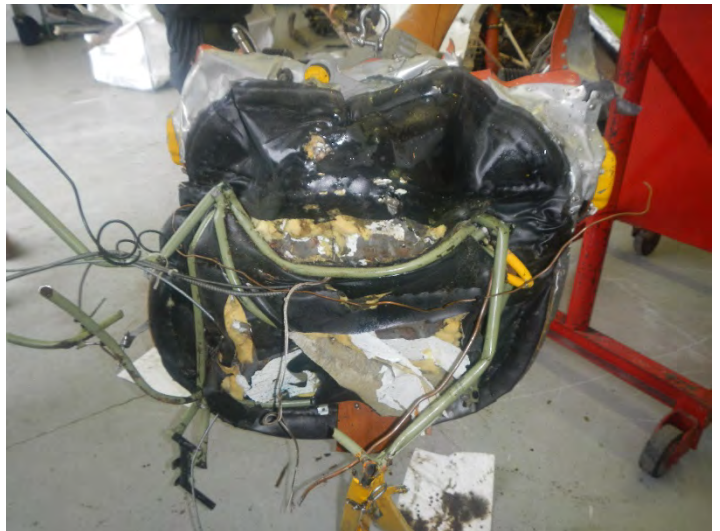
The engine was separated from the airframe, but the fuel tank, forward airframe structure, and firewall remained with the engine and were all symmetrically deformed around the backside of the engine. The propeller hub remained attached to the propeller flange and the spinner dome was flattened aft symmetrically. Both of the fixed-pitch wooden blades were separated, with the fractures of blade oriented aft. The carburetor mount was fractured and was previously examined by the NTSB IIC at the accident site.

The fuel tank, firewall, engine and airframe mounts, and exhaust systems were removed to facilitate examination of the engine. Upon removal of the firewall, it was noted that the magneto mounting flanges were fractured. The fuel tank was punctured and torn in multiple locations.

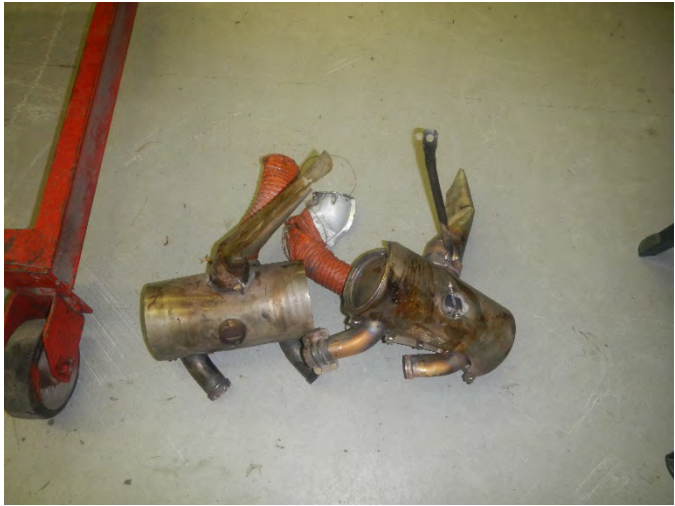
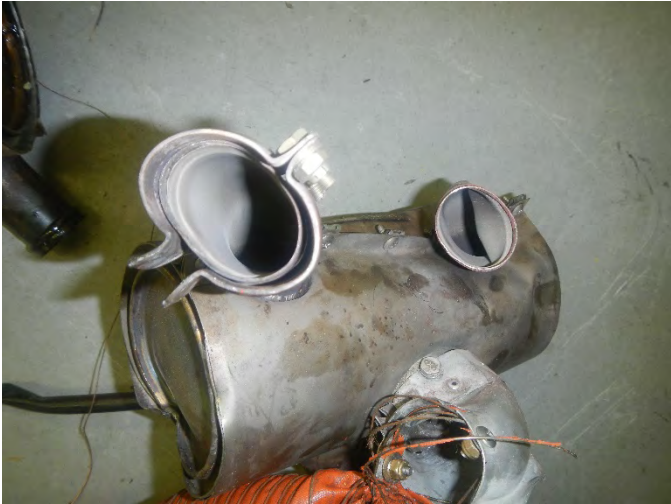
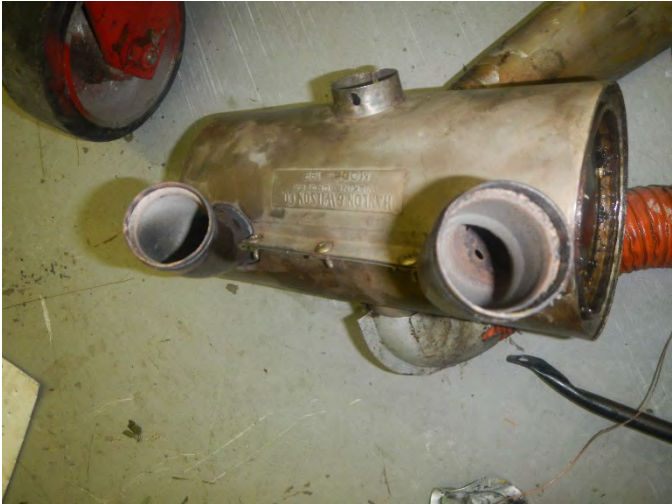
| Condition: | The exhaust system remained attached to the engine and the tailpipes were flattened. No pre-accident anomalies were noted |

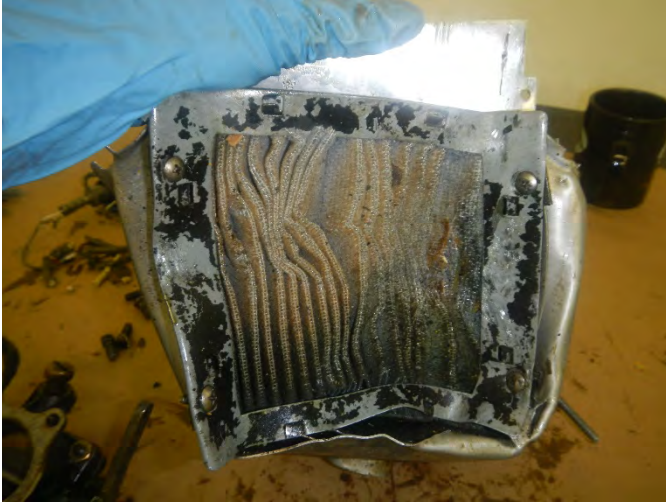
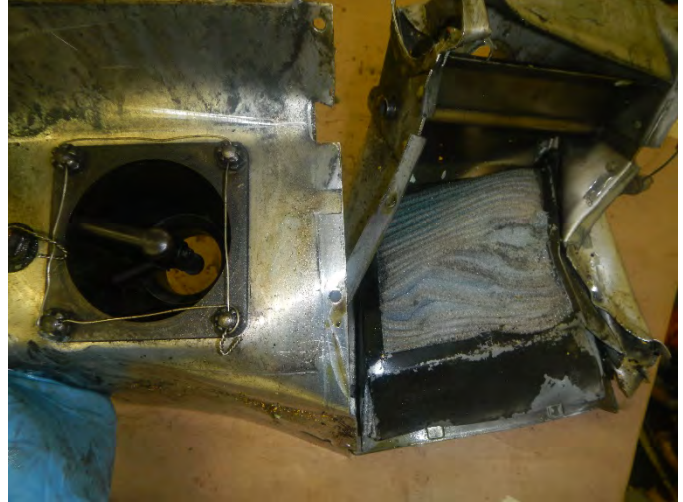
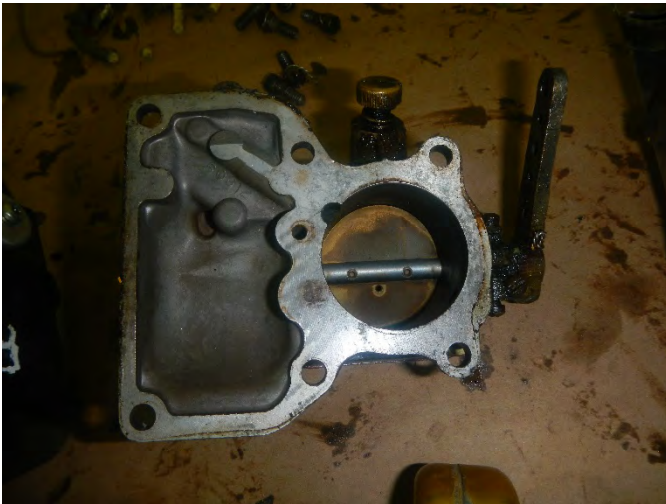
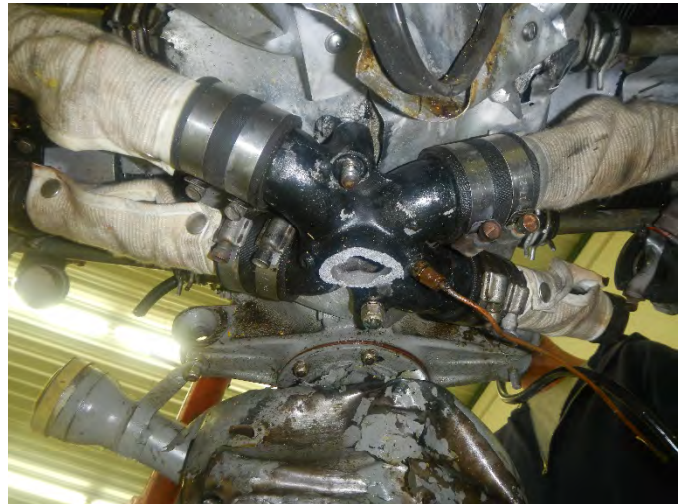
The induction airbox was deformed around the carburetor bowl. The filter remained in place in its bracket. The pleats were deformed but unobstructed. The backside of the filter displayed a light blue tint. The throttle valve functioned properly and no obstructions were noted in the intake system.

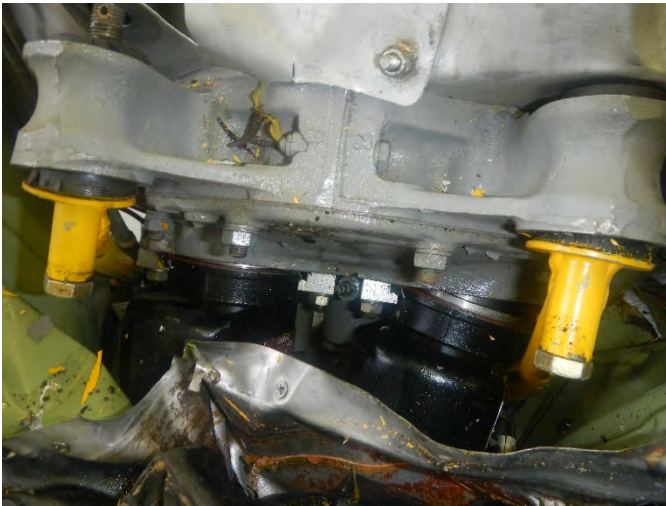
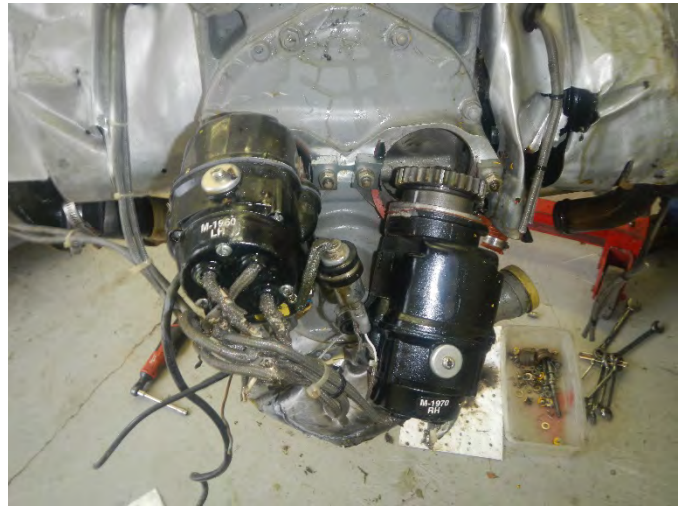
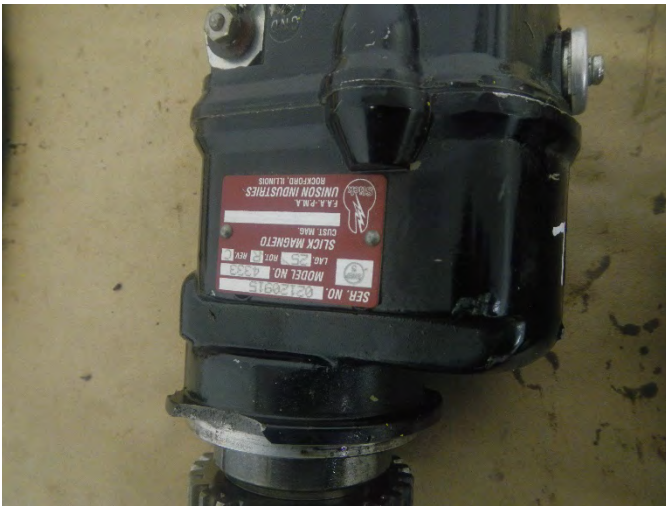
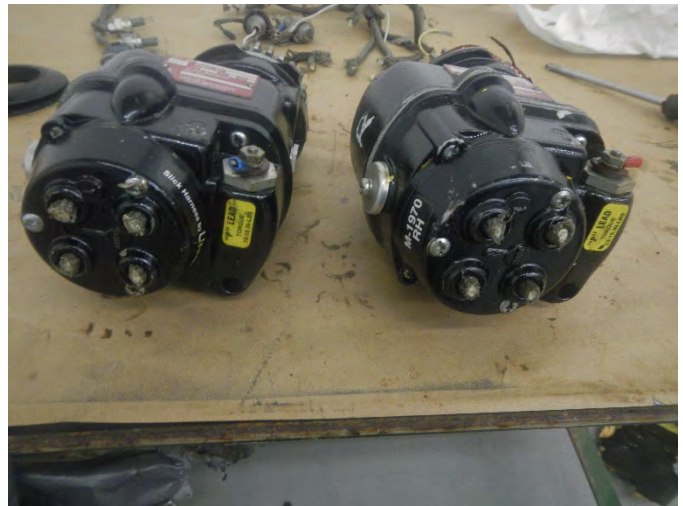
**Condition:** The magneto mounting flange was fractured, but the magneto remained in place until the firewall was removed and the damaged ignition harness leads were cut. Manual rotation of the drive gear resulted in a spark from the cut ignition leads, in firing order when the impulse coupling snapped. No pre-accident anomalies were noted.

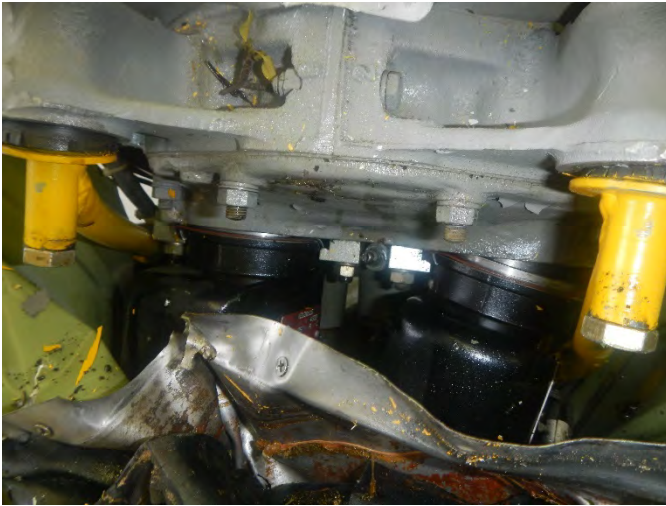
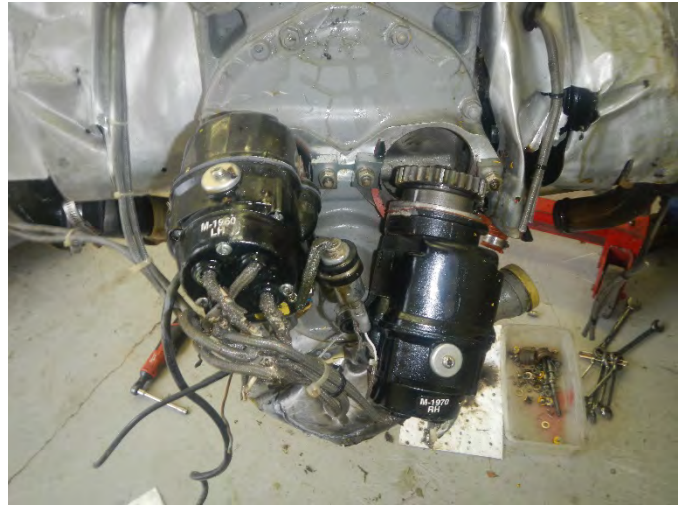
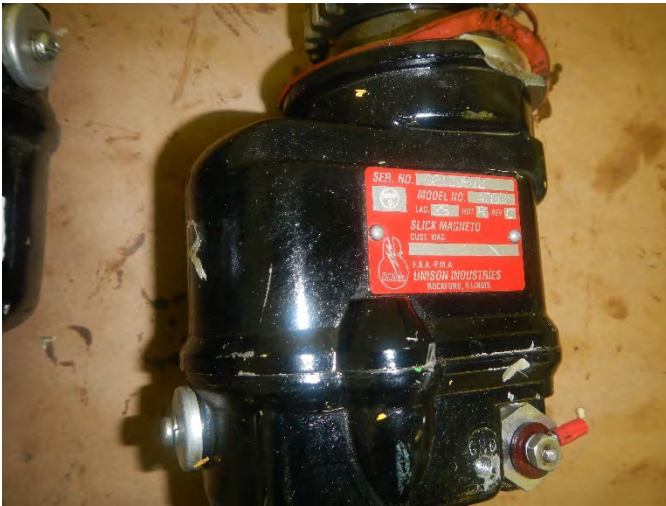
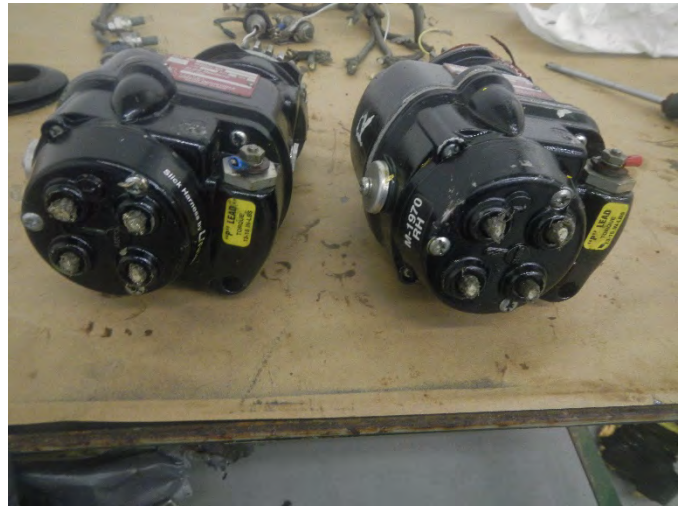
**Condition:** The magneto mounting flange was fractured, but the magneto remained in place until the firewall was removed and the damaged ignition harness leads were cut. Manual rotation of the drive gear resulted in a spark from the cut ignition leads, in firing order when the impulse coupling snapped. No pre-accident anomalies were noted.

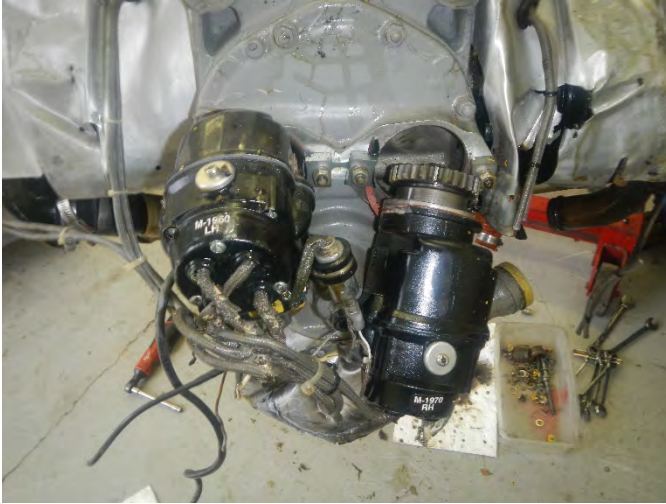
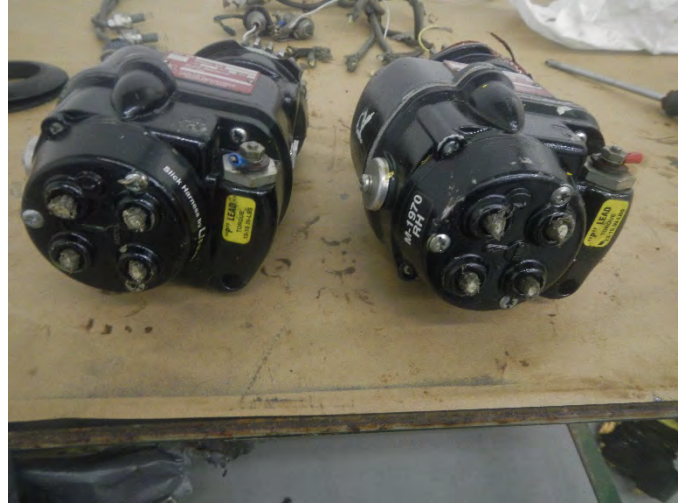
The ignition harness sustained pinching and tearing damage from the firewall impingement. The leads were cut to remove the damaged areas. The leads produced a spark at the cuts with no pre-accident anomalies noted. The terminal ends remained secured to their respective sparkplugs.

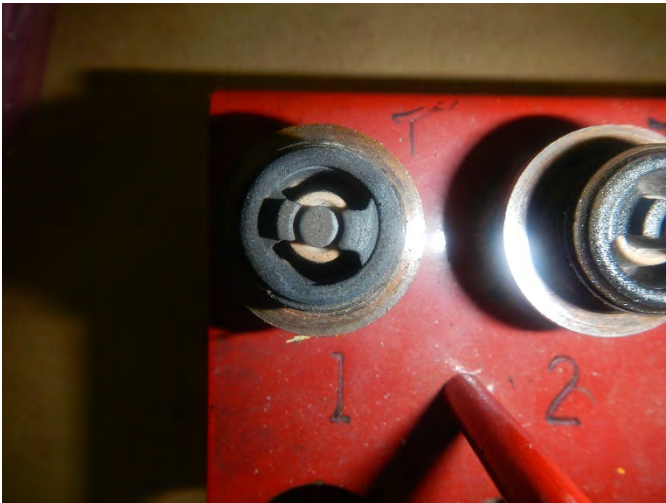
1T

The sparkplugs remained secured to their respective cylinders with no pre-accident anomalies noted. The top sparkplugs were removed and all displayed lean operating signatures with no signs of lead or carbon fouling. The bottom sparkplugs were documented utilizing a lighted borescope. The #2 and #4 bottom plugs were oil soaked.

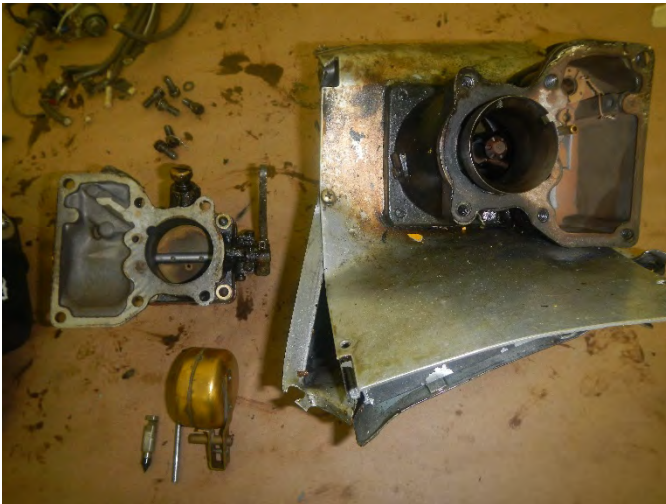
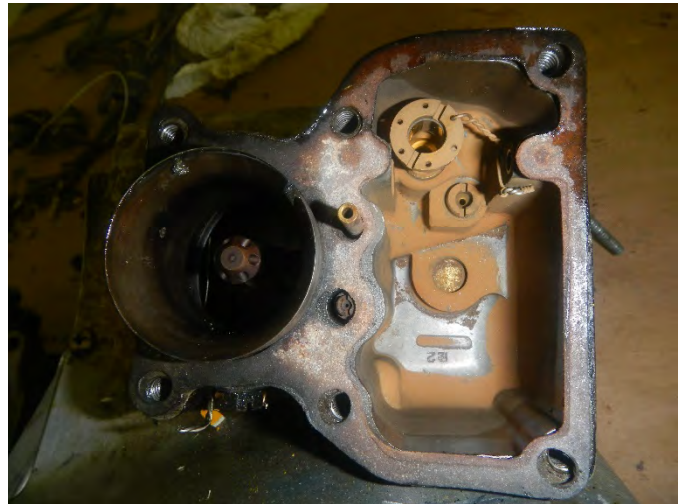
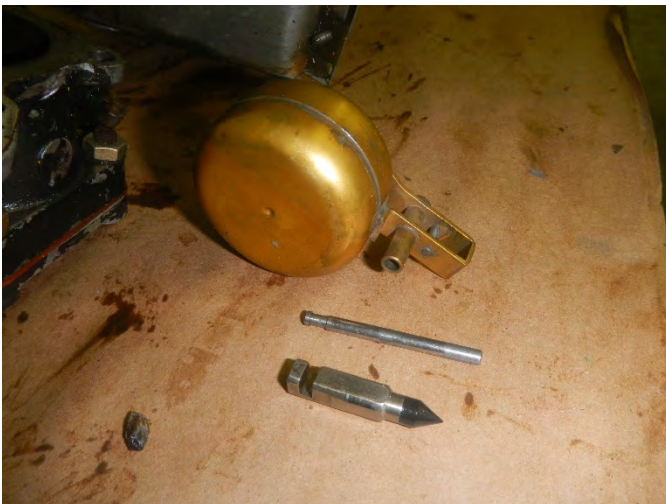
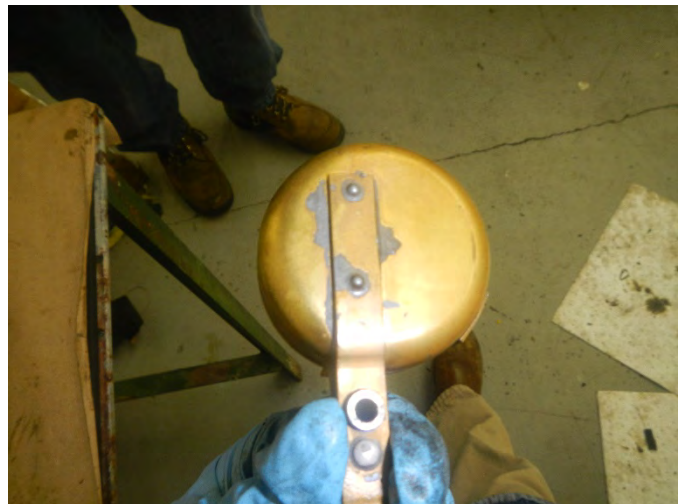
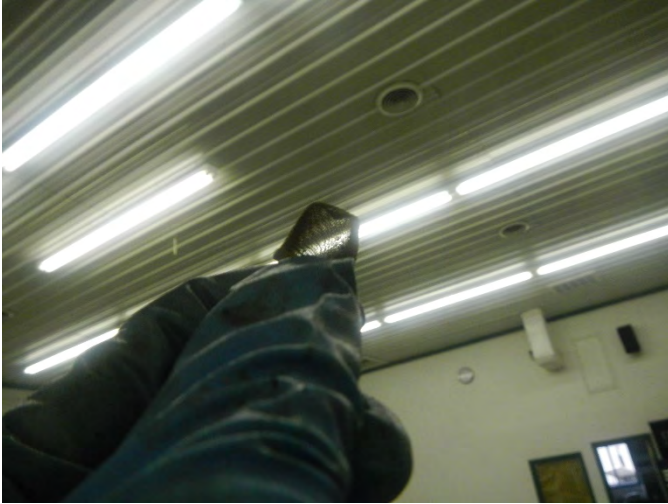
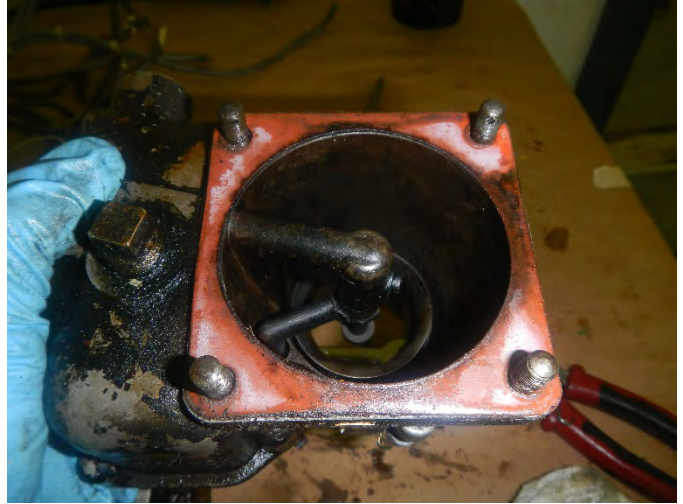
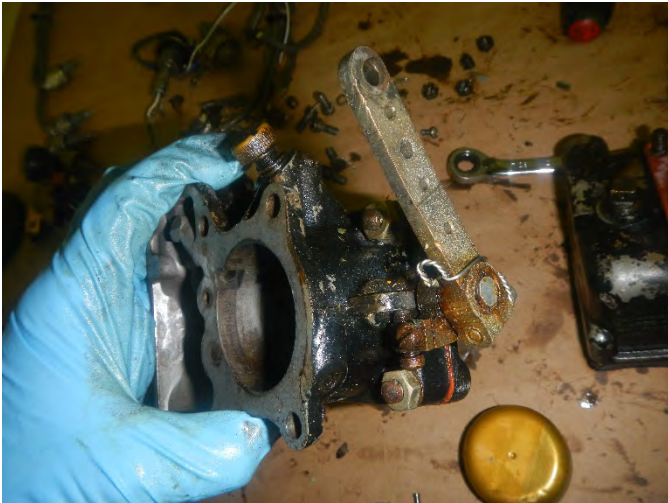
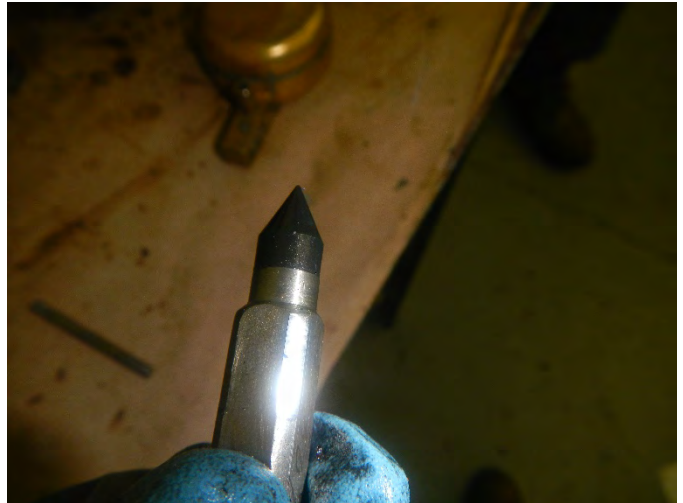
The carburetor mounting flange was fractured and the carburetor with induction airbox were separated from the engine. The inlet fitting was fractured. The carburetor was previously examined at the accident site. Upon disassembly, the NTSB IIC noticed no fuel in the carburetor bowl. During the follow-on examination, the carburetor components were examined with no pre-accident anomalies noted with the inlet screen, needle, float, throttle valve, venturi, or nozzles. Rust colored powder and corrosion was adhering to the bowl walls, but the corrosion was not loose or obstructing any orifices. The carburetor float and needle were reassembled in the carburetor bowl and the bowl was filled with water. With the bowl filled, no fluid leaked out of the fractured inlet fitting. With the bowl only about  $\frac{3}{4}$  full, the float would drop and fluid would leak from the fractured fitting.

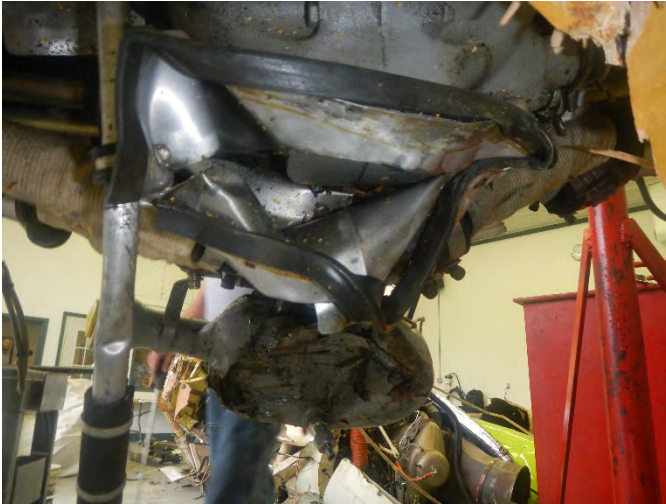
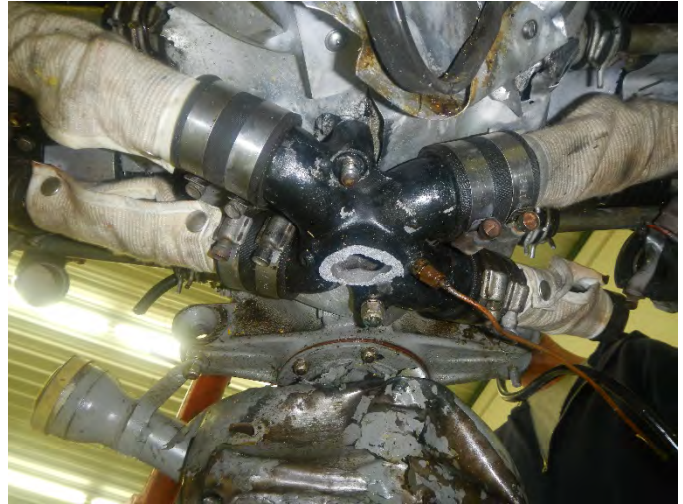
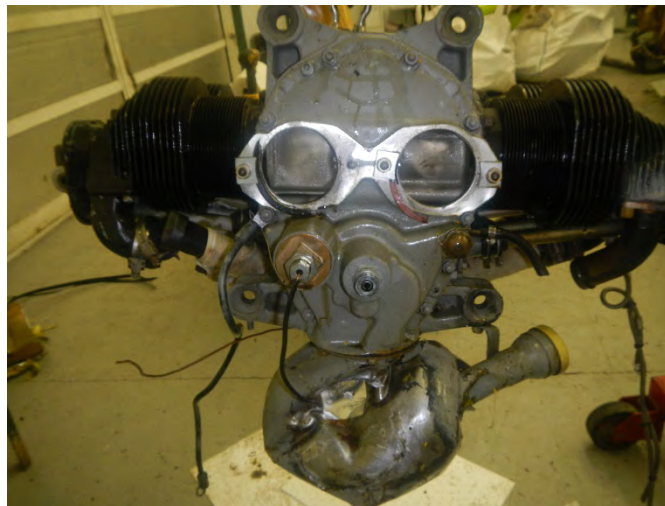
Condition: The oil sump sustained significant deformation damage, but remained attached to the bottom of the engine. No pre-accident anomalies were noted with the sump and all of the engine components appeared well lubricated.

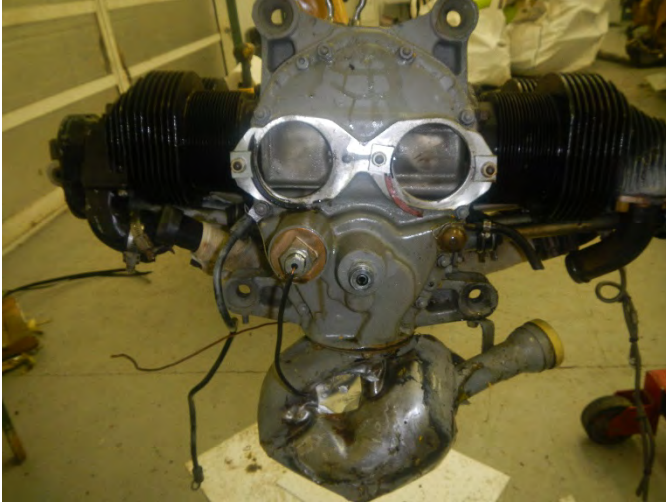
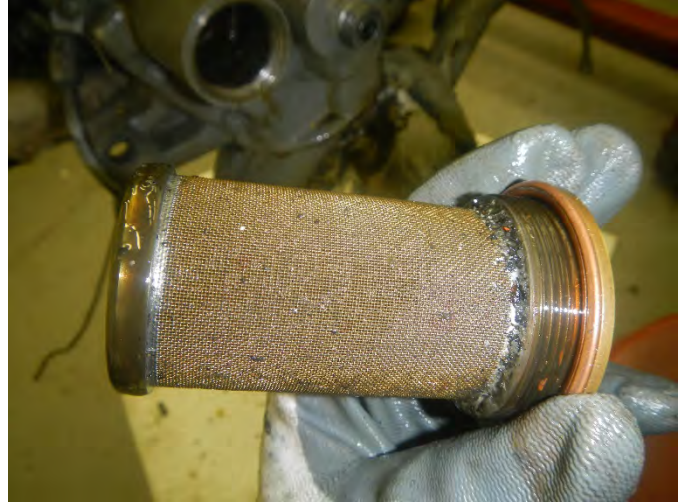
The oil screen was secured in place with safety-wire. Removal of the screen showed small flakes of non-ferrous metallic material as well as dirt and carbon-like material, but the screen was not obstructed or blocked.

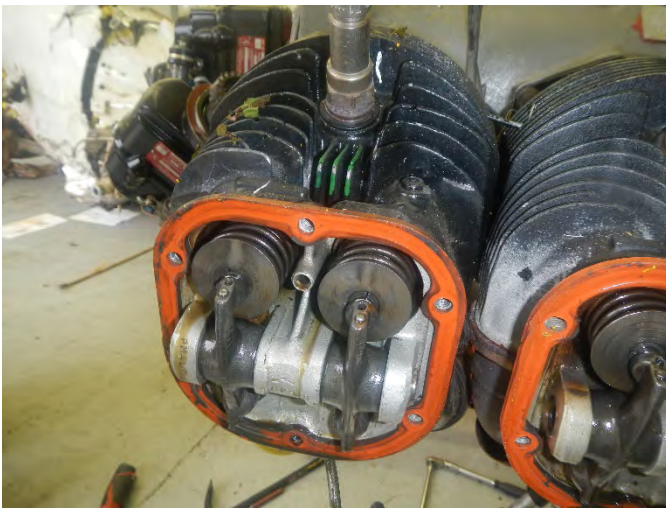
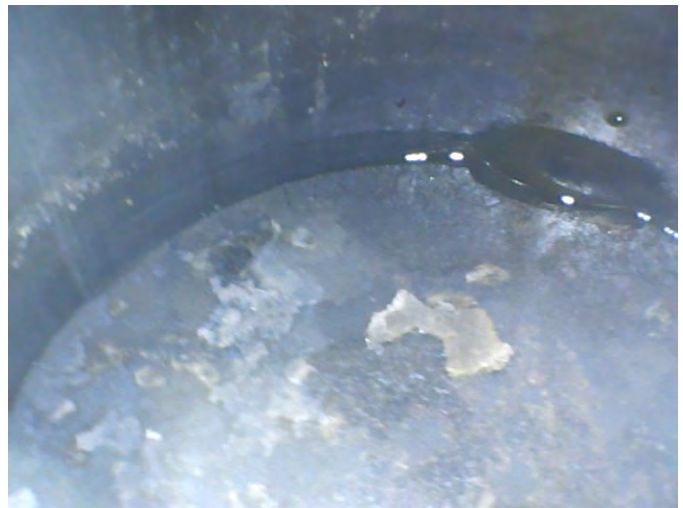
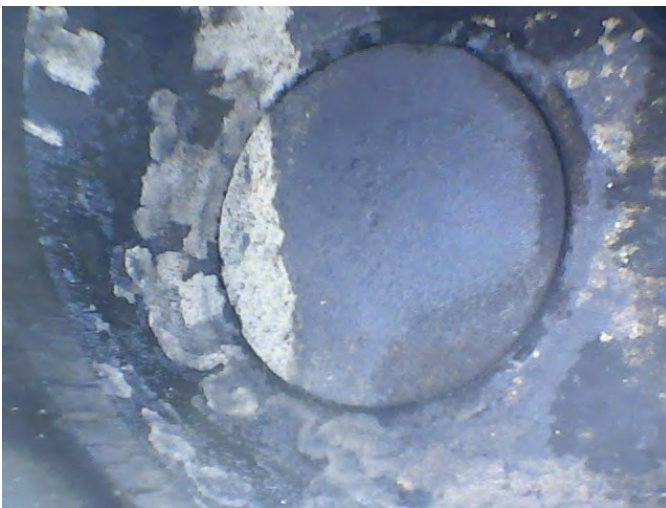
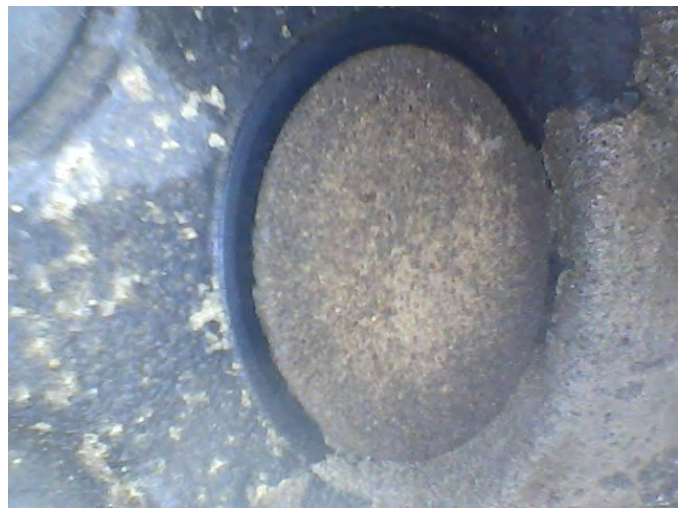
The cylinder remained attached to the crankcase with no external anomalies noted. The rocker cover was removed and the rockers were intact as were the springs. The cylinder was inspected and documented via a lighted borescope with no pre-accident anomalies noted with the piston, barrel, cylinder head, valves or valve seats. The cylinder produced thumb compression and the rockers/valves moved through their normal range during crankshaft rotation.

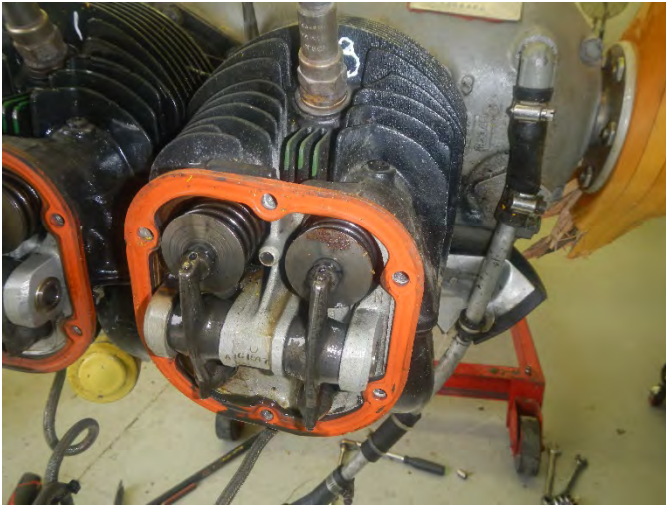
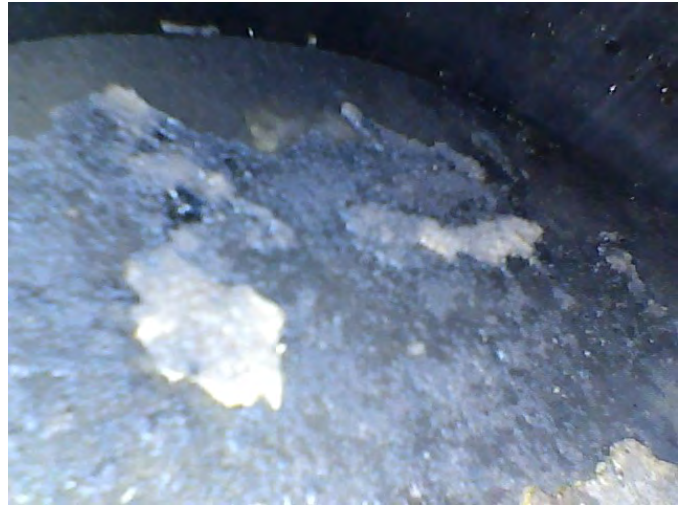
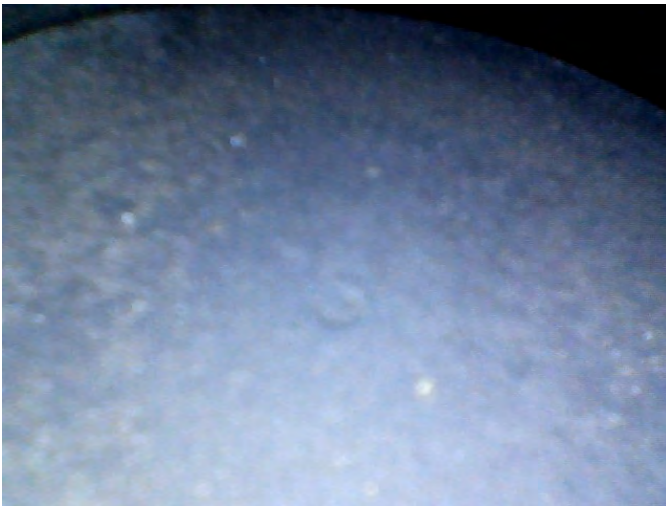
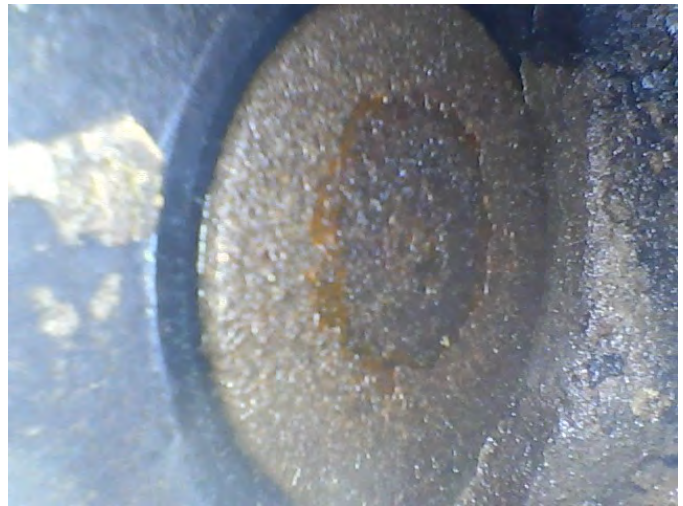
Condition: The cylinder remained attached to the crankcase with no external anomalies noted. The rocker cover was removed and the rockers were intact as were the springs. The cylinder was inspected and documented via a lighted borescope with no pre-accident anomalies noted with the piston, barrel, cylinder head, valves or valve seats. The cylinder produced thumb compression and the rockers/valves moved through their normal range during crankshaft rotation.

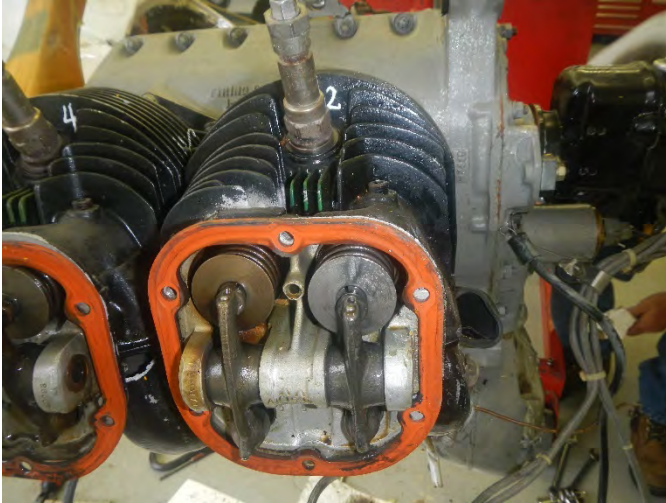
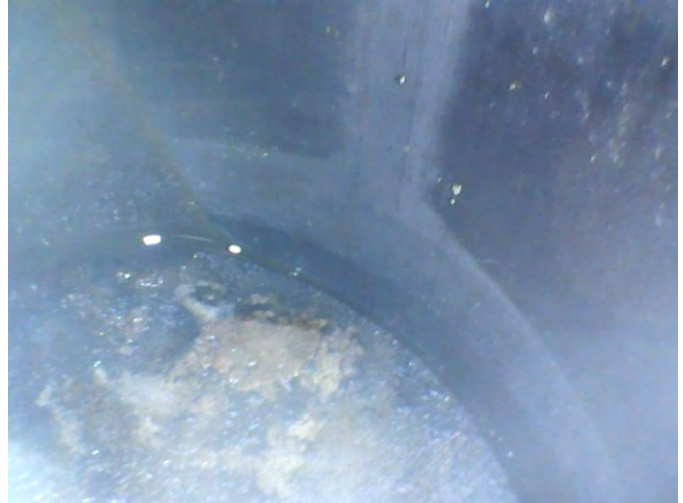
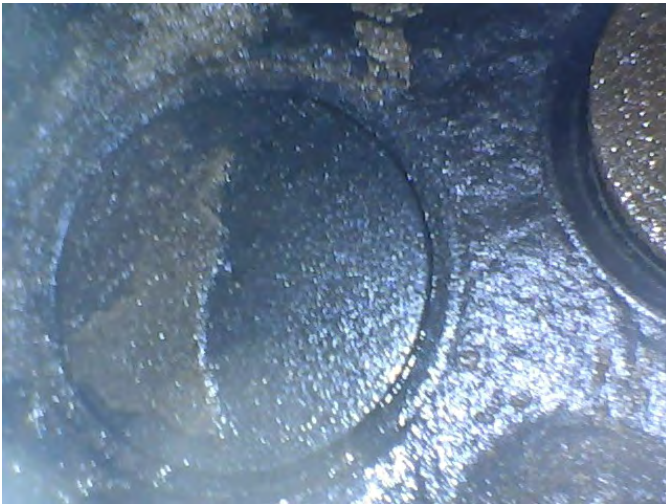
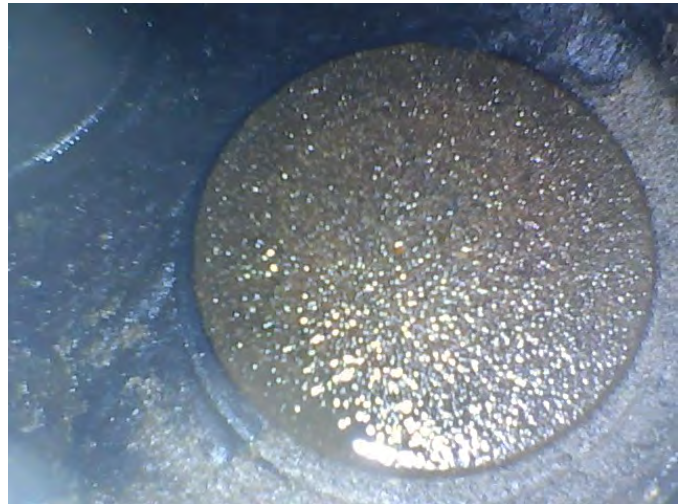
Condition: The cylinder remained attached to the crankcase with no external anomalies noted. The rocker cover was removed and the rockers were intact as were the springs. The cylinder was inspected and documented via a lighted borescope with no pre-accident anomalies noted with the piston, barrel, cylinder head, valves or valve seats. Oil was observed in the cylinder and coated the cylinder components. The cylinder produced thumb compression and the rockers/valves moved through their normal range during crankshaft rotation.

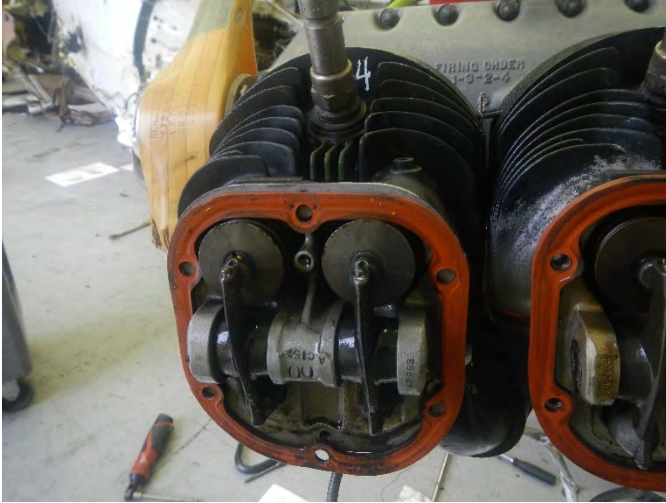
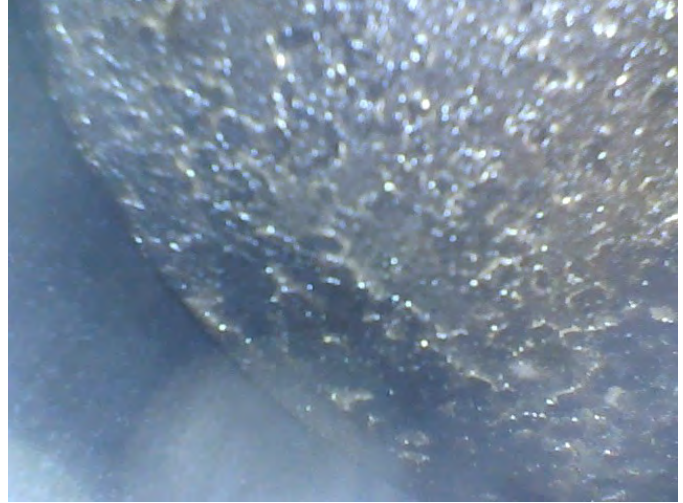
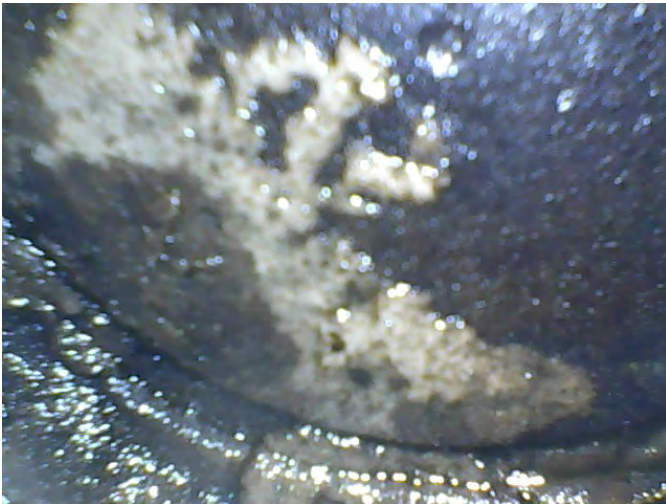
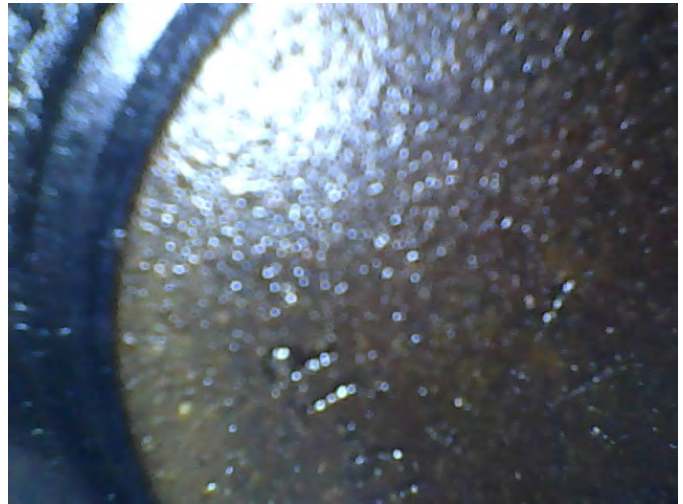
Condition: The cylinder remained attached to the crankcase with no external anomalies noted. The rocker cover was removed and the rockers were intact as were the springs. The cylinder was inspected and documented via a lighted borescope with no pre-accident anomalies noted with the piston, barrel, cylinder head, valves or valve seats. Oil was pooled in the cylinder and coated the cylinder components. The cylinder produced thumb compression and the rockers/valves moved through their normal range during crankshaft rotation.

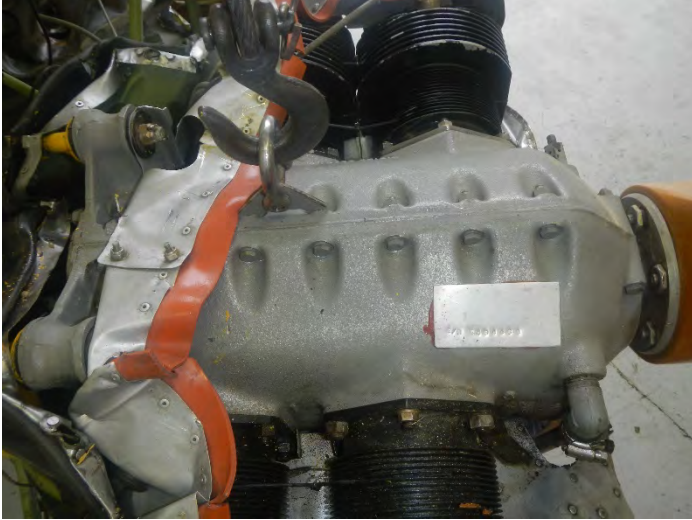
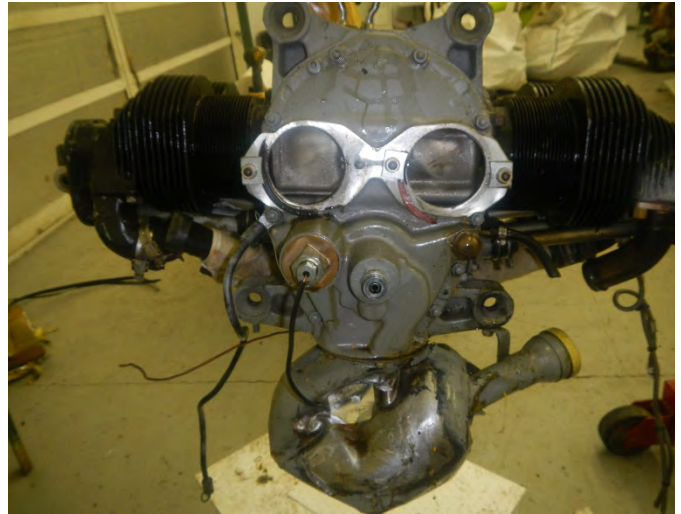
Condition: The crankcase halves and accessory case remained intact and secured to each other. No external pre-accident anomalies were noted. Rotation of the crankshaft did not result in any binding from the main bearings.

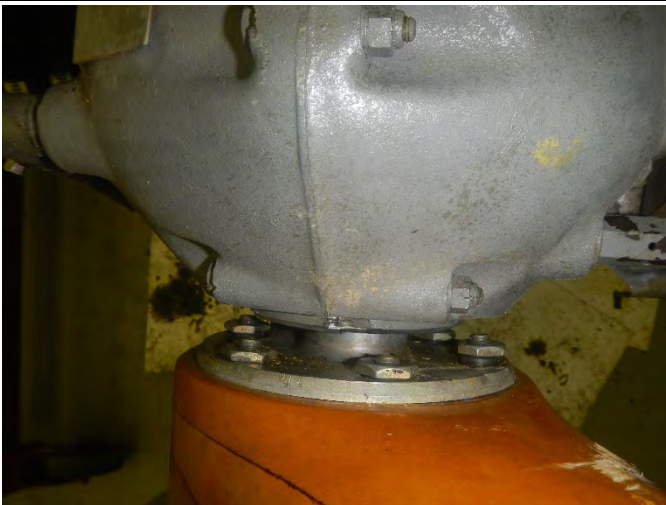
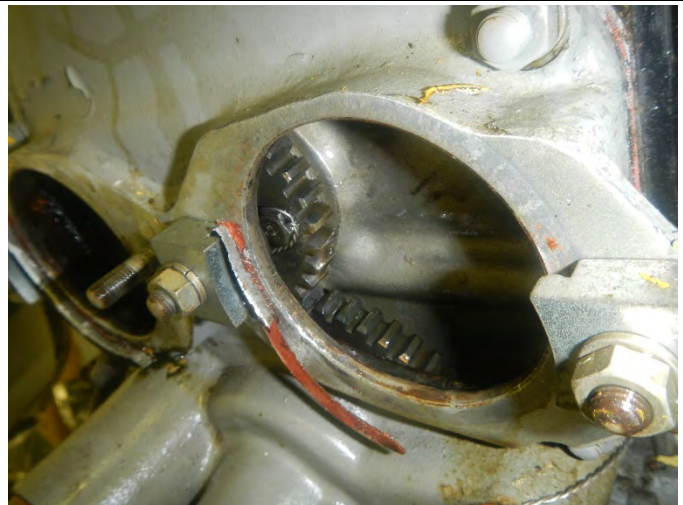
Condition: The crankshaft was not observed in its entirety, but continuity was confirmed from the propeller aft to the accessory end, and out to each connecting rod and piston. No pre-accident anomalies were noted with the crankshaft or crankshaft gear.

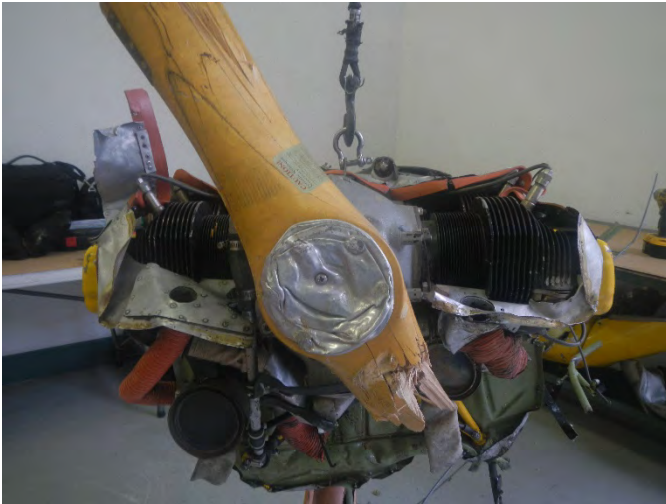
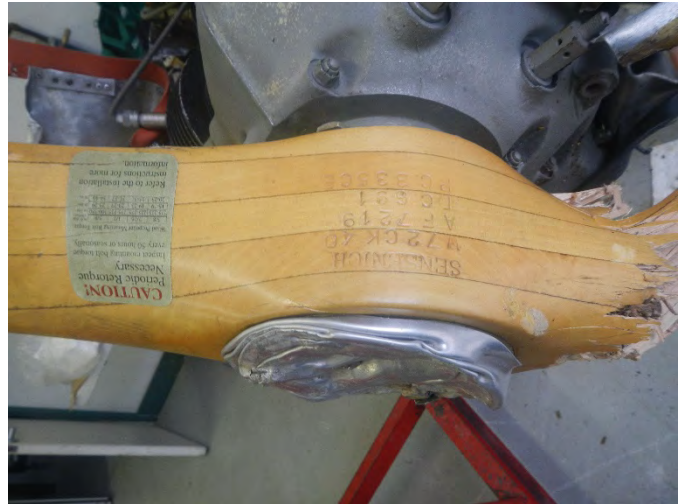
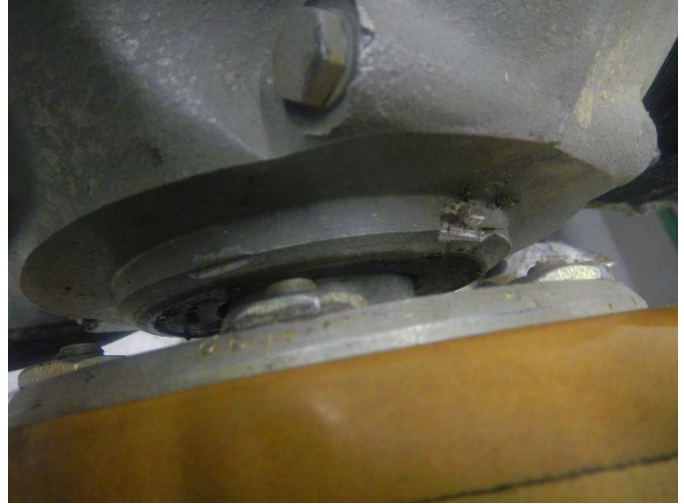
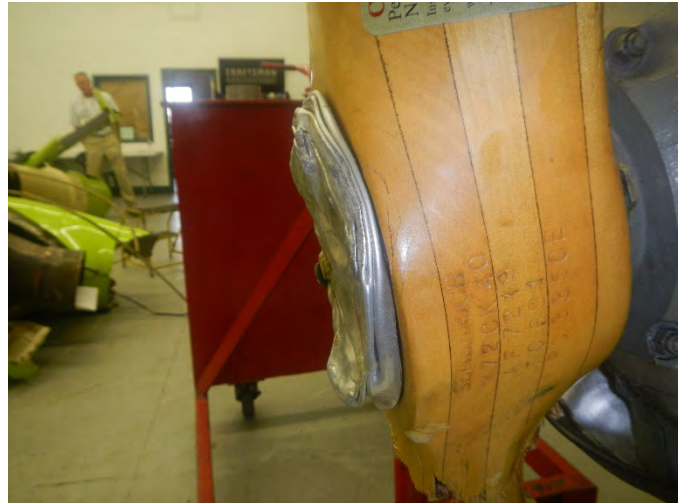
| Condition: | The fixed-pitch wooden propeller remained attached to the crankshaft. Both blades were fractured, with the fractures of one blade bent aft. The propeller spinner dome was flattened aft symmetrically against the hub. The propeller bolt nuts left an impression on the crankcase nose seal area with no sign of rotational smearing noted in the impressions. | | |
