# NATIONAL TRANSPORTATION SAFETY BOARD

## MATERIALS LABORATORY FACTUAL REPORT

Report No. 19-083

Place : Middletown, New York  
Date : May 5, 2018  
Vehicle : Aeronca 7AC, N84396  
NTSB No. : ERA18FA141  
Investigator : Doug Brazy, AS-ERA

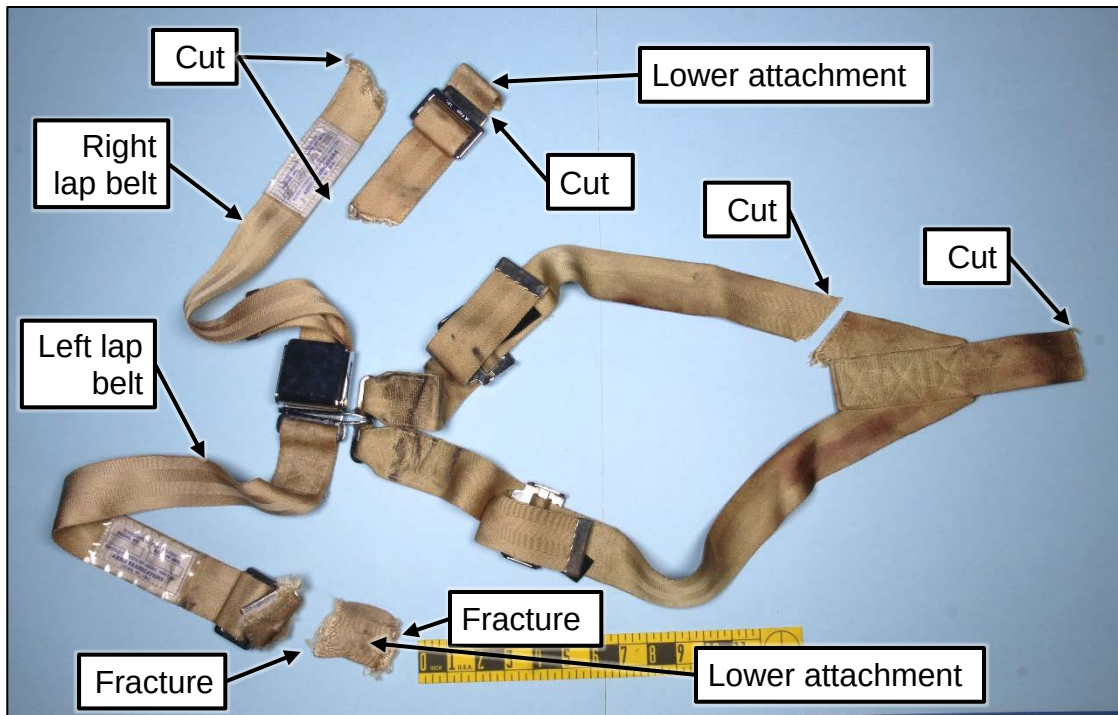
The front seat belt assembly was received in three pieces as shown in figure 1. The upper aft portion of the shoulder harness with the upper attachment hardware was not received. The webbing at the aft end of the shoulder harness had a straight end face with limited deformation to the fibers, and individual fiber ends had a smooth flat appearance, features consistent with a cut end. Similar features were observed on the separation in the right strap of the shoulder harness and in the right lap belt at the lower attachment location. The right lap belt was separated into two pieces between the white data label and the length adjustment hardware, and the fracture had a more jagged appearance compared to the other cut surfaces. However, the individual fiber ends had

smooth flat appearances consistent with a cut end. The locations of the cut surfaces of the front seat belt assembly are indicated in figure 1.

The front left lap belt was separated at two locations at the lower attachment location as shown in figure 1. The separations occurred on either side of the lower attachment location adjacent to the length adjustment hardware. Fibers at both locations were displaced and splayed out consistent with overstress fracture. Optical images showing closer views of typical fiber fracture features are shown in figure 7. Many of the fiber ends had a mushroom appearance consistent with overstress fracture under a high rate of loading. The fabric of the lap belt appeared smooth and silky with no evidence of preexisting wear, stains, cuts, warping, or abrasions.

Figure 1. Overall view of the front seat belt assembly.

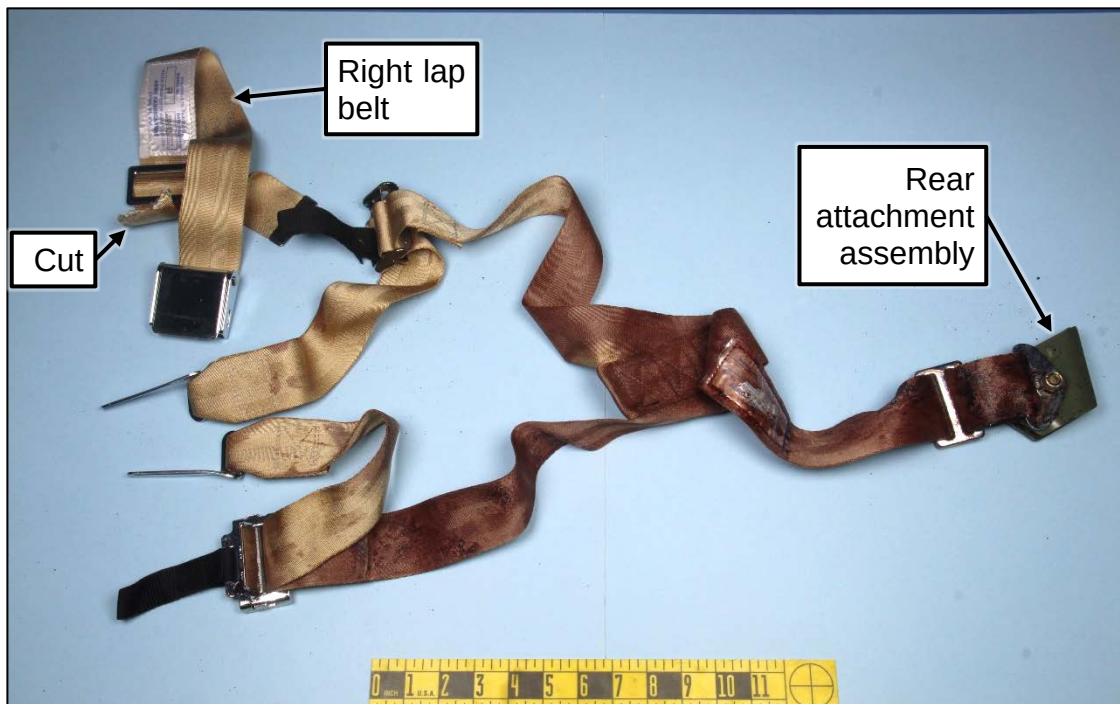
The rear shoulder harness assembly was received intact with the intact rear attachment assembly separated from the airframe as shown in figure 2. The rear right lap belt was received as shown, and the cut end indicated in figure 2 was received with markings indicating that it had been cut. The lower attachment end of the right lap belt and the entire left lap belt were not included with the submitted components from the rear assembly.

Figure 2. Overall view of the rear seat belt assembly with attached rear shoulder harness rear attachment assembly.

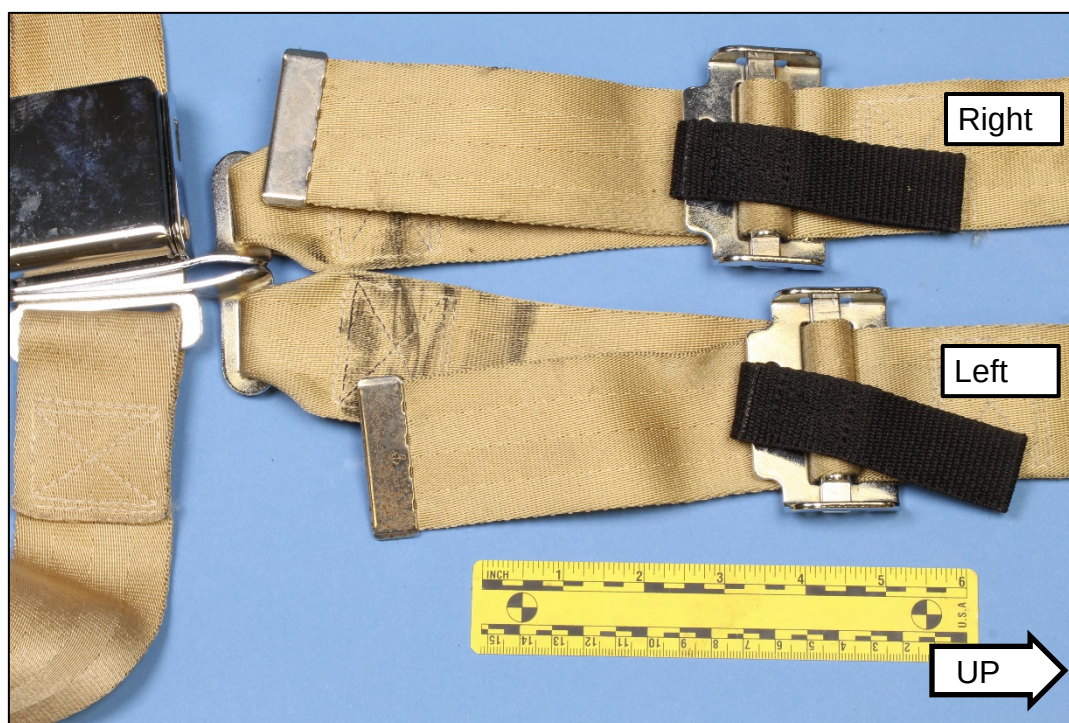
The length adjuster for the left and right straps on the front shoulder harness were received positioned at approximately  $\frac{1}{2}$  the length of the adjustable portion such that the loose end was 6 inches long and 5.5 inches long on the right and left sides, respectively (see figure 3). Buckle attachment fittings on the lower end of the front right and left shoulder harness straps were bent as shown in figures 4 and 5. The upper end of the fitting on the right strap shown in figure 4 was bent inward (toward the harness centerline) 11.3 degrees relative to the lower end, and the upper end of the fitting on the left strap shown in figure 5 was bent inward 13.6 degrees relative to the lower end.

Figure 3. Length adjusters on the front right and left shoulder harness straps.

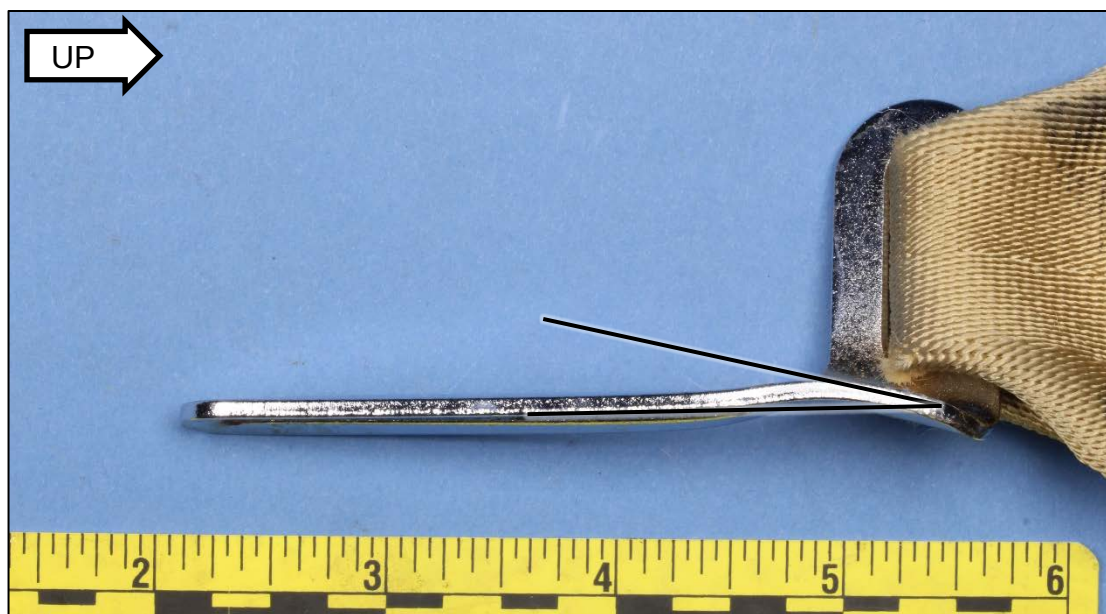
Figure 4. Buckle attachment fitting on the front right shoulder harness strap. The lines indicate the angle of bending.

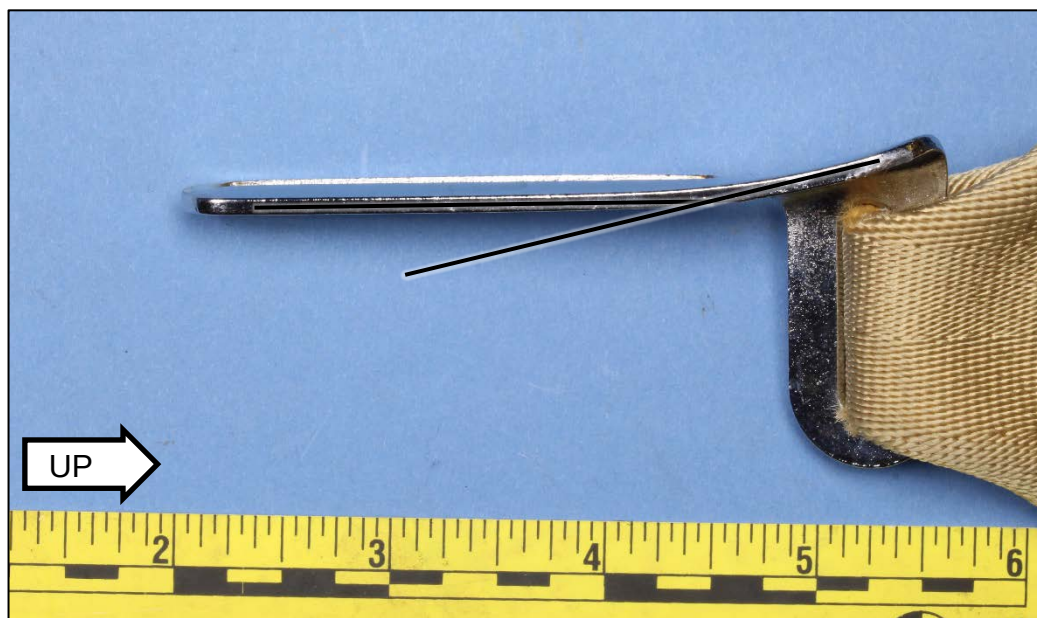
Figure 5. Buckle attachment fitting on the front left shoulder harness strap. The lines indicate the angle of bending.

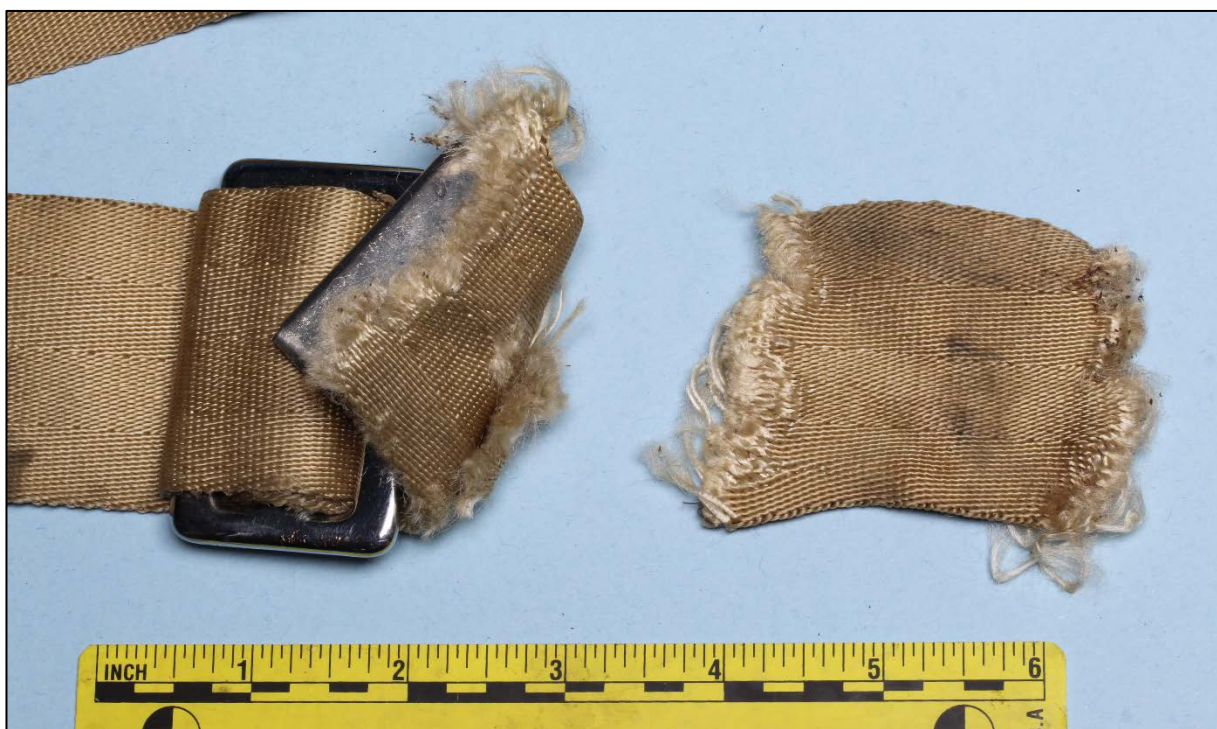
Figure 6. Closer view of fractures at the anchor point for the front left lap belt.

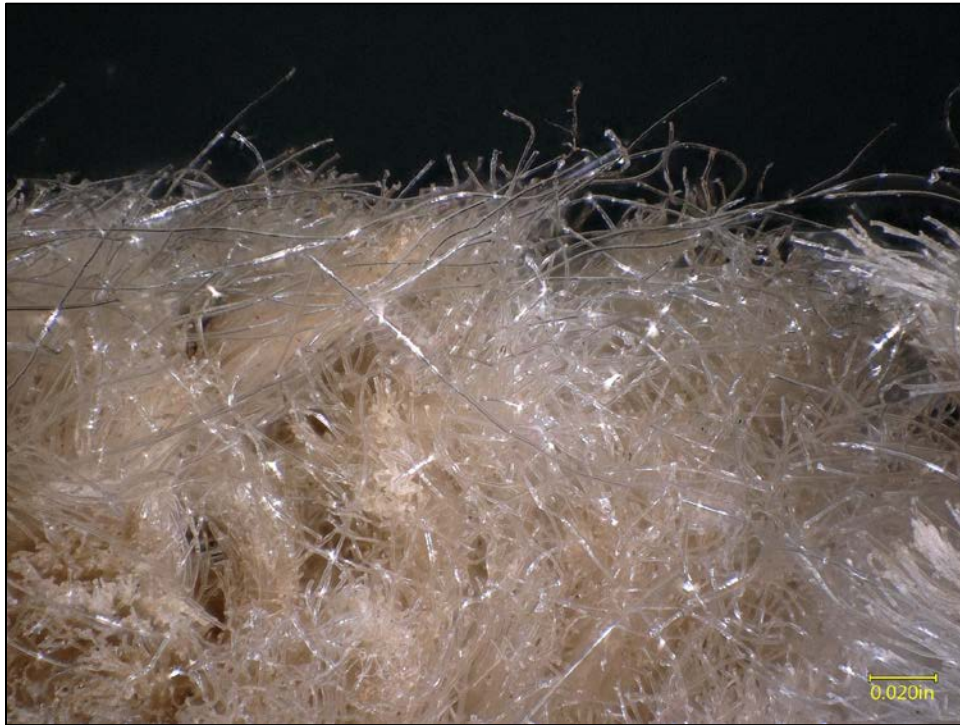
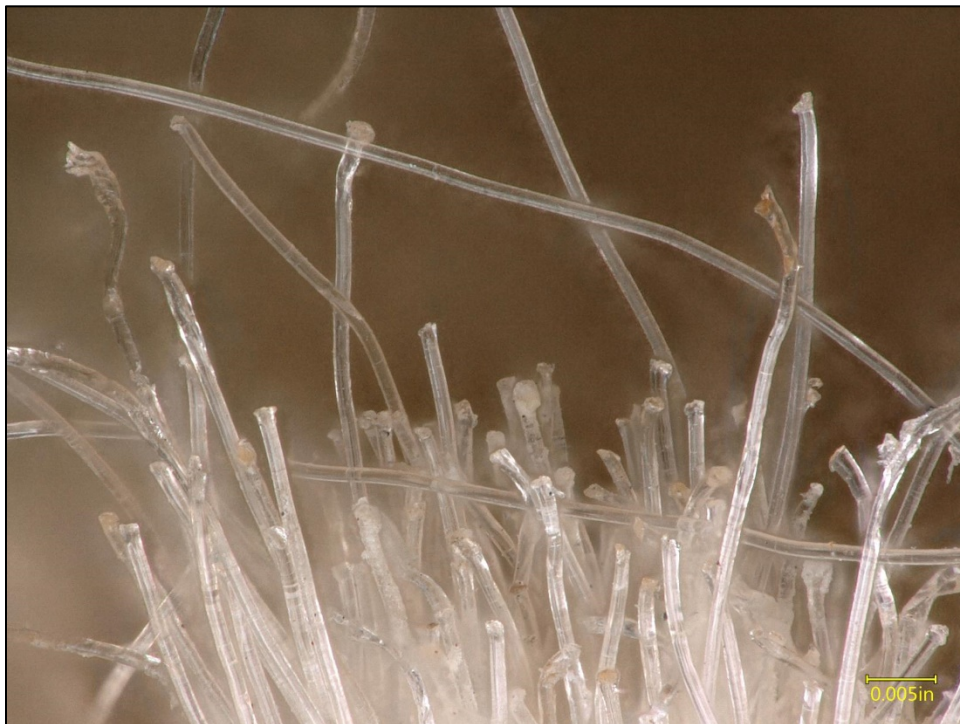
Figure 7. Optical images of typical fractured fibers for the front left lap belt fractures shown in figure 6.

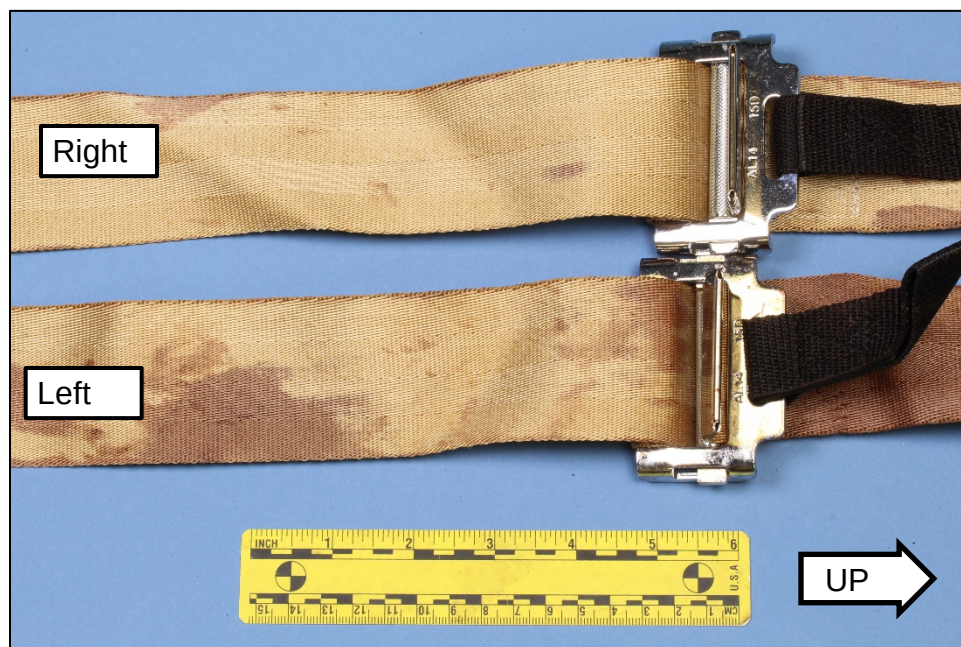
The length adjuster for the left and right straps on the rear shoulder harness were received positioned at the full extent of the adjustment such that the metal tip of the loose end was adjacent to the adjuster (see figure 8). Buckle attachment fittings on the lower end of the rear left and right shoulder harness straps were bent as shown in figures 9 and 10. The upper end of the fitting on the right strap shown in figure 9 was bent inward 14.9 degrees relative to the lower end. The upper end of the fitting on the left strap shown in figure 10 was only slightly bent compared to the others with the upper end bent inward 3.2 degrees relative to the lower end.

Figure 8. Length adjusters on the rear right and left shoulder harness straps.

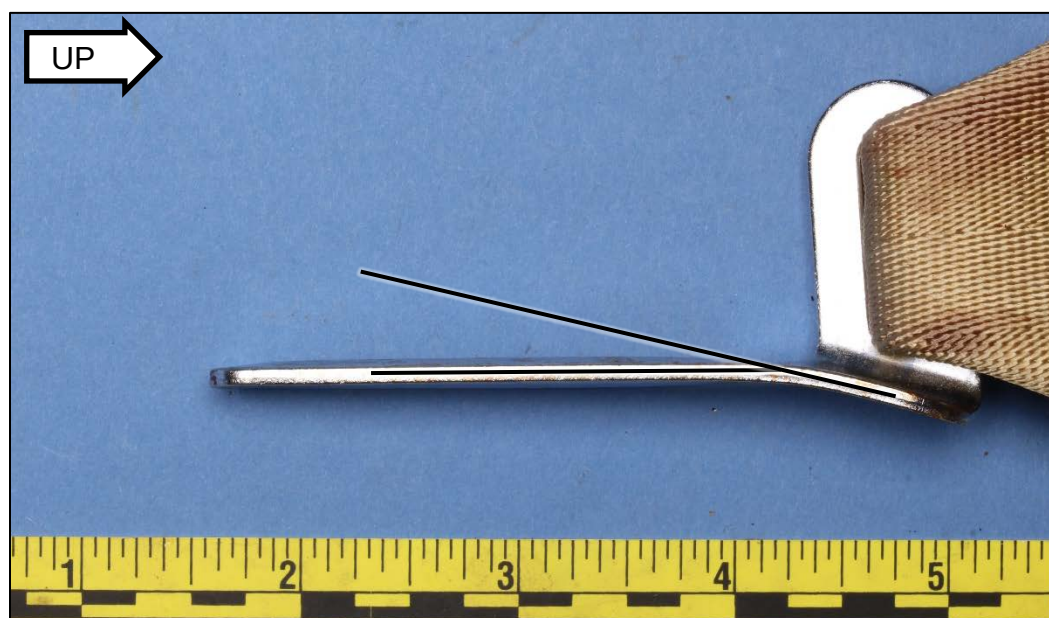
Figure 9. Buckle attachment fitting on the rear right shoulder harness strap. The lines indicate the angle of bending.

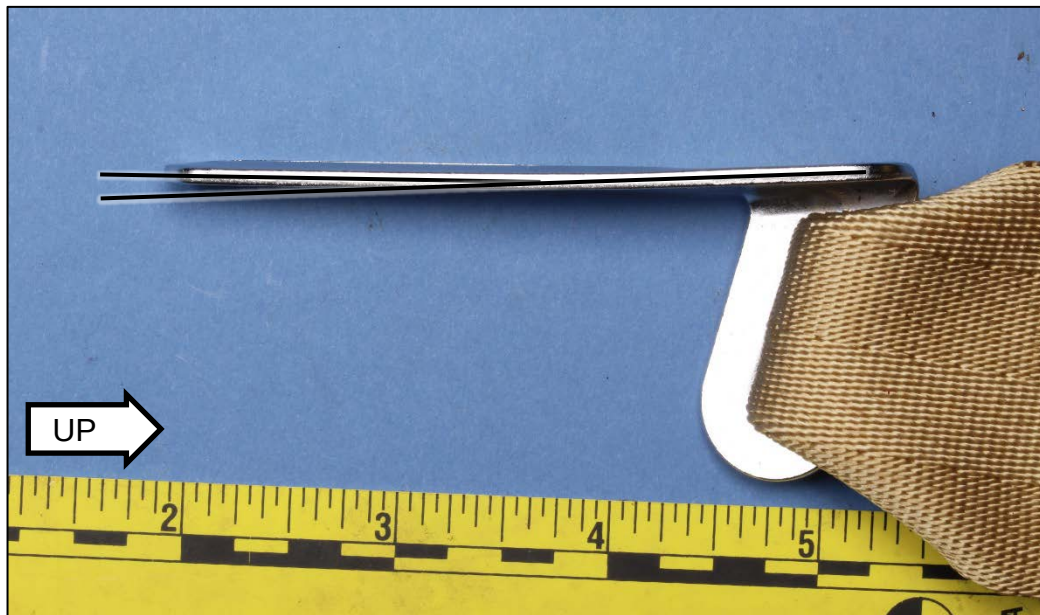
Figure 10. Buckle attachment fitting on the rear left shoulder harness strap. The lines indicate the angle of bending.

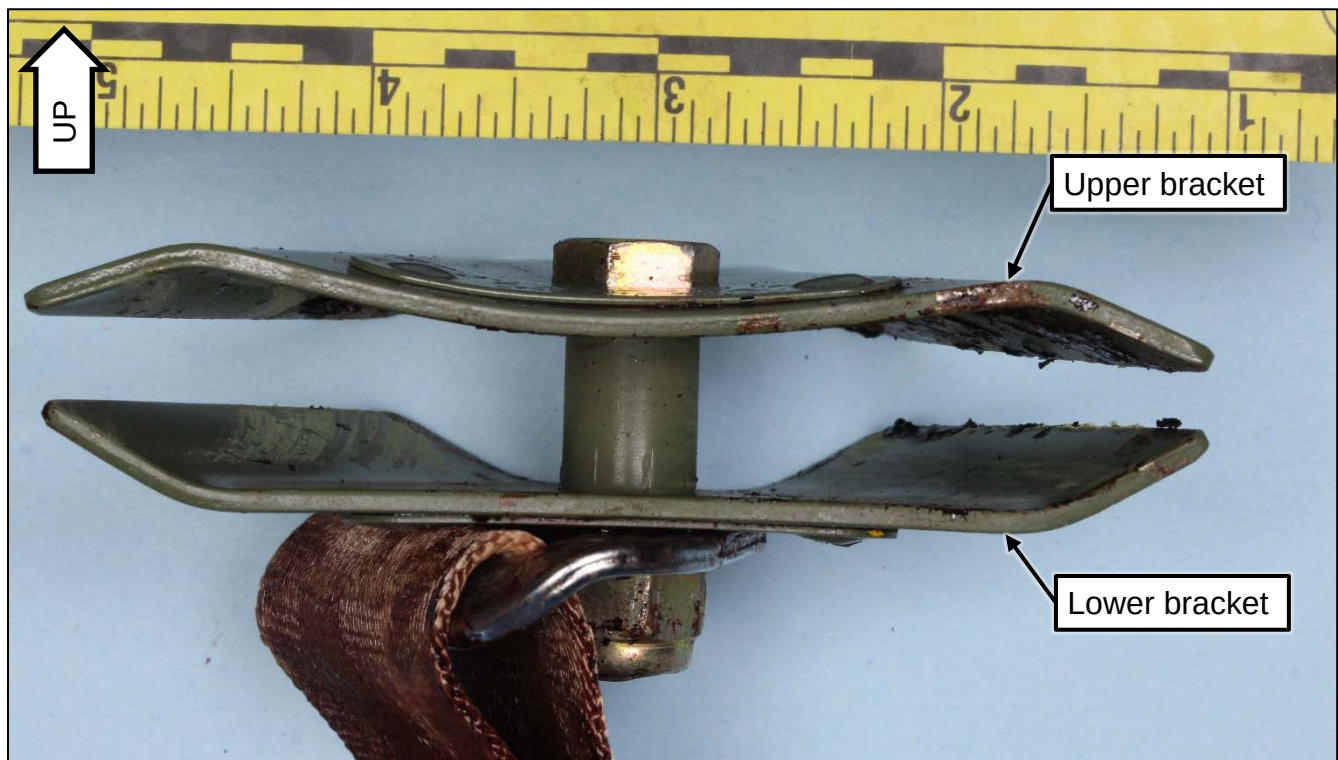
A close view of the rear shoulder harness rear attachment assembly is shown in figure 11. For comparison, a diagram of the rear attachment assembly from a similar viewpoint included in installation instructions provided by a representative of the Wag-Aero Group is shown in figure 12.<sup>1</sup> As installed, the upper and lower brackets of the rear attachment assembly are fastened around angular structural tubing near the location where two angled members meet. According to installation instructions and as shown in figure 12, the attachment bolt for the assembly is installed with the head against the

triangular fitting on the lower side of the assembly and a washer and nut installed against the bracket on the upper side of the assembly. As shown in figure 11, the head of the attachment bolt was on the upper side of the assembly as installed in the accident airplane. No washer was included in the assembly as installed.

As shown in the view of the rear attachment assembly presented in figure 11, the right and left sides of the upper bracket were bent upward relative to the center of the bracket. On the lower side of the assembly, the triangular fitting was rotated such that the edge representing the hypotenuse of the triangle was approximately parallel to the left edges of the attachment brackets.

Figure 11. Rear shoulder harness rear attachment assembly as viewed looking aft.

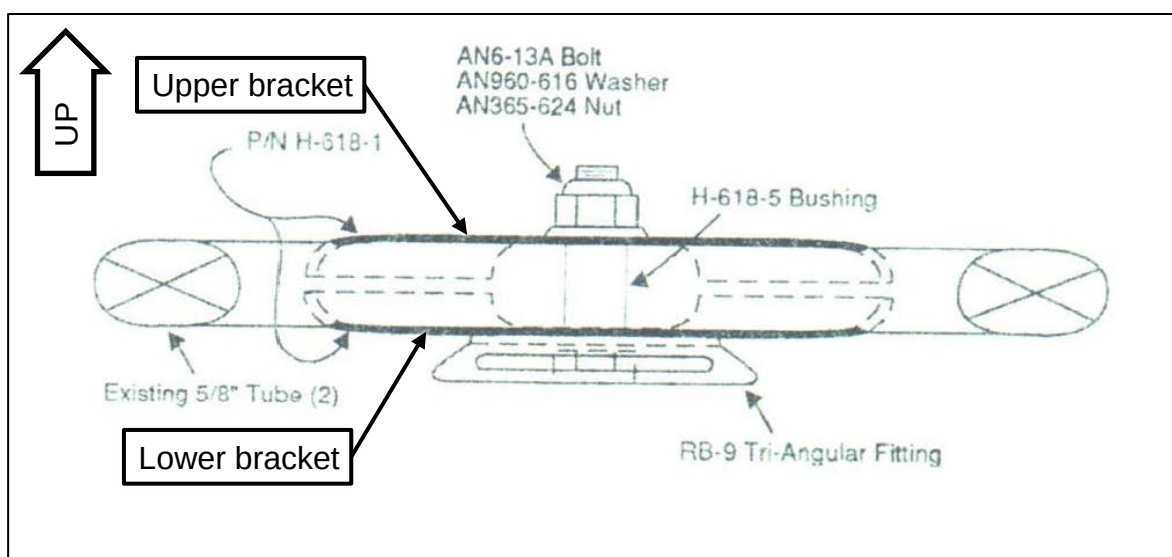
Figure 12. Diagram from the shoulder harness installation instructions showing the rear shoulder harness rear attachment assembly as viewed looking aft. (Instructions provided by Wag-Aero Group.)

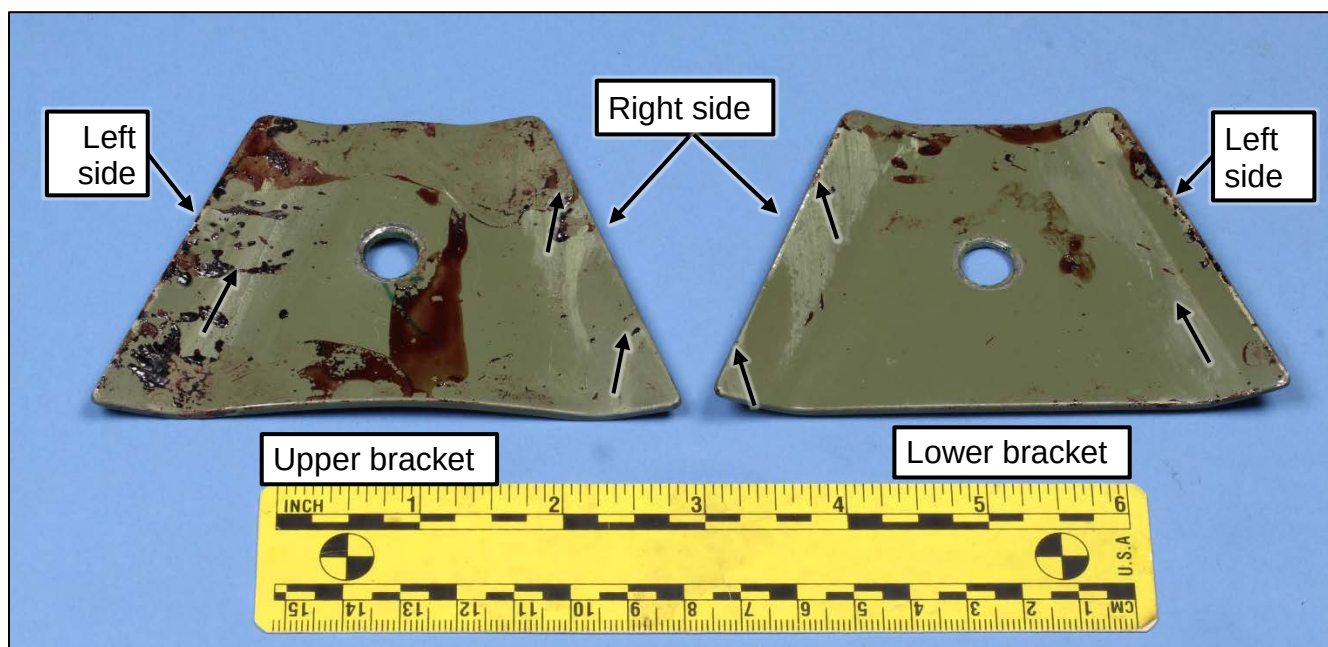
Next, the rear attachment assembly was disassembled by unscrewing the nut from the bolt. A photograph of the interior surfaces of the upper and lower brackets after disassembly are shown in figure 13. Sliding contact marks were observed on the surfaces corresponding to contact and relative motion between the brackets and the airframe. Unlabeled arrows in figure 13 indicate the relative direction of the sliding contact. The sliding contact marks on the left side of the brackets were approximately parallel to left edge of the bracket, and the marks on the right side generally turned toward the right edge. The overall pattern of the witness marks was consistent with the brackets sliding forward along the left airframe tube while the right tube slipped between the right edges of the brackets.

Figure 13. Interior faces of attachment brackets from the rear shoulder harness rear attachment assembly after disassembly. Unlabeled arrows indicate the relative direction of motion for the mating structural frame in areas showing sliding contact marks.
