# Continental Motors

## ENGINE EXAMINATION REPORT

| ENGINE MODEL | IO-470-K |
| AIRCRAFT REGISTRATION | N486T |

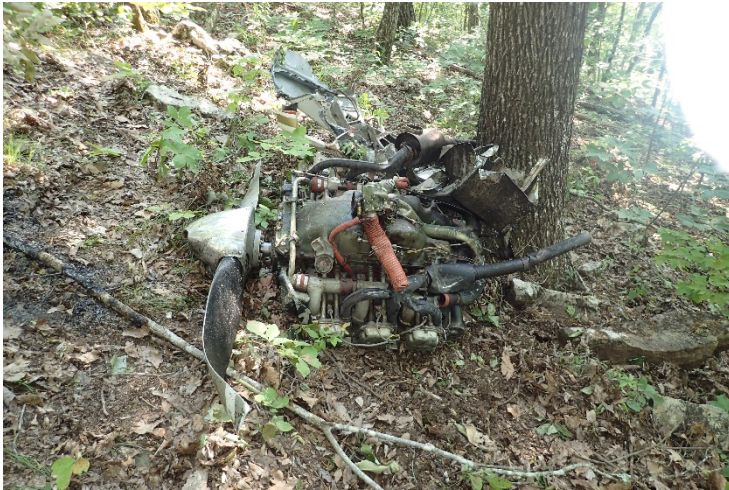
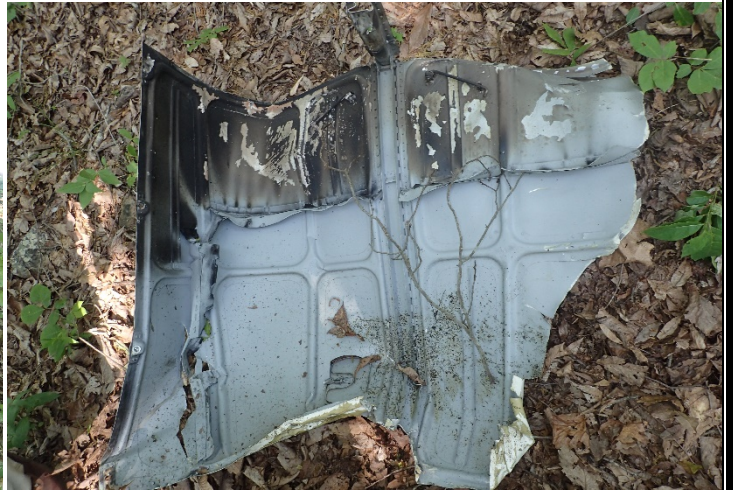
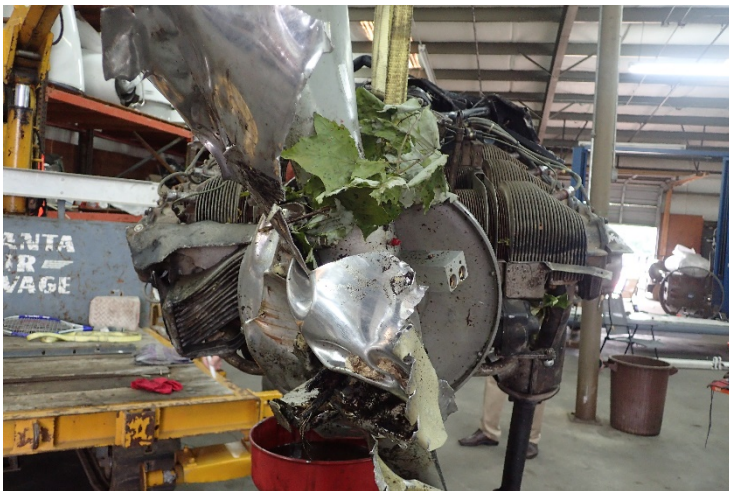
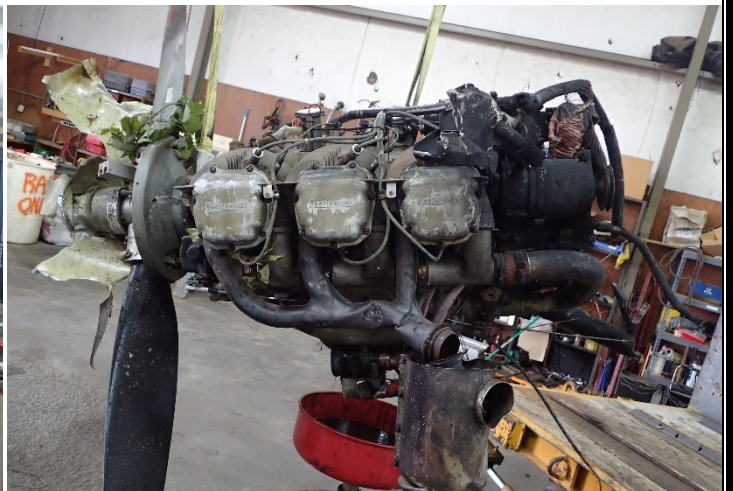
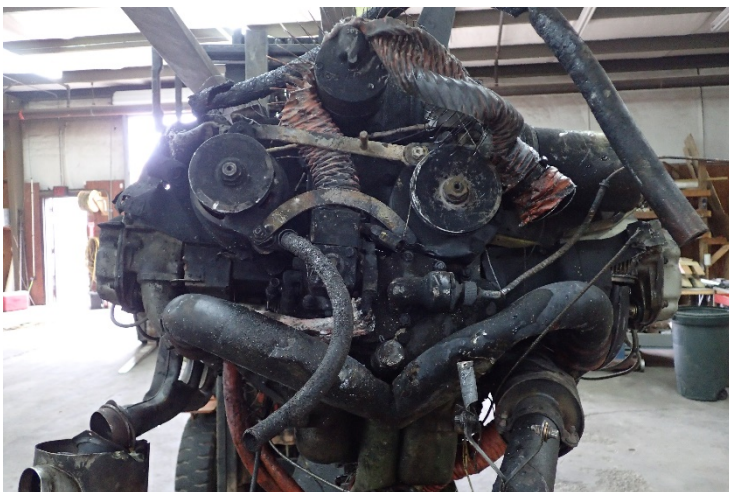
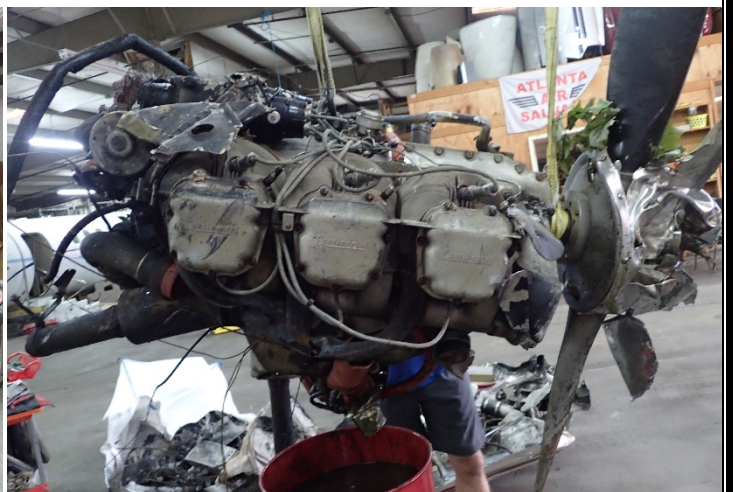
The engine came to rest upside down and was resting against a tree several feet away from the primary wreckage and post-crash fire site. The engine sustained impact damage signatures and displayed thermal damage signatures to the aft portion of the engine; the area of thermal damage corresponded with the thermal damage and sooting patterns on the upper cowling. The cowling displayed soot streaking towards the aft of the cowling.

The engine was transported to and inspected at Atlanta Air Recovery in Griffin, Georgia. The crankcase remained intact and displayed minor impact damage signatures and significant thermal damage signatures to the aft portion of the crankcase. The propeller flange remained attached to the rest of the crankshaft and there were no visible cracks noted in the crankshaft. All six cylinders displayed minor impact damage signatures and cylinders #1, and #2 displayed minor soot discoloration towards the aft of the cylinders.

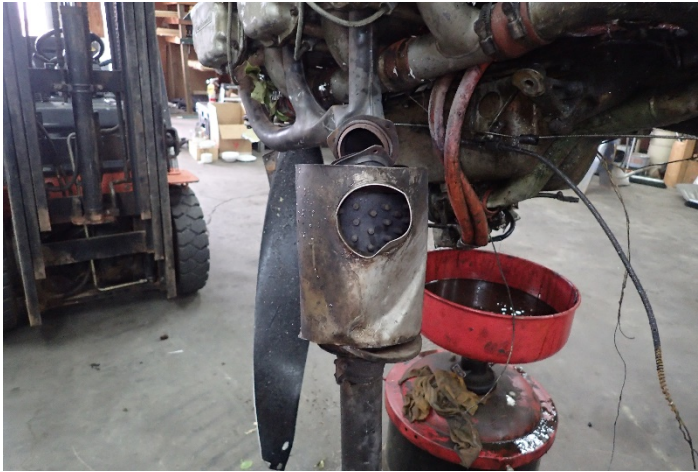
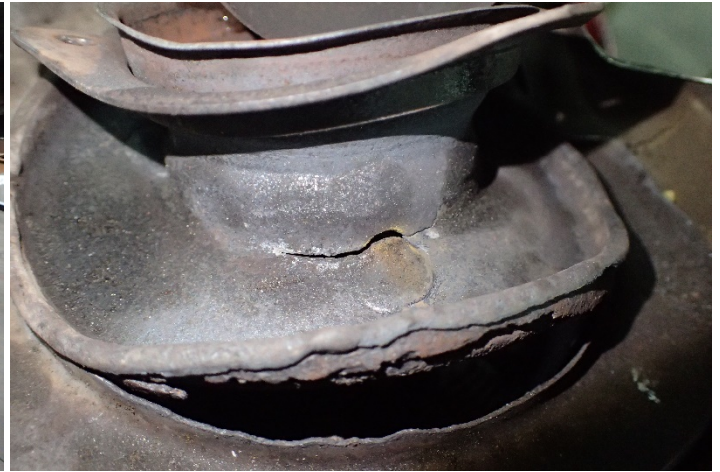
#### EXHAUST SYSTEM

**Condition:** The exhaust system remained attached to the engine and displayed impact damage signatures. The left side exhaust muffler/heat exchanger assembly displayed several cracks in multiple locations. The left side exhaust muffler/heat exchanger was retained by the NTSB to be examined by the NTSB materials laboratory.

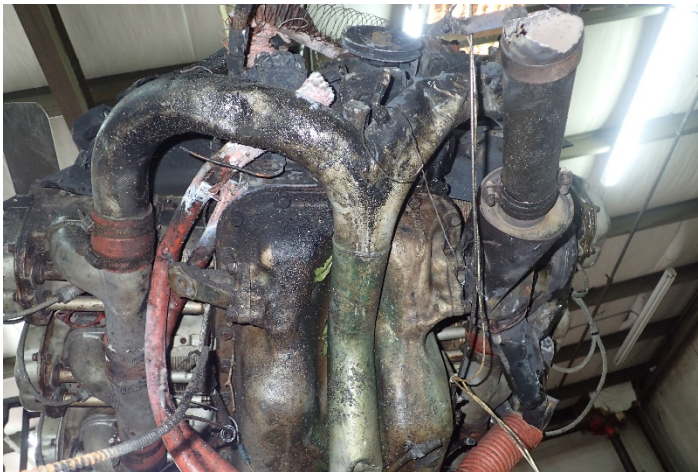
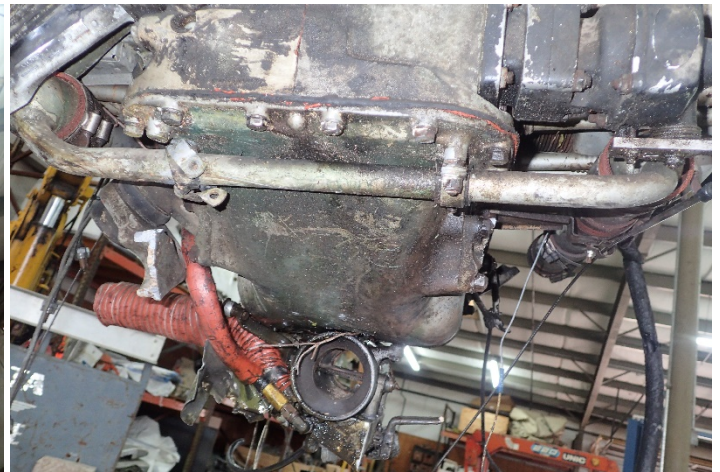
#### INDUCTION SYSTEM

**Condition:** The induction system displayed impact damage signatures and some thermal damage signatures; the thermal damage signatures were concentrated to the induction Y-tube towards the aft of the engine. There were no signs of induction leaks or blockages noted.

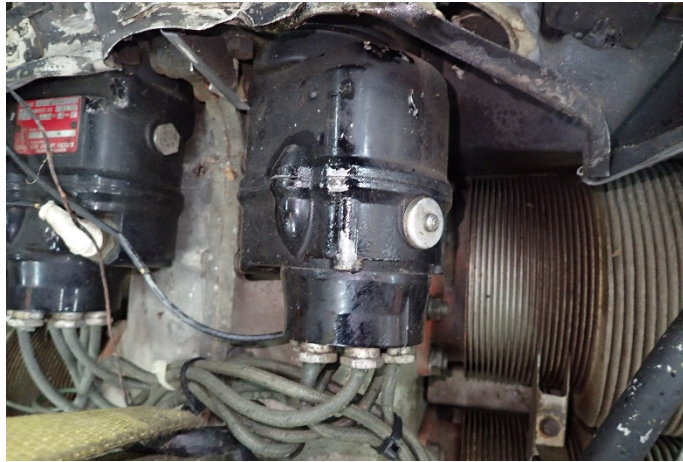
**PAGE 7 of 29****IGNITION SYSTEM****LEFT MAGNETO**

The magneto remained attached to its installation point and displayed minor impact damage signatures; there were no thermal damage signatures noted to the magneto. During crankshaft rotation it was noted that the impulse coupling would operate normally. The magneto was capable of creating a spark to each ignition lead in the correct order and was in sync with the right magneto.

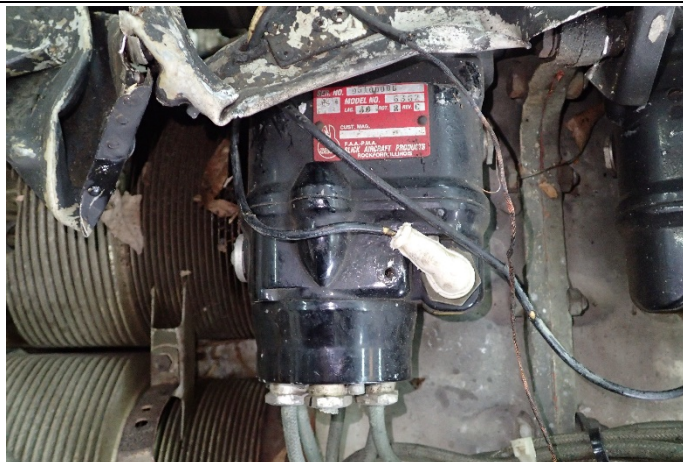
**RIGHT MAGNETO**

The magneto remained attached to its installation point and displayed minor impact damage signatures; there were no thermal damage signatures noted to the magneto. During crankshaft rotation it was noted that the impulse coupling would operate normally. The magneto was capable of creating a spark to each ignition lead in the correct order and was in sync with the left magneto.

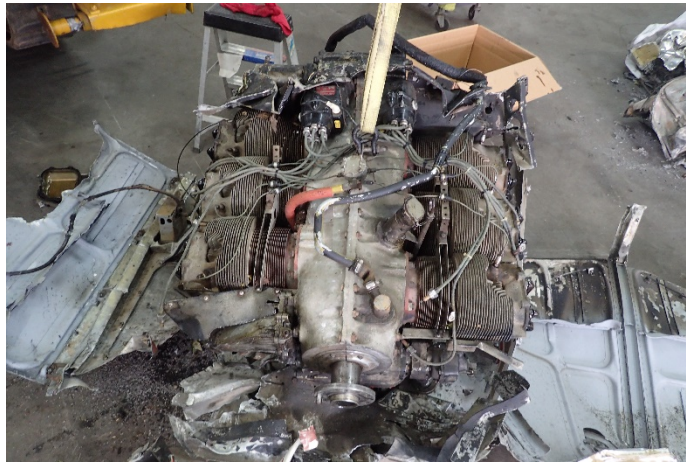
## IGNITION HARNESS

The ignition leads remained attached to the magnetos and to the spark plugs. Several of the ignition leads displayed impact damage signatures and were partially severed. There were no signs of thermal damage to the ignition leads. There were no anomalies noted with the ignition harness.

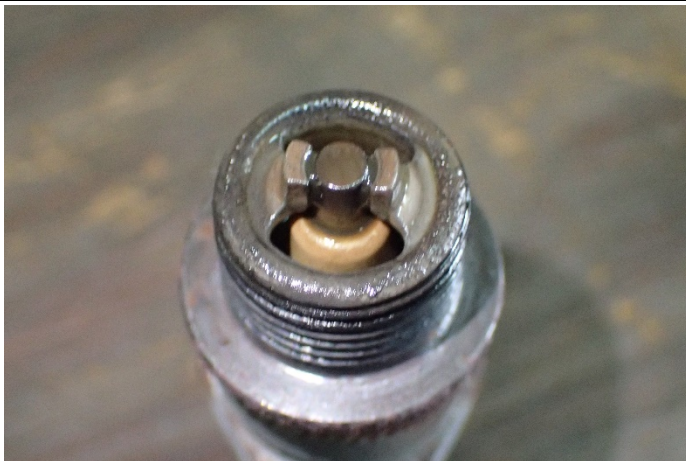
#1 Top

All of the spark plugs remained in their cylinders. The top spark plugs were removed and the electrodes were visually inspected; the electrodes displayed normal operating and wear signatures. The bottom spark plugs were inspected using a lighted borescope. The #1 spark plug was submersed in engine oil; the rest of the electrodes displayed normal operating and wear signatures.

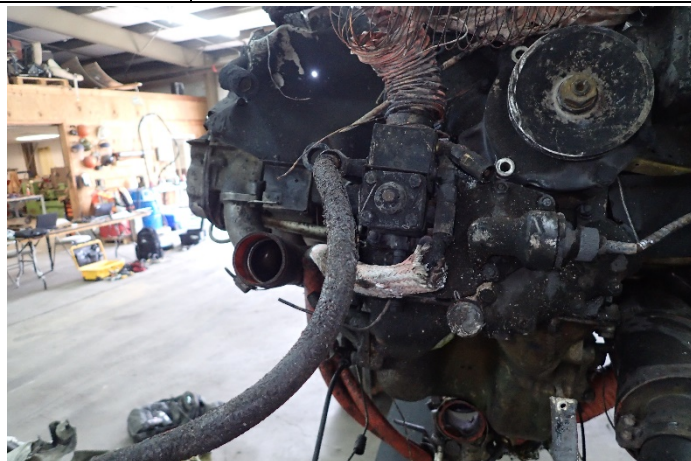
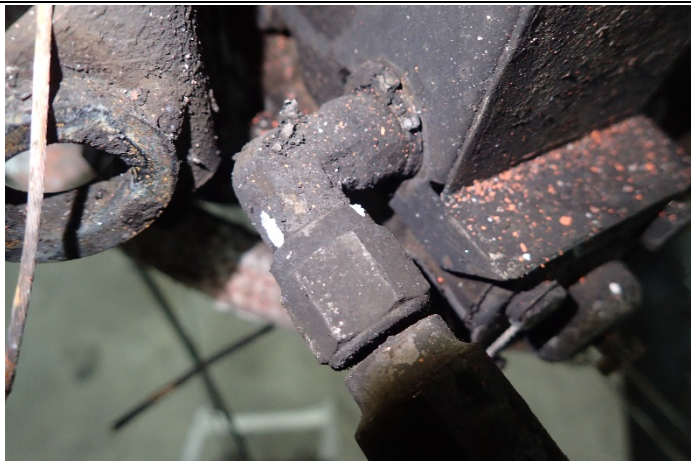
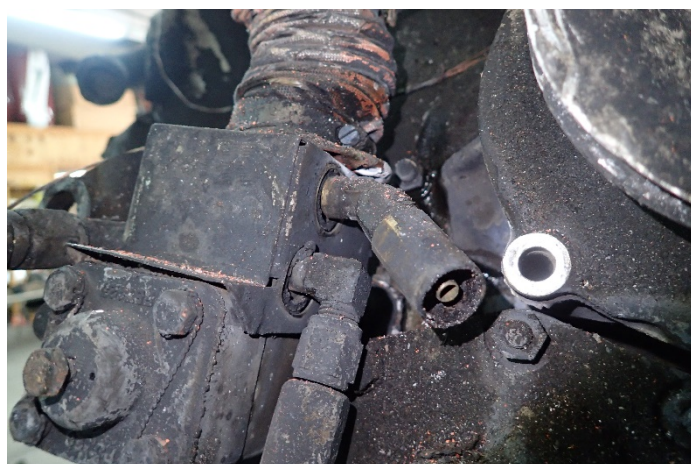
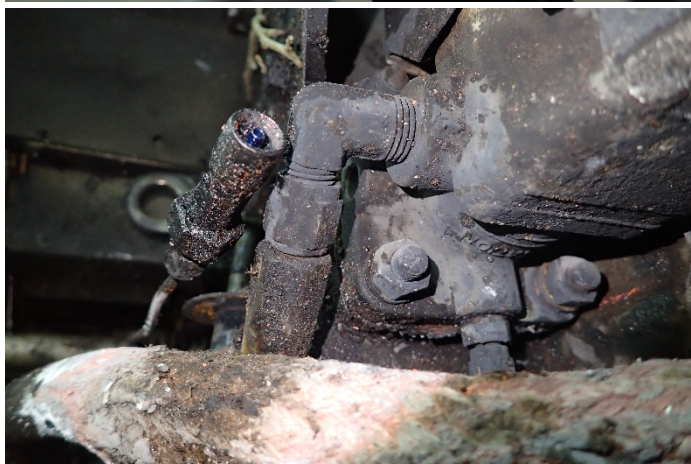
## FUEL SYSTEM

| FUEL PUMP | Manufacturer: Romec | P/N: 638156-9R? | S/N: 24334 RA |
|---|---|---|---|
| Condition: | <p>The fuel pump remained attached to its installation point and displayed thermal damage signatures. The fuel lines were inspected and checked for security. The fuel inlet AN fitting was noted to be loose and was able to be turned approximately 90 degrees to be tight; the vapor return, fuel pump outlet, and the mixture return AN fittings were all tight. The vapor return fuel line displayed significant thermal damage signatures and the hose was completely destroyed. The fuel pump inlet fuel line displayed significant thermal damage and the majority of the fuel line had burned away. The fuel pump outlet and mixture return fuel line displayed significant thermal damage near the AN fittings at the fuel pump. The fuel pump was removed and it was noted that the pump drive was capable of rotation. After removal, 100LL fuel was poured into the fuel pump inlet with the inlet AN fitting set in the position it was found at the recovery facility. It was noted that fuel leaked from the AN fitting as well as multiple locations along the thermally damaged fuel line. After the fuel was poured into the pump the pump drive was rotated by hand; it was noted that the fuel pump was capable of pumping the residual fuel.</p> | | |

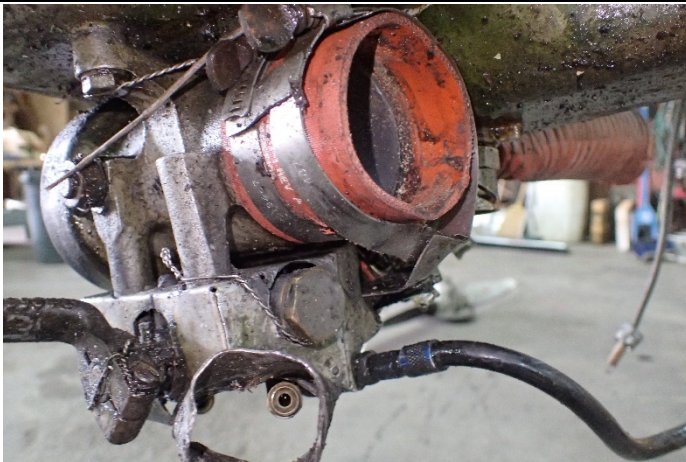
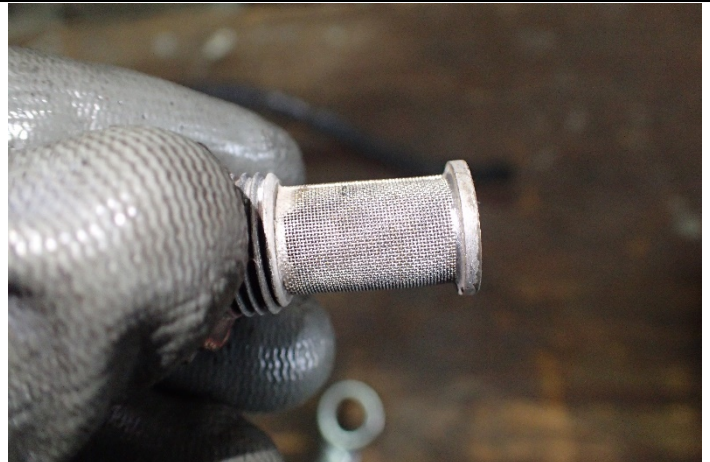
## THROTTLE BODY METERING UNIT

The throttle and metering assembly remained attached to its installation point and displayed impact damage signatures; there were no thermal damage signatures noted. The fuel lines were checked for security and it was noted that all of the lines were secure. The fuel inlet screen was removed and it was noted to be clear of any contaminants. There were no anomalies noted with the assembly.

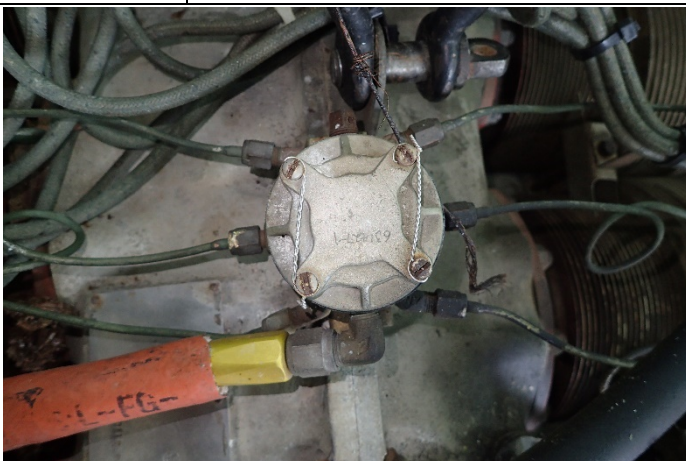
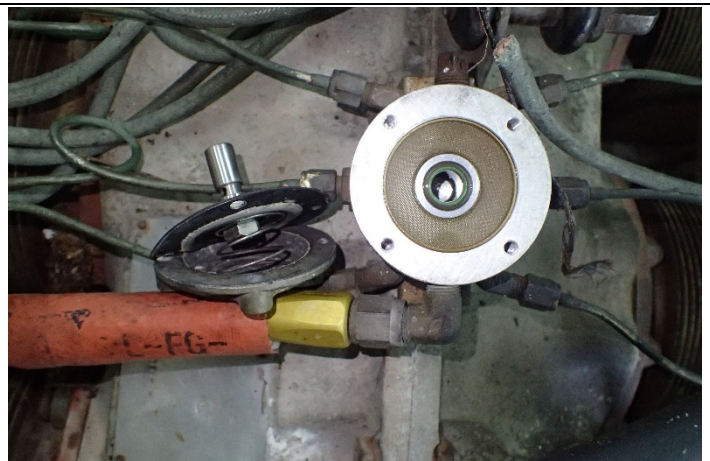
## FUEL MANIFOLD VALVE

The manifold valve remained attached to its installation point and displayed minor impact damage signatures; there were no thermal damage signatures noted. All of the fuel lines were checked for security; the lines were all secure. The manifold valve was disassembled and the internal components were visually inspected. The internal components displayed normal operating signatures.

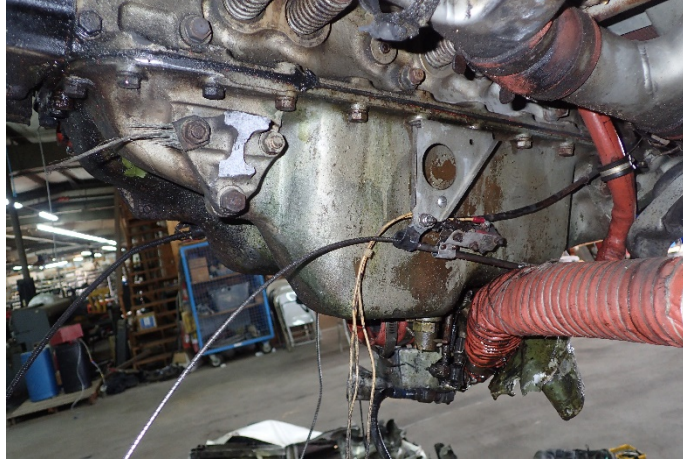
#### OIL SUMP

Condition: The oil sump displayed impact damage signatures around the throttle body attach point; the oil sump was breached. There were no anomalies noted.

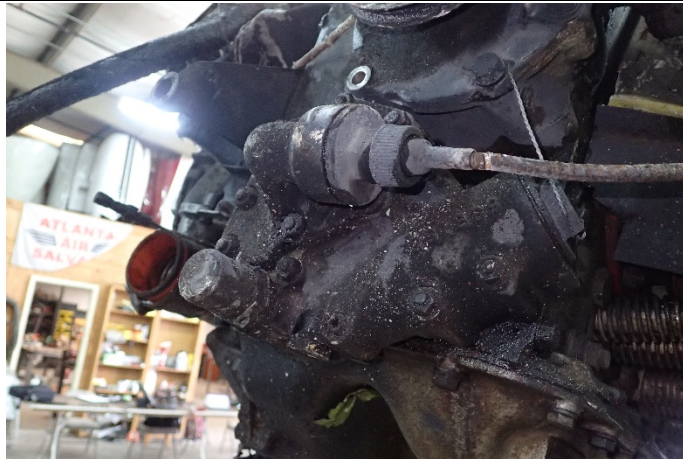
#### OIL PUMP

Condition: The oil pump displayed thermal discoloration and was covered in soot. There were no signs of oil leaks around the oil pump.

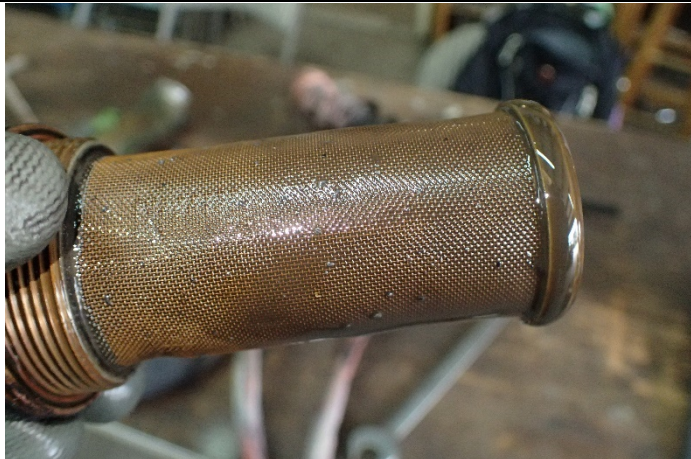
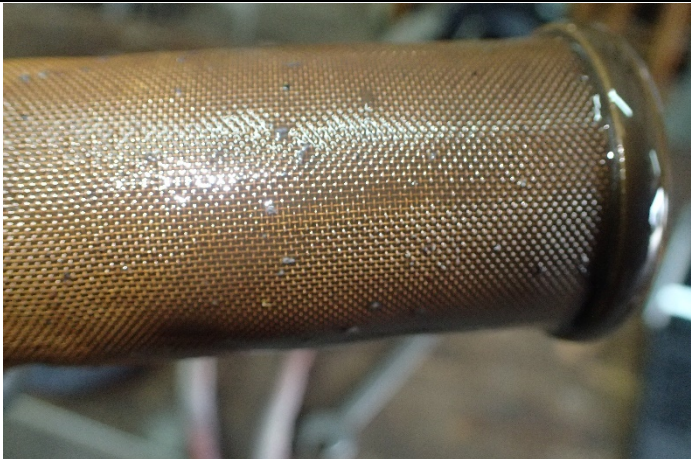
| OIL SCREEN | |
|---|---|
| Condition: | The oil screen remained installed and was secure. The screen was removed and there were no metallic material present in the screen. There were no anomalies noted during the oil screen inspection. |

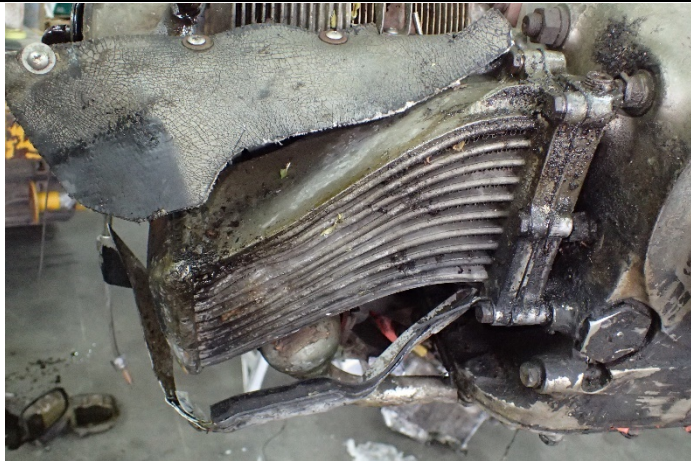
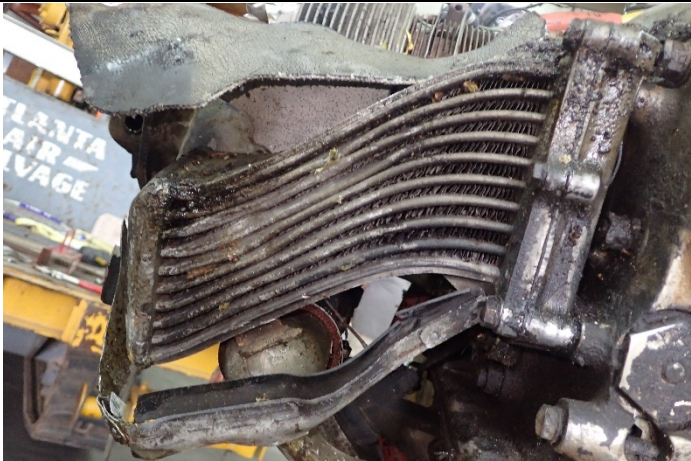
| OIL COOLER | Manufacturer: Not observed | P/N: Not observed | S/N: Not observed |
|---|---|---|---|
| Condition: | The oil cooler remained attached to its installation point and displayed a significant amount of impact damage. There were no anomalies noted with the oil cooler. | | |

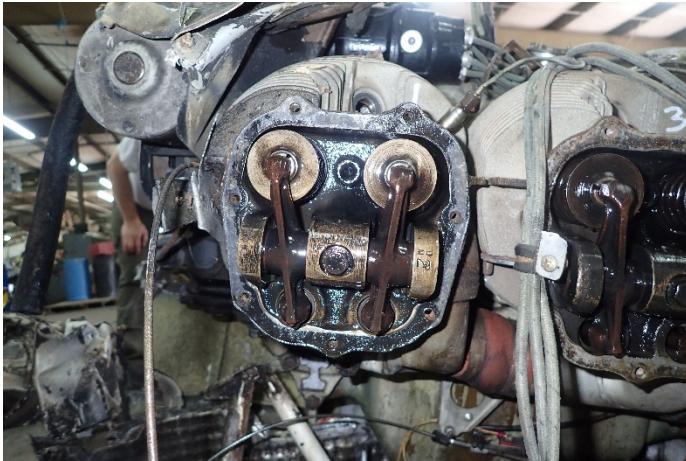
#1 Cylinder

Condition: All of the cylinders were inspected using a lighted borescope. The piston faces, cylinder bores, and valve heads displayed normal operating and combustion signatures. The overhead components (valve, springs, and rocker arms) displayed normal operating and lubrication signatures. During crankshaft rotation all of the cylinders displayed good thumb compression and suction.

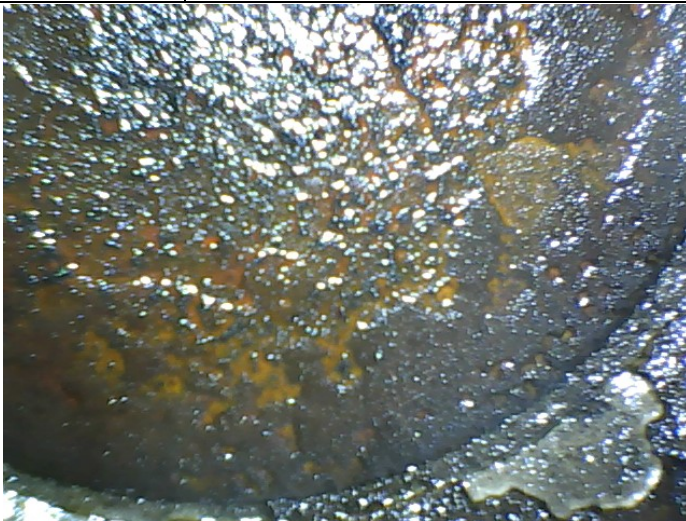
#1 Exhaust

The valve heads were inspected using a lighted borescope. All of the valve heads displayed normal operating and combustion signatures. During crankshaft rotation all of the valves operated normally. There were no anomalies noted with the valves.

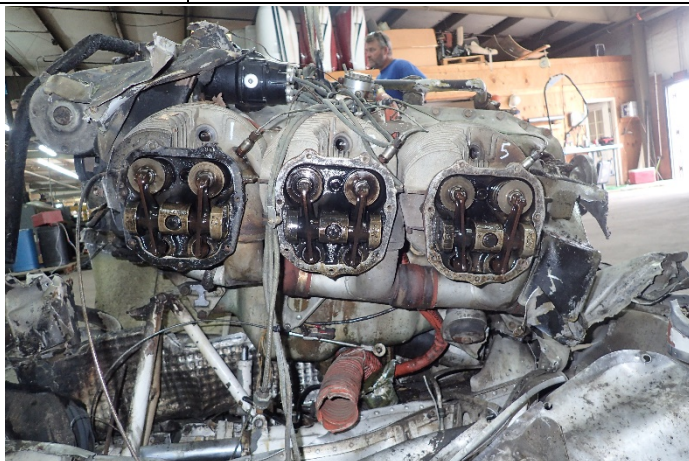
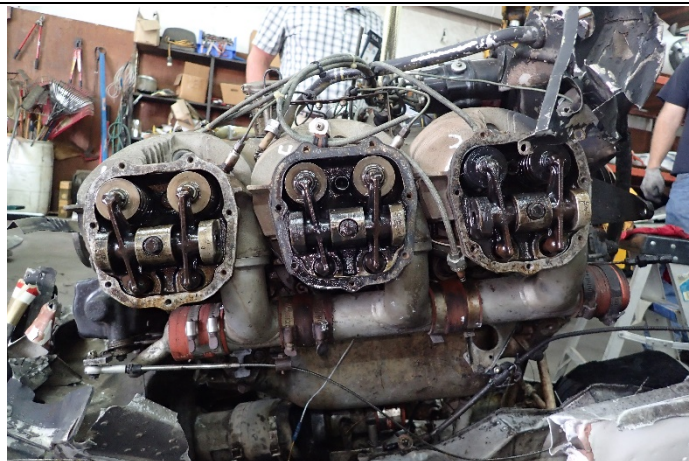
### ROCKER ARMS AND SHAFTS

All of the rocker arms remained secured to their installation points and were undamaged. The rocker arms displayed normal operating and lubrication signatures; during crankshaft rotation all of the rocker arms operated normally.

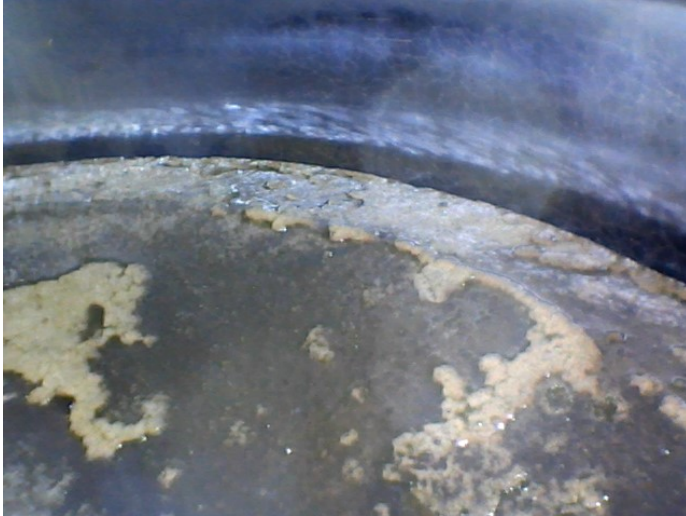
#1 Piston

The pistons were inspected using a lighted borescope. The piston faces displayed normal operating and combustion signatures; there were no signs of detonation or pre-ignition. During crankshaft rotation all of the pistons operated normally. There were no anomalies noted with the pistons.

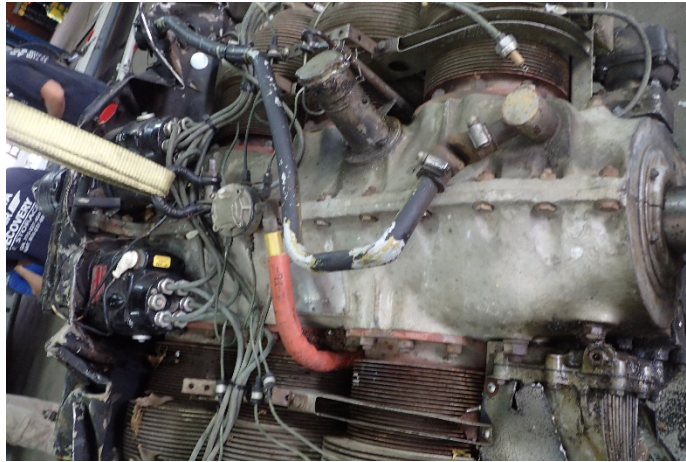
| Condition: | The crankcase remained intact and displayed minor impact damage signatures. The aft portion of the engine displayed thermal discoloration and sooting. There were no signs of oil leaks around the crankcase. | | | |

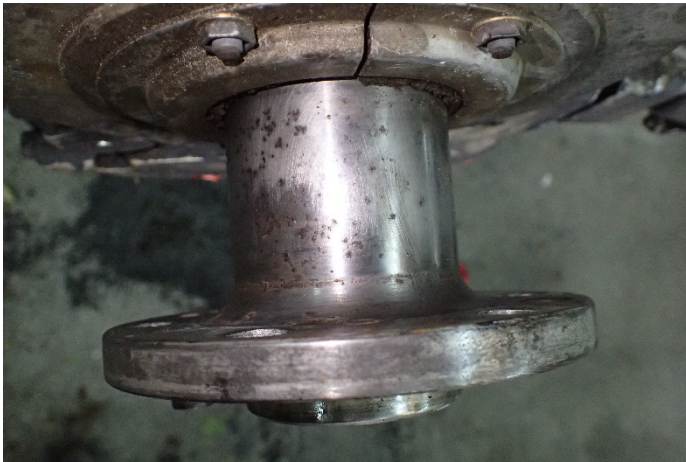
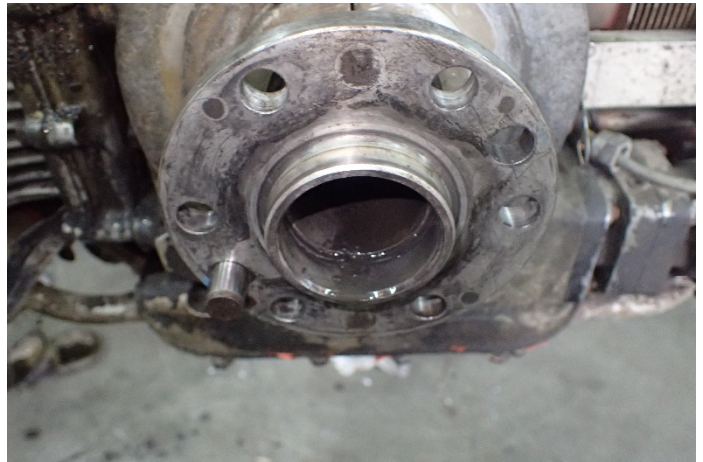
The propeller flange remained attached to the rest of the crankshaft; there were no cracks noted in the external portion of the crankshaft. Continuity was established between the crankshaft, camshaft, connecting rods, and associated components. There were no anomalies noted with the crankshaft.

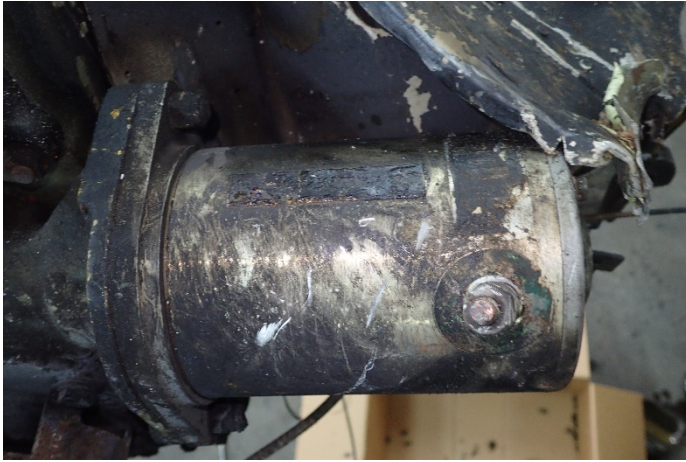
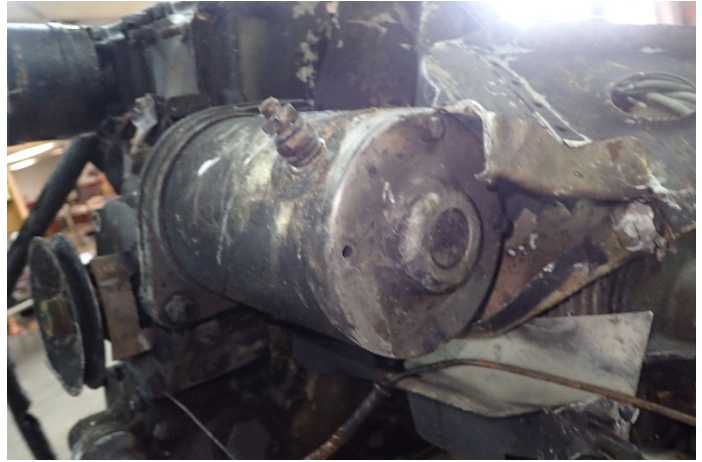
### STARTER

The starter remained attached to the starter adapter and displayed impact damage signatures as well as thermal damage signatures. There were no anomalies noted with the starter.

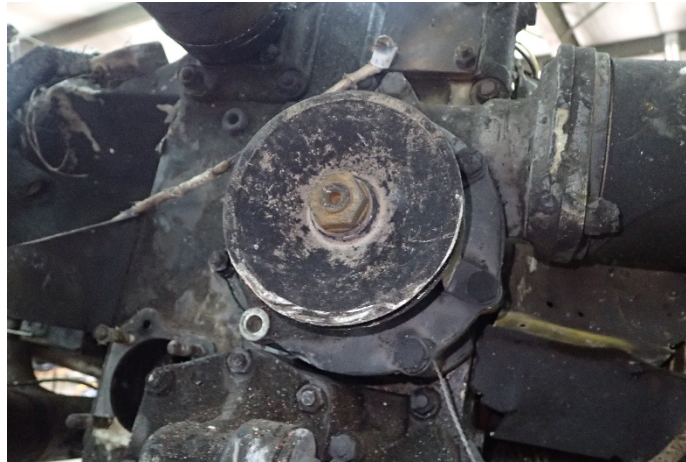
### STARTER ADAPTER

The starter adapter remained attached to its installation point and displayed thermal damage signatures. There were no anomalies noted with the starter adapter.

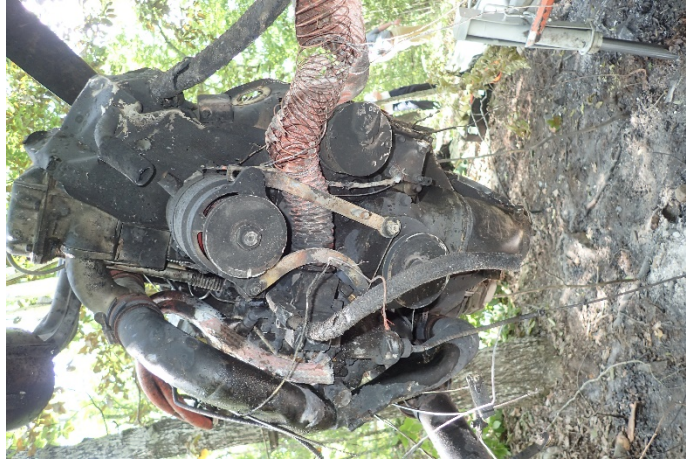
## ALTERNATOR

The alternator remained attached to its installation point and displayed thermal damage signatures; the alternator drive belt was not observed during the examination. The alternator drive was capable of normal rotation; there were no anomalies noted with the alternator.

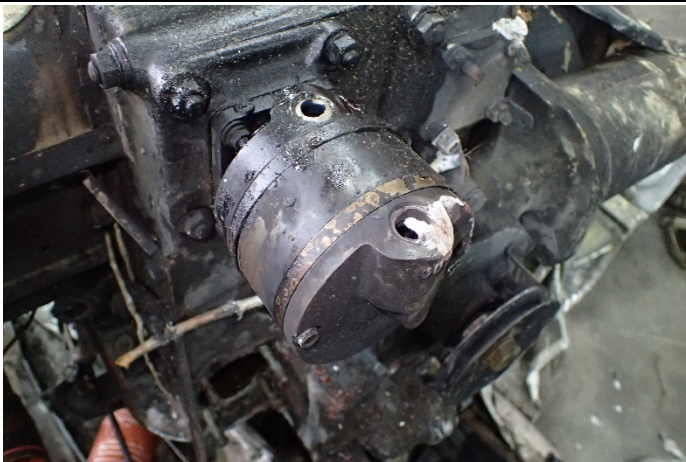
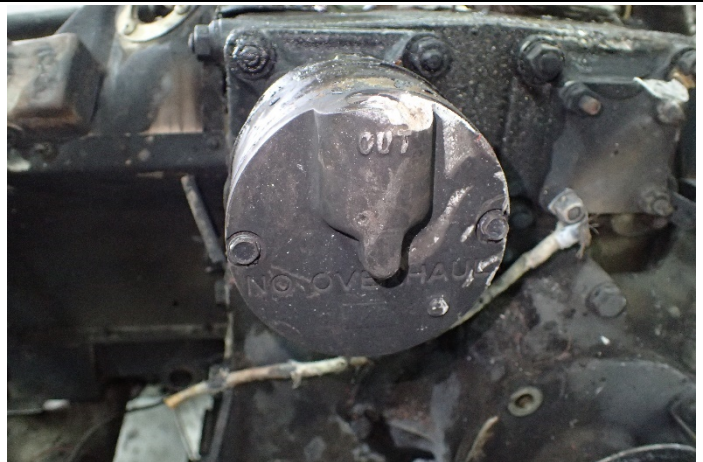
## VACUUM PUMP

The vacuum pump remained attached to its installation point and displayed thermal damage and impact damage signatures. There were no signs of oil leaks around the vacuum pump installation. There were no anomalies noted with the vacuum pump.

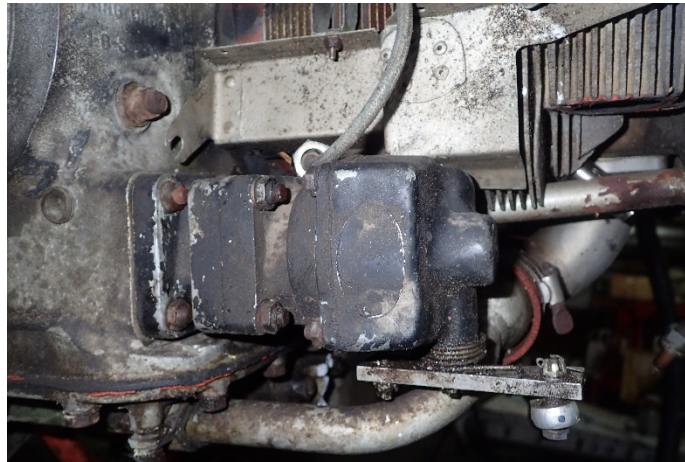
### PROPELLER GOVERNOR

The propeller governor remained attached to its installation point and displayed minor impact damage signatures; there were no thermal damage signatures to the governor. There were no anomalies noted.

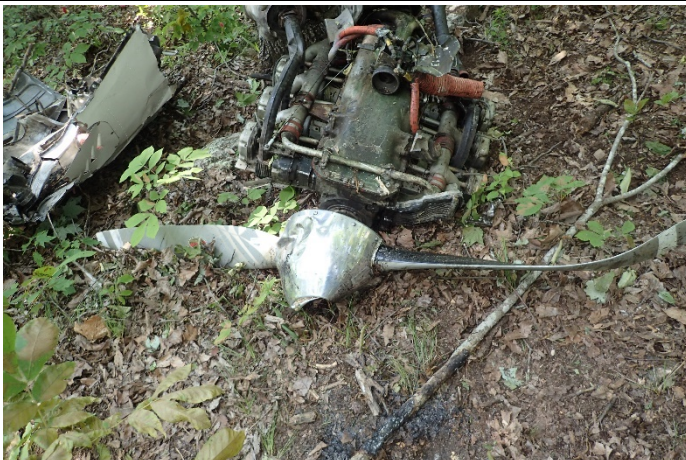
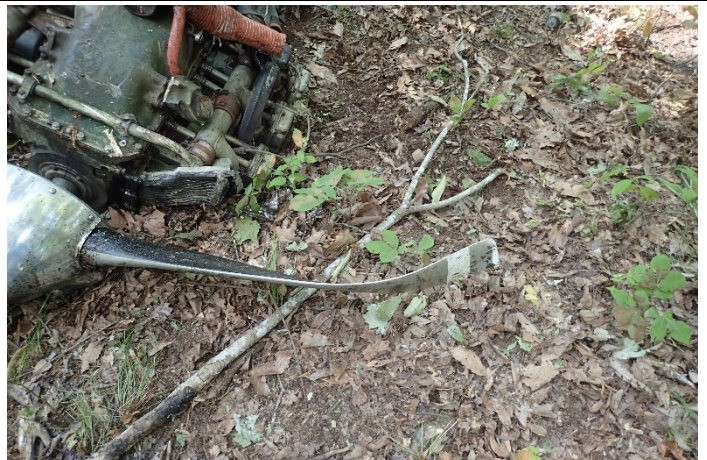
### PROPELLER

The two blade, constant speed propeller remained attached to the crankshaft and displayed impact damage signatures. Both propeller blades remained within the propeller hub; Propeller blade "A" displayed minor twisting deformation at the propeller blade tip and a portion of the tip had sheered from the rest of the blade. Propeller blade "B" displayed minor damage; there was no bending or twisting deformation noted with the blade.
