# NATIONAL TRANSPORTATION SAFETY BOARD

## MATERIALS LABORATORY FACTUAL REPORT

Report No. 18-090

Place : Jacksonville, Alabama  
Date : May 12, 2018  
Vehicle : Beech BE35-A33, N486T  
NTSB No. : ERA18FA146  
Investigator : Ralph Hicks, AS-ERA

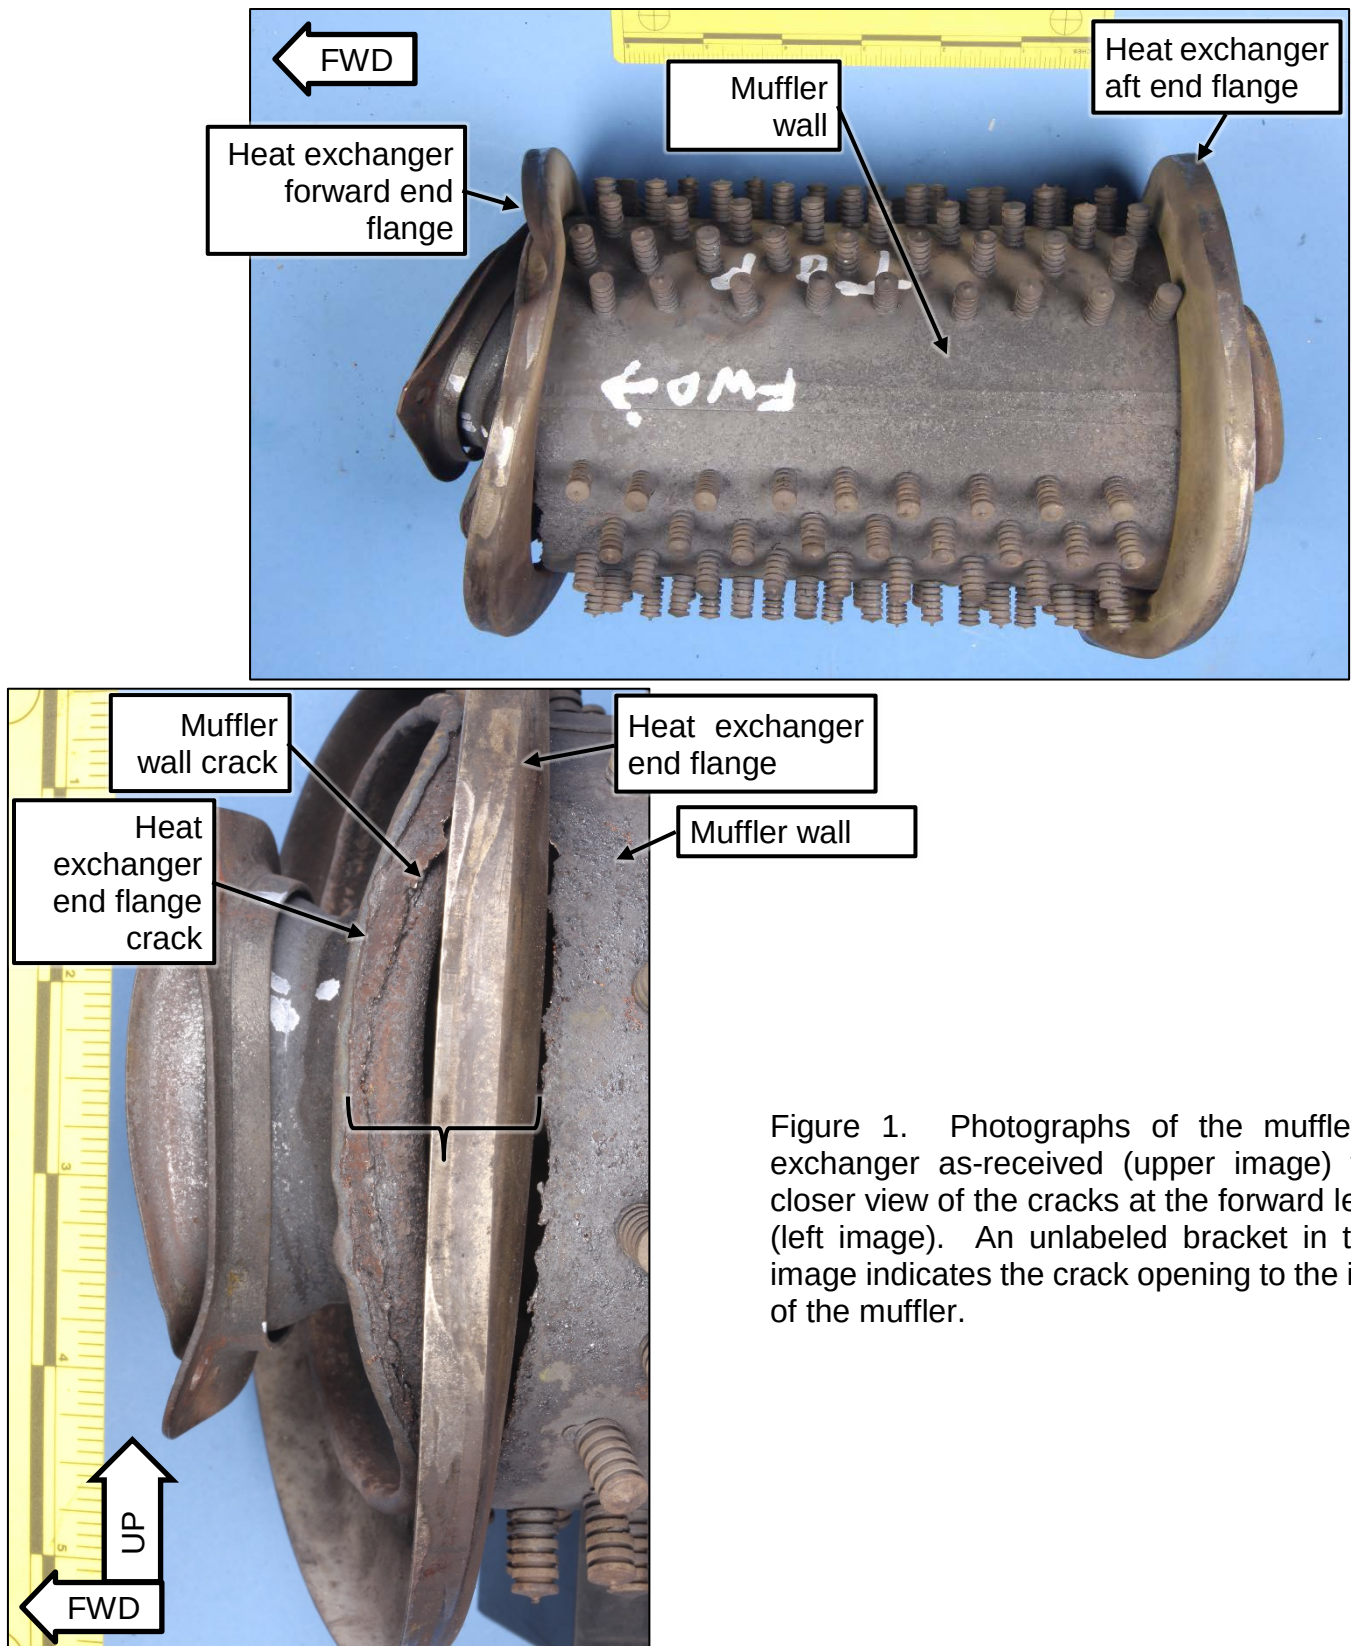
An overall view of the submitted muffler heat exchanger assembly is shown in figure 1. Cracks were observed in multiple locations including the forward left side shown in the left image in figure 1. On the heat exchanger portion of the assembly, the forward end flange and aft end flange were bent forward at the left side and the lower left side, respectively. The exhaust pipe attachment segments at the forward and aft ends of the muffler were bent to the right relative to the muffler axis. At the crack location on the left side forward end, the muffler end face was displaced forward at the outer circumference, exposing a crack opening from the interior to exterior of the muffler and heat exchanger as indicated with a bracket in figure 1.

Figure 1. Photographs of the muffler heat exchanger as-received (upper image) with a closer view of the cracks at the forward left side (left image). An unlabeled bracket in the left image indicates the crack opening to the interior of the muffler.

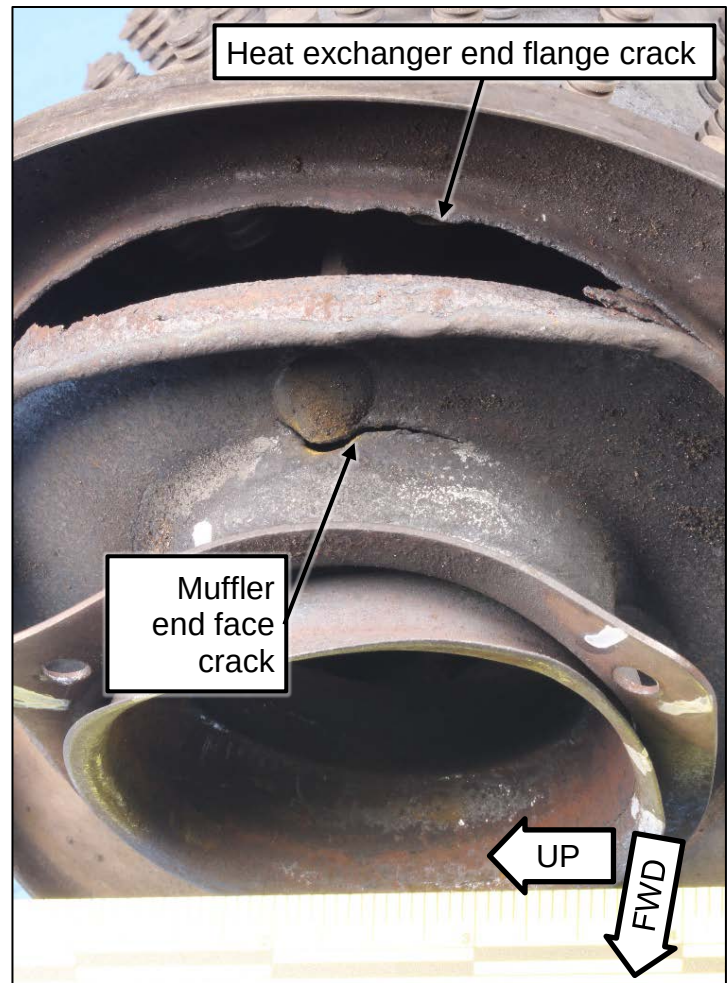
A crack was present in the muffler forward end face as indicated in figure 2. The crack was located adjacent to one of 3 welds for internal baffles attached to the end face next to the exhaust stack attachment tube. Three cracks were also present in the muffler aft end face adjacent to each of the 3 similar welds on the aft end face.

Oxidized fracture features were also observed on the crack surfaces through the heat exchanger forward end flange shown in figure 2. The length of the oxidized portion of the crack at the left side of the end flange was 4.5 inches long. At the top of the forward end flange, the oxidized portion of the crack was 1.75 inches long.

Some of the cracks in the muffler end faces such as the crack noted in figure 2 had a crack opening that allowed for examination under the optical stereomicroscope, and visible fracture features appeared to be covered with oxidation and exhaust deposits. The four cracks in the muffler end faces (1 in the forward end and 3 at the aft end) were each approximately 0.8 inches to 0.9 inches long.

Figure 2. View of the forward end of the heat exchanger muffler showing cracks in the shroud end flange and muffler end face.

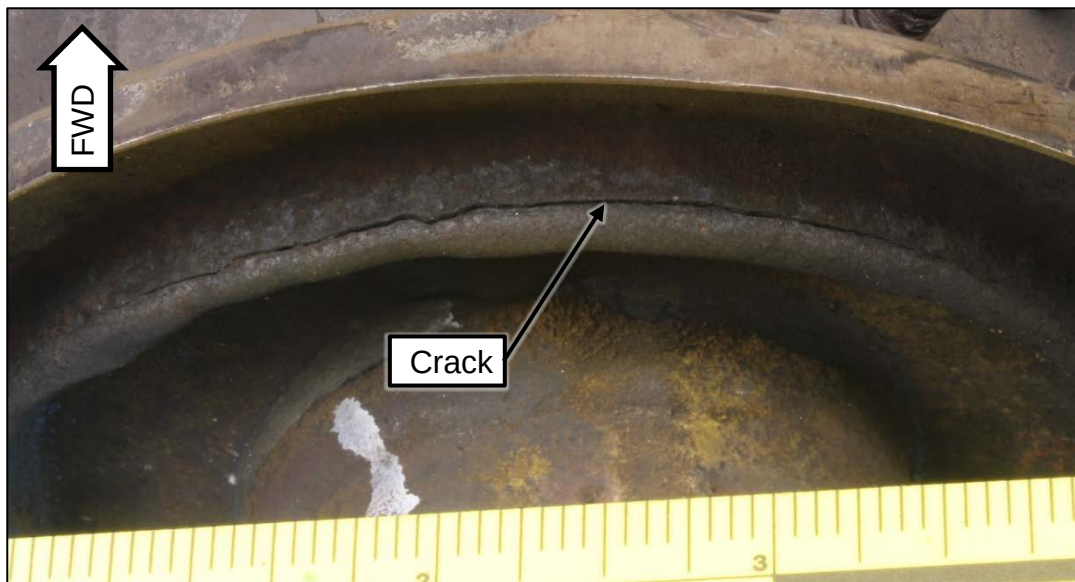
At the aft end of the heat exchanger, the crack through the aft end flange at the upper side of the assembly (indicated in figure 3) was 4.25 inches long. The upper portion of the aft end flange had limited deformation, and crack surfaces were not exposed for examination. At the lower left side of the assembly, the heat exchanger aft end flange was deformed, and the crack fracture features were exposed. The fracture features through the thickness were covered in oxides, and the length of the oxidized portion of the crack measured 2.25 inch. At one end of the crack, light gray fracture features were observed consistent with a relatively recent fracture with no significant oxidation.

Figure 3. Crack in the aft shroud end flange adjacent to the weld at the top of the muffler heat exchanger.

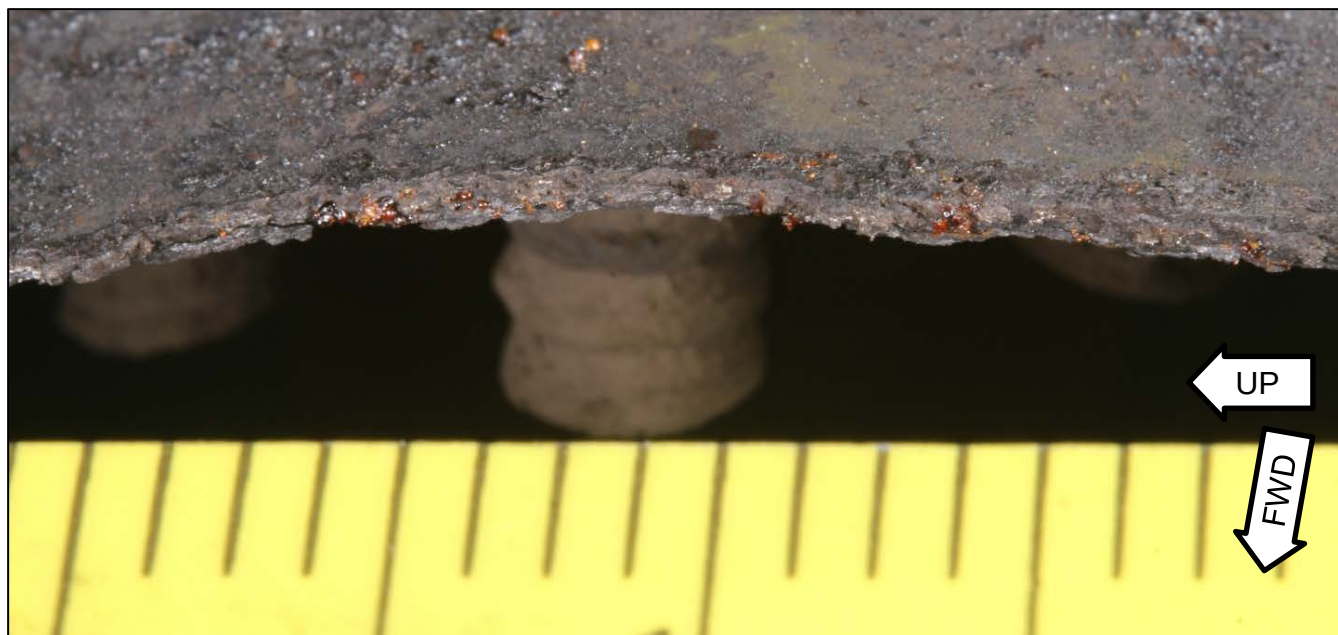
Crack fracture features were examined using an optical stereomicroscope. In the muffler wall crack at the forward left side, fracture features generally were covered with oxides and exhaust deposits across the thickness of the fracture. A close view of typical fracture features observed near the middle of the crack through the muffler wall is shown in figure 4. Near the ends of the muffler wall crack, light gray fracture features were observed as shown in figure 5, consistent with a relatively recent overstress fracture. The through-thickness oxidized portion of the crack in the muffler wall measured 3.35 inches long circumferentially.

Figure 4. Fracture surface near the middle of the crack in the muffler wall as viewed looking aft.

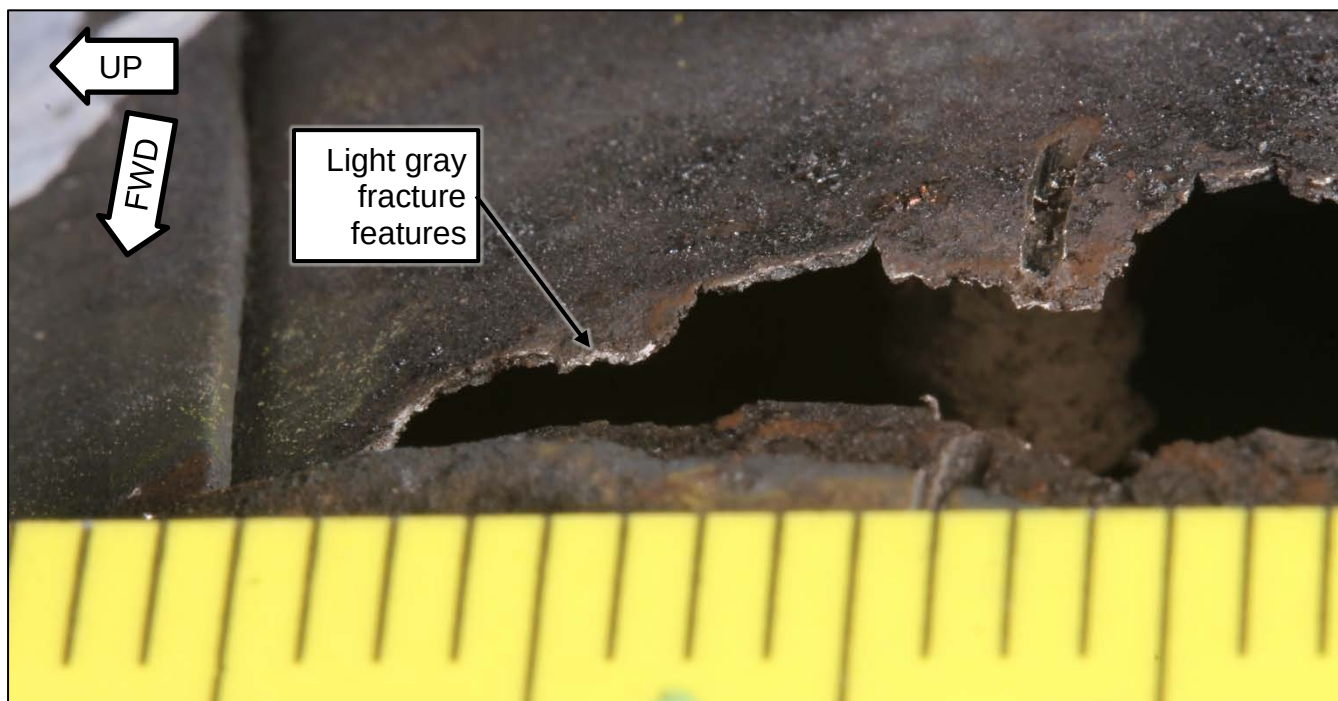
Figure 5. Fracture surface at the upper end of the crack in the muffler wall as viewed looking aft.

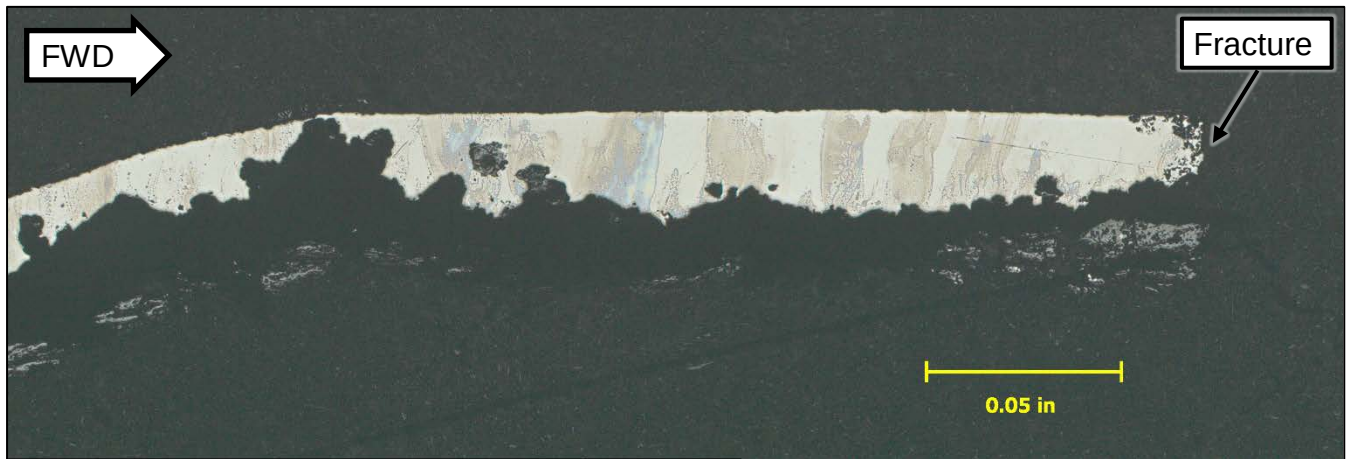
Views of the polished cross-sections of the muffler wall forward and aft of the crack are shown in figures 6 and 7. The muffler wall aft of the fracture showed significant thickness variations associated with oxidation, and in one area aft of the crack, the wall was corroded nearly through the thickness in the plane of polish. As shown on the forward side of the fracture, the muffler wall showed branching intergranular cracks through the thickness at the fracture surface and through much of the thickness in areas forward of the fracture. Branching intergranular cracks were also observed on and adjacent to the fracture through the heat exchanger forward end flange shown in figure 8.

Figure 6. Brightfield optical micrograph of the as-polished cross-section through the muffler wall near the middle of the crack showing the wall cross-section adjacent to the fracture. Color variations on the unetched surface are due to staining from polishing and rinse agents that were retained in the oxides and deposits that later bled onto the surface during drying.

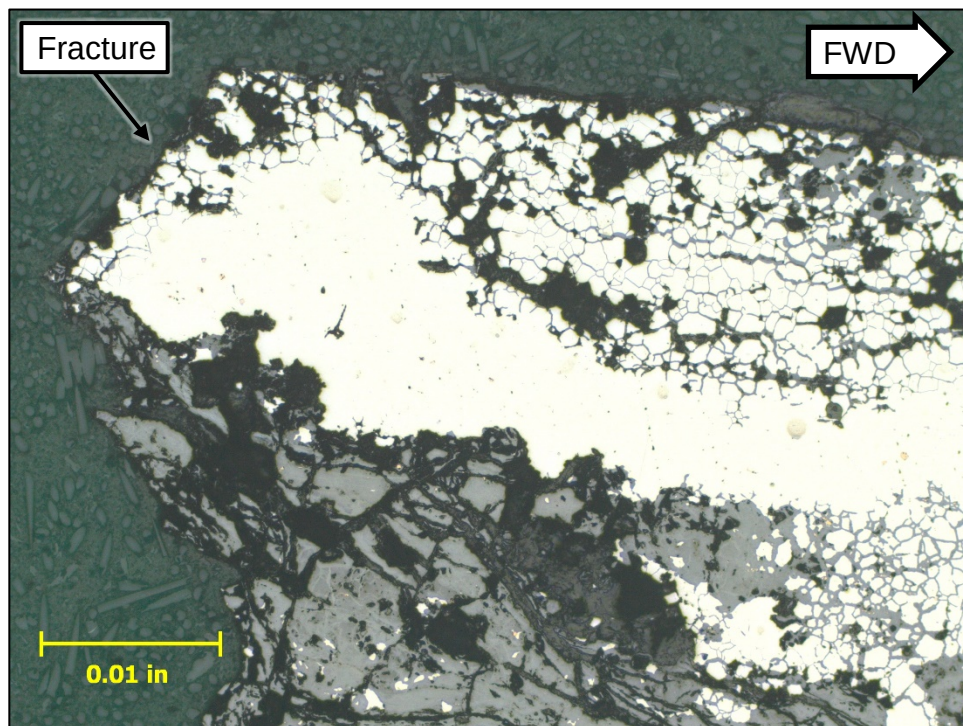
Figure 7. Brightfield optical micrograph of the as-polished cross-section through the muffler wall showing the cross-section forward of the fracture.

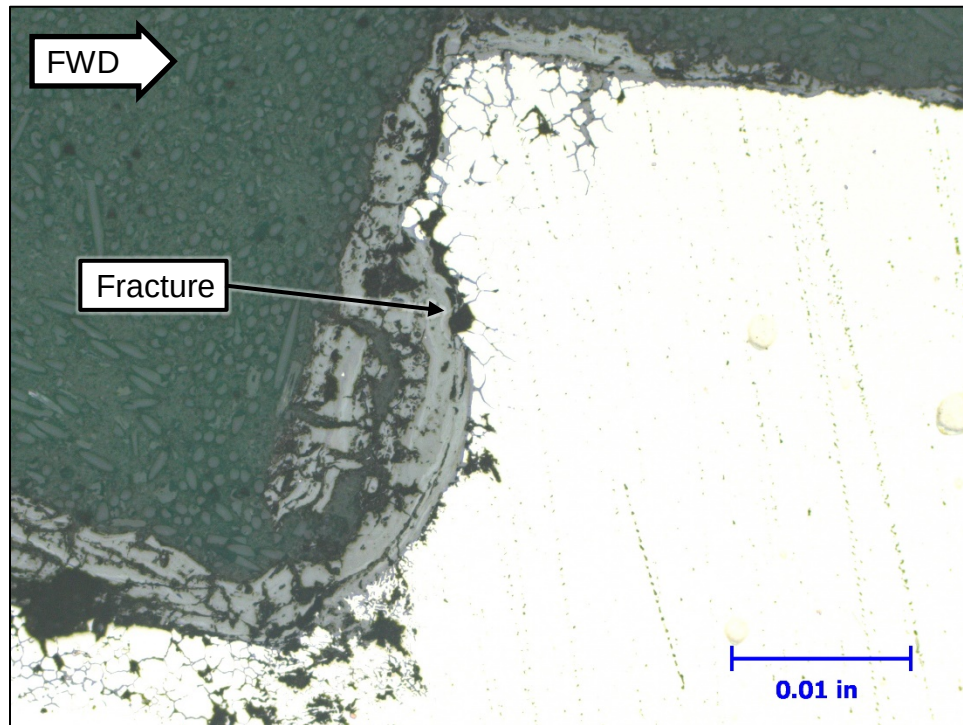
Figure 8. Brightfield optical micrograph of the as-polished cross-section at the forward side of the fracture through the shroud forward flange.

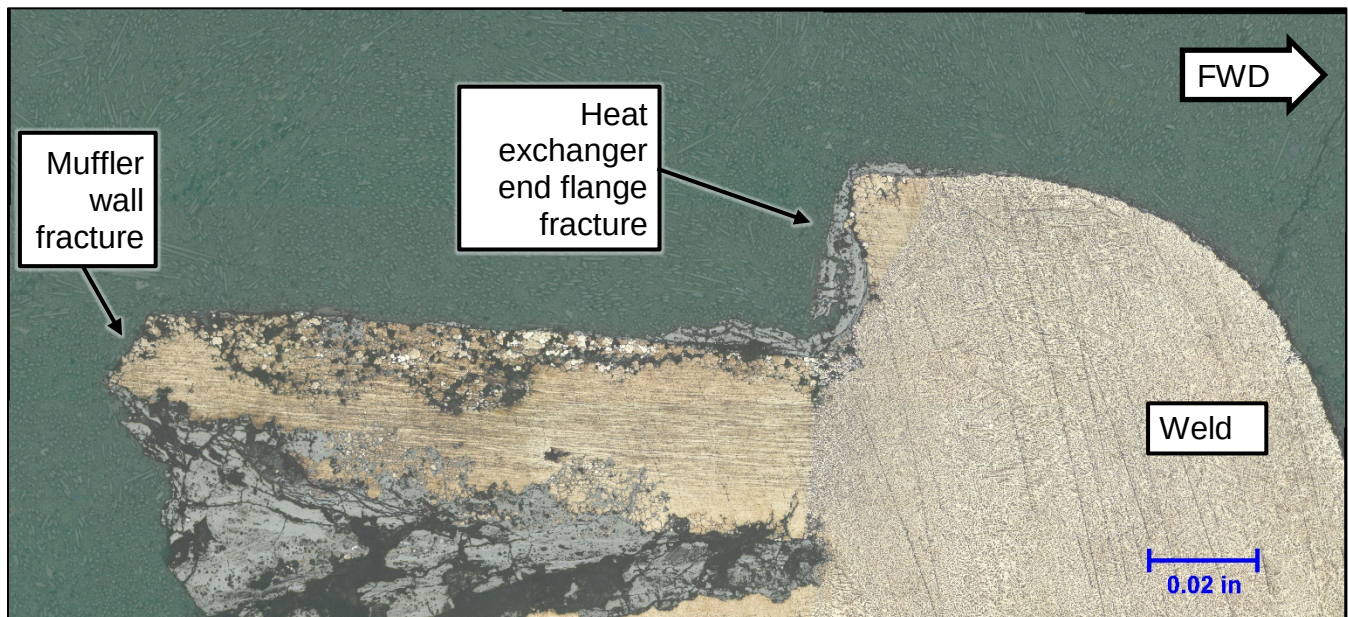
The polished cross-sections were etched using Vilella's reagent, and an overall micrograph showing the etched microstructure at the forward sides of the fracture is shown in figure 9. The fracture through the muffler wall occurred approximately 0.13 inch aft of the weld bead, and the fracture through the heat exchanger end flange occurred within 0.013 inch aft of the weld bead.

Figure 9. Brightfield optical micrograph of the polished cross-section forward of the cracks as etched with Vilella's reagent.
