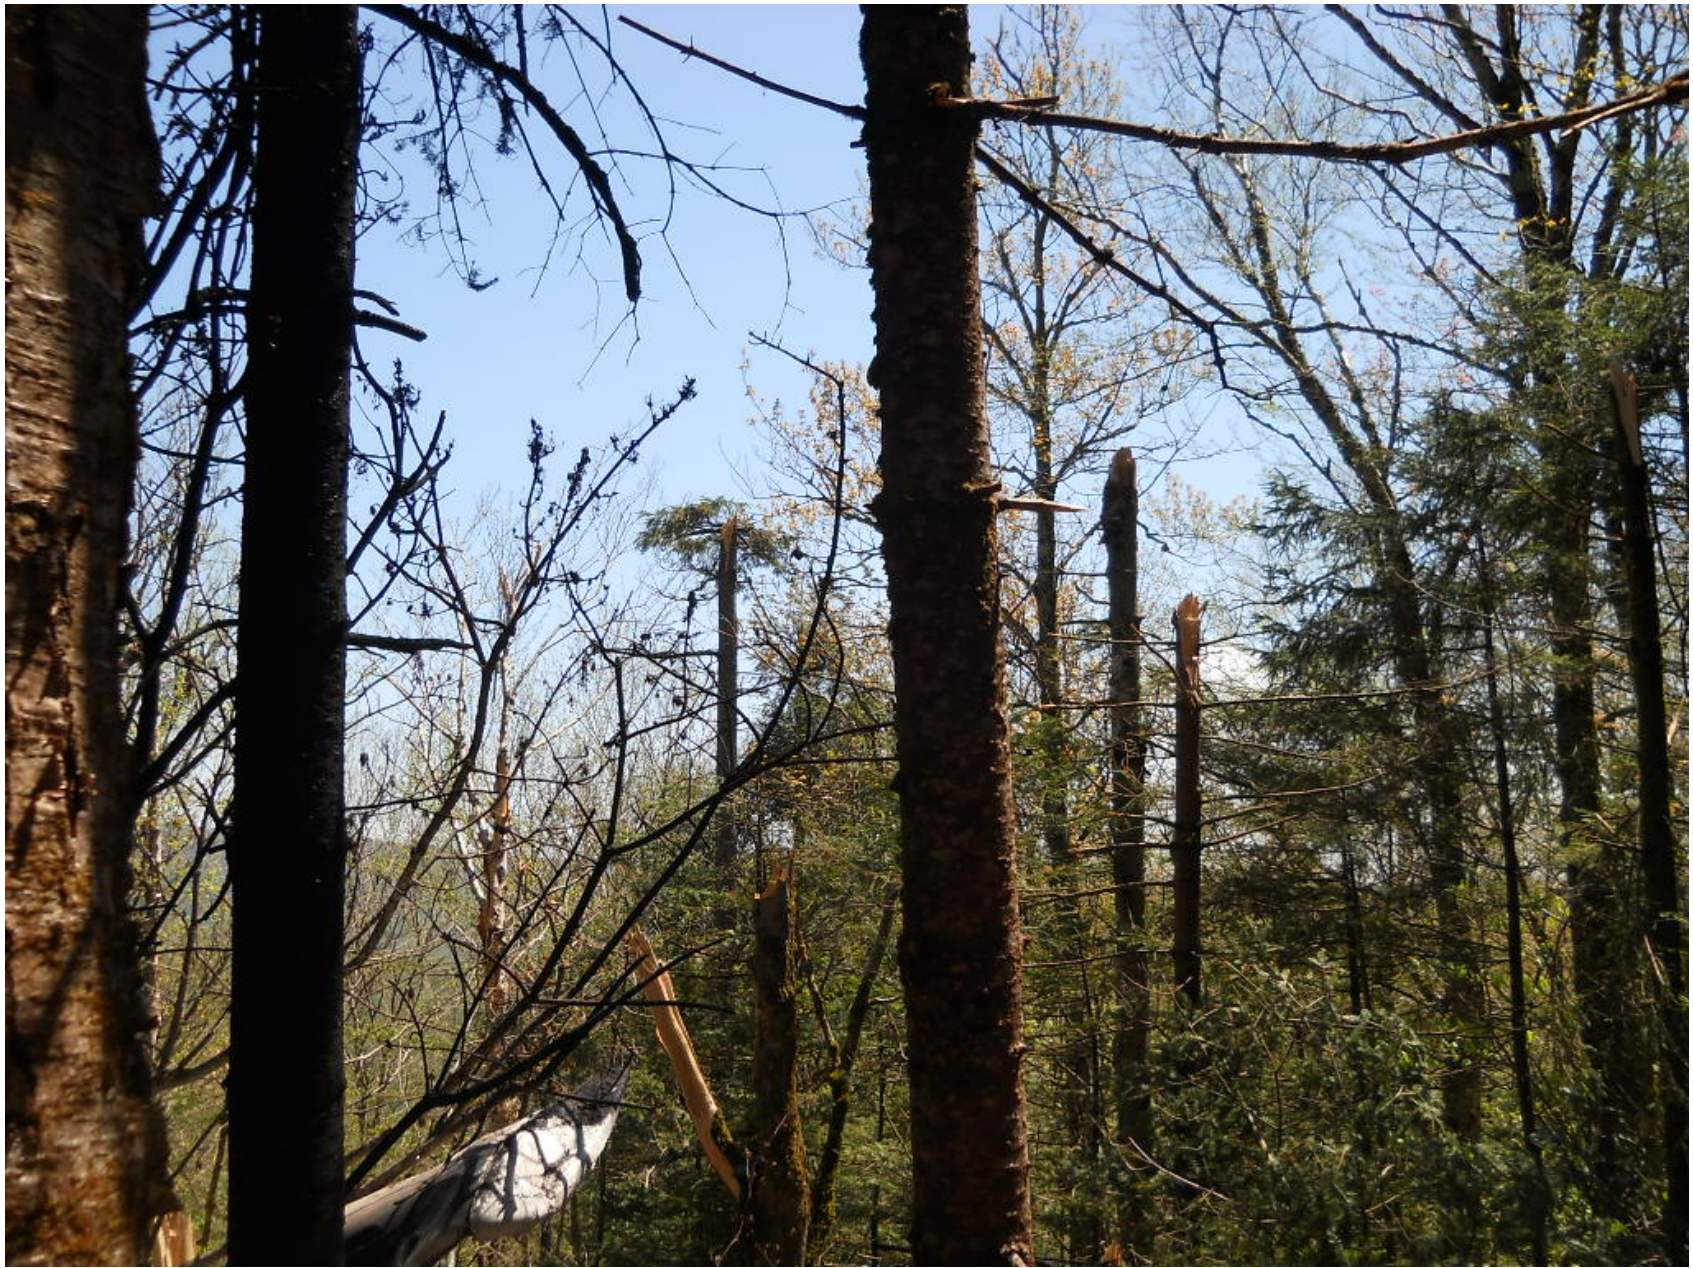
**Photo 1 – Debris Path**

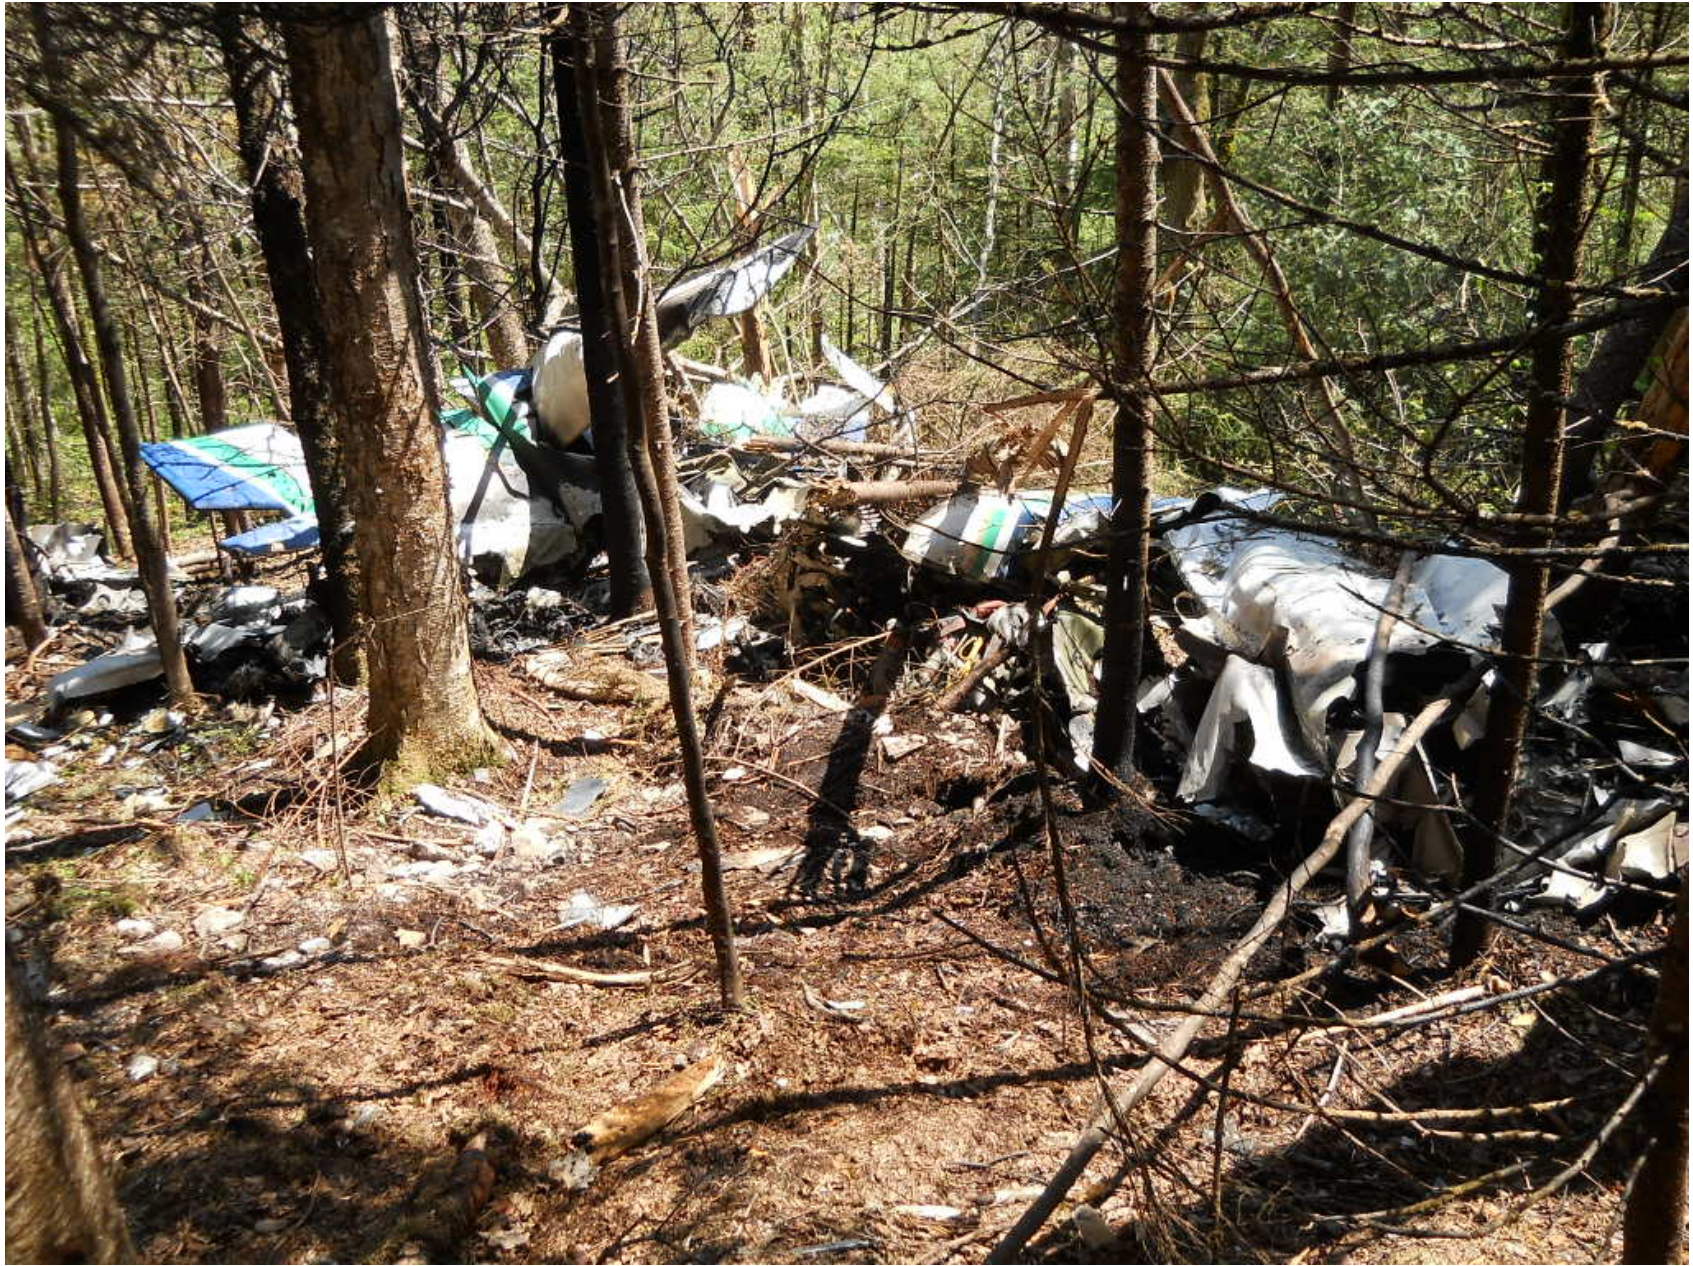
**Photo 2 – Main Wreckage**

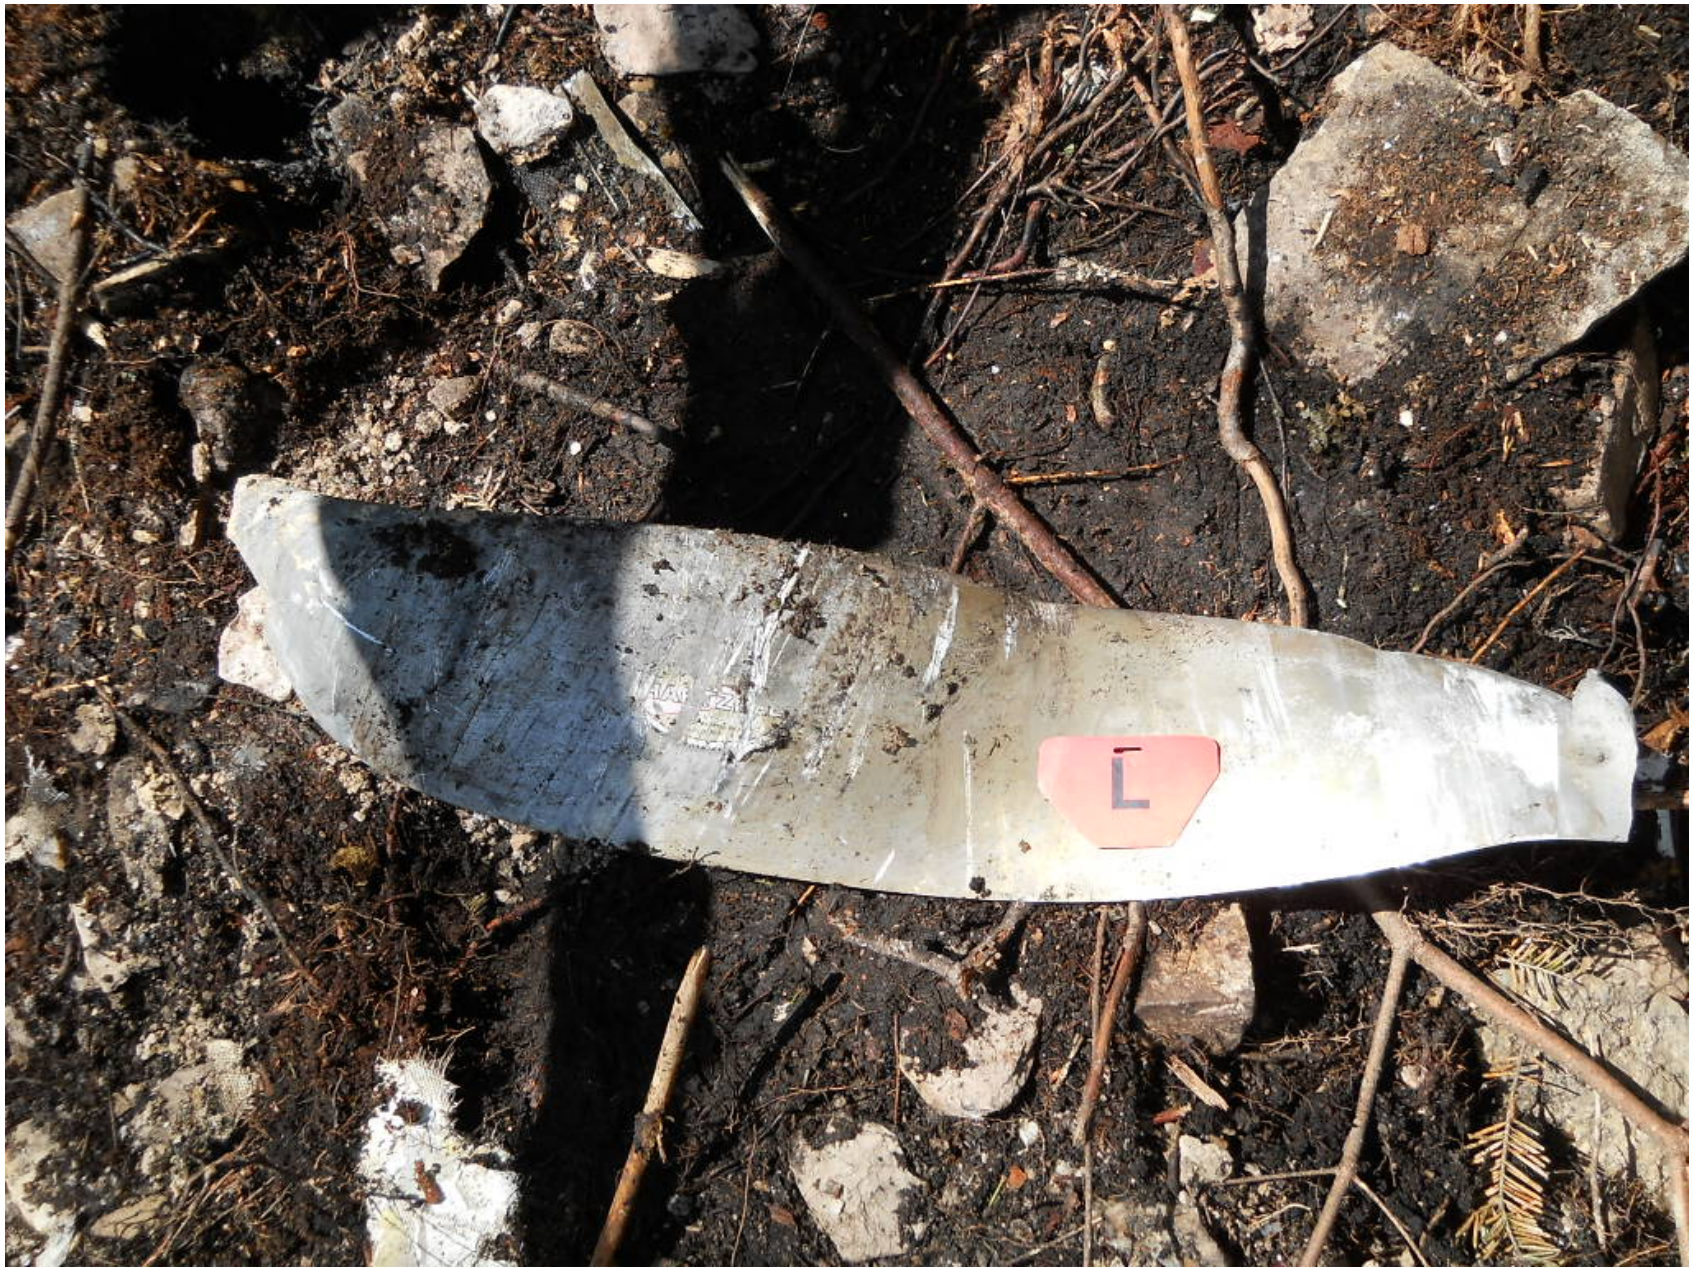
**Photo 3 – Left Propeller Blade**

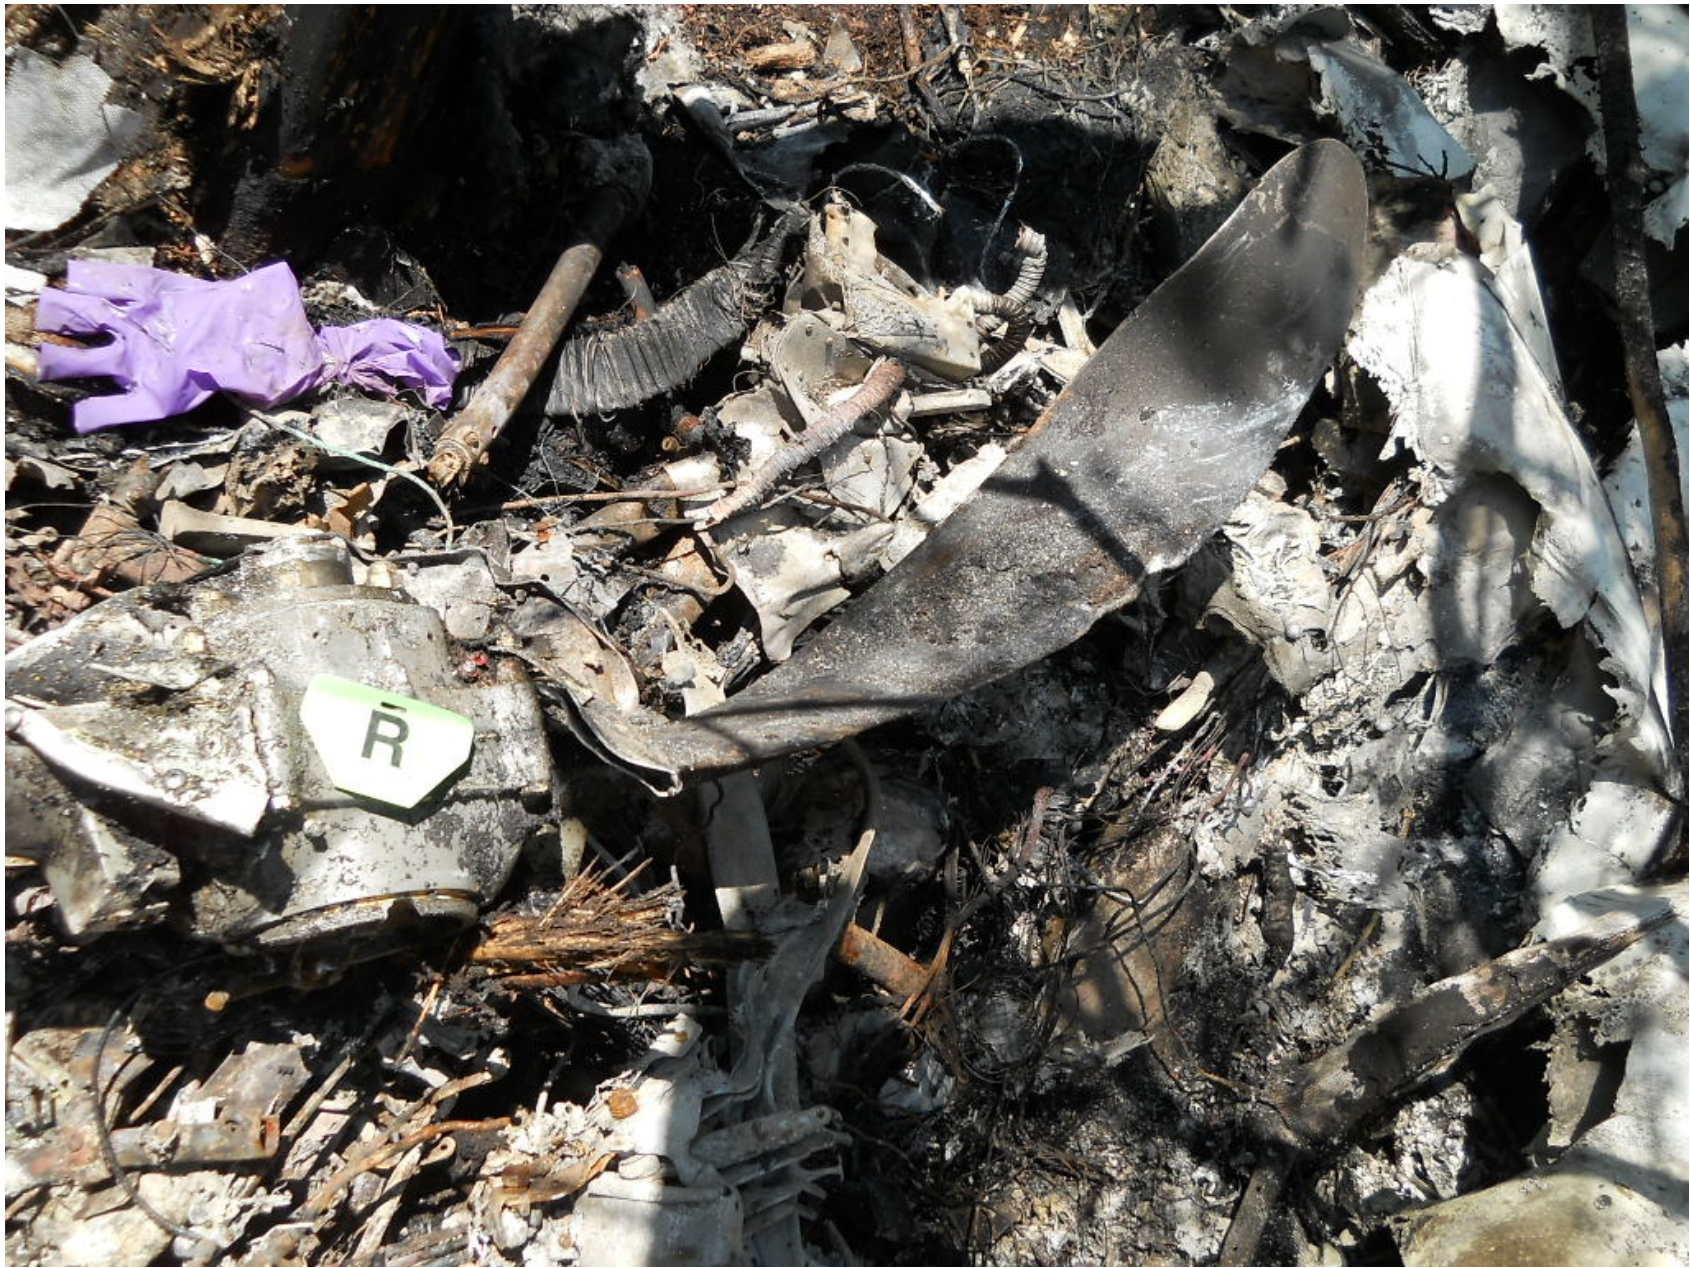
**Photo 4 – Right Propeller**

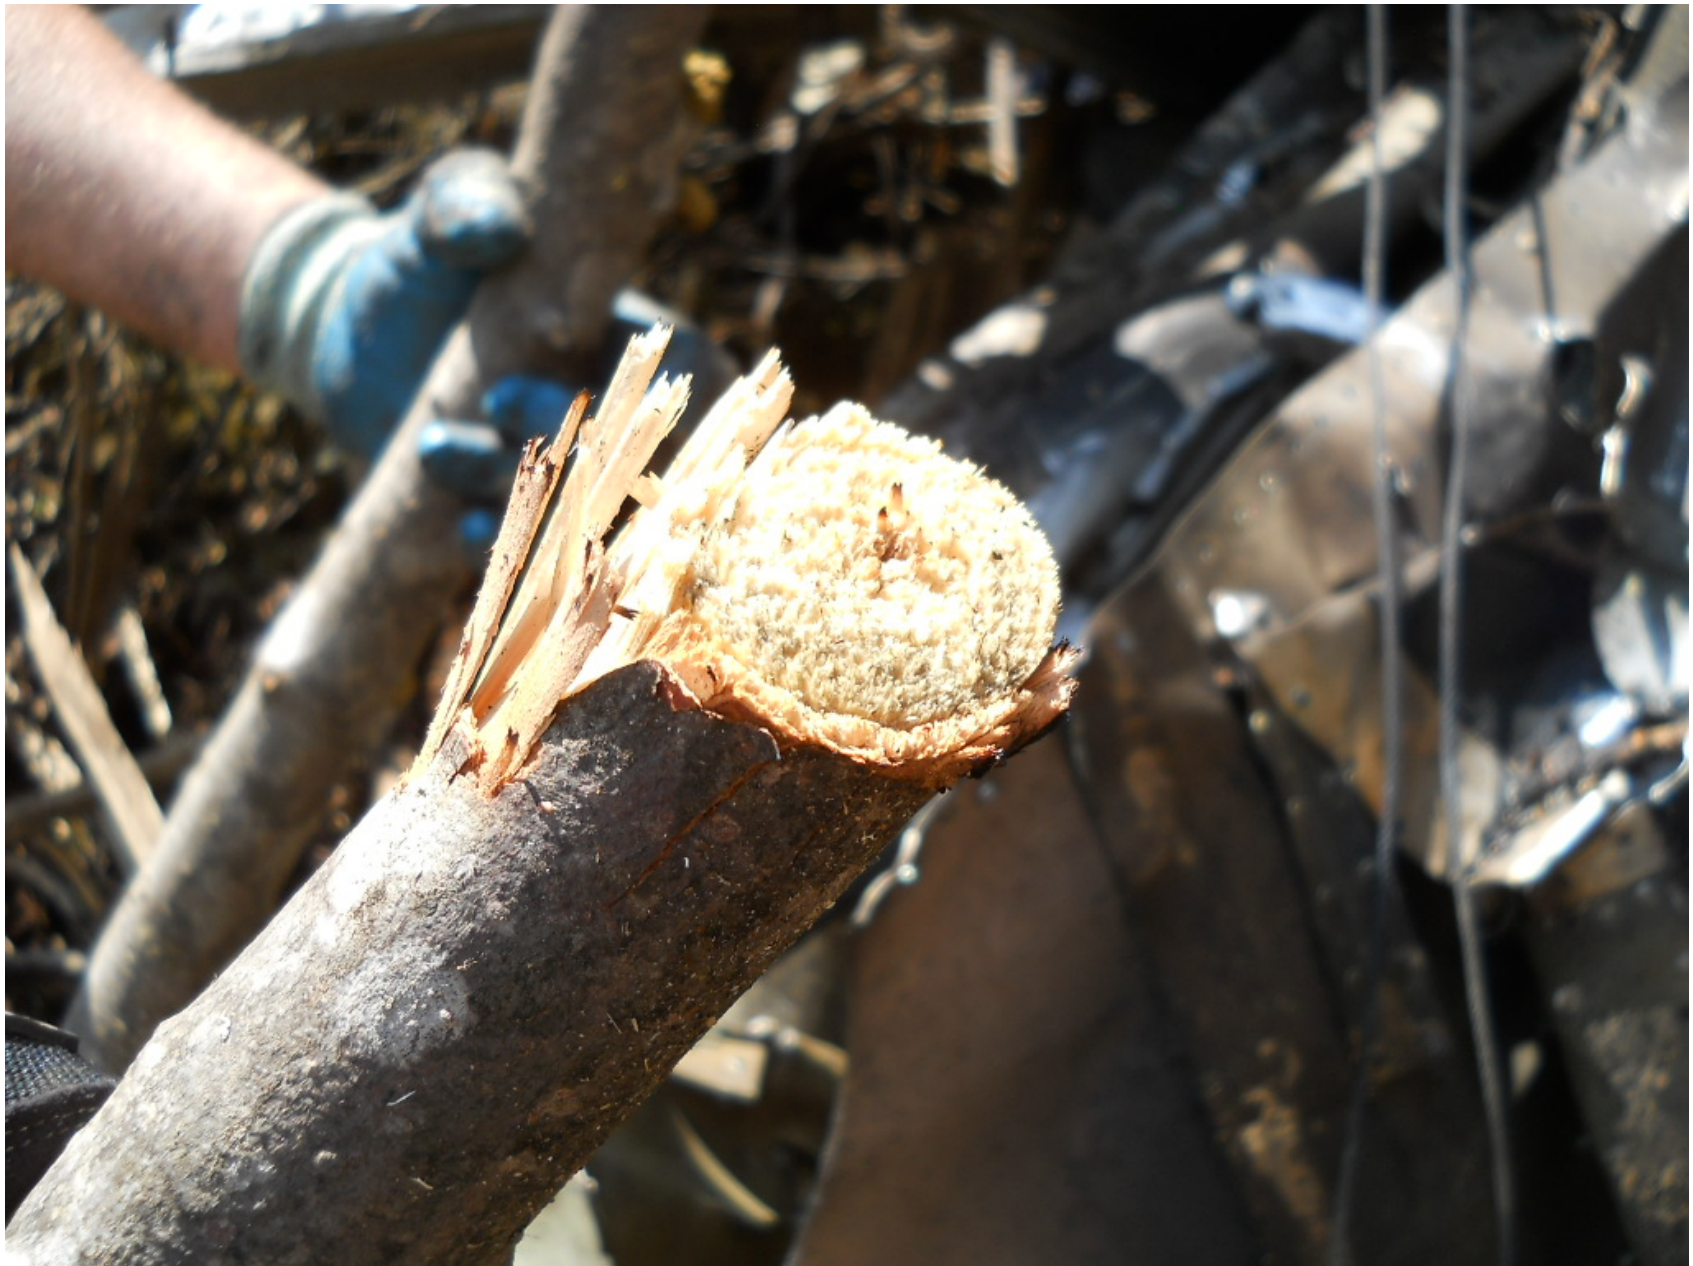
**Photo 5 – Cut Branch With Black Paint Transfer**

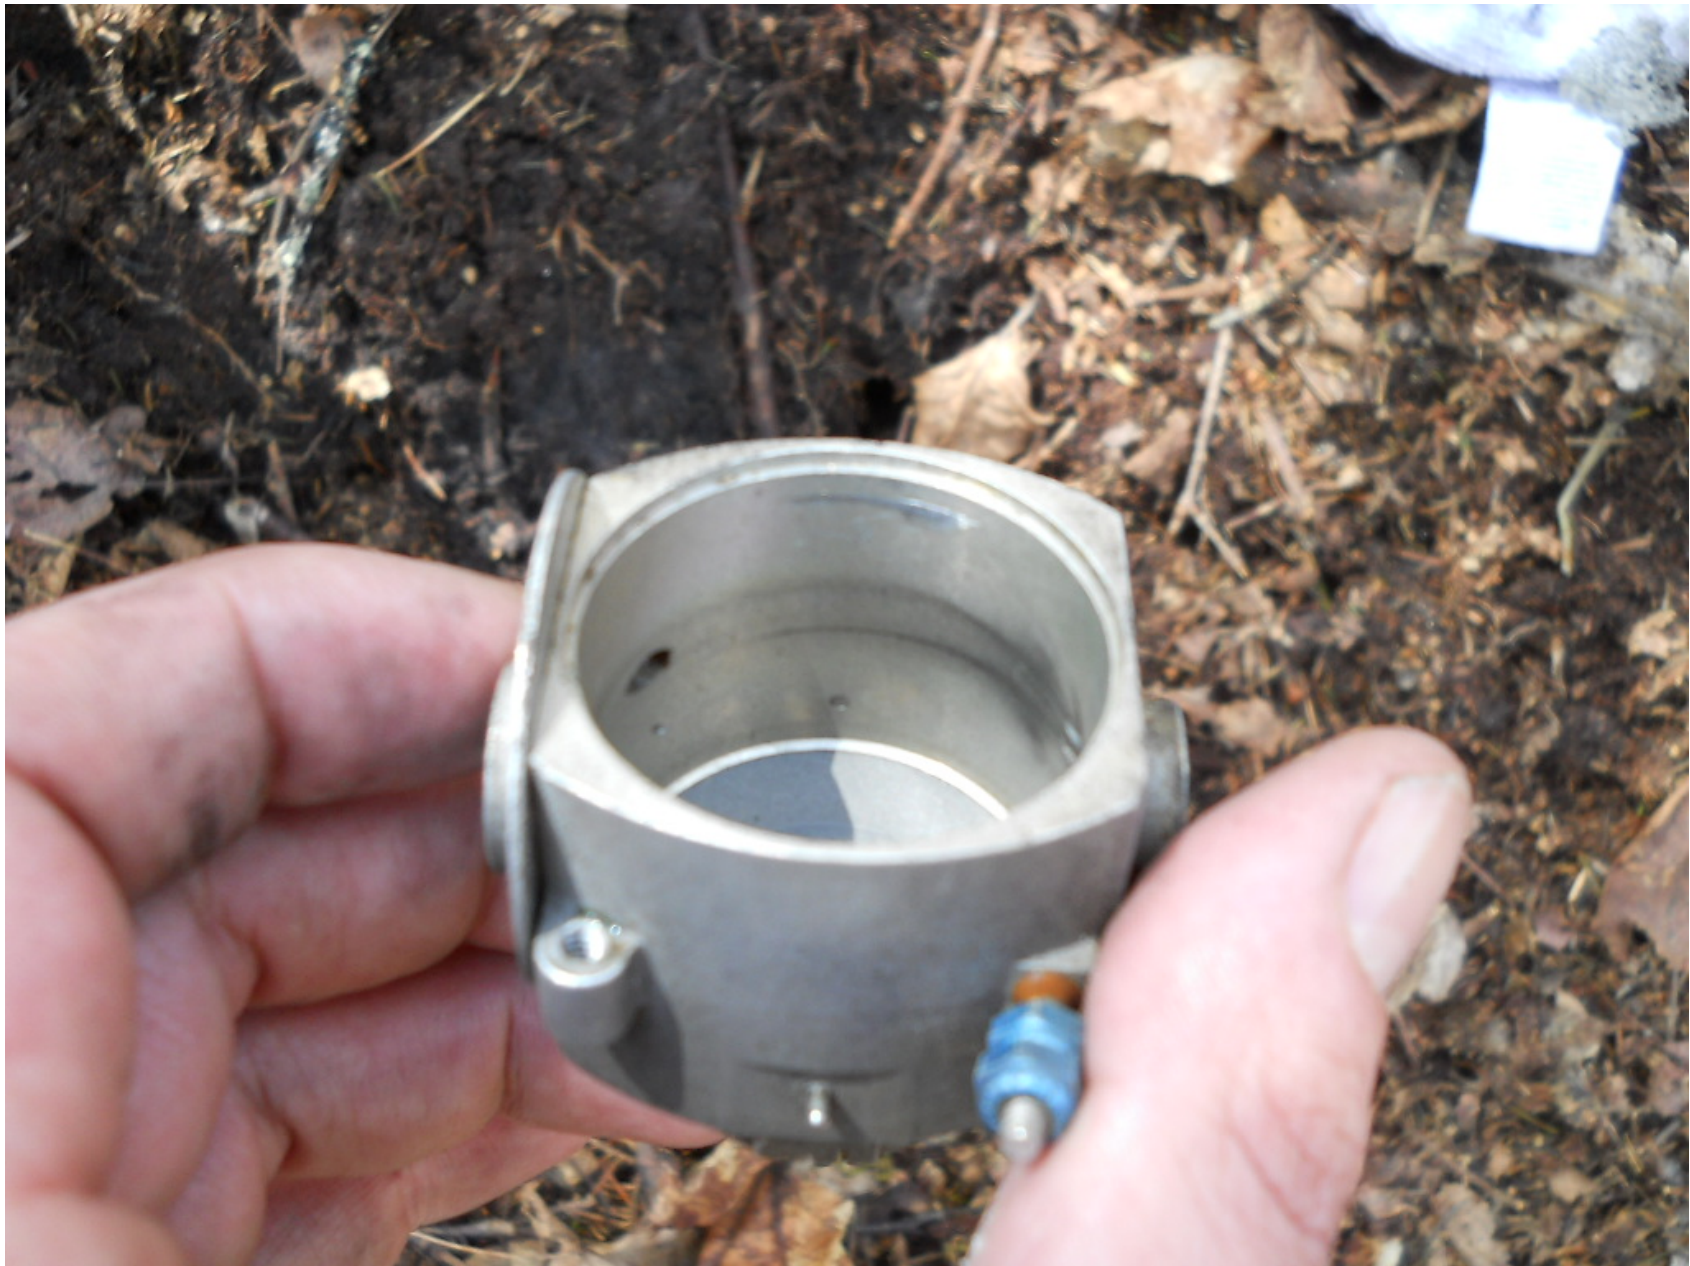
**Photo 6 – Gyro Housing**
