## **AIRFRAME AND ENGINE EXAMINATION FACTUAL REPORT**

**NTSB ACCIDENT NUMBER: ERA18FA150**

**ACCIDENT LOCATION: Chesapeake, Virginia**

**AIRCRAFT REGISTRATION/ TYPE: N6177W/ Piper PA 28-140**

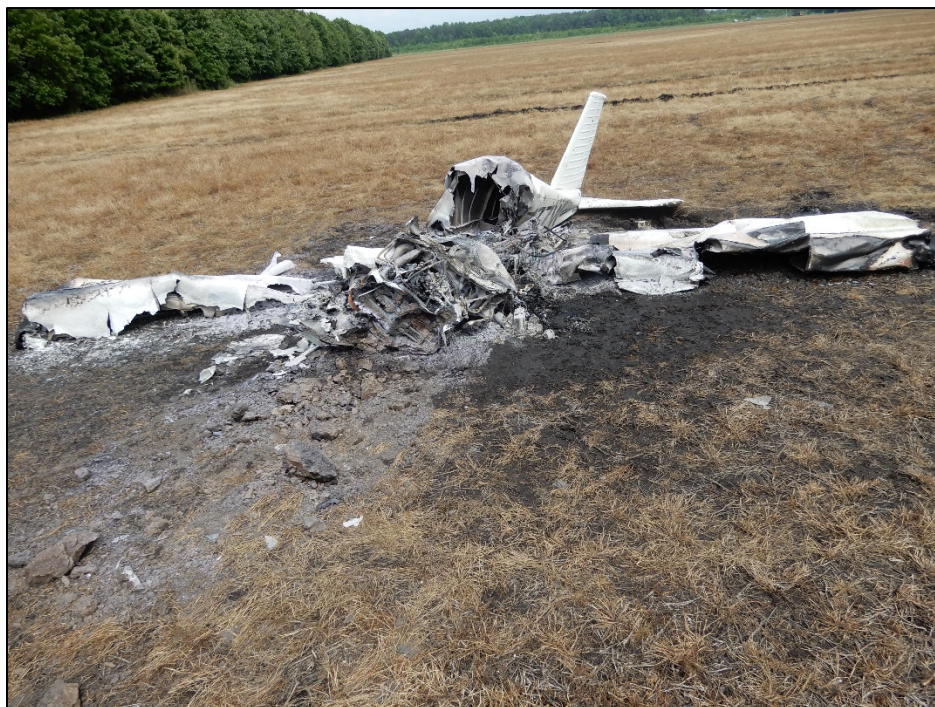
Photo 1: View of the airplane at the accident site

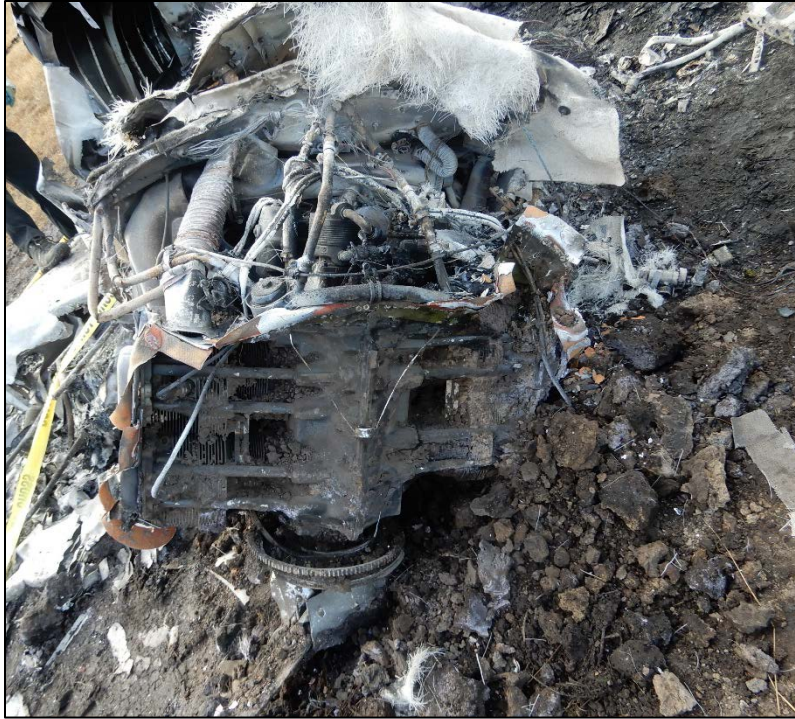
The engine remained attached to the firewall. The vacuum pump was observed at the accident site attached to the accessory section of the engine but missing one of two assembly screws holding the unit together. The single screw that was installed was finger tight (See Additional Investigative Information Section).

Photo 2: View of engine at the accident site

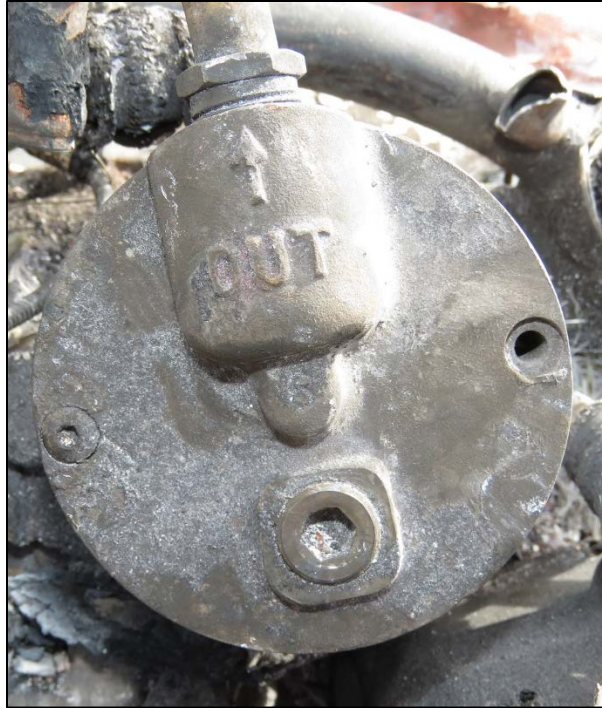
The pump's casing, housing ends, and rotor were consistent with Aero Accessories components. Fretting of the stator and end covers indicated that the pump ran with the missing casing screw for an undetermined amount of time. The stator as found was assembled correctly. However, the six stator vanes were not consistent with Aero Accessories manufactured stator vanes.

The pump exhibited no indication that it failed to operate during the flight. Even though the remaining casing screw was loose and the other missing, there was no indication of mechanical damage or breaking up or seizing of the rotor or vanes. The damage to the drive components/shear coupling appeared to be entirely fire related. The inspection found that the stator and rotor had been installed correctly during the last assembly of the pump. Aero Accessories Inc. issues no overhaul manual for the Aero 3200 series pumps.

Photo 3: Vacuum Pump attached to the engine. Note the right casing screw was found missing.

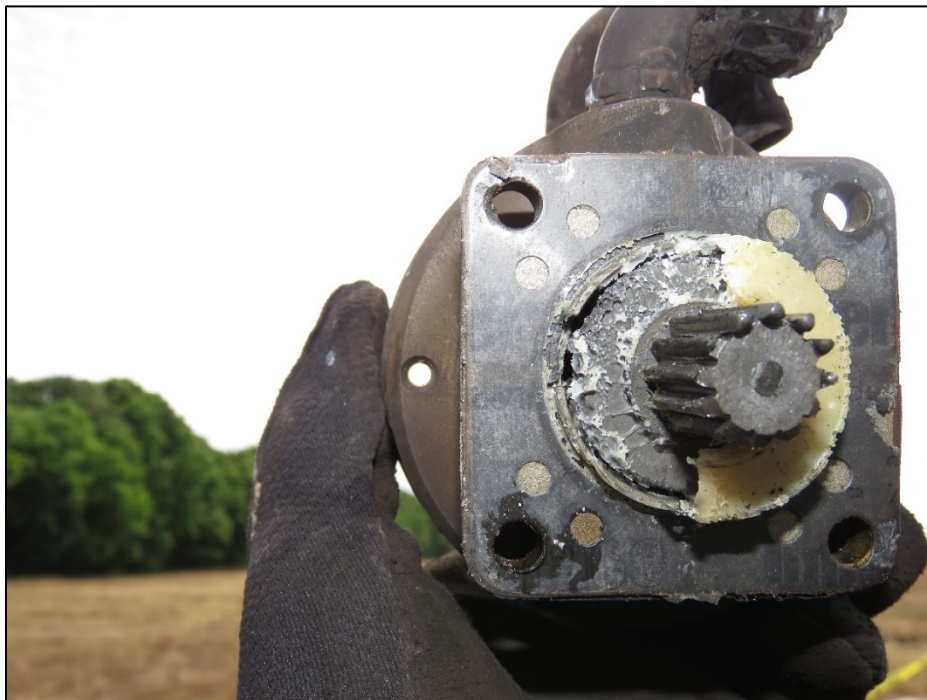
Photo 4: Vacuum Pump Gear Drive.

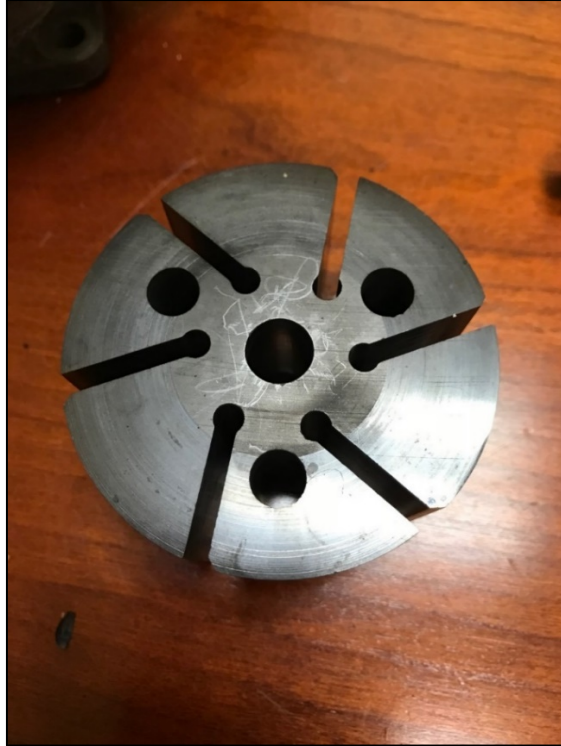
The condition of the body/ stator was consistent of one that was severely worn. Inspection of the stator vanes indicated that replacement vanes were installed after the pump was manufactured. The vanes were worn on the sides and very loose in the rotor slots and were looser than what is acceptable during overhaul or new manufacturer for a pump. The internal examination revealed no indication of damage, other than fire damage.

Photo 5: View of Stator from Vacuum Pump

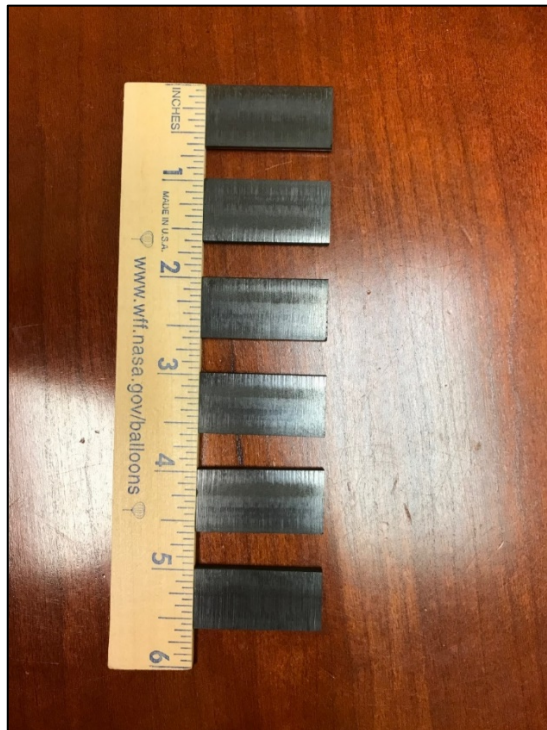
Photo 6: View of vanes removed from vacuum pump
