# NATIONAL TRANSPORTATION SAFETY BOARD

MATERIALS LABORATORY FACTUAL REPORT

Report No. 18-056

Place : Chesapeake, Virginia  
Date : May 22, 2018  
Vehicle : PA28-140, Piper Cherokee  
NTSB No. : ERA18FA150  
Investigator : Adam Gerhardt, AS-ERA

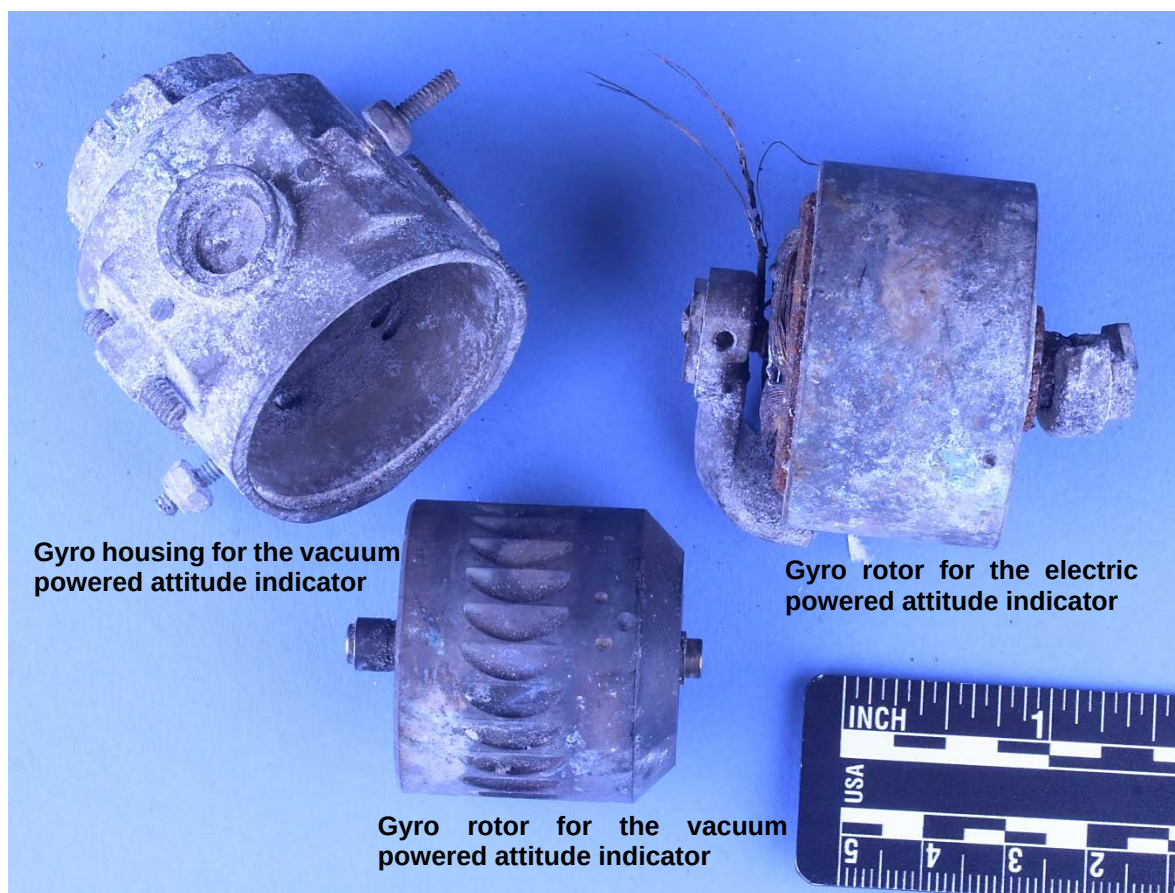
Figure 1 shows a photograph of the as-received gyro rotor and housing for the vacuum powered attitude indicator and rotor for the electric powered attitude indicator. The surface of these parts was covered with black soot and oxide from exposure to a fire. Bench binocular examination of the outer surface of the rotors and the inner surface of the housing for the rotor revealed no evidence of circumferential score (gouge) marks.

Figure 1. As-received gyro parts for the vacuum and electric powered attitude indicators.

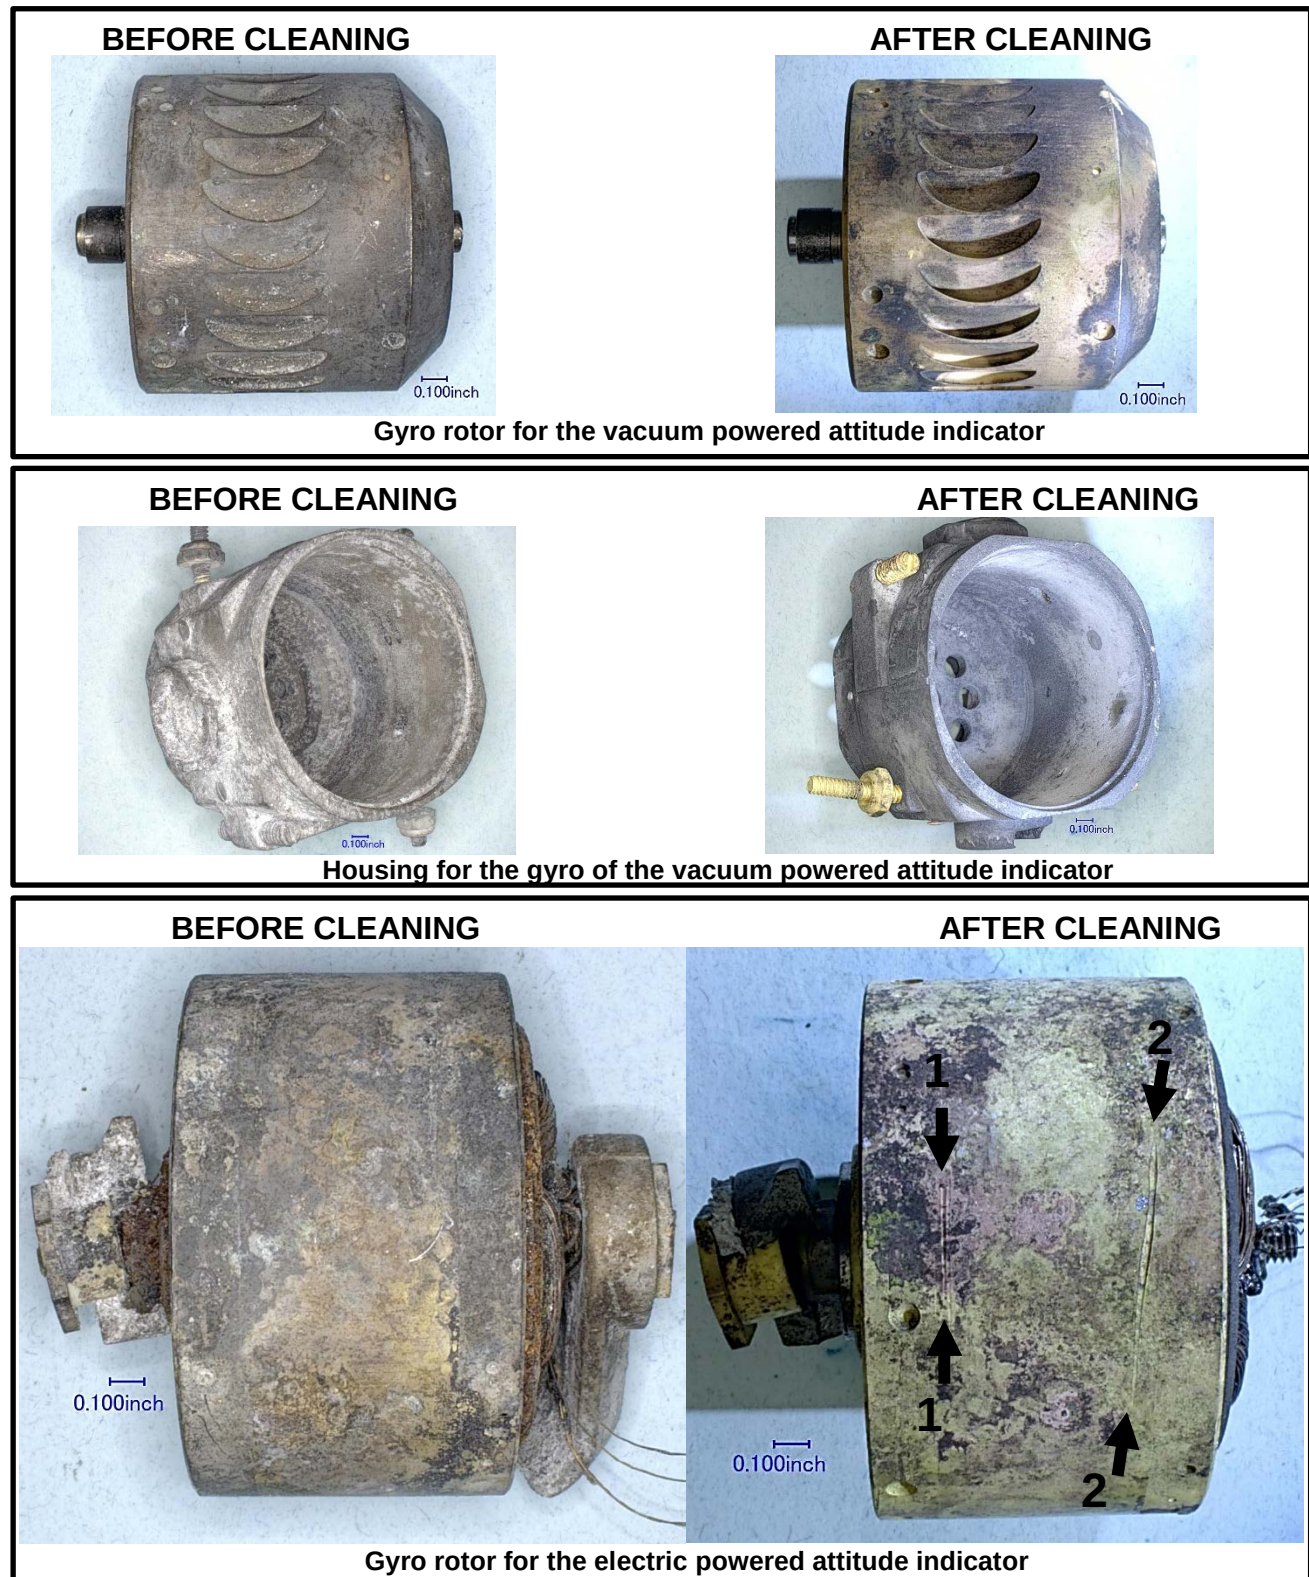
The parts were immersed in a solution of Evapo-Rust, a commercial cleaner. The Evapo-Rust cleaning process exposed the bare surface of the gyro rotors for the vacuum and electric powered attitude indicators but did not remove black oxide from the surface of the housing for the vacuum powered attitude indicator. The housing for the vacuum powered attitude indicator was immersed in a heated chromic solution, a cleaning solution prescribed in ASTM G1, Designation C.1.1, titled "Standard Practice for Preparing, Cleaning and Evaluating Corrosion Test Specimens" for cleaning corrosion products on aluminum alloys. Bench binocular examination of the cleaned outer surface of the rotor and the inner surface of the housing for the vacuum powered attitude indicator revealed no evidence of circumferential gouge marks. The cleaned surface of the rotor for the electric attitude indicator revealed evidence of a circumferential gouge mark in the area between arrows "1" in figure 2. The length of the gouge mark measured approximately 0.3 inches. Another gouge mark was found in the area between arrows "2" in figure 2 that was on a slight diagonal relative to the circumference. The length of this gouge mark measured approximately 0.7 inches. Both gouge marks were found on the same side of the rotor.

Figure 2. Photograph of the gyros parts before cleaning (left side of page) and after cleaning (right side of page).
