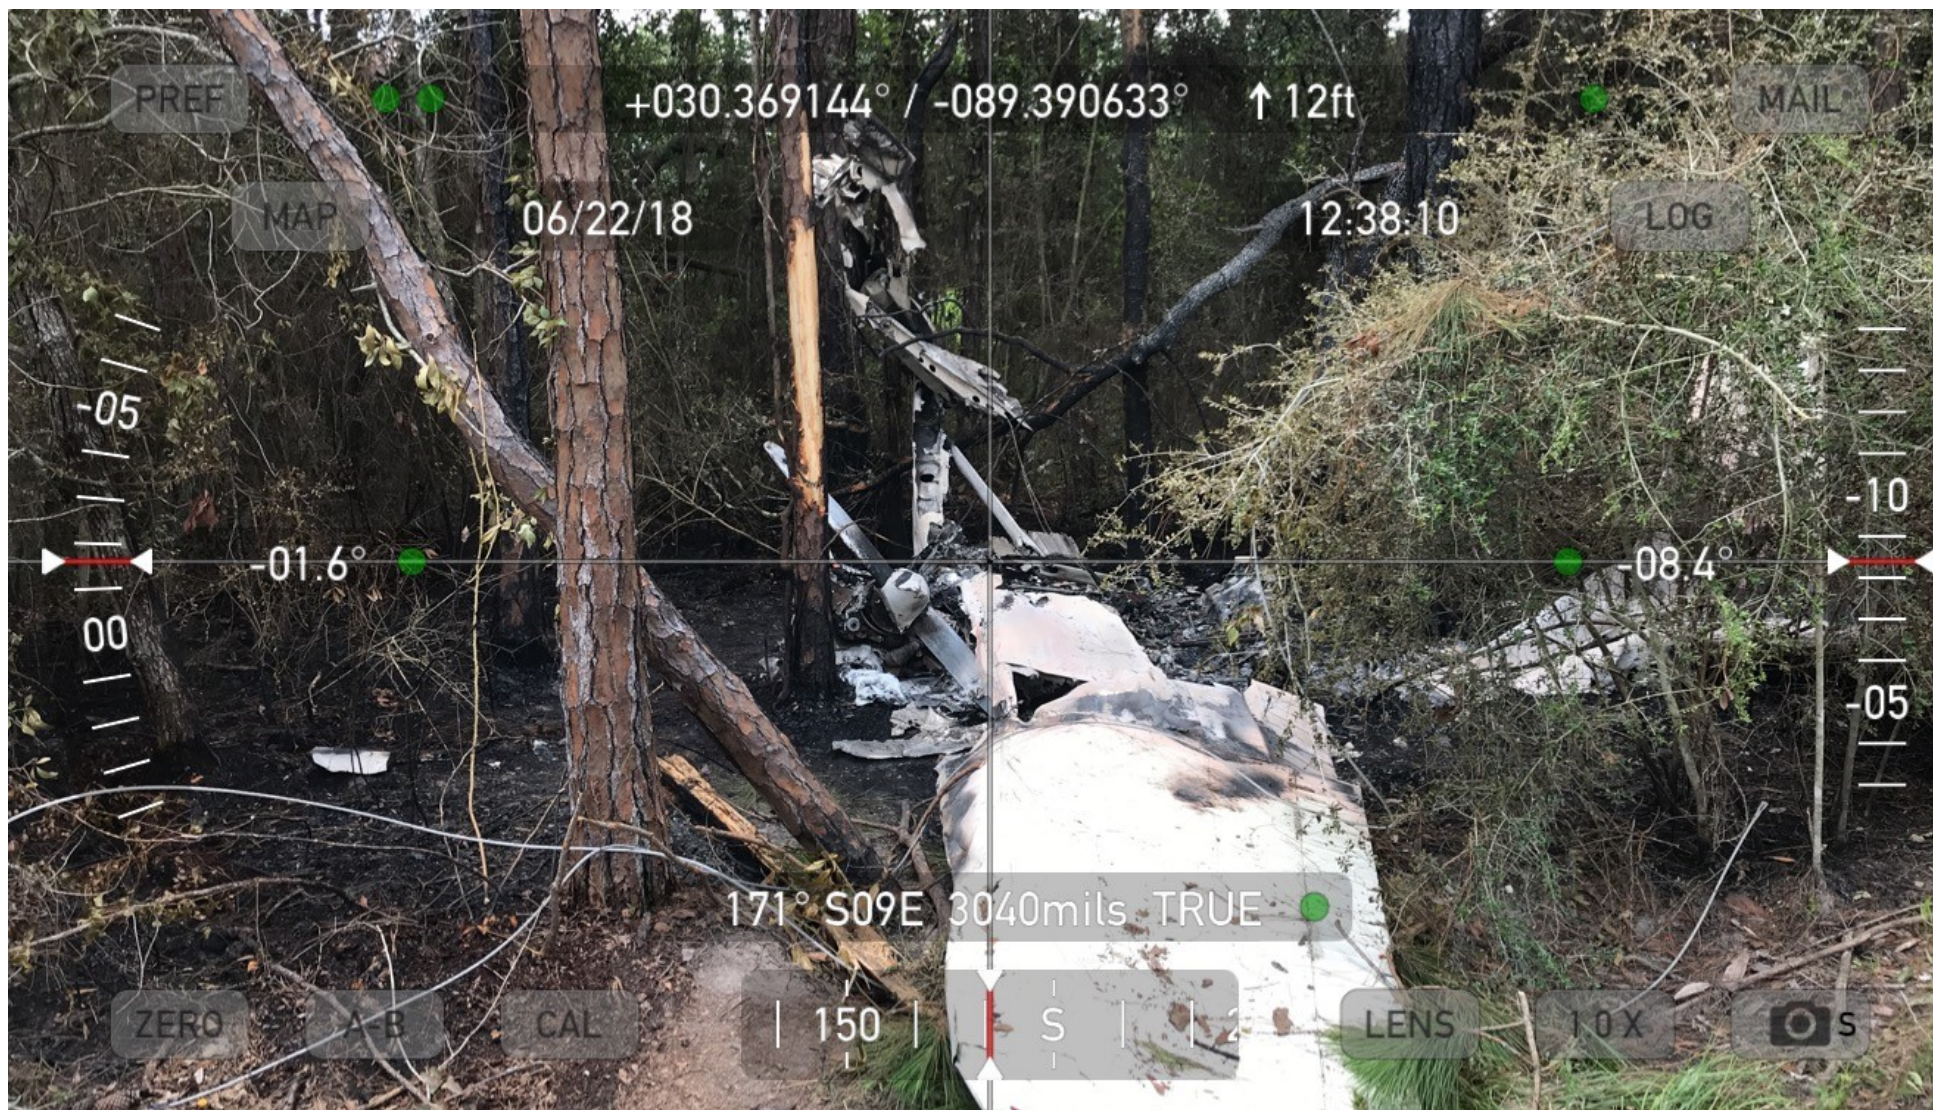
Photo 1 – View of Main Wreckage as Found (FAA)

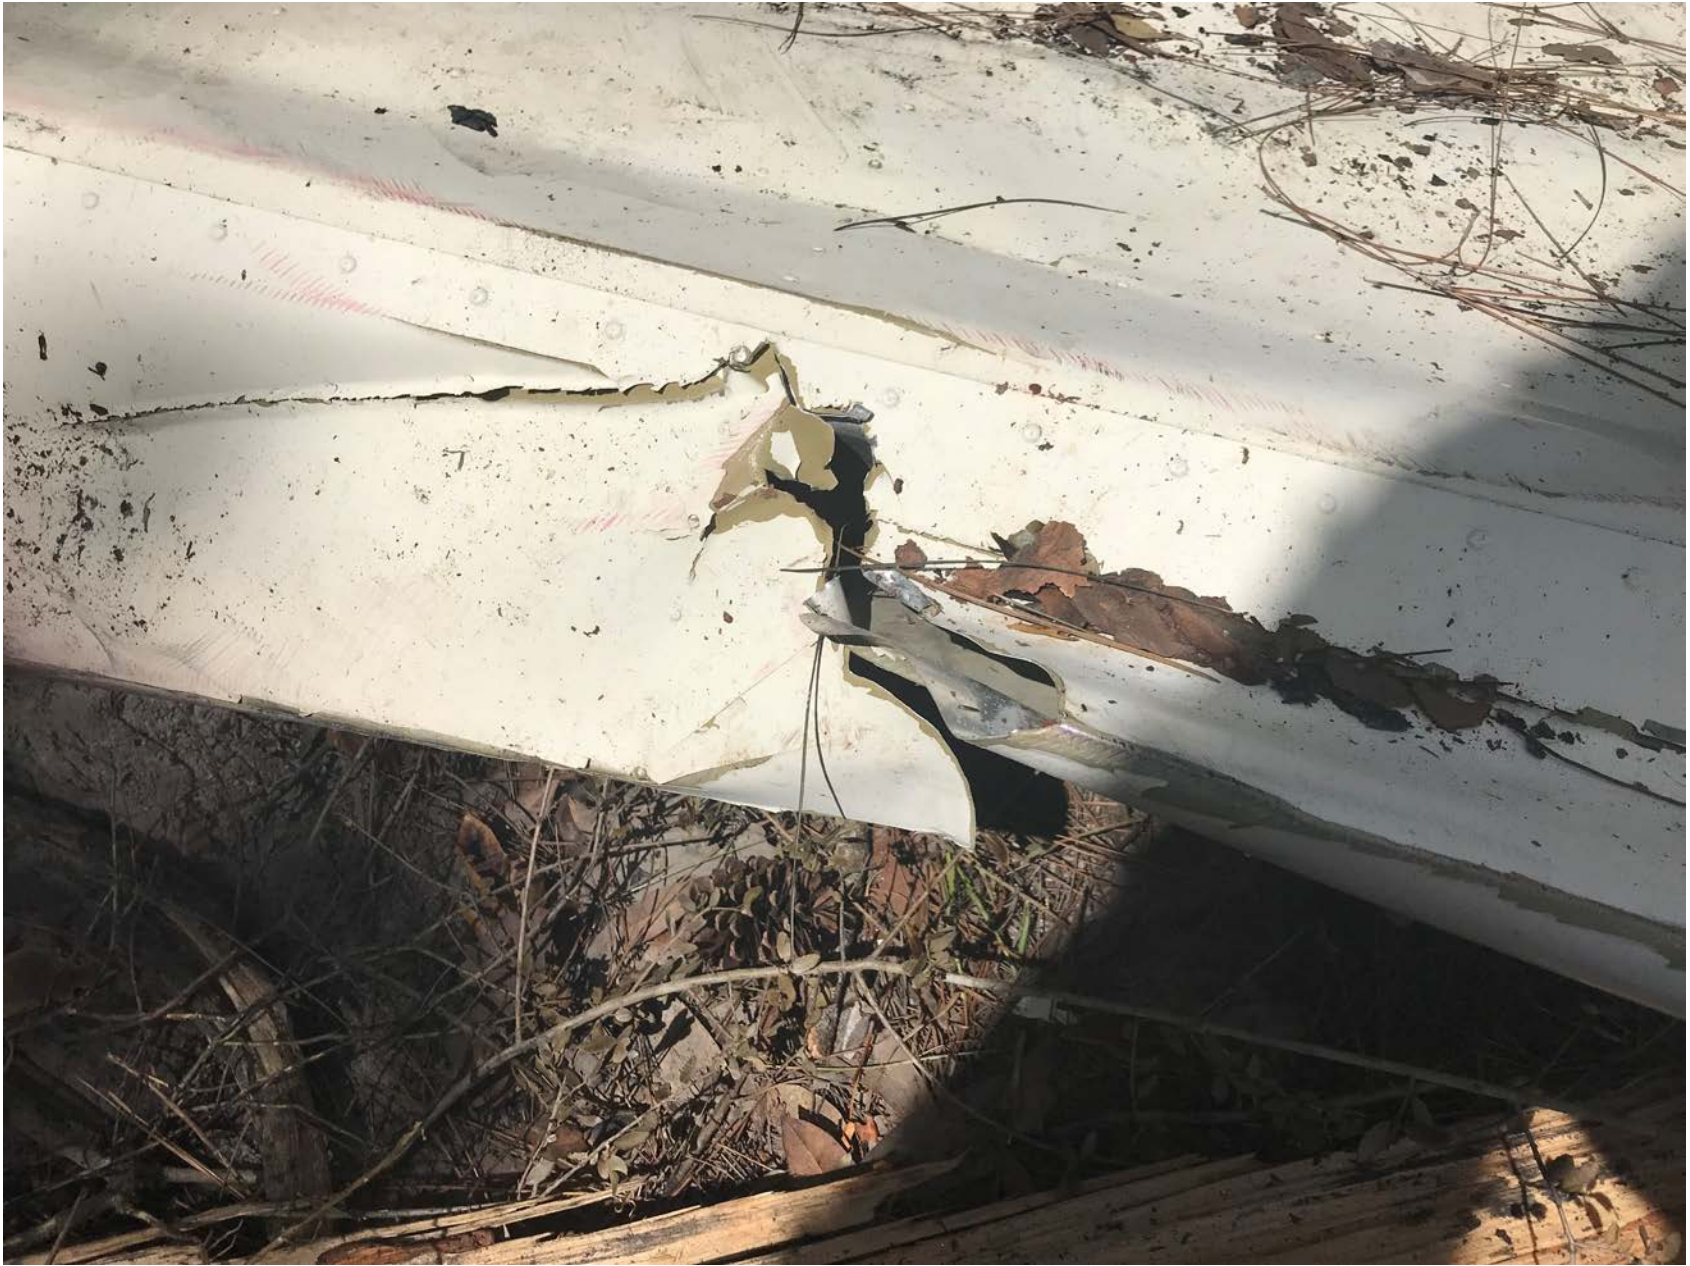
**Photo 2 – View of Left Wing Leading Edge as Found (FAA)**

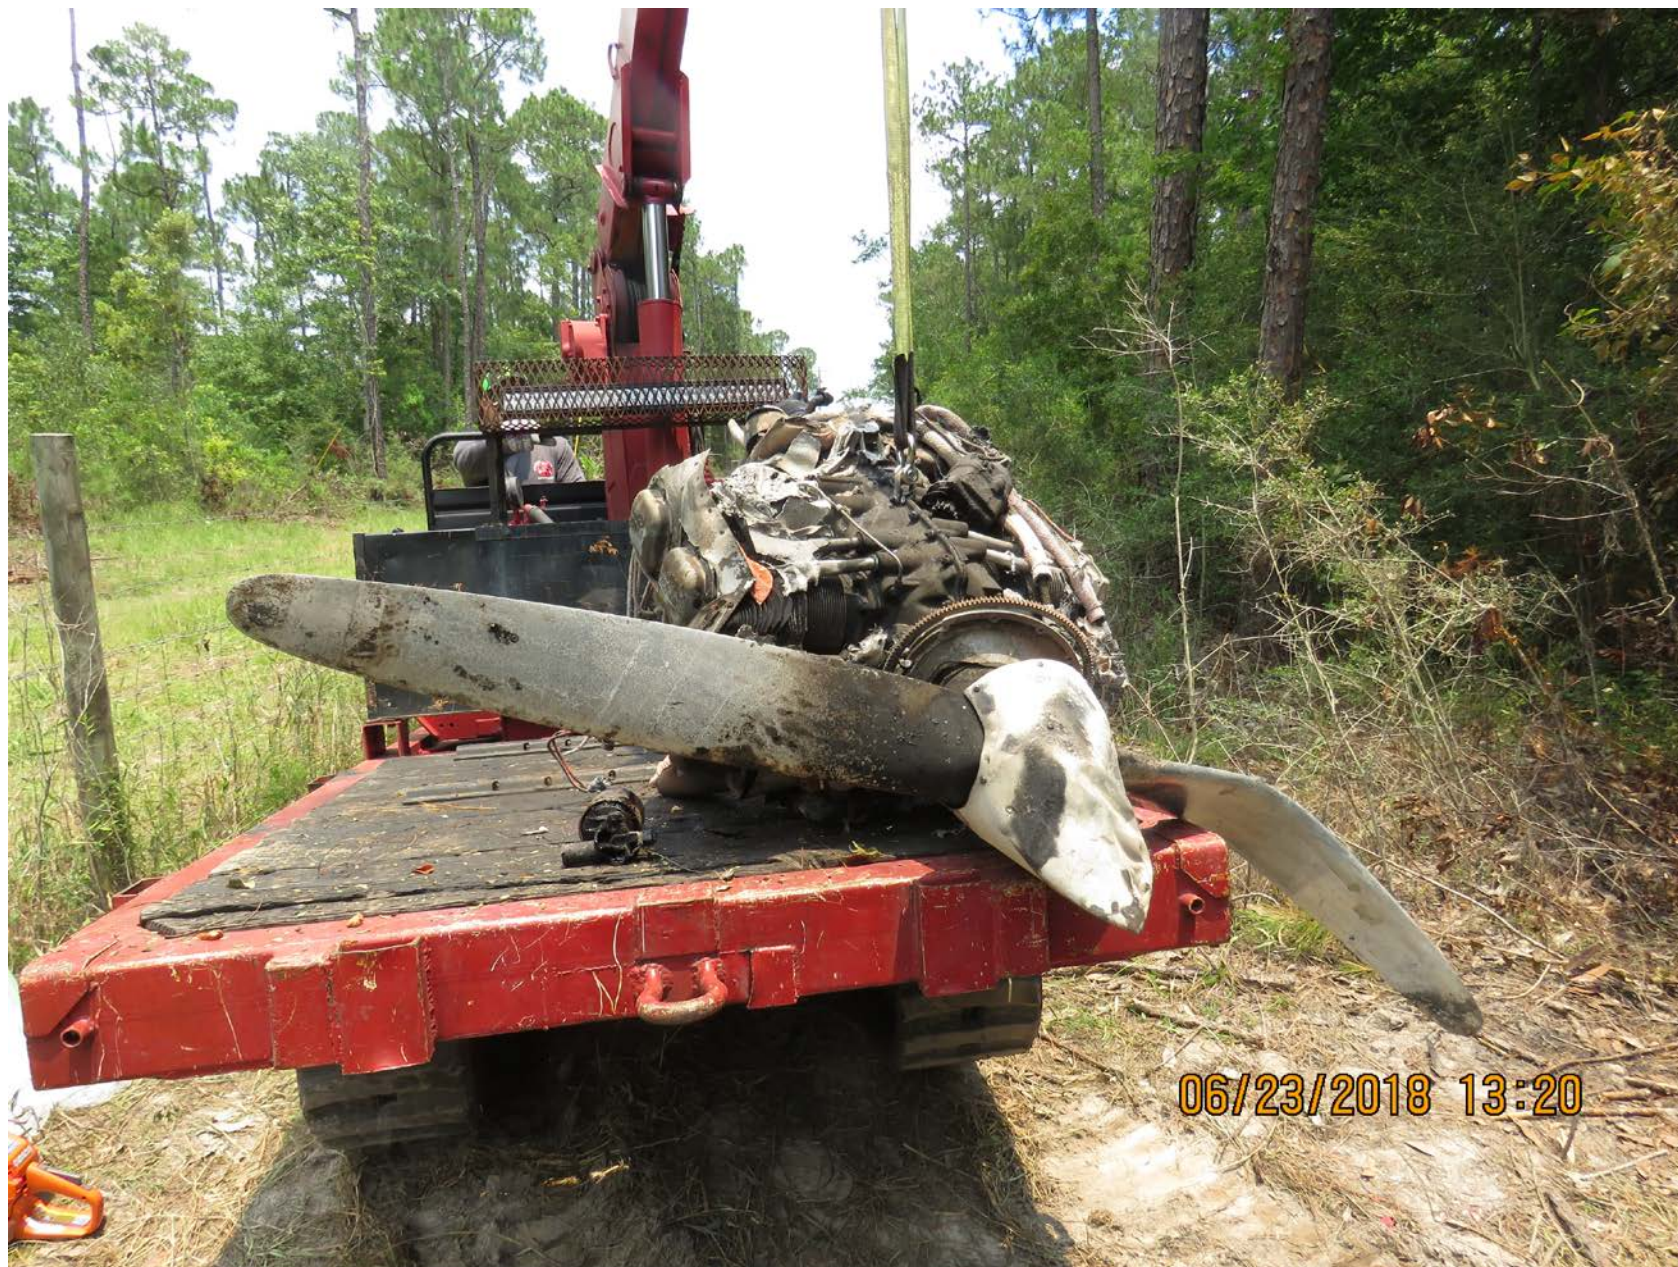
**Photo 3 – View of Engine after Recovery (Lycoming)**

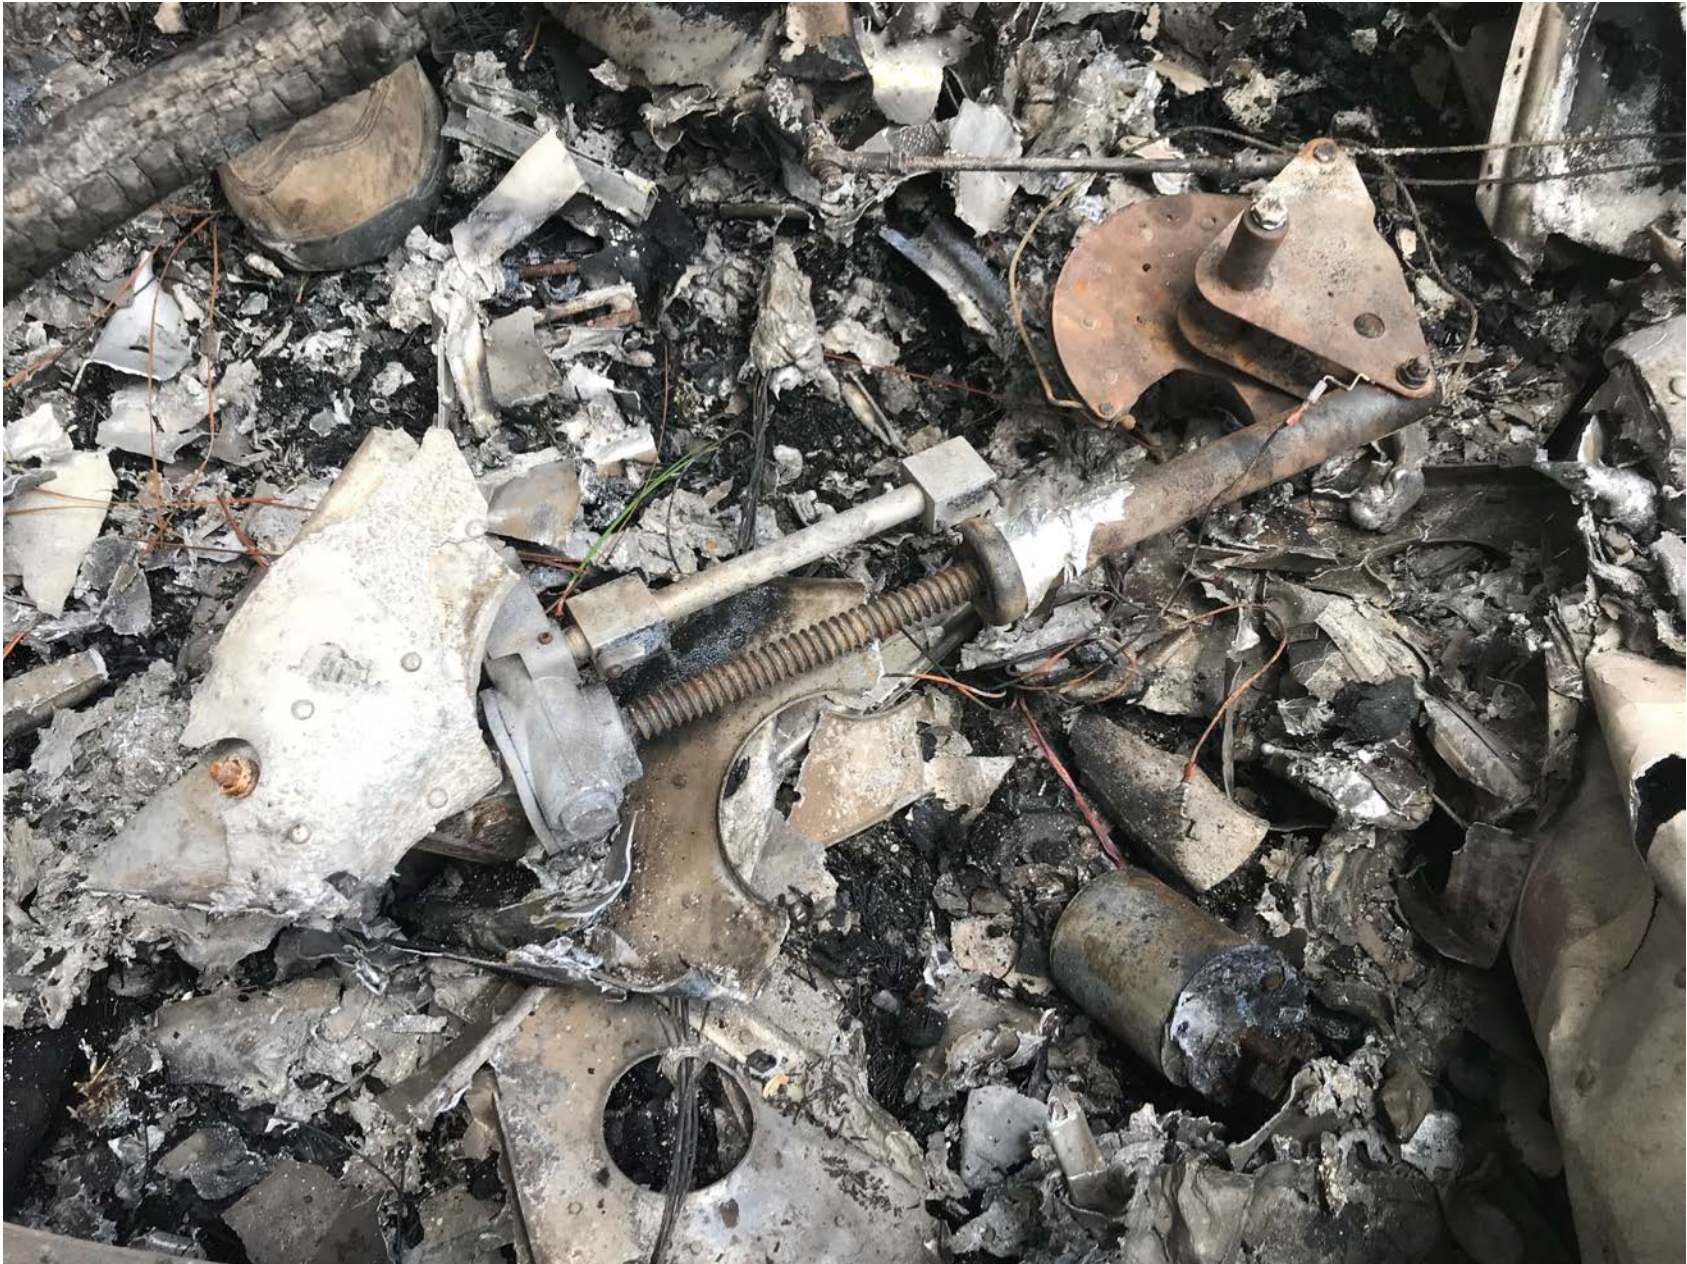
**Photo 4 – View of Flap Actuator as Found (FAA)**

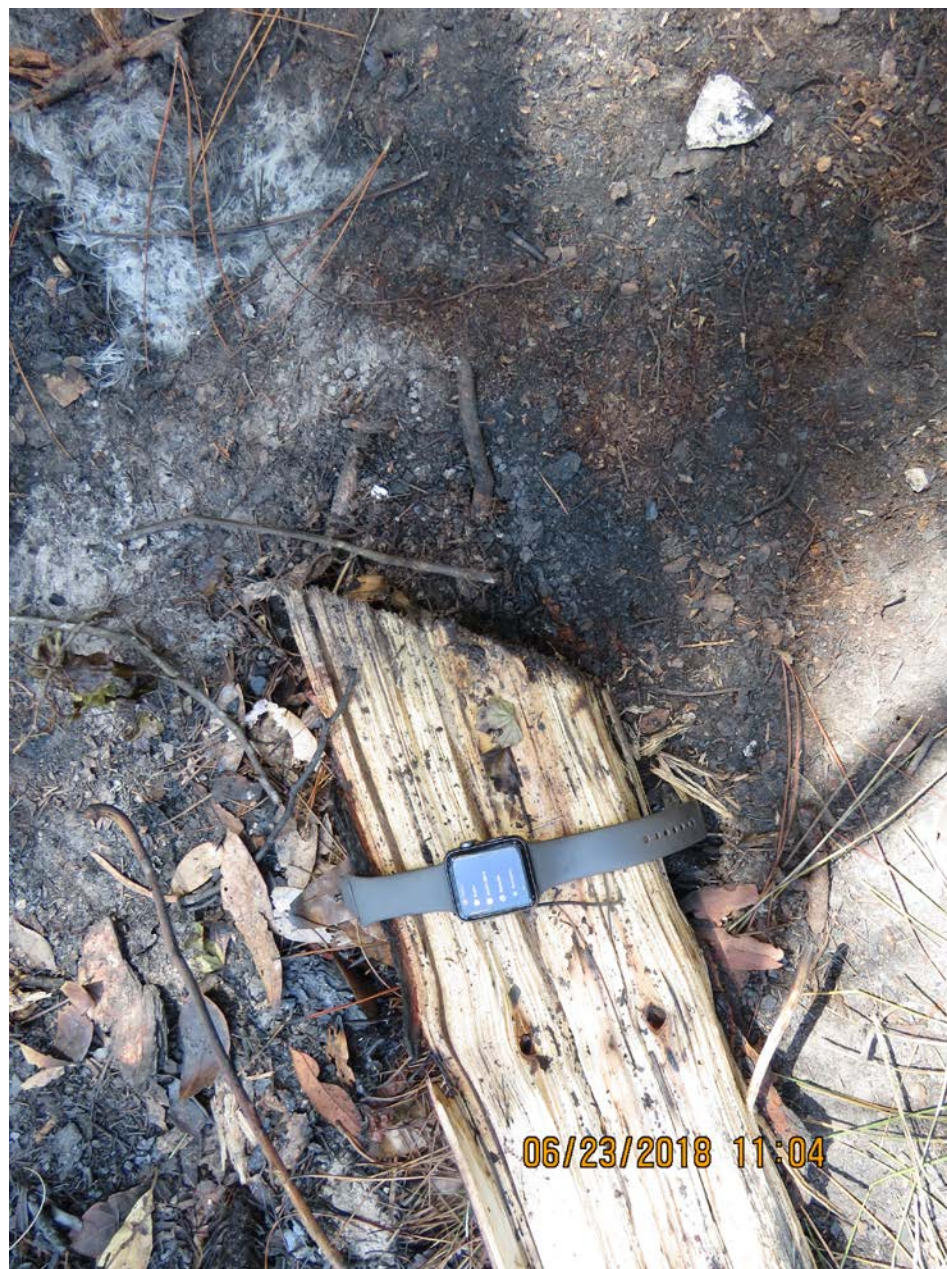
**Photo 5 – View of Angular Cut to Fractured Tree Trunk at Site (FAA)**

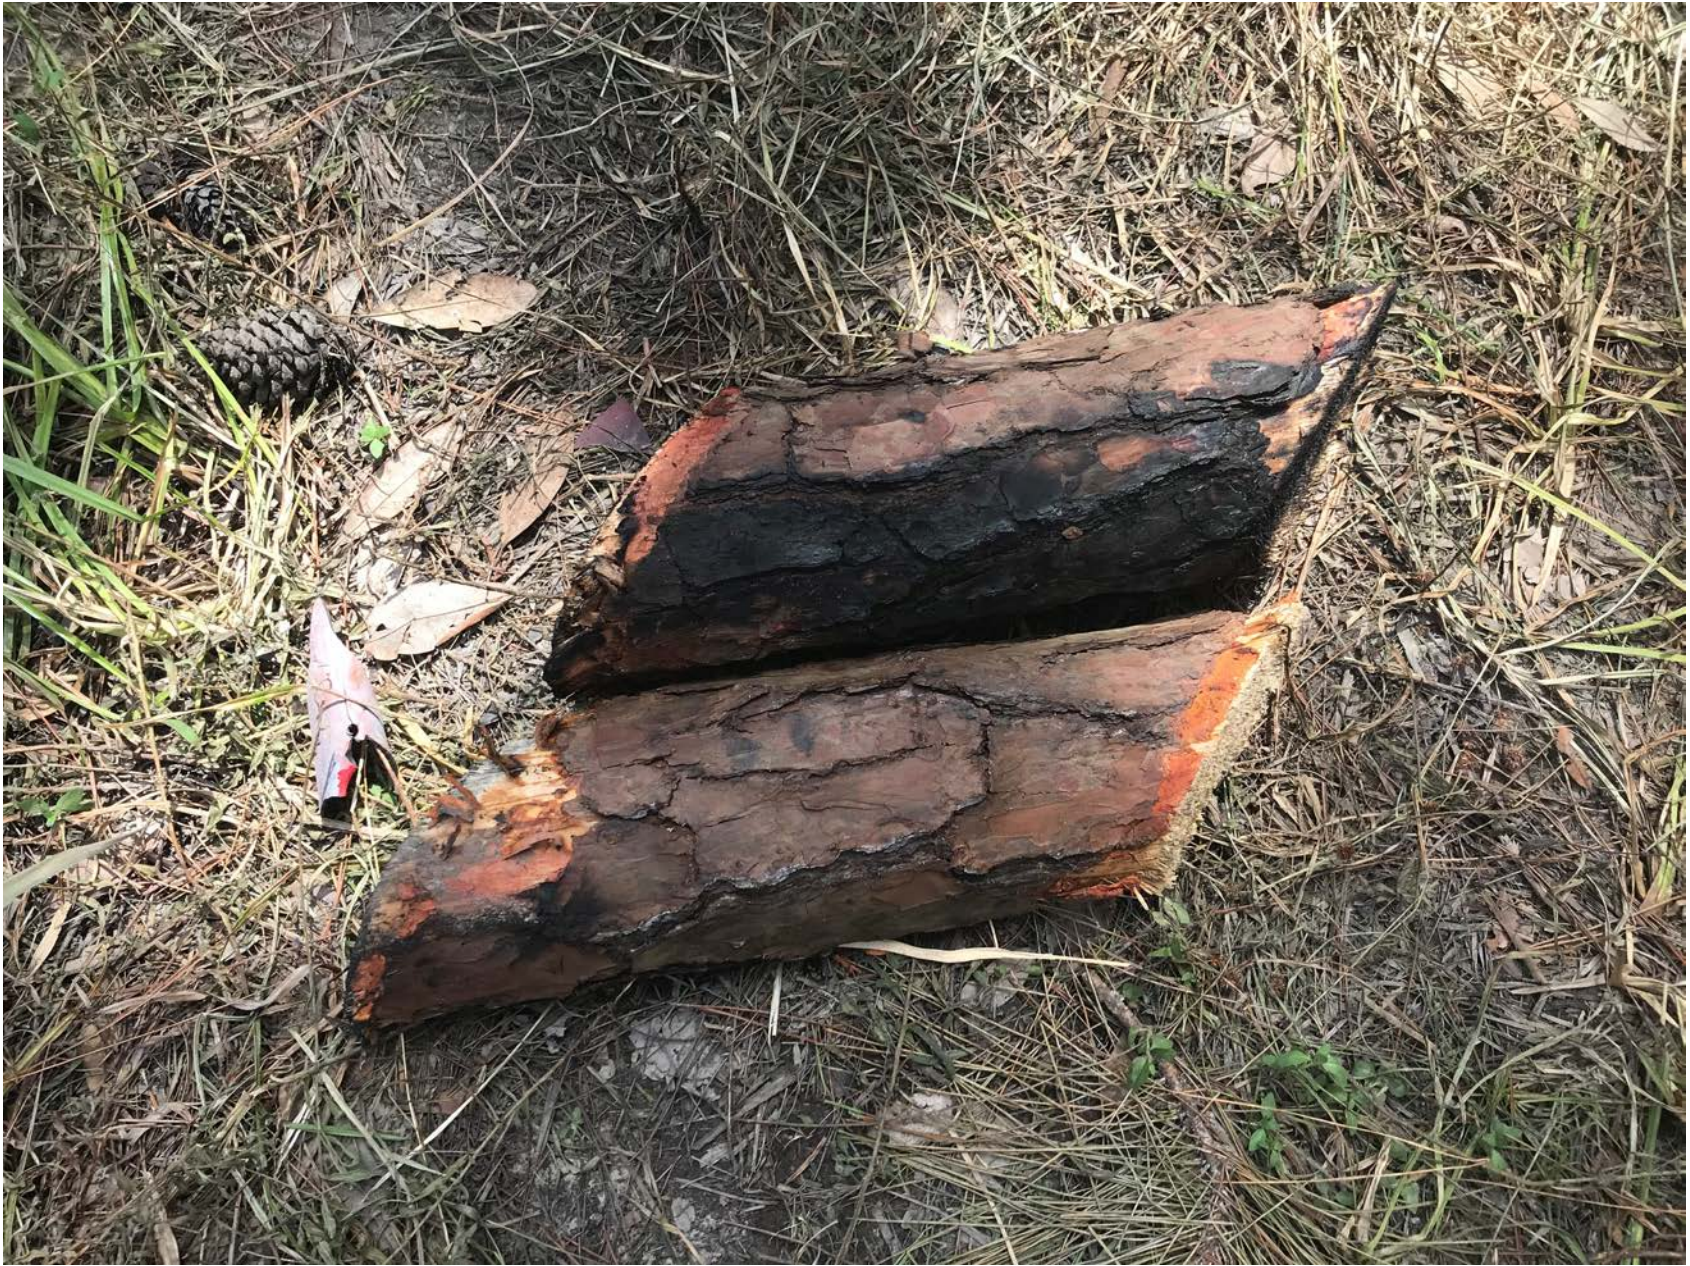
**Photo 6 – View of Angularly Cut Tree Trunk Sections at Site (FAA)**
