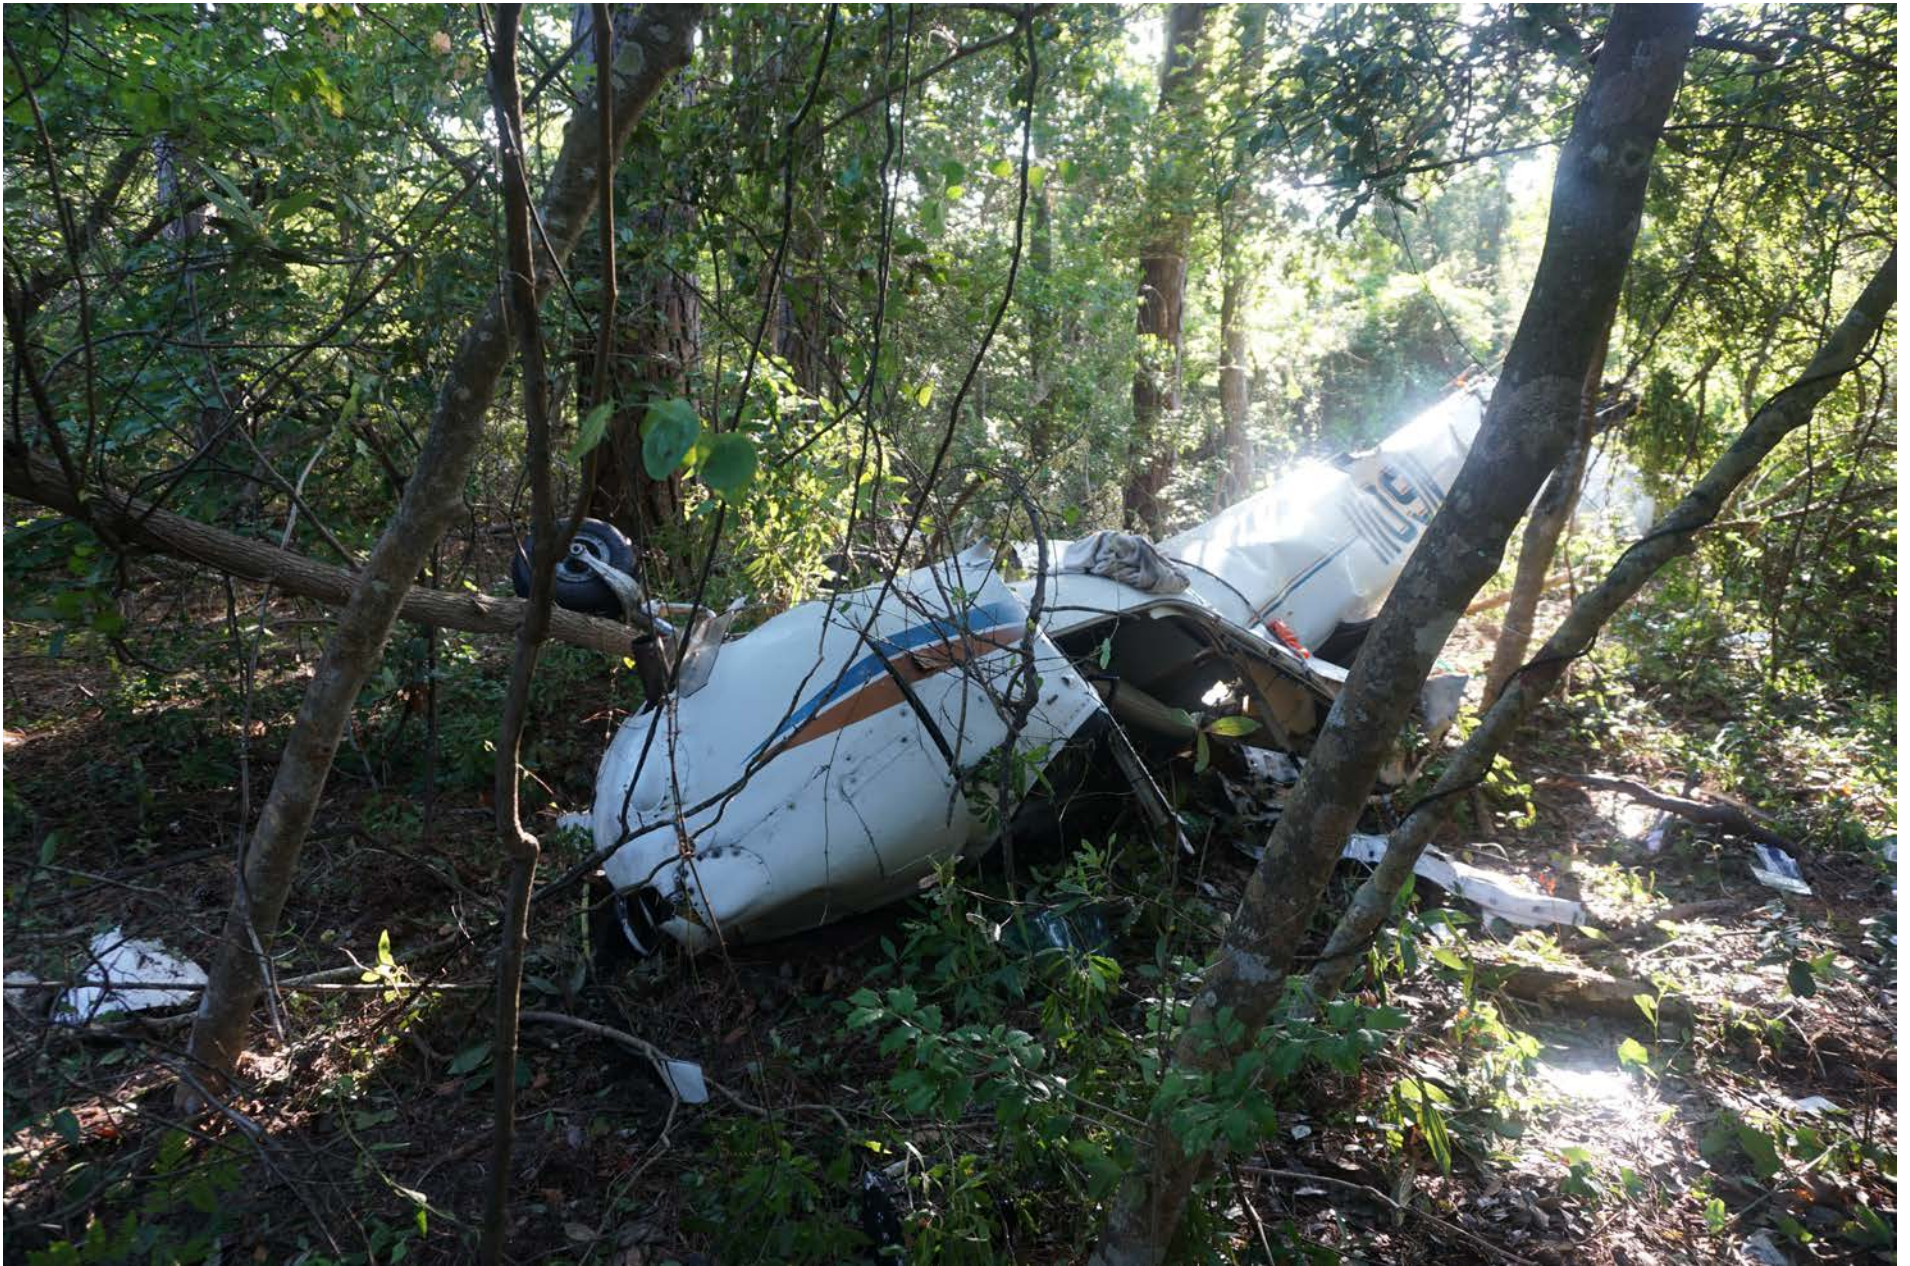
**Photo 1 – Front view of wreckage of airplane**

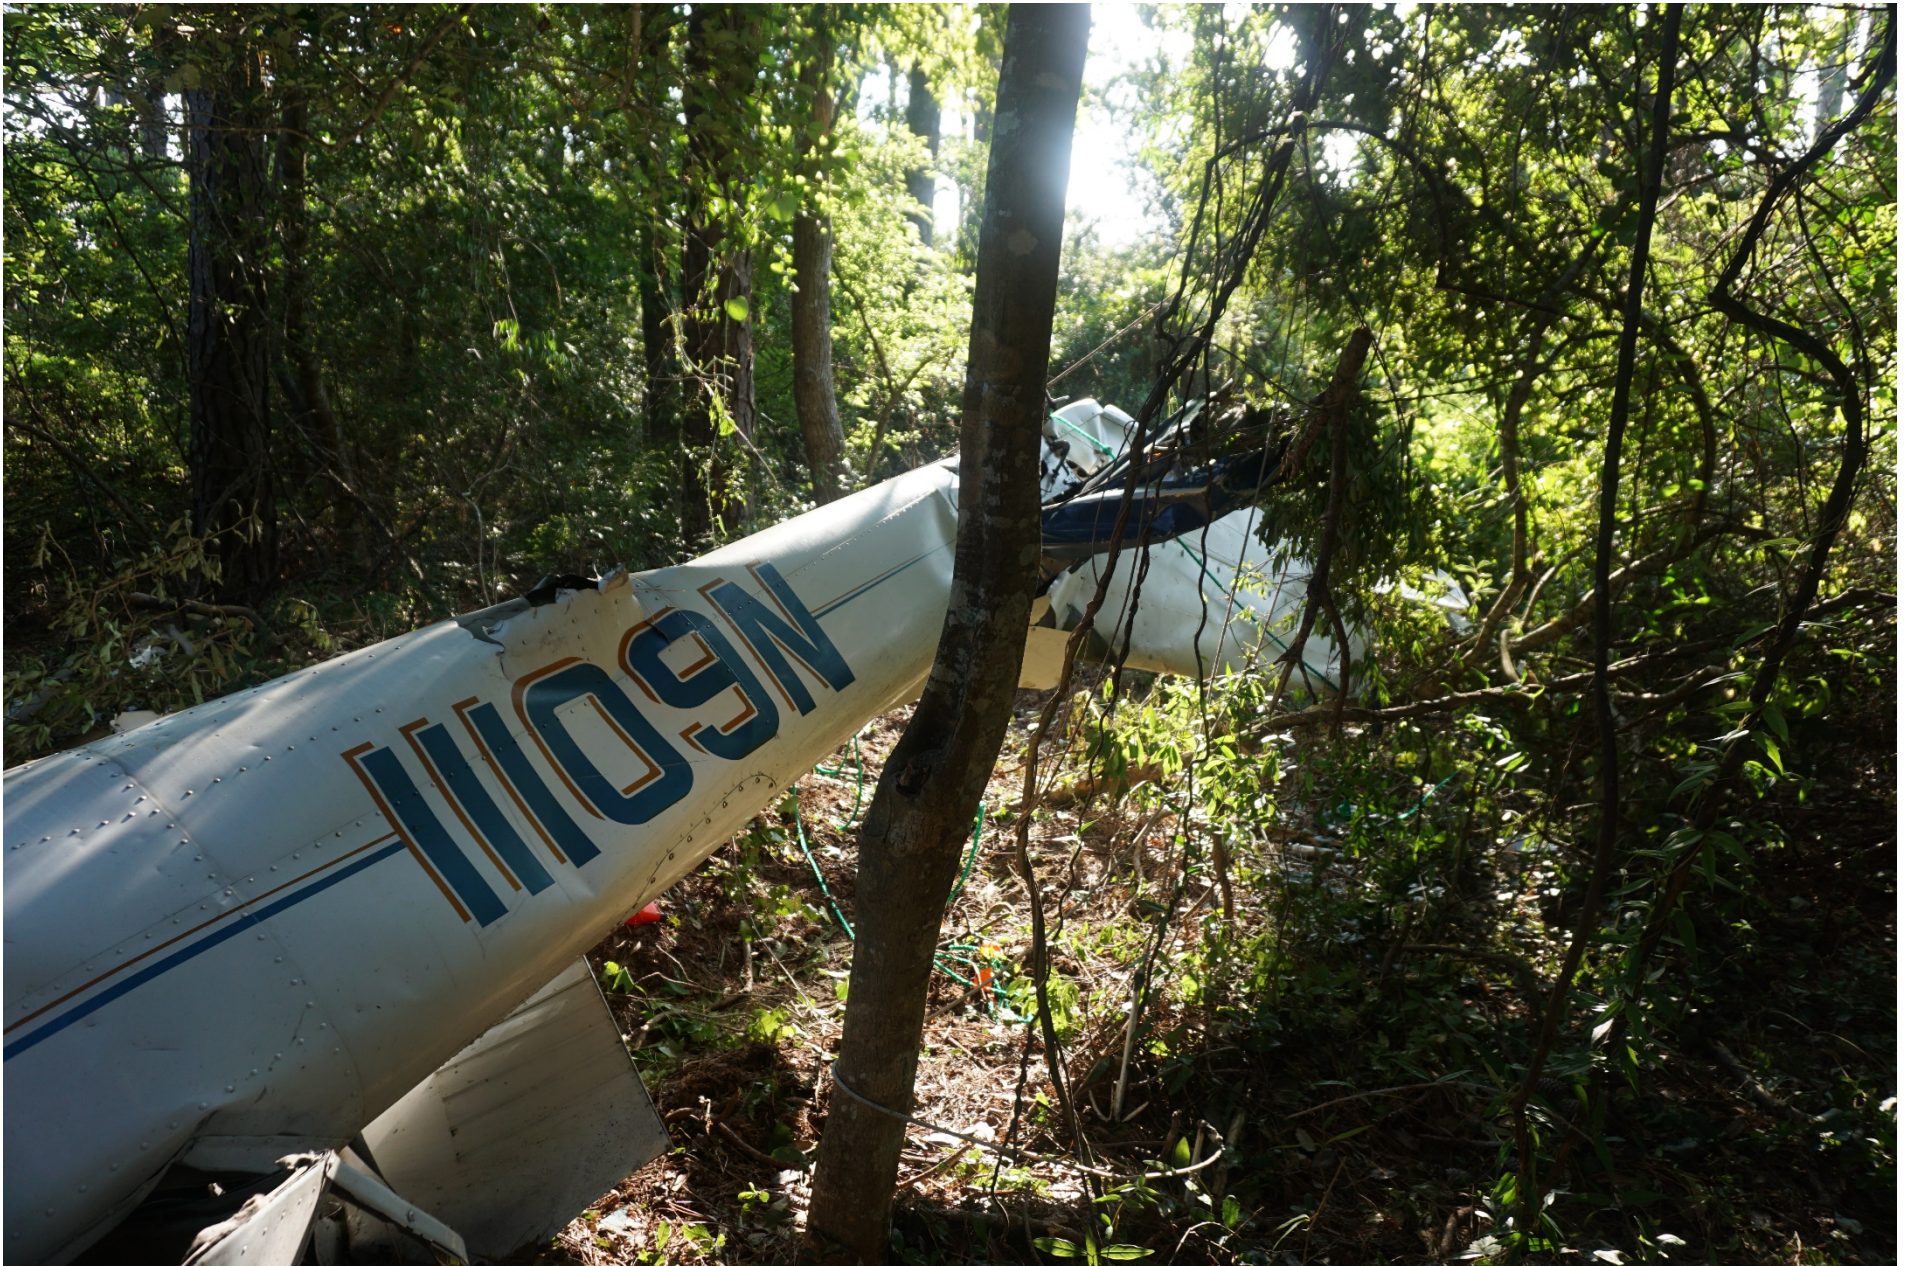
**Photo 2 – View of the damaged right side of the empennage**

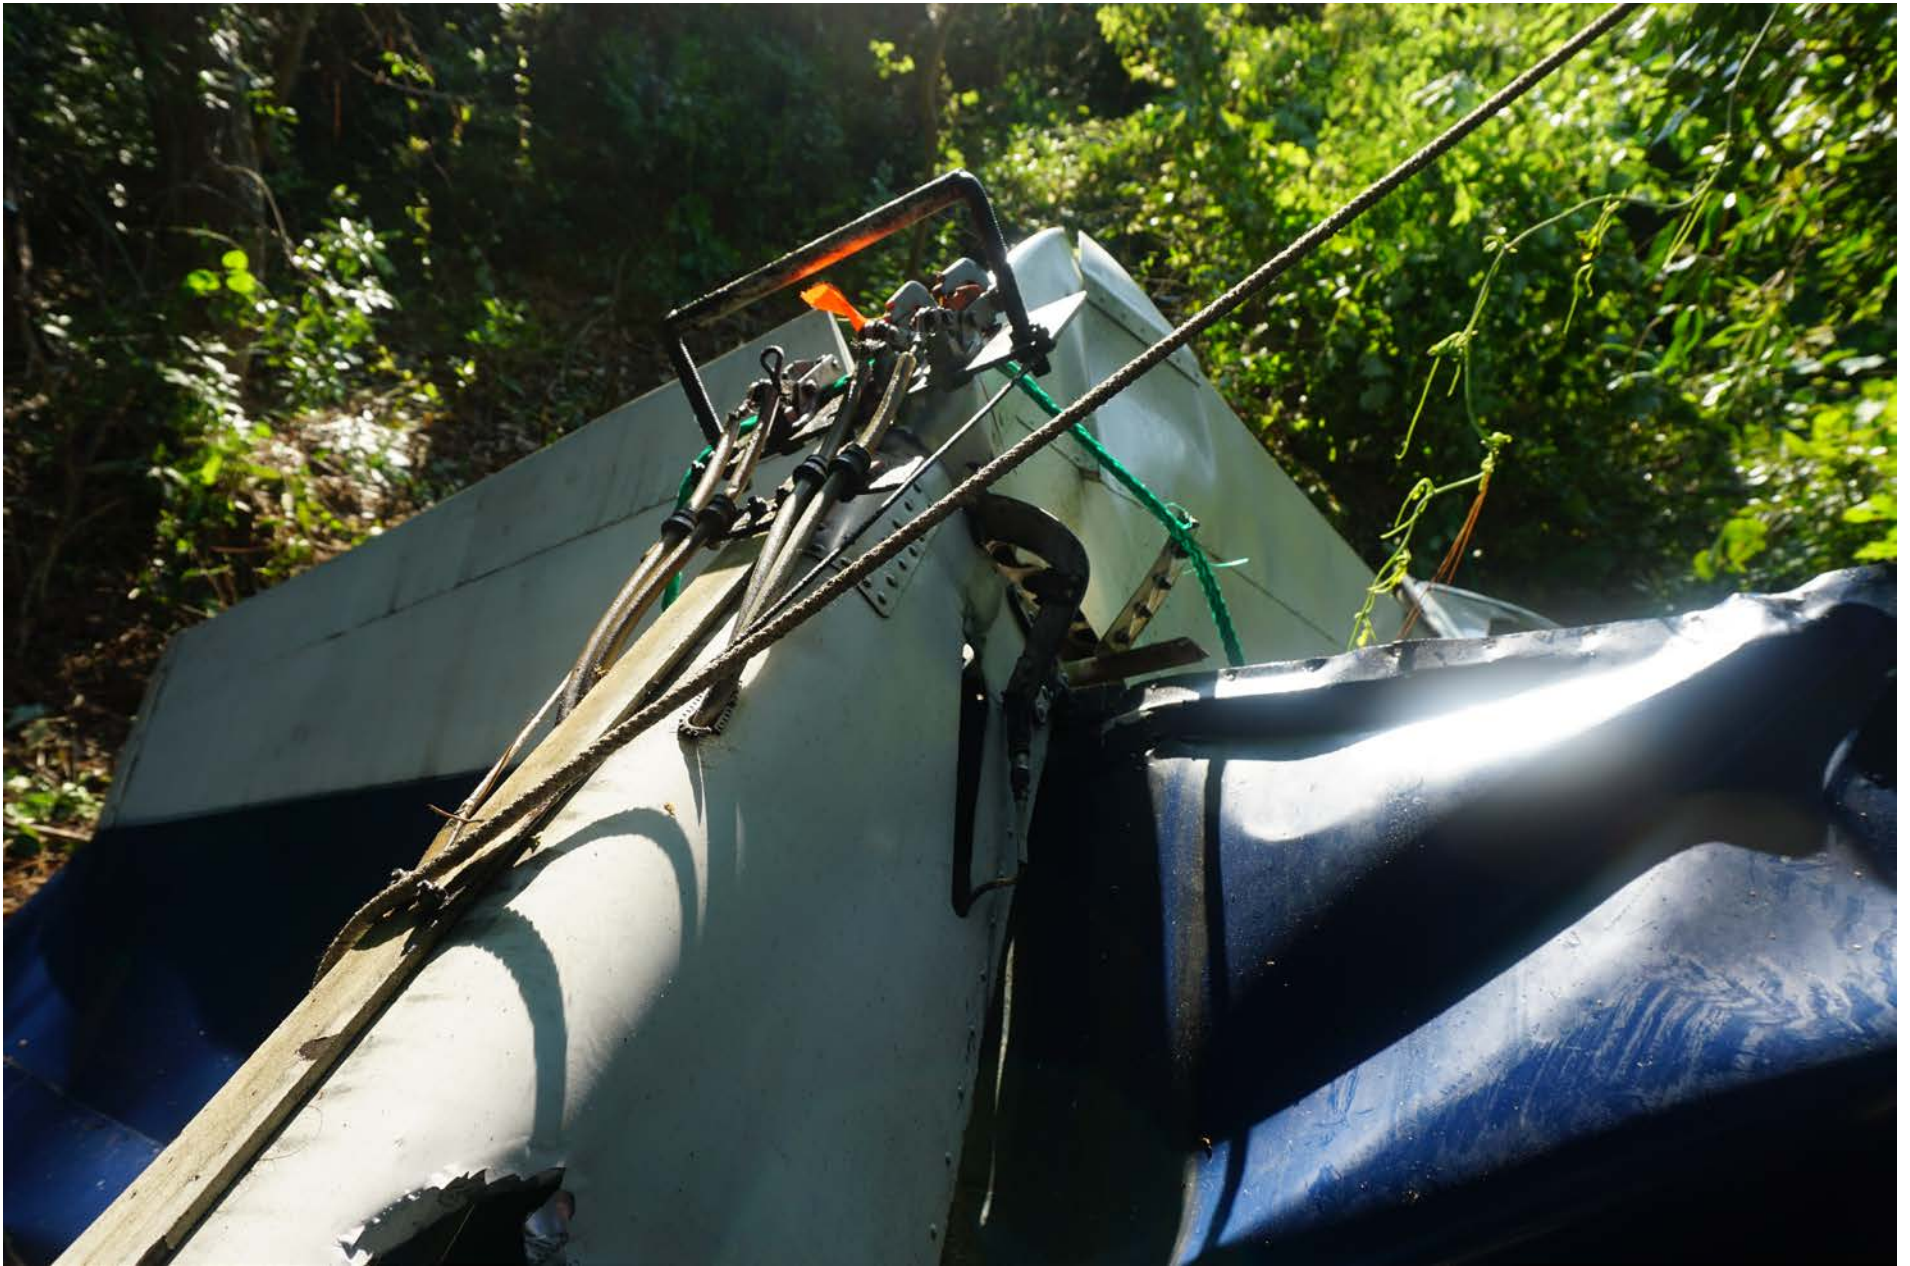
**Photo 3 – View of banner tow rope entangled right horizontal stabilizer**

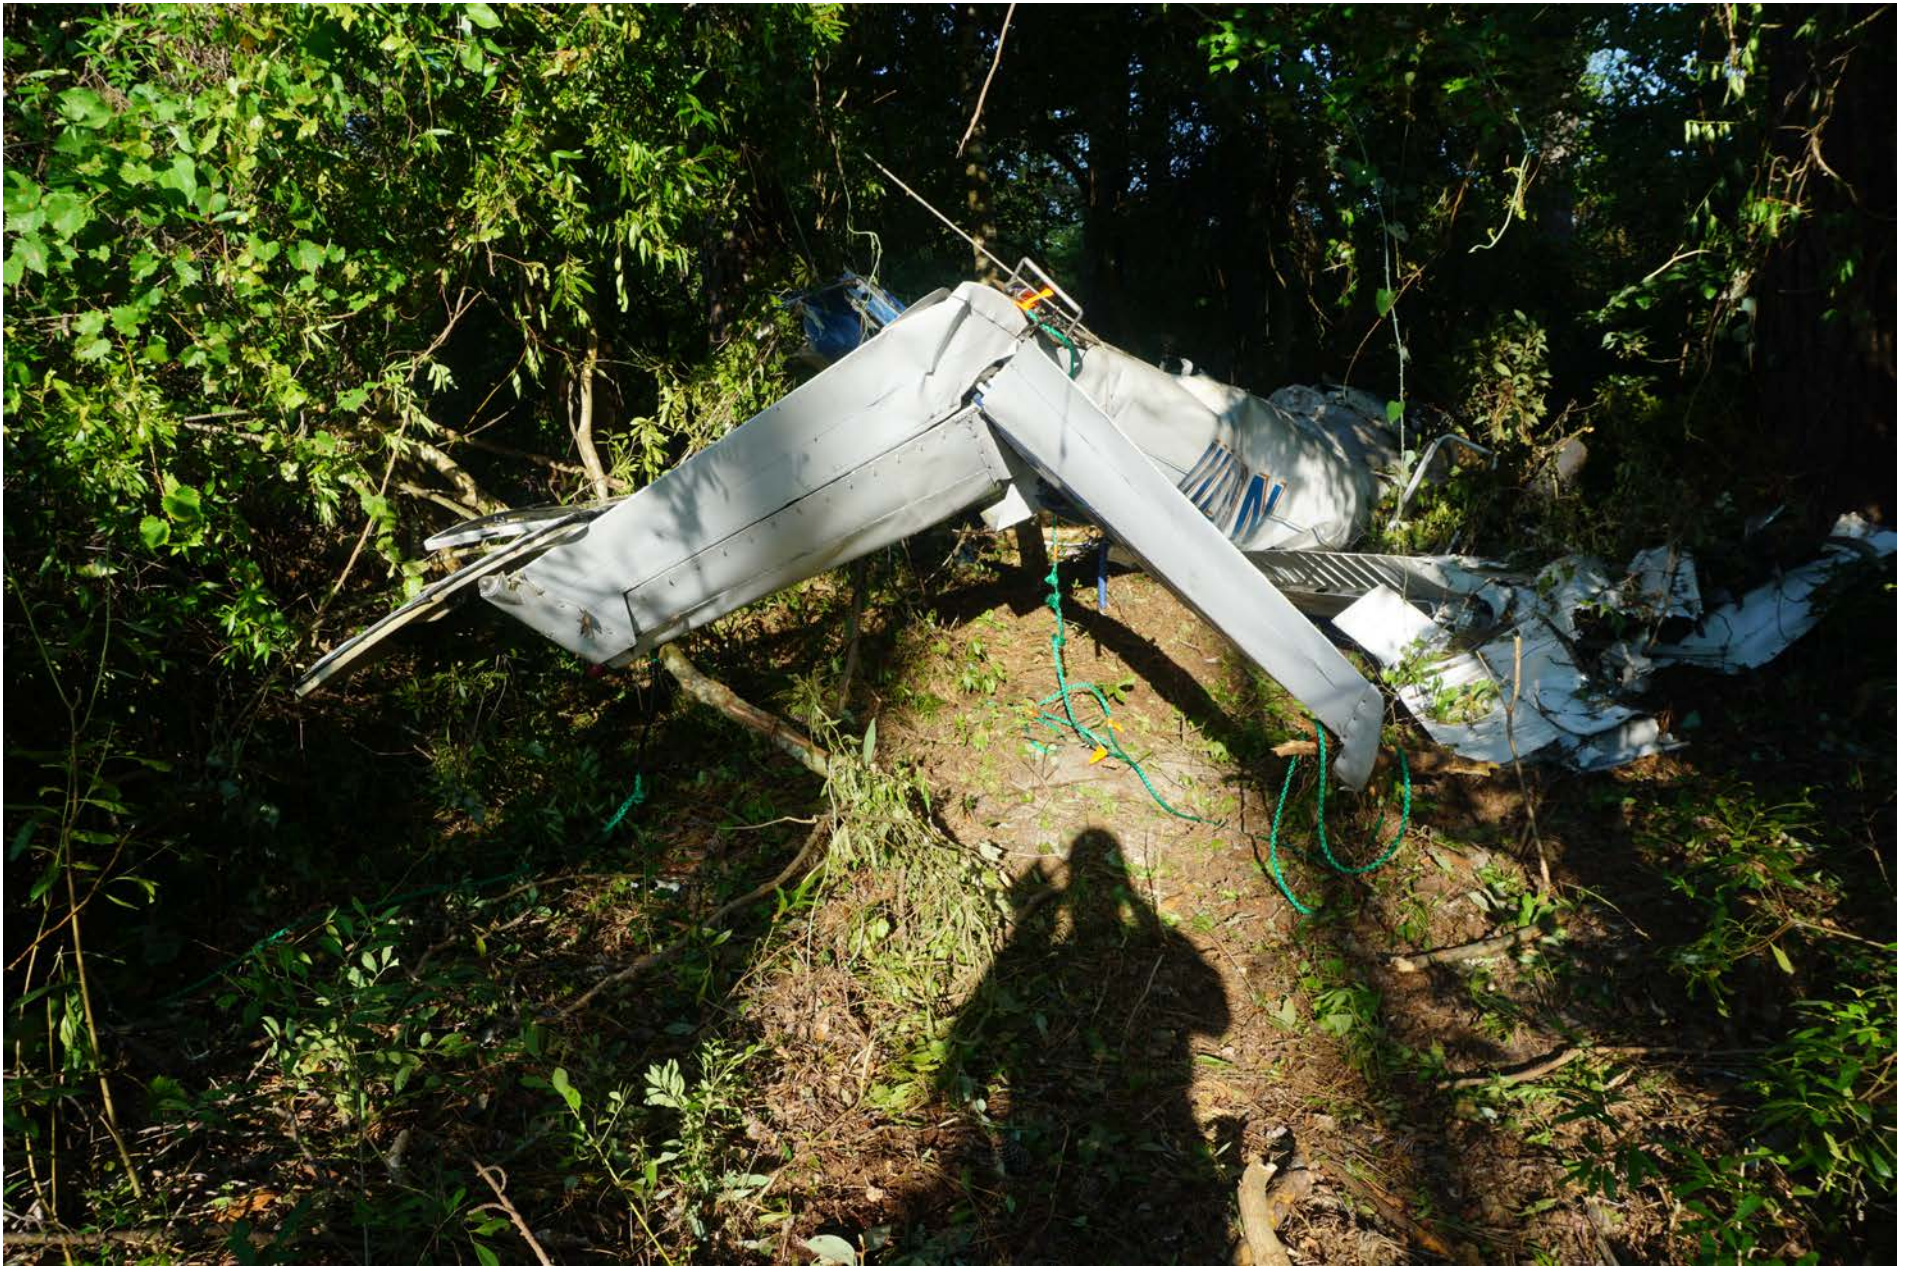
**Photo 4 – View of damaged vertical and horizontal stabilizer**

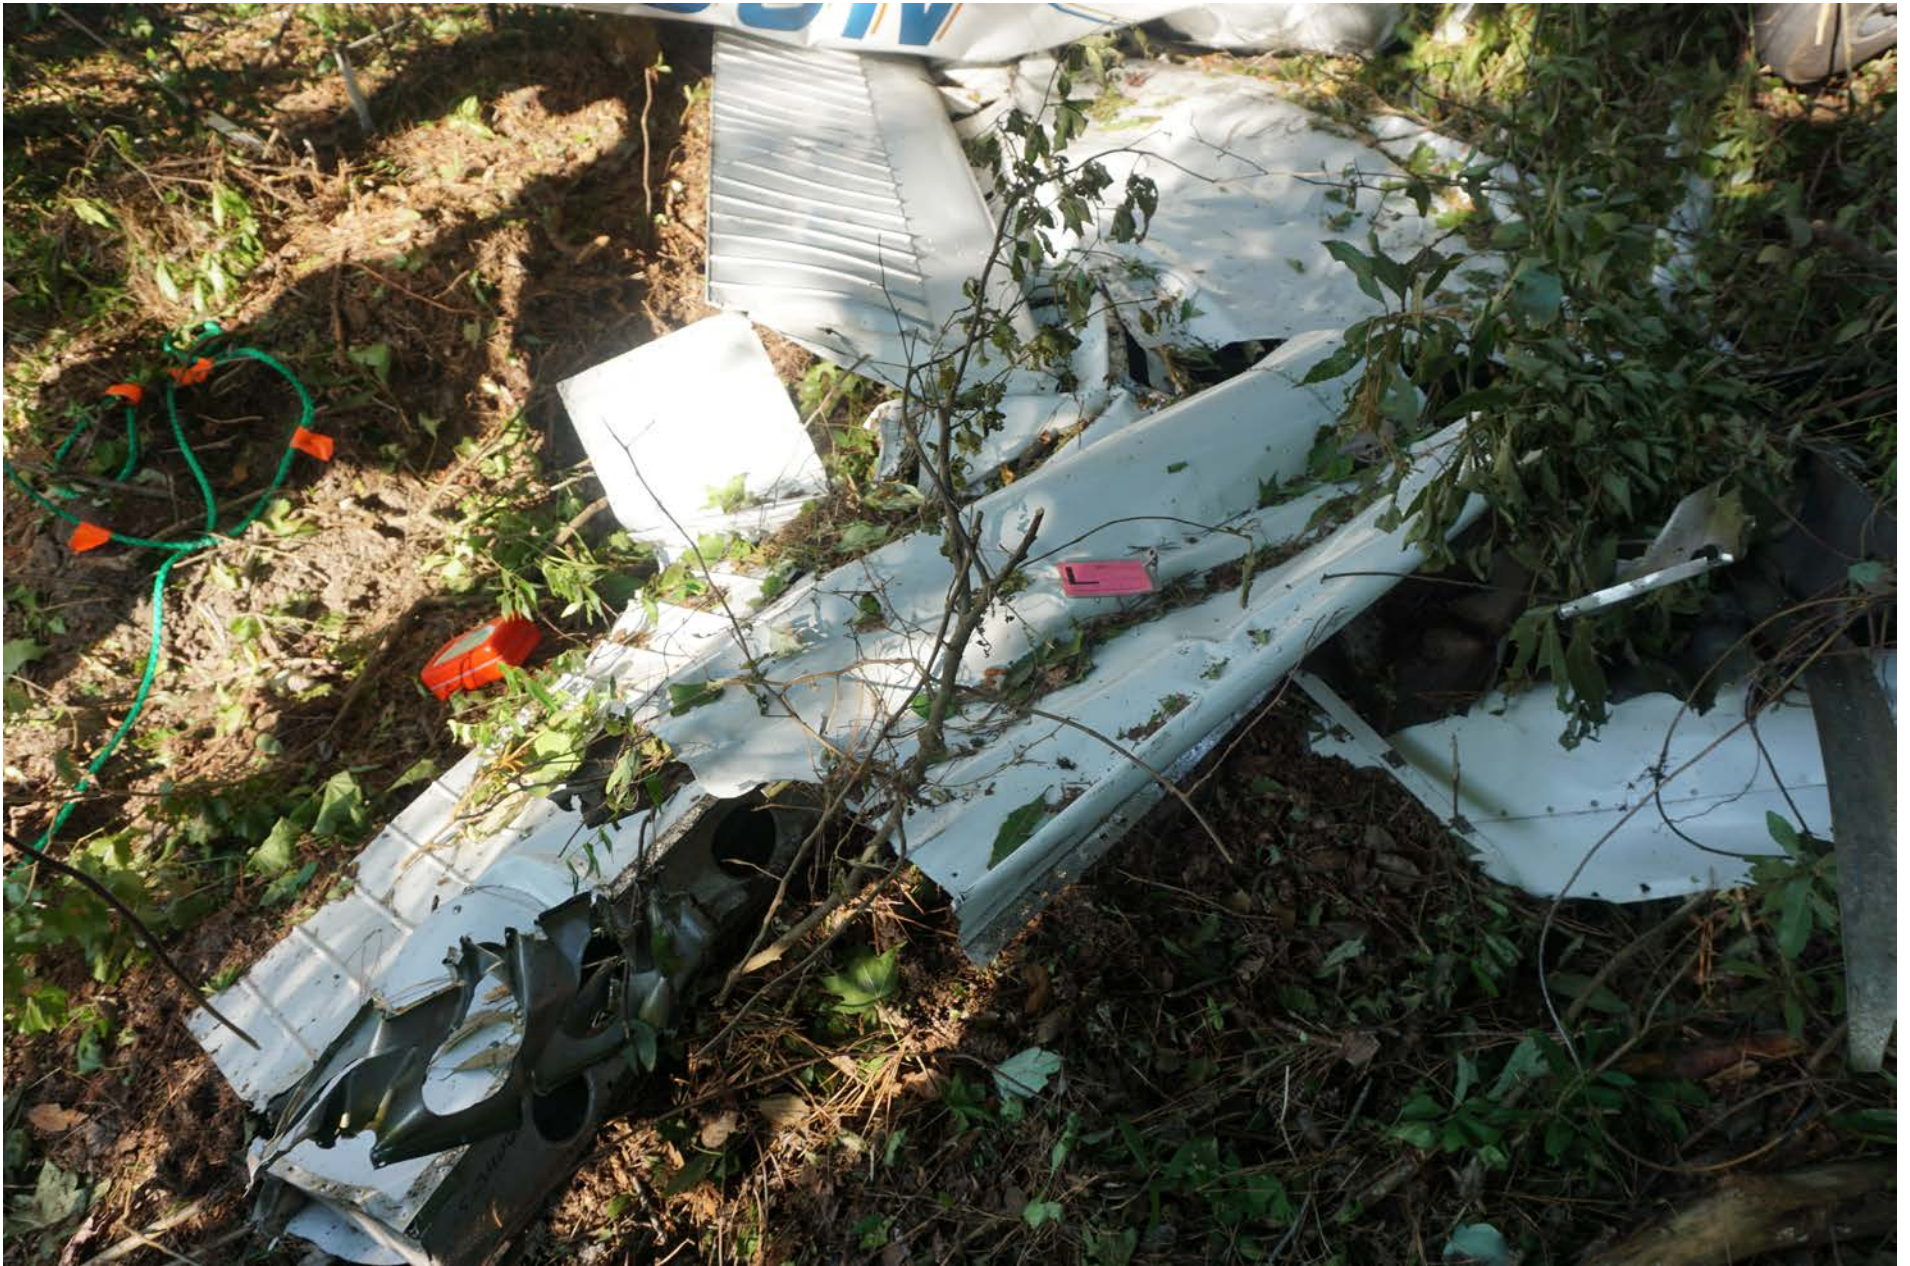
**Photo 5 – View of left wing showing damage**

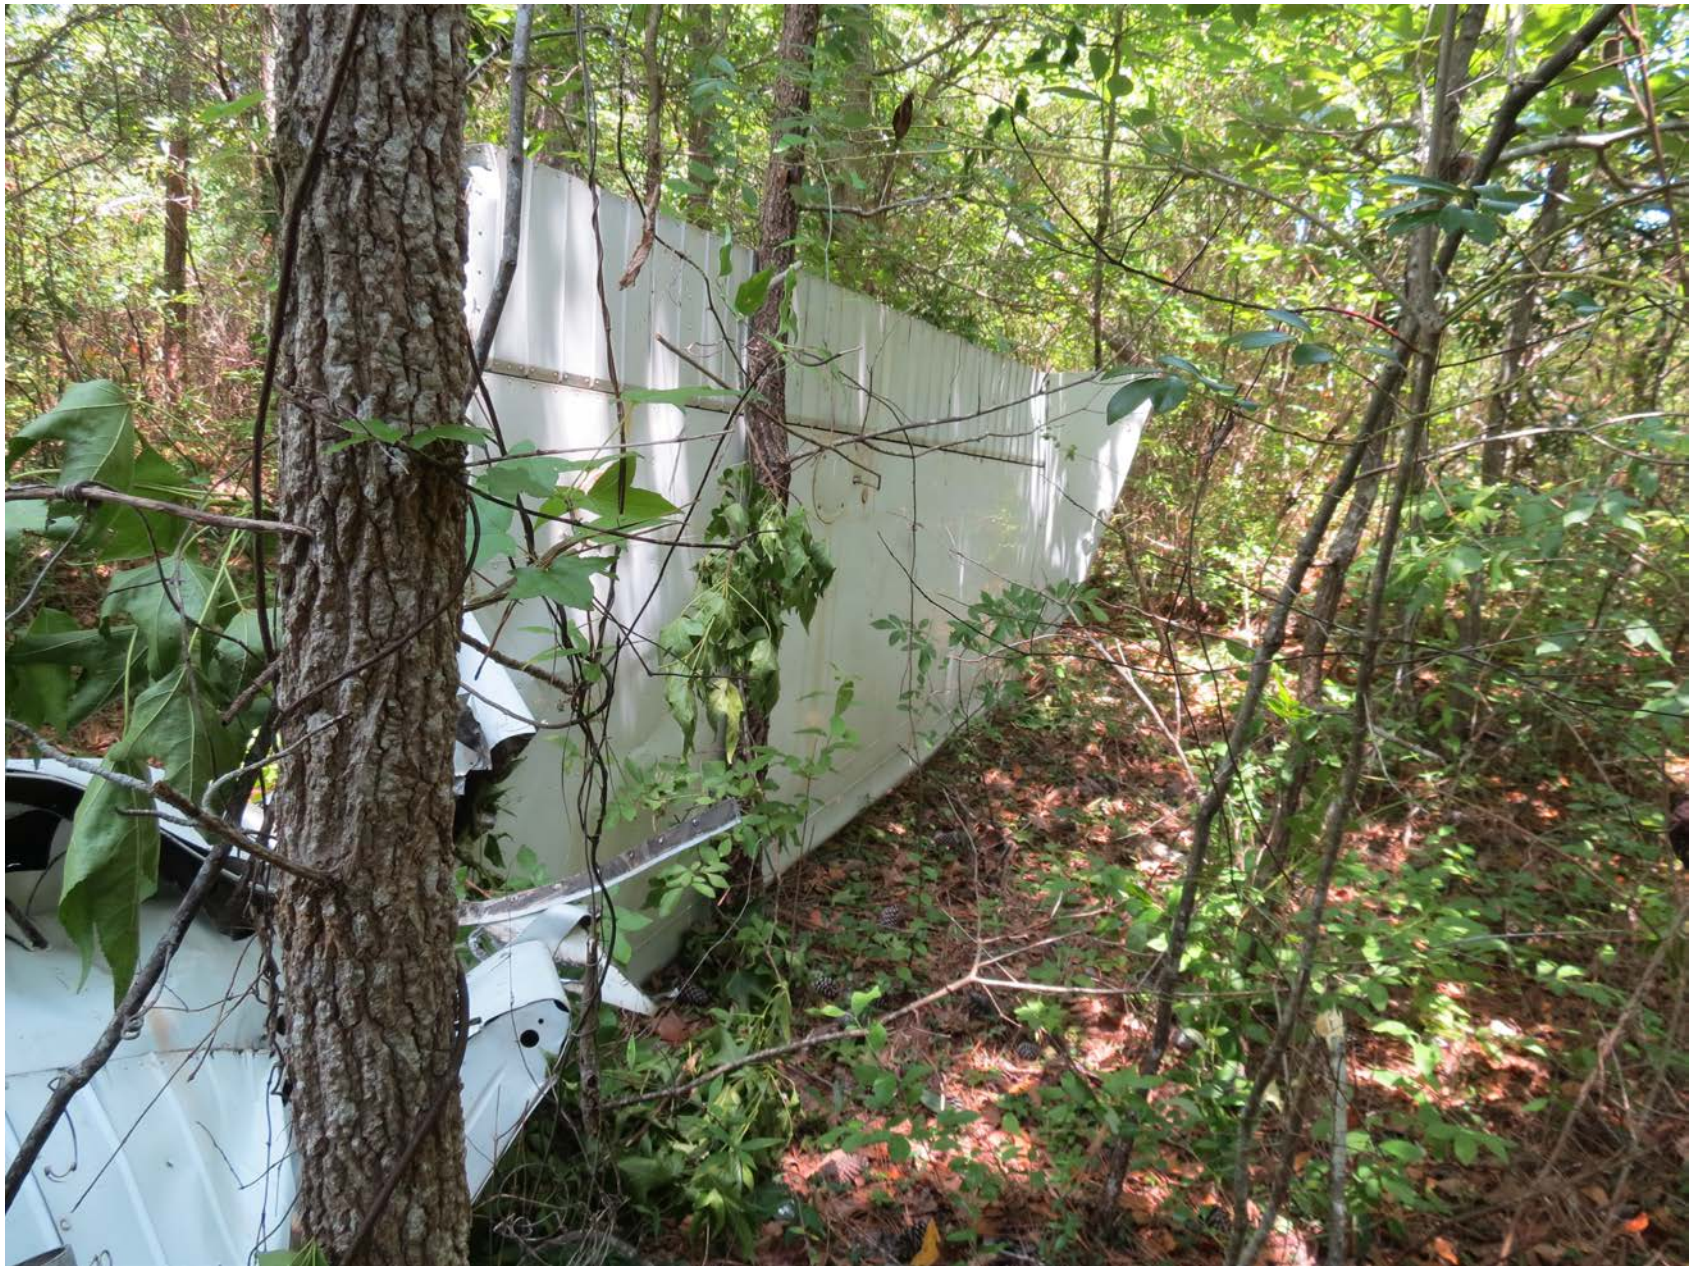
**Photo 7 – View of damaged outboard right wing**
