# NATIONAL TRANSPORTATION SAFETY BOARD

## MATERIALS LABORATORY FACTUAL REPORT

Report No. 20-001

Place : Williamsburg, VA  
Date : 7/8/2018  
Vehicle : Robinson R44  
NTSB No. : ERA18FA187  
Investigator : Douglas Brazy

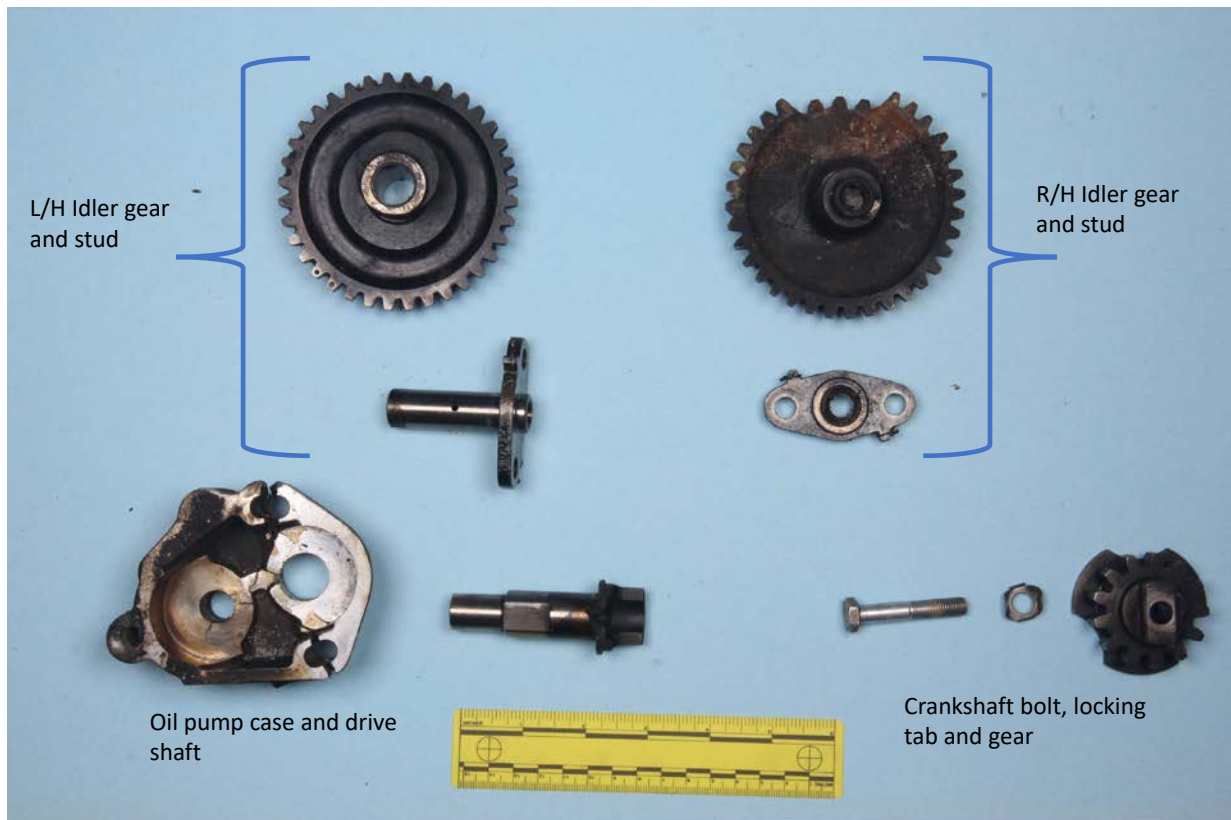
Accessory section idler gears, crankshaft gear, crankshaft bolt and locking tab, oil pump housing and drive shaft (Figure 1).

Figure 1: Accessory section gears and components as received.

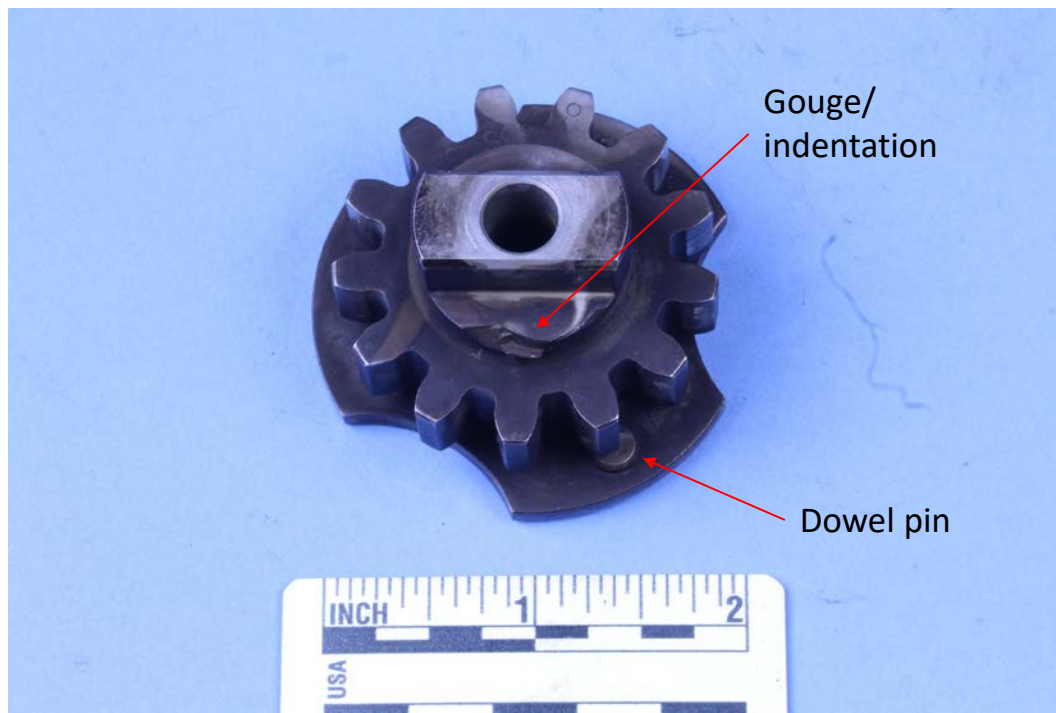
The crankshaft gear (Figure 2) exhibited a mostly stained and blackened appearance on the top side and a clean appearance on the bottom side. On the top side a gouge was observed in one area of the oil pump drive boss. This gouge was characterized by material displacement in a direction towards the bottom side. Examination of the gear teeth using a stereo microscope did not reveal any unusual wear patterns. A portion of the crankshaft dowel pin remained attached to the crankshaft gear (Figure 3). Examination of the dowel pin's fracture surface using a stereo microscope revealed features consistent with shear overstress.

Figure 2: Crankshaft gear (top side).

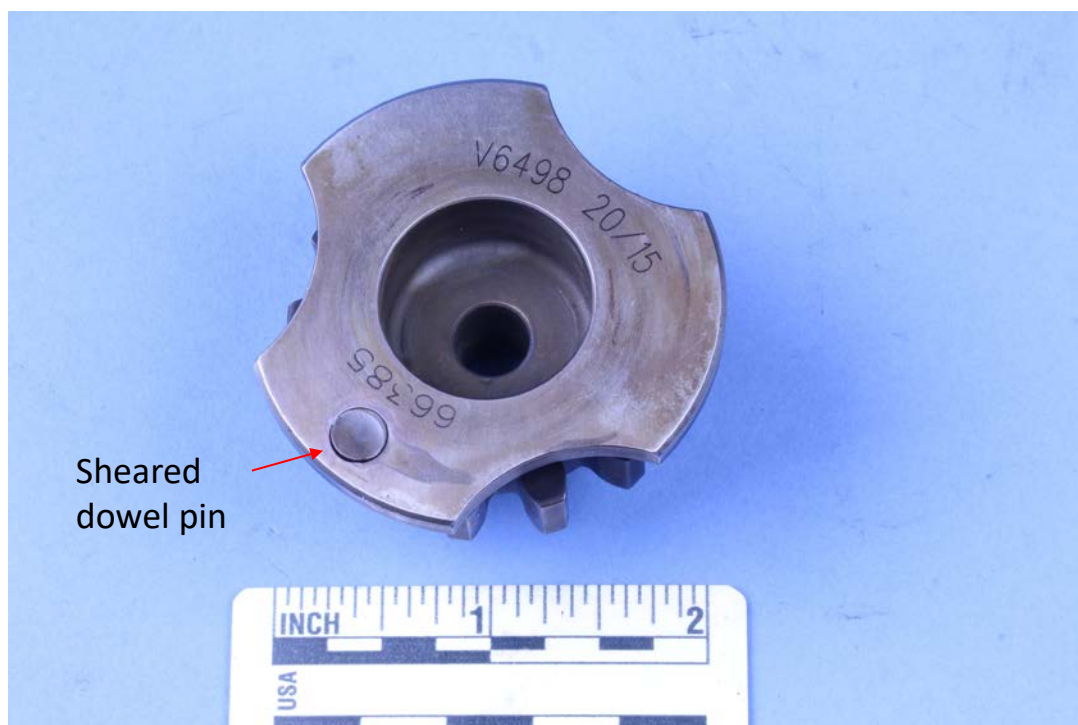
Figure 3: Crankshaft gear (bottom side).

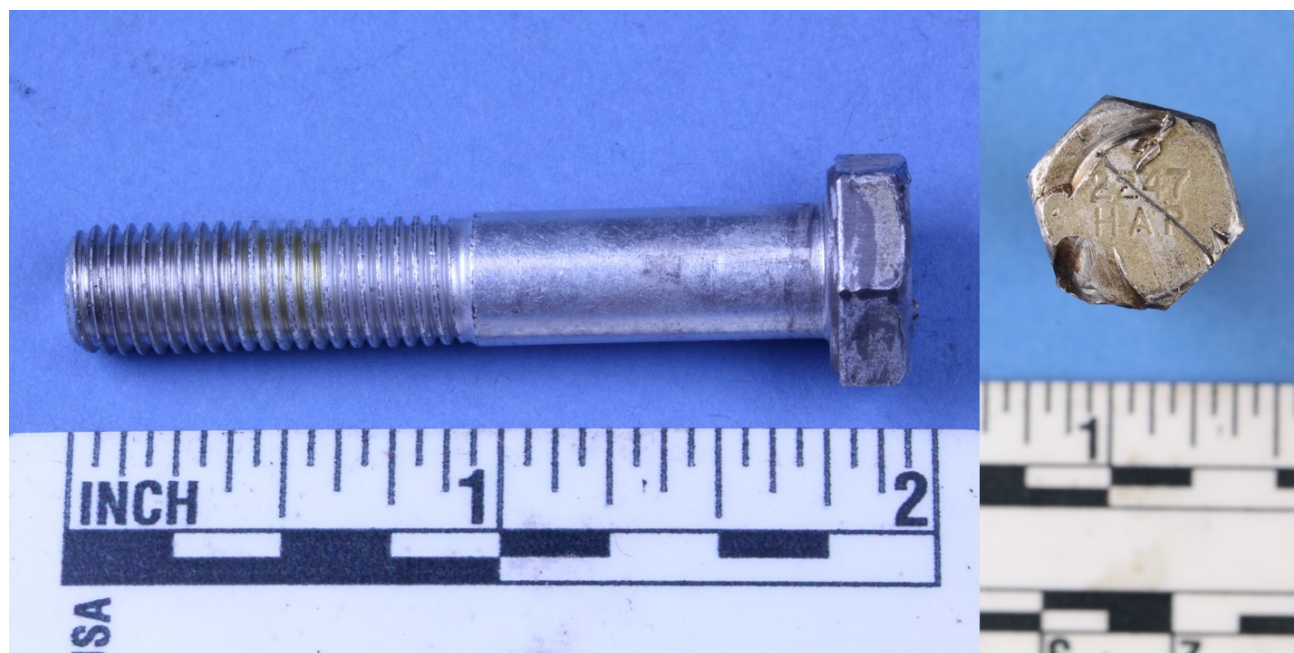
The crankshaft gear bolt (Figure 4) had the following head marking “2247 HAP”. Examination of the threads using a stereo microscope did not reveal any unusual wear or other conditions that would affect the bolt's function. Some gouges were observed on the bolt head. These gouges were characterized by material displacement in a direction towards the crankshaft gear.

Figure 4: Crankshaft bolt.

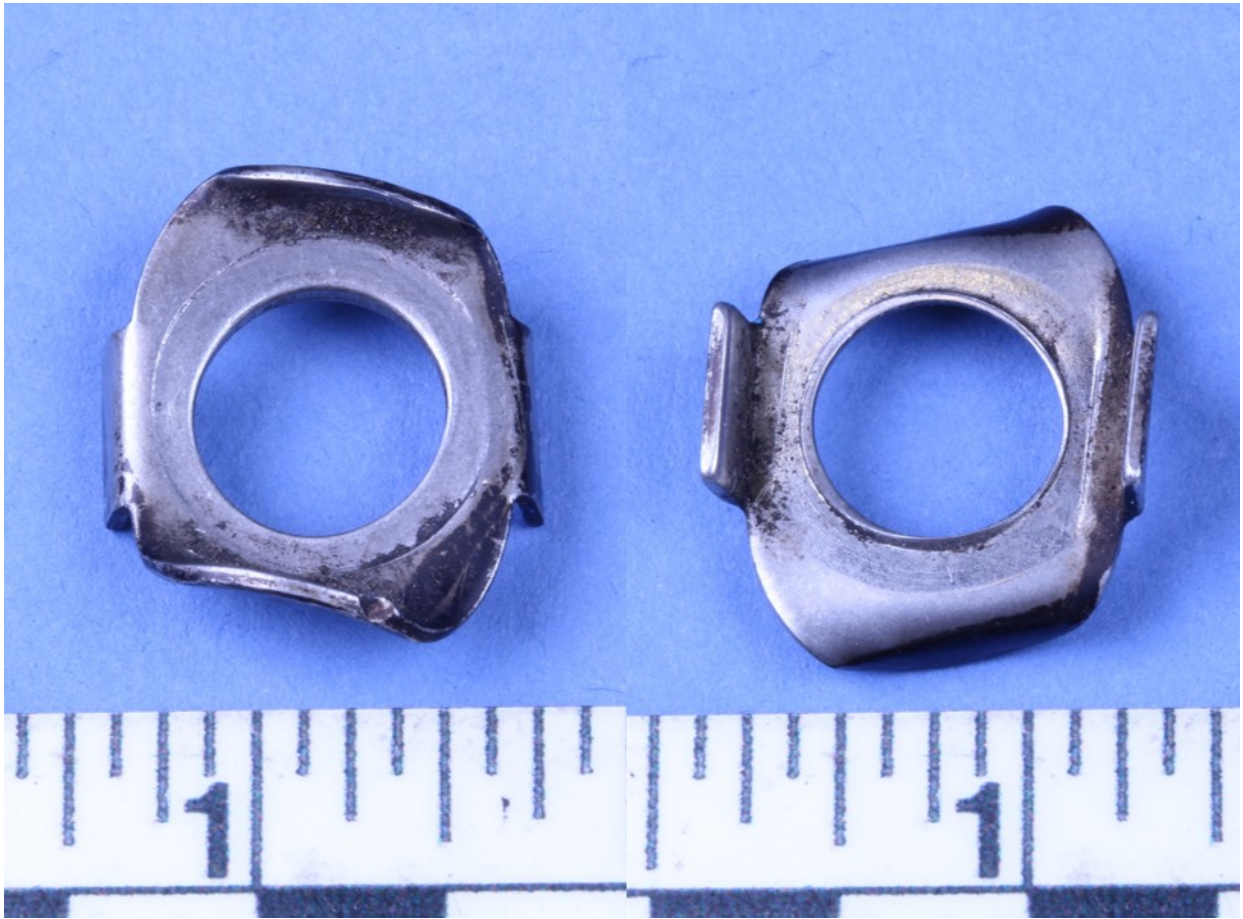
The crankshaft bolt locking tab (Figure 5) was not deformed and the bends in the tabs were in proper position to prevent rotation of the bolt in relation to the crankshaft gear. Examination of the locking tab using a stereo microscope did not reveal any features consistent with the bolt having rotated within the locking tab.

Figure 5: Both sides of the crankshaft bolt locking tab.

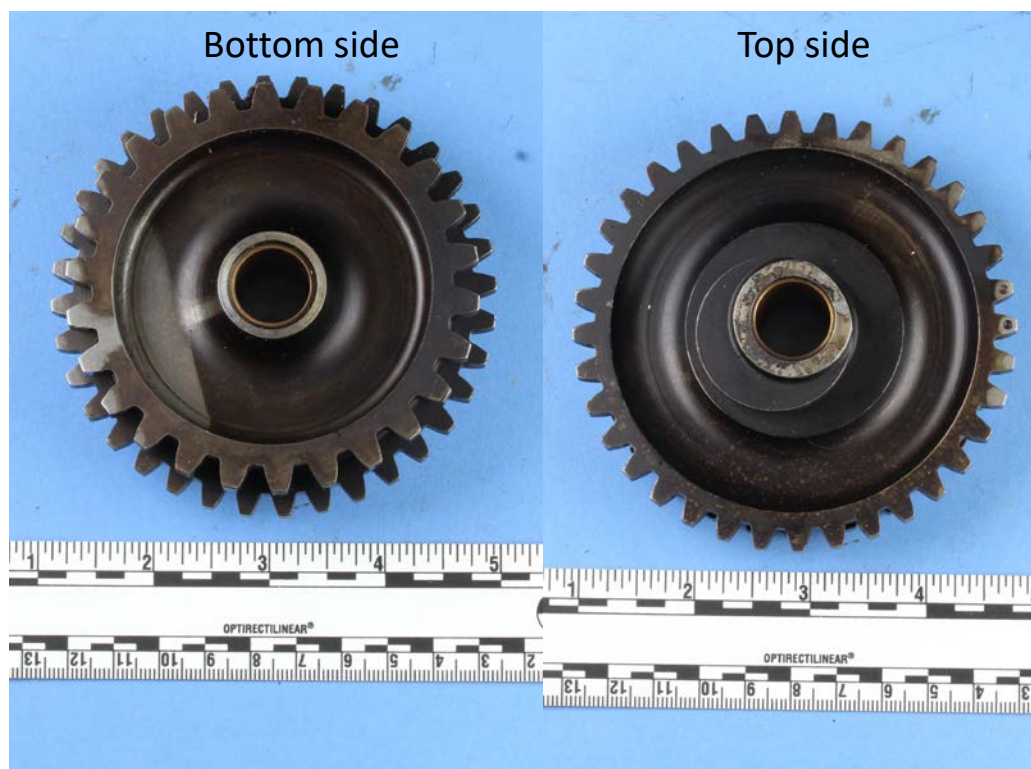
The left-hand idler gear (Figure 6) exhibited a blacked and stained appearance on both the top and bottom sides. Examination using a stereo microscope did not reveal any damage or unusual wear markings on any of the gear teeth. Examination of the gear's bore and bushing did not reveal any unusual wear. The left-hand idler gear's stud was not damaged and fit the gear bore allowing for rotation of the idler gear.

Figure 6: Left-hand idler gear.

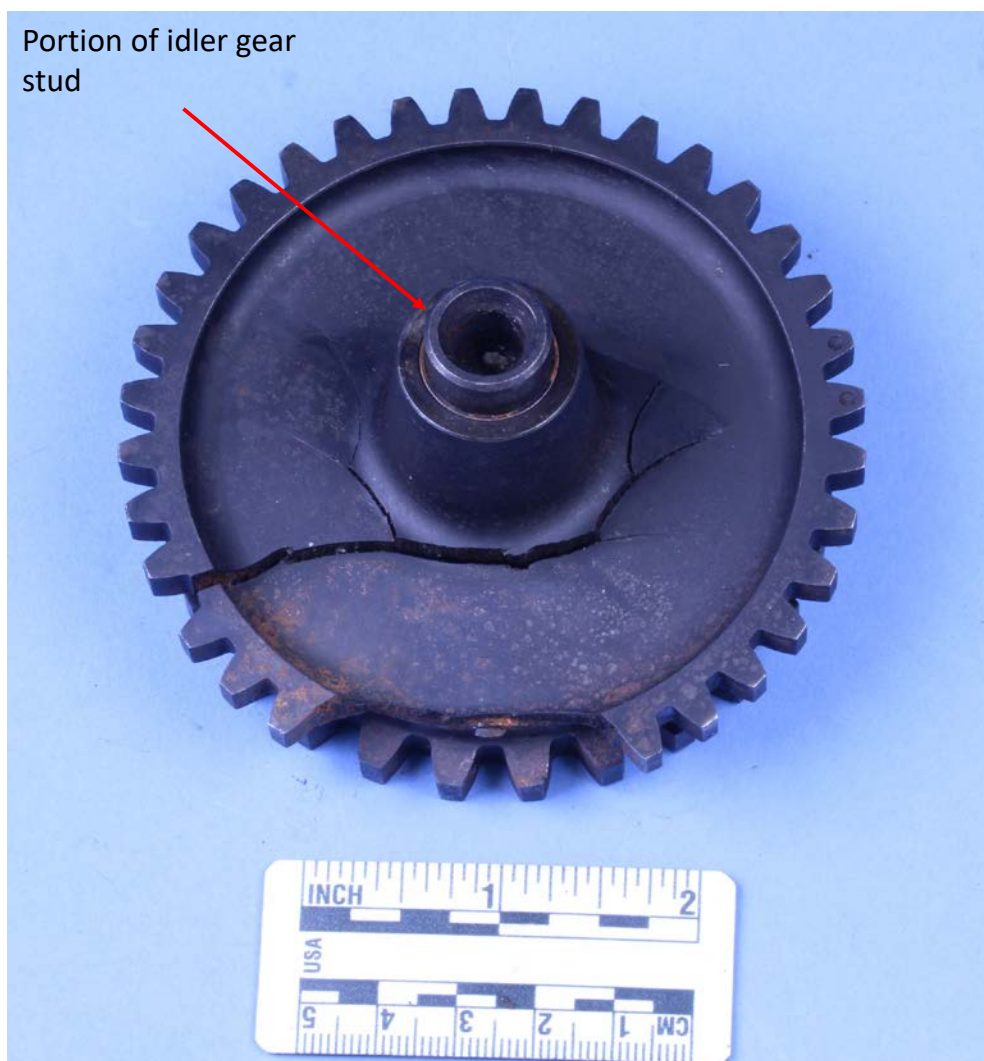
The right-hand idler gear (Figures 7, 8) exhibited a blackened and stained appearance on both the top and bottom sides. This idler gear exhibited multiple fractures. A portion of the top side of the gear had been displaced towards the bottom side. Examination of the fractures using a stereo microscope revealed features consistent with bending overstress fractures. Examination of the gear teeth still present on the gear did not reveal any damage or unusual wear patterns. A portion of the right-hand idler gear stud had fractured and remained in the gear's bore. Examination of the gear stud's fracture surface revealed fracture features consistent with bending overstress.

Figure 7: Right-hand idler gear (top side).

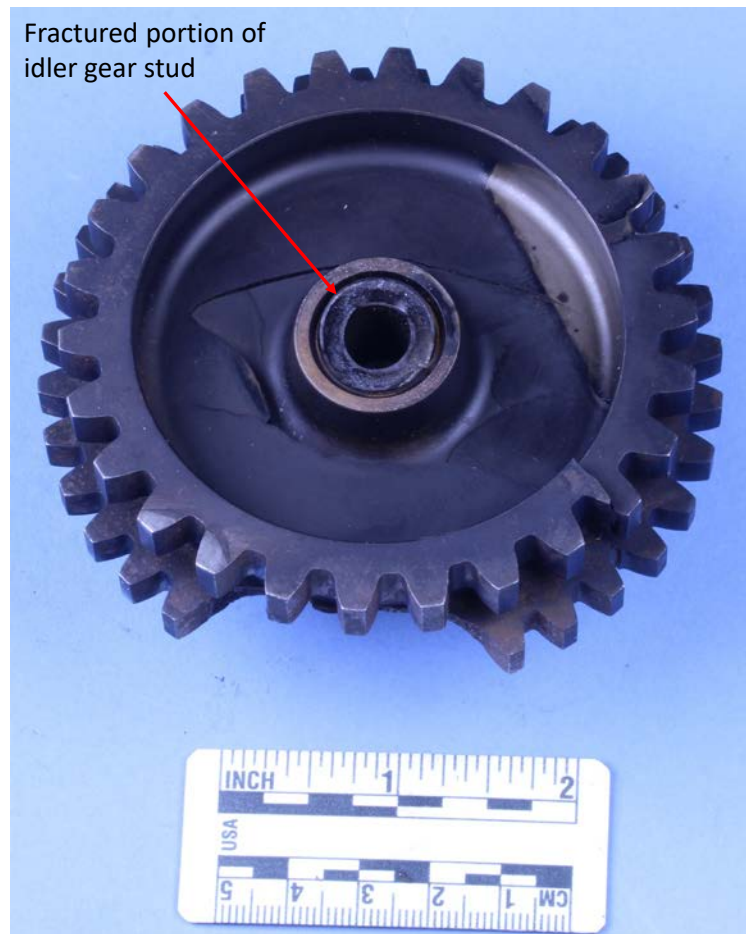
Figure 8: Right-hand idler gear (Bottom side).

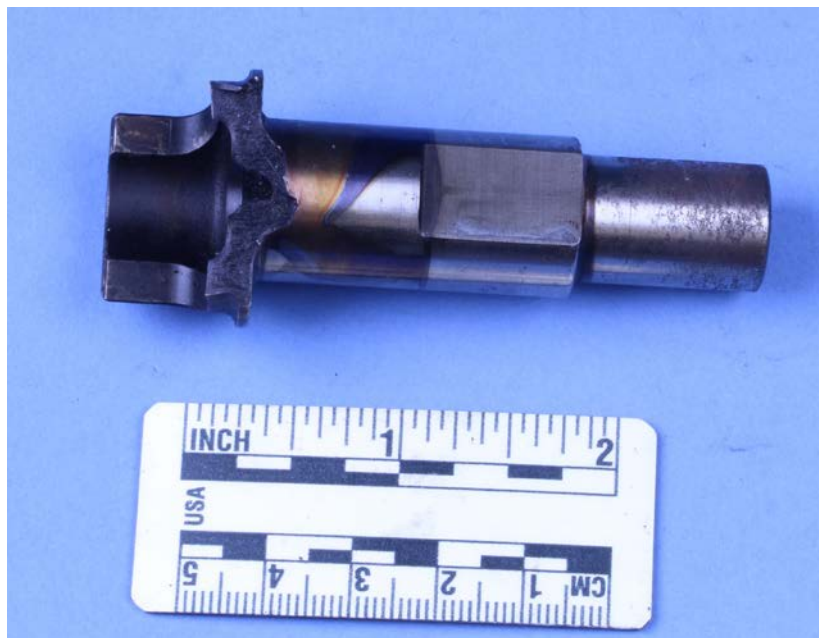
The oil pump drive shaft (Figure 9) exhibited a band of gold and blue thermal discoloration on the shank near the yoke end. One of the halves forming the drive shaft yoke had fractured. Examination of the fracture surface using a stereo microscope revealed fracture features consistent with a bending overstress fracture.

Figure 9: Oil pump drive shaft with fractured yoke.

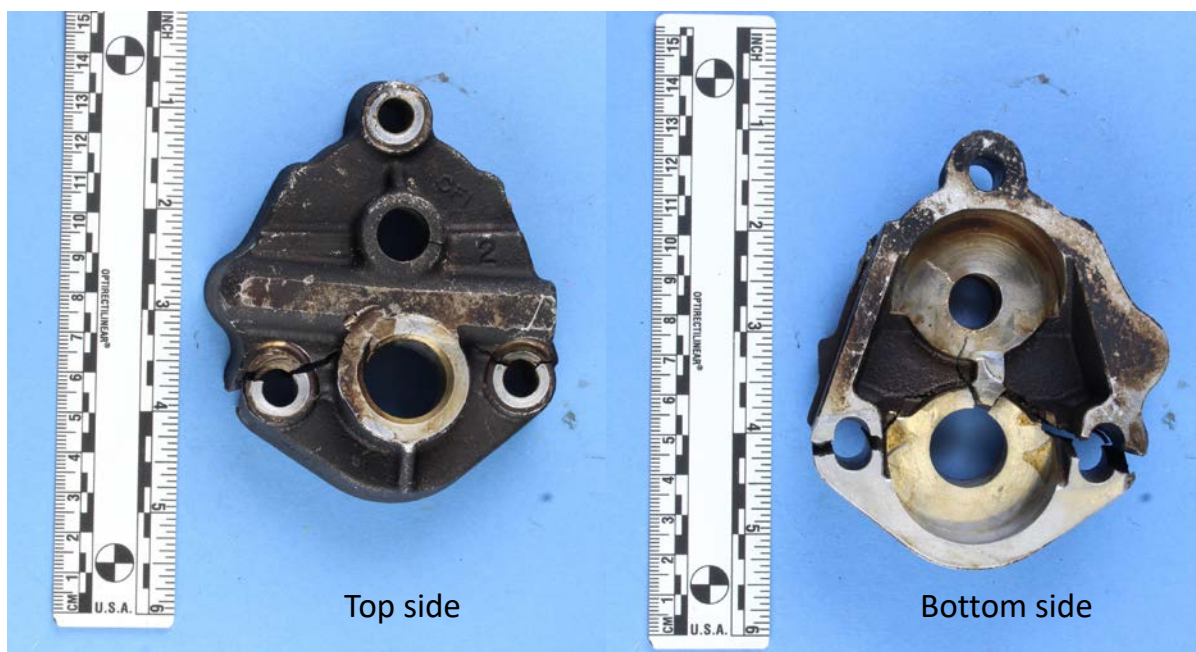
The oil pump housing (Figure 10) was made from aluminum. It exhibited a mostly blackened appearance on the top side and partially blackened on the bottom side. The oil pump housing had fractures along the two of the three bolt hole bores for the attachment bolts. The deformation of the oil pump housing and the fractures in the bolt hole bores were consistent with bending overstress. The oil pump housing along with the drive shaft are depicted in figure 11.

Figure 10: Oil pump housing.

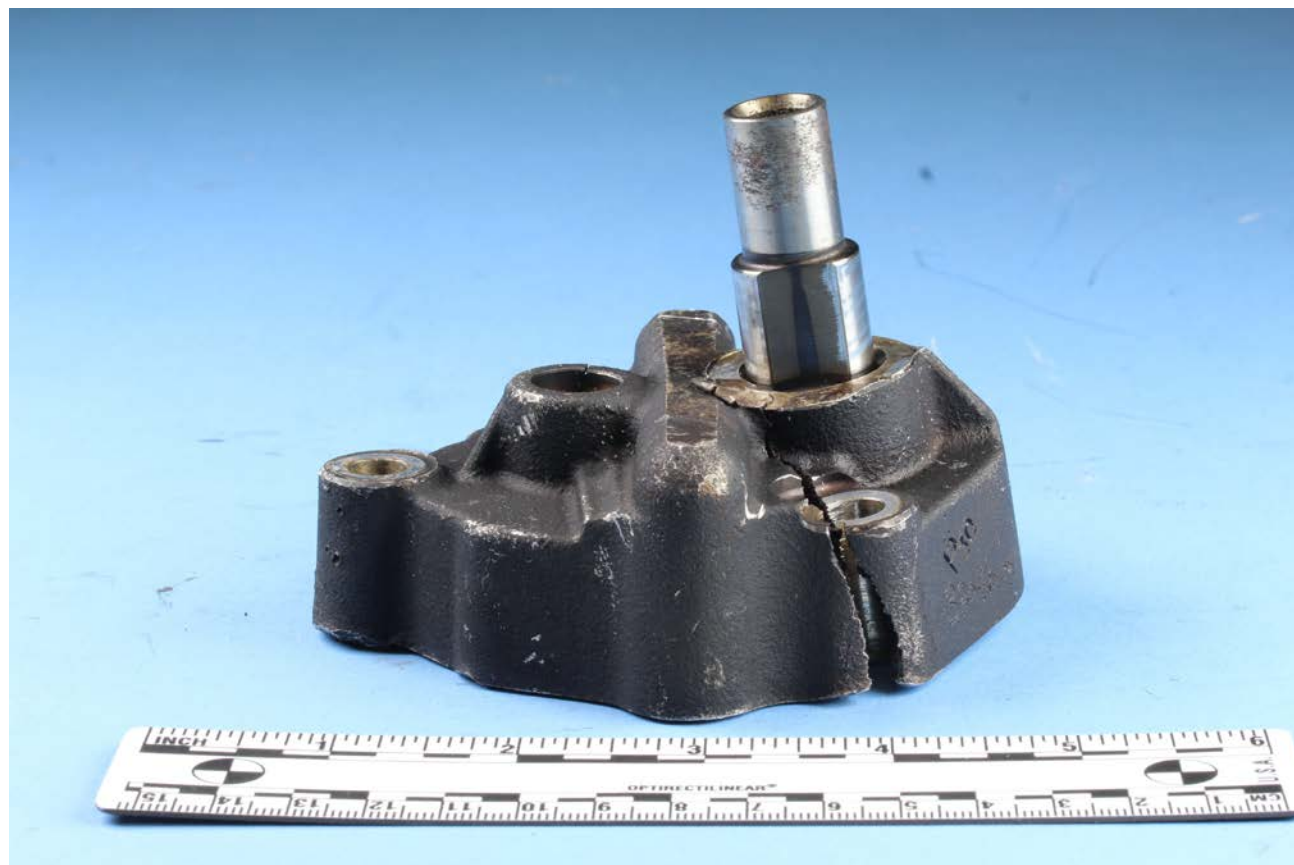
Figure 11: Oil pump housing and drive shaft.
