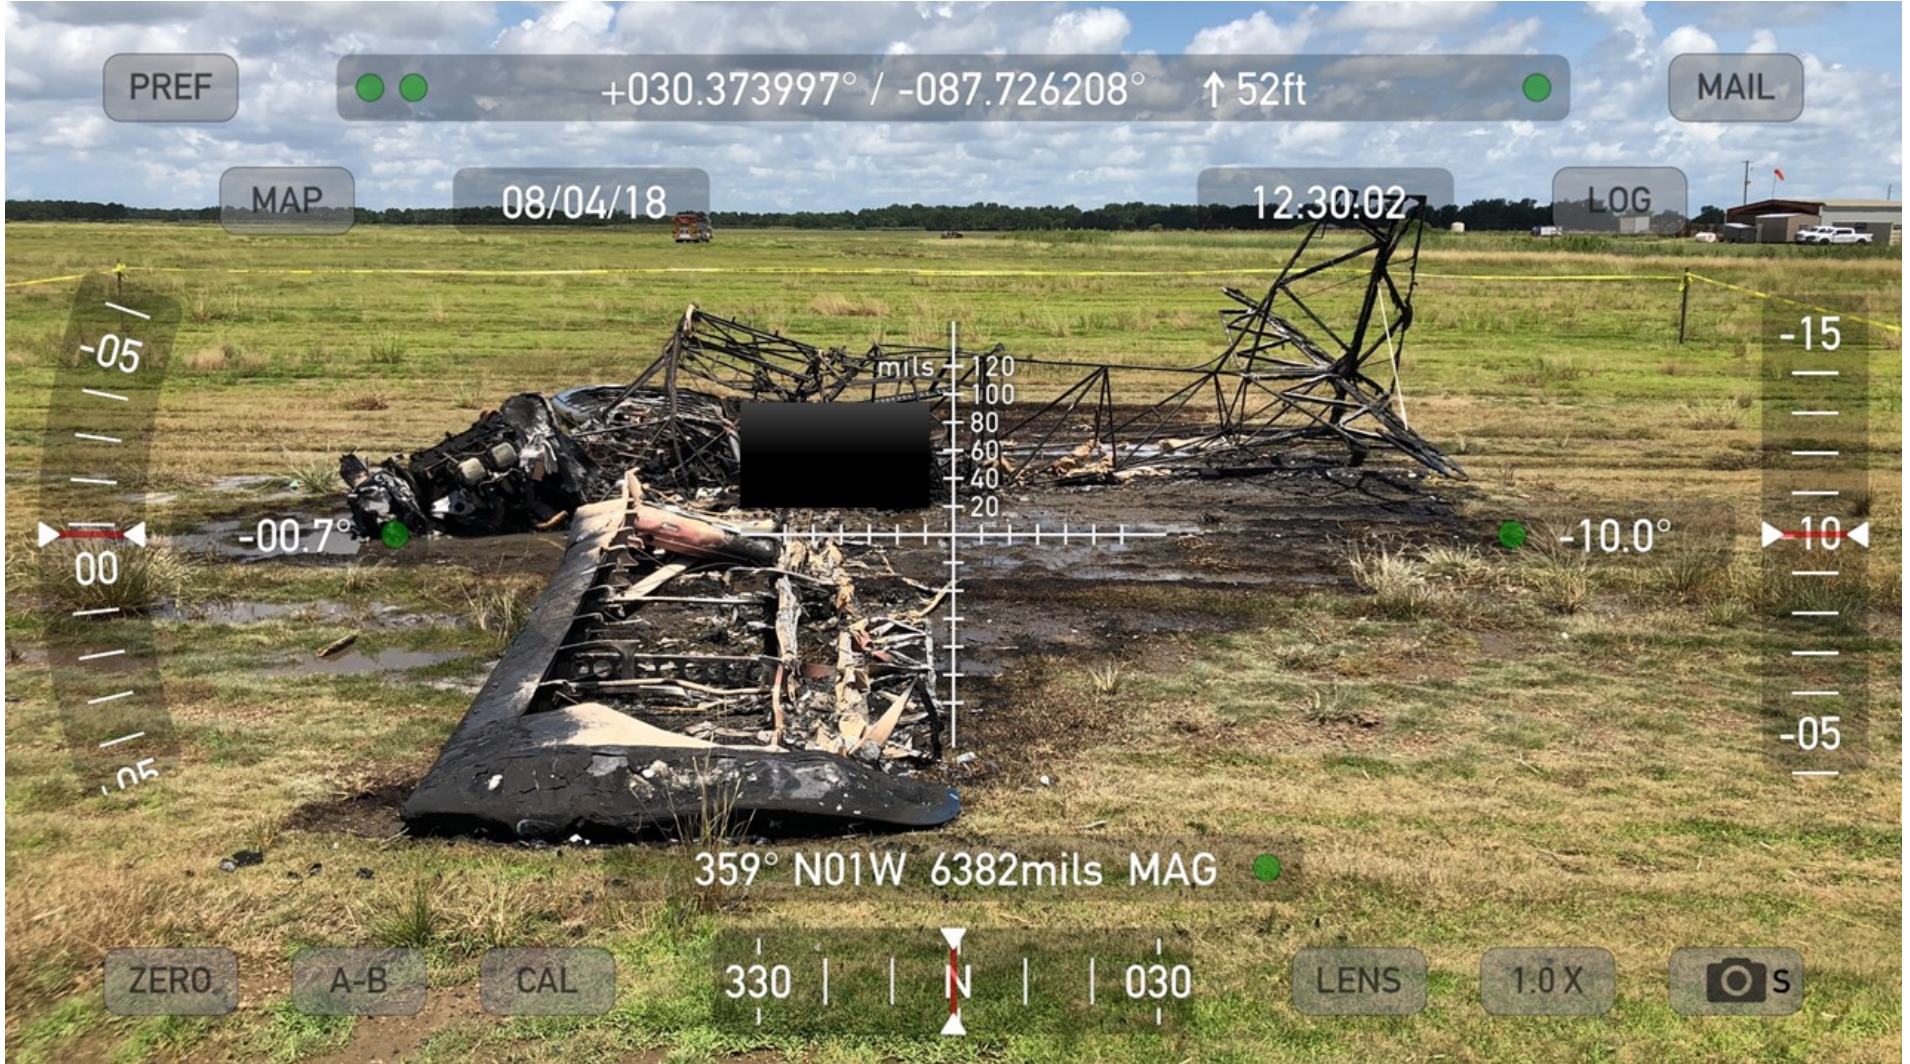
**Photo 1 – Photograph of left profile view of airplane damage prior to recovery by fire/rescue. (Courtesy of Foley, Alabama Fire Department)**

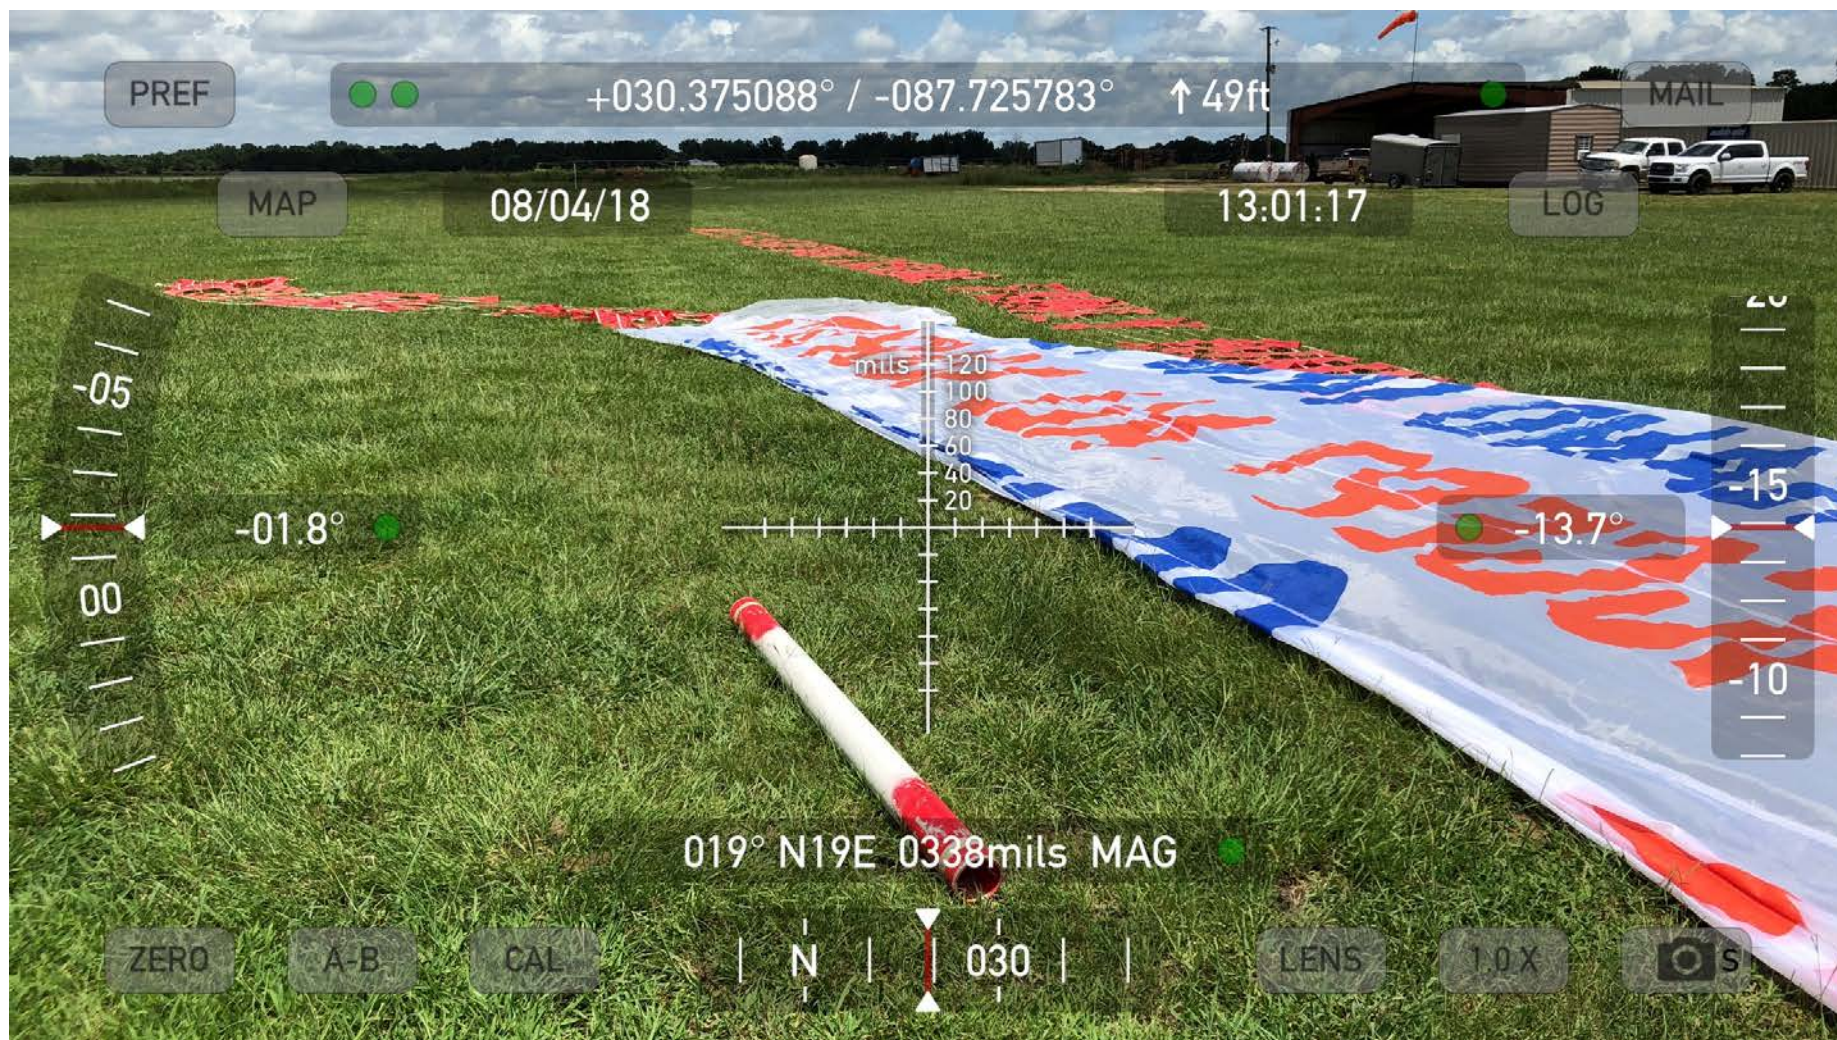
**Photo 2 – Photograph of advertising banner after being released by the pilot. (Courtesy of Foley, Alabama Fire Department)**

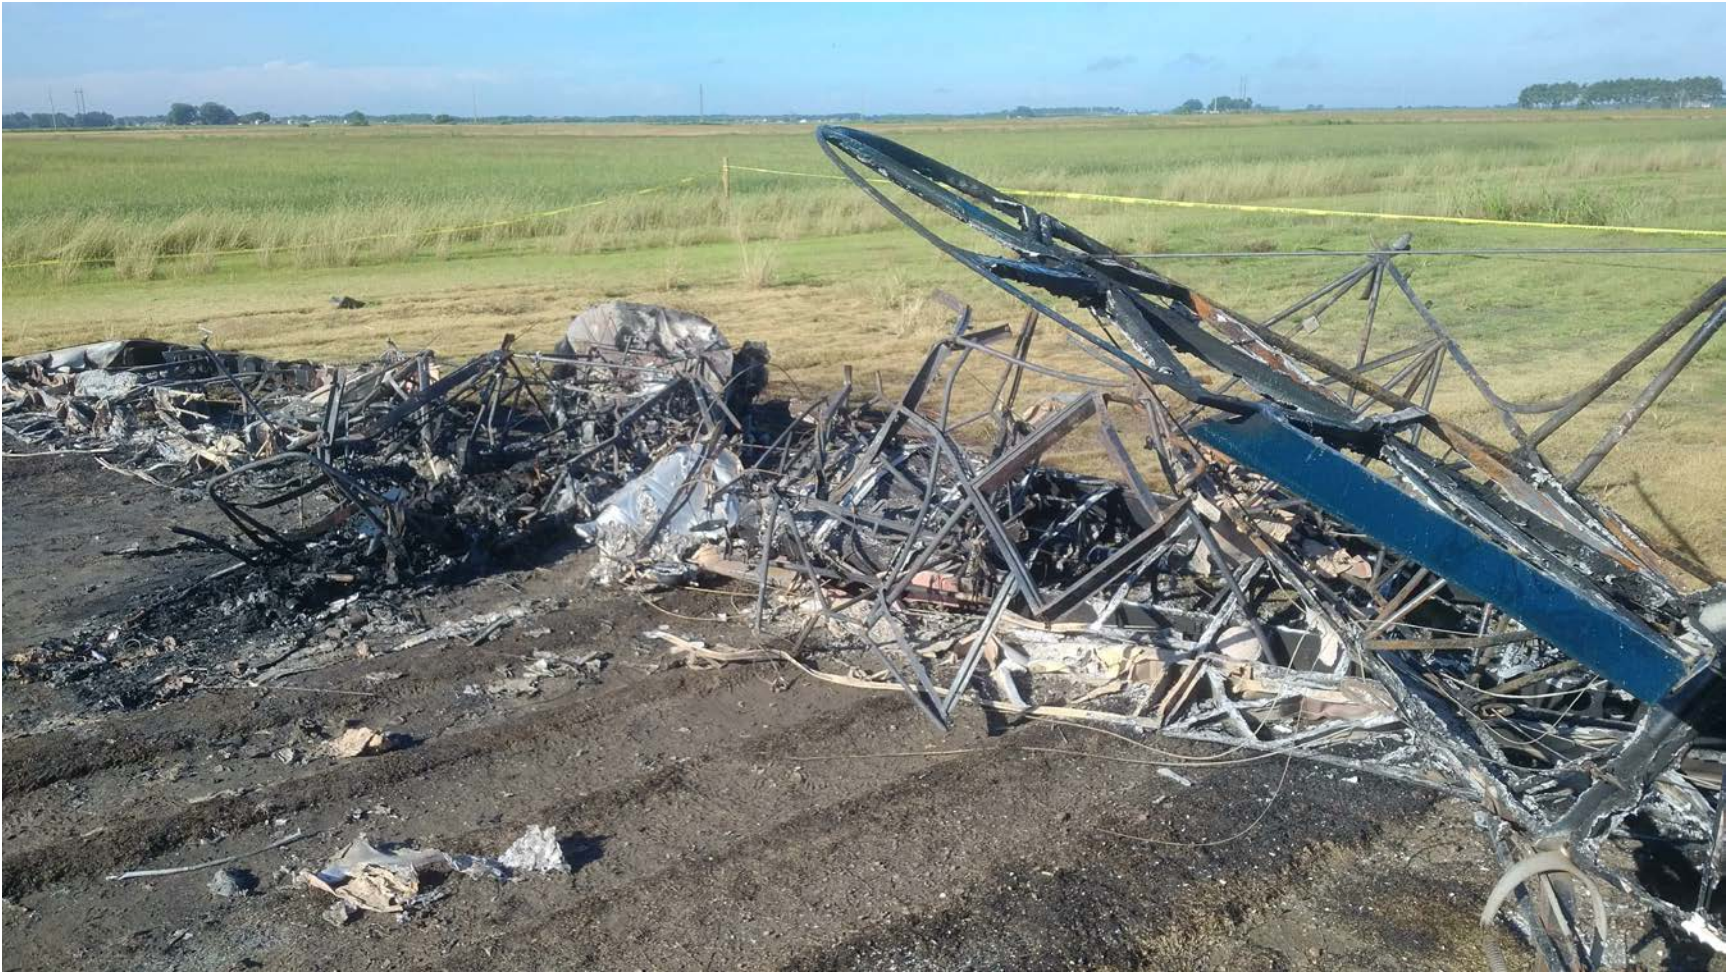
**Photo 3 – Photograph of right aft quartering view of wreckage. The tail has been moved by fire/rescue to facilitate recovery.**

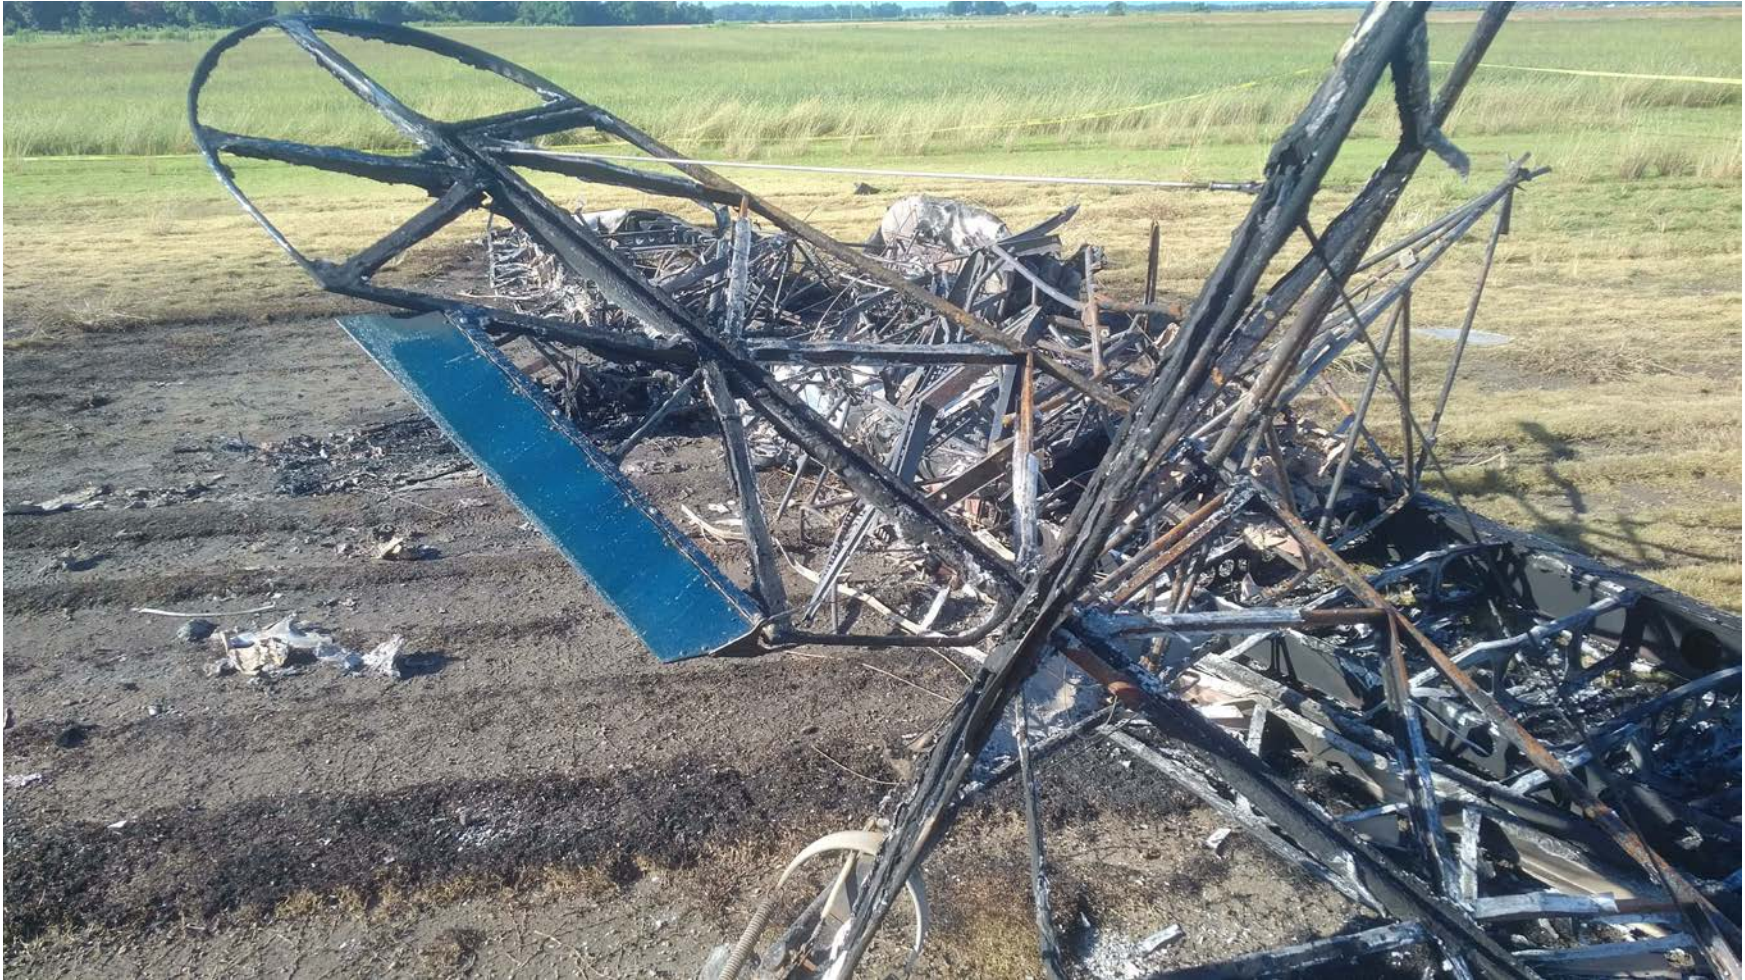
**Photo 4 – Photograph of thermal damage to vertical and horizontal stabilizer. Note trim tab is constructed of metal and relatively free of fire damage.**

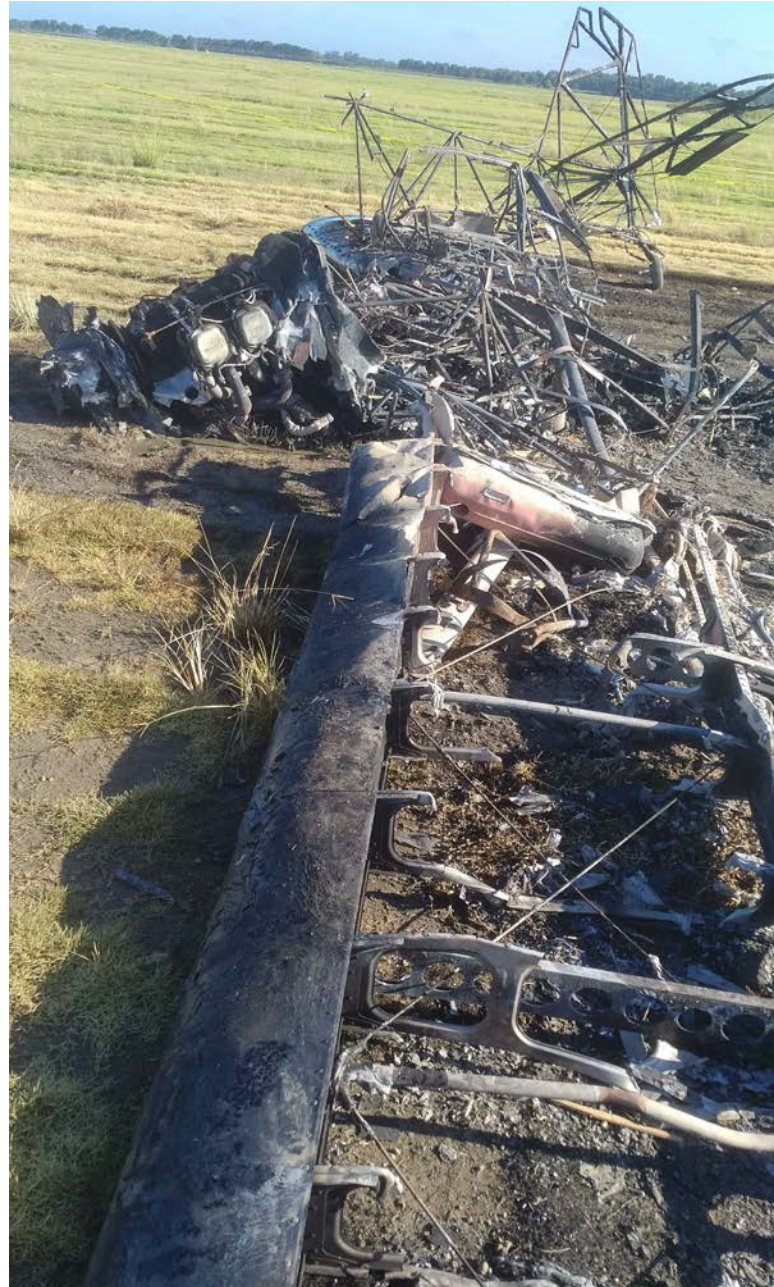
**Photo 5 – Photograph of damage to left wing of airplane looking towards engine and fuselage.**

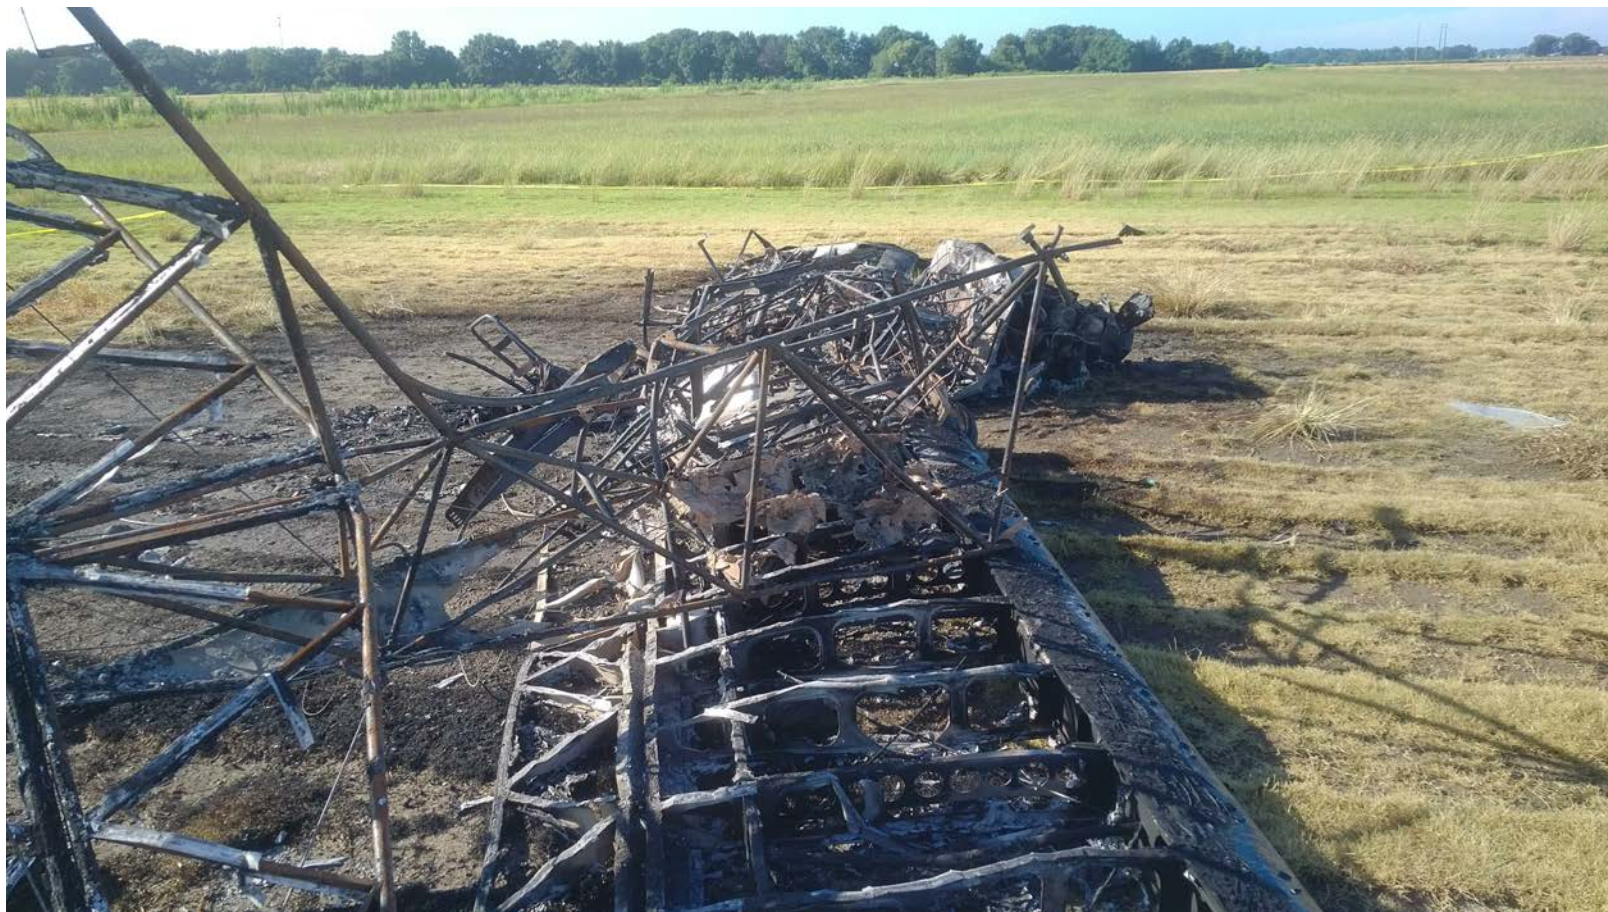
**Photo 6 – Photograph of damage to right wing of airplane looking towards fuselage.**

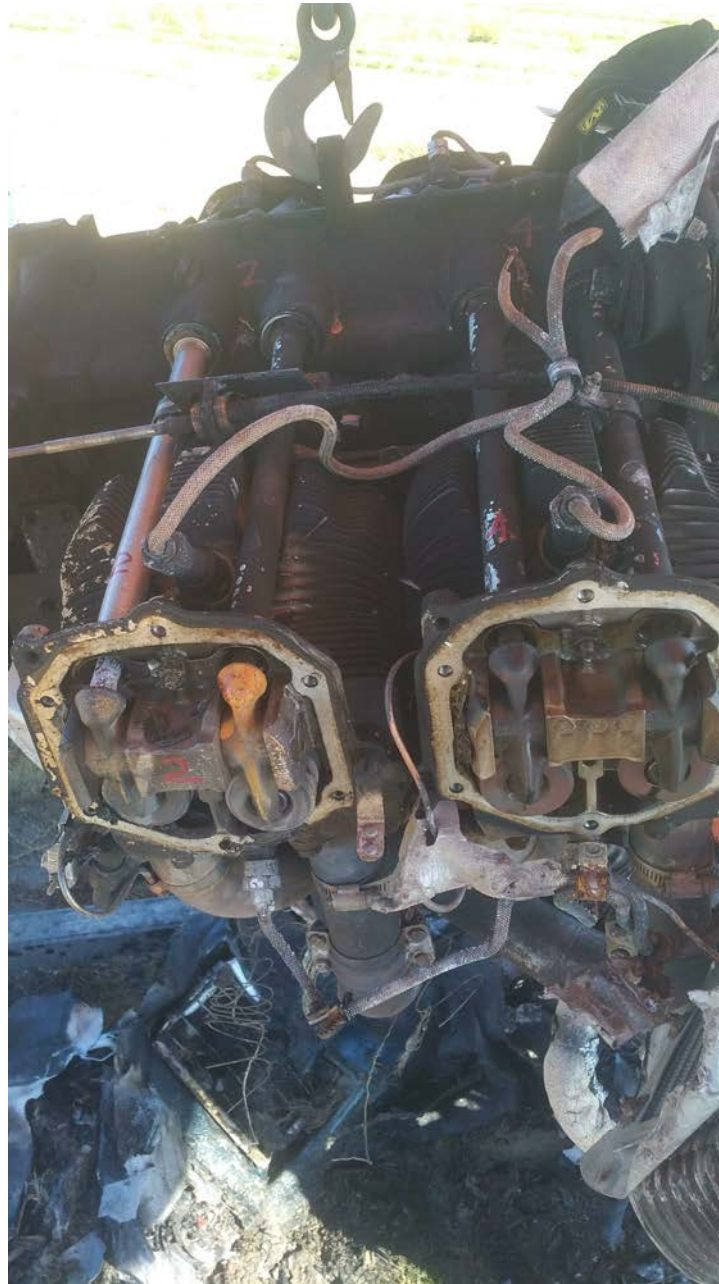
**Photo 7 – Cylinders No. 2 and 4 with valve covers removed. Note post-crash fire damage to No. 2.**

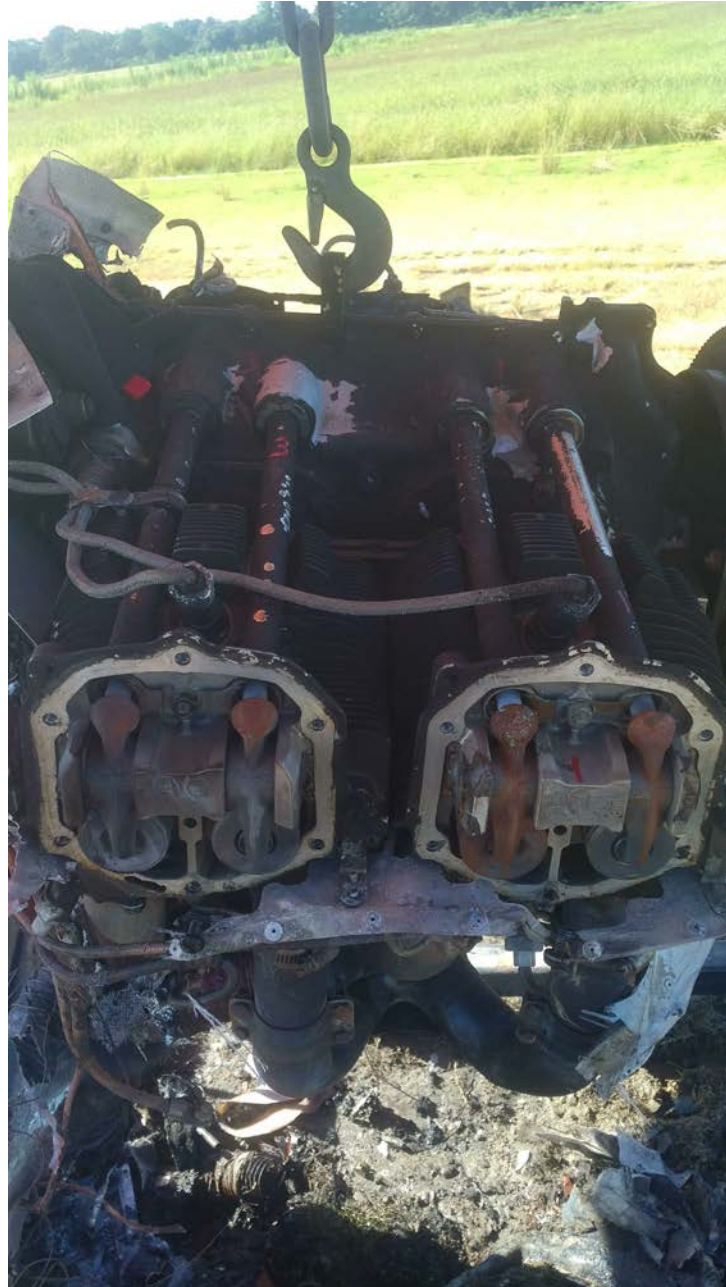
**Photo 8 – Cylinders No. 1 and 3 with valve covers removed. Note post-crash fire damage to rocker arms.**

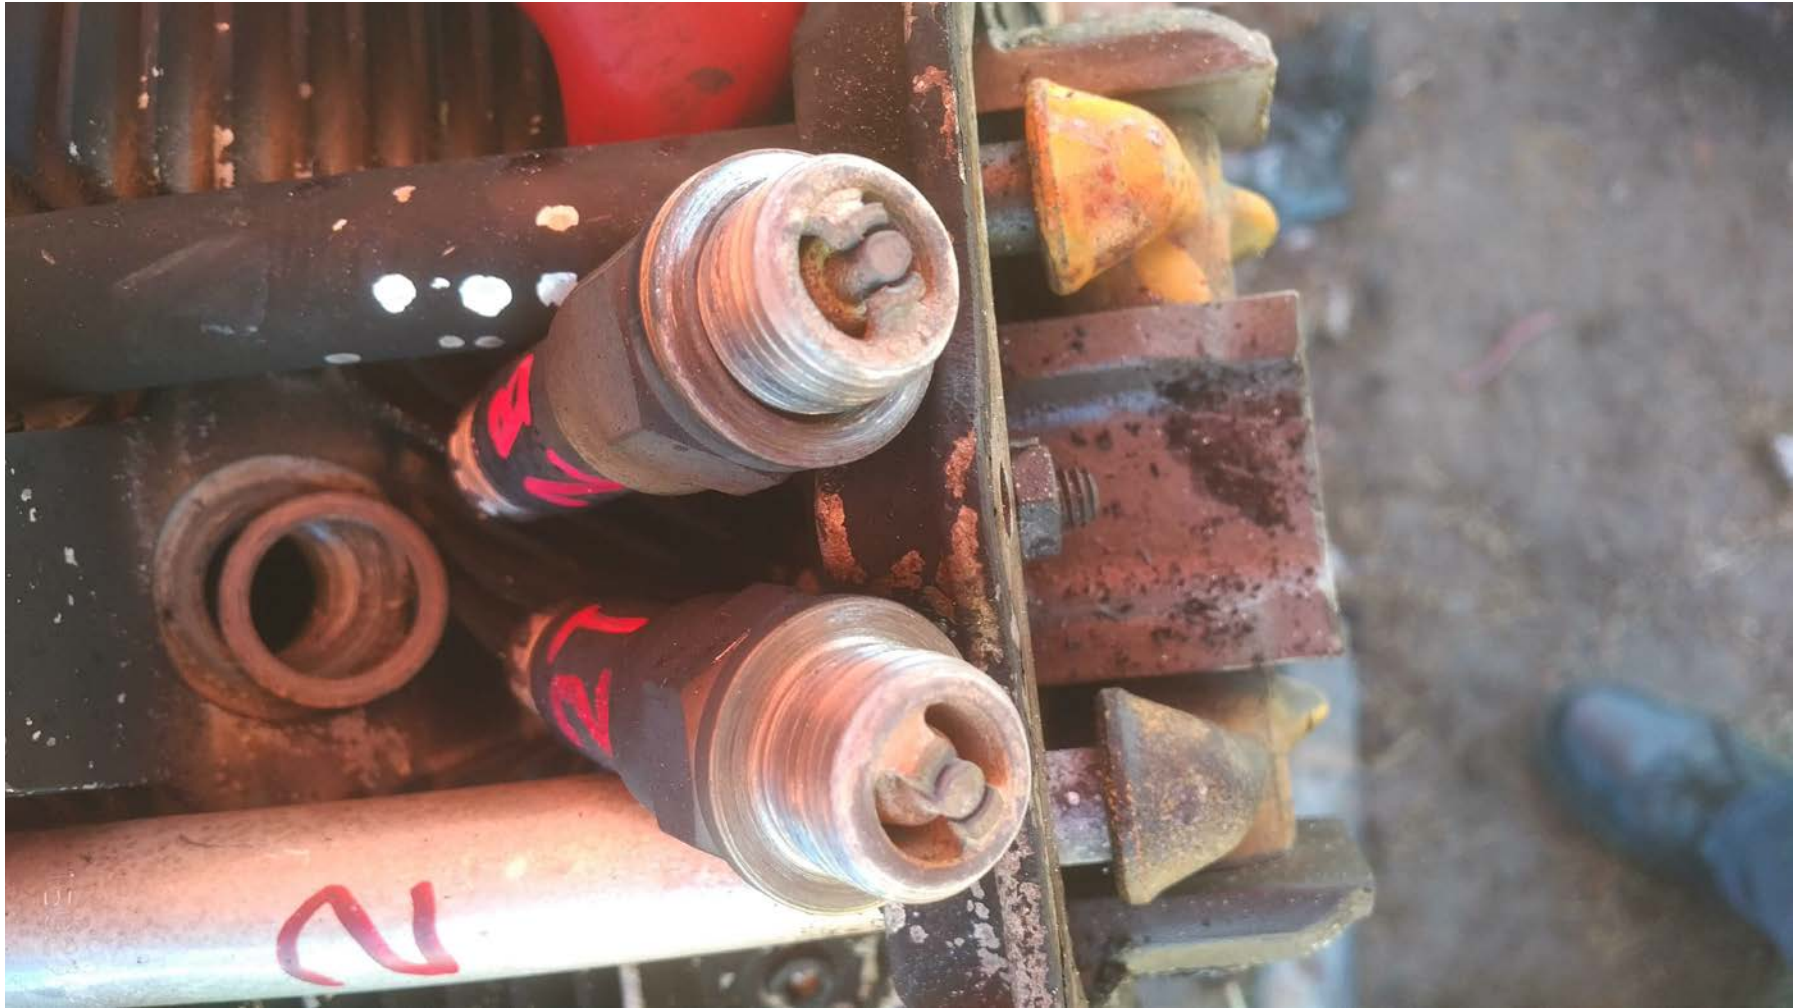
**Photo 10 – Photograph of the No. 1 top and bottom spark plugs free of damage or degradation. Note: All spark plugs exhibited similar signatures.**

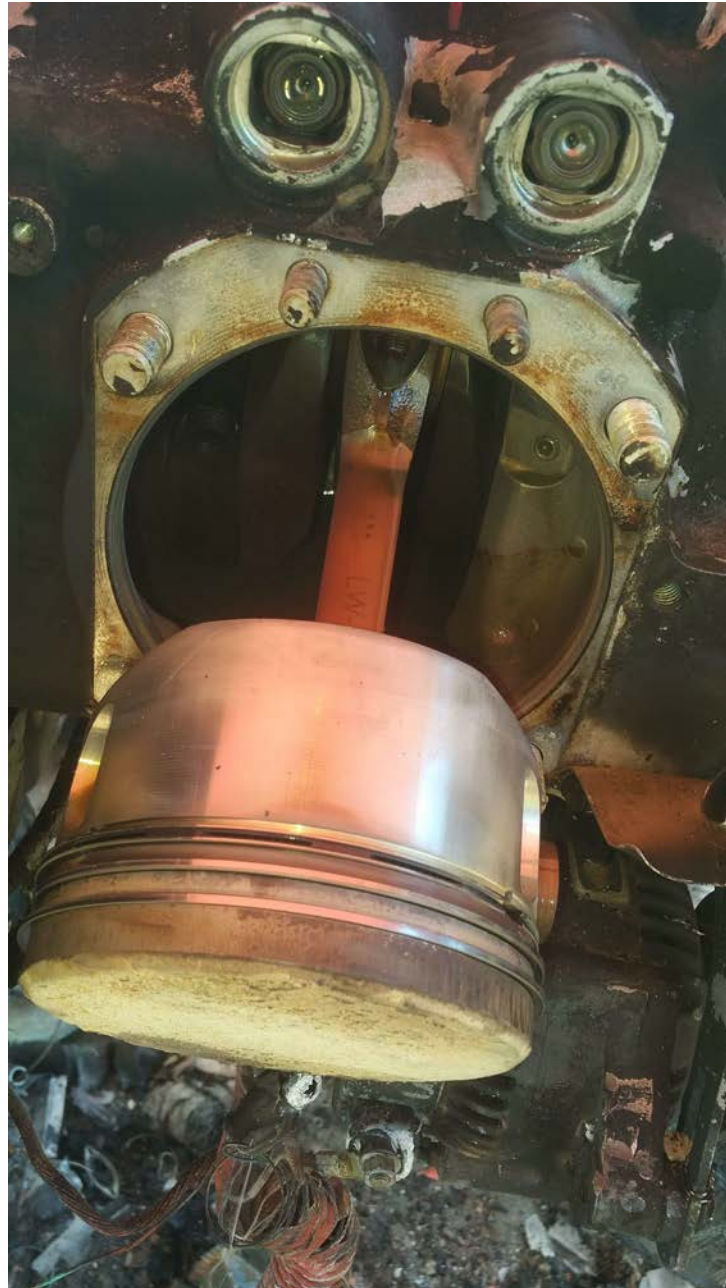
**Photo 11 – Photograph of the No. 1 cylinder exhibiting normal wear and free of damage.**
