## MEMORANDUM FOR RECORD

**Subject:** ERA18FA230 – Carburetor Icing Potential Test

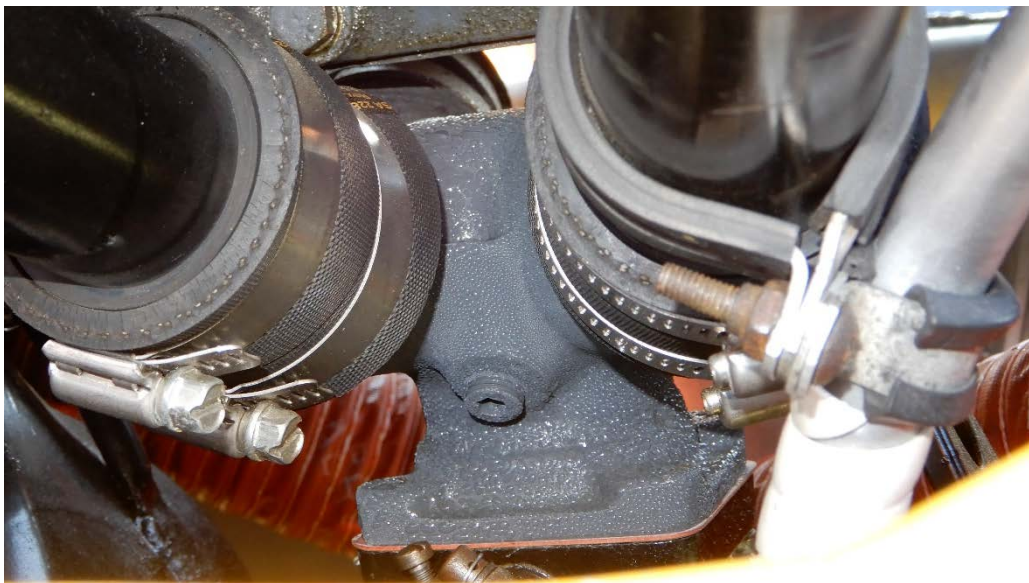
Then, the airplane was restarted and sat at idle power for about 5 minutes. After that time, the engine was shutdown and condensation was noted on carburetor and intake of the engine. At the time of the test, the temperature was 82.4° F and the dewpoint was 59°F.

*Picture 1. View on condensation on exemplar engine.*
