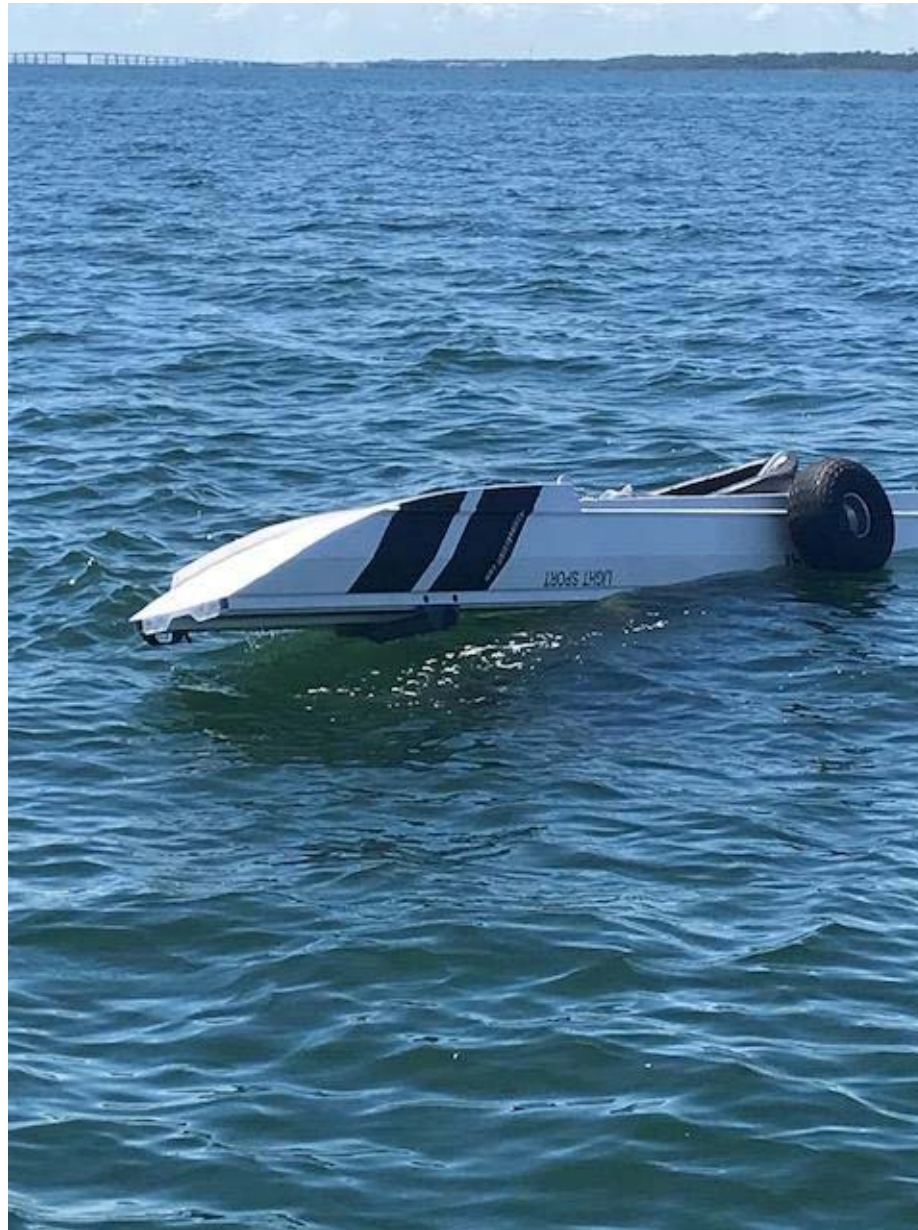
**Photo 1 – Wreckage in the water before recovery.**

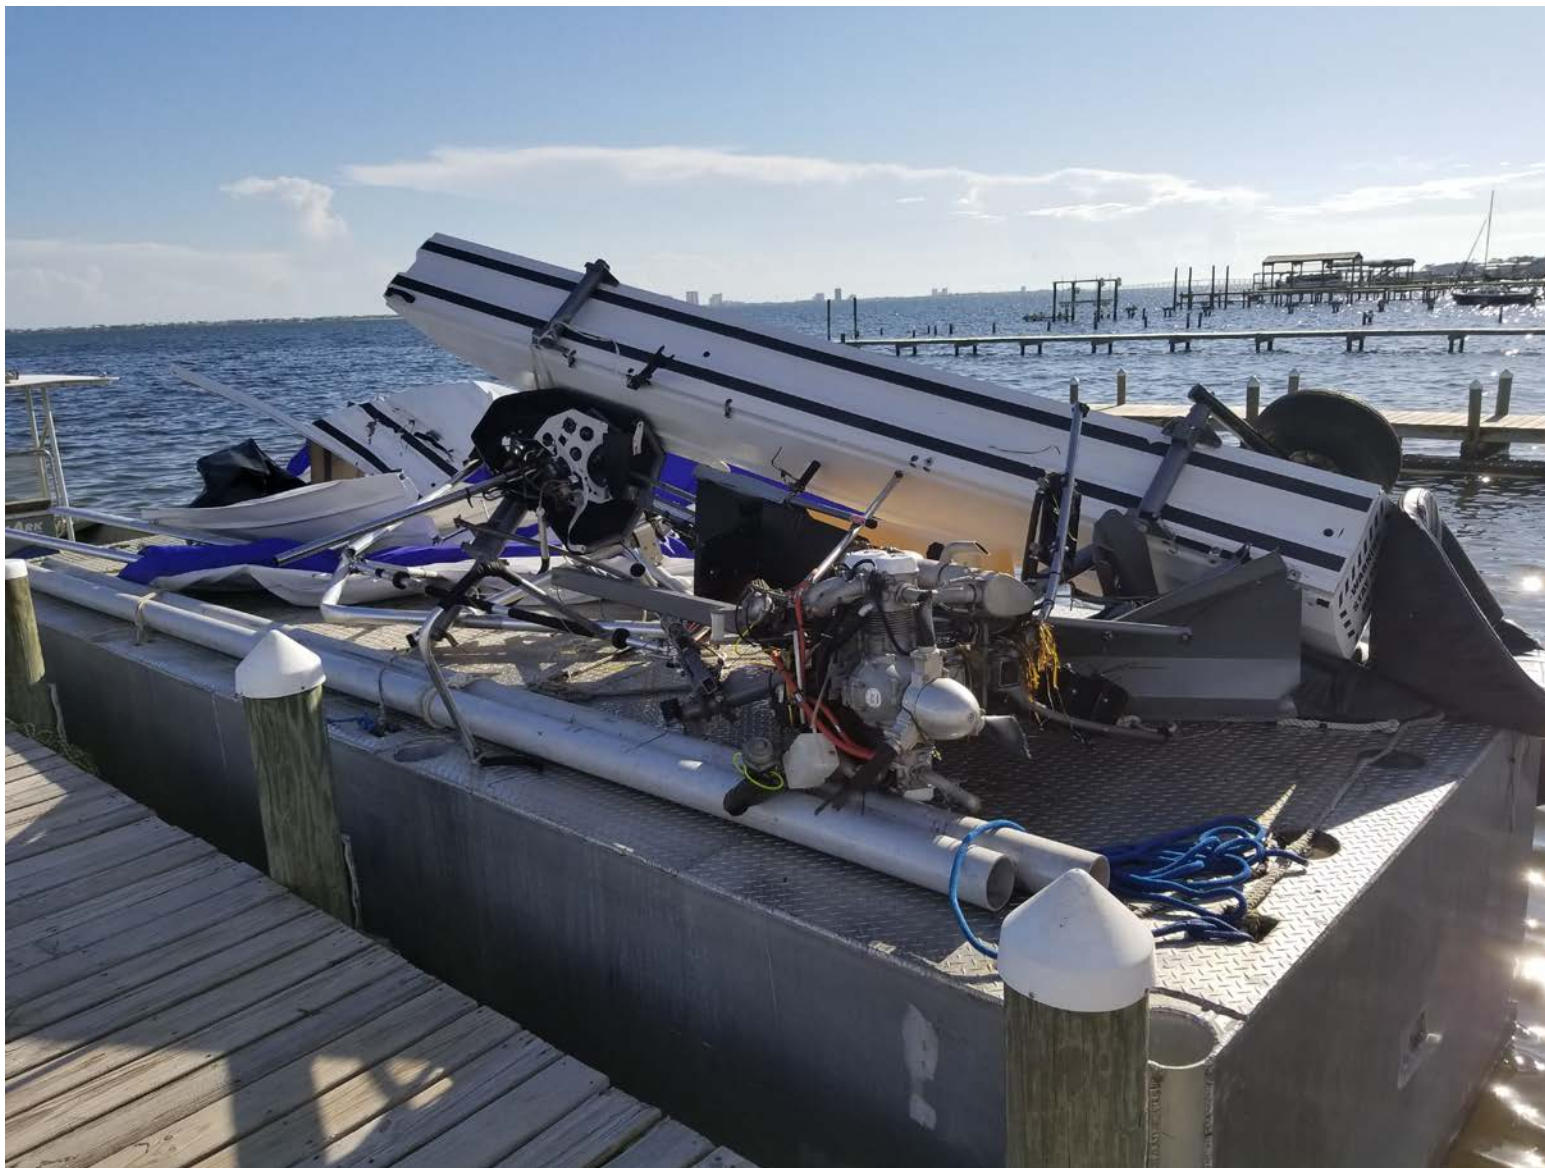
**Photo 2 –Wreckage on recovery barge.**

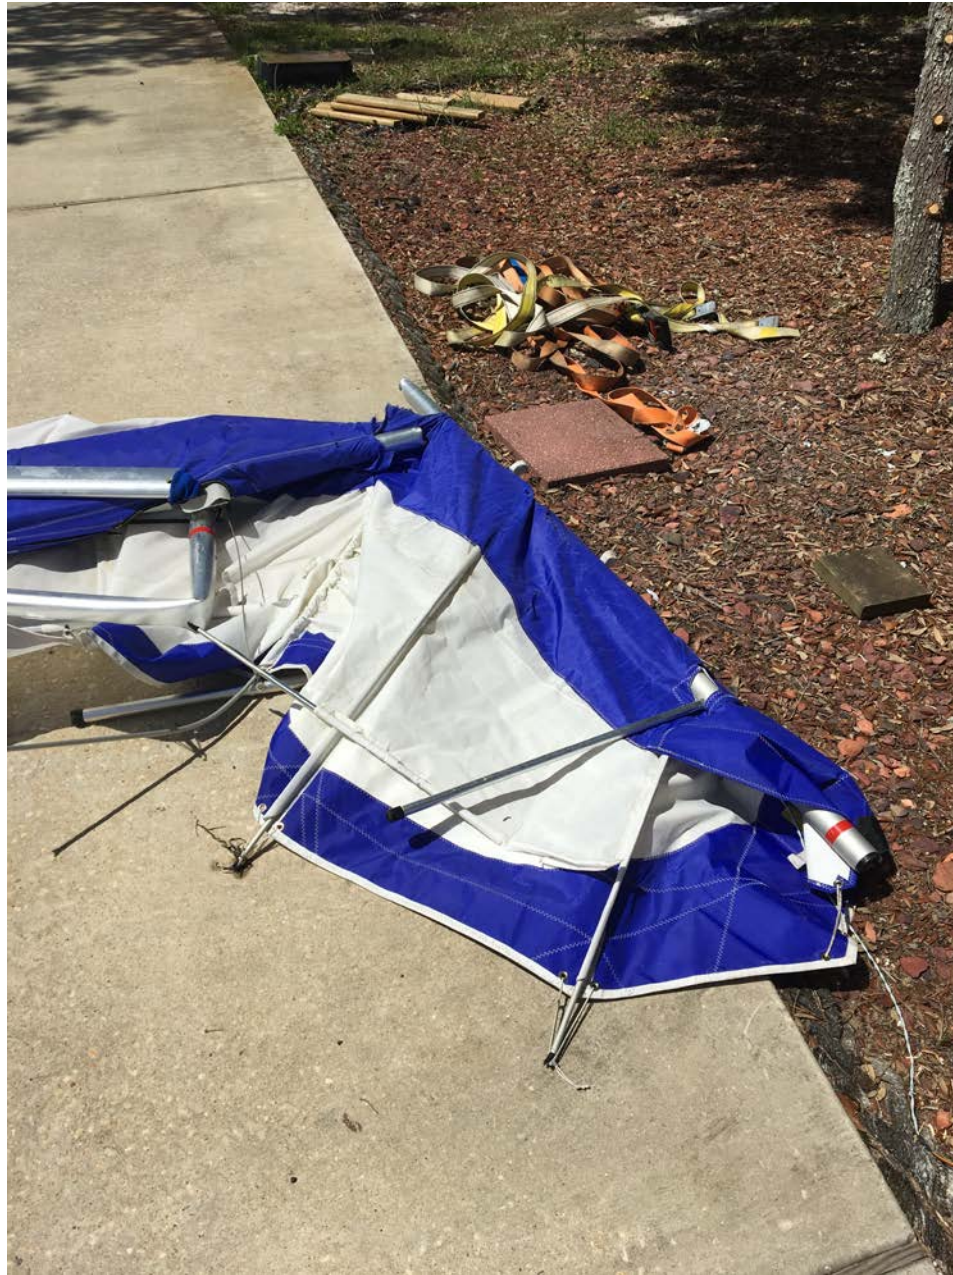
**Photo 3 – Close up of left wing damage.**

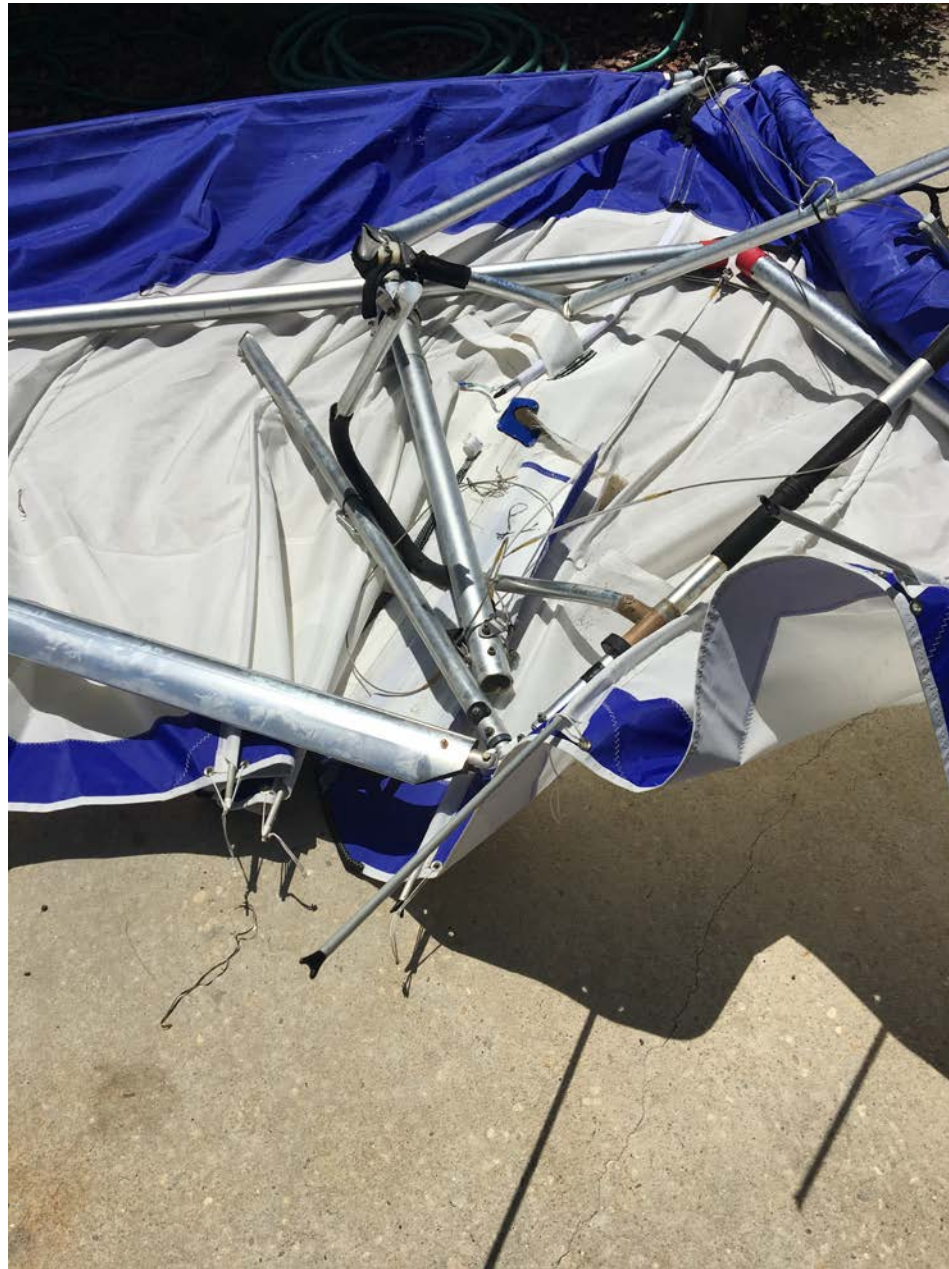
**Photo 4 – Close up of damage to wing structure. Note the wing is upside down to facilitate examination. The left side of the photograph is the right wing.**

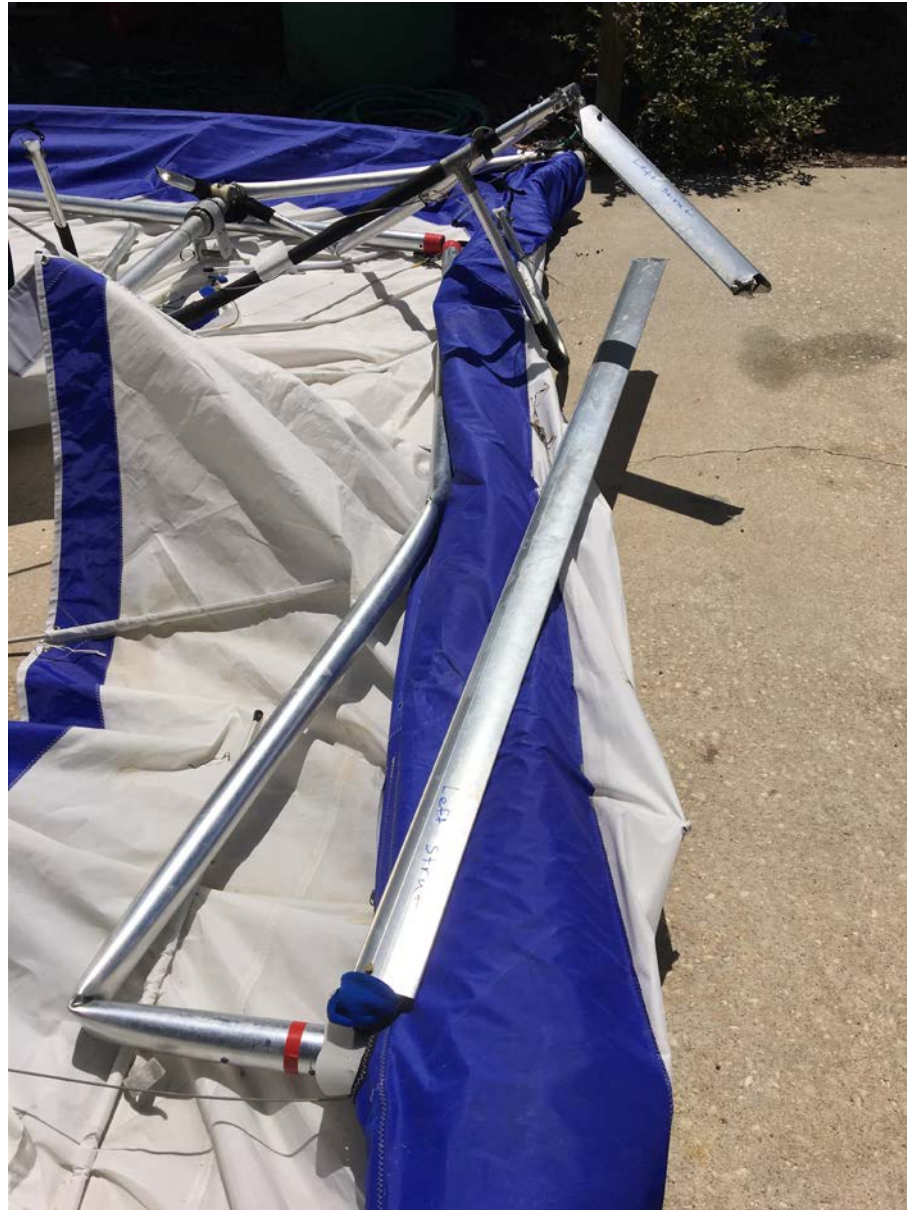
**Photo 5 – View of left wing and strut damage.**

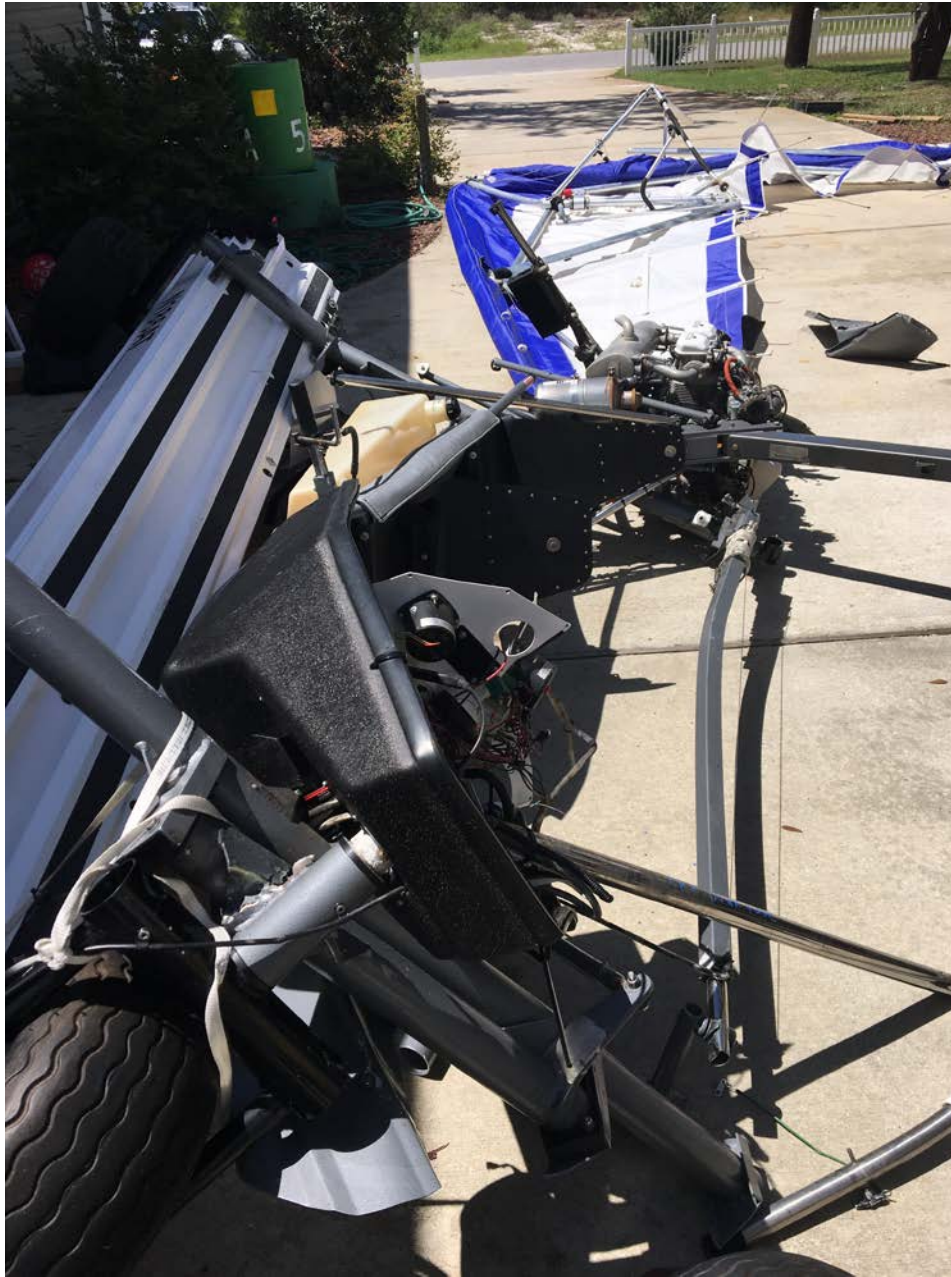
**Photo 6 – Overall view of fuselage, right float and wing in background.**
