# NTSB RECORD OF CONVERSATION

**Adam Gerhardt**  
**Air Safety Investigator**  
**Eastern Region, Office of Aviation Safety (ERA)**  
**National Transportation Safety Board**

**NTSB Accident Number: ERA18FA240**

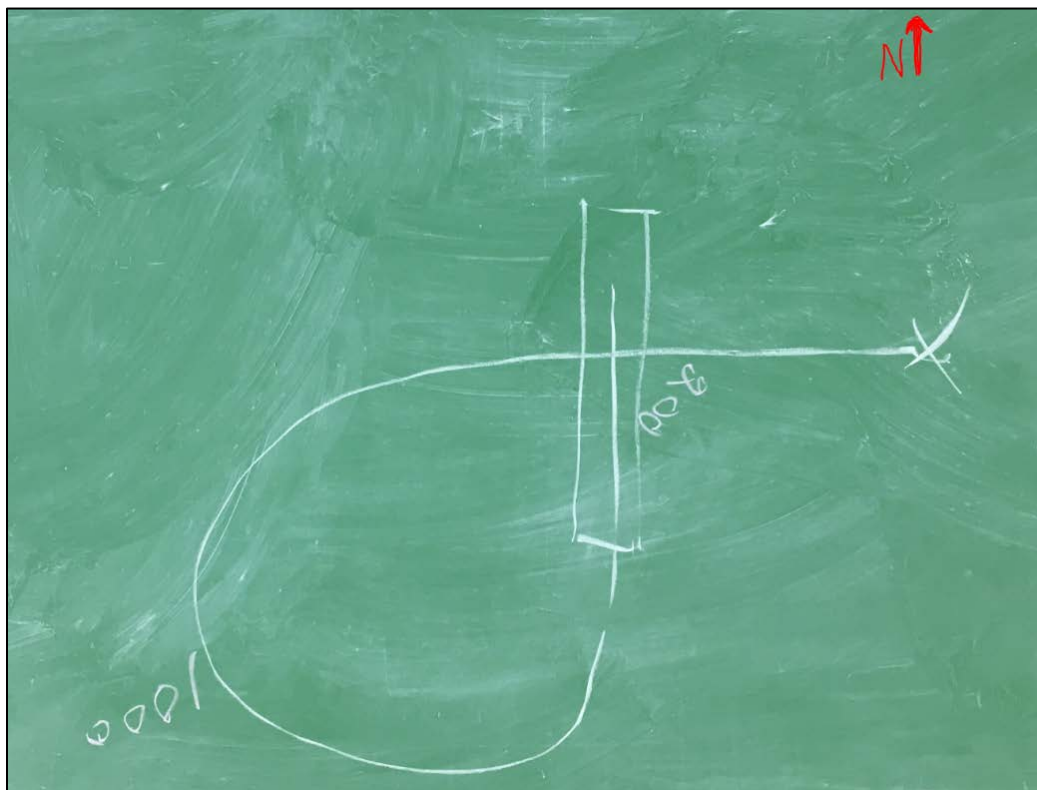
- He reported that he was on a taxiway at M04 airport, observing the accident airplane takeoff. The airplane departed to the south from runway 19, climbed to about 1,000 ft above ground level (agl), and then completed a 270° descending turn. He then observed the airplane cross over the airfield, in a level pitch and bank attitude, about 200 to 210 knots. After the airplane crossed over the airfield, and was flying east bound over a cotton field, he observed the left wing and winglet "oscillate 5 times" and then the wing "exploded." He immediately saw "blue styrofoam," which he said he knew was part of the internal wing structure. Next, the airplane pitched up about 90°, the right wing separated from the airplane and the airplane descended and disappeared into the cotton field. Refer to Figure 1 below.

*Figure 1: Depiction of the flight path, as drawn by Mr. Harris. The 1000 and 200 denotes the altitude above ground. The X denotes the estimated location of the accident site.*
