# **NATIONAL TRANSPORTATION SAFETY BOARD**

## **Wing Examination**

**Factual Report**  
**By Adam M. Gerhardt**

Location: Covington, Tennessee  
Date: September 1, 2018  
Aircraft: Experimental, Amateur-built, JETEZ  
Registration: N815EY  
Operator: Individual  
NTSB Number: ERA19FA240

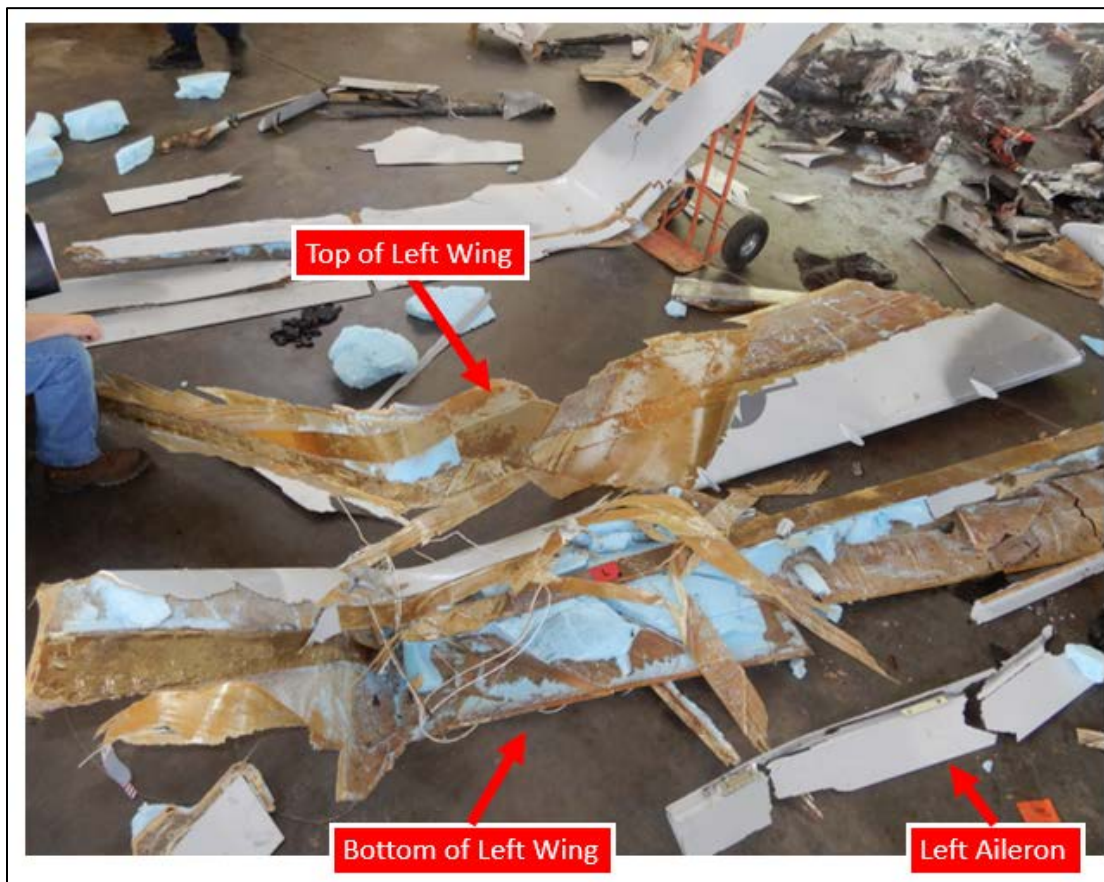
The left wing had fragmented into several pieces. Portions of the left wing's upper skin plys displayed evidence of fiber material transfer from the lower wing skin. Portions of the left wing's upper spar cap and upper wing skin had a glossy appearance with no obvious evidence of fiber material transfer. The left winglet skin panels showed evidence of fiber material transfer between the winglet skin and the winglet spar caps.

Figure 1: Overview of left-wing fragments, laid out after recovery from accident site

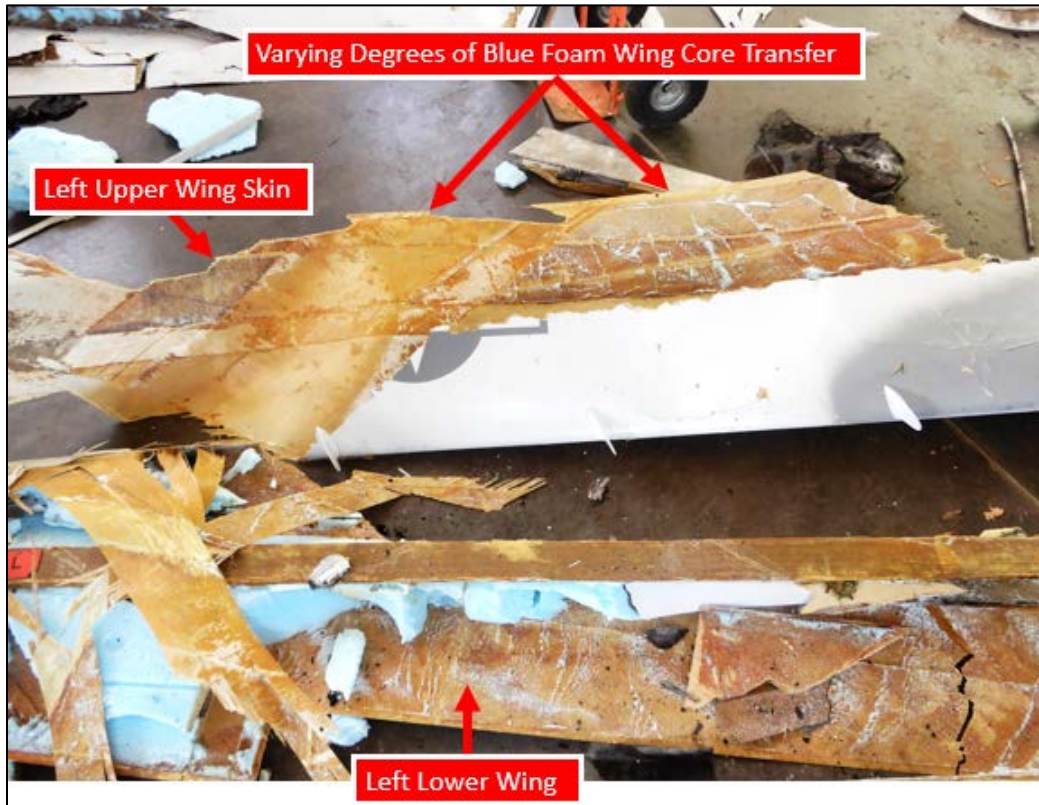
Figure 2: Overview of Internal Left-Wing Skin

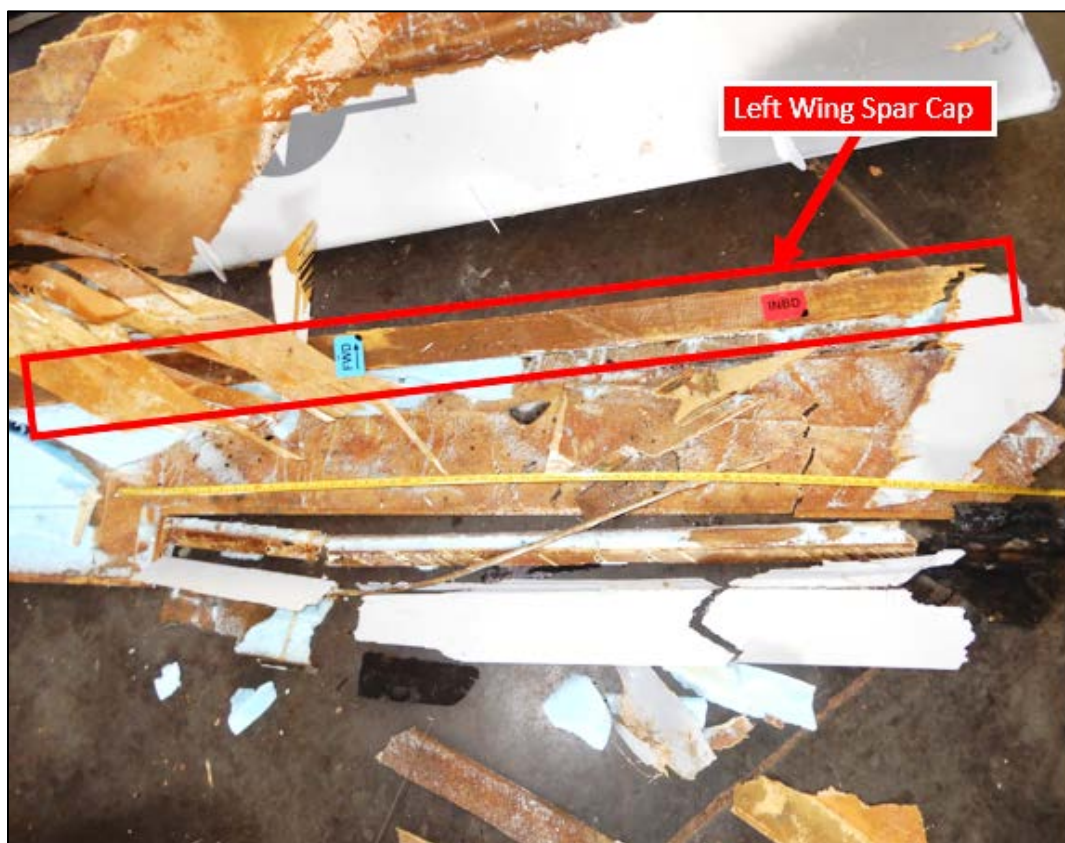
Figure 3: Overview of portion of left-wing spar cap

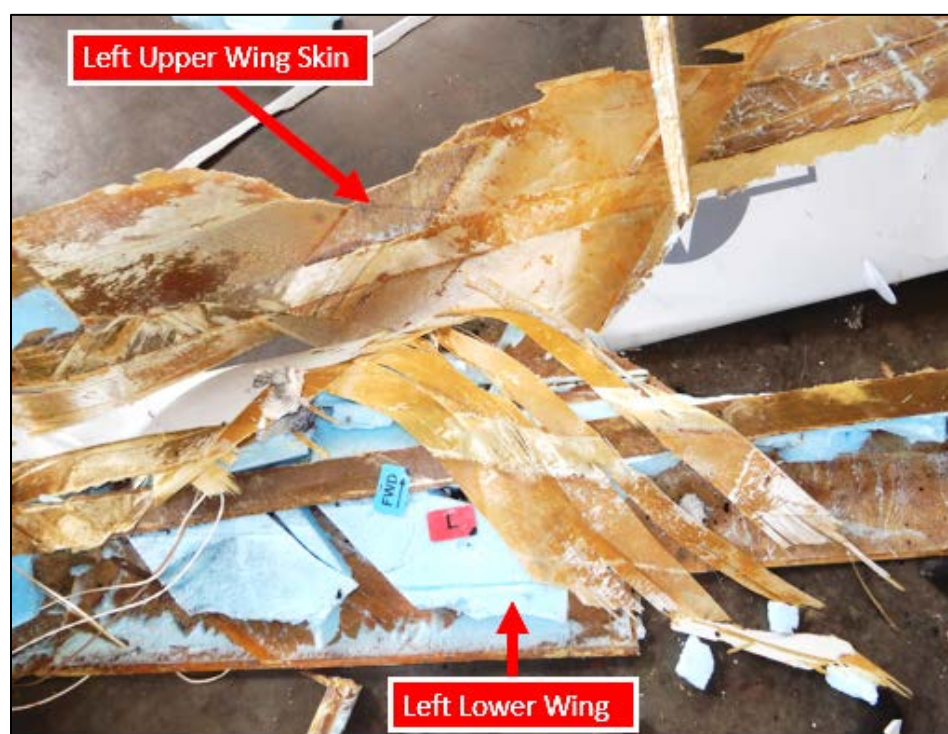
Figure 4: Overview of portion of the left-wing upper and lower skin and wing spar

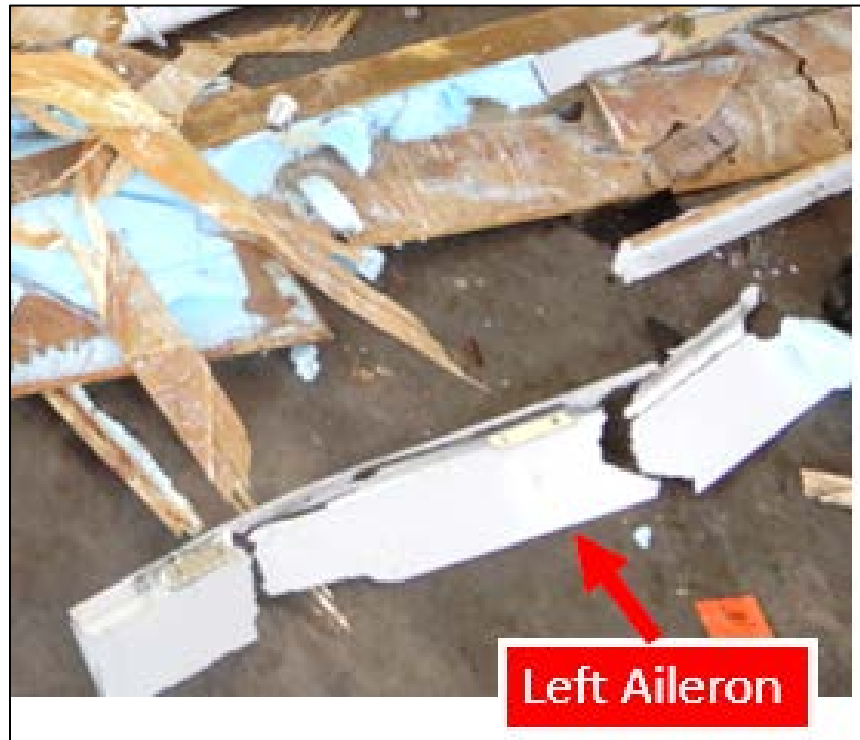
The left aileron was fragmented into multiple pieces. The inboard bracket displayed fire damage and was the only bracket to display fire damage, and still had wing skin attached to it. The outboard and middle bracket had pulled through the wing skin. All screws were found on the brackets. The leading-edge balance weight was bent upwards at the inboard edge of the outboard hinge, consistent with wingtip upward bending. The aileron control rod also had evidence of wing upward bending. The aileron fragments were consistent with overload.

Figure 5: Overview of Left Aileron

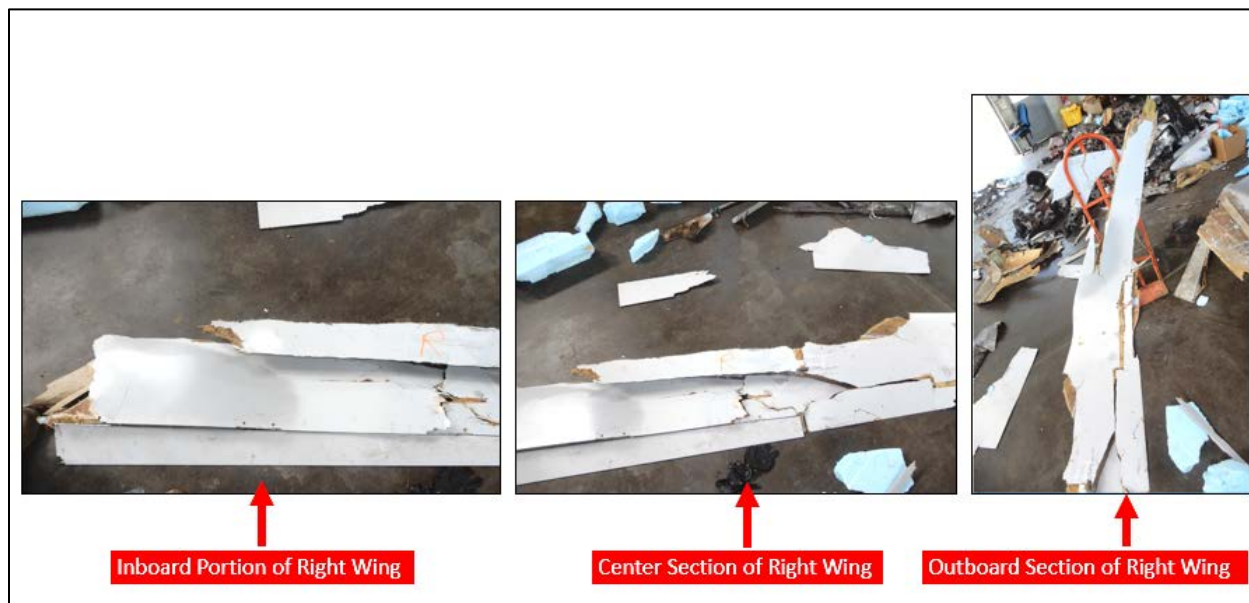
The right wing had fragmented into several pieces. There was evidence of fiber material transfer between the wing upper skin plies throughout the wing area.

Figure 6: Overview of right wing laid out after recovery from accident site

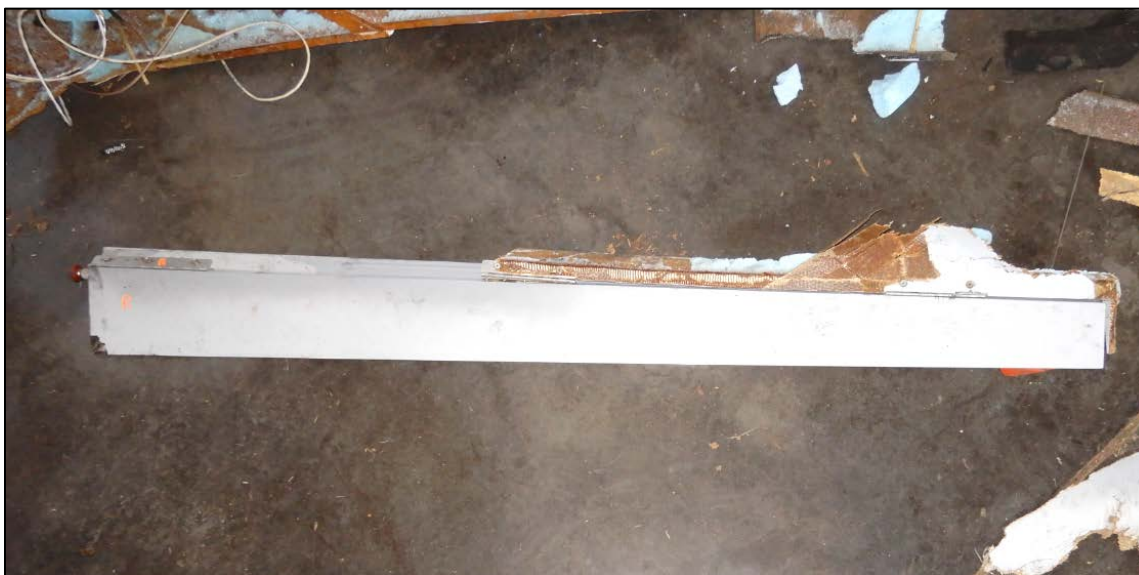
The right aileron remained intact in one piece but had separated from the right wing. The inboard bracket separated from the wing skin. The middle and outboard brackets remained attached to the wing skin. All screws were found on the brackets.

Figure 7: Right Aileron

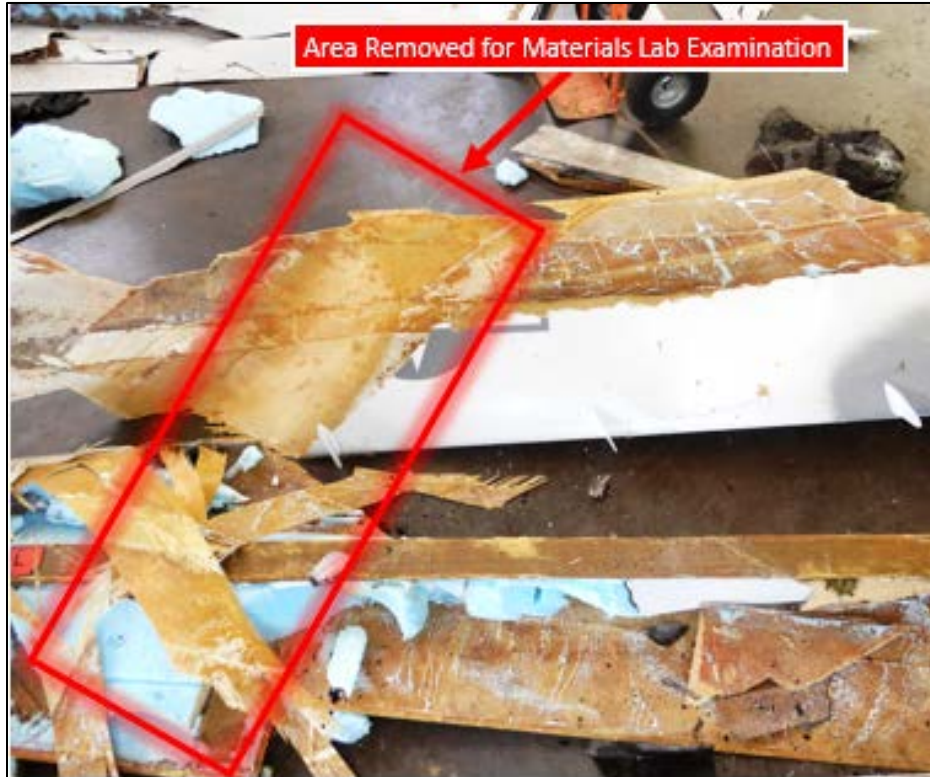
The left wing was measured from the winglet toward the inboard portion of the wing. With the winglet marking the start of the measurement, of 0 inches, a section of the upper spar cap and mating upper wing skins were removed for examination in NTSB Materials Laboratory in Washington, DC. The section removed began at 41 inches inboard of the winglet, continuing to 100 inches inboard of the left winglet. Reference the NTSB Materials Laboratory factual report for additional information.

Figure 8: Area Removed for Materials Lab Examination
