# NATIONAL TRANSPORTATION SAFETY BOARD

## MATERIALS LABORATORY FACTUAL REPORT

Report No. 19-074

Place : Covington, Tennessee  
Date : September 1, 2018  
Vehicle : JetEZ Experimental, N815EY  
NTSB No. : ERA18FA240  
Investigator : Adam Gerhardt, AS-ERA

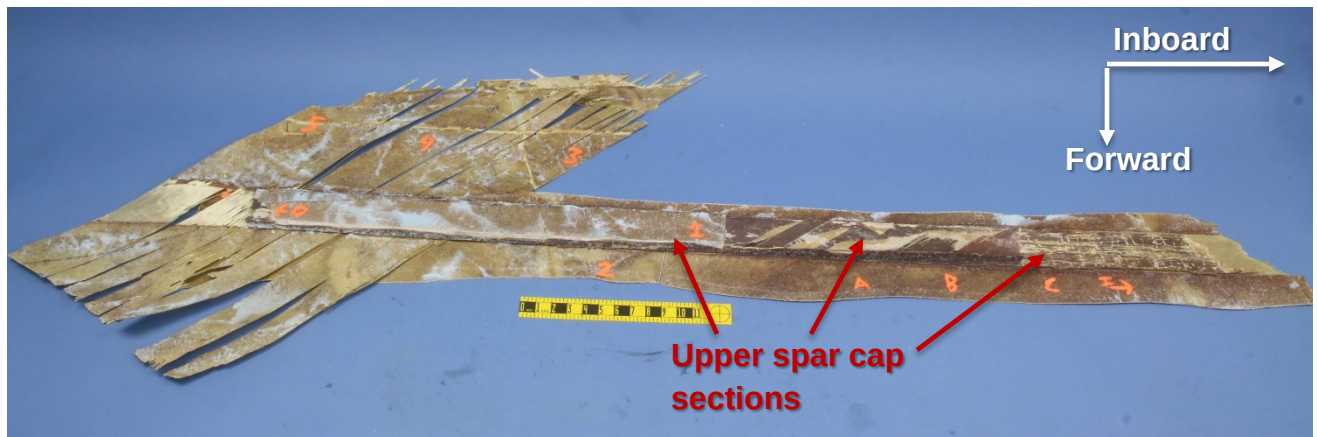
Figure 1 shows the components received from the left wing by the Materials Laboratory, viewed from below looking upward as re-assembled to show the relative positions of the pieces prior to the accident. The components received included three spar cap sections, two sections of excised out upper wing skin, and three tattered plies of wing skin from just below the outermost skin. Several of the received components had been marked after the accident. Based on the markings, the components in this report will be referred to as the following (and are shown in Figure 2 through Figure 10):

Figure 1 – The sections of the upper wing skin and spar cap from the left wing, reconstructed in their relative positions prior to the accident.

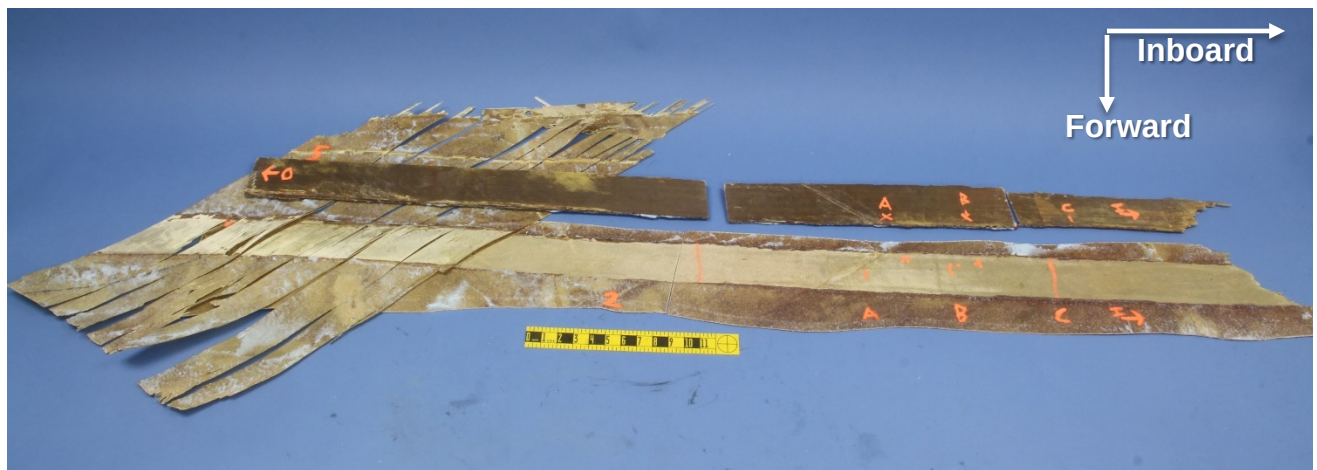
As demonstrated in Figure 1 through Figure 2, the two outer wing skin sections mated, the three wing skin plies mated with each other on the outboard region of the upper wing skin, and the upper spar cap upper surfaces mated with the skin along an approximately 3-inch wide strip shown in Figure 2. This strip was visible on Figure 2, Figure 4, Figure 6, and Figure 8 and exhibited a lighter yellow color in contrast to the darker color present on most of the rest of the lower facing surfaces of the spar and wing skin. This strip on the skin corresponded to where the three spar cap sections had been positioned and was consistent with a resin-starved or dry laminate. The mating upper faces of the spar cap sections exhibited the dark amber color, consistent with the cured resin used in the construction of the composite spar cap. These faces were generally smooth in texture with a faint imprinted pattern consistent with the mating unbalanced plain-weave fabric of the wing skin visible in Figure 9. These mating upper faces of the spar cap sections were absent loose or broken fiber remnants.

Figure 2 – The section of the wing skin and the upper spar cap sections from Figure 1, with the cap sections inverted and removed from their position on the wing skin.

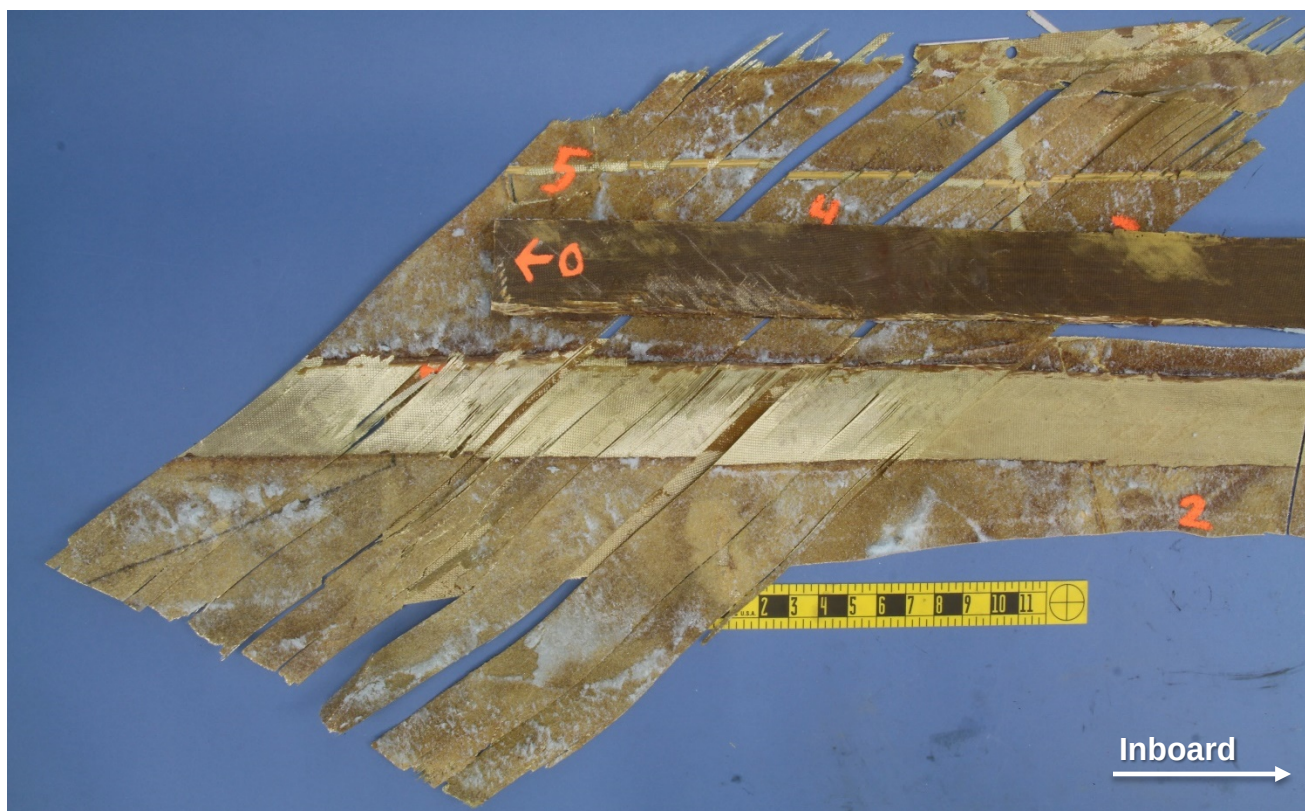
The three loose wing skin ply pieces (3, 4, and 5) were delaminated from the upper wing skin. Shown best in Figure 4, these separated skin plies were oriented at a 45° to the upper wing skin and spar cap. They had delaminated at the same ply layer on the upper and lower sides. In addition, these loose plies exhibited the same 3-inch strip on the lower surfaces corresponding to the position to which the spar cap section upper surfaces mated.

Figure 4 – View of Figure 3, with the spar cap segment removed and inverted in place.

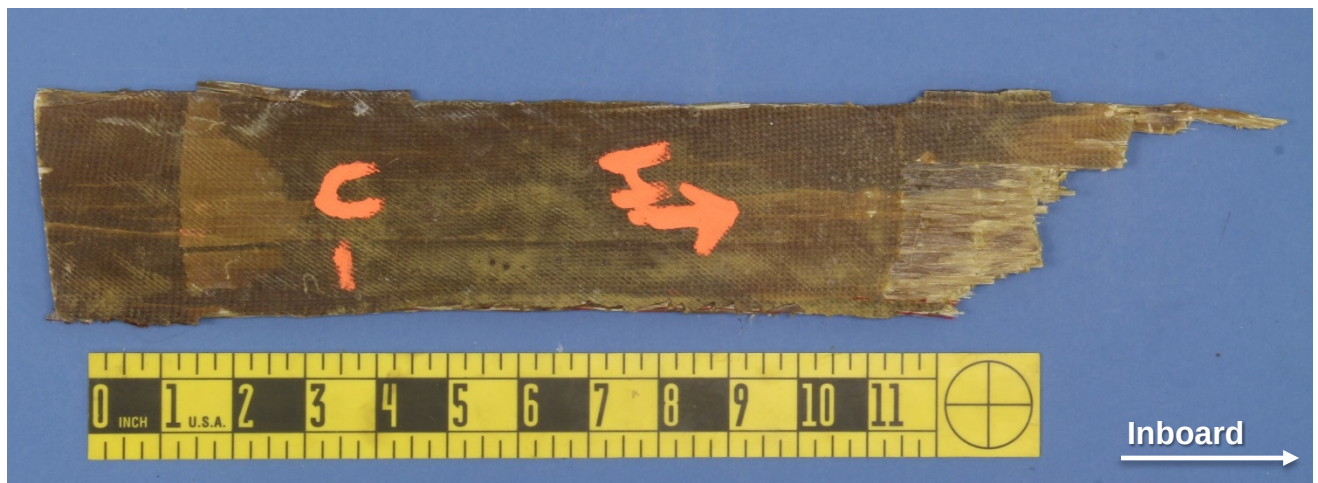
Of note was the condition of the three spar cap pieces. The upper surface of all three pieces exhibited a generally smooth surface with a dark yellow-brown color, consistent with cured epoxy resin. Figure 9 and Figure 11 show a closer view of a typical area of the upper surface of the spar cap pieces. In general, this surface was smooth, exhibiting an imprint of the mating 45° unbalanced plain-weave fabric of the upper wing skin and wing skin plies. As shown in Figure 12, there was no significant amount of fiber pullout or breakage on the upper spar cap upper surfaces.

Figure 9 shows the upper surface of the spar cap segment C, and Figure 10 shows the lower surface. The upper surface of this spar segment exhibited the flatter, smoother surface present on the other spar segments. The lower surface exhibited a rougher texture and consisted of fiber fracture among multiple layers and fracture in the matrix resin. The general orientation of the lower surface of spar cap segment C was angled downward from inboard to outboard (i.e., cross sectional thickness of the submitted fragment increased from inboard to outboard). Adjacent the fracture surface on the upper side was a rectangular-shaped area that was inconsistent with the smooth upper surface. This area was consistent with localized delamination and pullout of an individual ply.

Figure 9 – The upper surface of spar cap segment C.

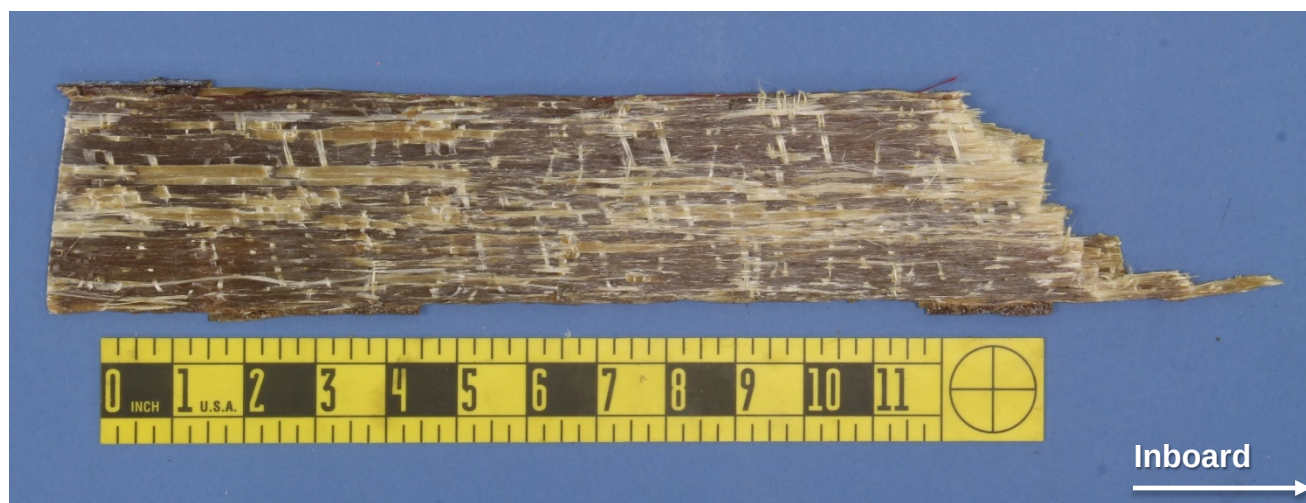
Figure 10 – The lower side of the spar cap segment C, showing intra-component fracture.

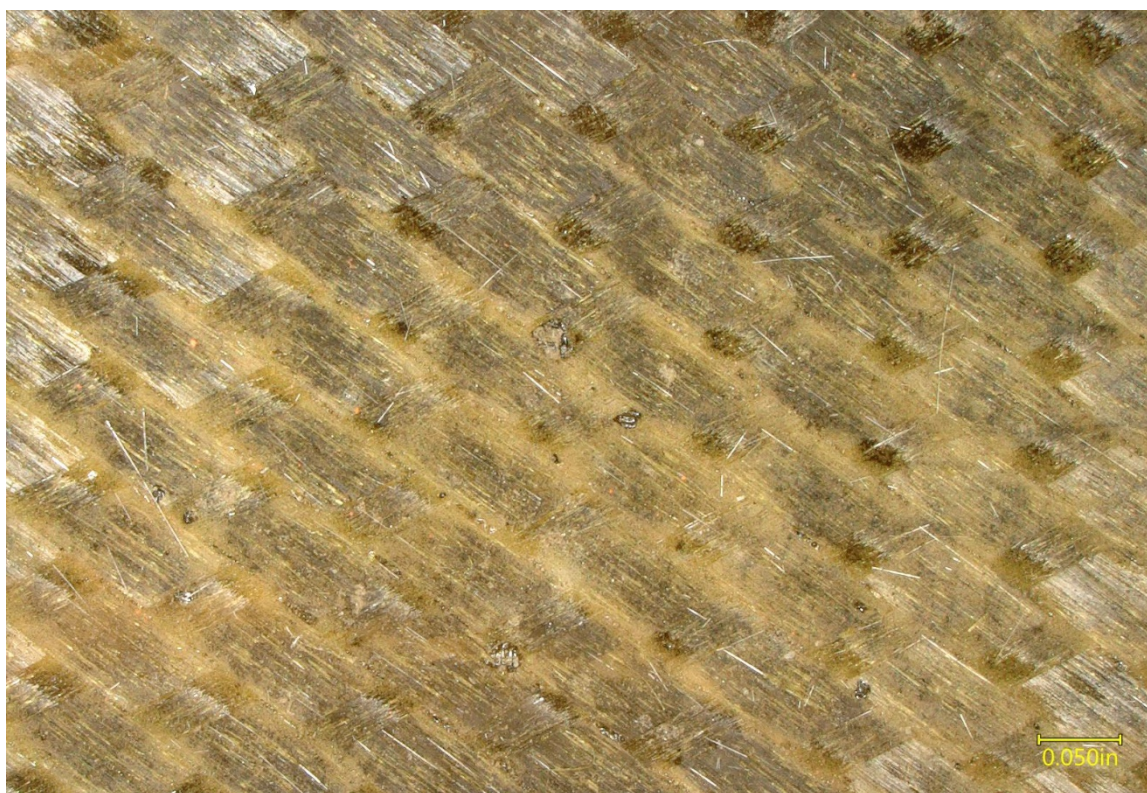
Figure 11 – Spar cap section C upper face, showing a flat surface with the underlying woven structure of the spar cap composite.

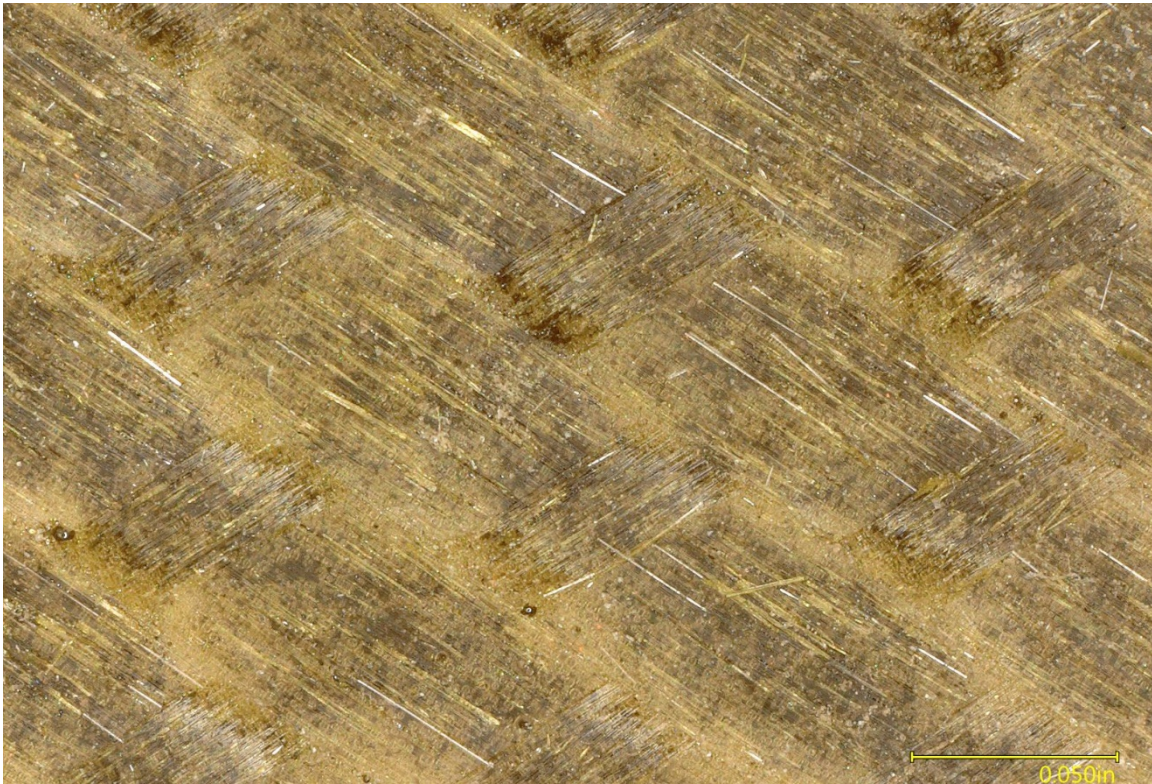
Figure 12 – Closer view of the spar cap section C surface in Figure 11.

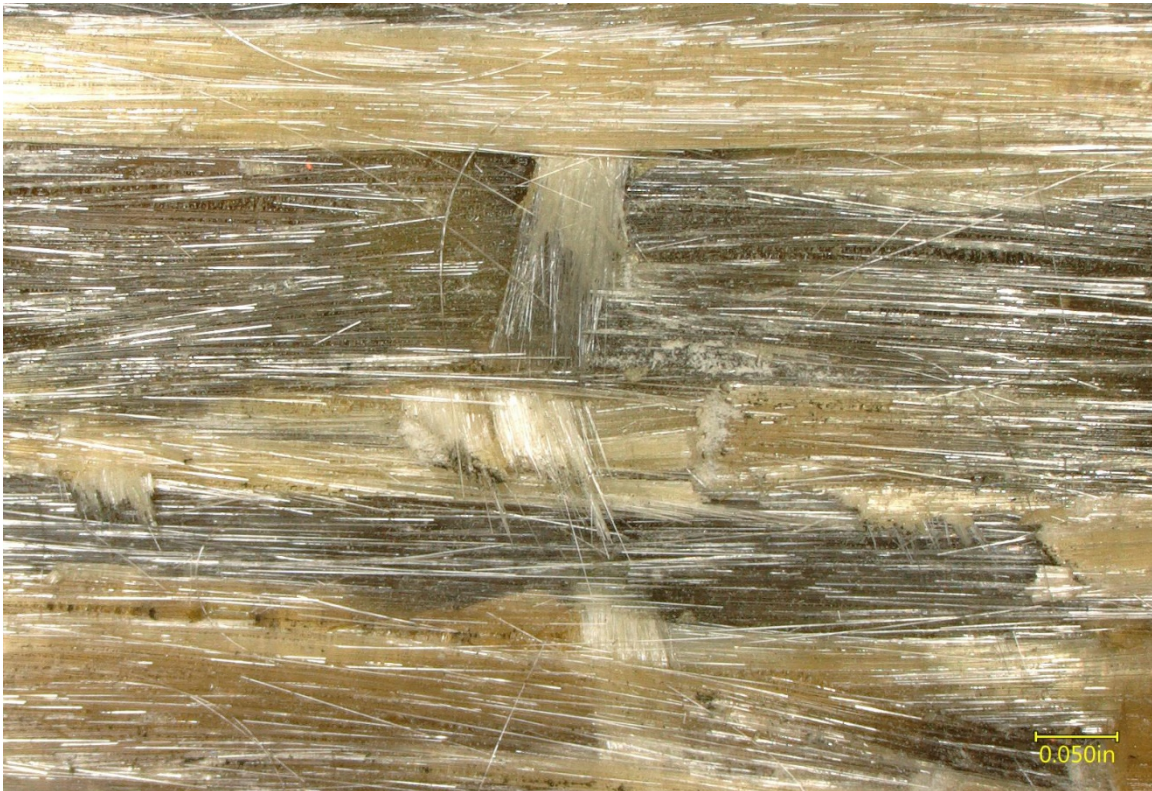
In contrast, the lower surfaces of the inboard spar cap pieces exhibited a rougher appearance. The lower surfaces, as typified in Figure 13, exhibited fracture of fibers in both woven (warp and fill) directions. These sets of fibers had fractured in multiple, rather than just one, layer. In areas where fiber fracture occurred, the fiber lengths varied. Figure 14 shows a closer area with fracture of the matrix. In this figure, small hackles were visible

Figure 13 – Spar cap section C lower surface face, fractured fibers and resin fracture features.

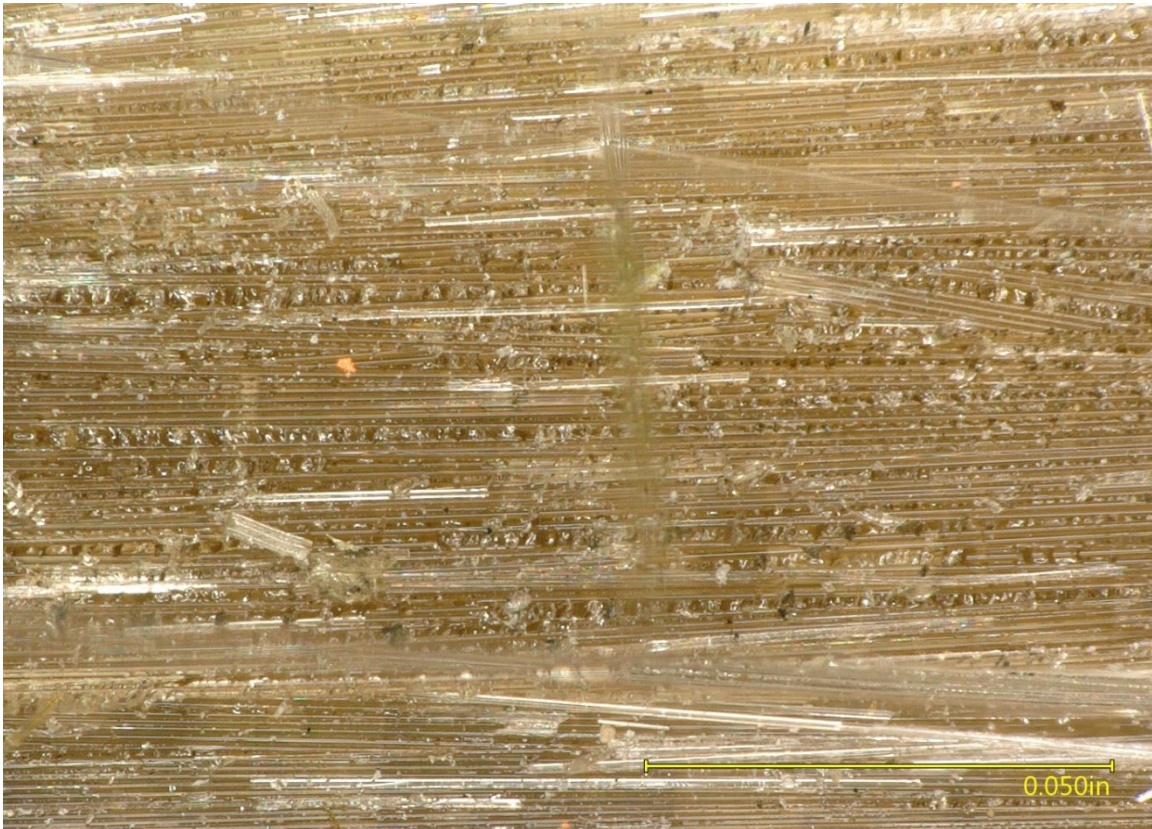
in the cured resin between parallel fibers. These fracture features were consistent with an angled translamellar fracture of the inboard spar sections.

Figure 14 – Closer view of the spar cap section C lower surface, showing hackles and matrix fracture between fibers.

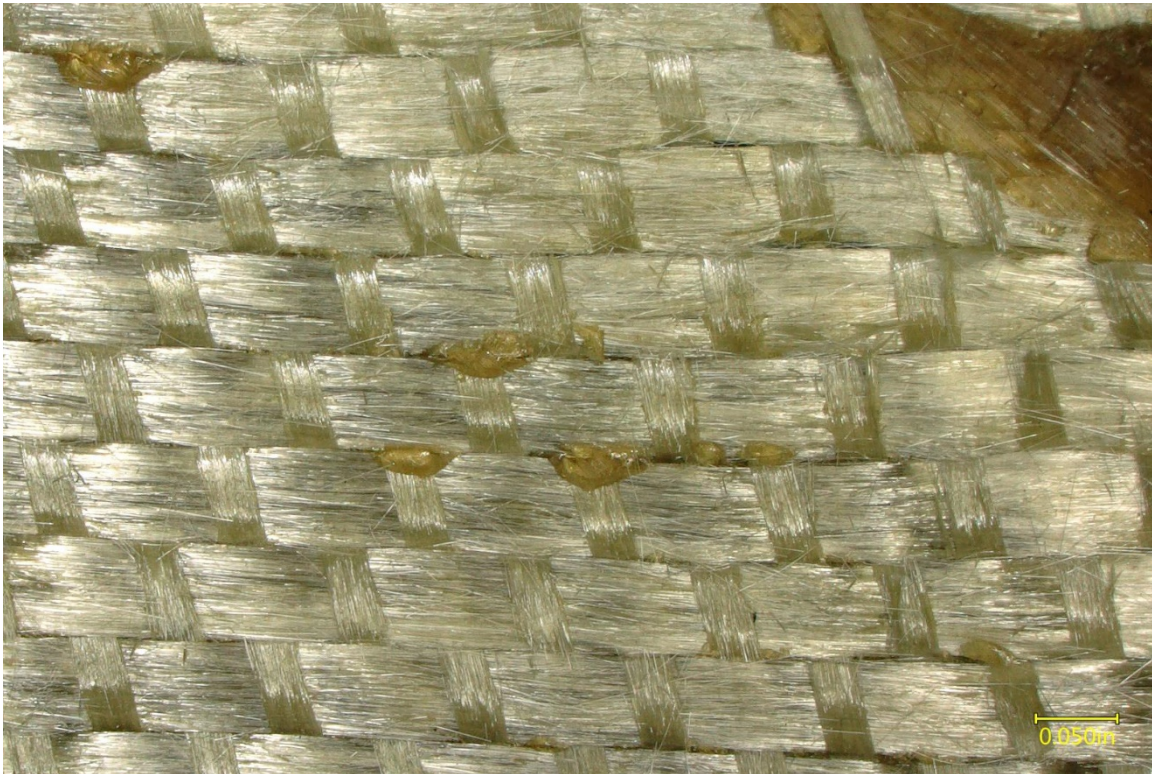
Figure 15 shows one of the mating faces of the wing skin plies that faced the upper spar cap. As shown in the figure, the unbalanced plain weave of the glass fibers was visible, most of them absent of resin infiltration. Figure 15 shows several resin globules, present on the lower surface of the one of the plies that faced the upper spar cap upper surface. These resin globules, which exhibited a general bead shape, were consistent with a lack of wetting and impregnation of the fabric by the resin.

These features on the 3-inch strip of the wing skins pieces and the upper surfaces of the upper spar cap sections were consistent with an adhesive disbond between the respective faying surfaces. Had the fracture been cohesive within the laminate structure, the features would be more consistent with the fracture on the lower surface of spar cap section C (shown in Figure 10). Had the fracture been cohesive within the adhesive bond between the upper surfaces of the upper spar cap and the wing skin pieces, there would be evidence of adhesive/resin remnants still adhered to both faying surfaces. This adhesive disbond was consistent with a lack of impregnation and interfacial interaction of the resin into and with the glass fiber fabric, creating a lack of strong adhesion between the wing skin and the spar cap. These issues were consistent with a fabrication problem at manufacturing of the layup, rather than an in-service or environmental degradation failure.

Figure 15 – The lower surface of loose ply 5 at the spar cap location, showing “dry fiber” weave and globules of resin between the weave gaps.

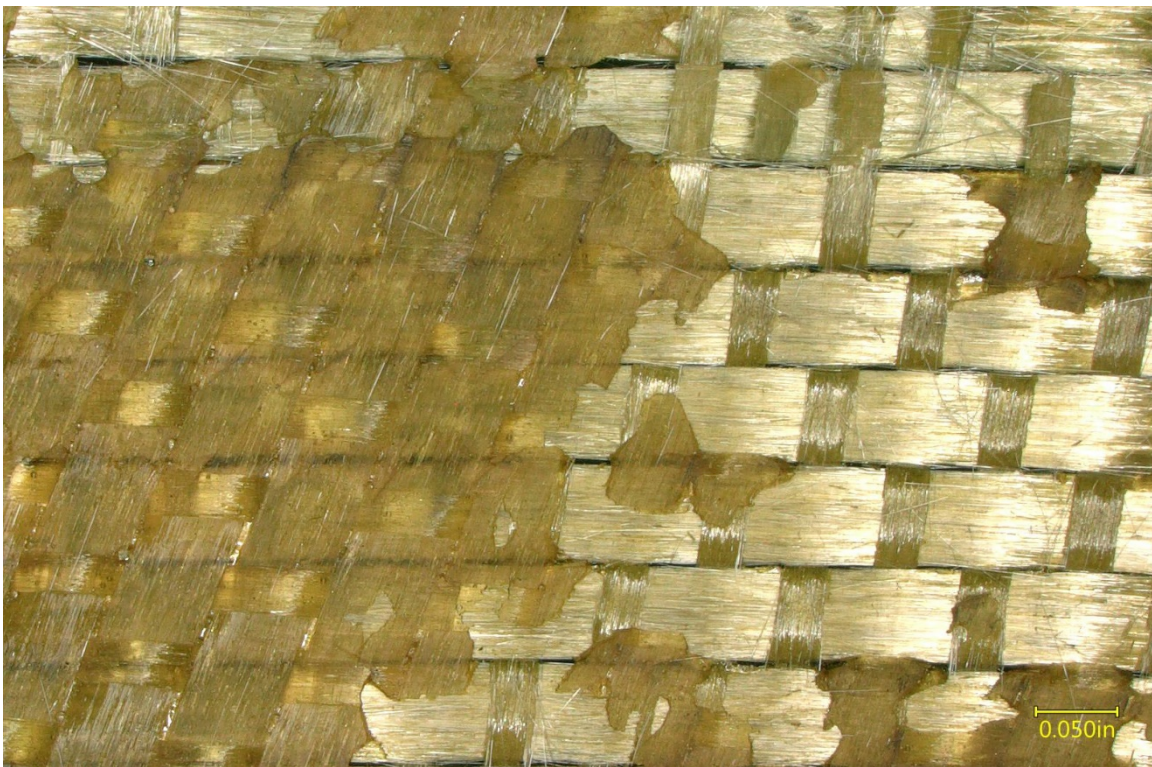
In contrast, the opposite side of this ply, which faced the upper wing skin, exhibited a flatter orientation of some of the resin. This face exhibited a higher degree of wetting/impregnation characteristics of the resin, as exemplified in the lower left of Figure 16. However, much of the fabric still exhibited areas with bare fibers, consistent with a lack of impregnation of the resin into the fabric.

Figure 16 – Lower face of the ply 5, showing resin fracture away from the spar cap location.

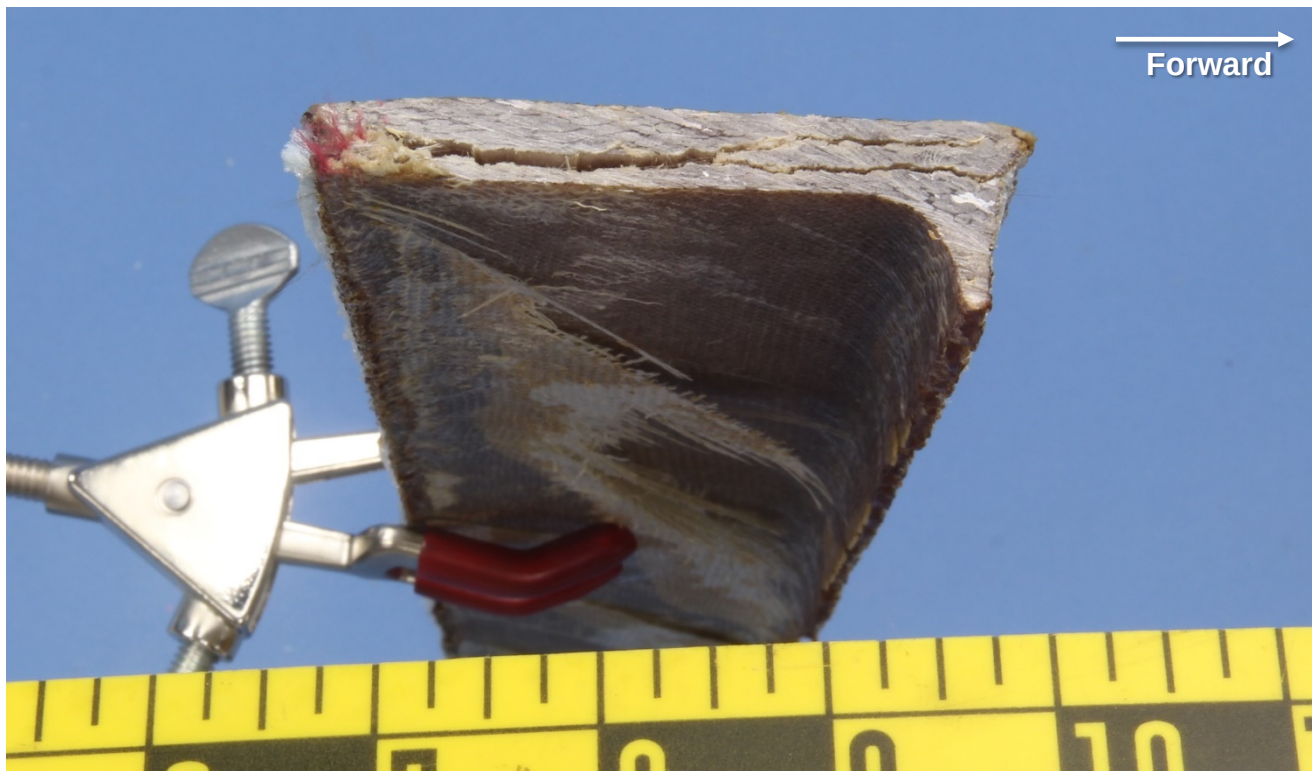
Figure 17 shows the inboard surface of spar cap section A/B. This surface was flat, consistent with having been cut or sectioned after the accident. The surface exhibited several cracks internal to the spar segment, oriented along the length of the spar. Figure 18 shows this same spar segment A/B inboard surface, but with the mating outboard cut surface of spar cap section C in place. The lower surface of the C segment, which had fractured, was consistent with the internal cracking present on the inboard side of segment

Figure 17 – The A/B section of the upper spar cap, looking outboard at the inboard section.

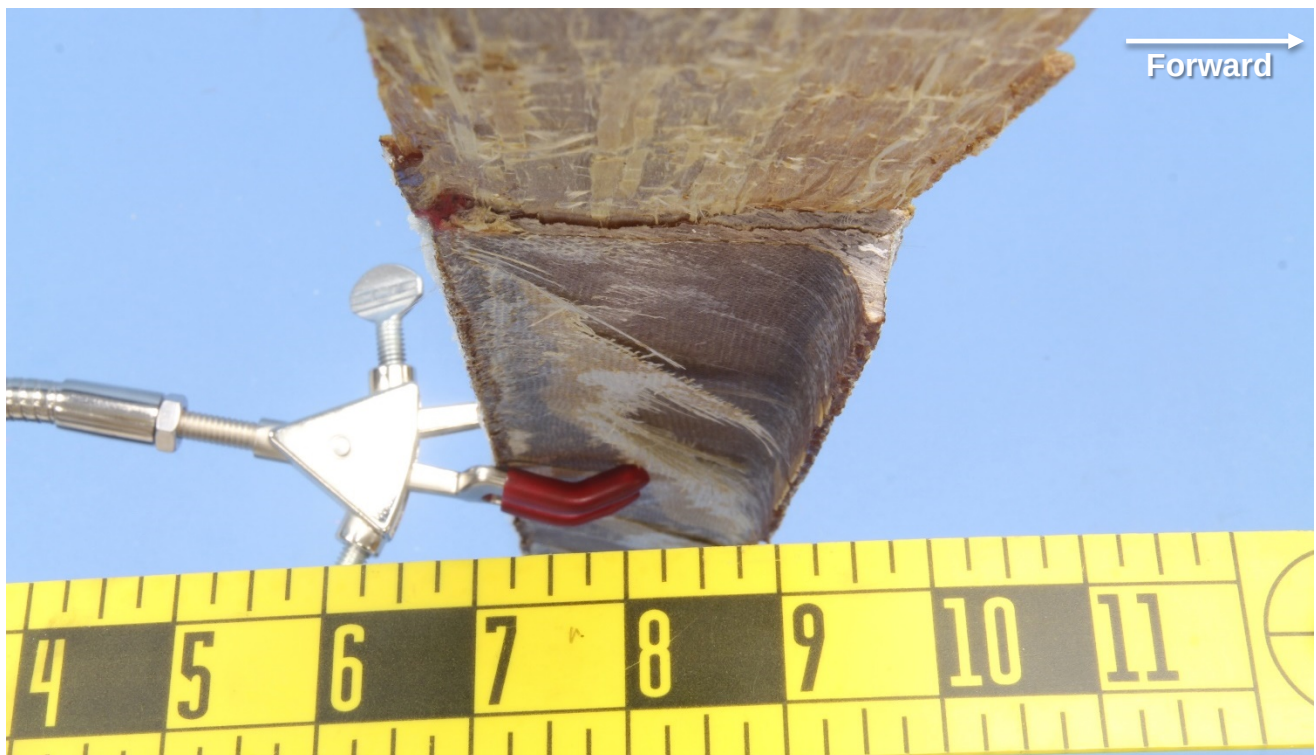
A/B. Therefore, the internal cracking on segment A/B was consistent with a continuation of the fracture of spar cap segment C.

Figure 18 – The A/B section of the upper spar cap, looking outboard with the inboard C section positioned to show the locations of the internal cracks and lower fracture surface.

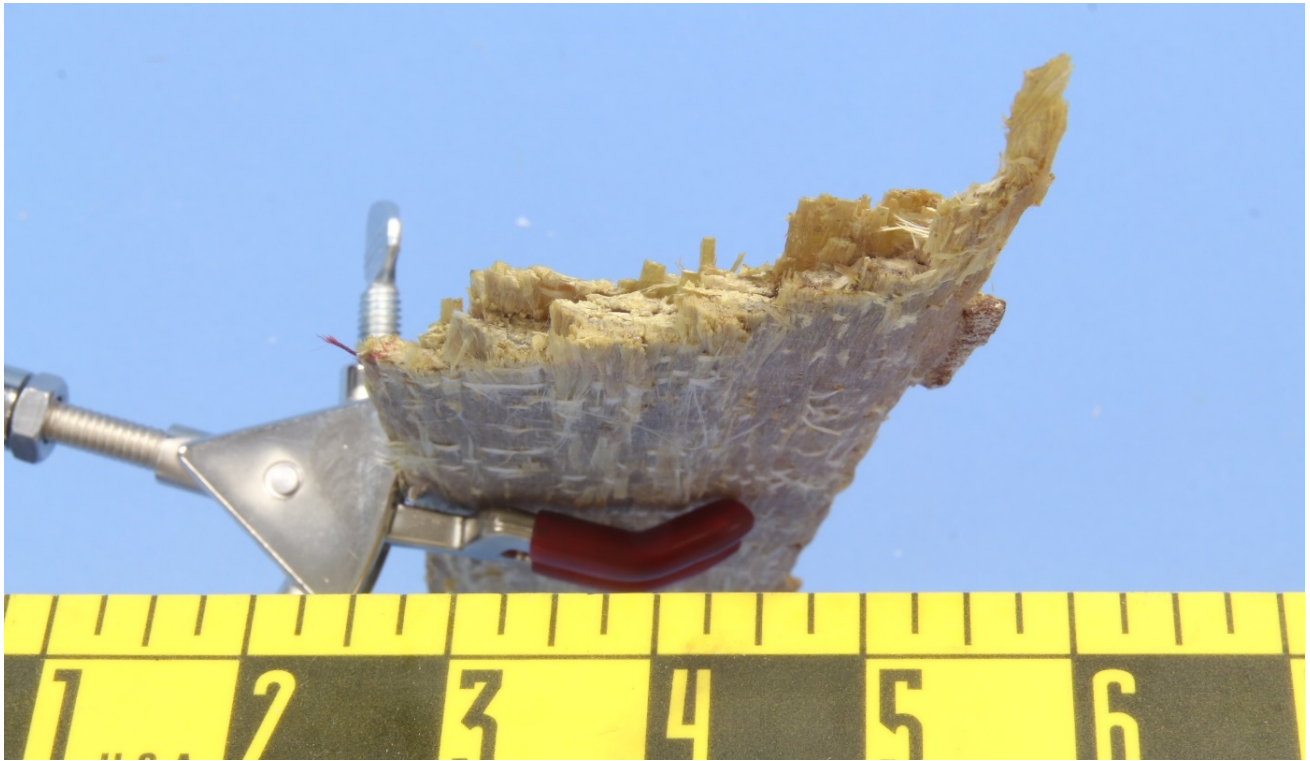
Examination of the spar cap segment C fracture surface found two general features. All along the fracture surface was fiber fracture. The fiber fracture near the upper surface was generally flat and the fibers were located close to the fracture surface (Figure 19). The fibers on the lower surface exhibited longer lengths away from the fracture surface, which were typically varied in length (Figure 20). These features were consistent with fiber pullout on the lower surface and fiber crushing or shearing on the upper surface. This fiber fracture pattern, along with the upper surface local delamination, were consistent with fracture of the spar cap section in upwards bending.

Figure 19 – Angled view of the underside of the inboard fracture of the spar cap C segment.

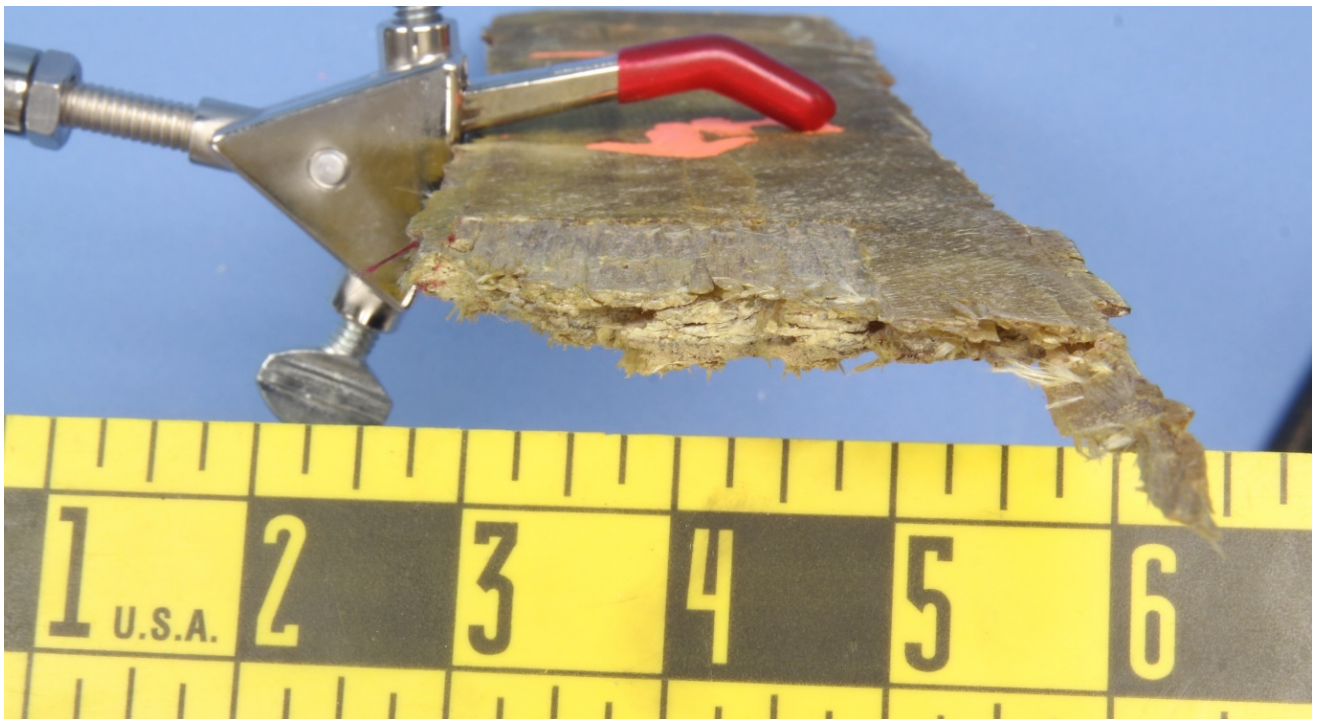
Figure 20 – Angled view of the upper face of the inboard fracture of the spar cap C segment.

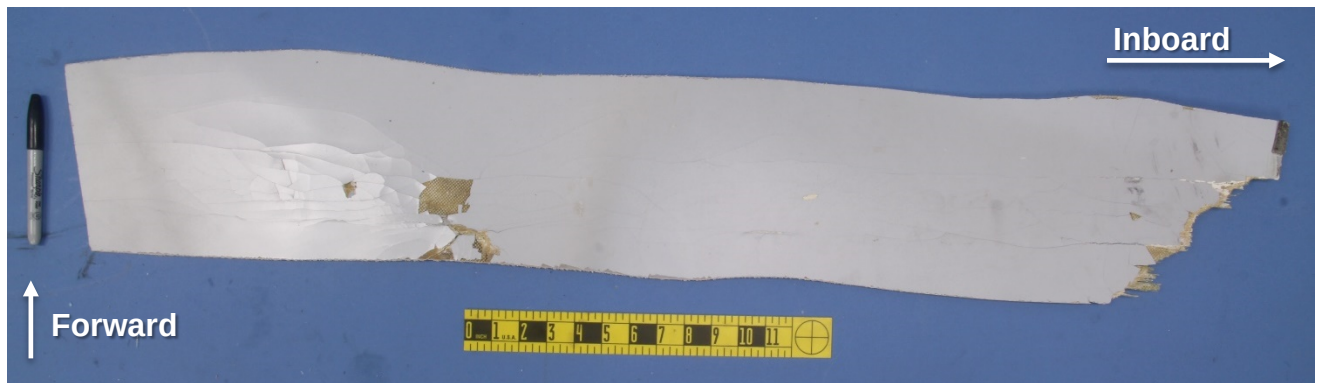
Figure 21 and Figure 22 show the upper (outer) surface of the inboard upper wing skin section. This surface still had the outer paint of the airplane adhered, which had cracked. In general, these cracks branched as one moved outboard from the inboard fracture. This branching orientation was consistent with crack propagation in the paint from the inboard fracture of the skin. Figure 22 shows a closer view of the inboard fracture surface of the skin section. For the most part, the paint was absent approximately 0.5 inches from the underlying composite fracture, which exhibited fiber pullout on the lower surface. This absence of paint was consistent with local paint peeling away from the outer skin surface. This fracture pattern was analogous to that of the C spar cap section, shown in Figure 18 and Figure 19. These features were all consistent with a bending fracture upward of this area of the wing, with the compressive stress side on the upper surface of the wing.

Figure 21 – The upper surface of the inboard left wing skin, as received.

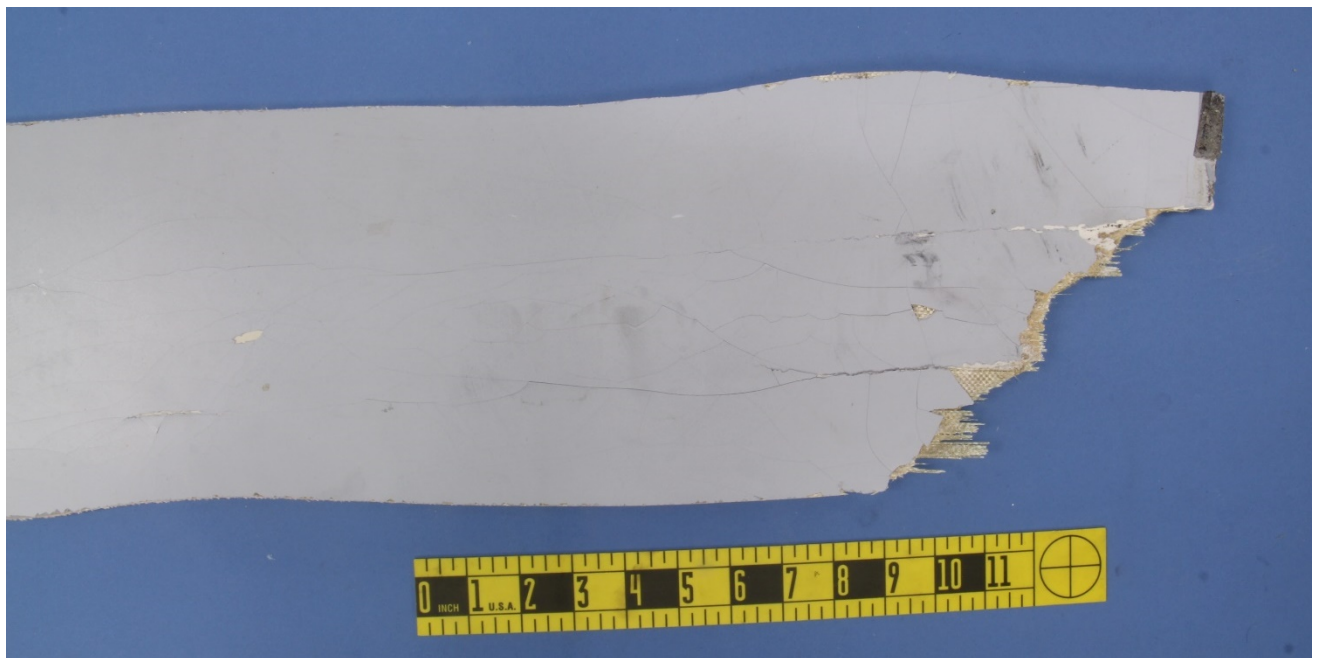
Figure 22 – Closer view of the inboard area of the wing skin section in Figure 21, showing paint cracking and absence adjacent to the fracture.
