# **NATIONAL TRANSPORTATION SAFETY BOARD**

## **UAS Aerial Imagery Report**

### **A. ACCIDENT ERA18FA251**

Location: Woburn, Massachusetts  
Date: September 15, 2018

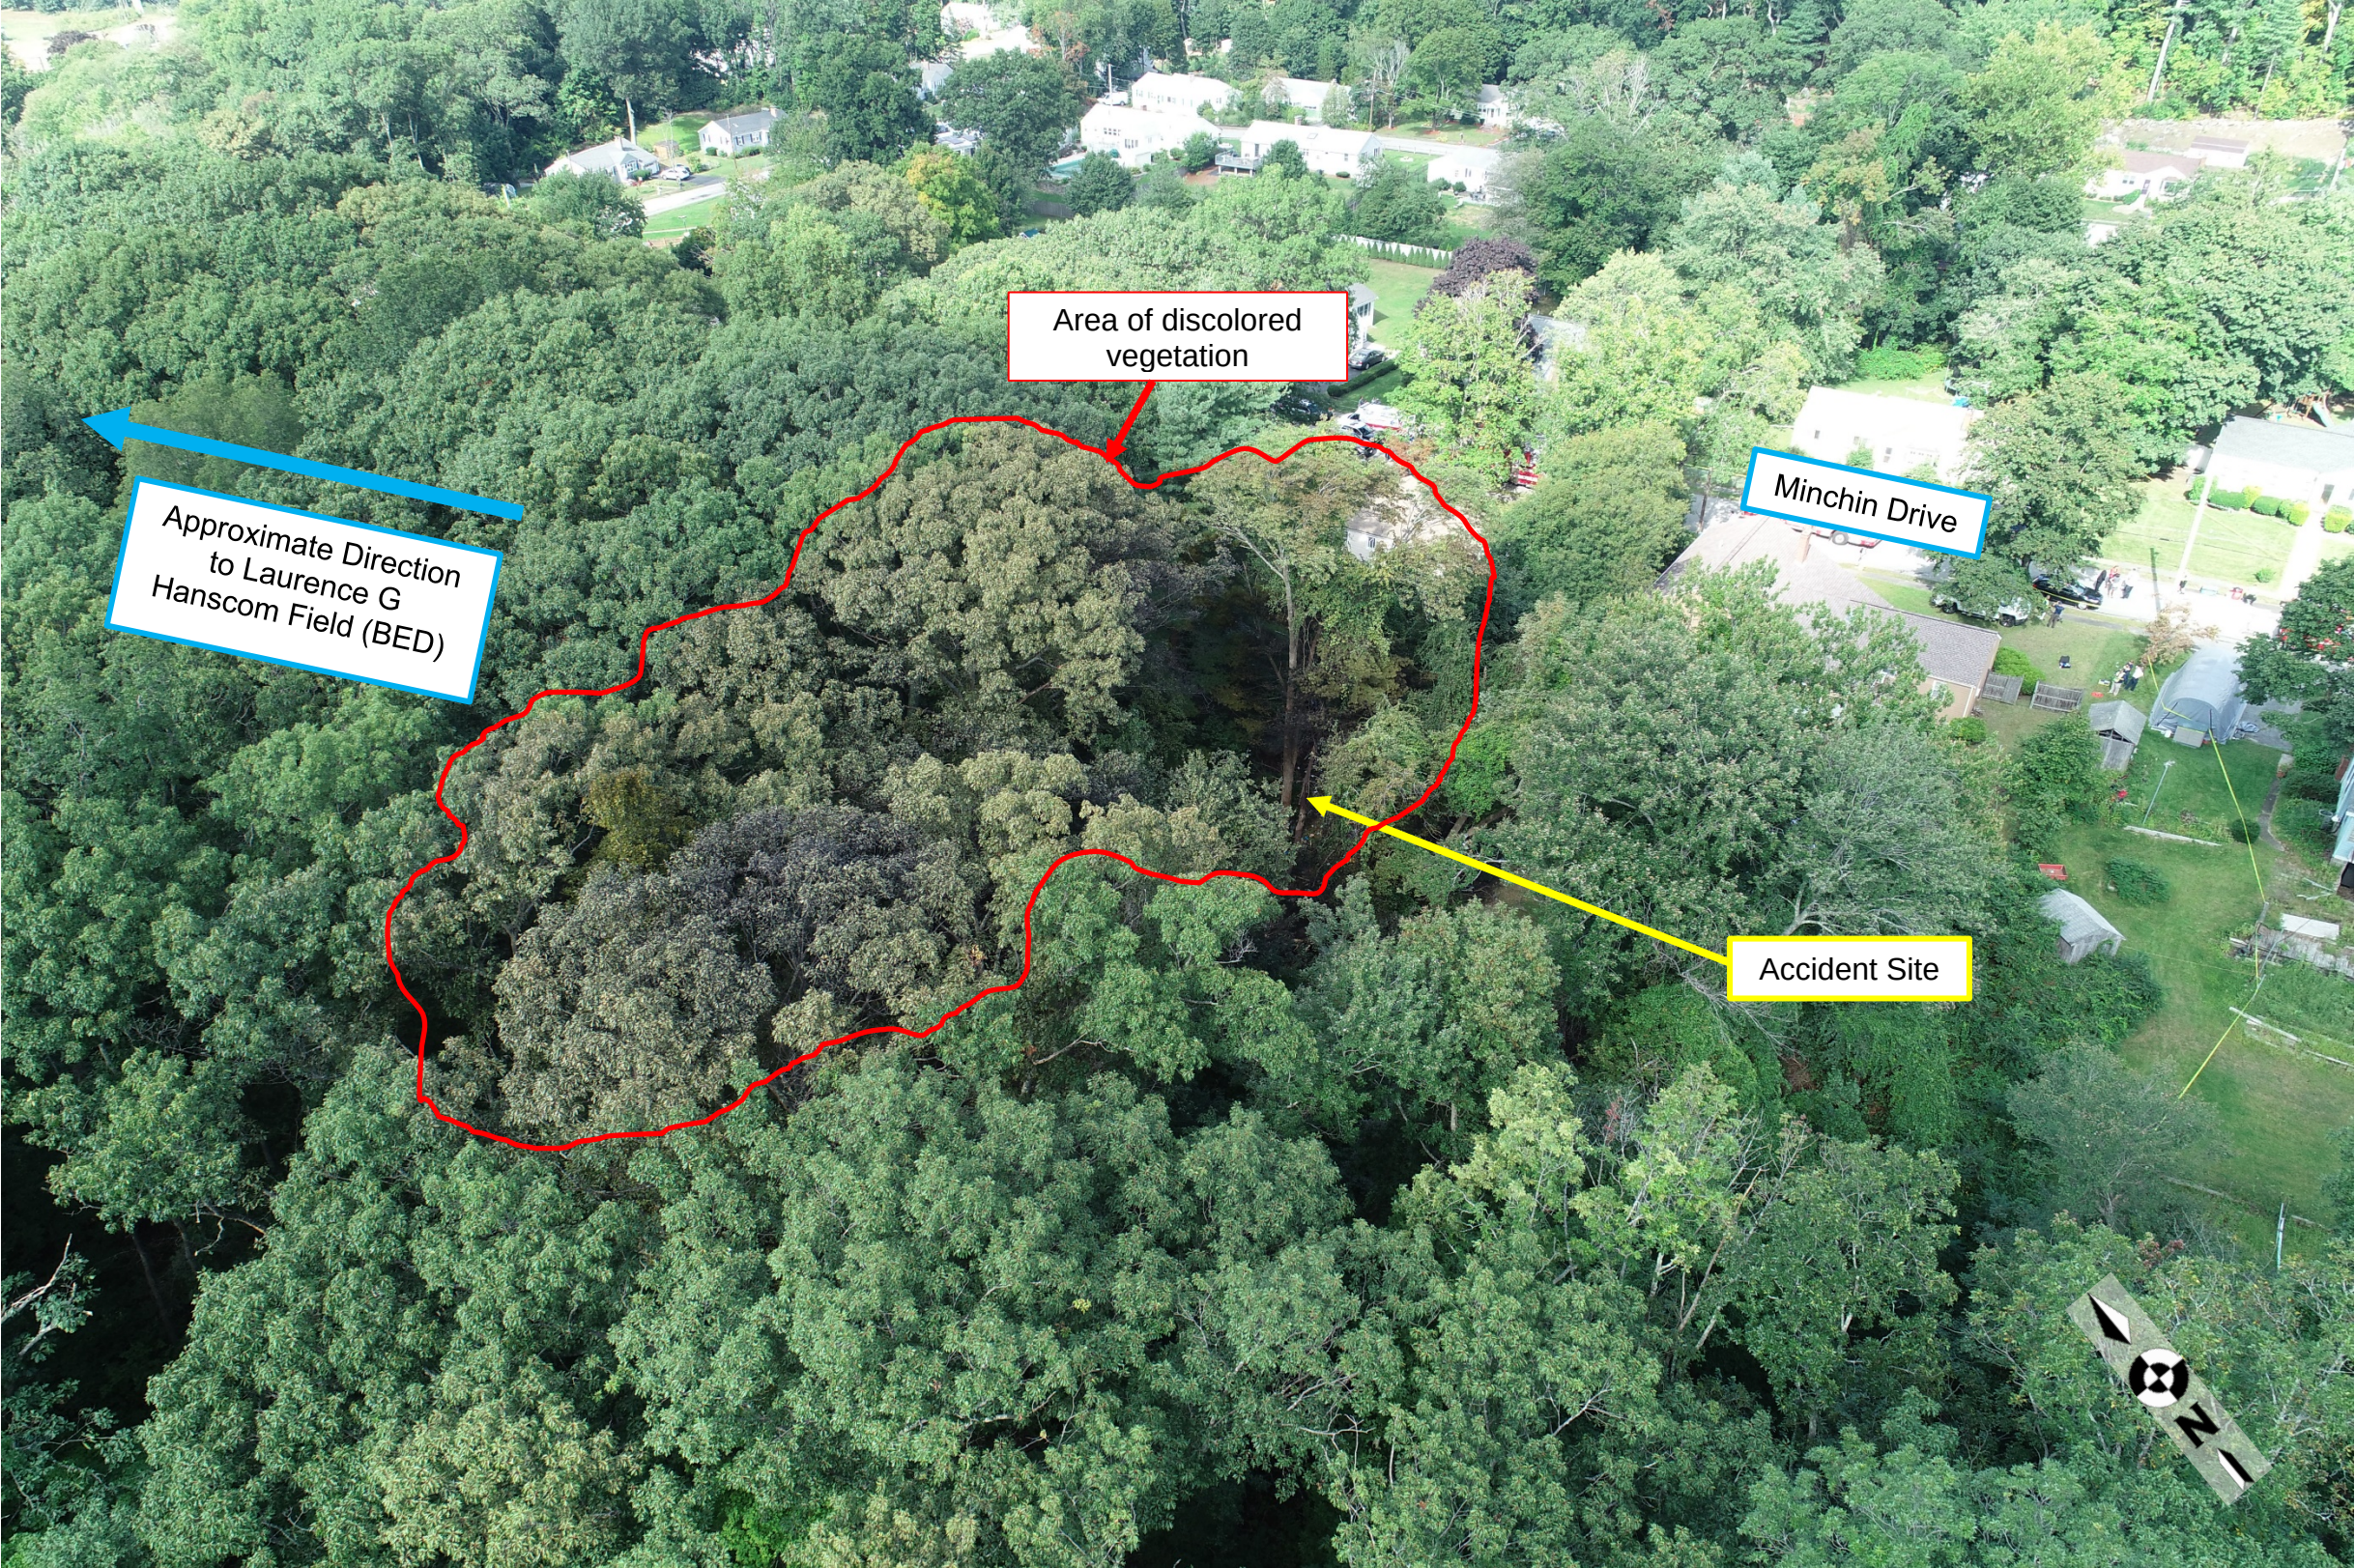
Figure 1 contains a still image taken from above the wreckage site looking towards Minchin Drive. An area of discolored vegetation is visible on the tree canopy around the accident site.

Figure 1 – Photo – Aerial view of accident site on the day of the accident, an area of discolored vegetation is noted (directional arrow approximated)

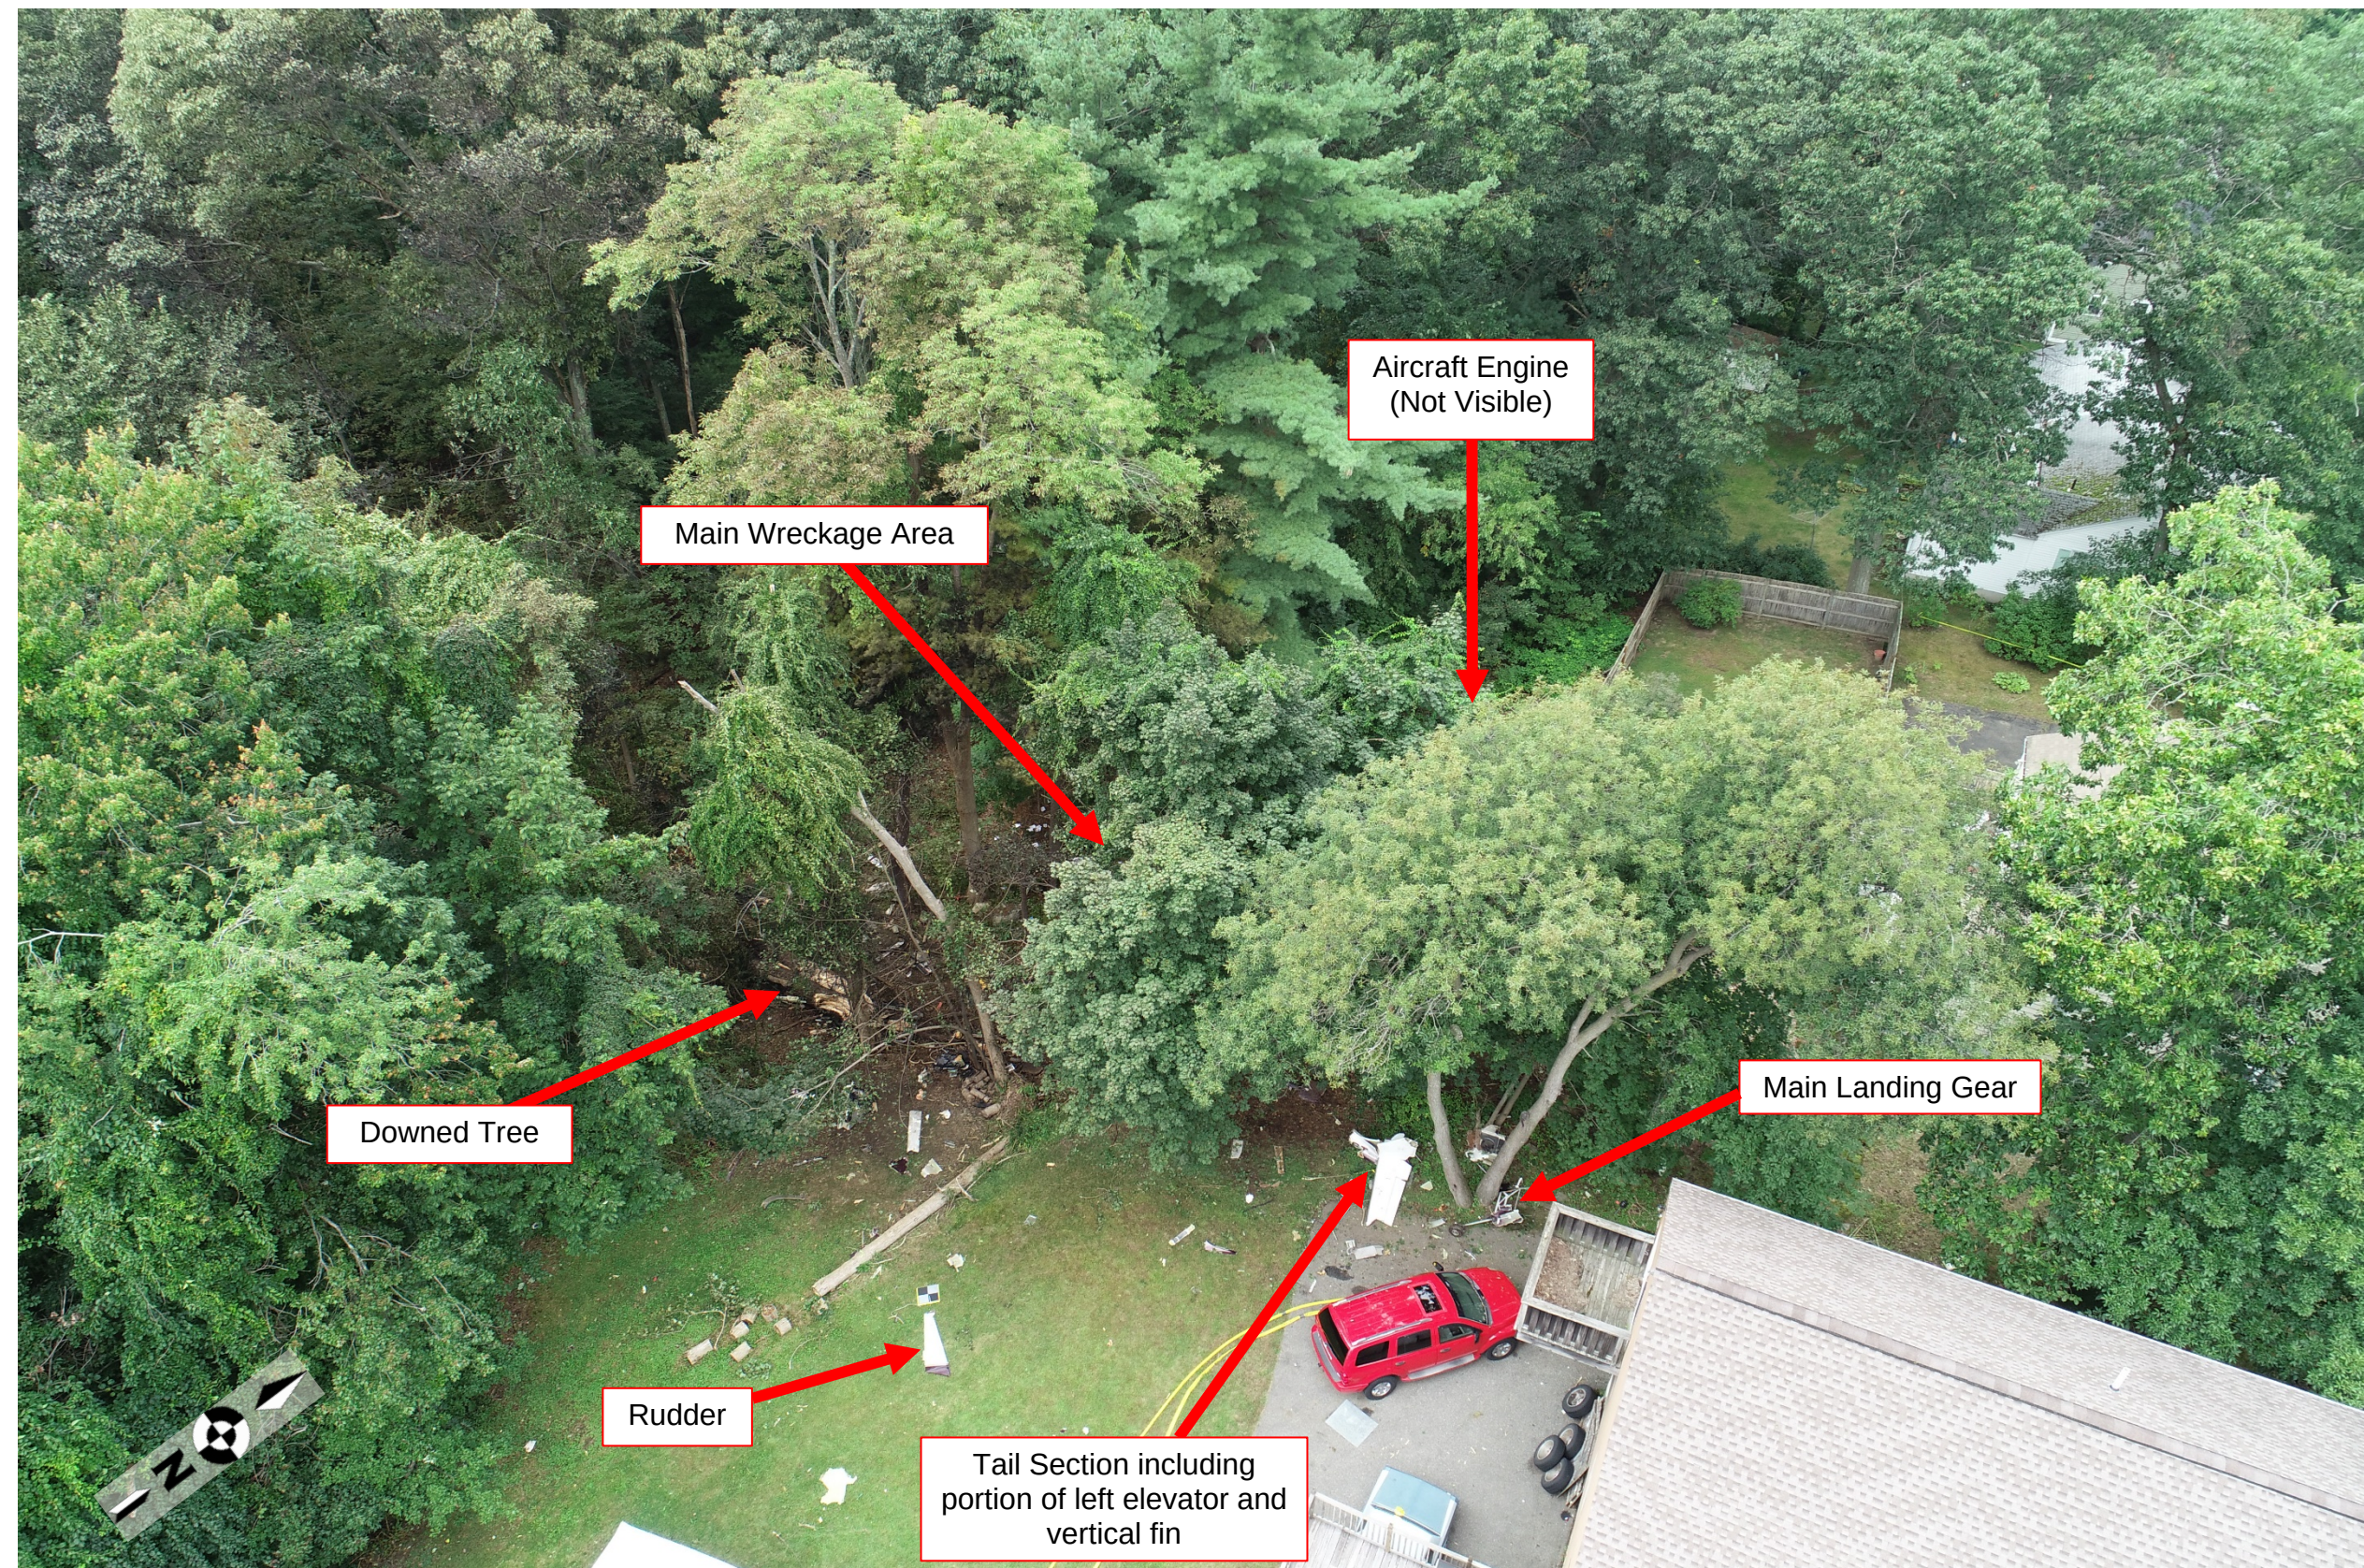
Figure 2 contains a still image of a side view of the accident site. Several pieces of the accident aircraft are visible including a section of the tail which includes a portion of the left elevator and vertical tail. Additionally, the rudder and the main landing gear is also visible. A section of a large tree that was downed due to the accident can also be seen.

Figure 2 – Photo - Aerial side view of accident site on the day of the accident (directional arrow approximated)

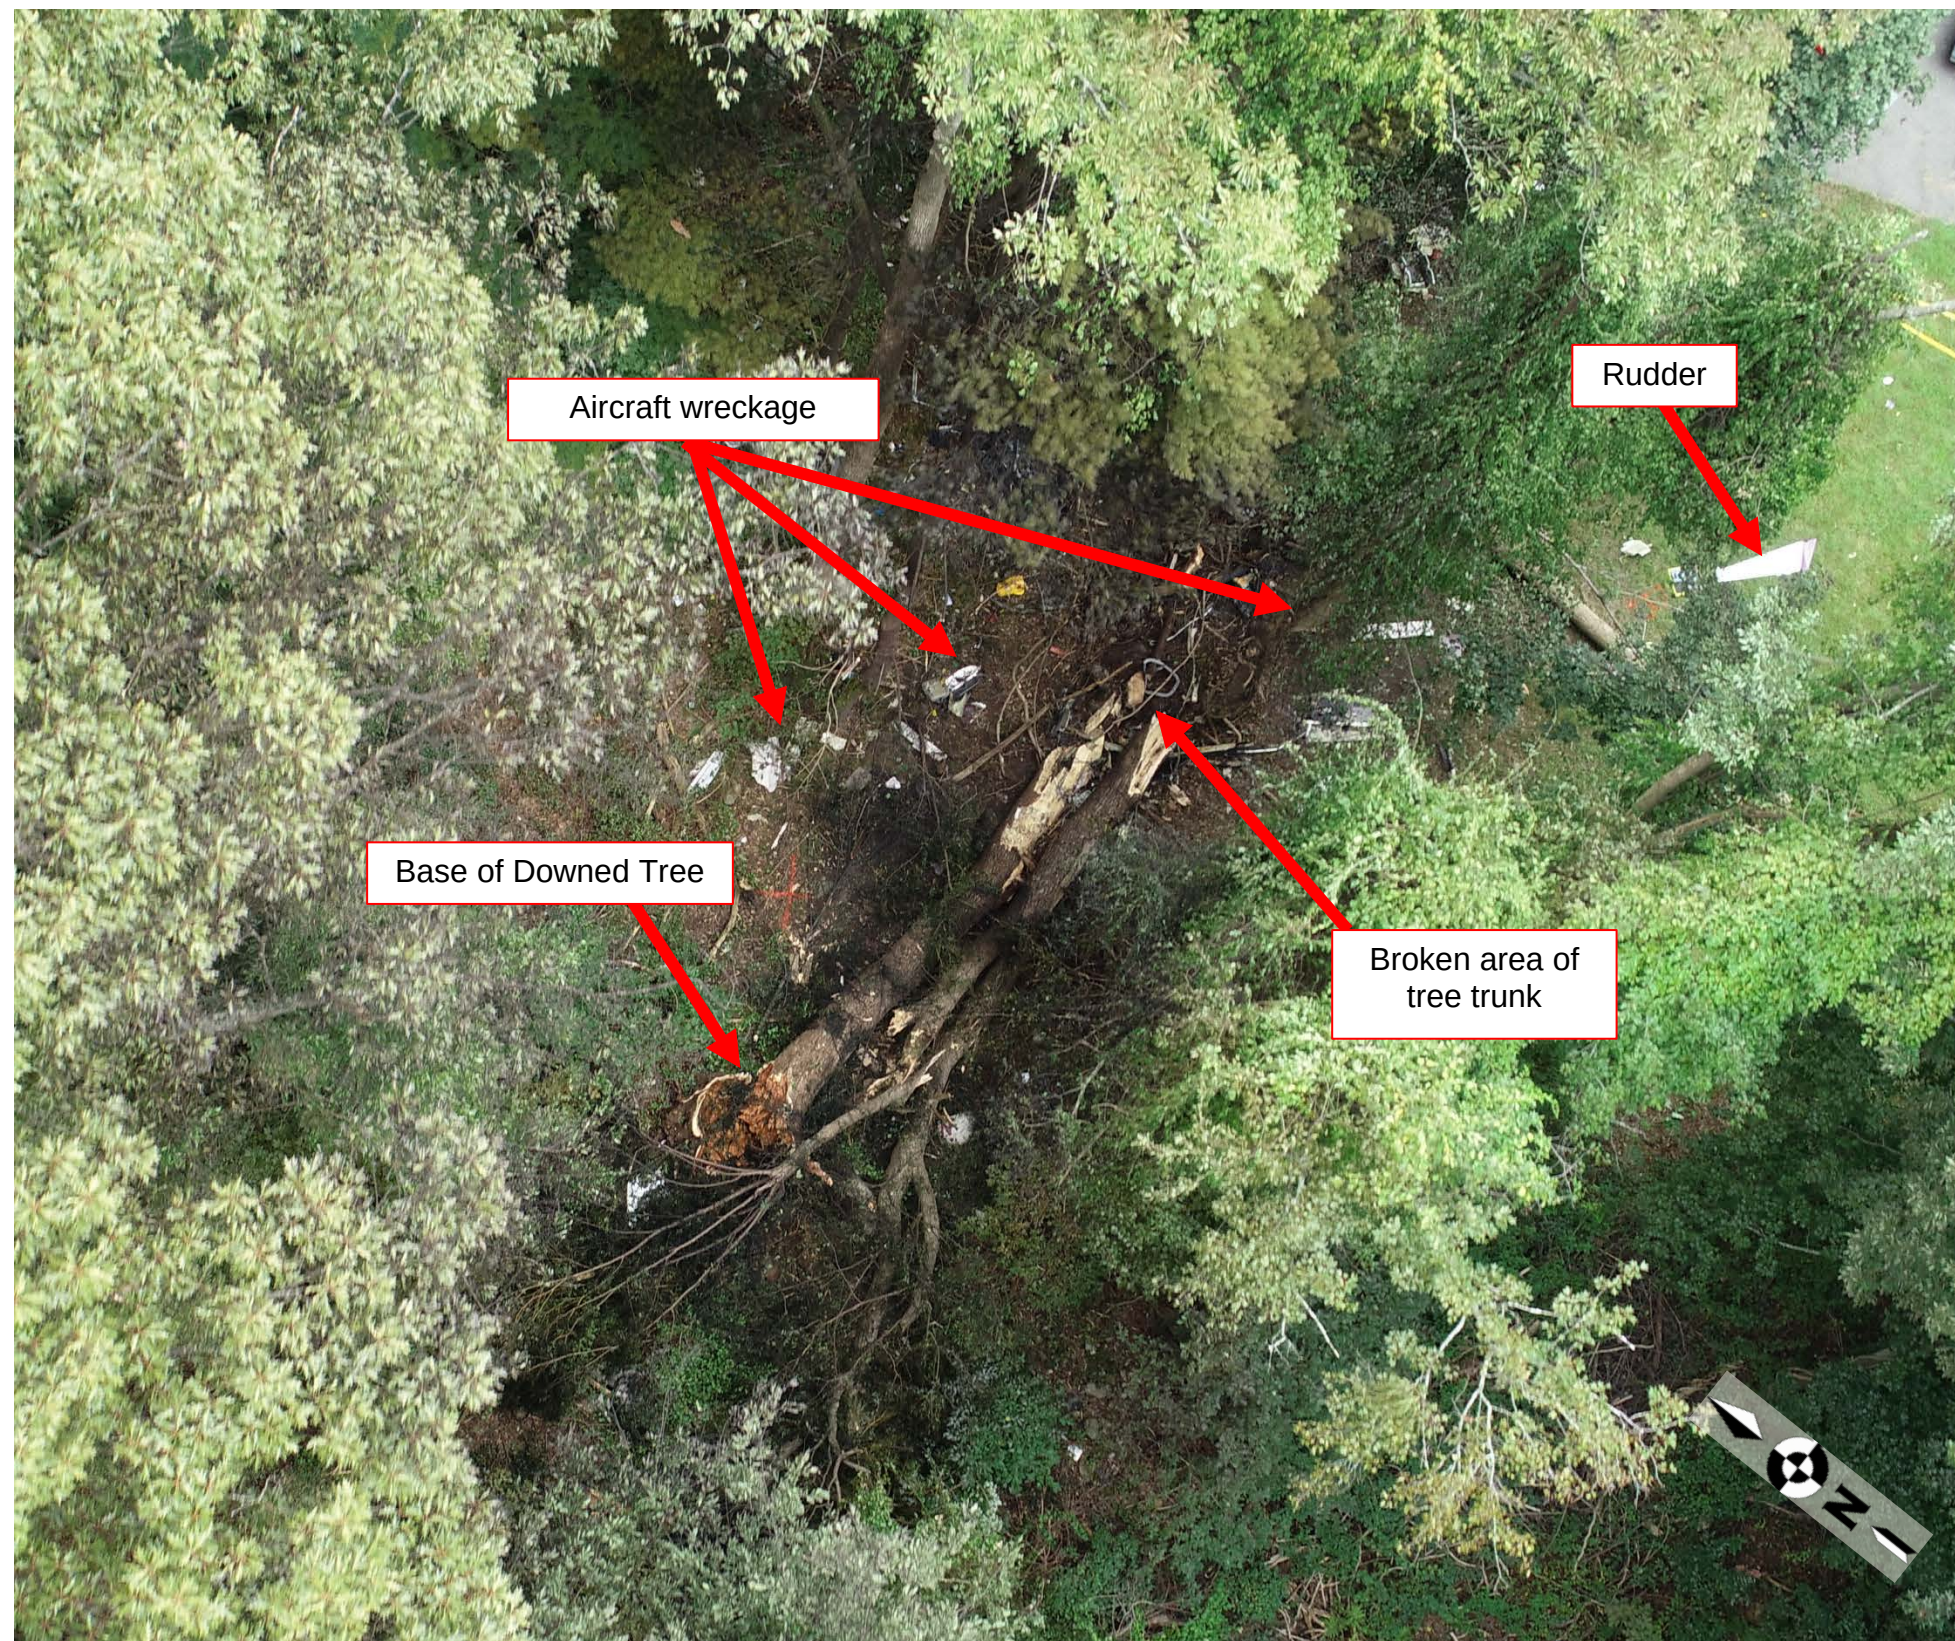
Figure 3 contains an overhead image of the accident site with a tree that was downed in the accident after impact with the accident aircraft.

Figure 3 - Photo (cropped) - Aerial view of showing additional wreckage and downed tree (directional arrow approximated)

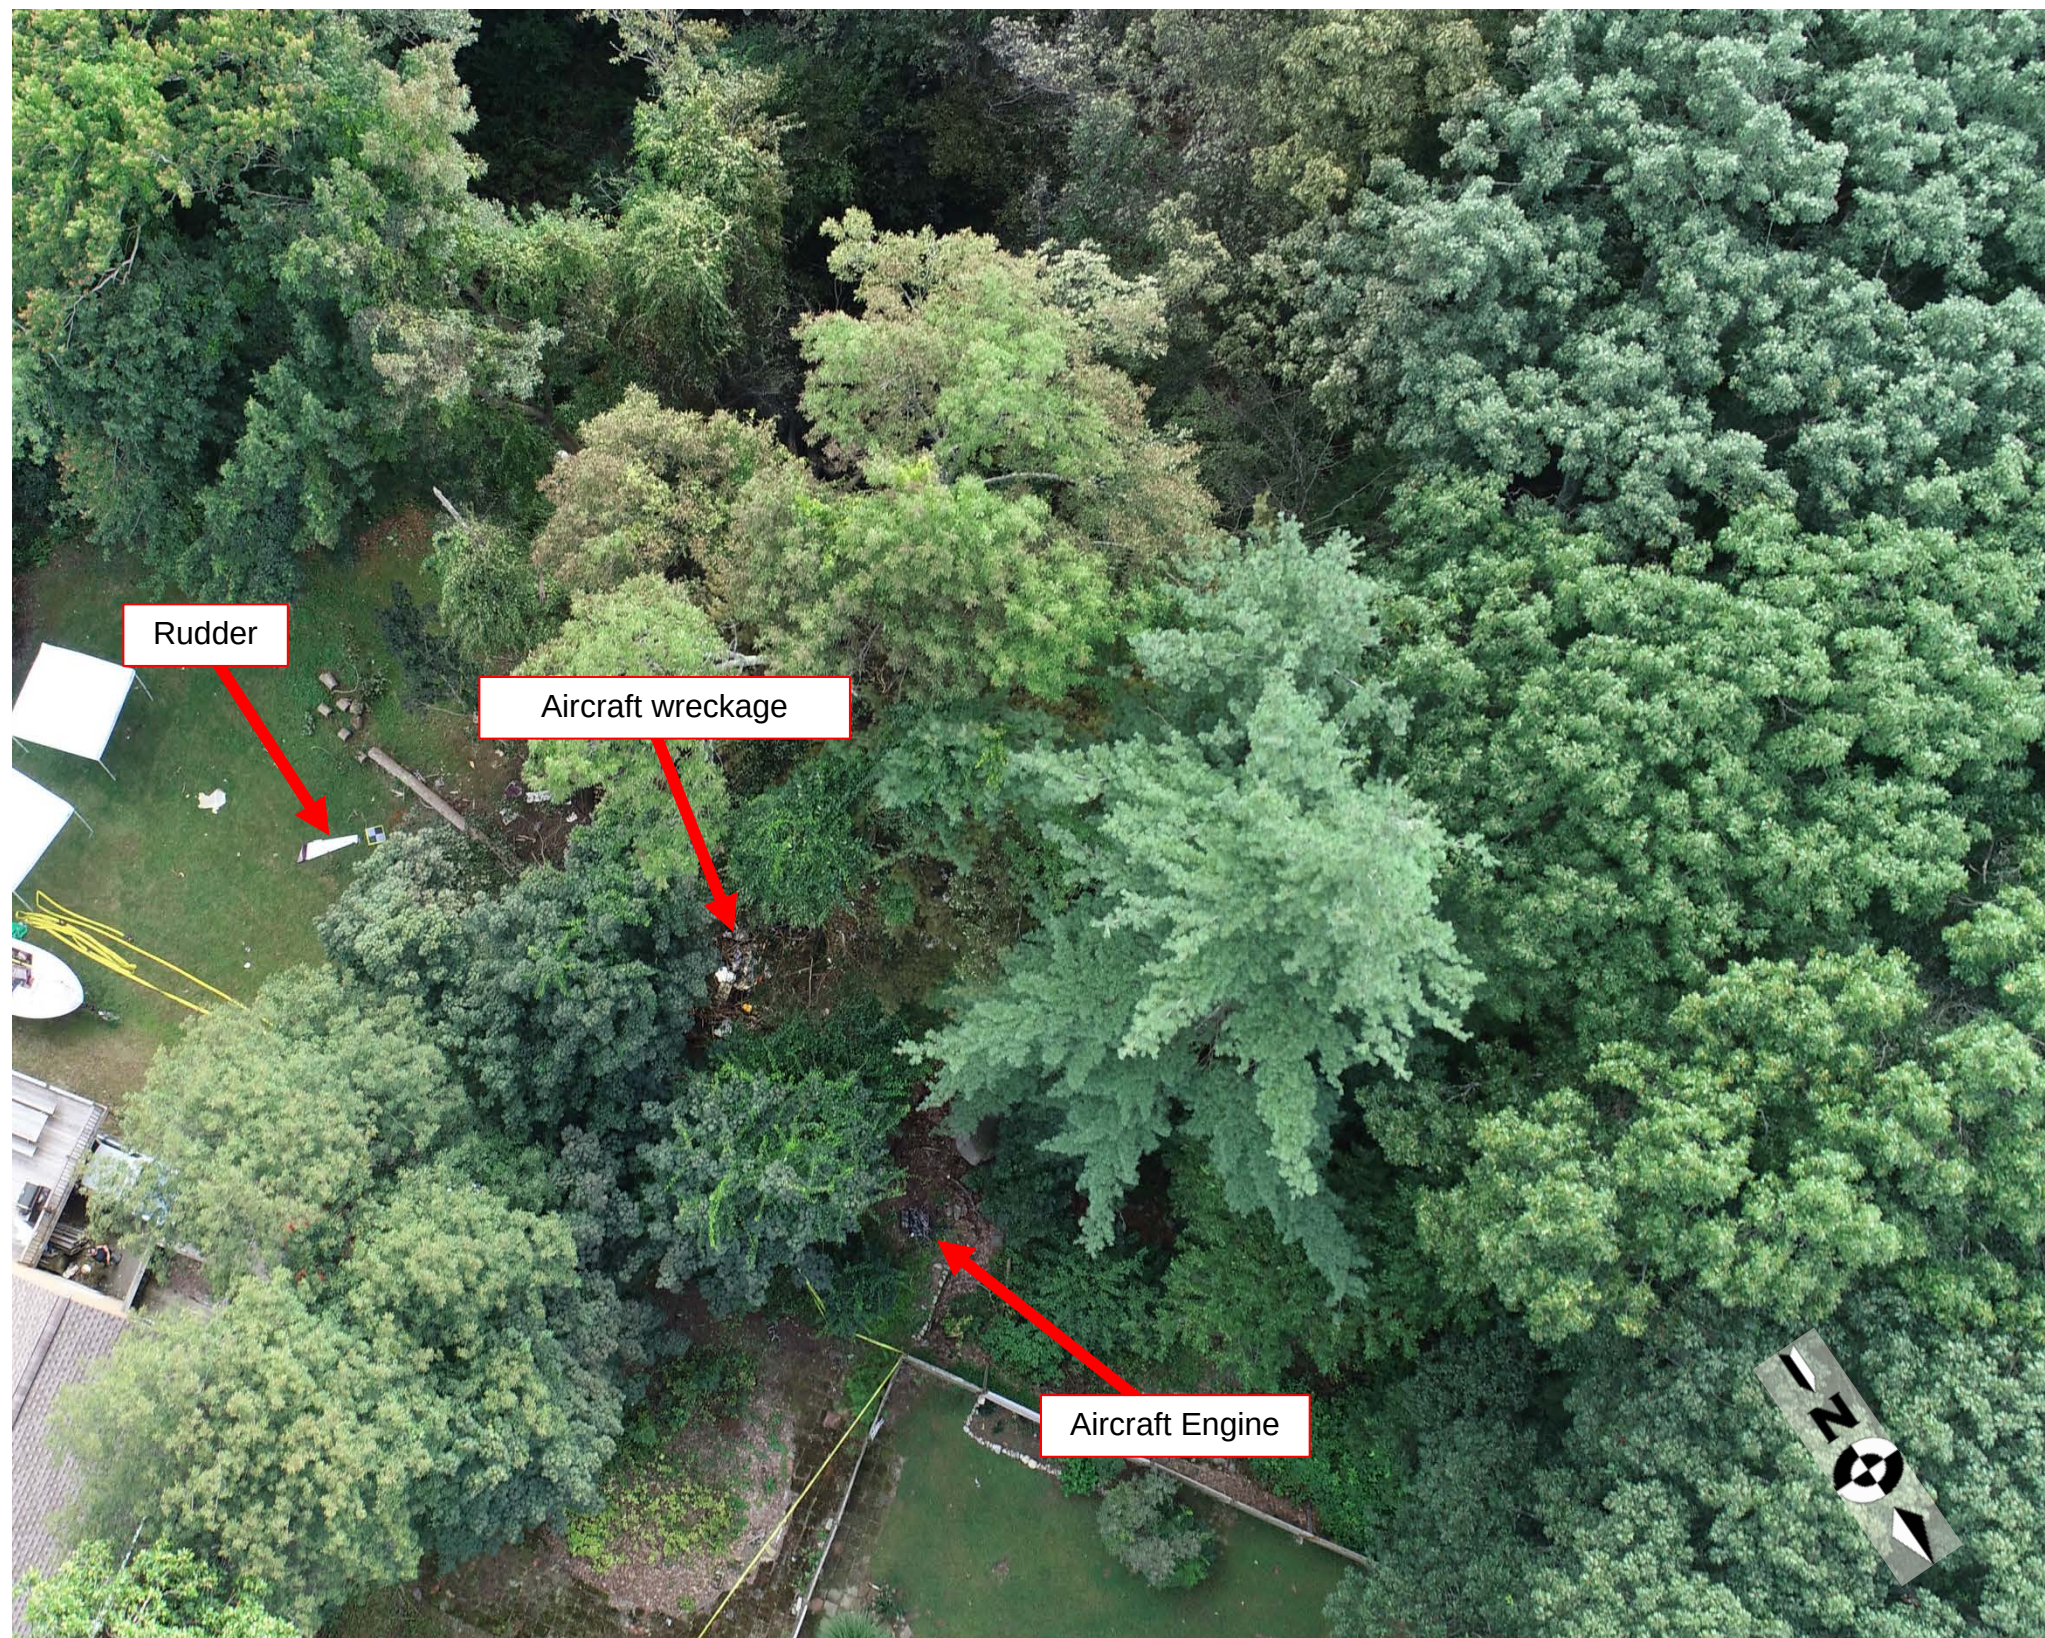
Figure 4 contains a still image of an overhead view of the accident site. Several pieces of the accident aircraft are visible including the rudder and aircraft engine.

Figure 4 – Photo (cropped) - Aerial view of showing additional wreckage and aircraft engine (directional arrow approximated)

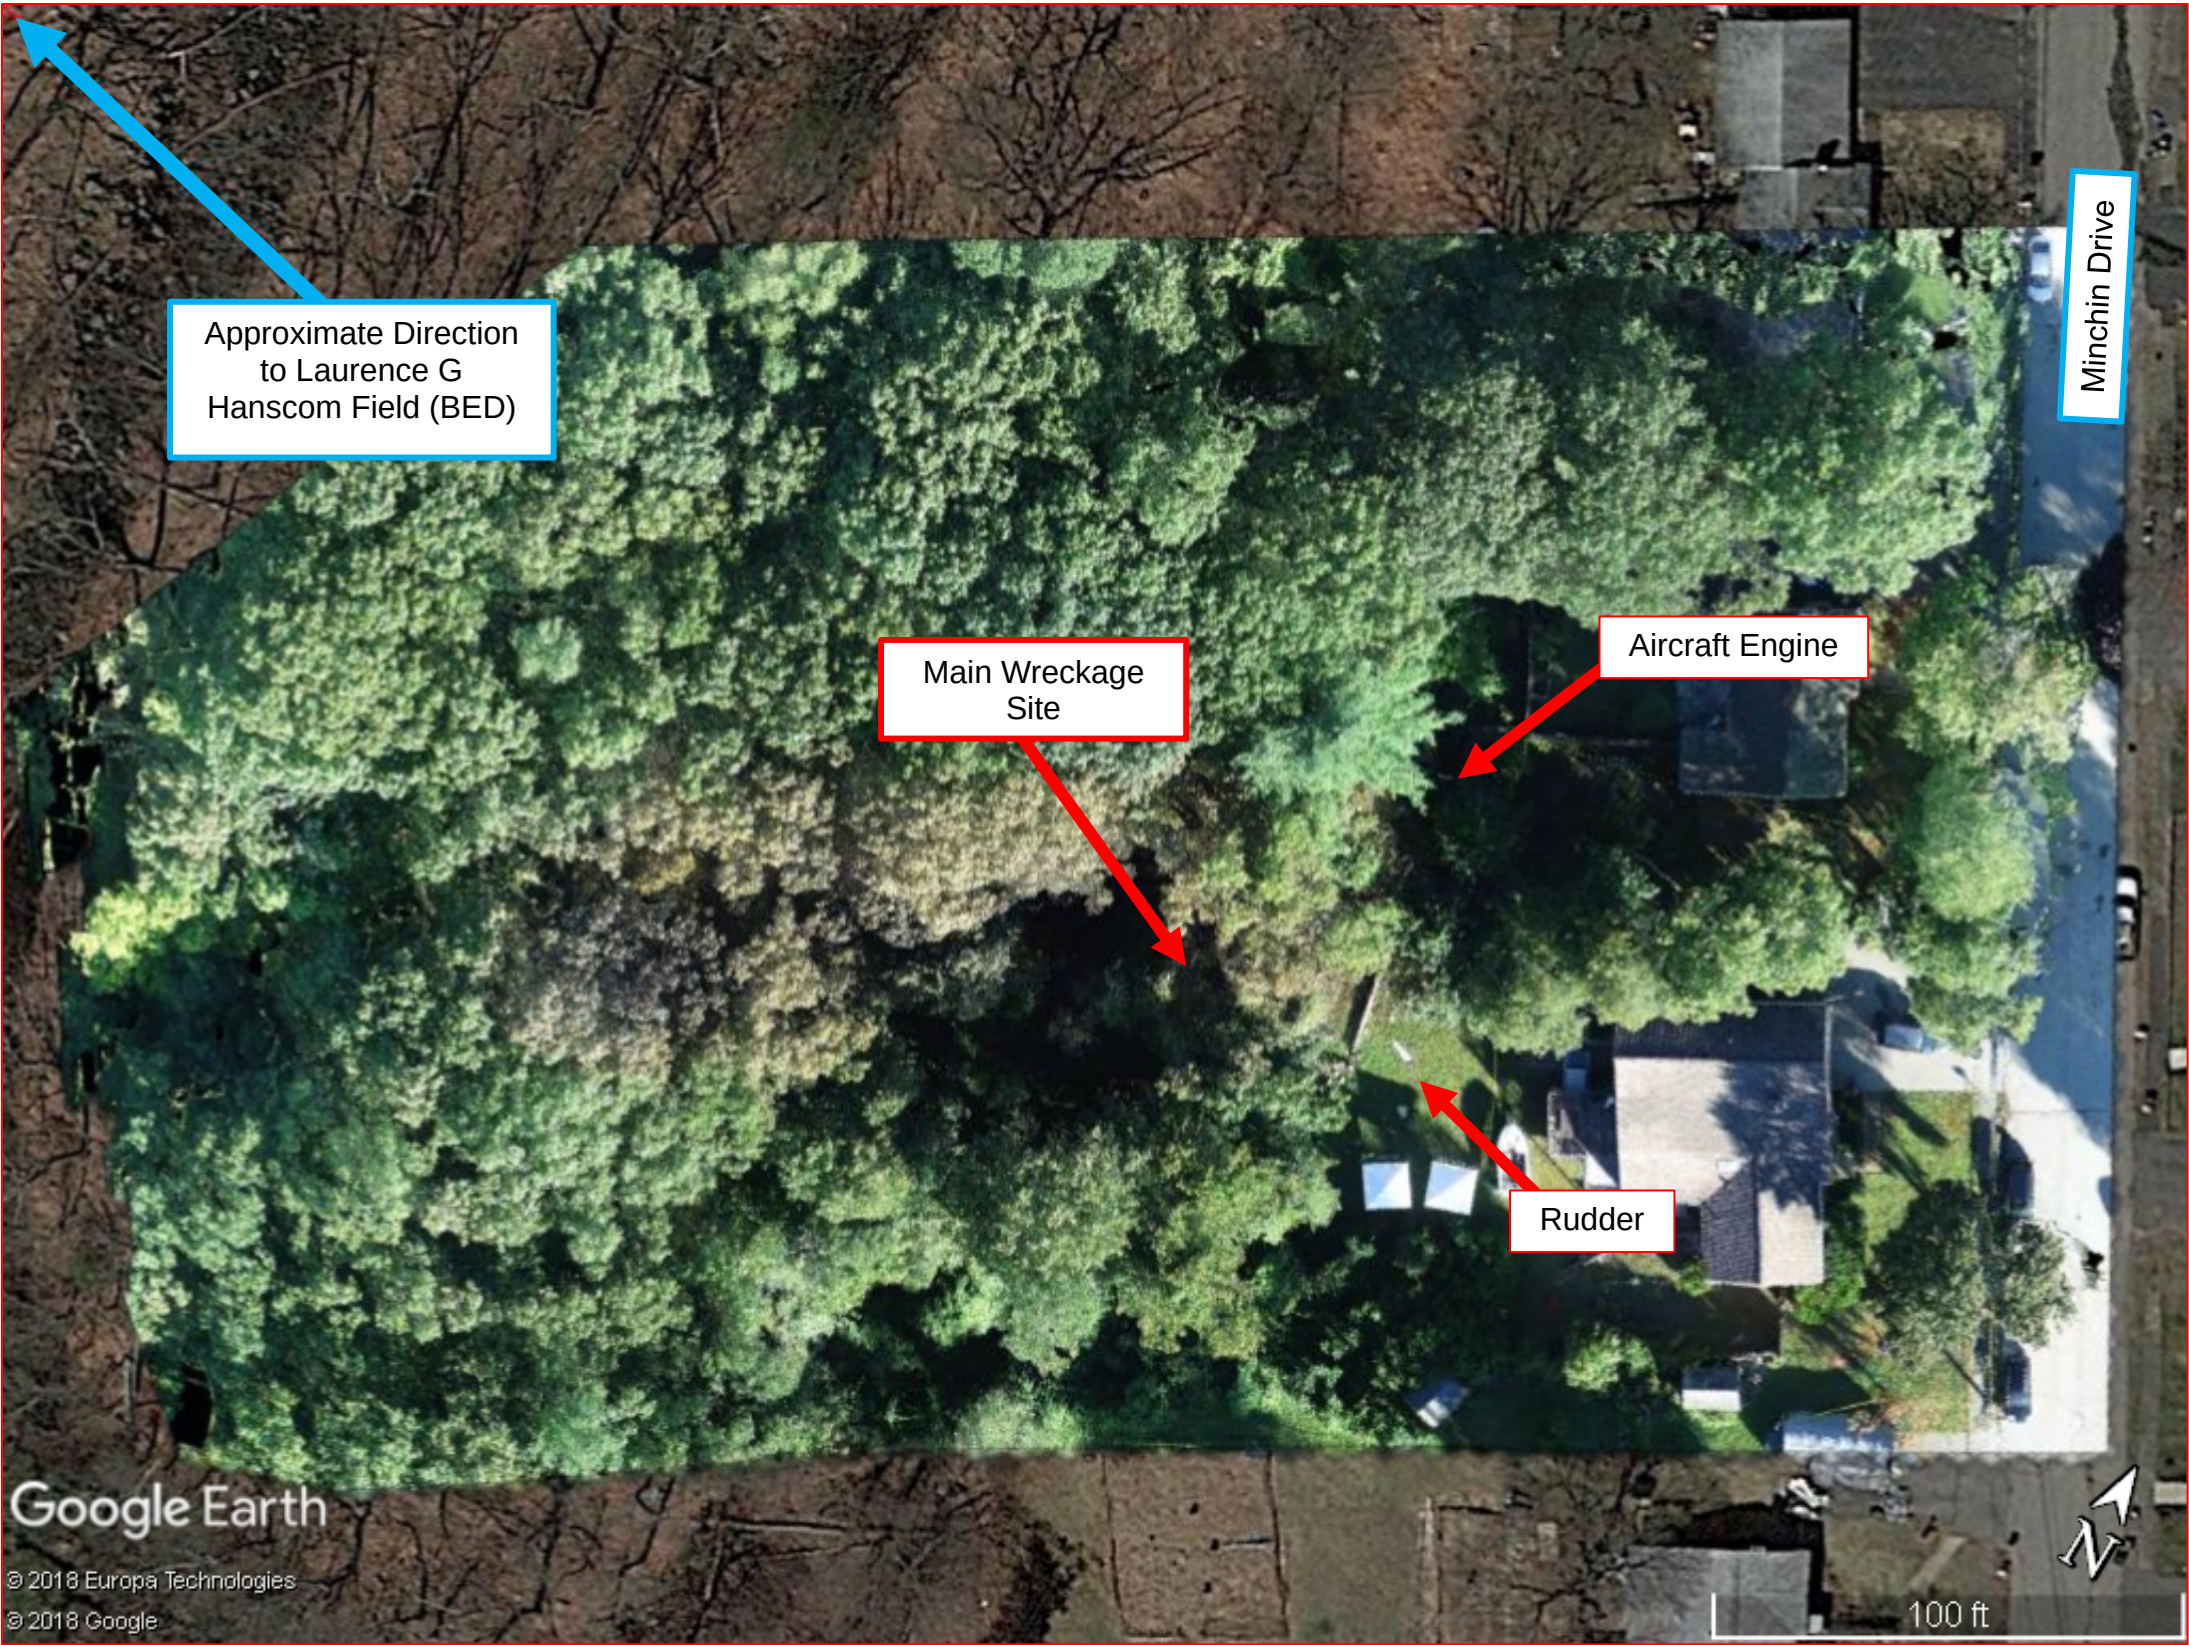
Figure 5 contains a screenshot of the orthomosaic map in Google Earth .kmz format.

Figure 5 – Orthomosaic image overlaid on Google Earth of accident site.
