## **NATIONAL TRANSPORTATION SAFETY BOARD**

# **EXAMINATION SUMMARY**

**ERA18FA251**

Location: Woburn, Massachusetts  
Date: September 15, 2018  
Time: 1103 EDT  
Airplane: Columbia Aircraft Mfg LC41-550FG, N2536T

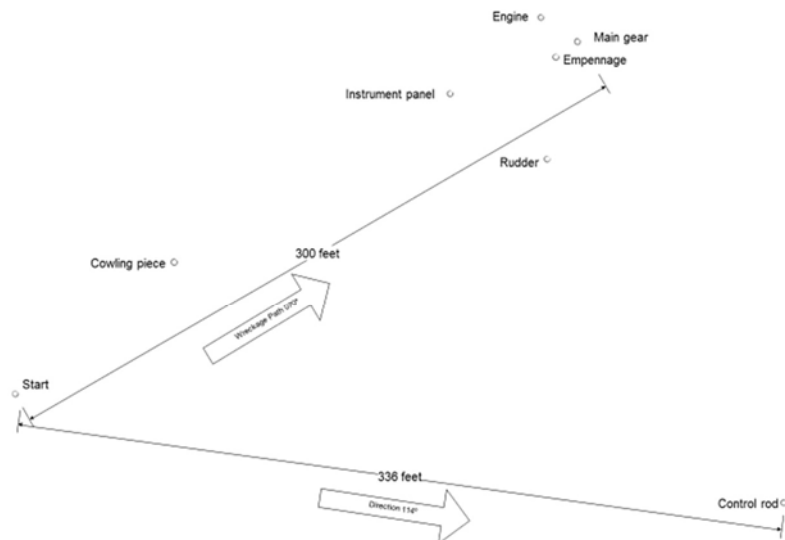
Figure 1 – Wreckage Diagram

The aircraft impacted trees and terrain and traveled through a wooded area for about 100 yards before coming to rest at the base of a hill in a residential area (Figure 1). The coordinates of the main wreckage were N 42° 27.224' W 071° 10.995' (GPS). Elevation: 222 ft. The airframe was highly fragmented. There was a postaccident fire that consumed about 20% of the wreckage. The engine separated from the firewall and the propeller separated from the engine during the impact sequence. All primary structural components and flight control surfaces were accounted for within the debris field. All wreckage, with the exception of one SD memory card, was examined at the accident site.
