## Air Safety Investigations Aircraft Incident/Accident Technical Report

| Aircraft Incident/<br>Accident Information | Year: 2006 | Make: Cessna | Model: LC41-550FG |
| Location: Woburn, MA | | Date: 09-15-18 | Time: 1102 EDT |
| Air Safety Investigator: Jennifer D. Barclay | | Report #: ASI-18-CU-T | Report date: 01-11-19 |

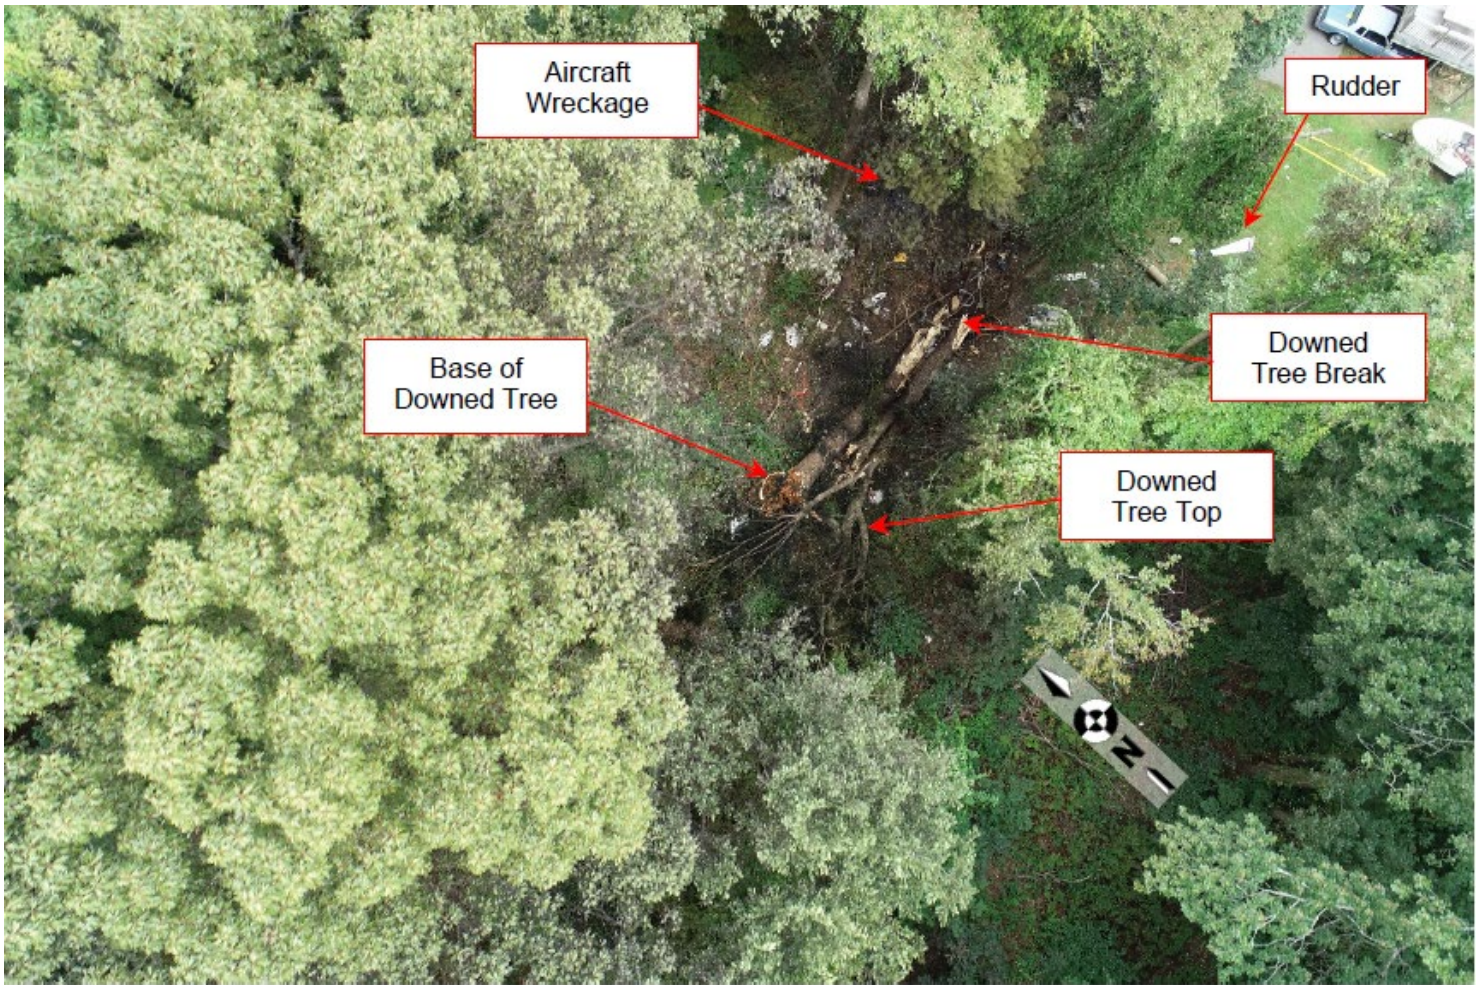
The aircraft impacted trees and traveled through a wooded area for about 100 yards before coming to rest at the base of a hill. Both wingtips and both horizontal stabilizer tips were located approximately halfway through the wreckage path. Portions of all flight controls were located along the path. The empennage and main landing gear were located the greatest distance from the initial impact point.

NTSB drone photo of site

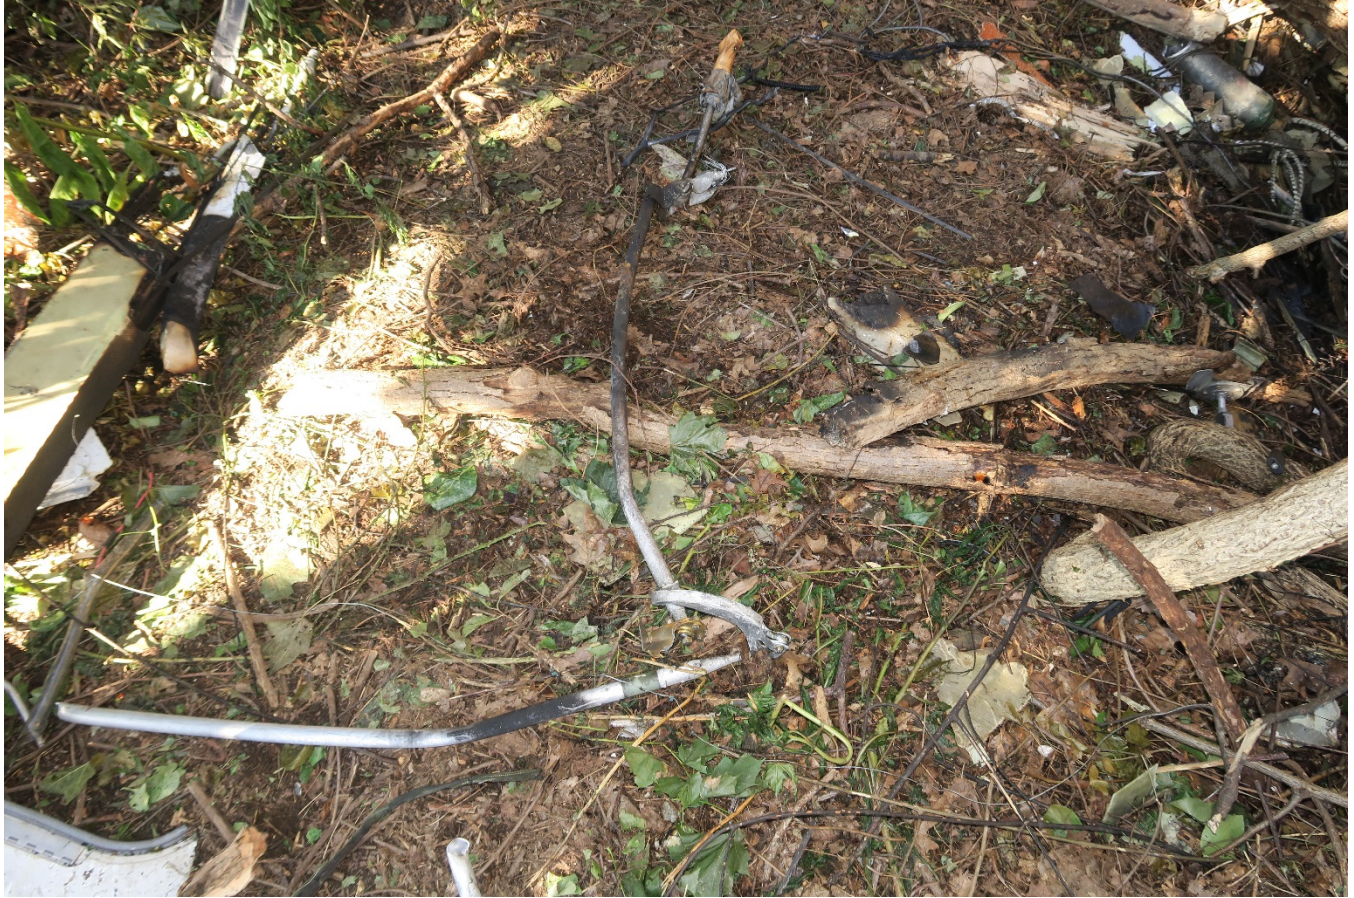
The aileron and elevator control tubes were found connected to the left and right side control sticks. The aileron control rod was intact from the side stick to the aileron torque tube bellcrank. The elevator push/pull tube was attached to the elevator interconnect assembly. The wing aileron control tubes and the fuselage elevator control tubes separated from their mounts and were found along the wreckage path.

Left side stick control tubes, On-site ASI-18-CU-057

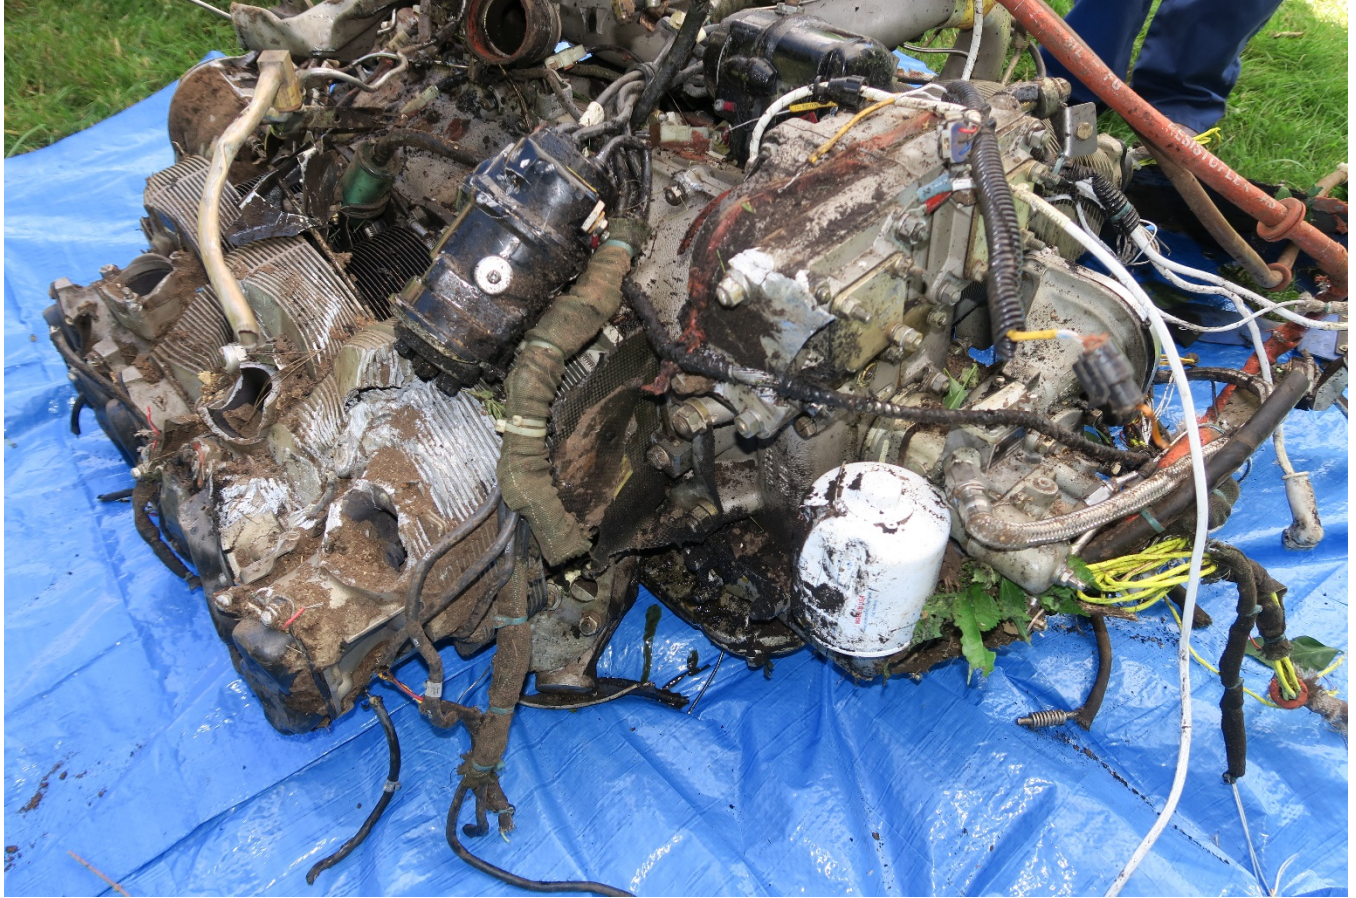
On-site ASI-18-CU-136

The engine sustained severe impact damage to the left side which prevented full rotation of the crankshaft. Crankshaft continuity was confirmed. Partial compression and valve train continuity were established. The left magneto was loose from its mounting pad but remained attached to the engine by the ignition leads.

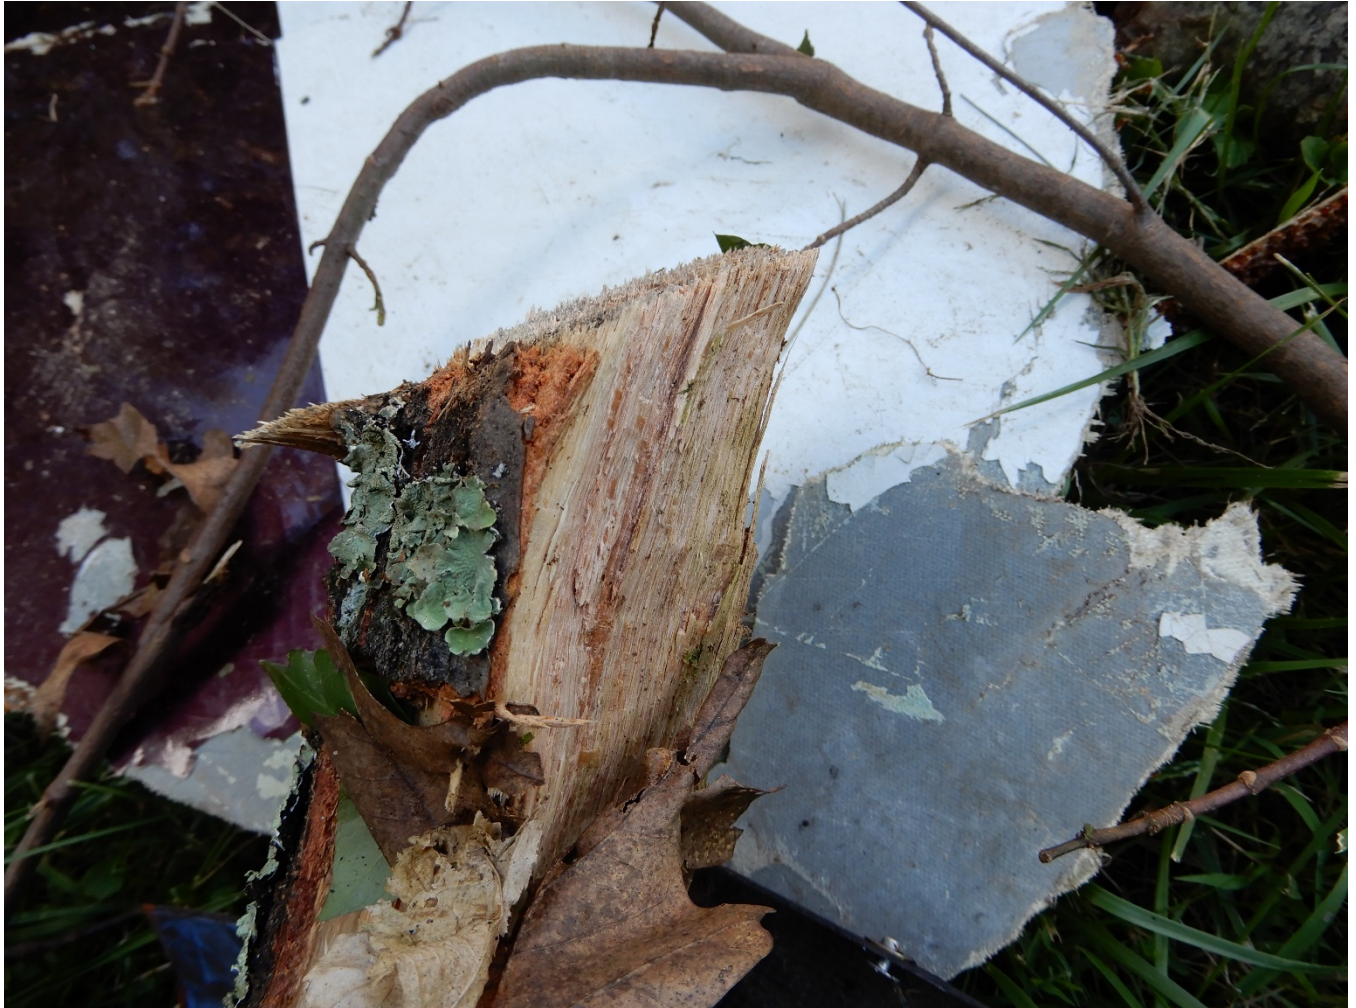
NTSB photo

The propeller was detached from the engine during impact. The blades were bent aft and exhibited chordwise scratching indicative of rotation under power as the aircraft traveled through the trees. Multiple branches, three to four inches in diameter, exhibited cuts that were consistent with propeller contact.
