# Continental Motors

## ENGINE EXAMINATION REPORT

| ENGINE MODEL | TSIO-550-C9B |
| FILE NUMBER | 18-188 |

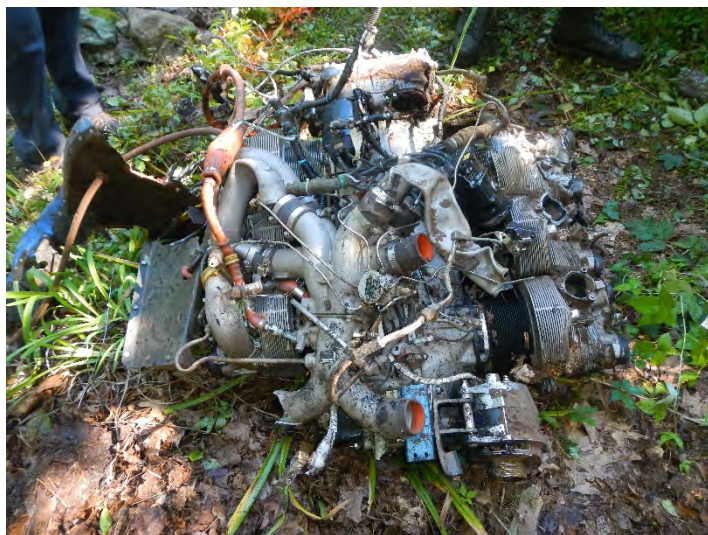
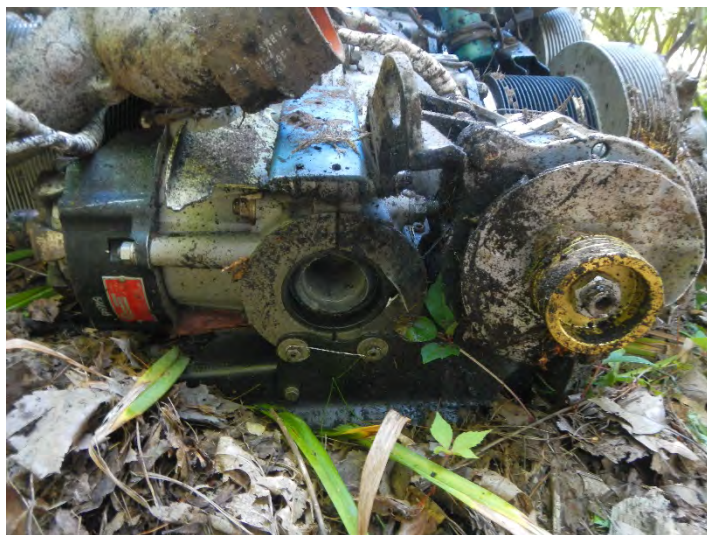
The engine was separated from the aircraft and came to rest in an upright position. The propeller, starter motor, intercoolers, turbochargers, and turbo charger components were separated from the engine. The left magneto was separated from the mounting pad but remained attached to the engine via the ignition leads. The left cylinders sustained significant impact damage that fractured numerous cooling fins, damaged the top sparkplugs, and displaced the #2 cylinder head in toward the engine centerline. The left intake tubes were separated from their cylinders. There were no external pre-accident anomalies noted with the engine or engine-related components.

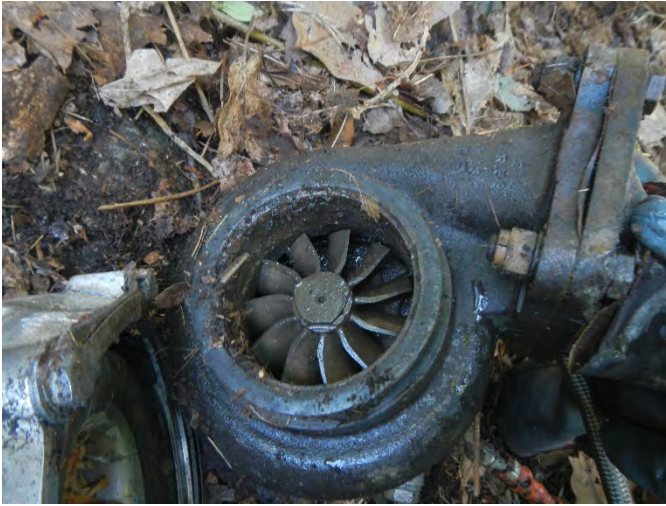
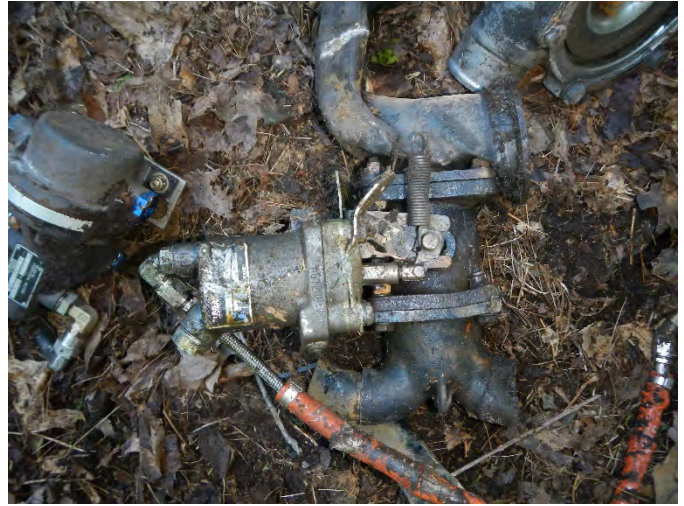
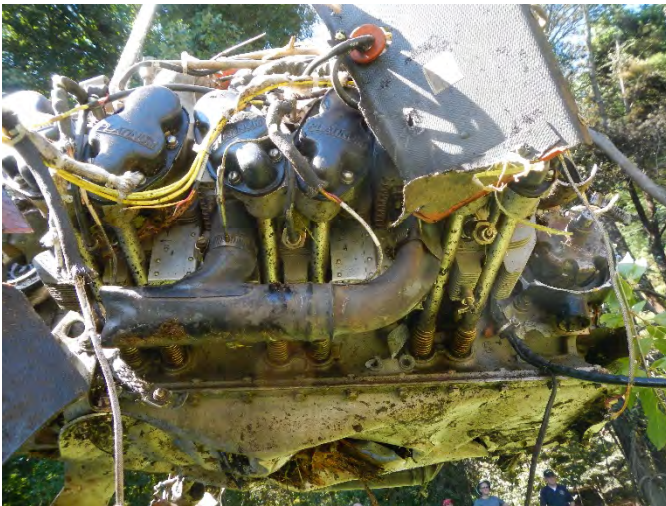
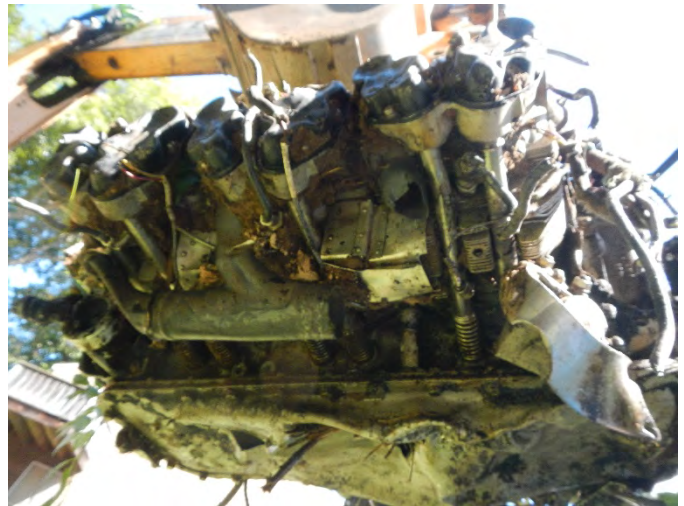
#### EXHAUST SYSTEM

The exhaust system sustained impact damage and numerous components were separated. However, no pre-accident anomalies were noted with the observed components.

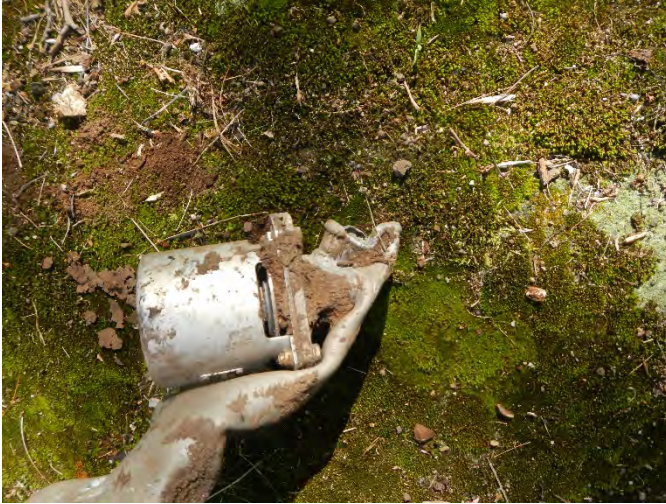
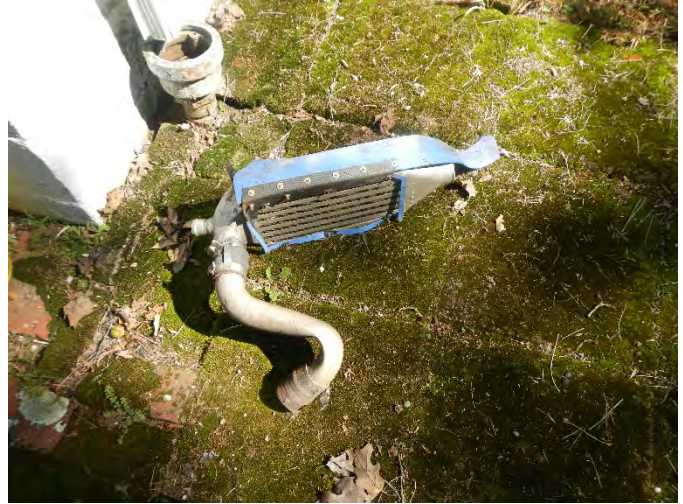
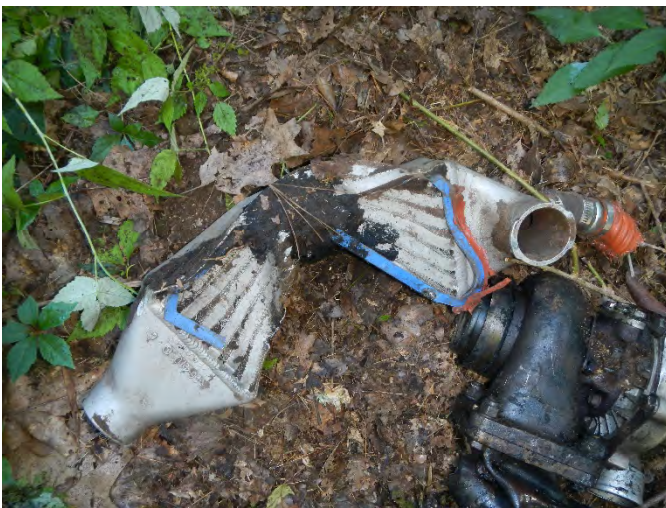
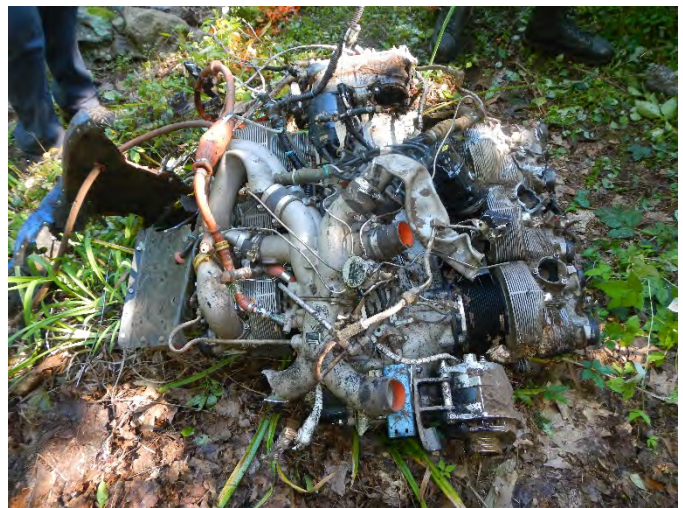
### INDUCTION SYSTEM

Condition: The induction system was fragmented with only the right intake tubes, intake plenum and throttle body remaining attached to the engine. The overboost valve and intercoolers were separated and impact damaged.

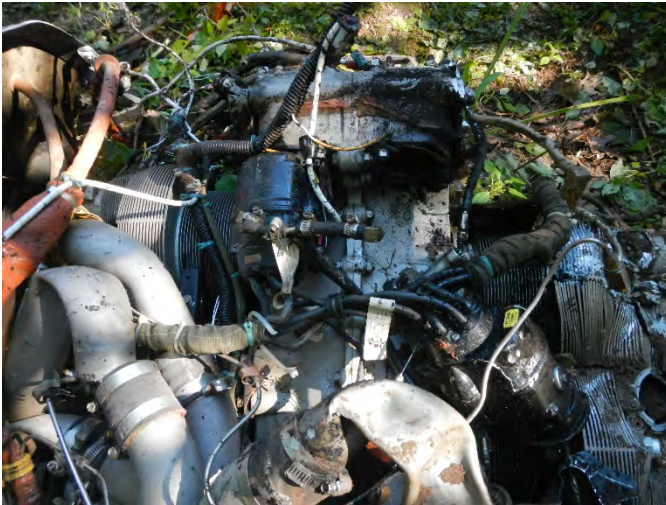
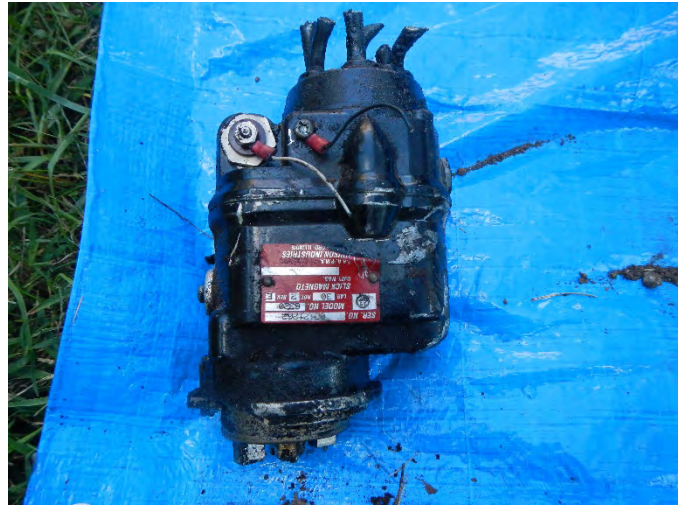
The left magneto was separated from its mounting pad and the housing sustained impact damage that deformed the housing in the capacitor area. The left magneto's ignition leads were cut near the harness cap. The magneto drive was manually rotated and a spark was observed in firing order during the audible snap of the impulse coupling.

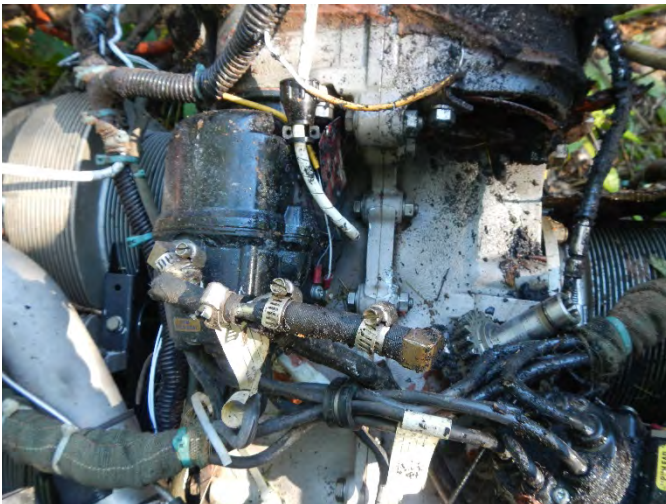
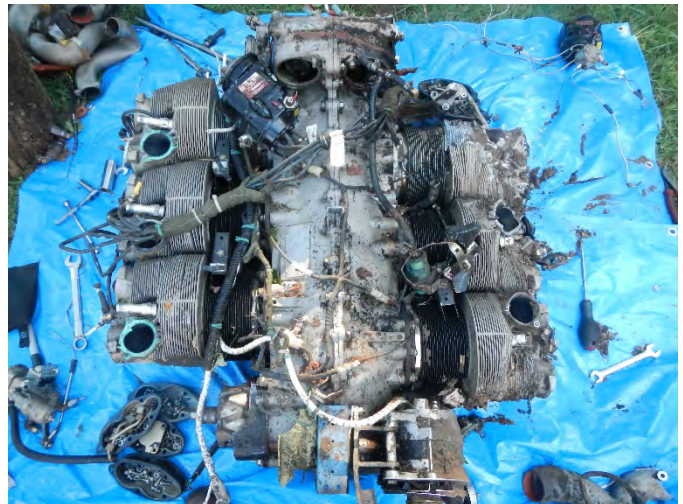
**RIGHT  
MAGNETO**

The right magneto remained attached to the mounting pad. Manual manipulation of the magneto revealed it was secured in place. The magneto was removed and the drive was manually rotated. The impulse coupling produced an audible snap, but a spark was not observed from any of the leads.

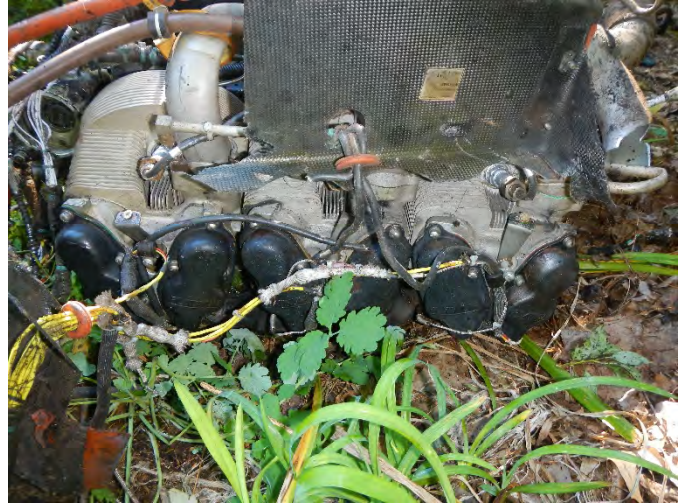
The ignition harness remained attached to each magneto. The left cylinders' ignition leads were fragmented. The damaged leads were cut from the harness for the functional testing of the magnetos. The terminal ends on the right cylinders' sparkplugs and the bottom left sparkplugs remained in place.

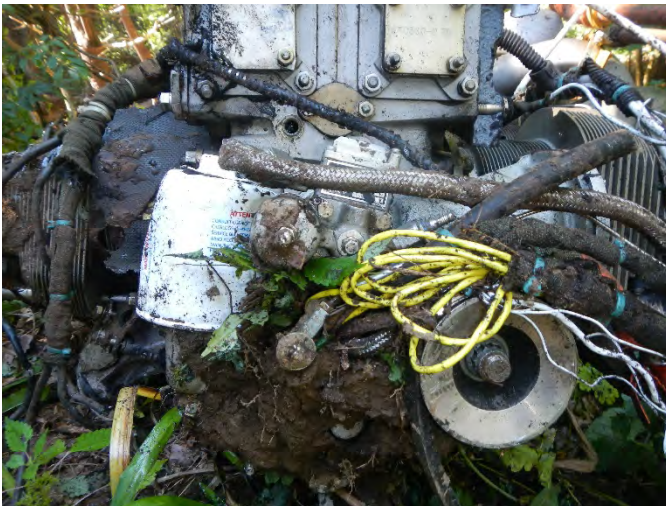
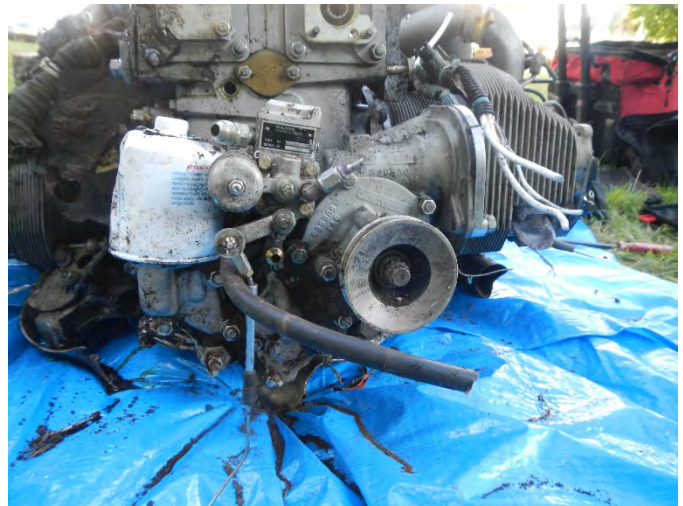
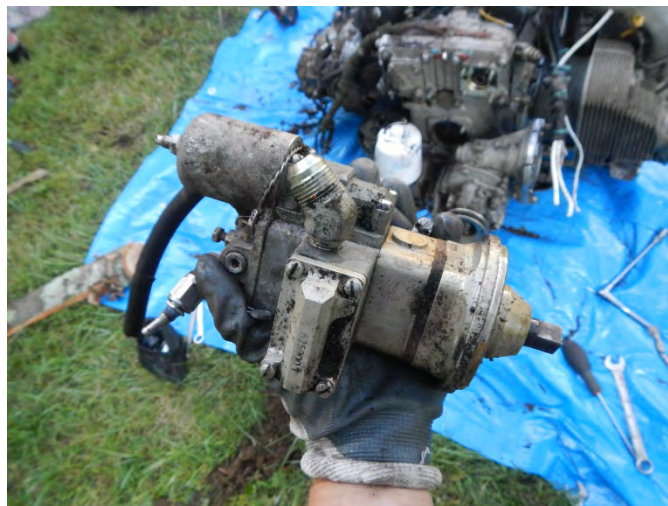
| FUEL PUMP | Manufacturer: Continental Motors | P/N: Not Recorded | S/N: Not Recorded |
|---|---|---|---|
| Condition: | The engine-driven fuel pump remained attached to the backside of the engine. The vapor return fitting was fractured, but all remaining b-nuts remained in place with no blue discoloration noted. The mixture control cable remained attached to the lever and the lever remained attached to the shaft. The lever, shaft and nut were marked and rotation of the lever resulted in a coinciding unbound rotation of the shaft. Fuel was recovered in the line between the engine-driven fuel pump and the fuel metering unit. Residual fuel was also recovered from the engine-driven fuel pump. Removal of the pump revealed that the drive coupling was intact. Rotation of the drive coupling while it was installed in the shaft resulted in a rotation of the pump. | | |

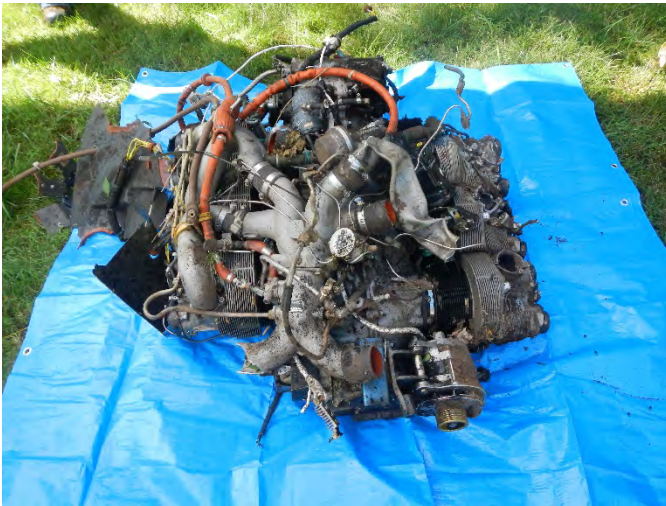
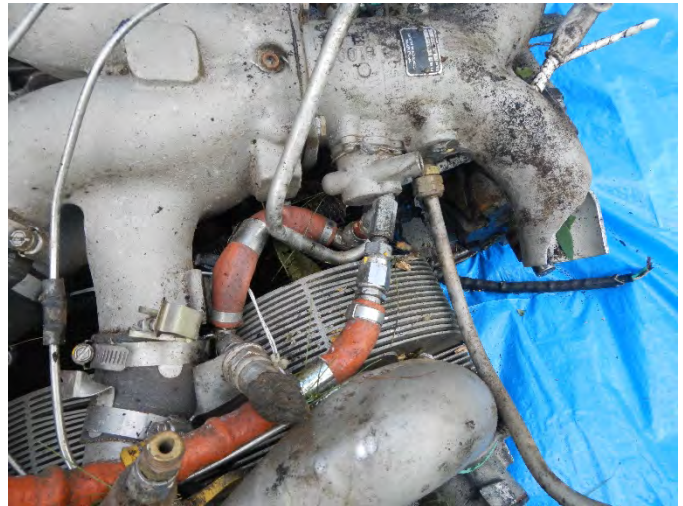
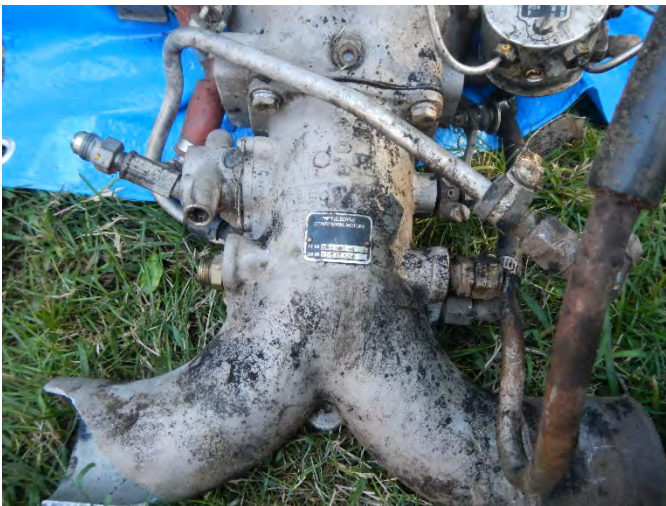
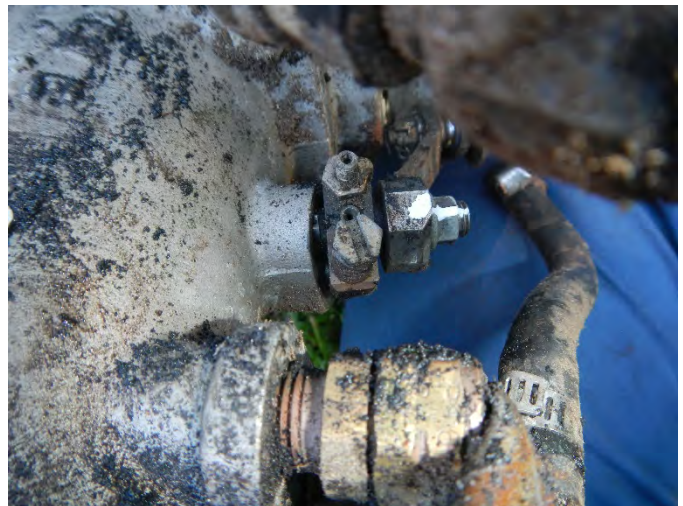
## THROTTLE BODY METERING UNIT

The throttle body and intake plenum were displaced to the right side of the engine. The throttle cable remained attached to the throttle lever which remained attached to the shaft; however, the shaft was bent. The lever, nut, and shaft were marked and rotation of the lever resulted in slipping of the lever (this was attributed to the bending damage of the shaft). Residual fuel was recovered in the line between the fuel metering unit and the fuel manifold valve even though the inlet fitting of the fuel manifold valve was fractured.

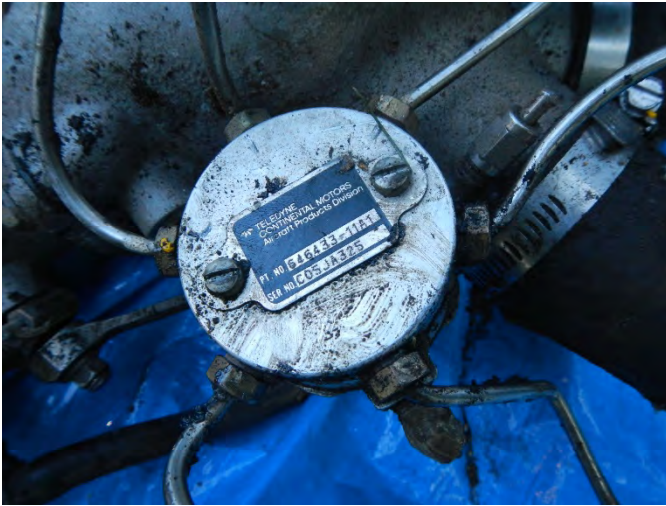
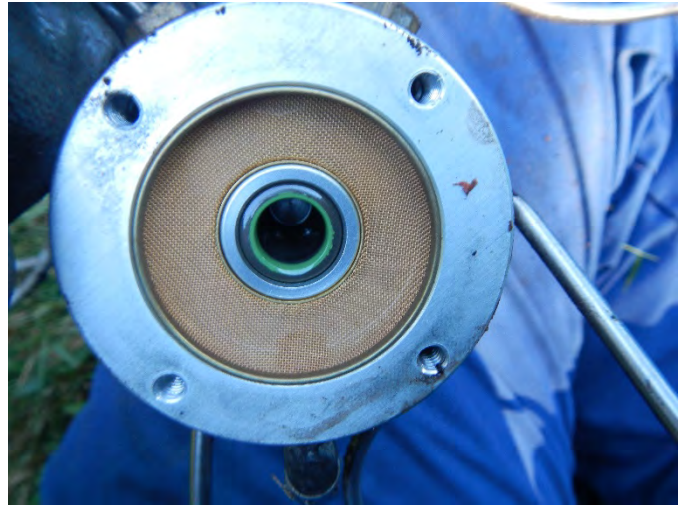
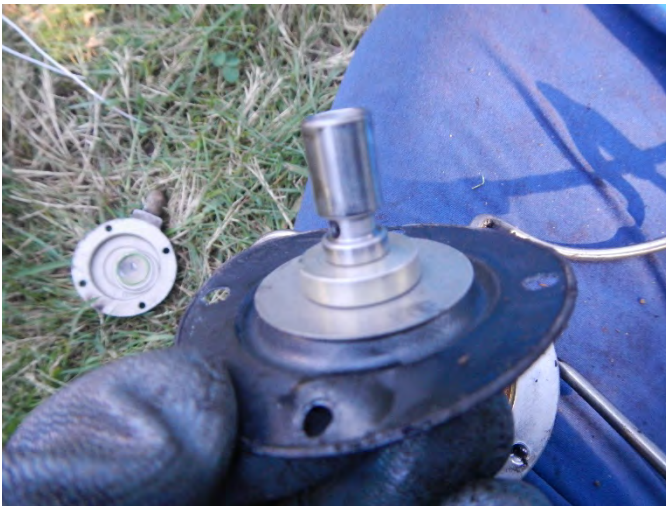
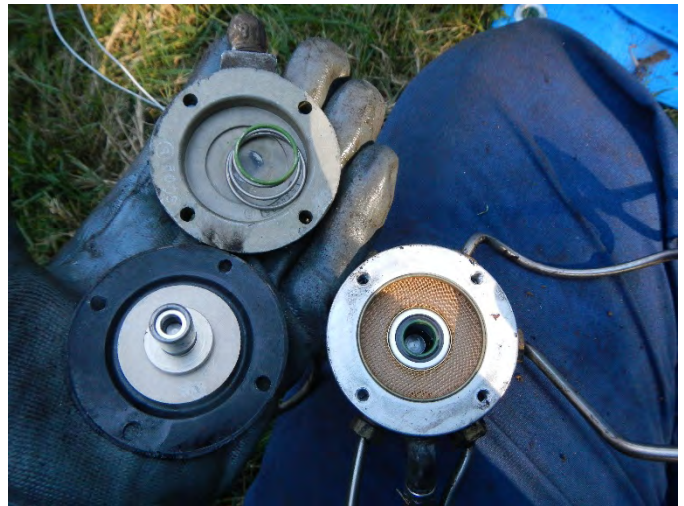
## FUEL MANIFOLD VALVE

The fuel manifold remained attached to the displaced throttle body. The manifold valve was disassembled, and residual fuel was observed in the housing and the screen was clear.

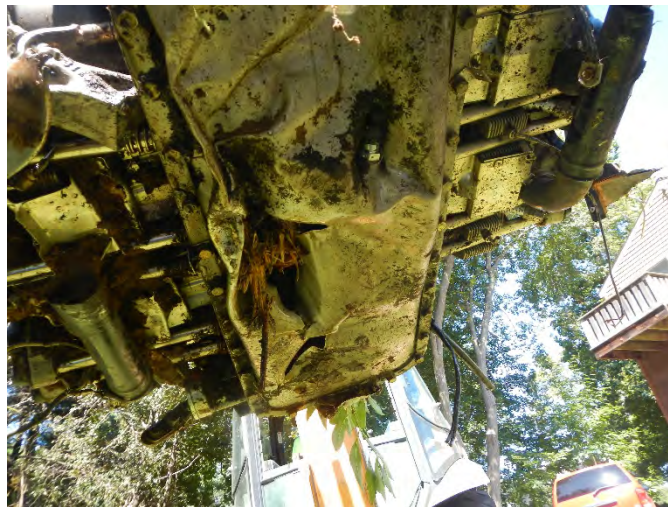
#### OIL SUMP

The oil sump was displaced up around the base of the engine and a large tear was present with wood embedded in the torn area. Residual oil was observed leaking from the torn area, and it was caramel in color with no abnormal odors.

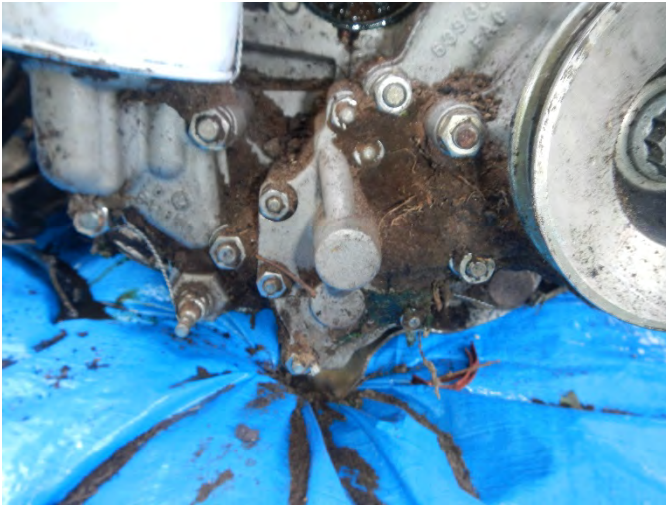
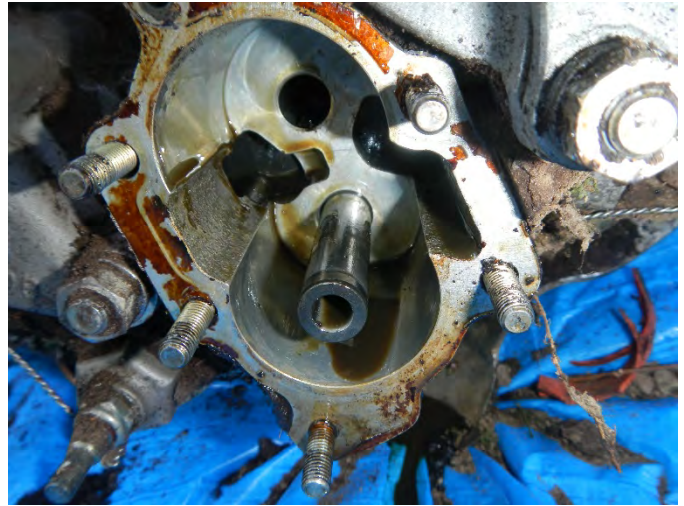
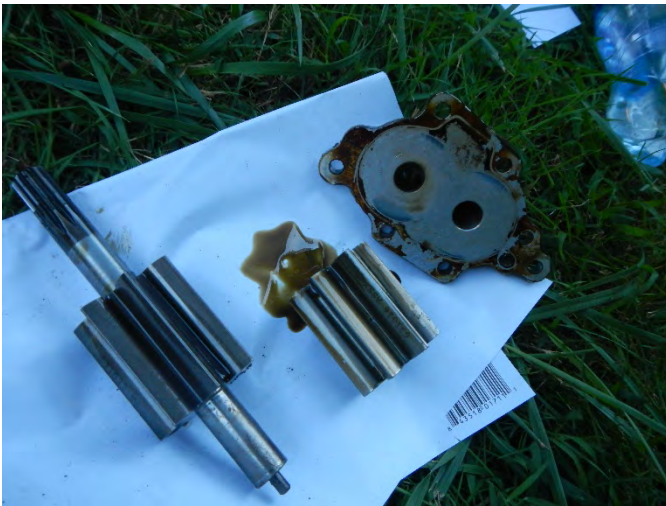
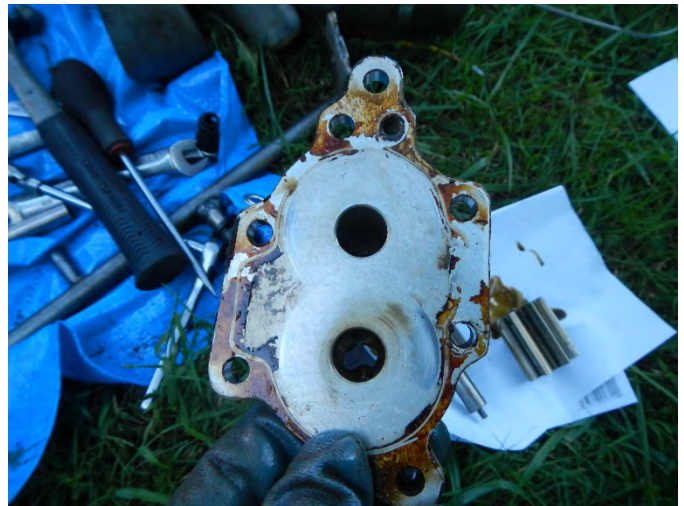
### OIL PUMP

The oil pump cap was removed and residual oil was observed in the pump housing. The gear were intact with no pre-accident anomalies noted with the gear and the housing walls.

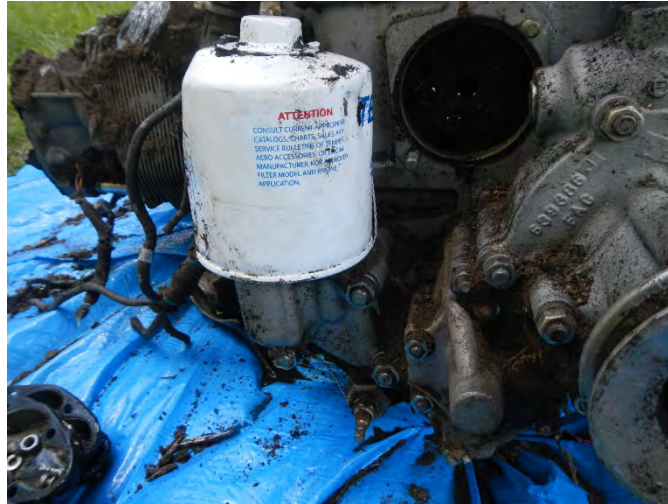
| Condition: | The oil filter remained attached to the adapter and the safety-wire was intact. There was no sign of lubrication or thermal distress on any of the observed engine components. | |

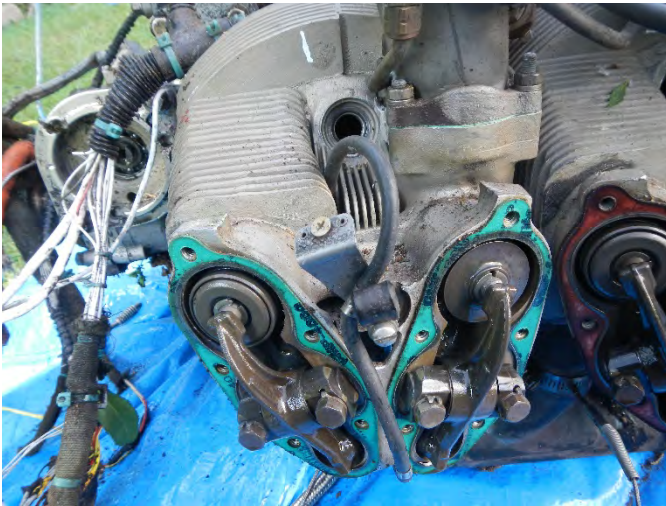
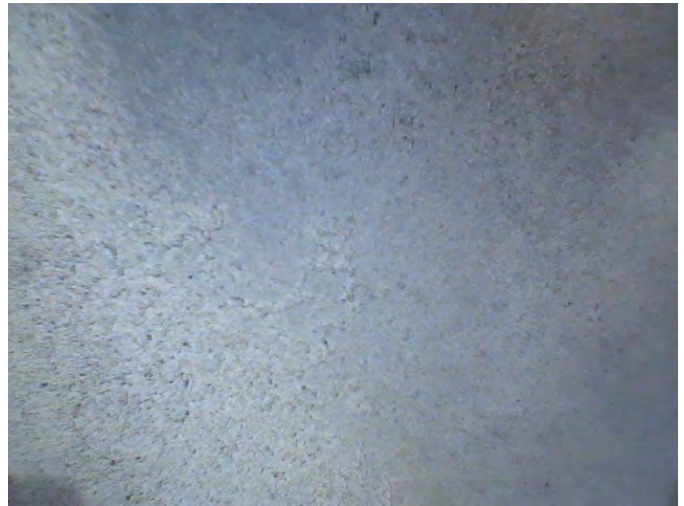
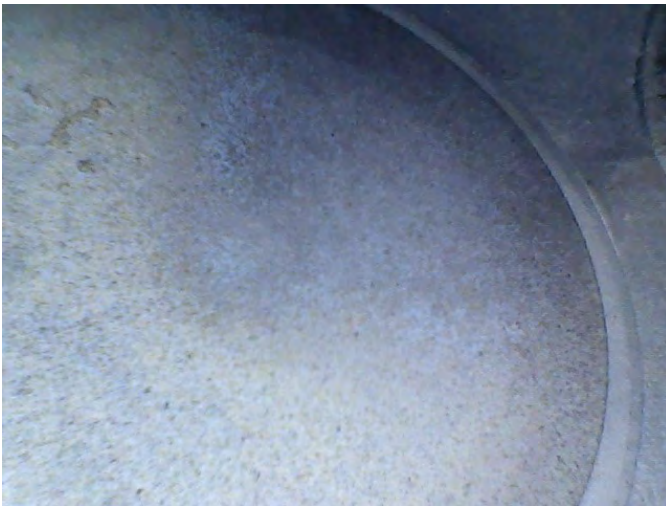
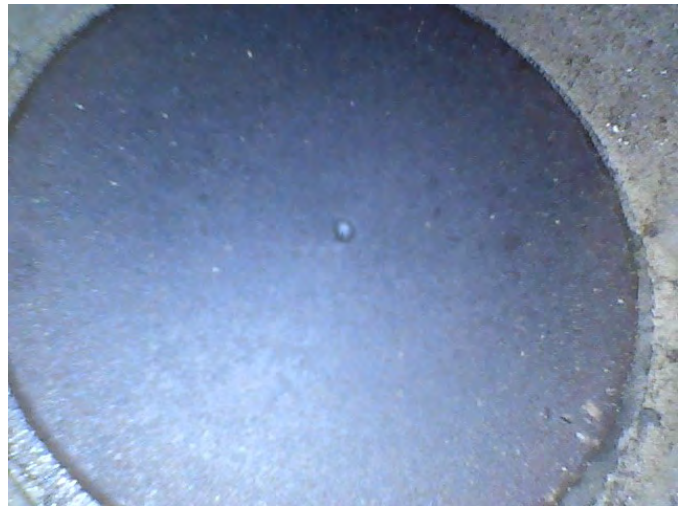
| CYLINDER #1 | P/N: 658603A1 | S/N: AC08JA998 | Head Date: Unknown |
|---|---|---|---|
| Condition: | The cylinder remained attached to the engine with no external anomalies noted. Borescope examination of the cylinder revealed light combustion deposits with no pre-accident anomalies noted with the piston, barrel, valves or valve seats. During the partial rotation of the crankshaft the cylinder produced thumb compression. | | |

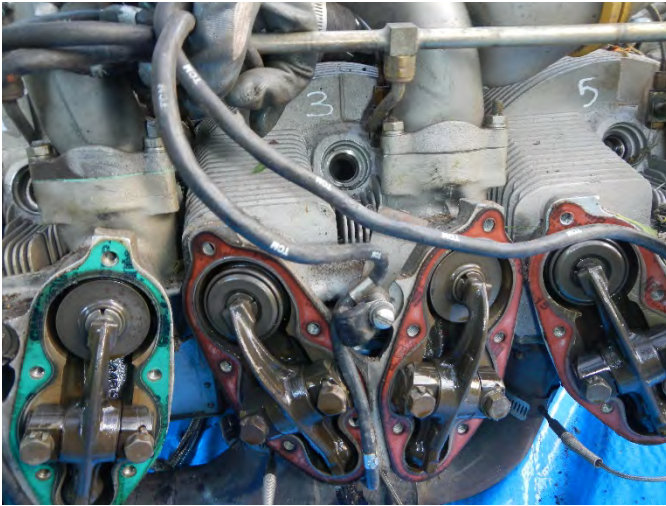
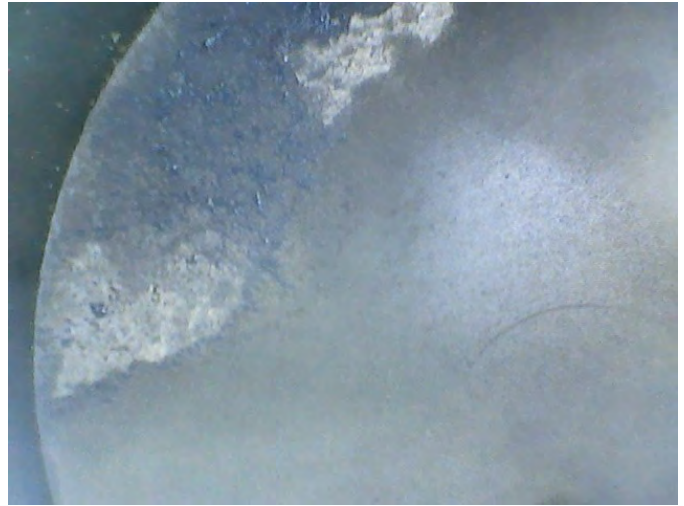
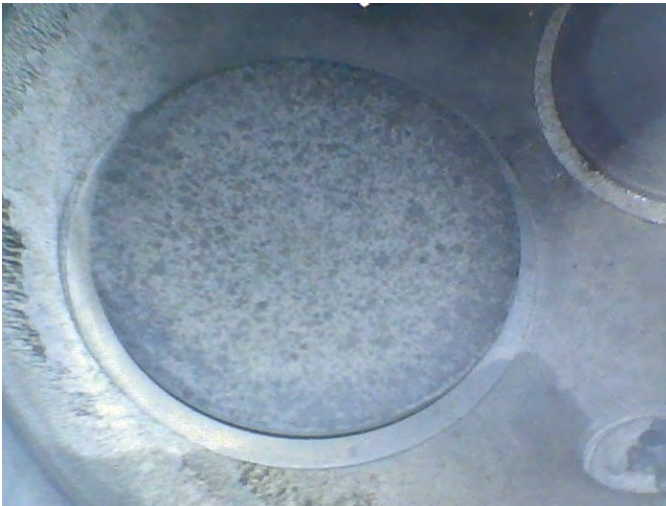
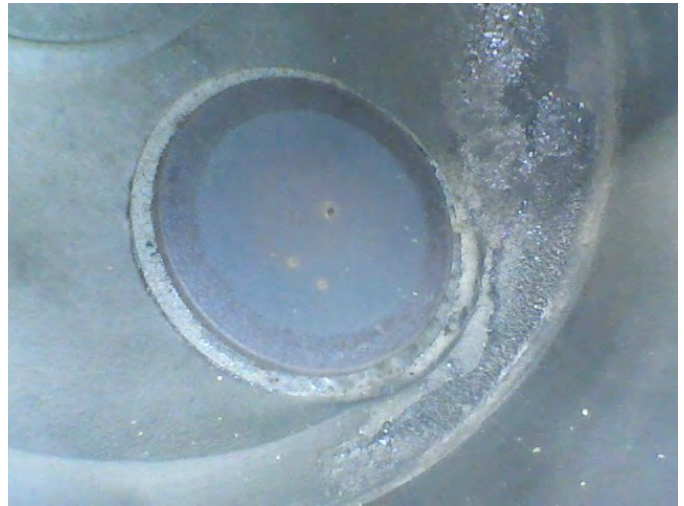
## CYLINDER #3

Condition: The cylinder remained attached to the engine with no external anomalies noted. Borescope examination of the cylinder revealed light combustion deposits with no pre-accident anomalies noted with the piston, barrel, valves or valve seats. During the partial rotation of the crankshaft the cylinder produced thumb compression.

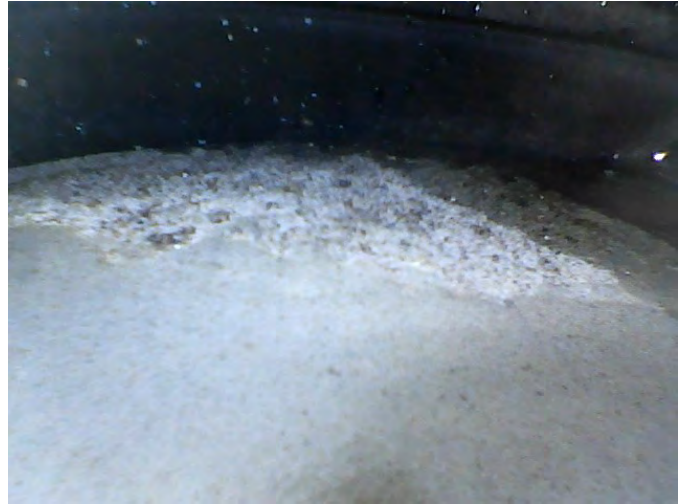
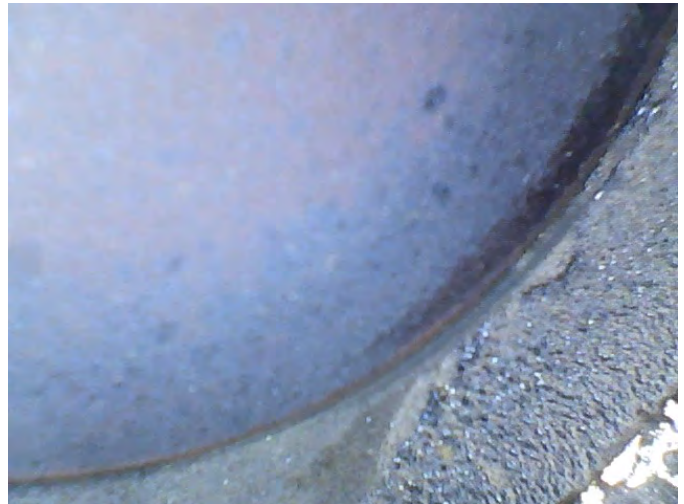
CYLINDER #5

The cylinder remained attached to the engine with no external anomalies noted. Borescope examination of the cylinder revealed light combustion deposits with no pre-accident anomalies noted with the piston, barrel, valves or valve seats. Piston/connecting rod movement was confirmed during the partial rotation of the crankshaft.

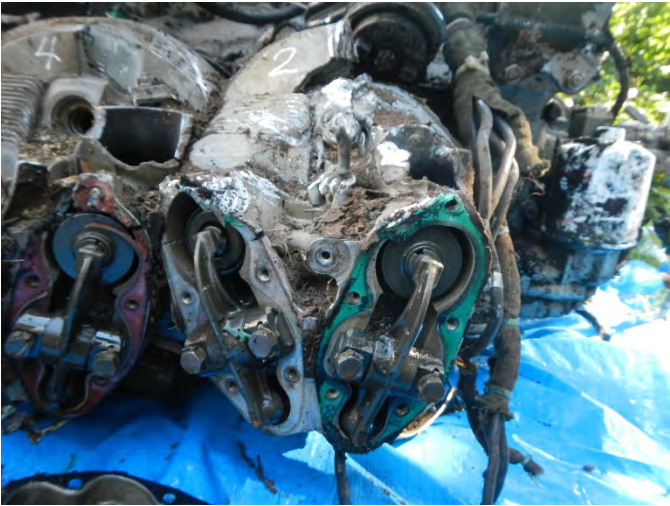
| Condition: | The cylinder remained attached to the crankcase but sustained significant impact damage that fractured and displaced the head toward the engine centerline. The intake and exhaust tubes were displaced from the cylinder and the sparkplugs were damaged. Only a portion of the cylinder's internal components was visible via borescope placement through the intake port. No pre-accident anomalies were observed with the observed components. | | |

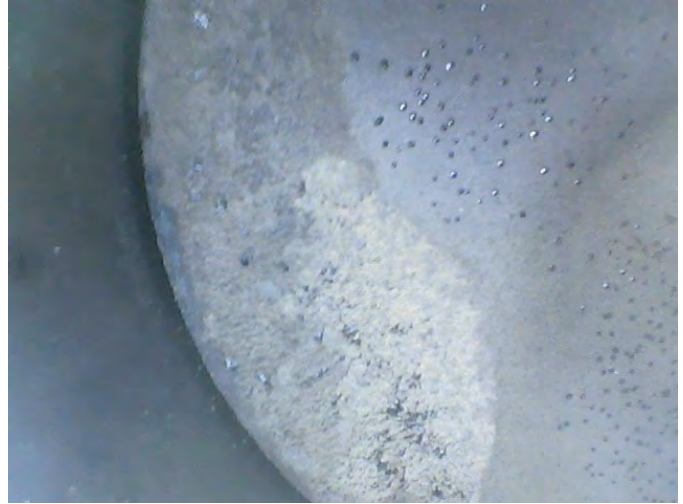
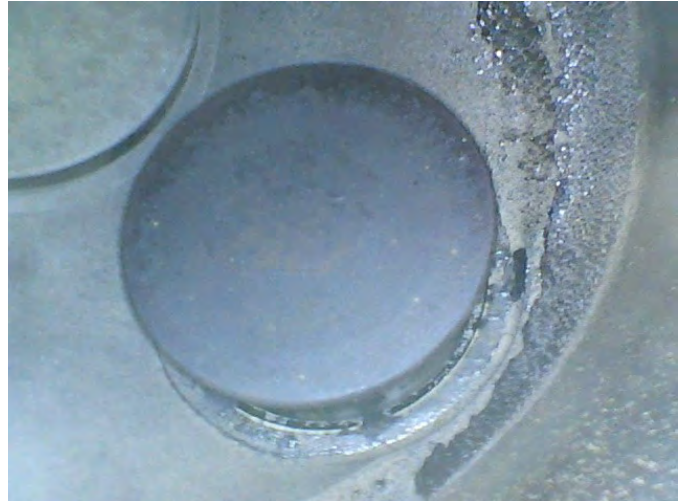
**CYLINDER #4**

The cylinder remained attached to the crankcase. It sustained impact-related damage to the cooling fins, intake port, fuel injector, and top sparkplug. Borescope examination of the cylinder revealed light combustion deposits with no pre-accident anomalies noted with the piston, barrel, valves or valve seats. Piston/connecting rod movement was confirmed during the partial rotation of the crankshaft.

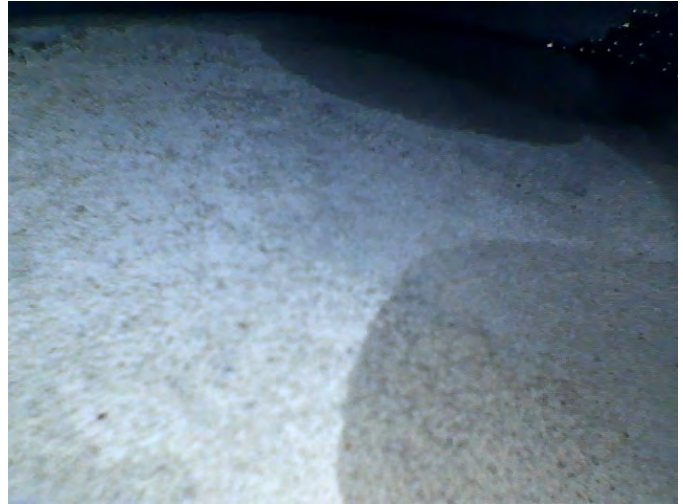
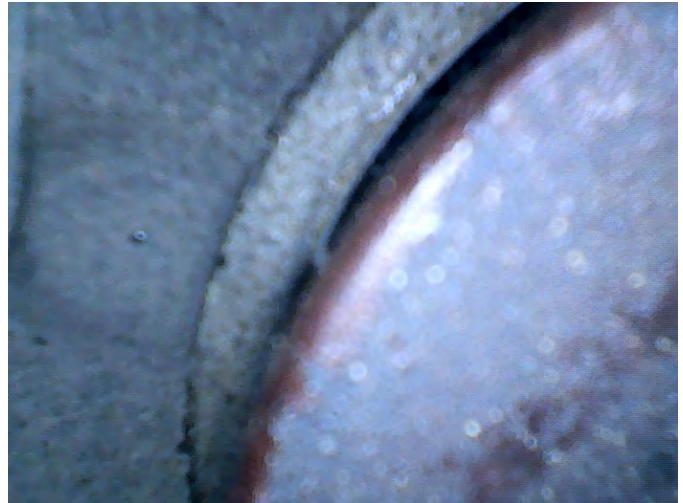
CYLINDER #6

The cylinder remained attached to the engine with impact-related damage sustained by the cooling fins, top sparkplug, fuel injector, and intake port. Borescope examination of the cylinder revealed light combustion deposits with no pre-accident anomalies noted with the piston, barrel, valves or valve seats. During the partial rotation of the crankshaft the cylinder produced thumb compression.

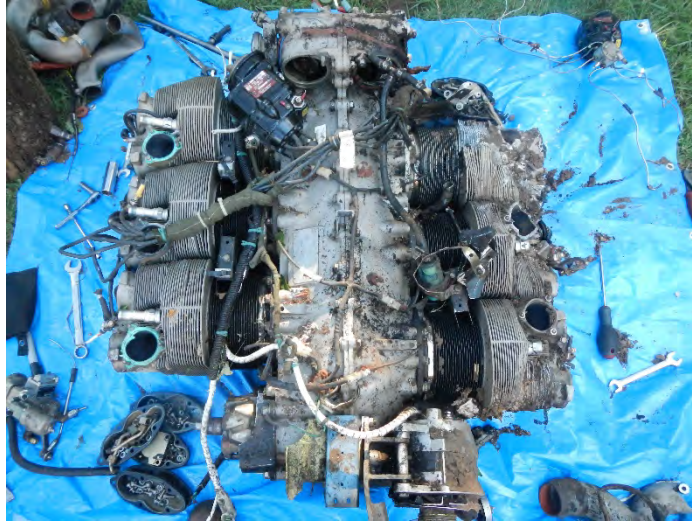
| Condition: | The crankcase remained intact and all the cylinders remained attached to the crankcase. | | | |

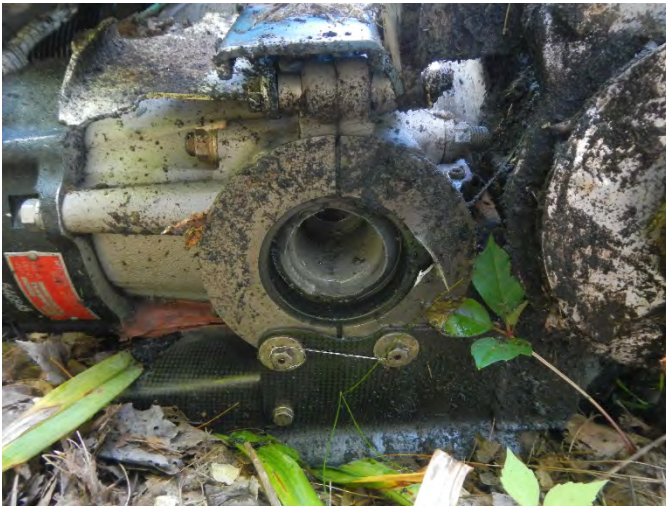
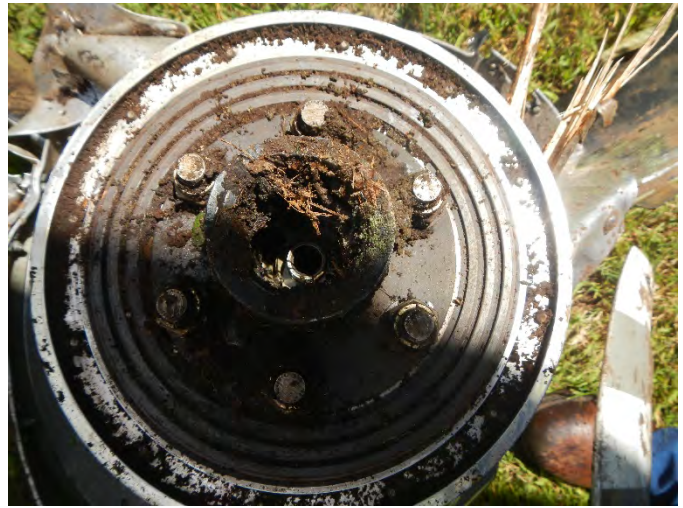
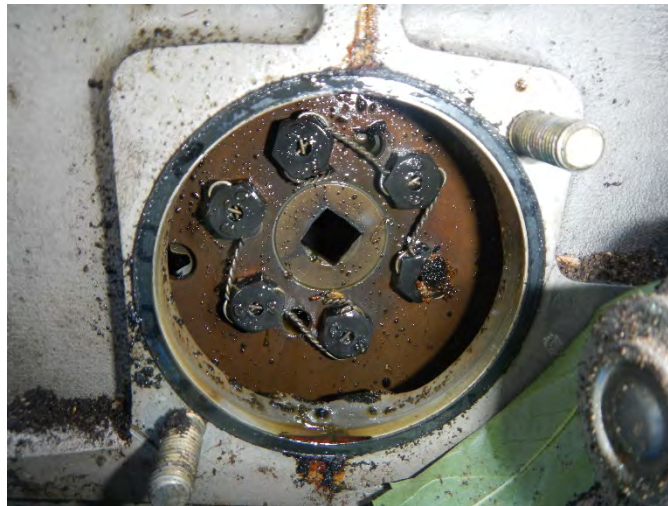
| CRANKSHAFT | Forging Number: Not Observed | S/N: Not Observed | Heat code: Not Observed |
|---|---|---|---|
| Condition: | The crankshaft was fractured aft of the propeller flange where it exits the nose seal of the crankcase. The fracture surface displayed 45-degree shear lips. The crankshaft was manually rotated by inserting an adapter into the right accessory drive gear. The crankshaft could not be rotated in its entirety due to the displaced #2 cylinder head, which prevented full movement of its connecting rod/piston. However, crankshaft continuity was confirmed from the aft accessory end, forward to the fractured crankshaft and gear-driven alternator on the front right side, and out to each connecting rod/piston. | | |

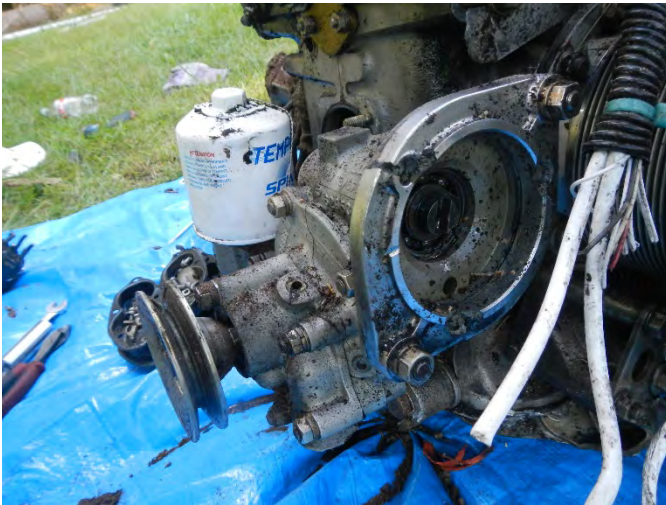
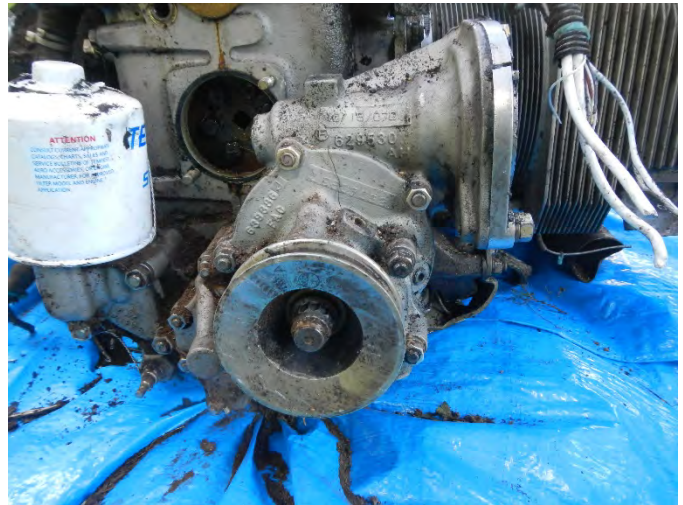
**STARTER  
ADAPTER**

The adapter remained attached to the backside of the engine and rotation of the drive pulley was observed during partial rotation of the crankshaft. No pre-accident anomalies were observed.

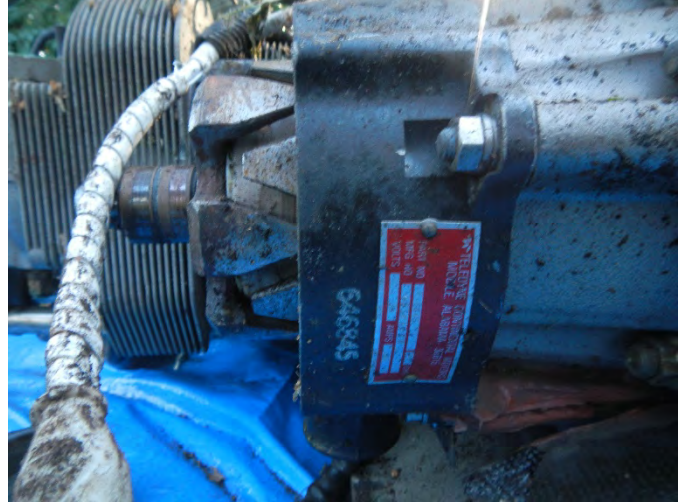
| Condition: | The engine-driven alternator remained attached to the front right side of the engine but sustained impact damage. It was not examined as part of this investigation. | | |

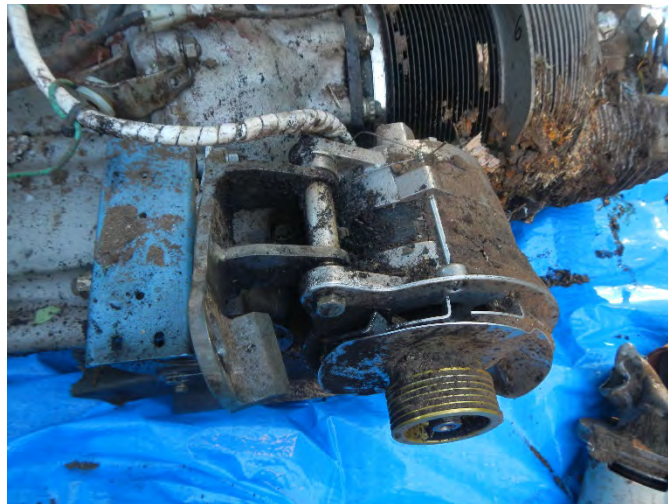
| Condition: | The belt-driven alternator Remained attached to its bracket which sustained deformation damage. It was not examined as part of this investigation | | |

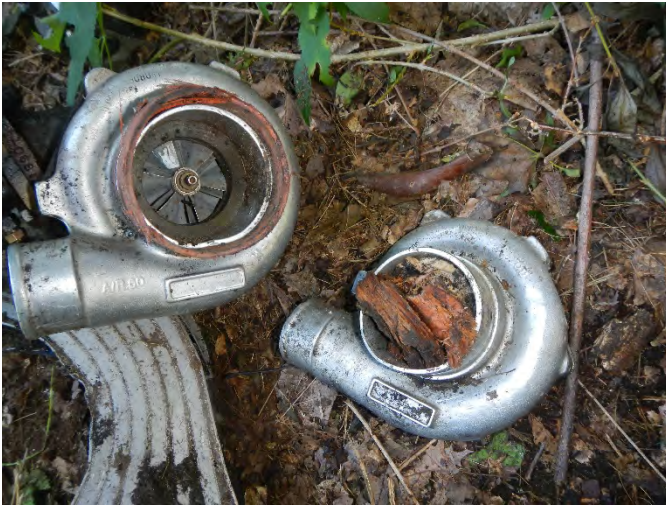
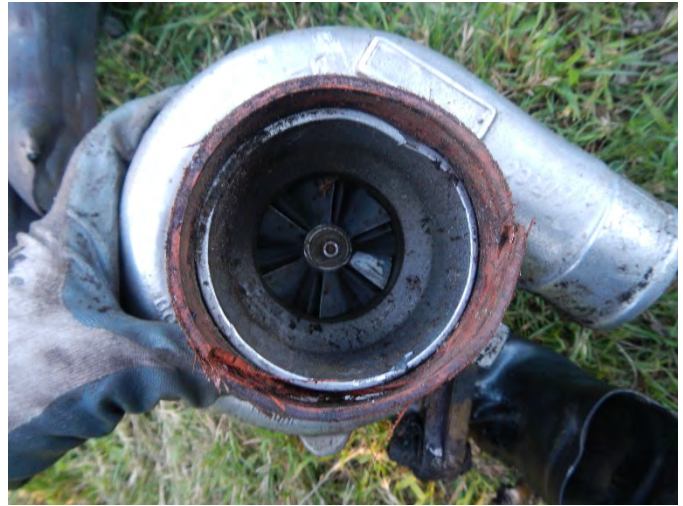
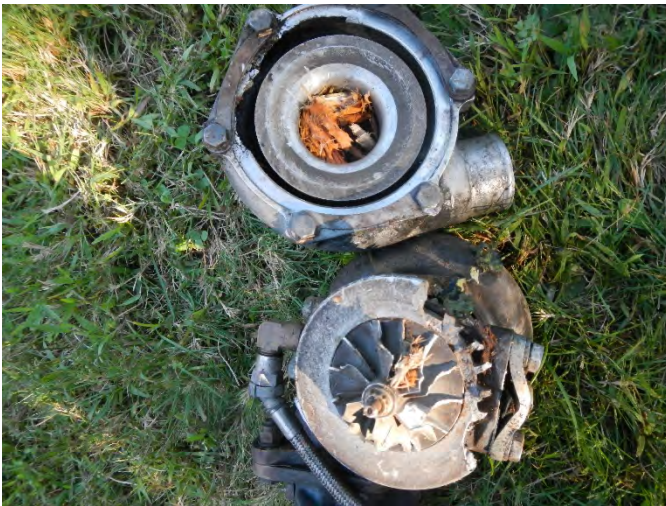
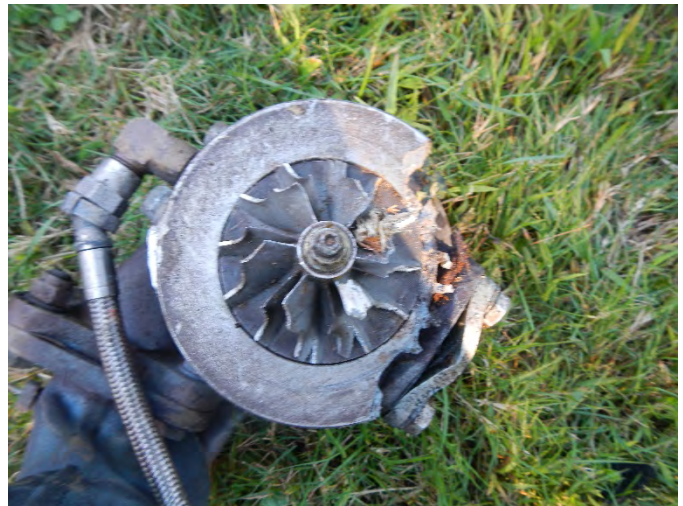
#### TURBOCHARGERS

The two turbochargers were separated from the engine. One turbocharger remained intact with no pre-accident anomalies noted with the impeller or turbine blades. The other turbocharger induction housing was separated, and impacted with wood fragments. The associated turbocharger's impeller blades were fractured and wood fragments were observed at some of the fracture points. The turbine blades were intact.
