# Continental Motors

## ENGINE EXAMINATION REPORT

| ENGINE MODEL | TSIO-550-C9B |
| FILE NUMBER | 18-188 |

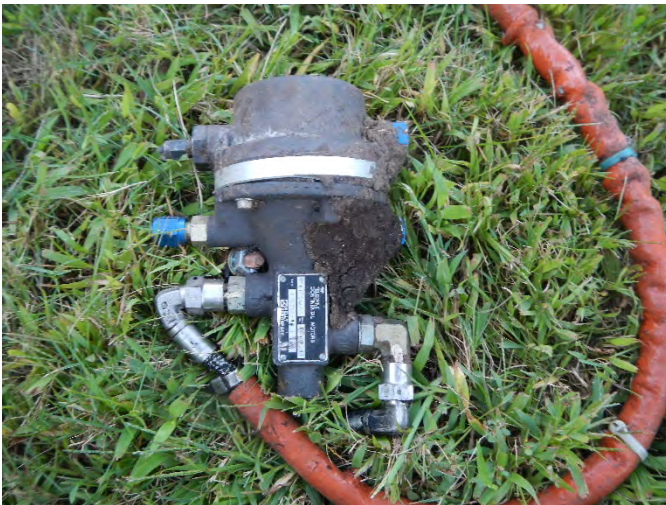
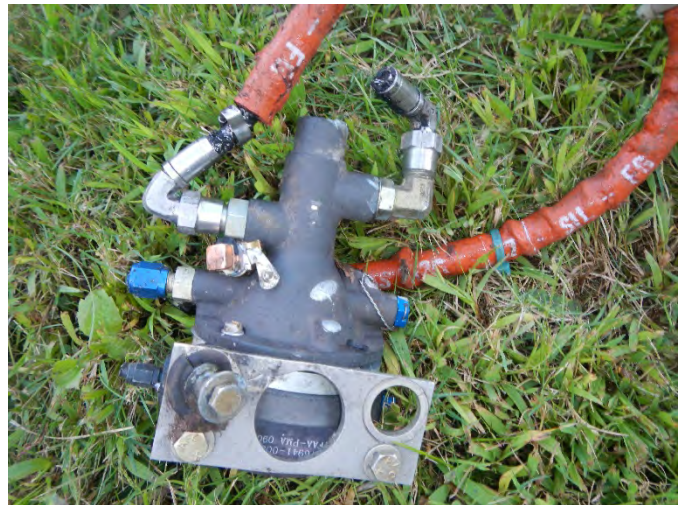
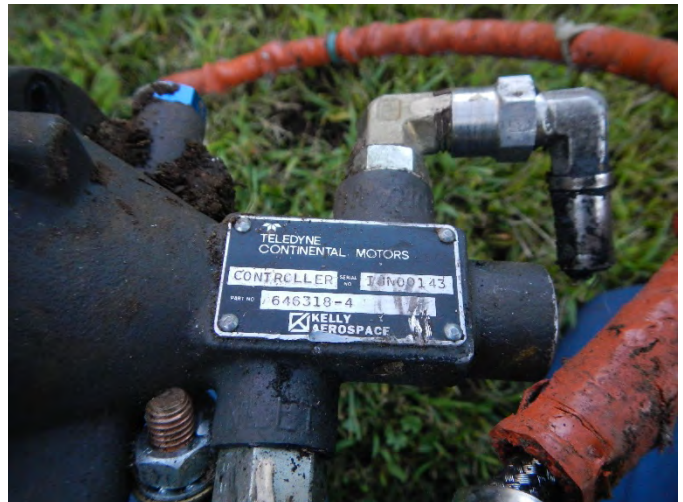
| Condition: | The pressure controller was separated from the engine and residual oil was observed in the inlet line, which remained attached. The cap of the controller was partially displaced. | | |

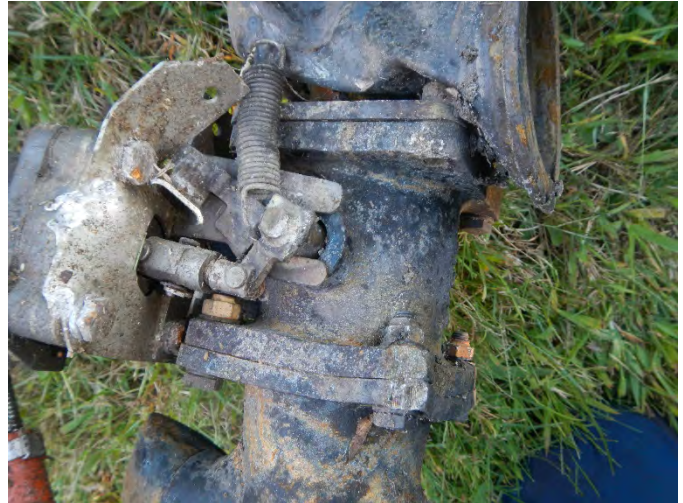
## WASTEGATE

The waste gate actuator remained with a piece of exhaust. The actuating arm remained attached to the wastegate with no pre-accident anomalies noted.

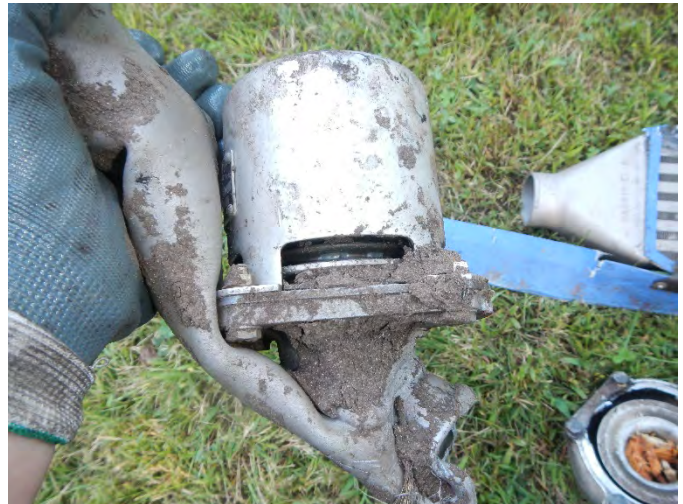
## OVERBOOST VALVE

The overboost valve remained attached to a flattened and distorted piece of intake tubing. No pre-accident anomalies were noted with the poppet valve.

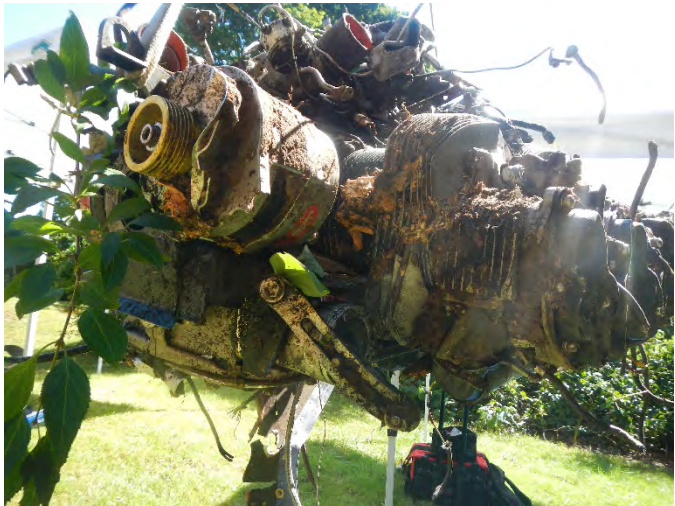
| Condition: | The propeller governor remained attached to the front left side of the engine, but the control lever/shaft was separated from the housing. | | |

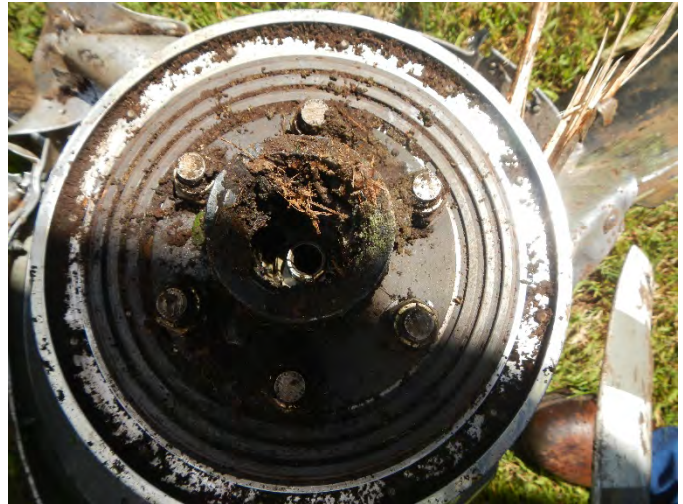
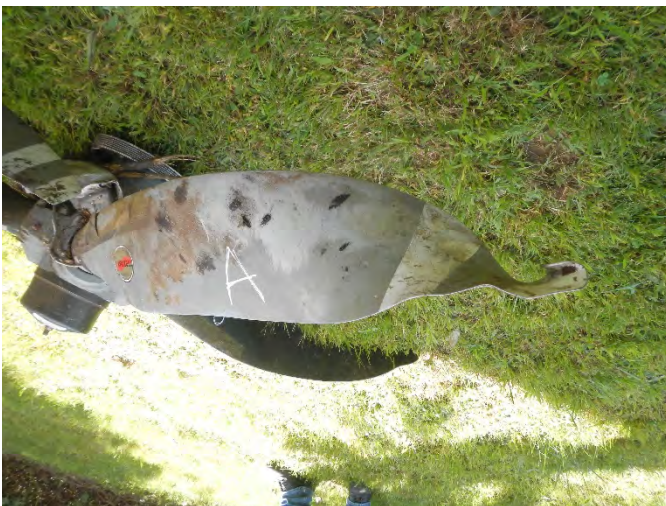
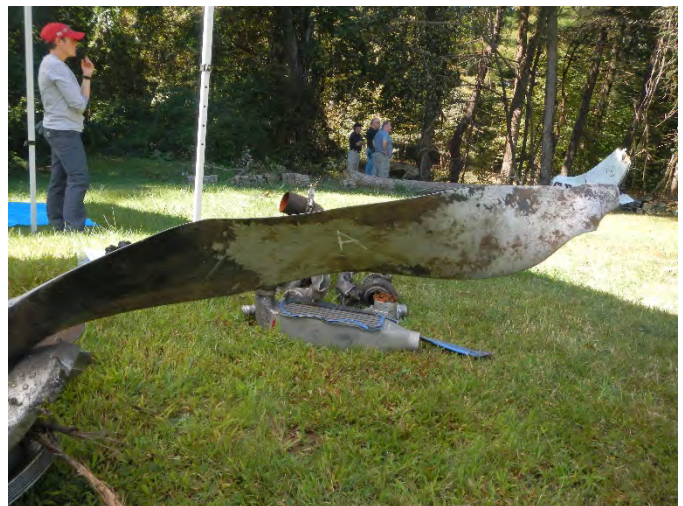
### PROPELLER

The three-bladed propeller hub remained intact and all three blades remained attached to the hub. All of the blades rotated independently within the hub, indicative of pitch change link fractures. The blades were arbitrarily labeled A, B, and C for descriptive purposes. Blade A displayed chord-wise paint burnishing, significant blade twisting toward low pitch, and s-bending on the trailing edge. Blade B was bent in half with impact-related damage on the trailing edge. Blade C was bent aft, twisted toward low pitch, with slight s-bending on the trailing edge. Two tree branches were observed at the accident site that displayed an angular cut with gray paint transfers.
