## Textron Aviation Examination Report

Examination of N400LE (ERA18LA010) on 11-28-17.

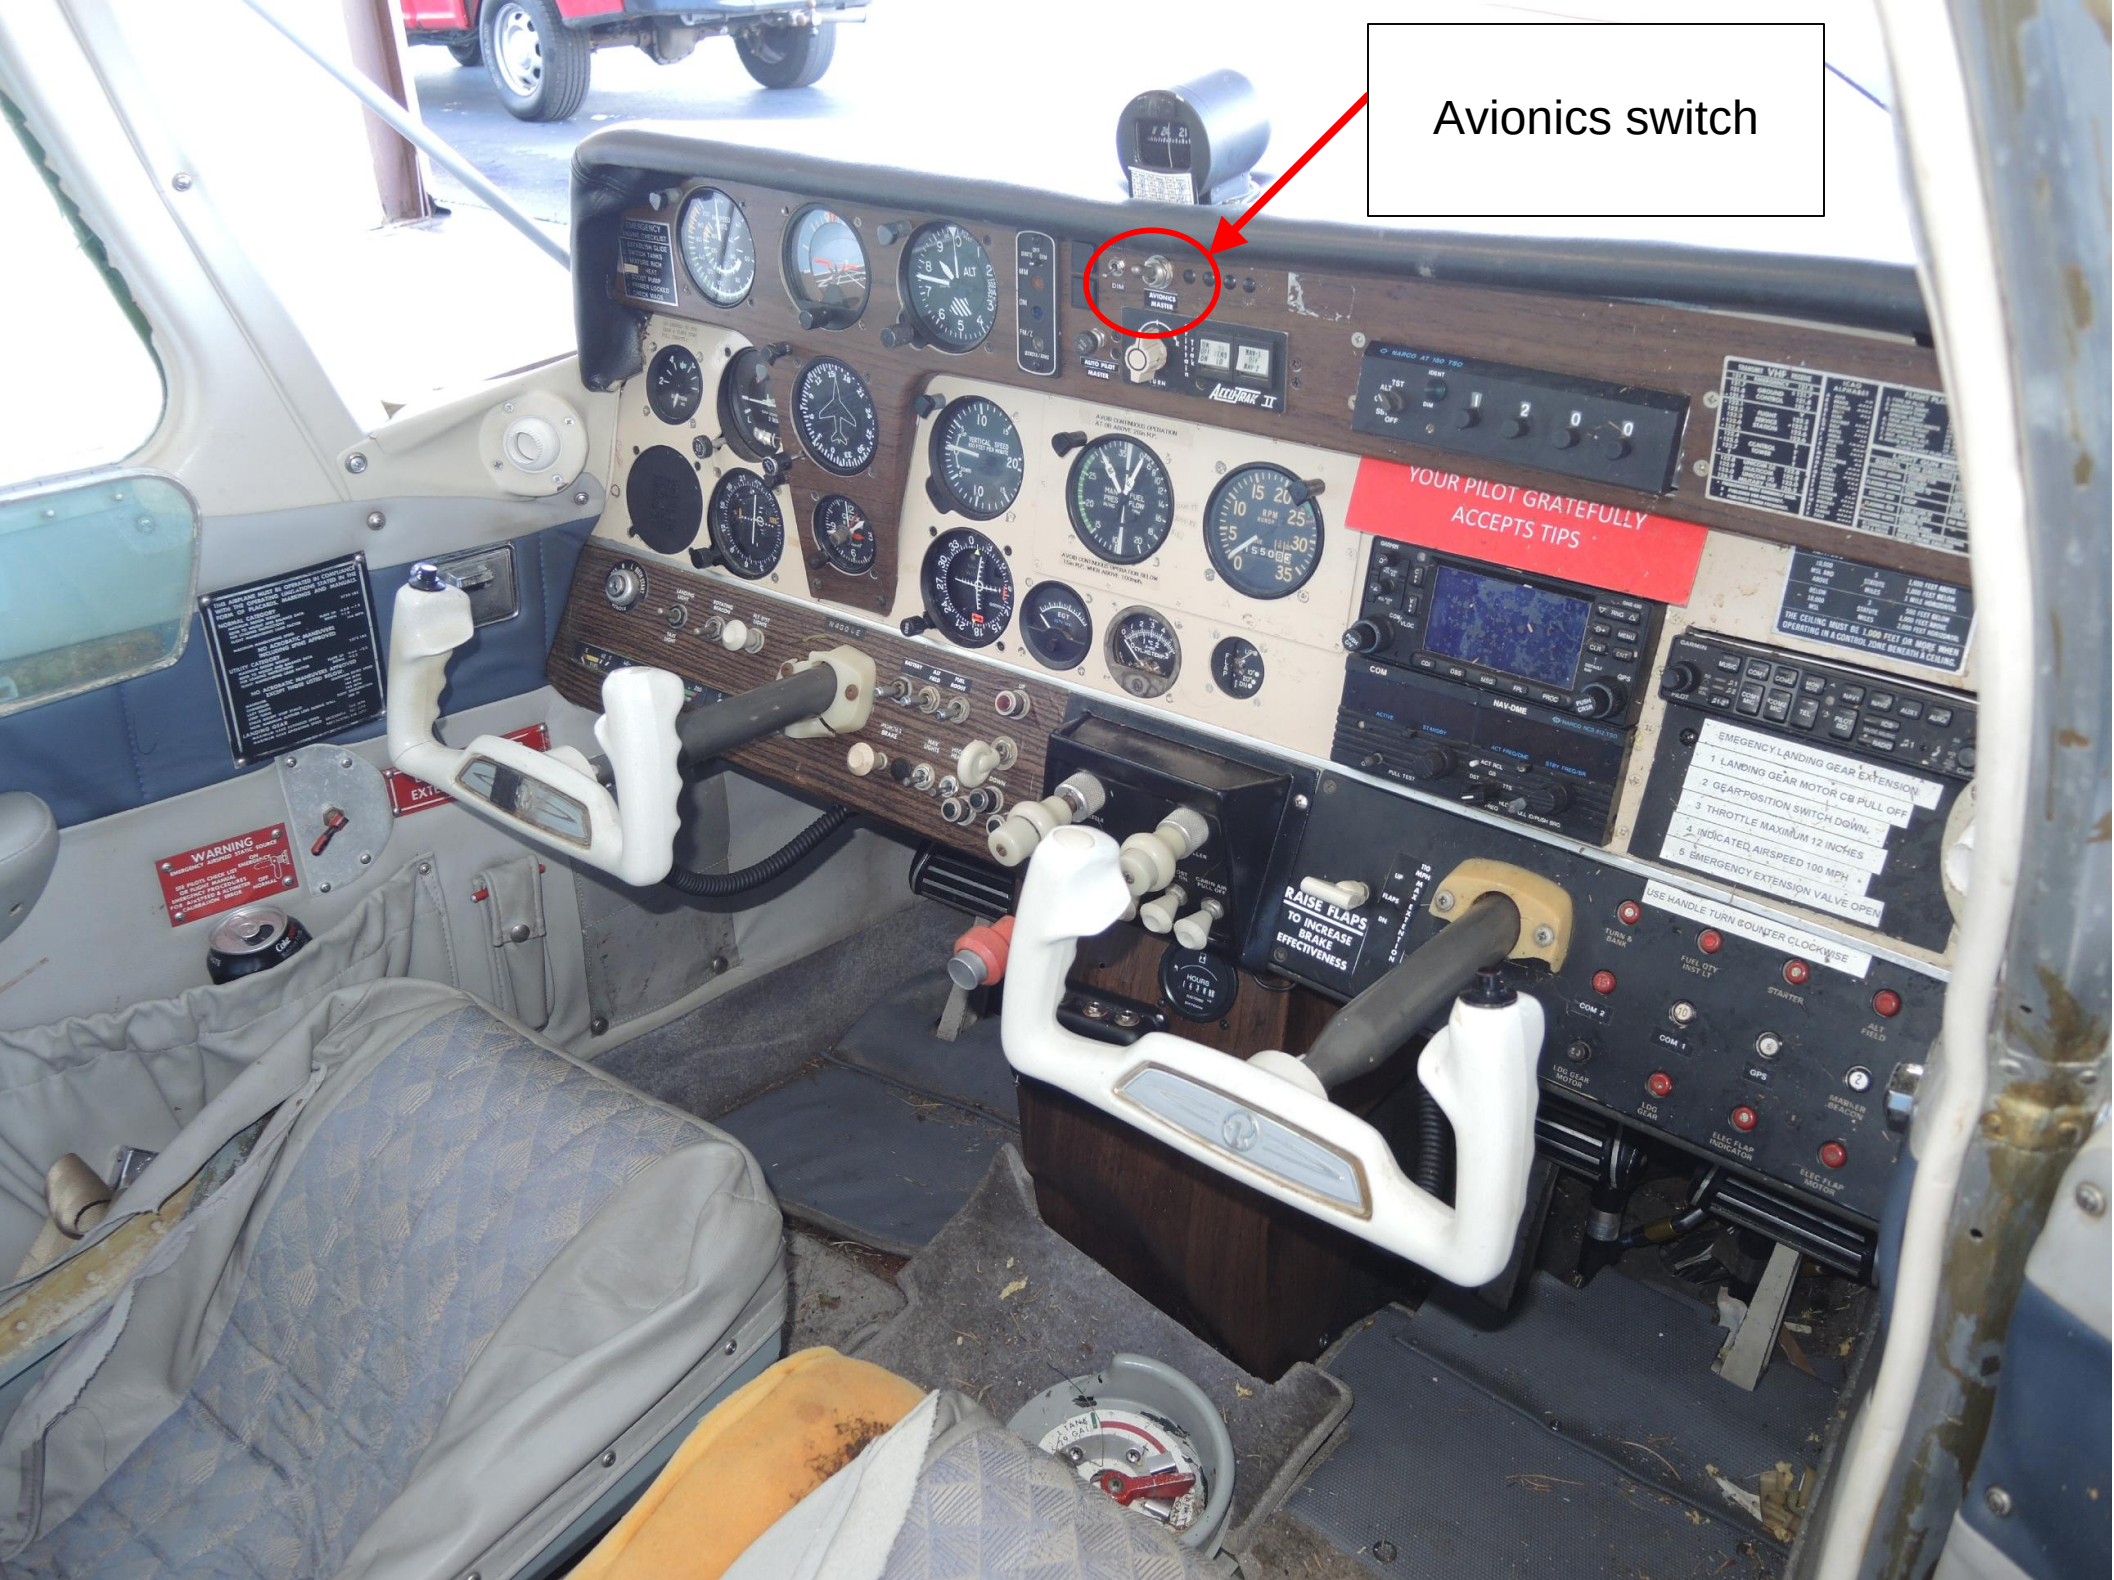
Avionics switch

The avionics switch was not originally installed in the aircraft. The wiring was not marked in the same manner as the originally installed wires. The wire insulation was marked M22759/16-14; indicating the wire was 14 gauge. Using an aviation grade wire stripper the size was confirmed to be 14 gauge.

No circuit protection was observed between the avionics switch and the bus bar.

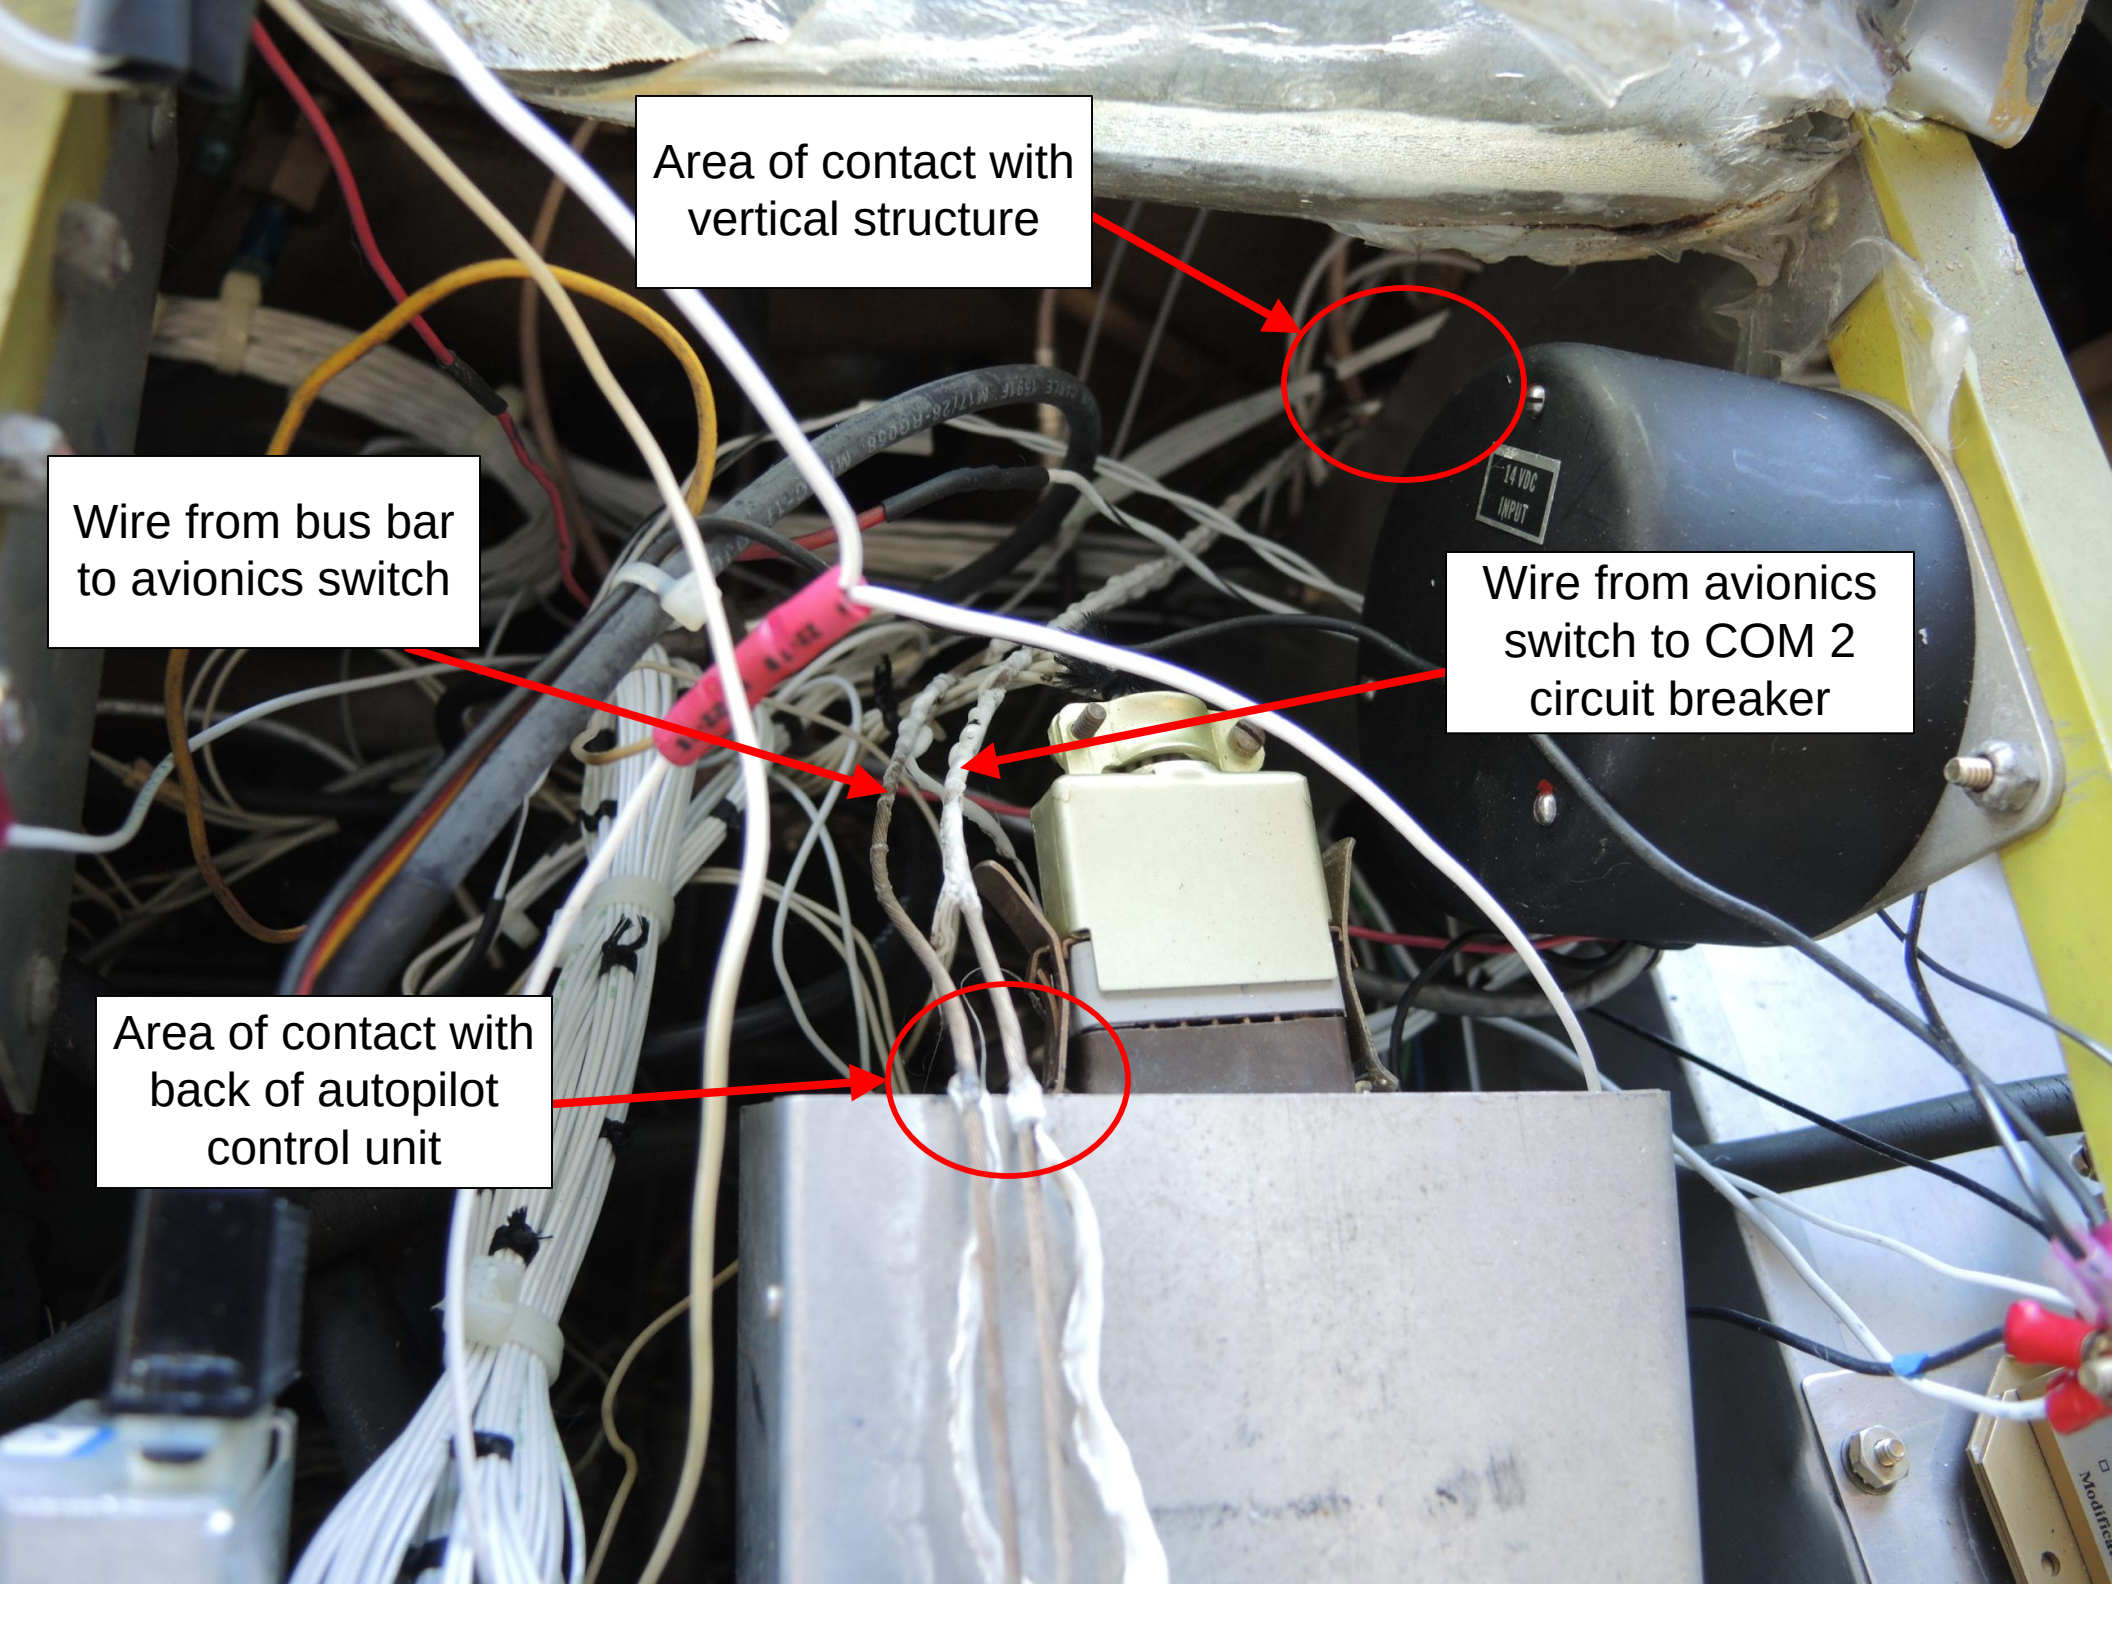
Avionics switch  
wiring

A majority of the insulation on the wire from the bus bar to the avionics switch was melted or completely missing. Evidence of arching was observed on the wire and the autopilot control unit where the wire crossed over the back of the autopilot control unit. Evidence of arching was also observed on the wire and the vertical support member where the wire passed around the support member. The wire had separated into two pieces under the instrument panel.

Portions of the wire from the avionics switch to the COM 2 circuit breaker exhibited melting where it was located near the other wire. Evidence of arching was observed on the wire and the autopilot control unit where the wire crossed over the back of the autopilot control unit. Evidence of arching was also observed on the wire and the vertical support member where the wire passed around the support member.

Area of contact with  
vertical structure

Wire from bus bar  
to avionics switch

Wire from avionics  
switch to COM 2  
circuit breaker

Area of contact with  
back of autopilot  
control unit

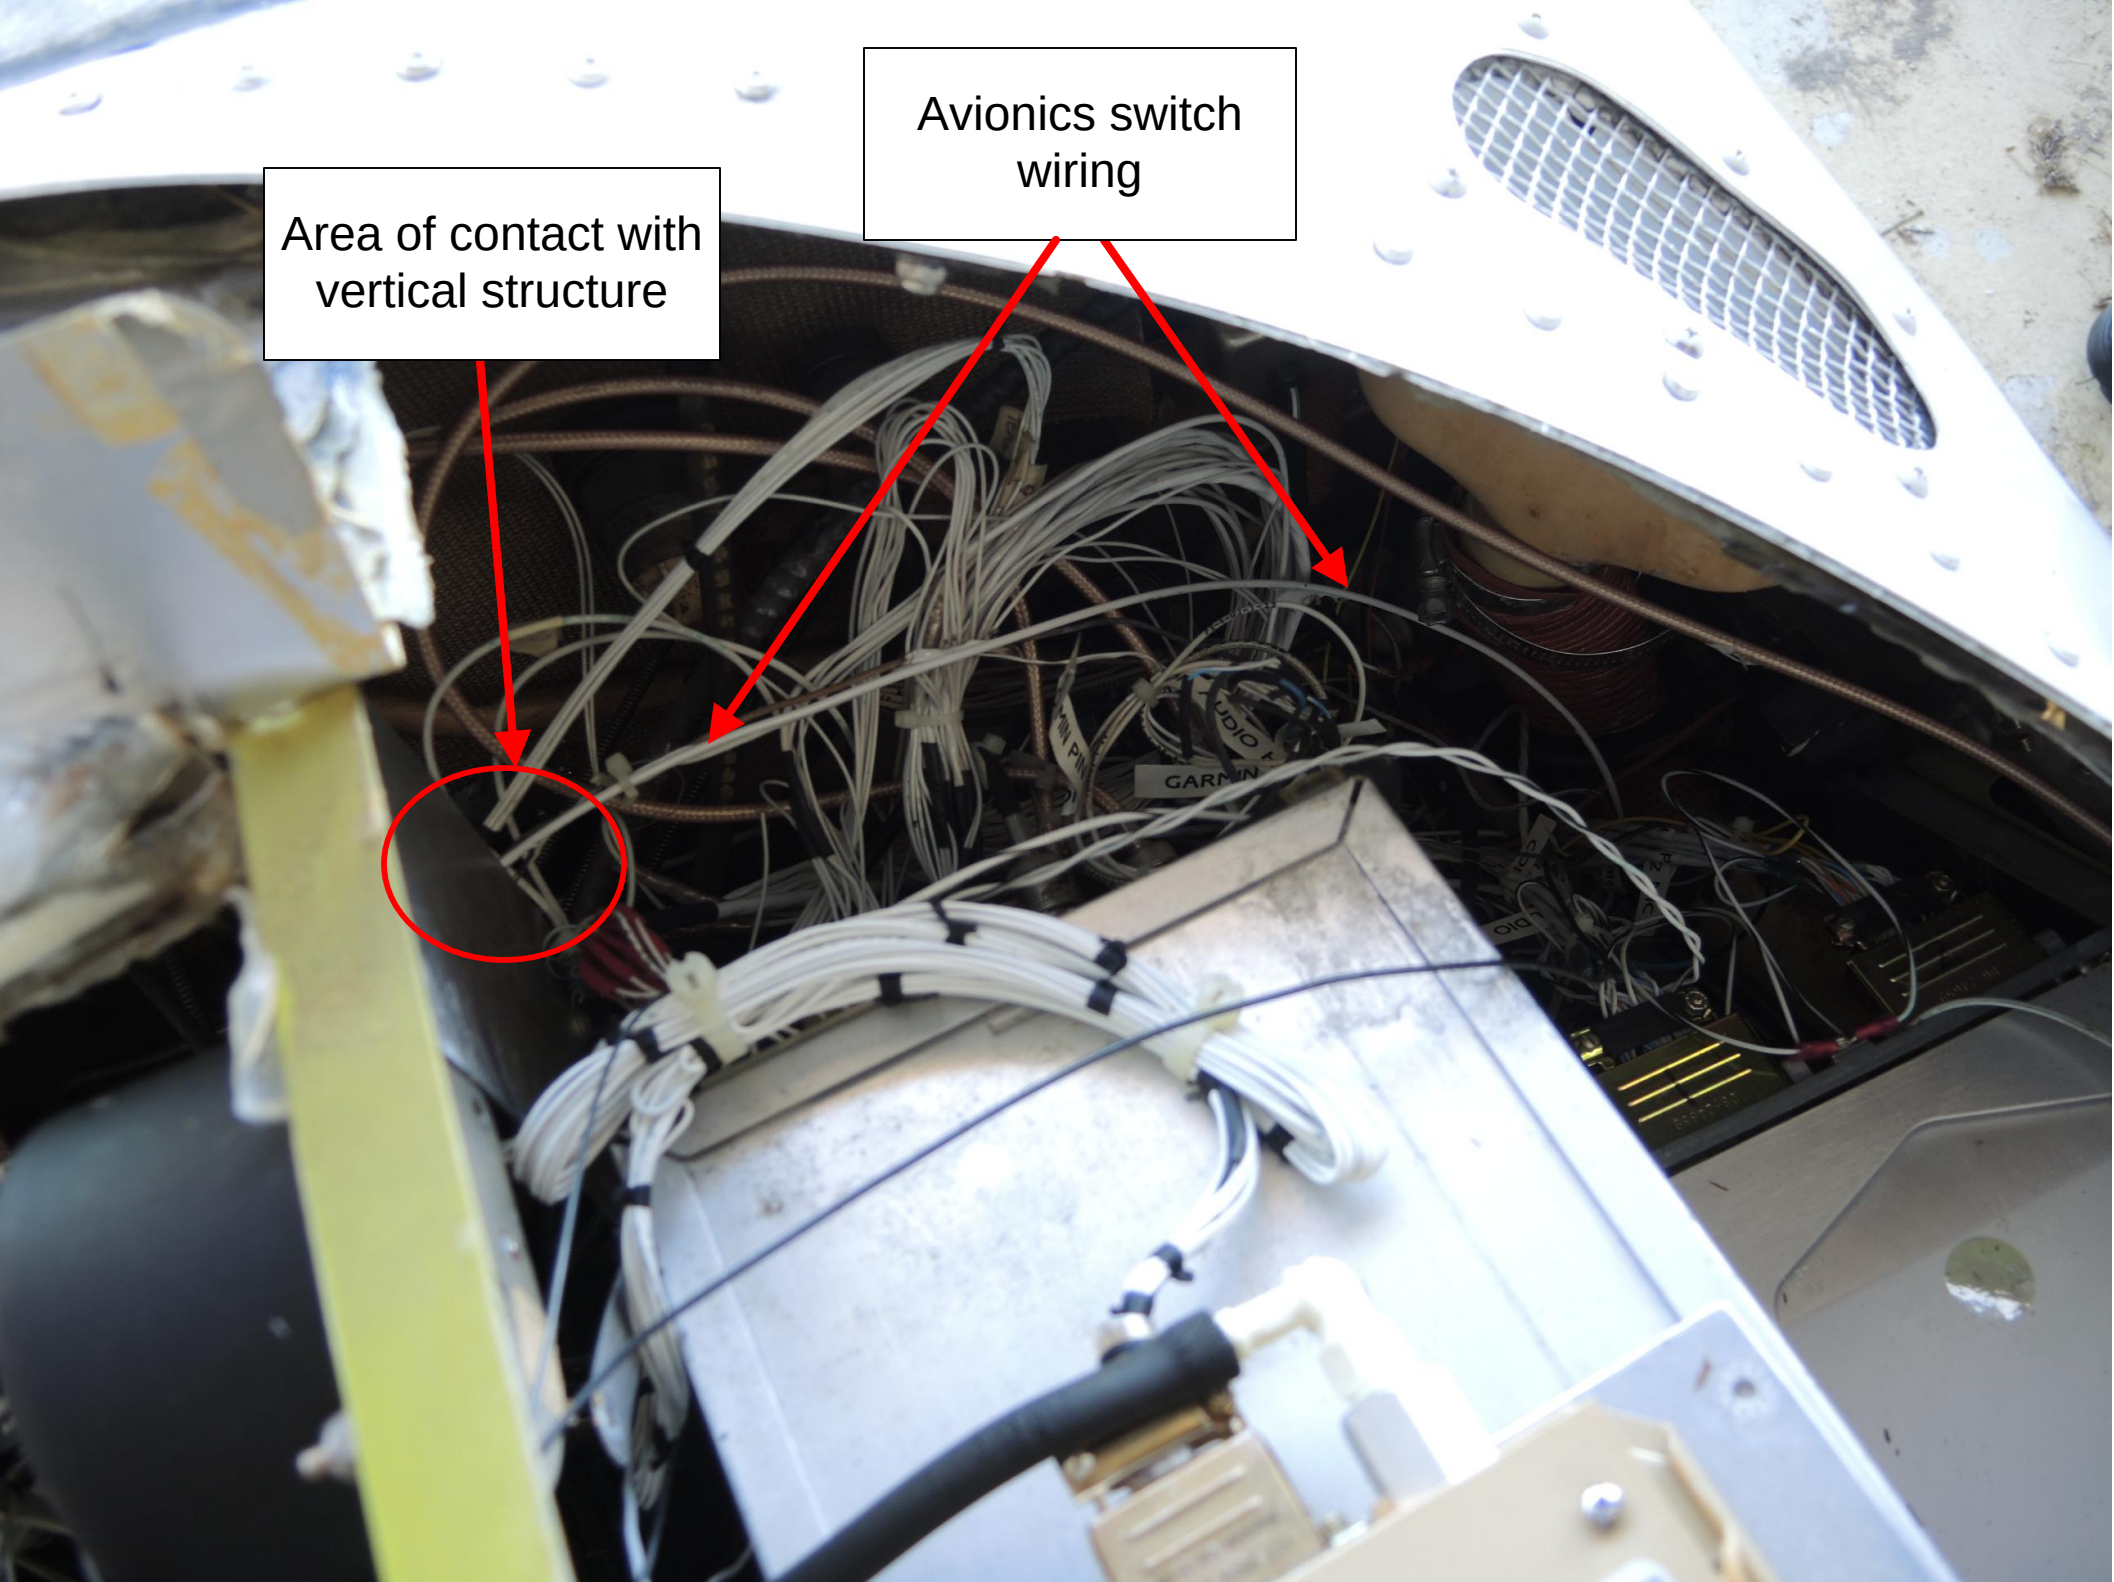
The avionics switch was located at the top center of the instrument panel above the autopilot control unit. Two wires were connected to it. One wire was attached to the electrical bus bar. The connection was co-located with the landing gear circuit breaker. The other wire was attached to the "COM 2" circuit breaker. This connection was then daisy chained to the other avionics circuit breakers forming an avionics bus. After leaving the avionics switch the wires traveled across the back of the autopilot control unit and around a vertical support member (made of a thin sheet of aluminum) before reaching the circuit breaker panel. No mechanical protection or supports were present on the wires. The two wires were tie wrapped together at various places. They were also tie wrapped to a larger wire bundle near the bus bar.

Wire to avionics  
switch

Avionics "bus"  
wiring

COM 2 circuit  
breaker

Landing gear  
circuit breaker

Bus bar

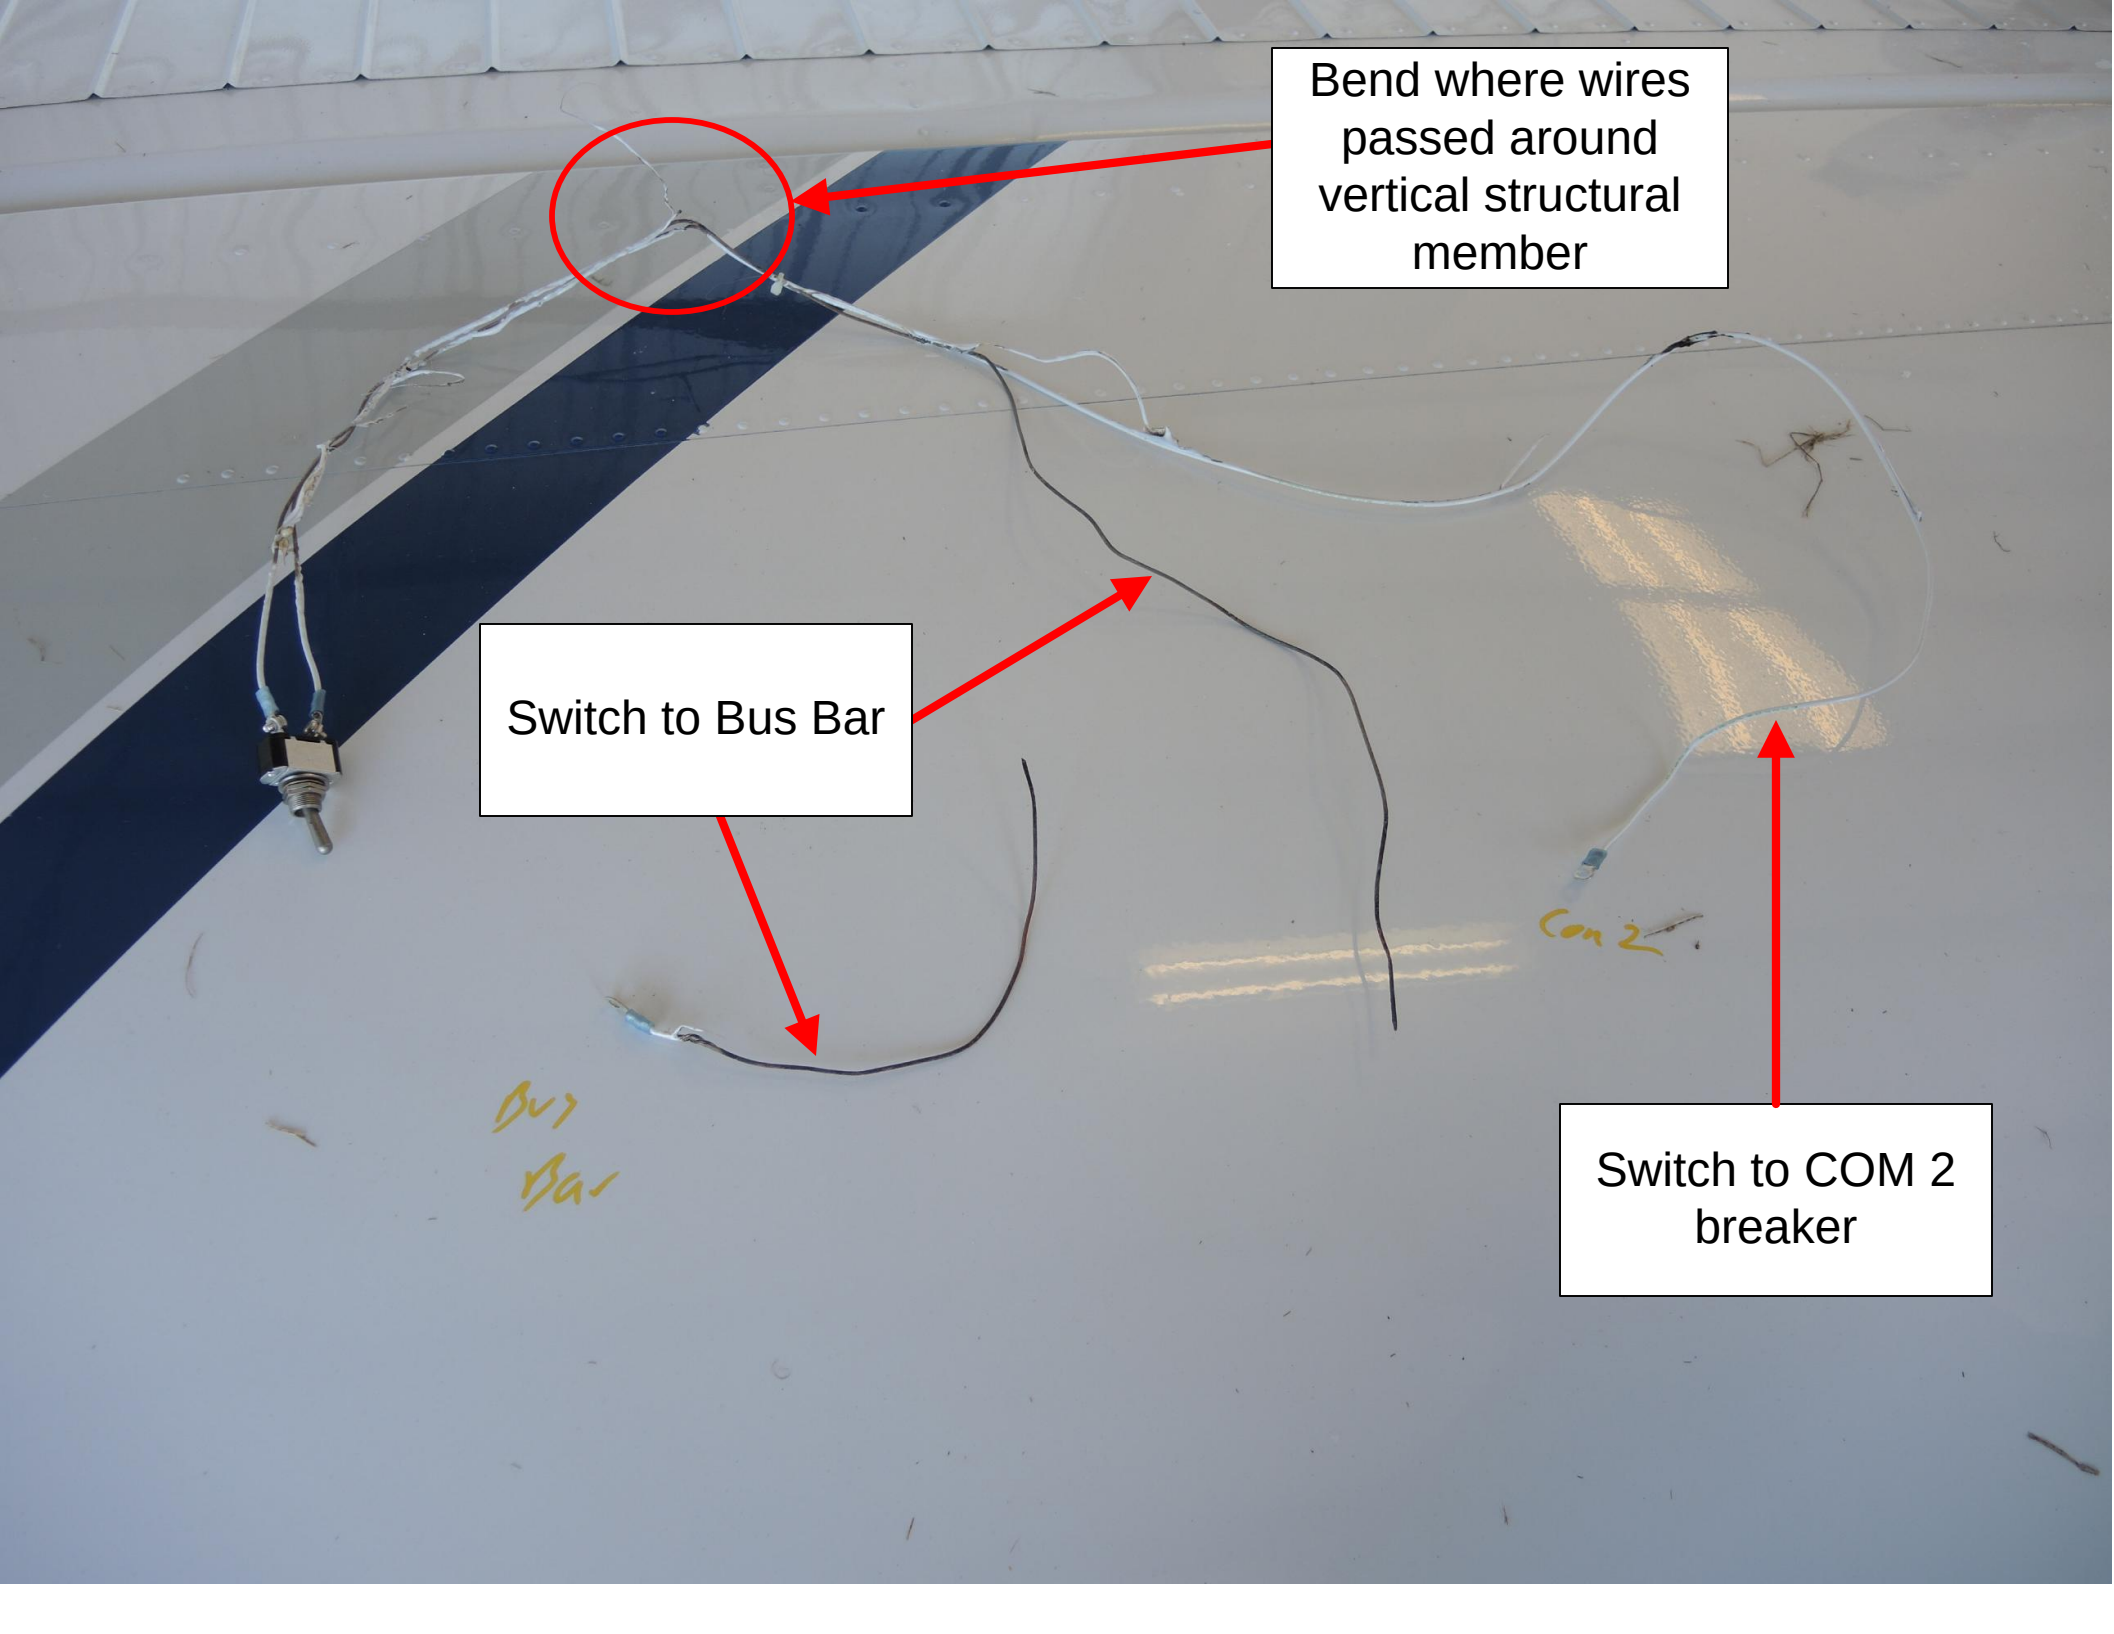
Switch to Bus Bar

Switch to COM 2  
breaker

Bus  
Bar

Com 2
