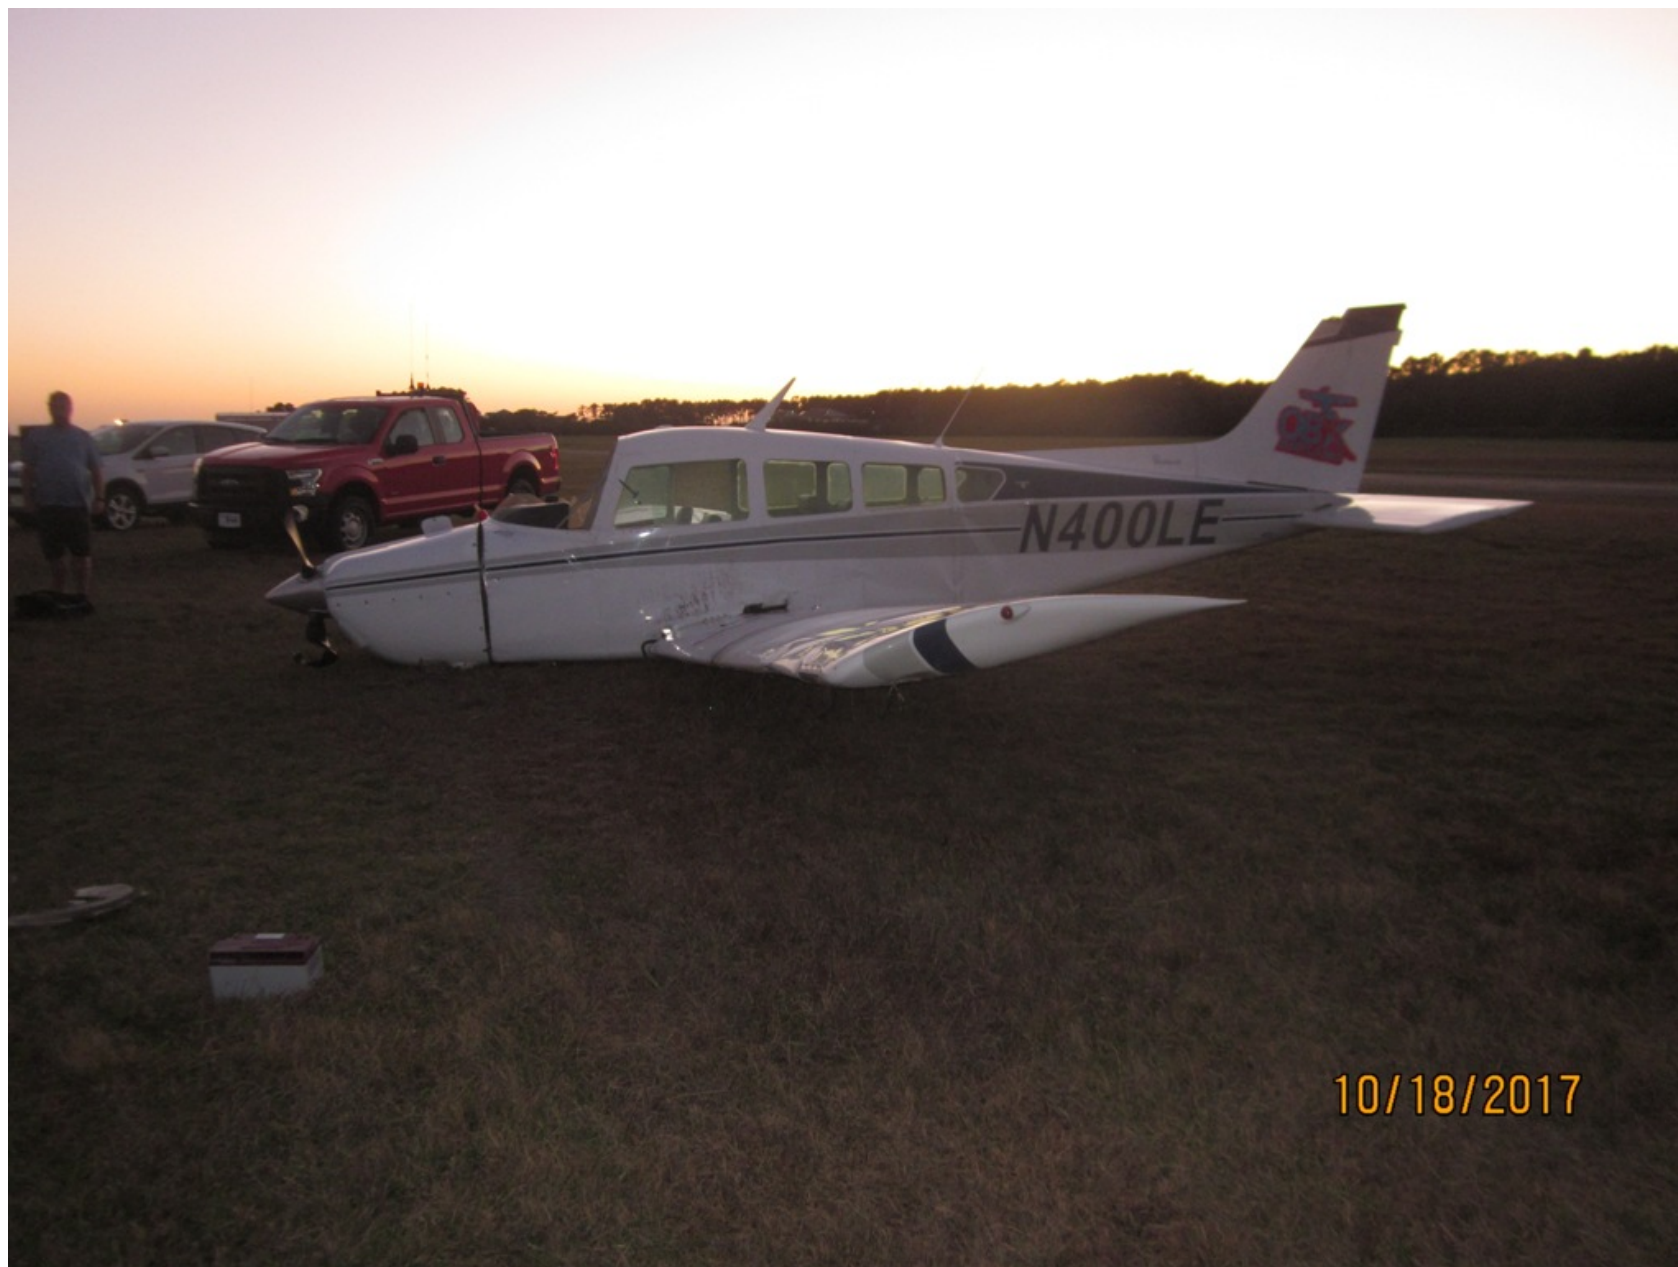
**Photo 1 – FAA Digital Photograph. Left Side View of the Airplane at the Accident Site.**

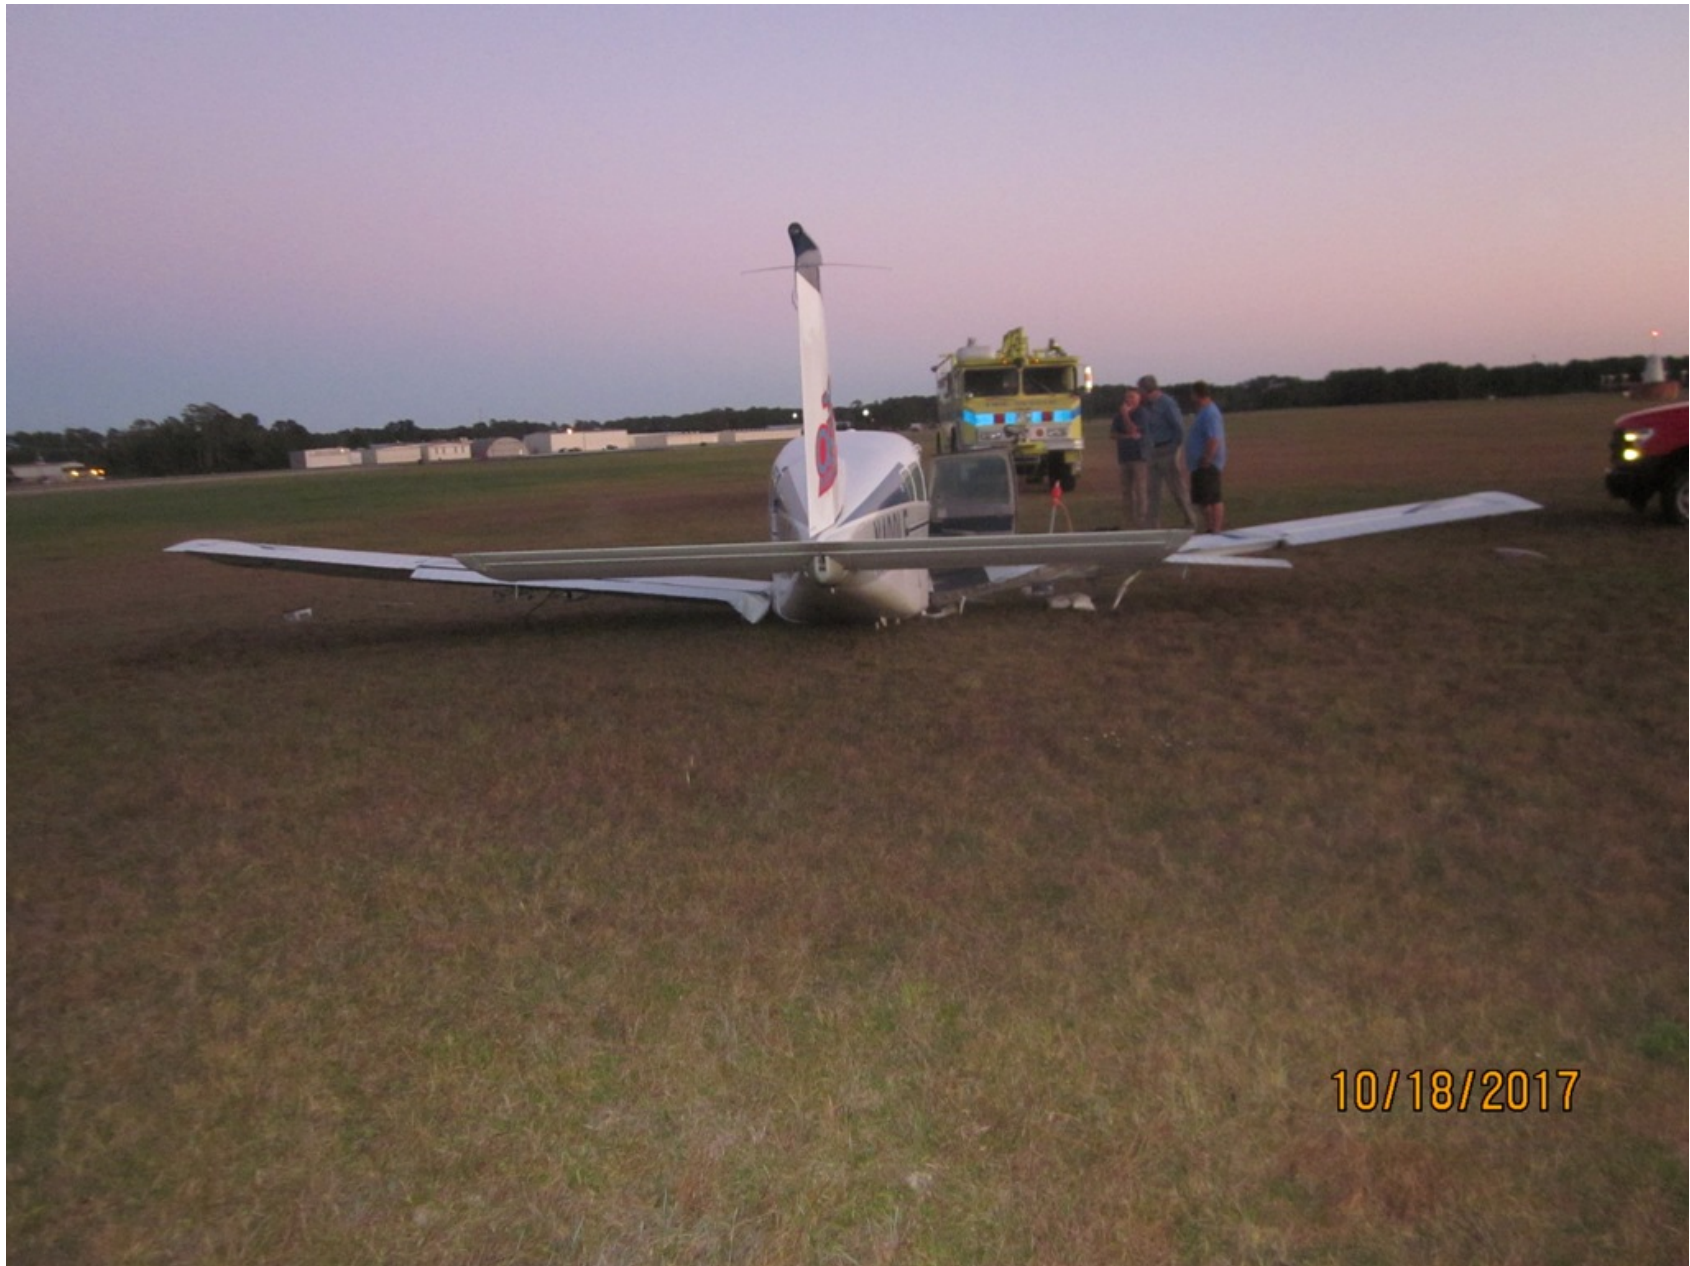
**Photo 2 - FAA Digital Photograph. Rear View of the Airplane at the Accident Site.**

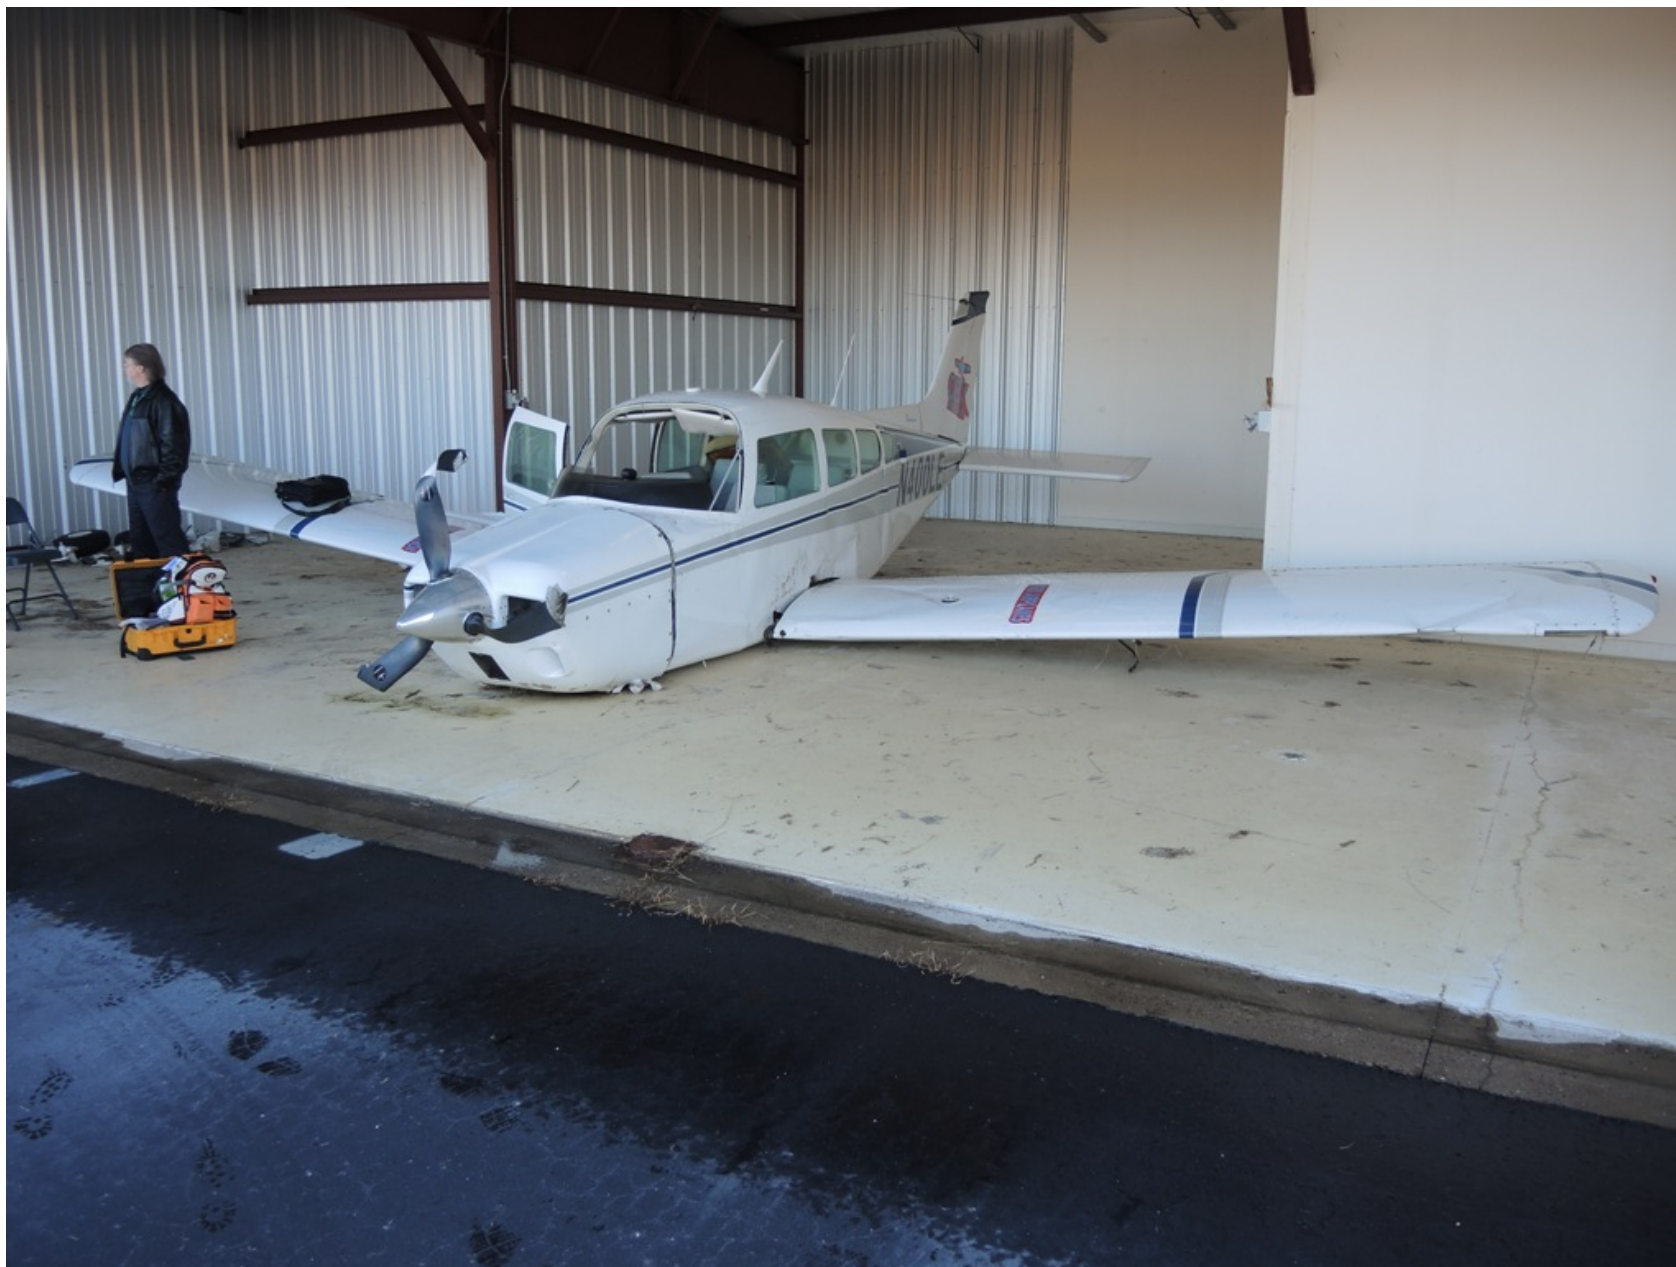
**Photo 3 – Textron Aviation Photograph. Left Forward Quartering View of the Airplane Following Recovery.**

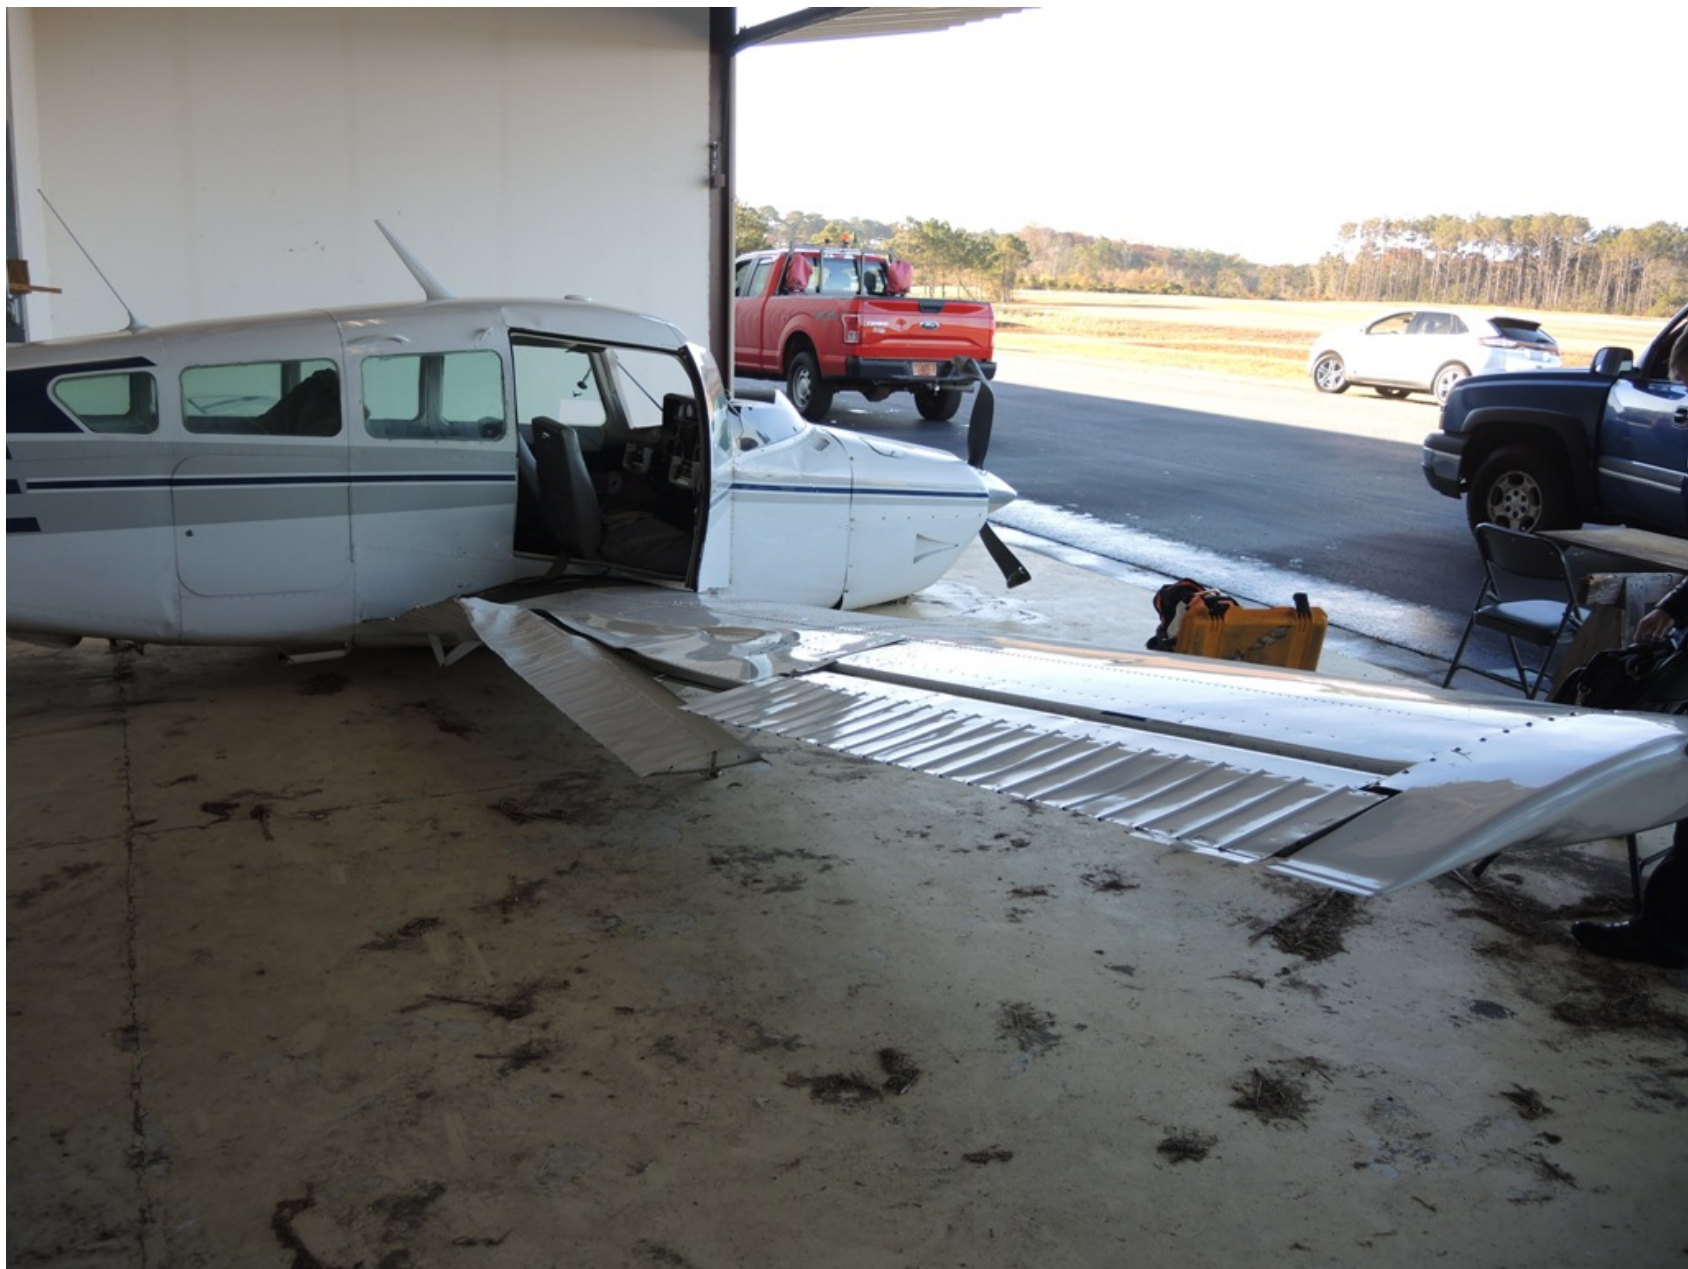
**Photo 4 - Textron Aviation Photograph. Right Rear Quartering View of the Airplane Following Recovery.**

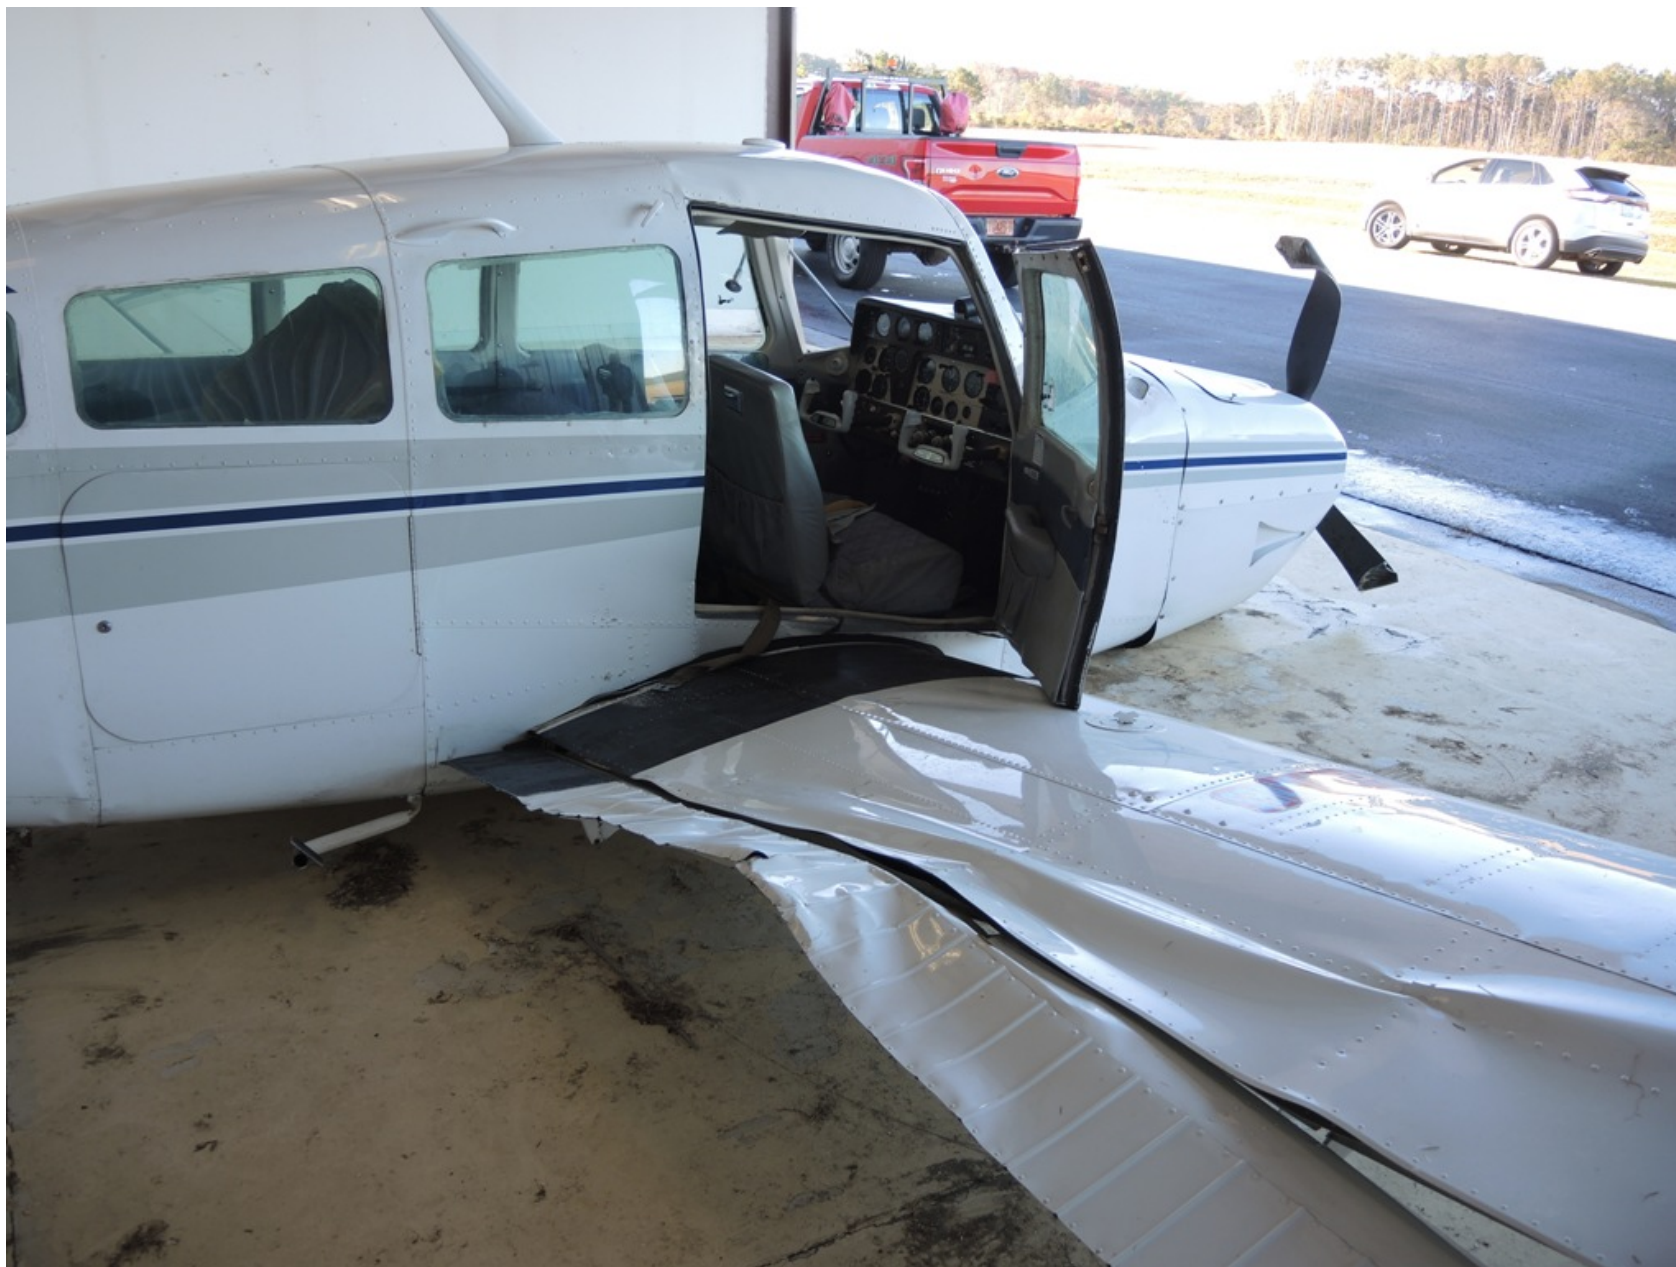
**Photo 5 - Textron Aviation Photograph. Close-Up Right Rear Quartering View of the Inboard Section of Right Wing and Section of Fuselage. Note the damage to the wing.**

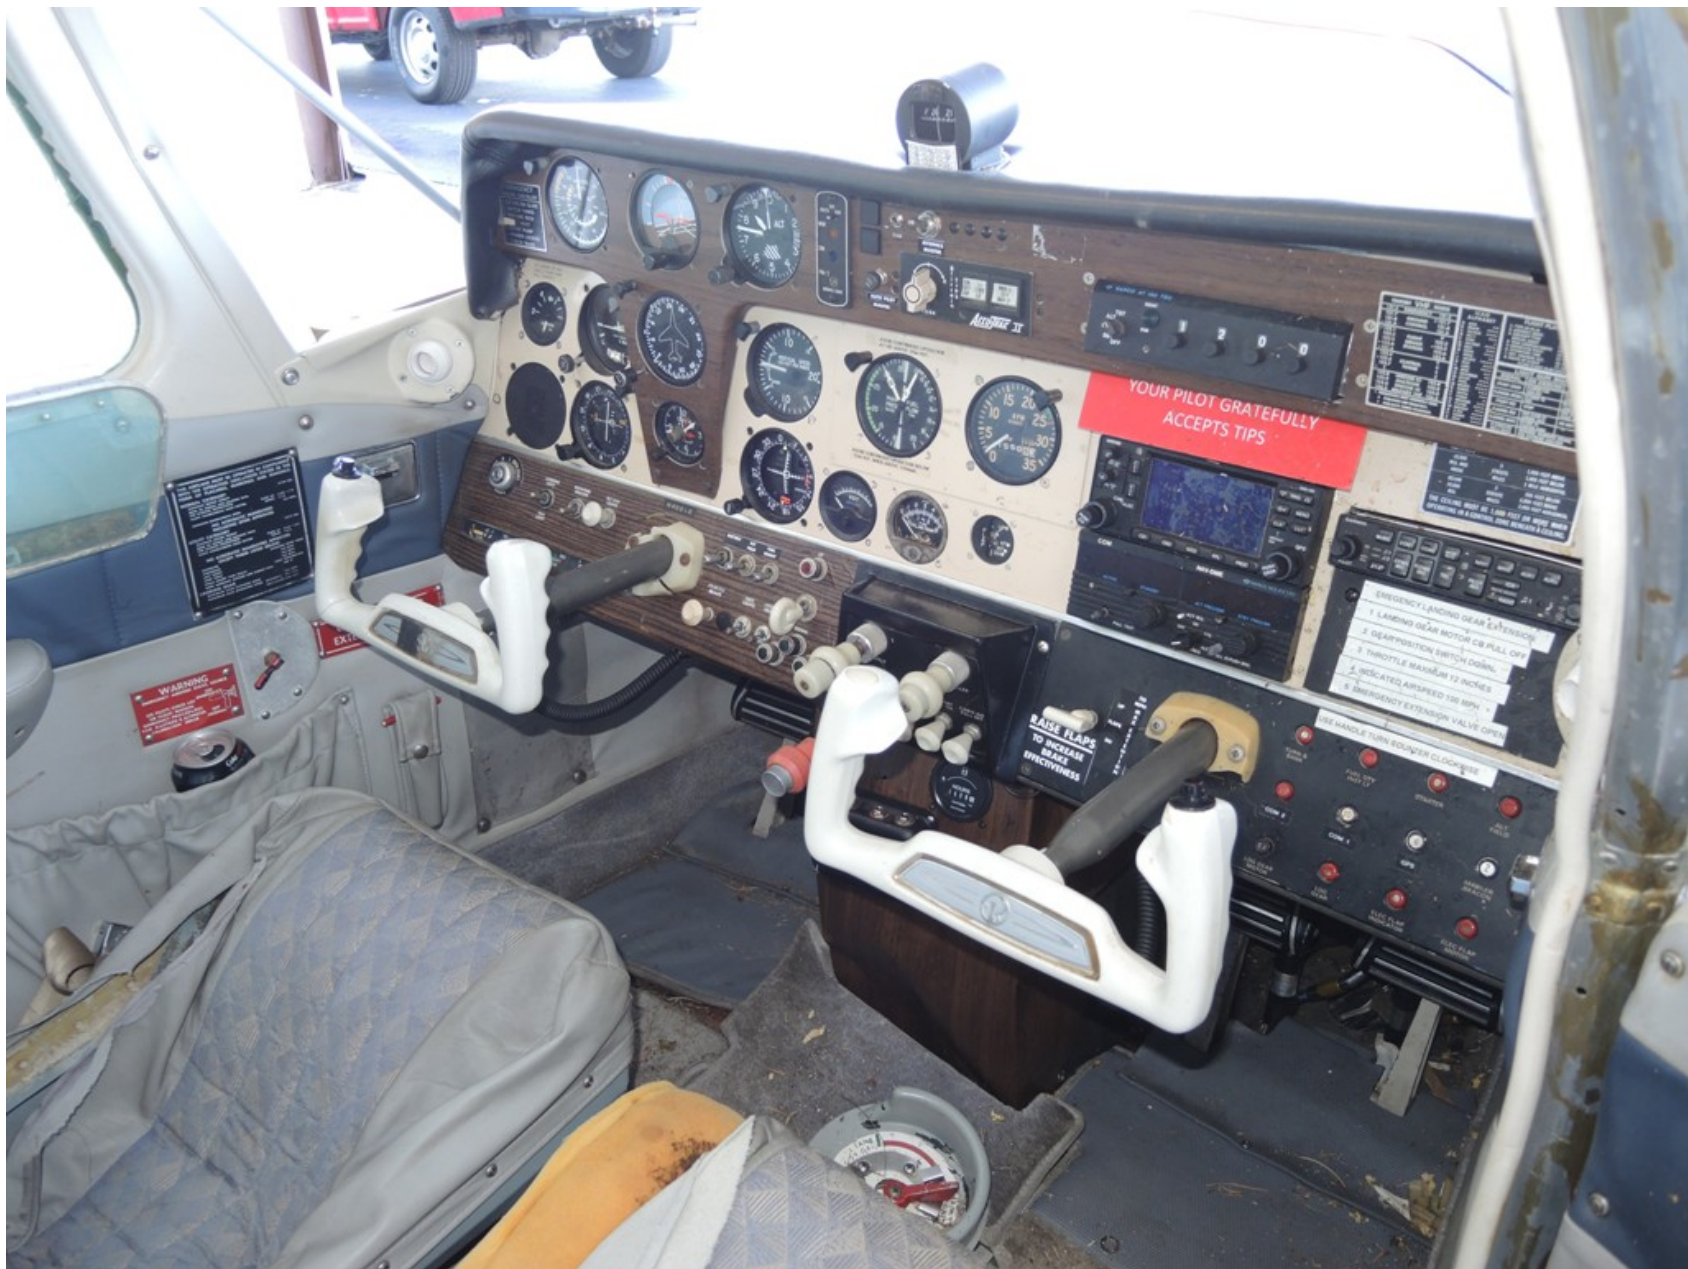
**Photo 6 - Textron Aviation Photograph. View of the Instrument Panel.**

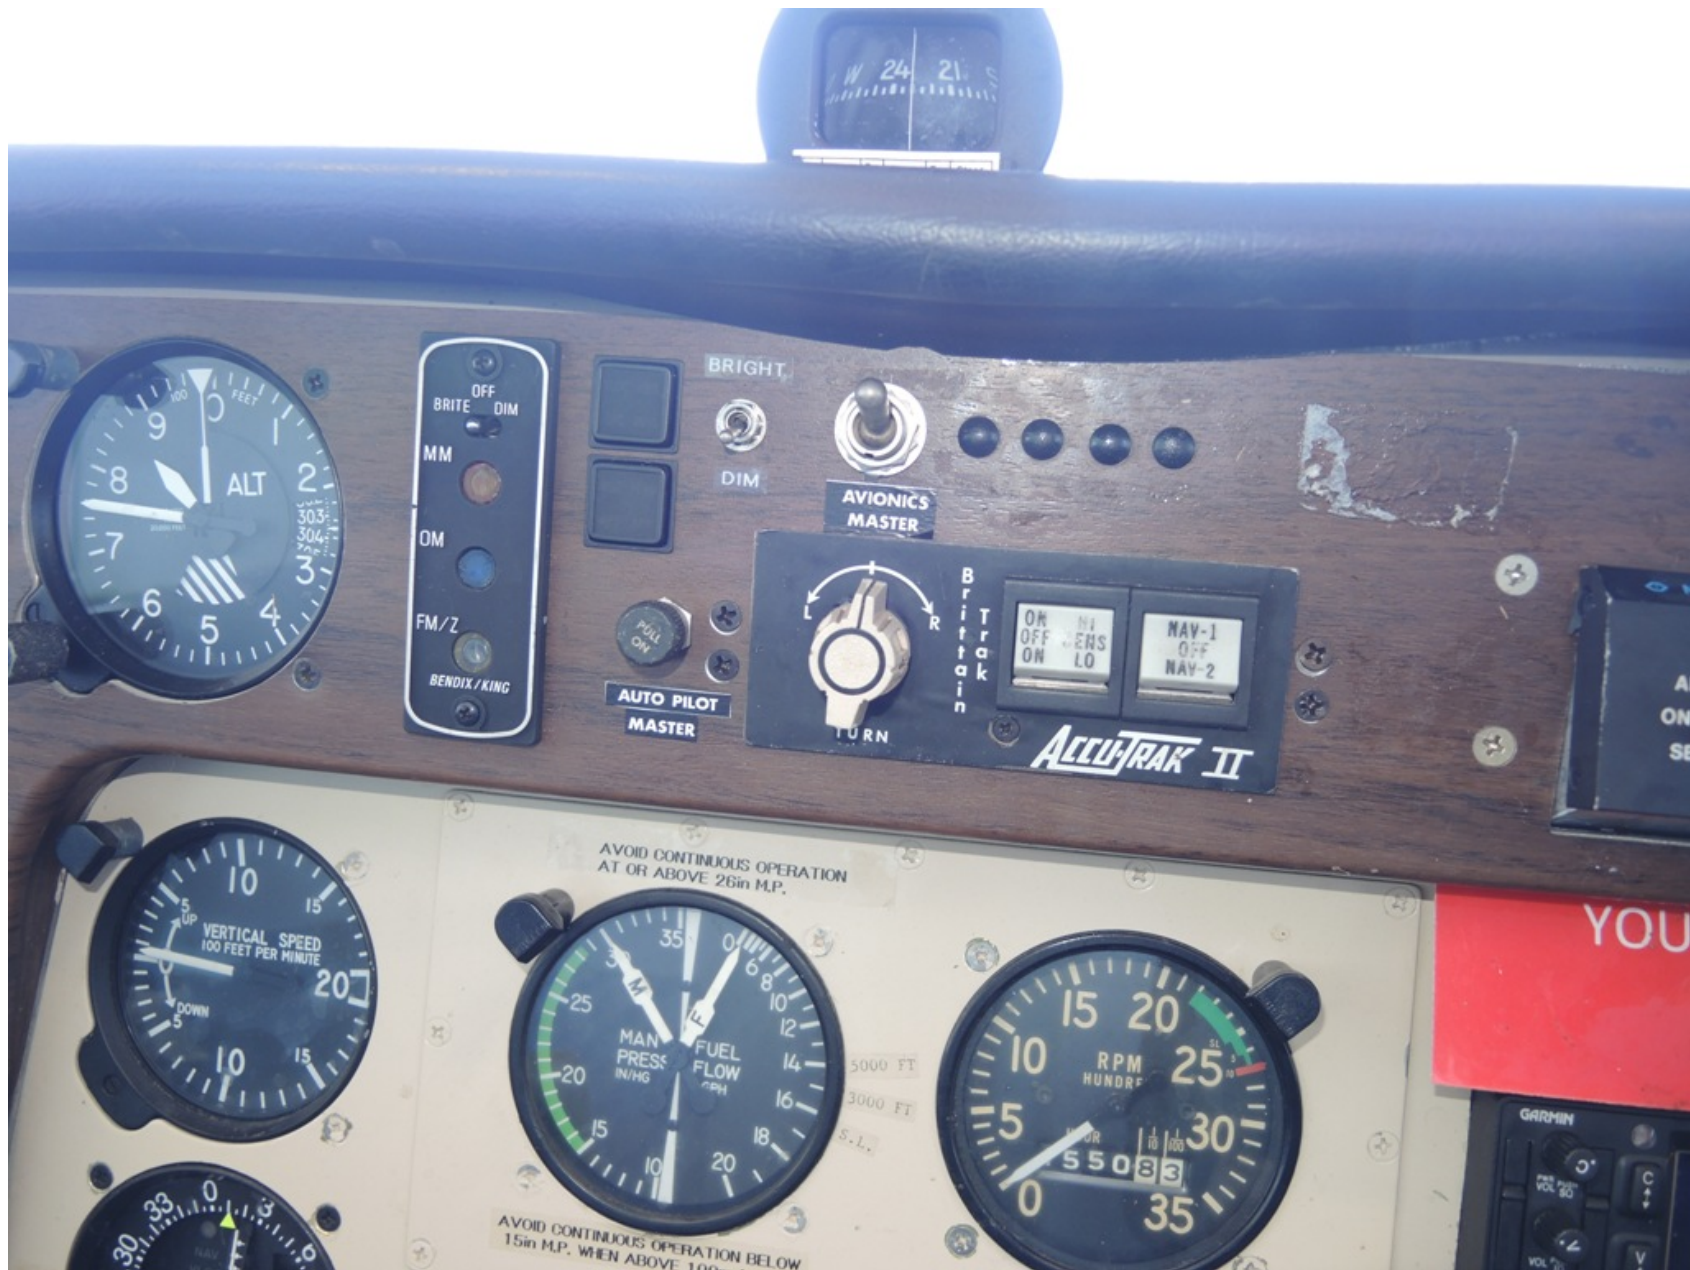
Photo 7 - Textron Aviation Photograph. View of the Instrument Panel Depicting the Avionics Master Switch.

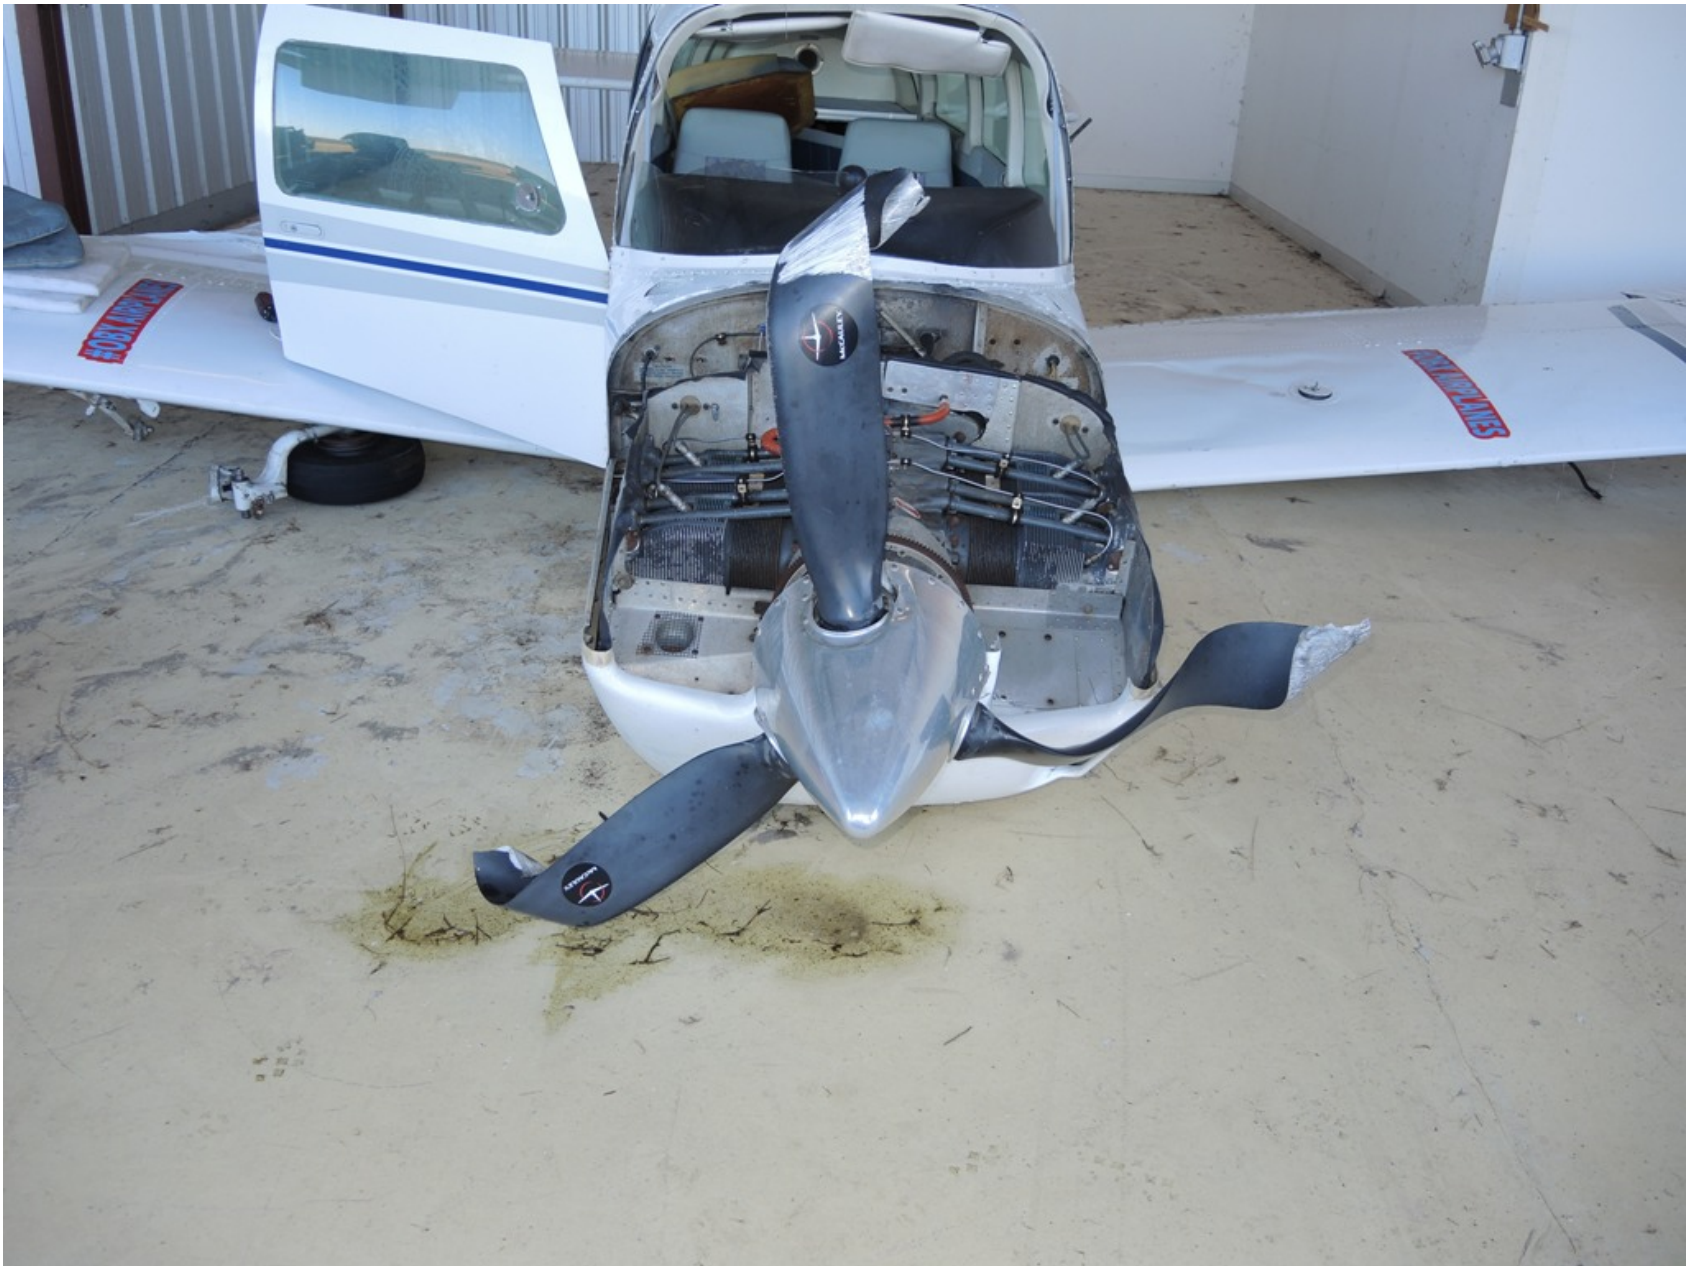
**Photo 8 - Textron Aviation Photograph. Front View of the Airplane Following Recovery. Note the Propeller Blade Damage.**

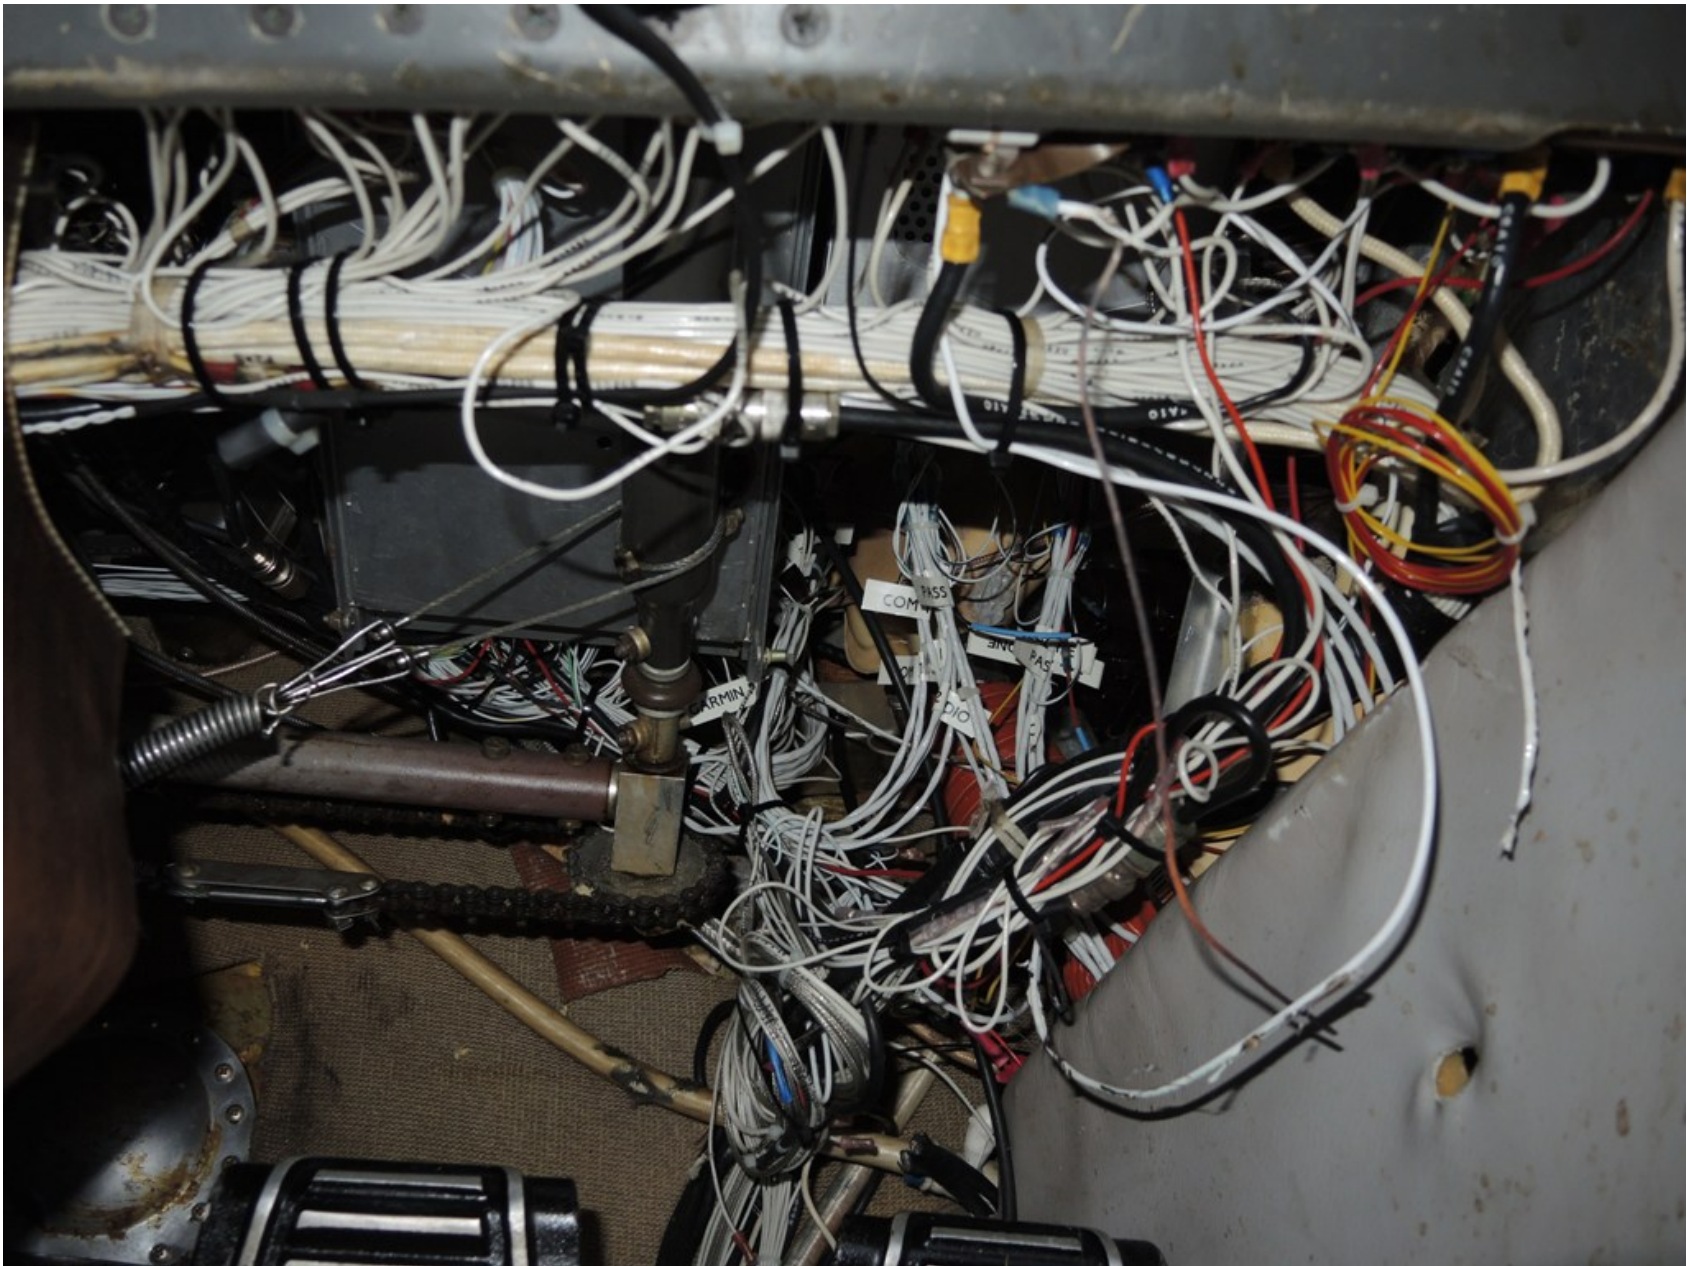
**Photo 9 - Textron Aviation Photograph. View of the Co-Pilot Side Lower Instrument Panel.**

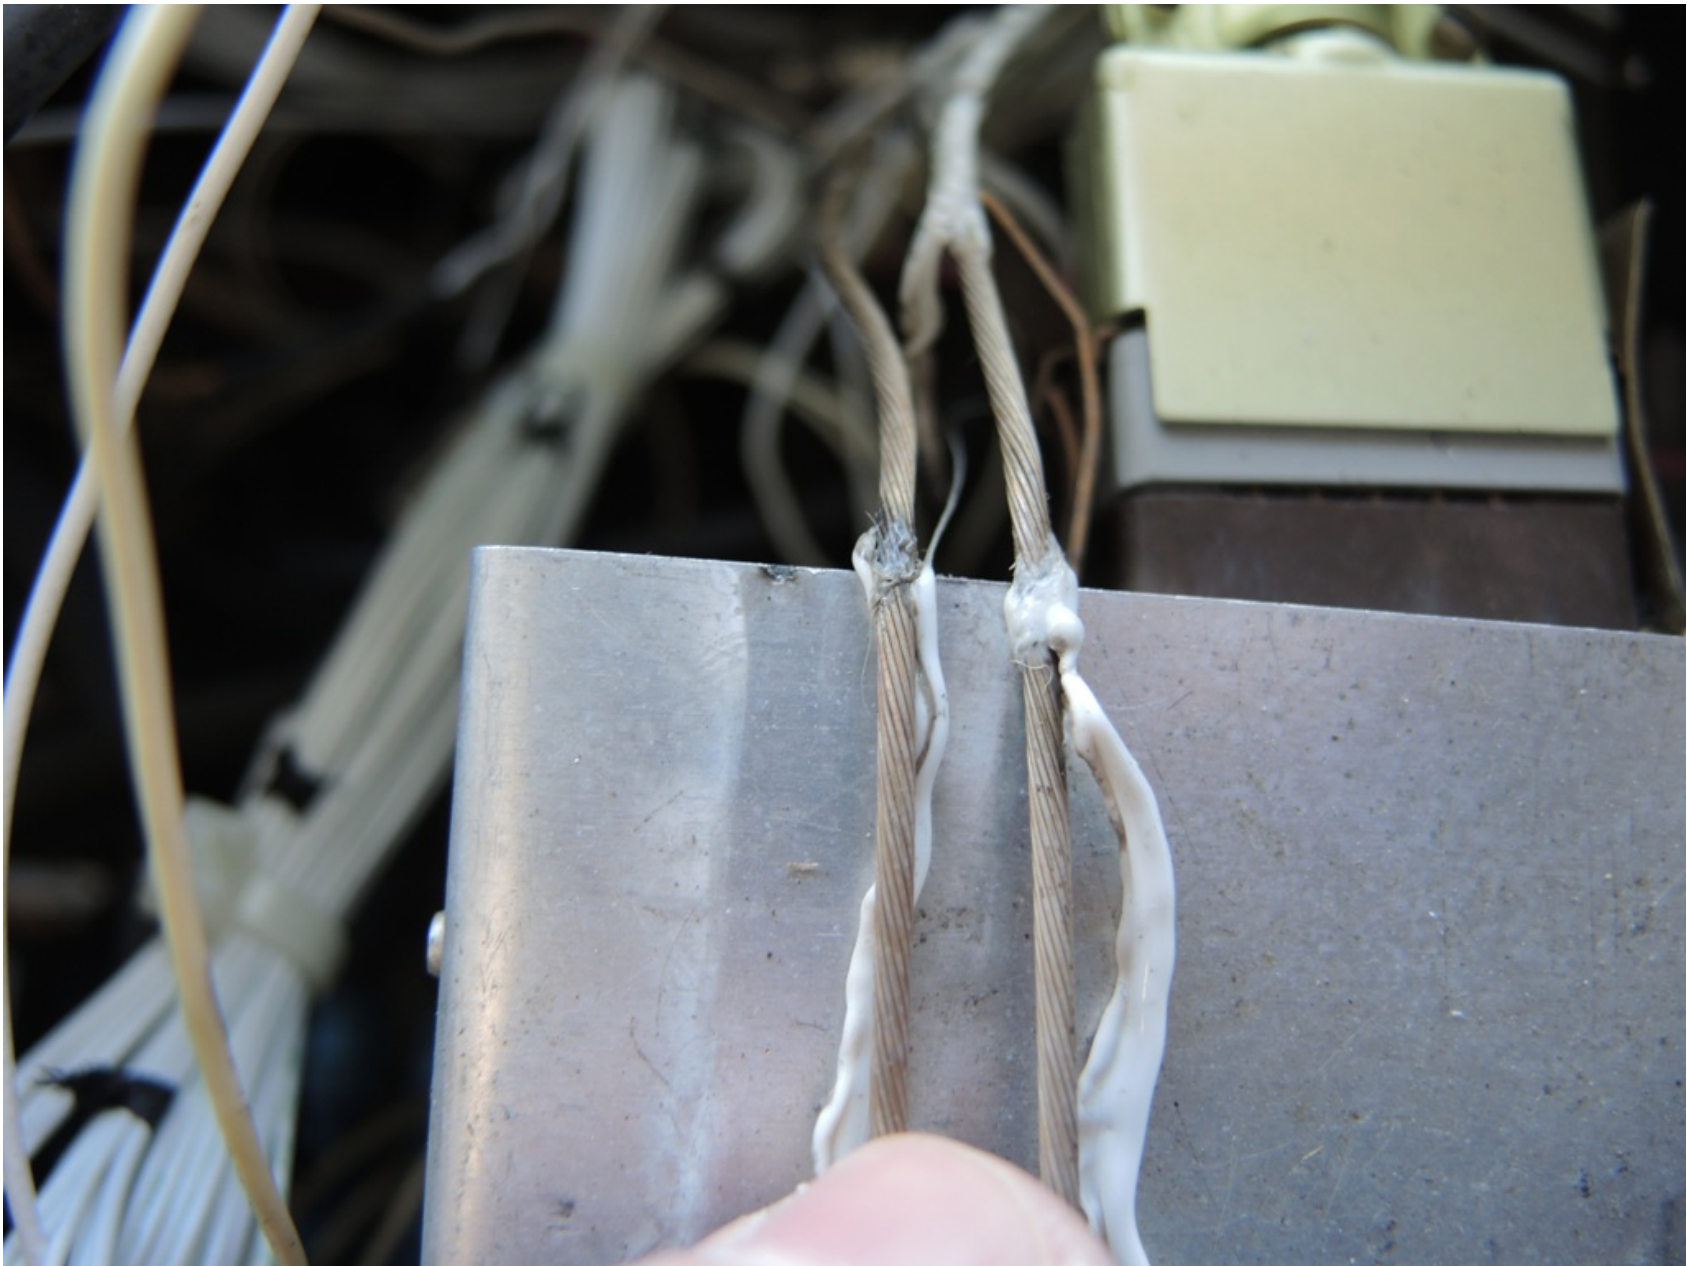
**Photo 10 - Textron Aviation Photograph. View of the Arcing damage to the Electrical Wire of the Avionics Master Switch and the Aft Portion of the Adjacent Autopilot Control Unit.**
