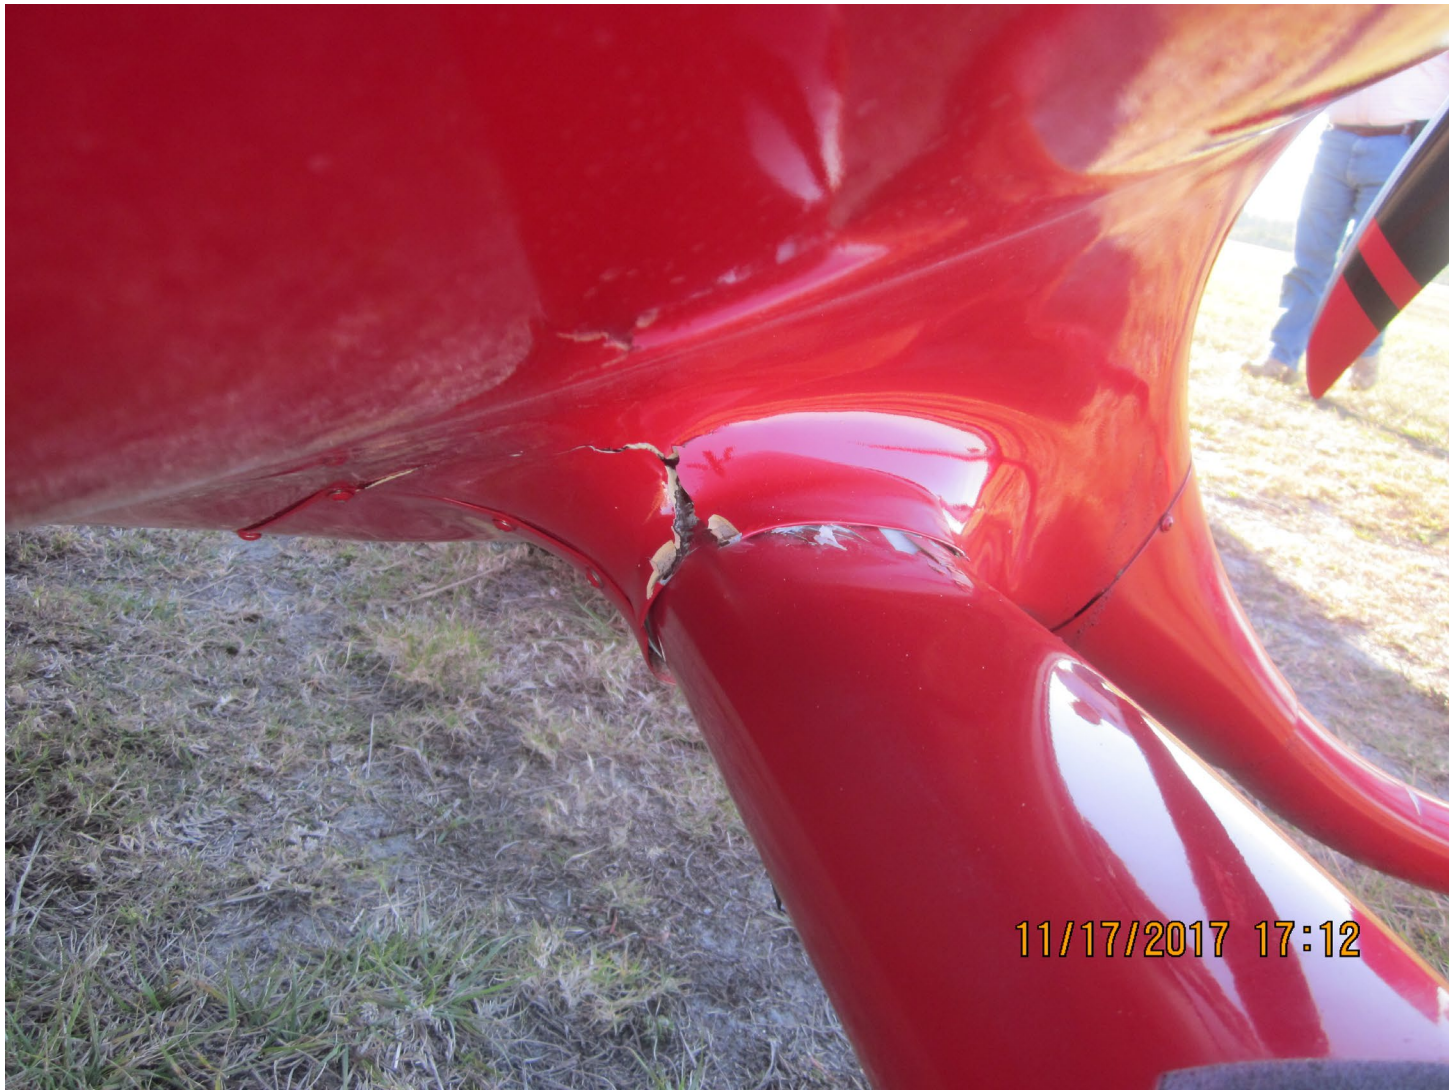
**Photo 2 – View of Damage to Landing Gear Strut (Courtesy of FAA)**

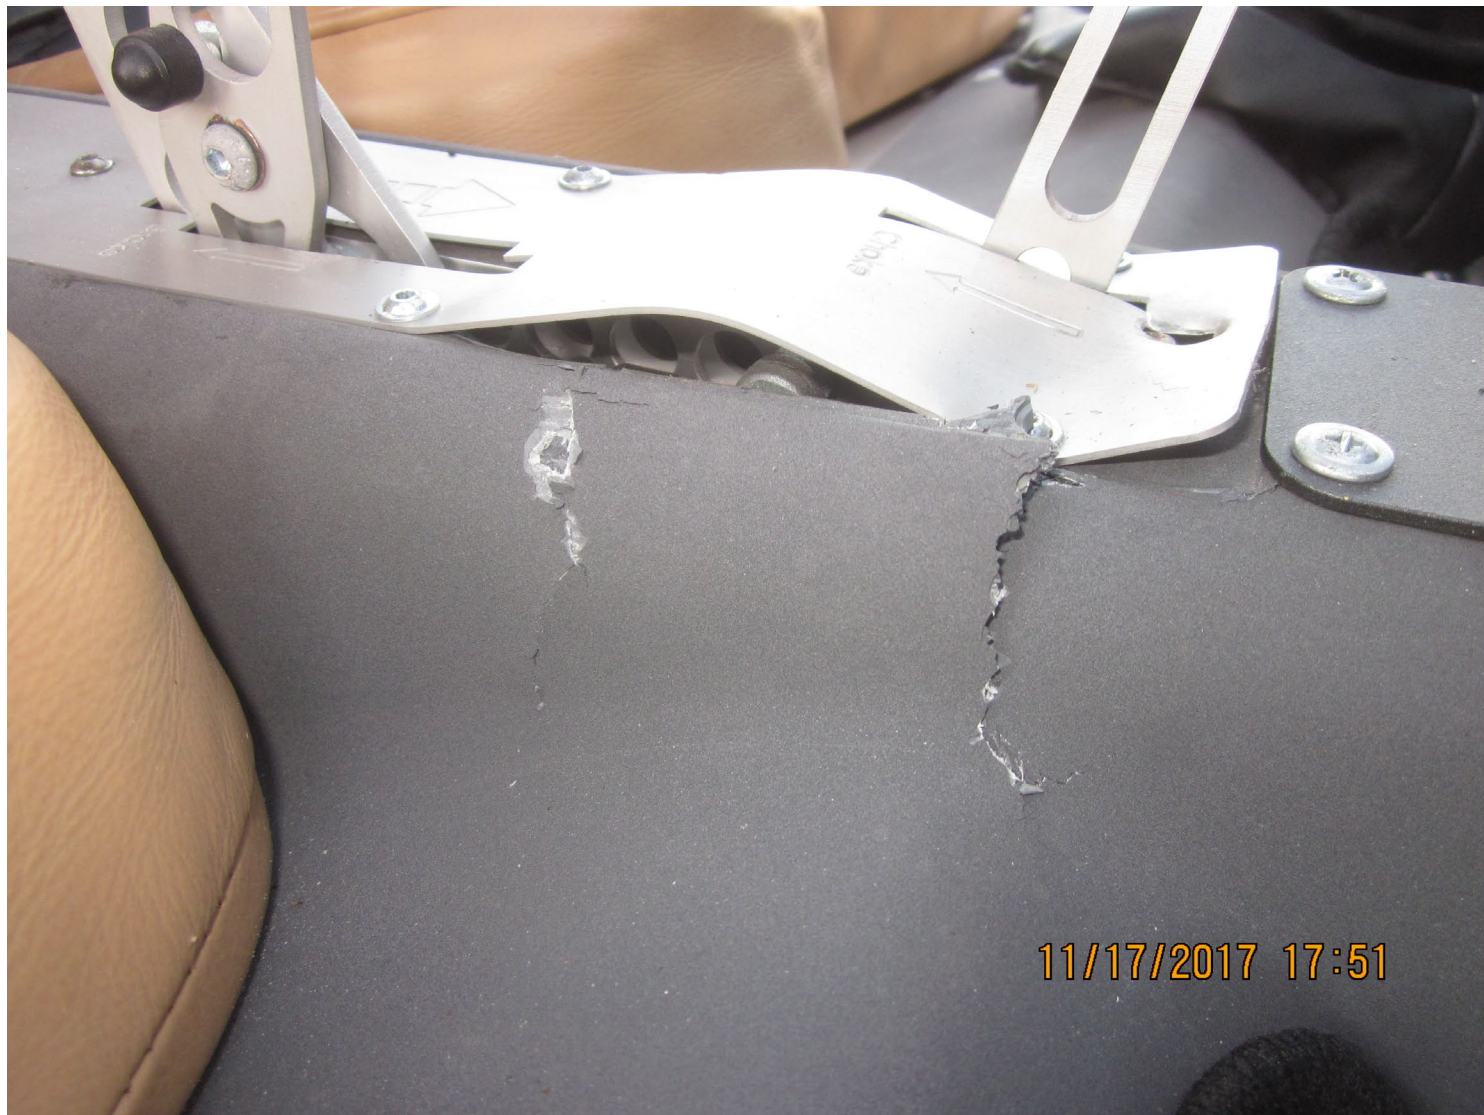
**Photo 3 – View of Compression Damage to Engine Control Quadrant (Courtesy of FAA)**

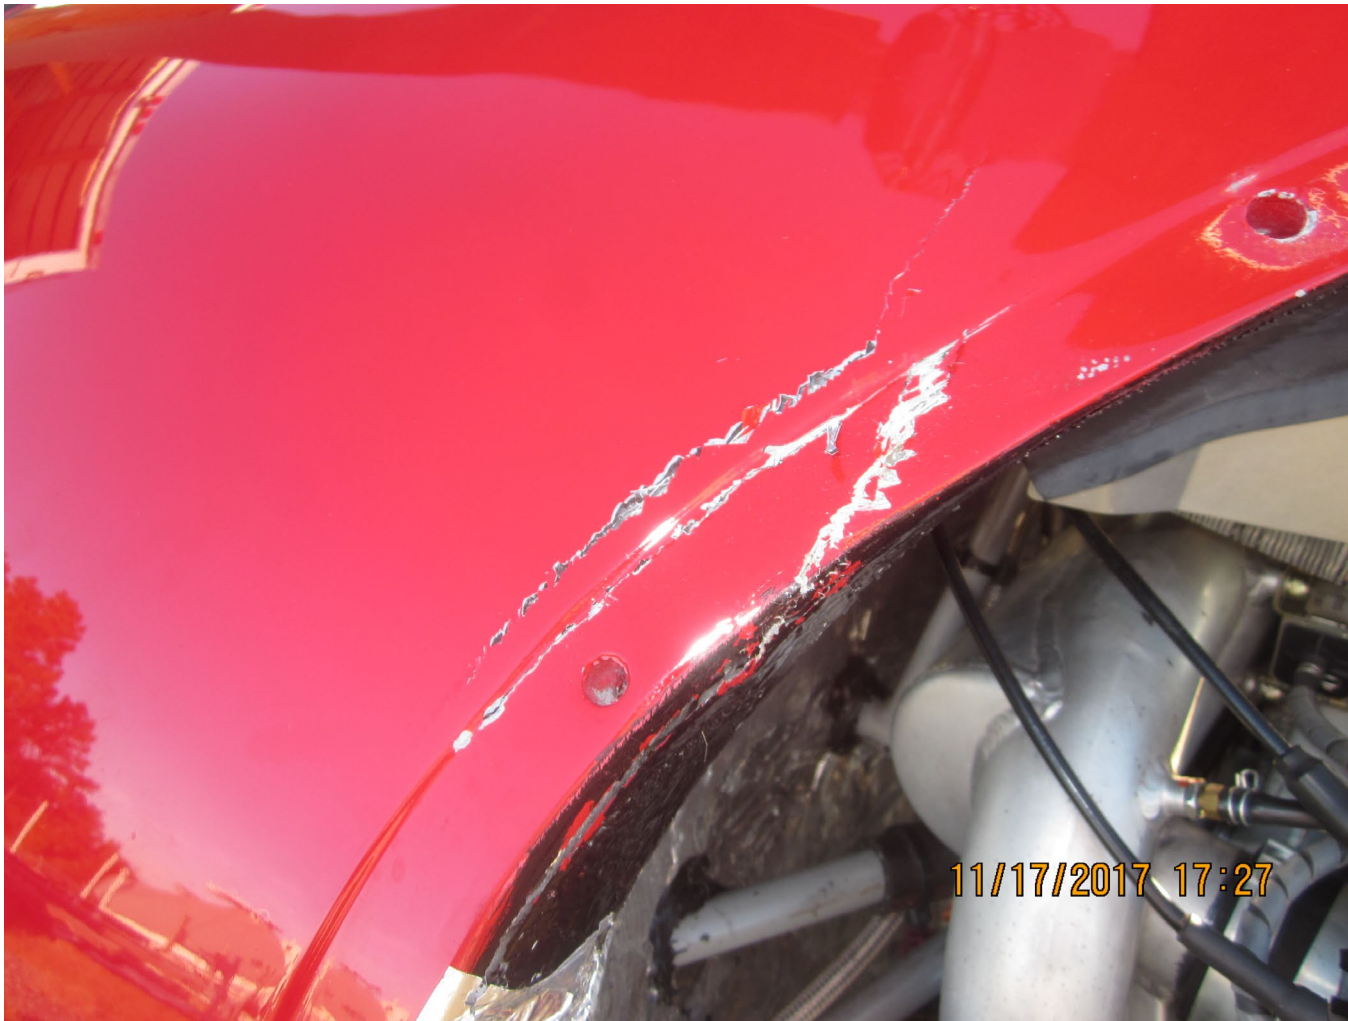
**Photo 4 – View of Damage to Airframe Aft of Engine Compartment (Courtesy of FAA)**
