**ERA18LA031**

**Piper PA-46-500TP – N863RB**

**NTSB ENGINE ACCESSORIES**

**EXAMINATION REPORT**

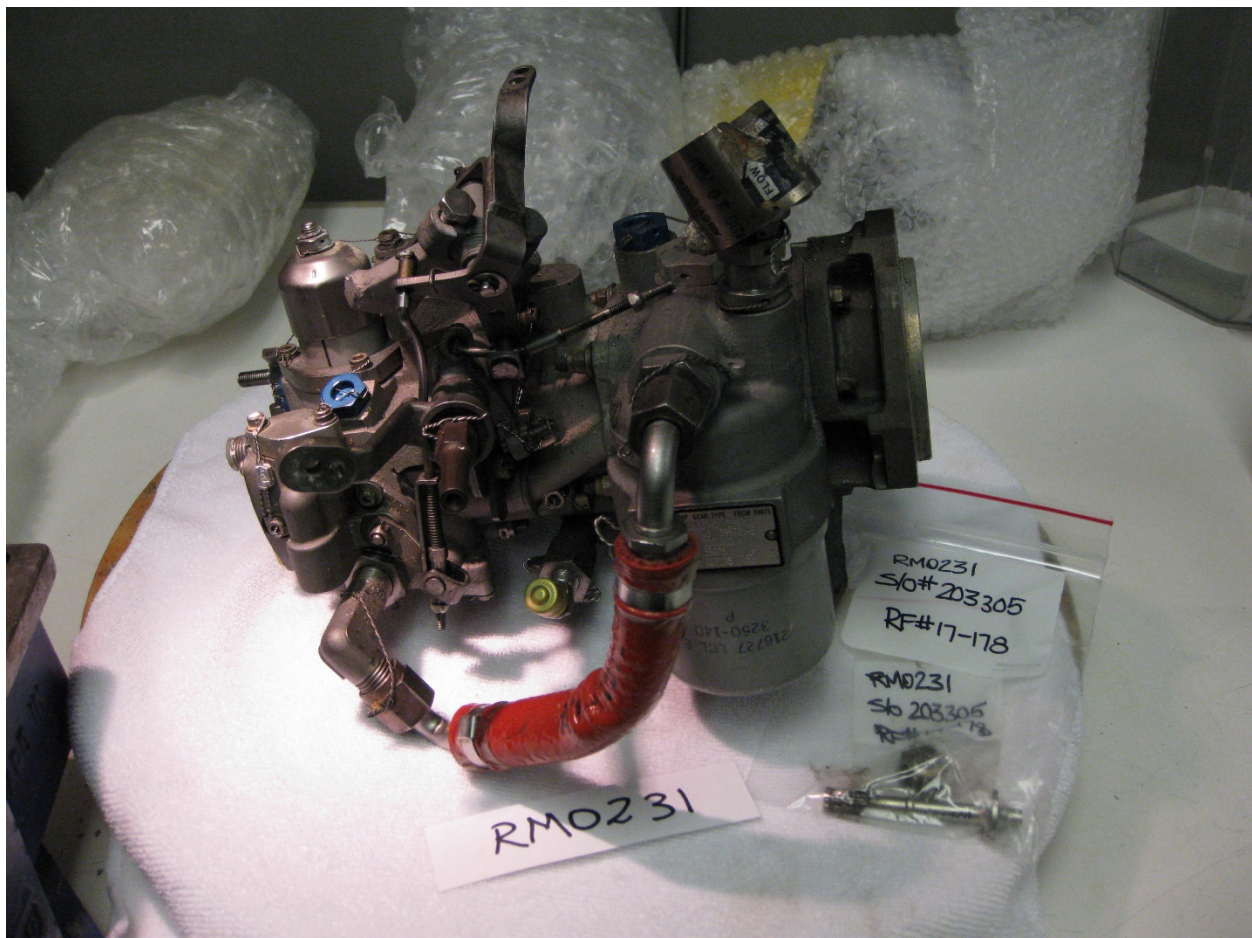
Picture 1. View of Fuel Pump and Fuel Control Unit

The fuel control unit and the fuel pump remained intact and attached. They were separated, and the plastic coupling was engaged and moved freely by hand.

The Px orifice was free of blockages. The Py orifice was not blocked. The Py bleed was not blocked. The throttle shaft was impact bent and straightened to facilitate testing. It broke during

the attempted straightening. When tested for air leaks, air was leaking between the air adapter and the drive body, which was within manufacturer tolerance.

The fuel control unit was mounted on a test stand. It was run for 10 minutes, manufacturer maximum fuel flow was not obtained, however, from the time the fuel control unit began to run the fuel flow dropped 8 pounds per hour over the 10 minutes. Throughout the test, the fuel temperature remained at 85° F.

The fuel control unit was removed from the test stand and disassembled for further examination. The flow body was removed and disassembled. The governor lever and enrichment lever were examined with no anomalies noted. The flyweight assembly was examined and the teflon tube remained intact, the bearings could be moved by hand, and grease was noted on the assembly. The metering valve moved freely when operated. The shutoff valve was oriented correctly and moved freely when operated by hand. The bypass valve diaphragm was removed, and no cracks were noted. The fuel control inlet screen was examined and no debris was noted in the screen and no screen wires were damaged. The acceleration bellows were measured and the manufactured length matched the measured length. The governor bellow was tested and no leaks were observed. The torque tube was pressure tested and no air was noted escaping from the torque tube. The bypass valve was examined under a microscope for metal burs and none were noted. The metering valve sleeve was examined under a microscope for extruded adhesive at the joint and none were noted. No evidence of galvanic corrosion was noted on the air inlet.

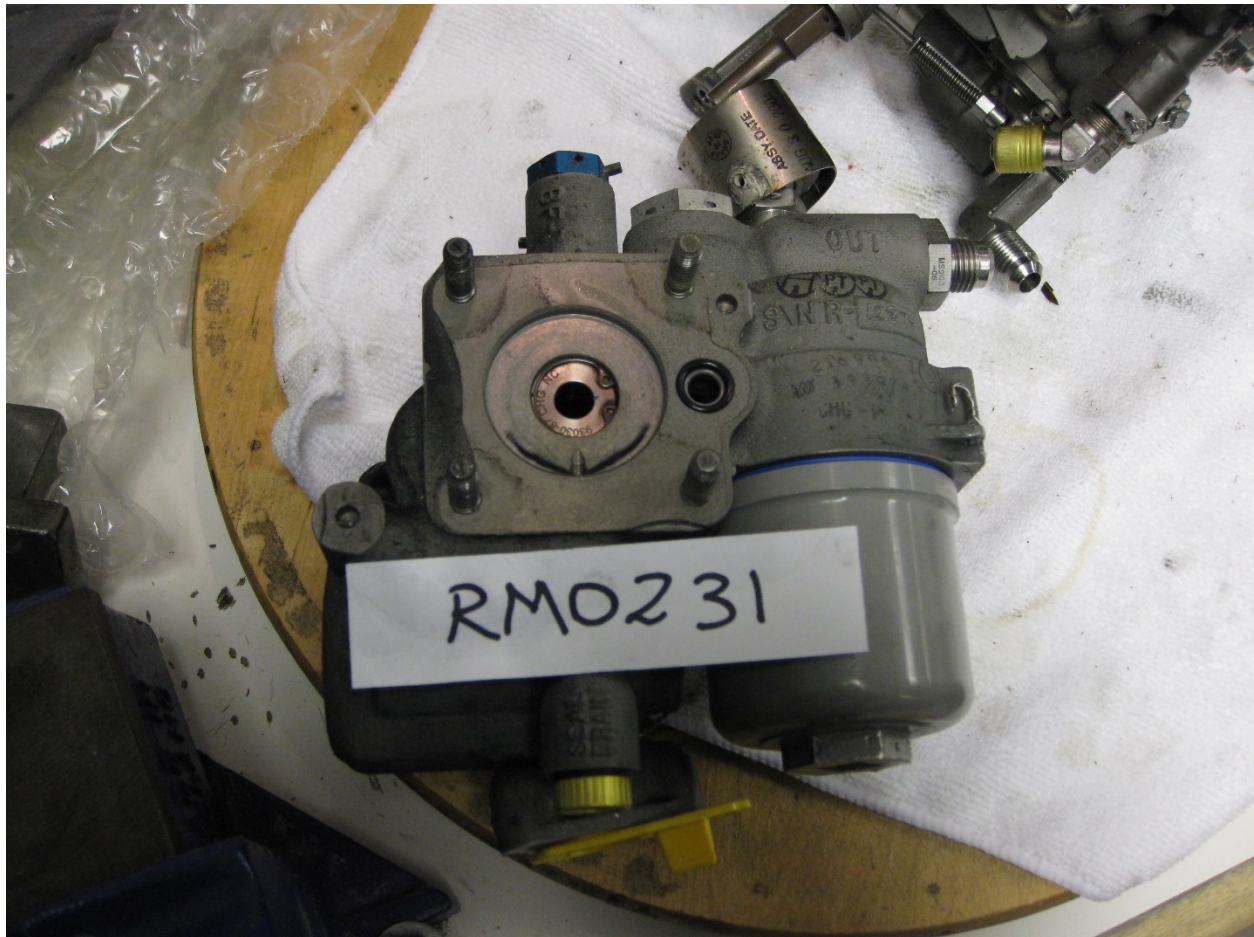
Picture 2. Engine Driven Fuel Pump

The fuel pump inlet screen was removed and no debris was noted. The outlet filter was removed and examined. There was a single piece of metallic debris in the filter. Fuel was removed from the fuel pump and no debris or water was noted.

The fuel pump was flow tested with a slave drive shaft. The results indicated that there was a slight leakage during tests at maximum power. However, at low rpm, there was no leakage.

It was disassembled and bluing was noted on one of the brass bushings on the bearing against the drive cover. The gears were examined and normal wear was noted.

The fuel pump drive shaft was examined and a torsional fracture was noted. It was sent to the lab for material hardness testing and to determine the material properties of the drive shaft and to confirm the fracture mode.

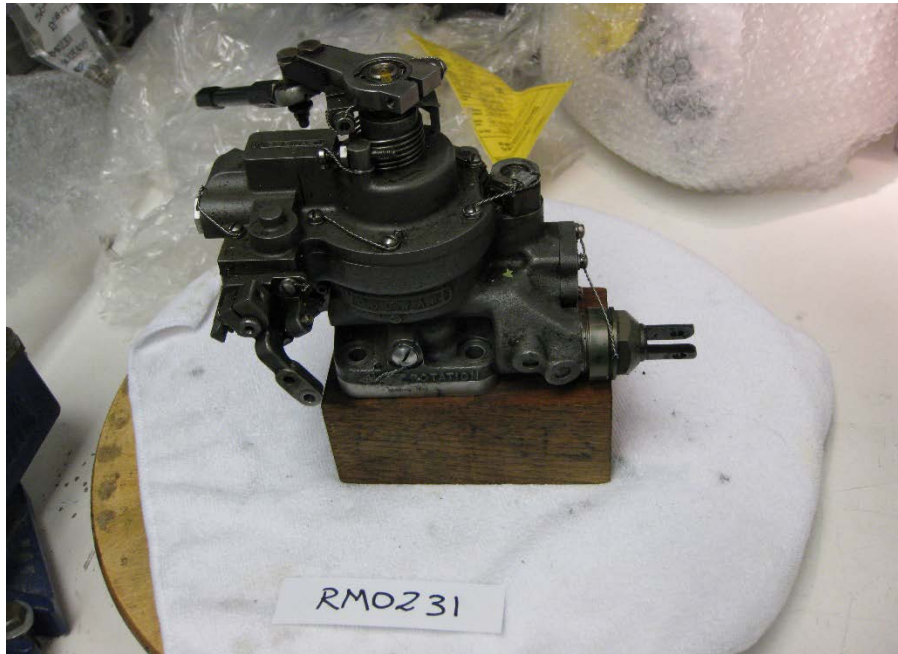
Picture 3. Propeller Governor

The propeller governor was examined, and the feathering stop was impact separated. The reset arm moved to the maximum stop operated without anomaly. The beta valve was operated by hand without anomaly. The propeller minimum speed anti tamper paint was present but broken. The driveshaft could be rotated by hand.

The propeller governor was bench tested and operated without any anomalies that would have contributed to the loss of torque during the accident sequence.

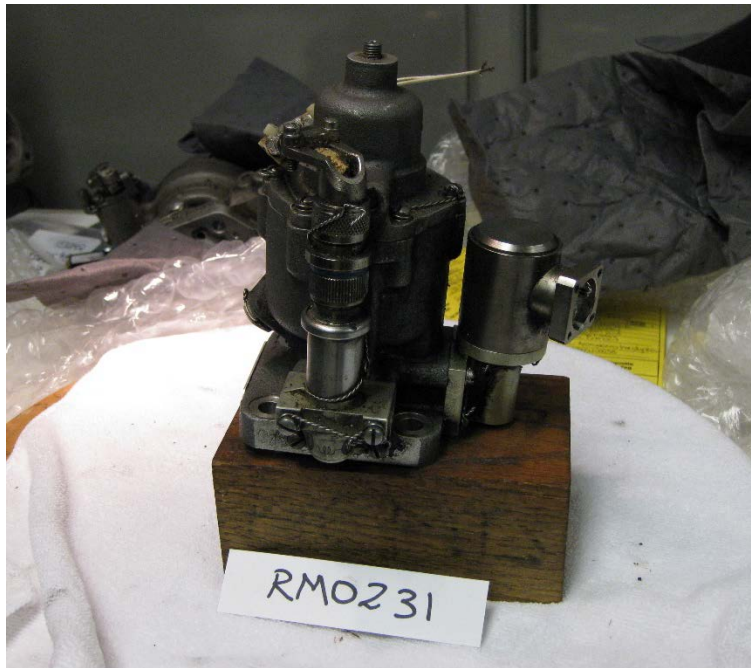
Picture 4. Propeller Overspeed Governor

The propeller overspeed governor was examined and the anti tamper paint for the maximum overspeed was present but broken. The drive shaft was rotated by hand.

The propeller overspeed governor was bench tested with a slave feather solenoid. During the bench test, the maximum and minimum speed was lower than manufacturer specifications, so a  $\frac{3}{4}$  turn inward adjustment was applied to the stop screw and then the overspeed governor operated within manufacturer specifications. Overall, it operated without any anomalies that would have contributed to the loss of torque during the accident.

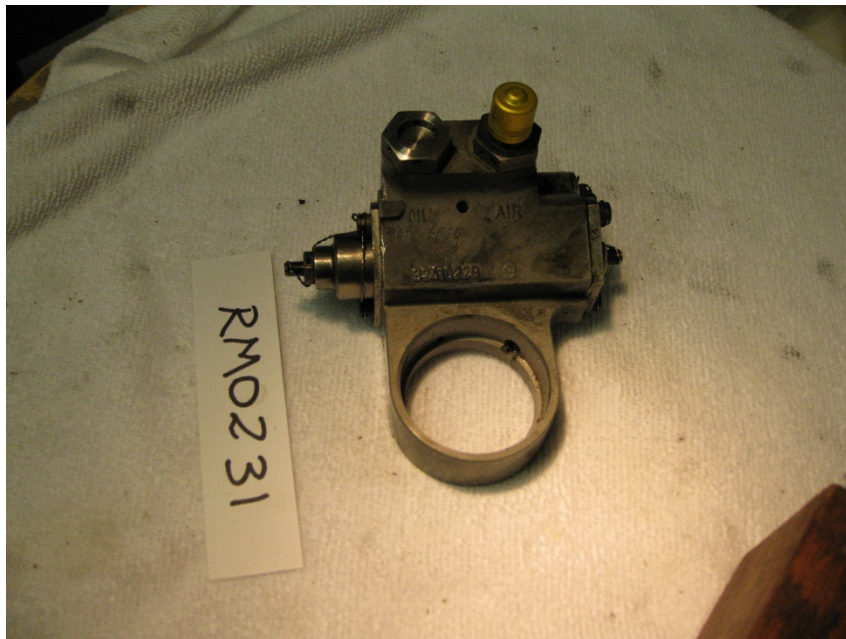
Picture 5. Torque Limiter

The torque limiter was placed on a test stand and the unit operated below the manufacturer specifications. A  $\frac{1}{4}$  turn of the adjustment screw was made and the torque limiter operated within the manufacturer specifications.

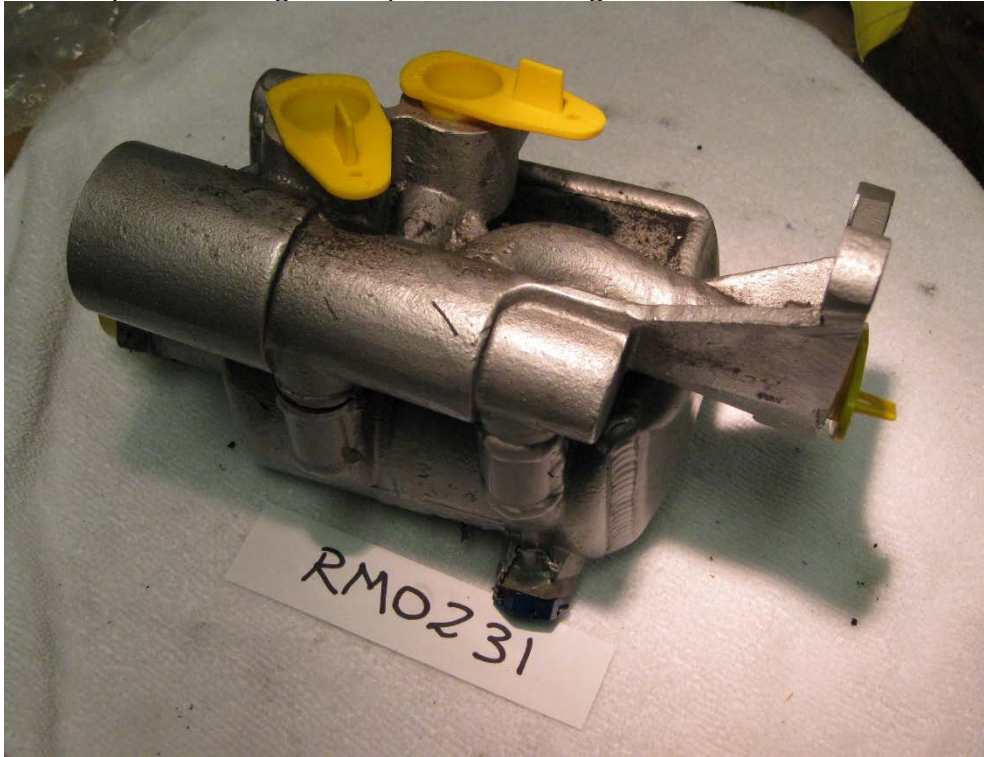
Picture 6. Fuel Oil Heat Exchanger

The fuel oil heat exchanger was examined. The thermal element was removed and tested and when exposed to a higher temperature, it elongated.
