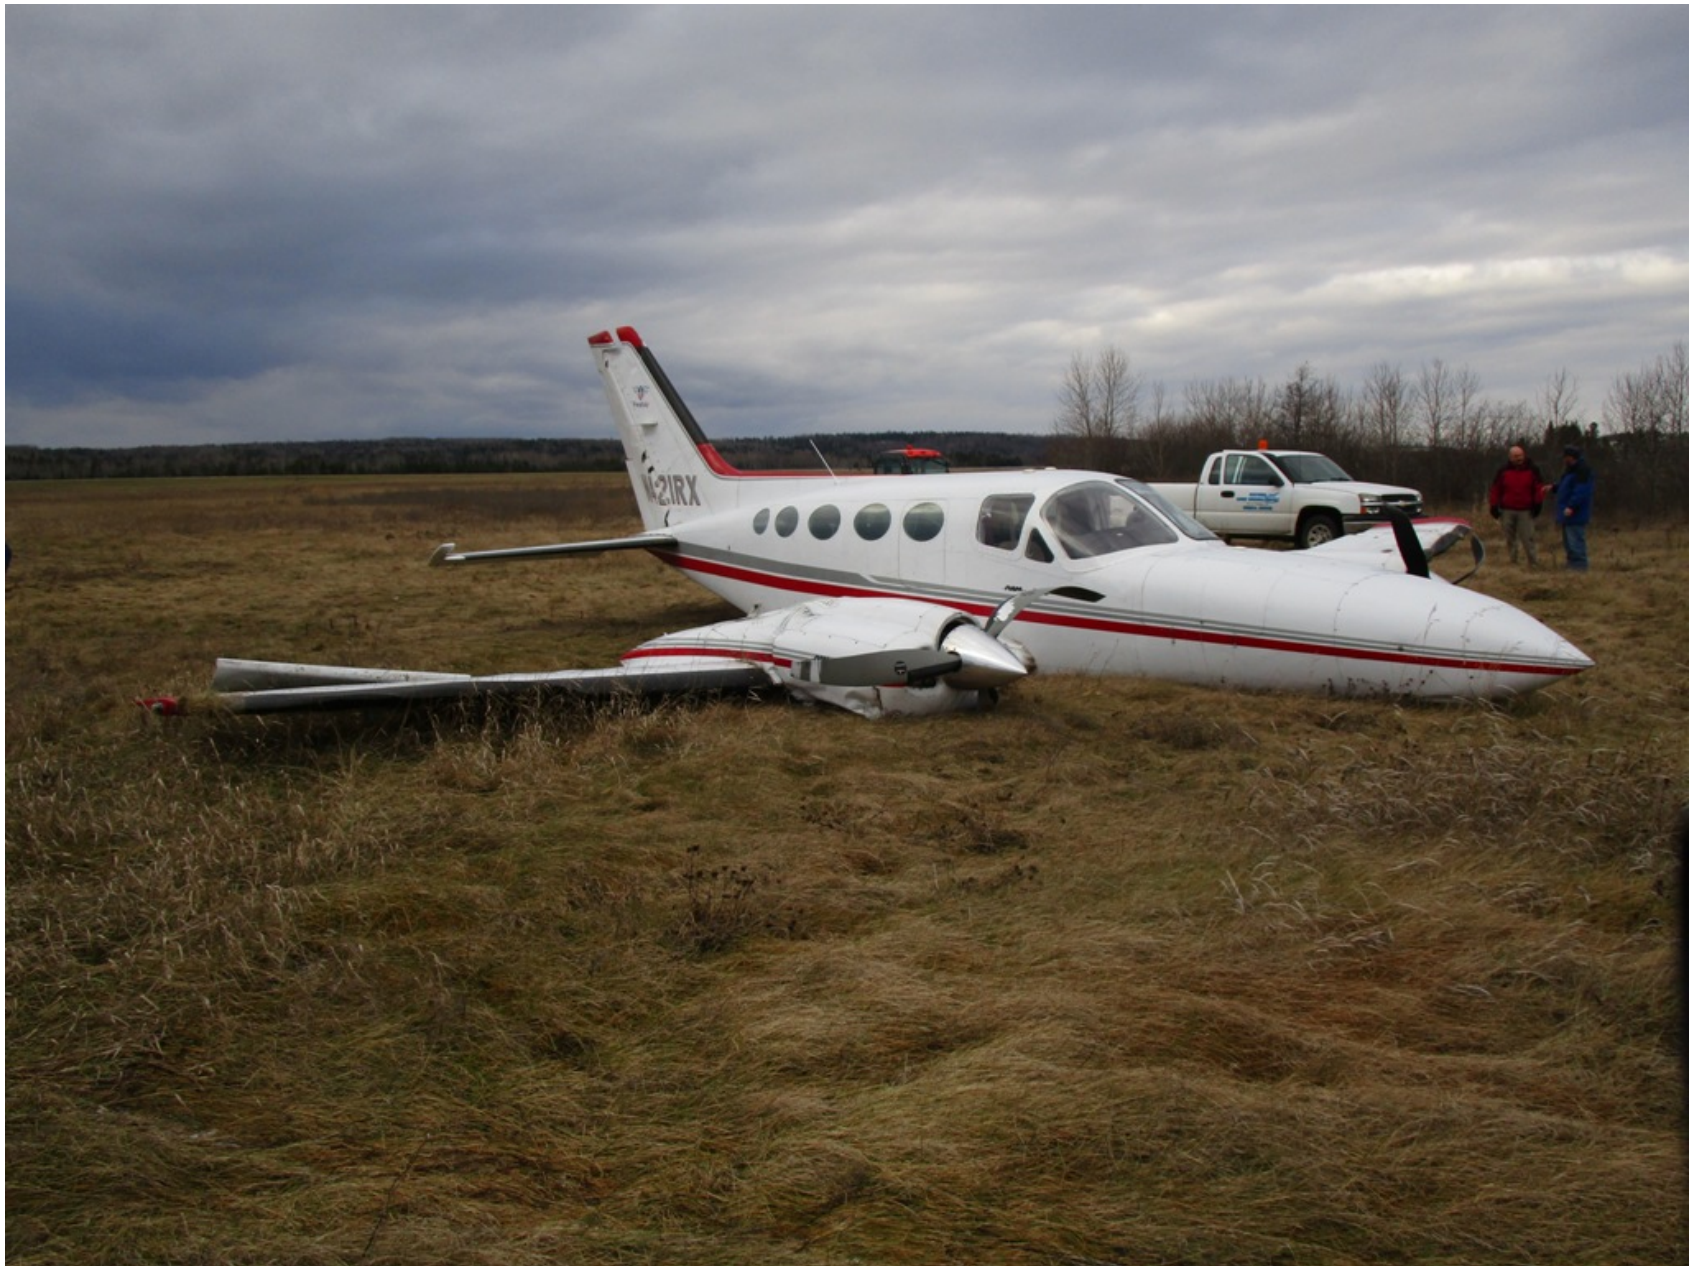
**Photo 1 – Main Wreckage (FAA Photo)**

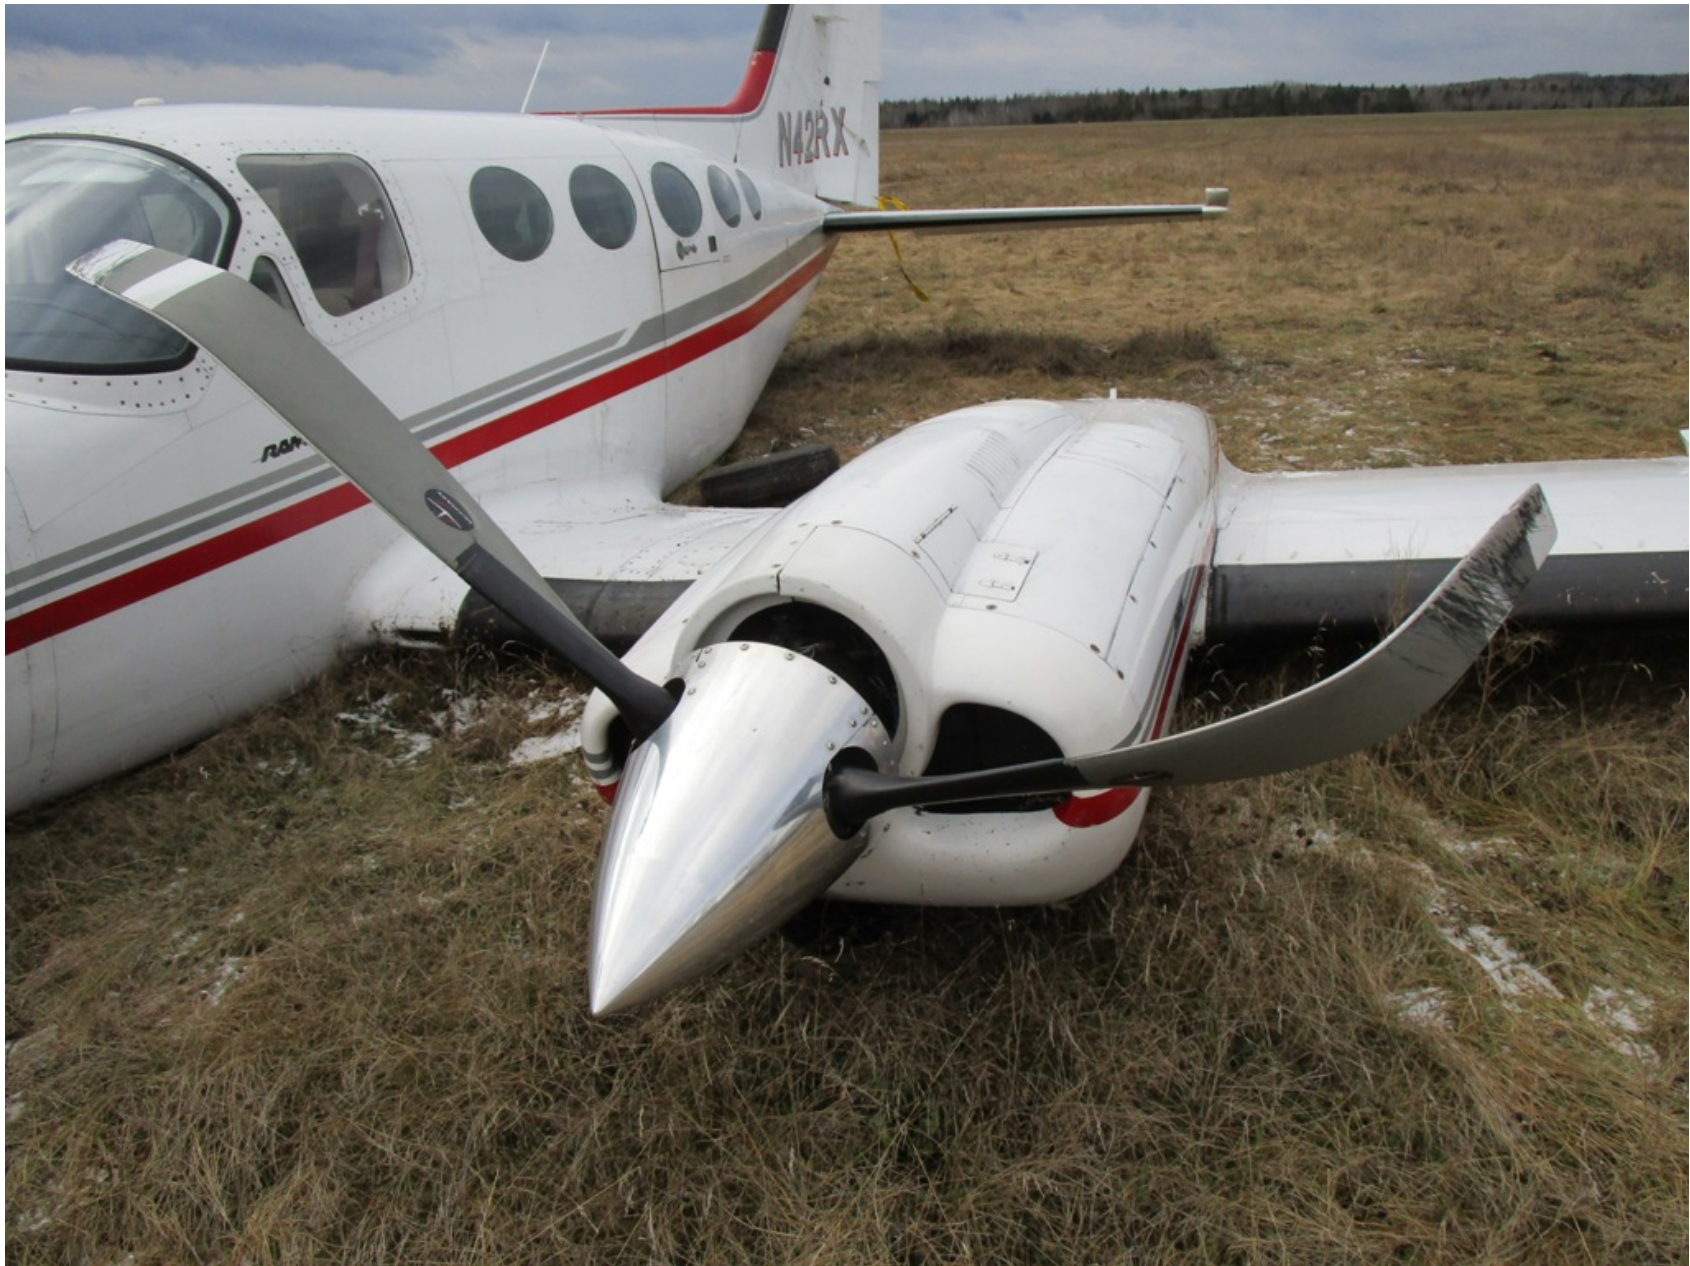
**Photo 2 – Left Engine and Propeller (FAA Photo)**

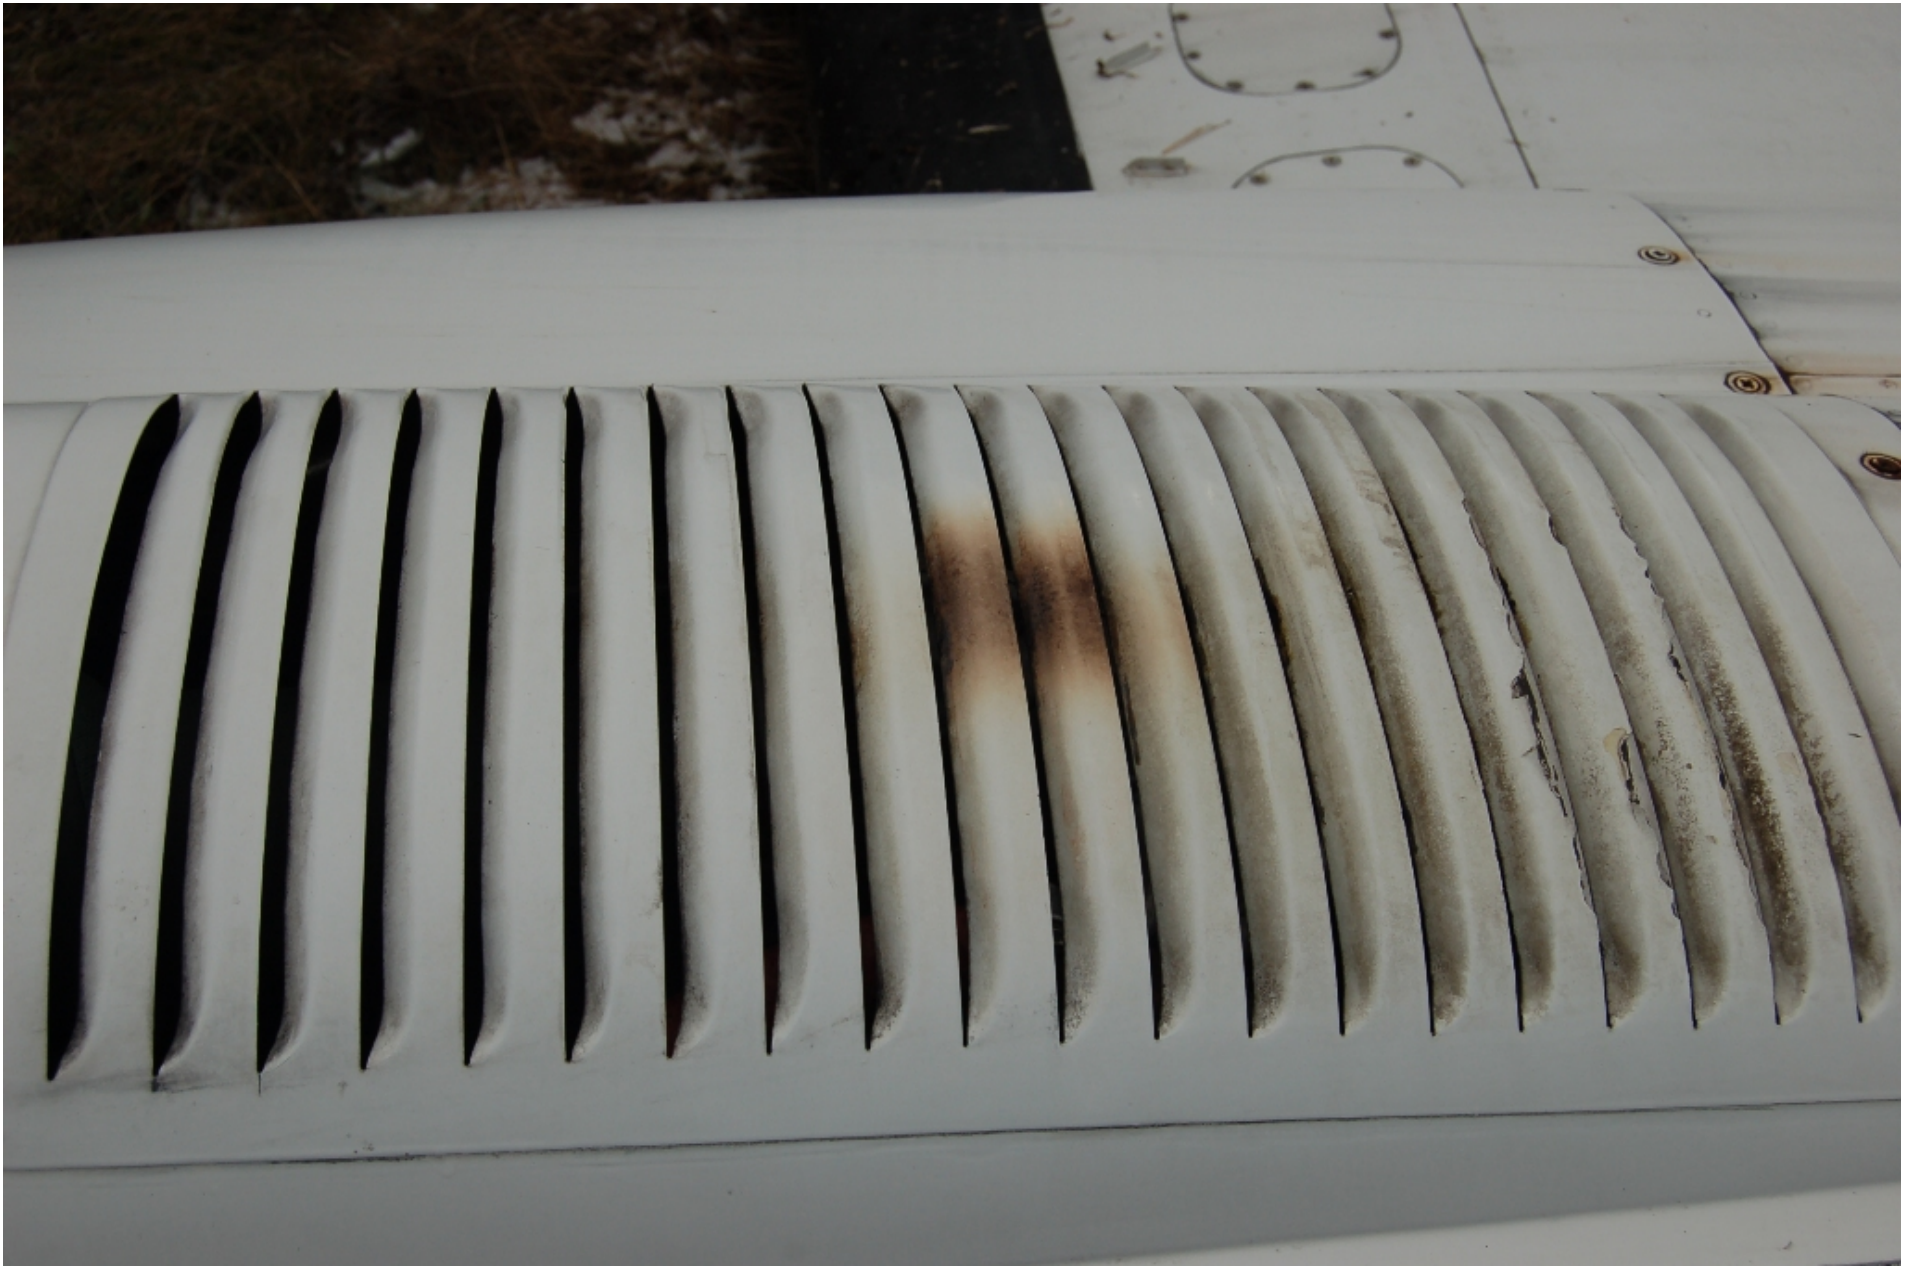
**Photo 3 – Fire/Heat Discoloration of Left Engine Nacelle Louvers**

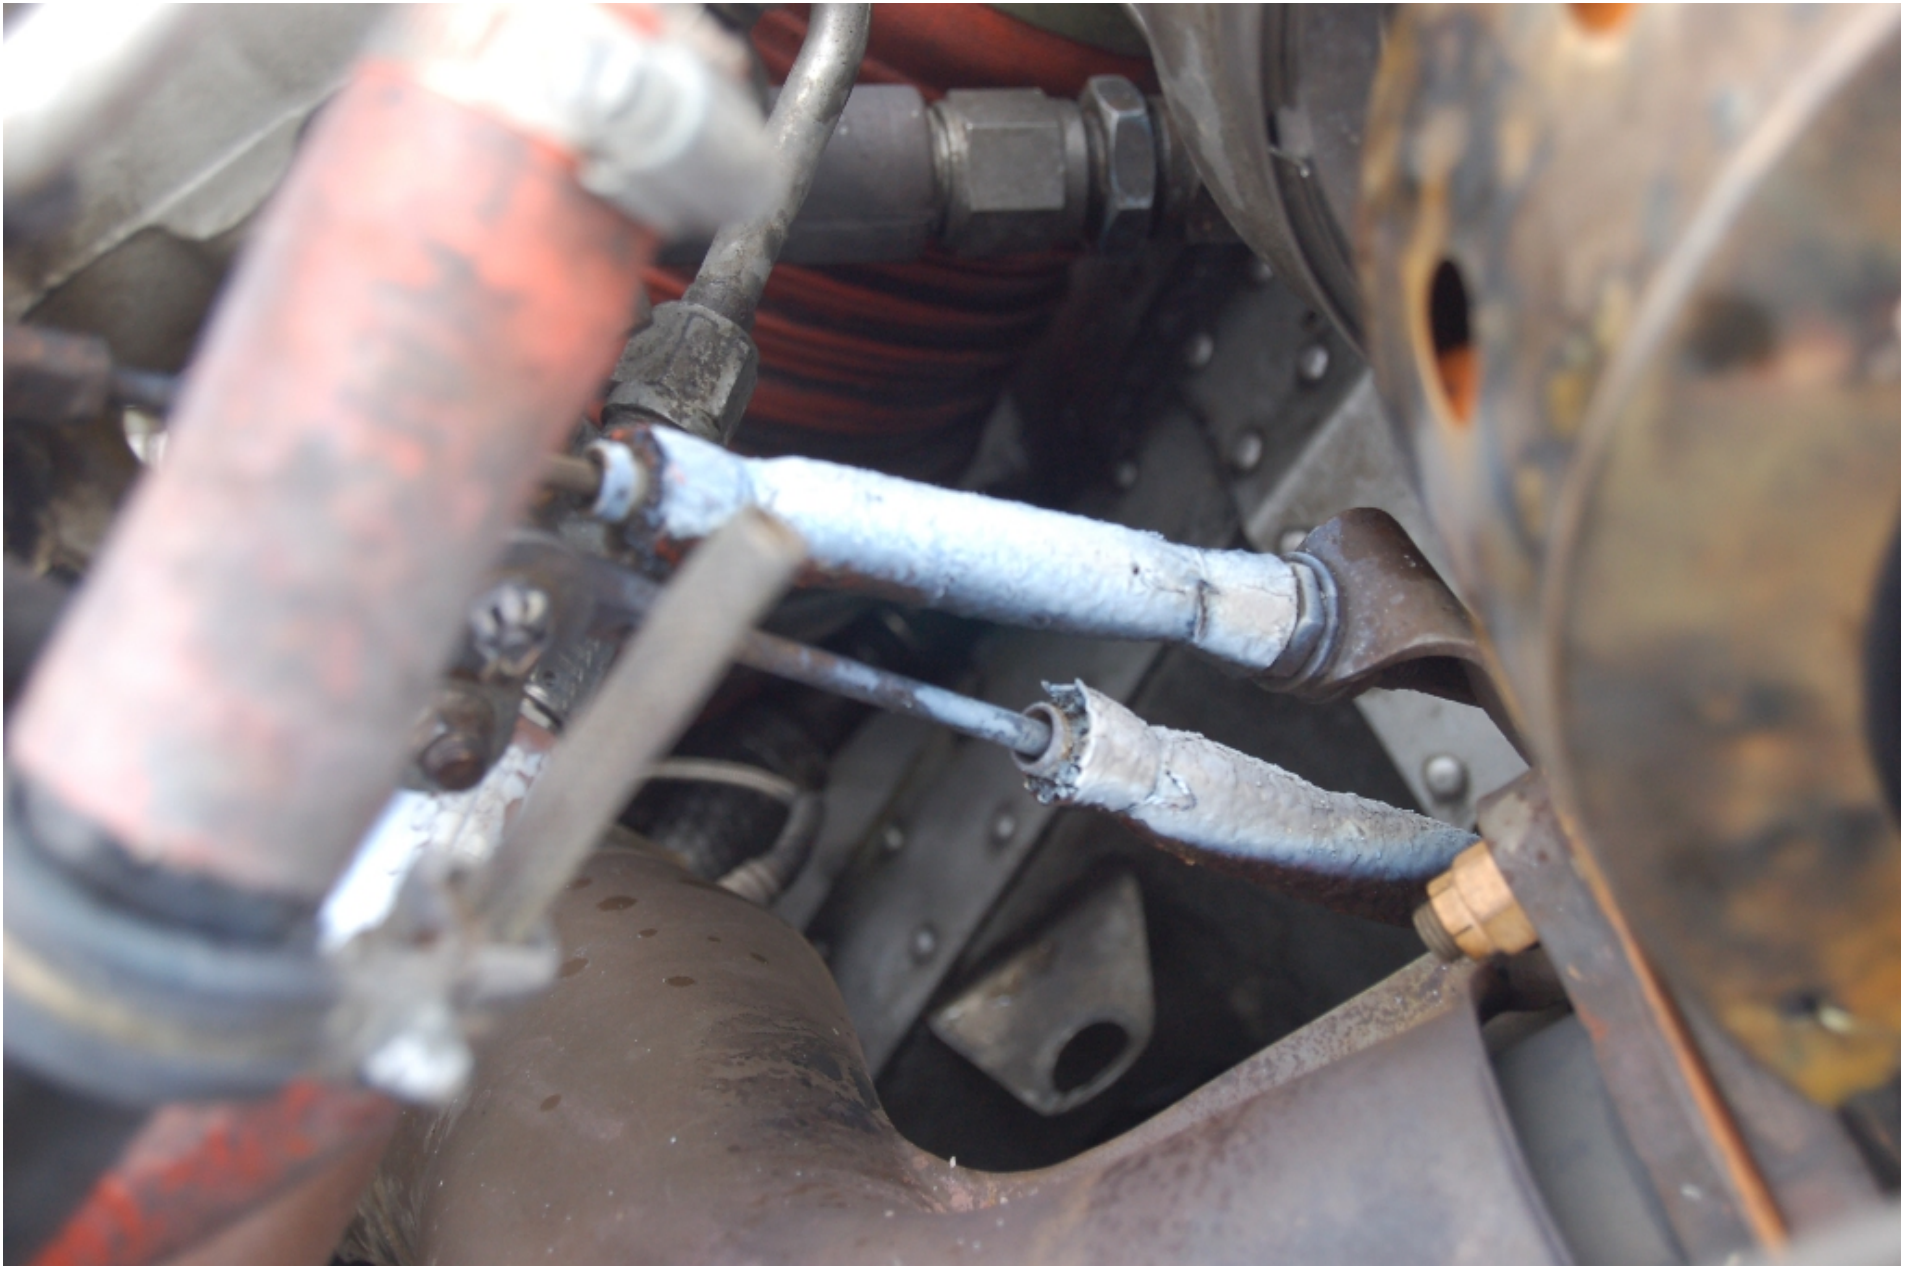
**Photo 4 – Discoloration on Left Engine Components (FAA Photo)**
