## **NATIONAL TRANSPORTATION SAFETY BOARD**

# **ENGINE EXAMINATION**

**ERA18LA038**

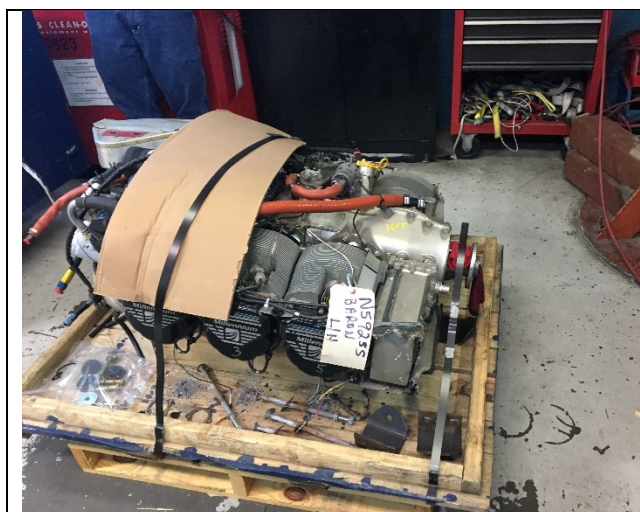
Overall condition of the engine, when the shipping crate was opened.

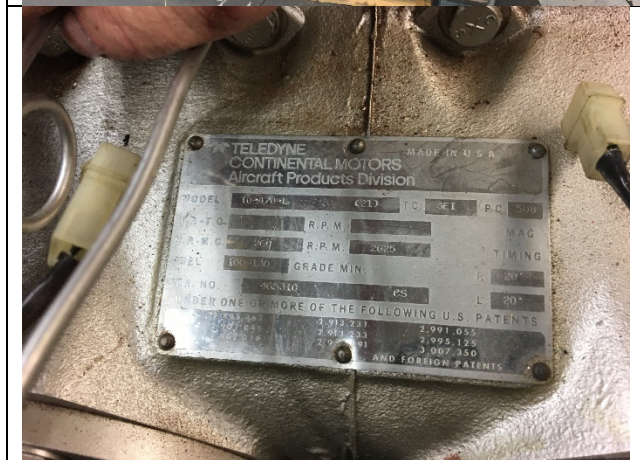
Engine identification plate: IO-470-L

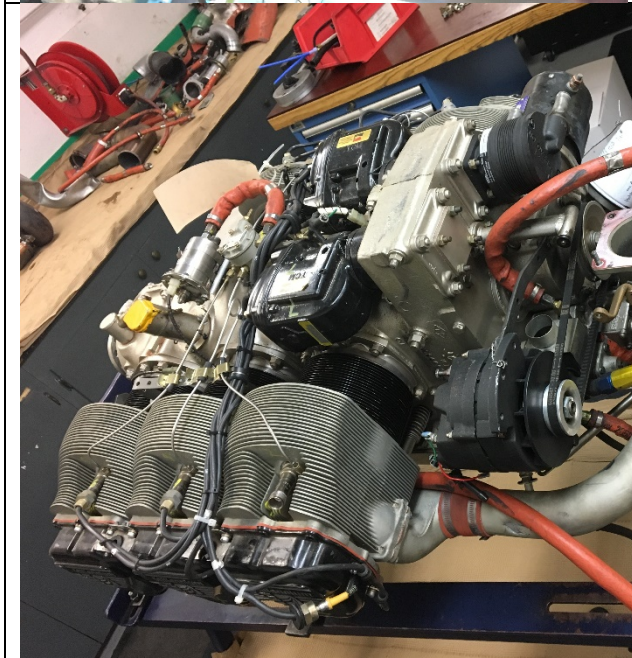
As tested the engine timing was set at 23 degrees. (timing per dataplate is 20 degrees)

Vacuum pump, alternator, propeller governor were removed

Engine oil was drained, and refilled

A set of straight exhaust stacks were installed

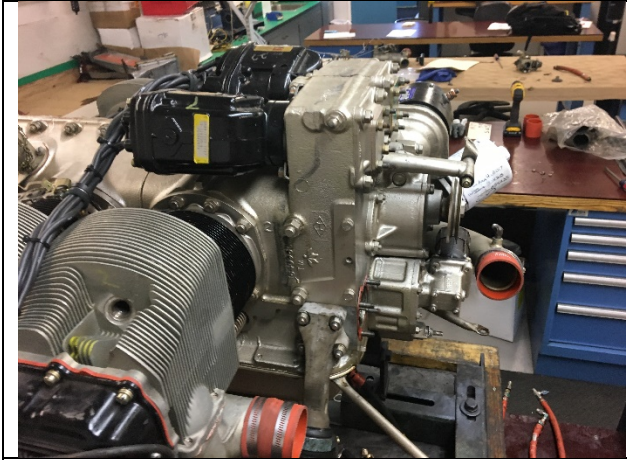
The top set of sparkplugs were removed, the plugs exhibited normal combustion signatures

A cold compression test was done:

19/47/4/4/35/7

After the engine run the compression test was redone, with a “hot” engine

74/73/75/71/76/75

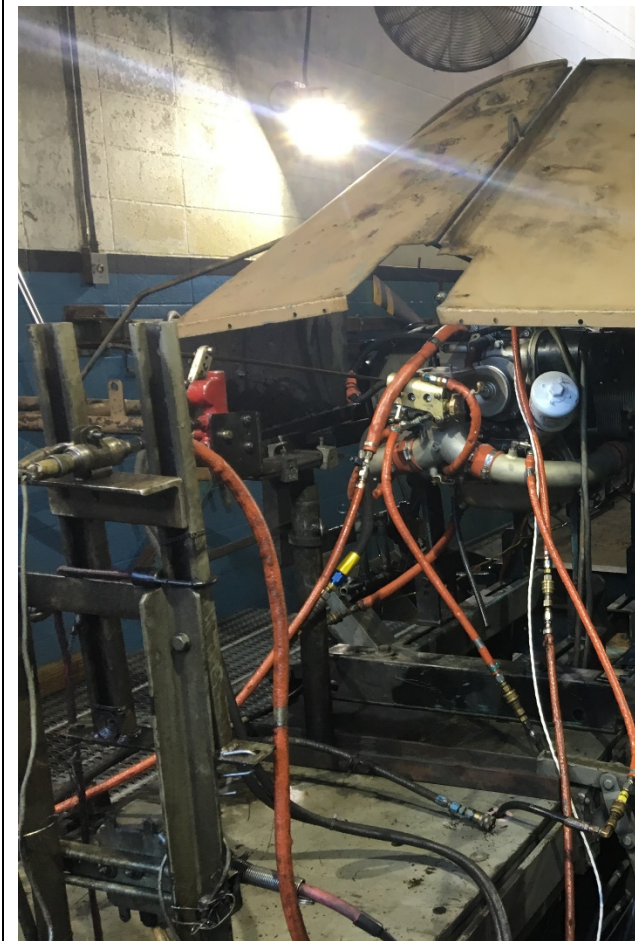
The mixture control was initially “wired” to the full rich position, for the test.

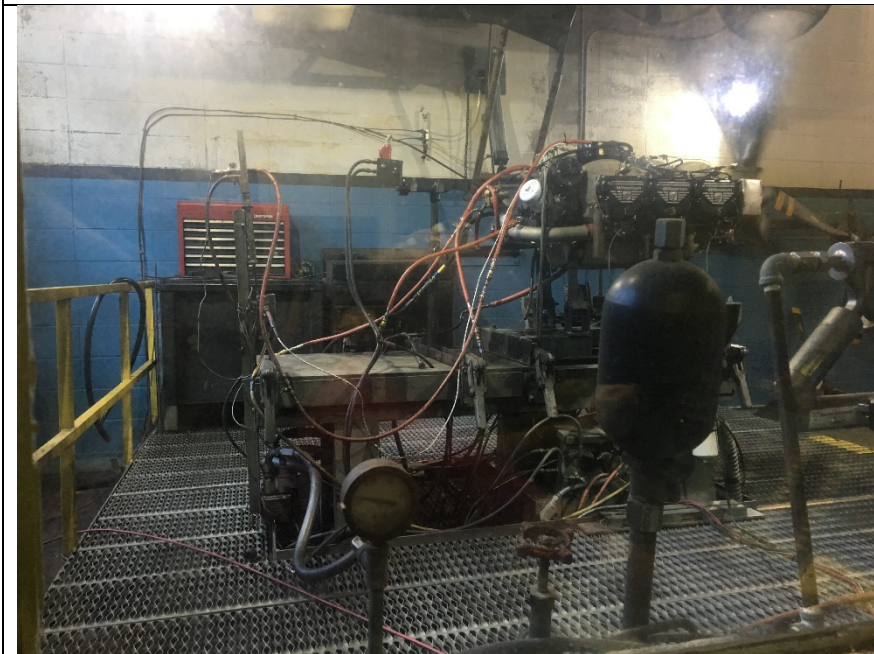
The engine would run to full power; However, when “jockeying” the throttle from idle to full power, the engine would stop. However, if the throttle was slowly advanced from idle the engine would continue to run.

The engine appeared to be running too rich, at the low power settings.

Additionally, during the magneto check, approx. 2100 rpm, the engine slowly stopped (left mag). Even though when tested by hand, the produced a spark, the left mag was then replaced. The test was repeated, and when the right mag was selected, the engine would slowly stop producing power.

Again, the mag appeared to be good, it was

| | undetermined why/if the combination of a rich mixture and magneto-engine timing of 3-degrees off, could stop an engine from producing power. |

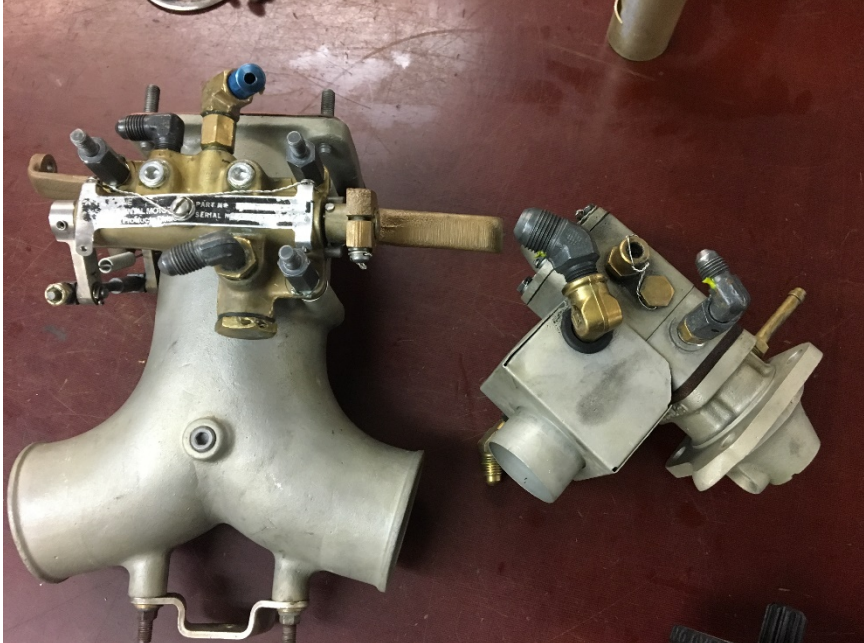
| | <p>After the engine run, the throttle body, fuel pump, and fuel manifold were bench tested: the test revealed that at the lower power settings, the mixture was overly rich.</p> |

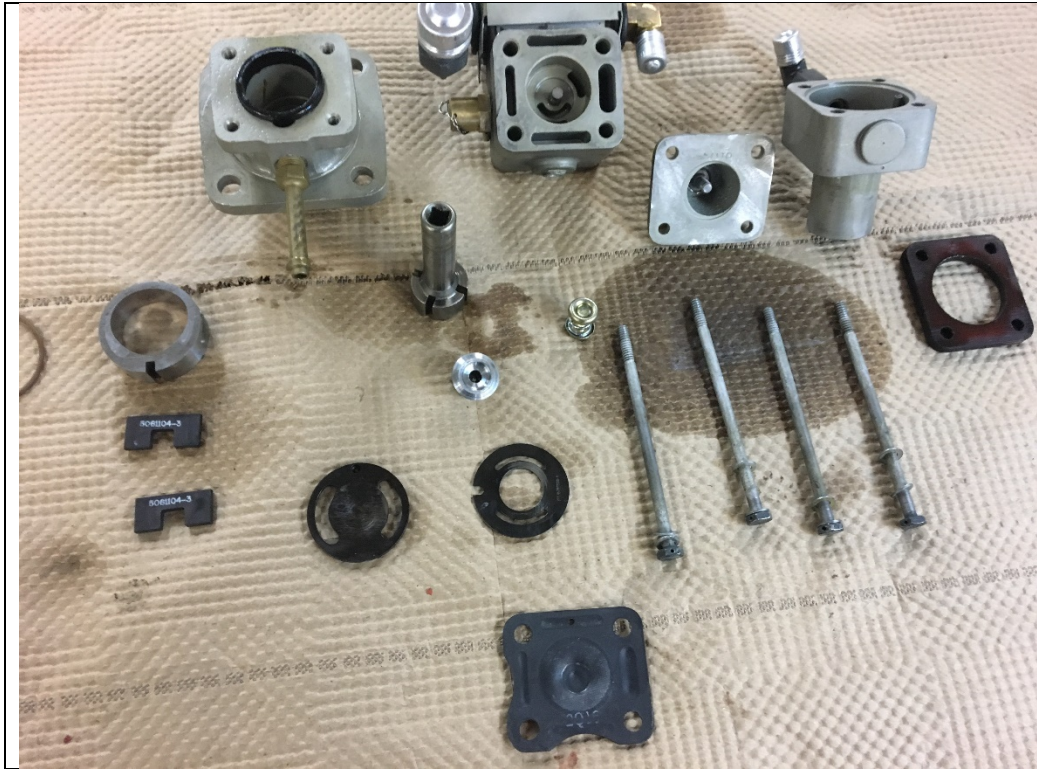
After the bench test, the fuel pump was disassembled. A small weep at the back of the pump was observed during the test, however, the diaphragm, appeared to be in good shape, even when viewed thru a microscope.

The engine's fuel mixture was overly rich at low power settings, however, a reason why the engine performed satisfactory on previous flights, but lost power on the accident flight was not found.
