Inspector Statement from Allan Crabbe FAA IIC, Jackson MS. FSDO

On May 1<sup>st</sup> 2018, Inspector Crabbe traveled to Hernando, MS with Inspector Albert McCray to witness an engine disassembly. The engine was recovered from the wreckage of N481ZK, an Experimental/Amateur Built Gyrocopter. The aircraft was built from a kit, titled Sparrow Hawk. The engine examined was a converted automobile engine, a Subaru 4 opposing cylinder engine, liquid cooled, and modified with a fixed pitch “pusher” propeller in the rear of the engine. The first four pictures are the “four corners of the engine for reference –

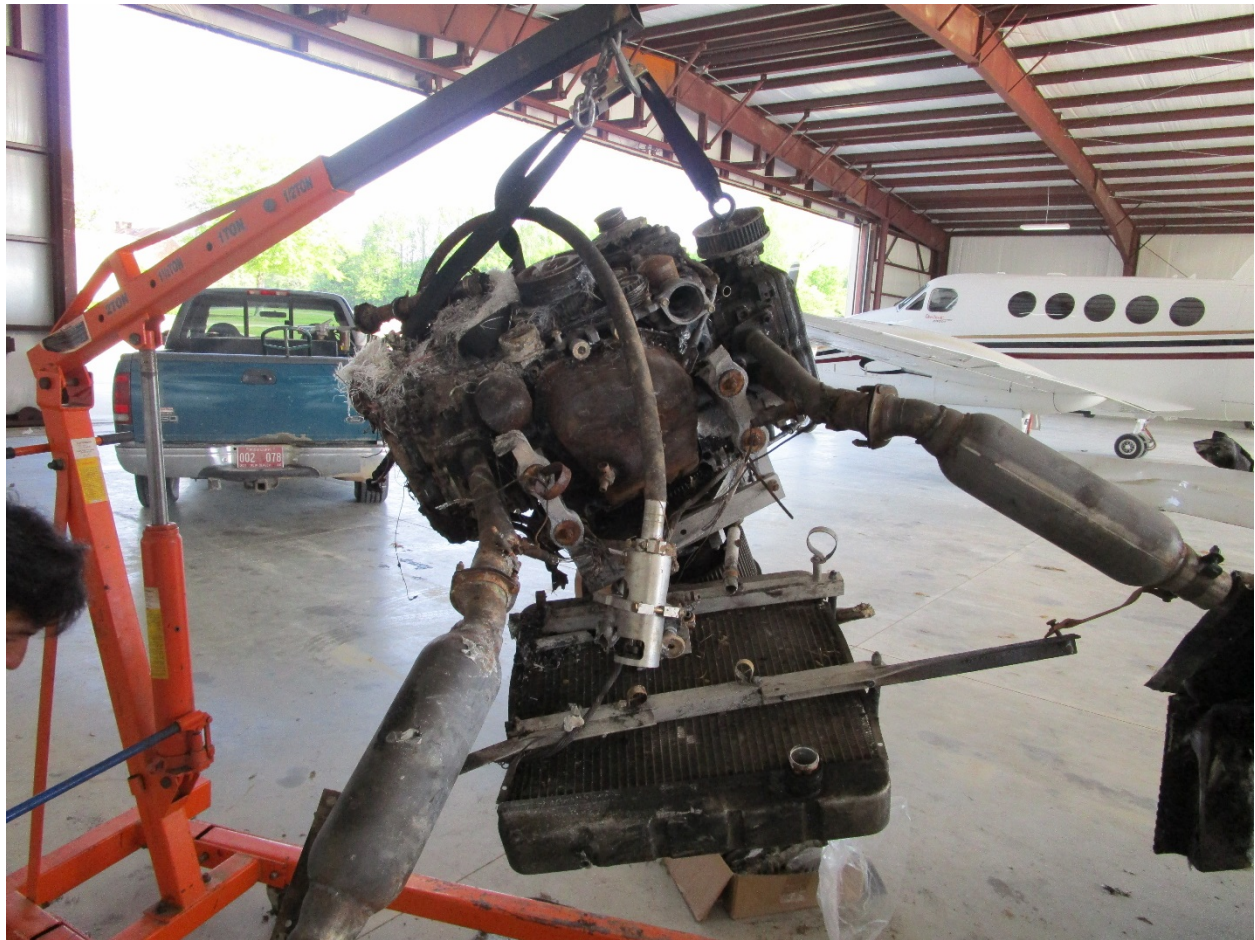
Bottom view of the engine with the front of the engine oriented at the top of the picture.

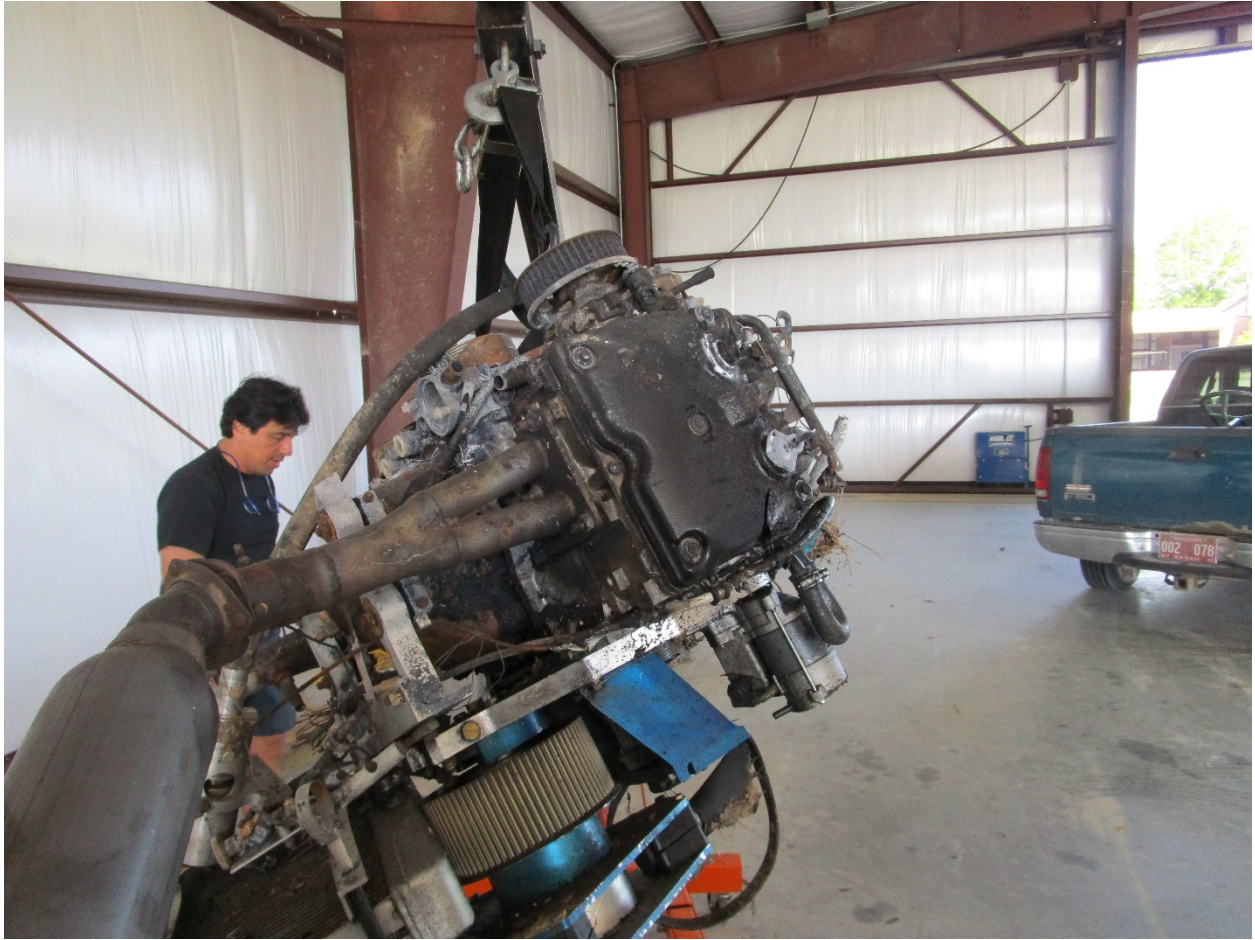
Left hand side of the engine.

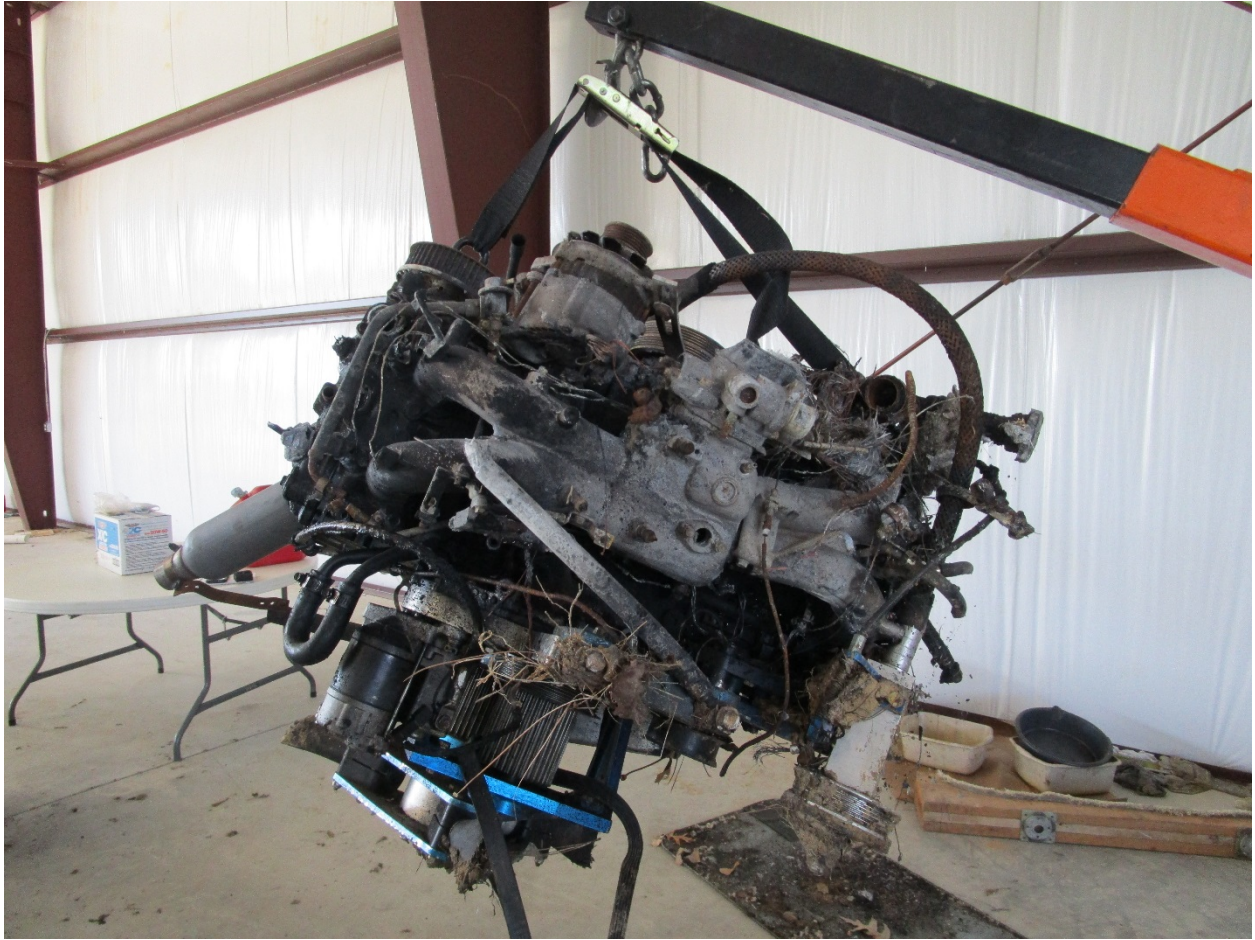
Top of the engine showing the throttle body injection/tubes.

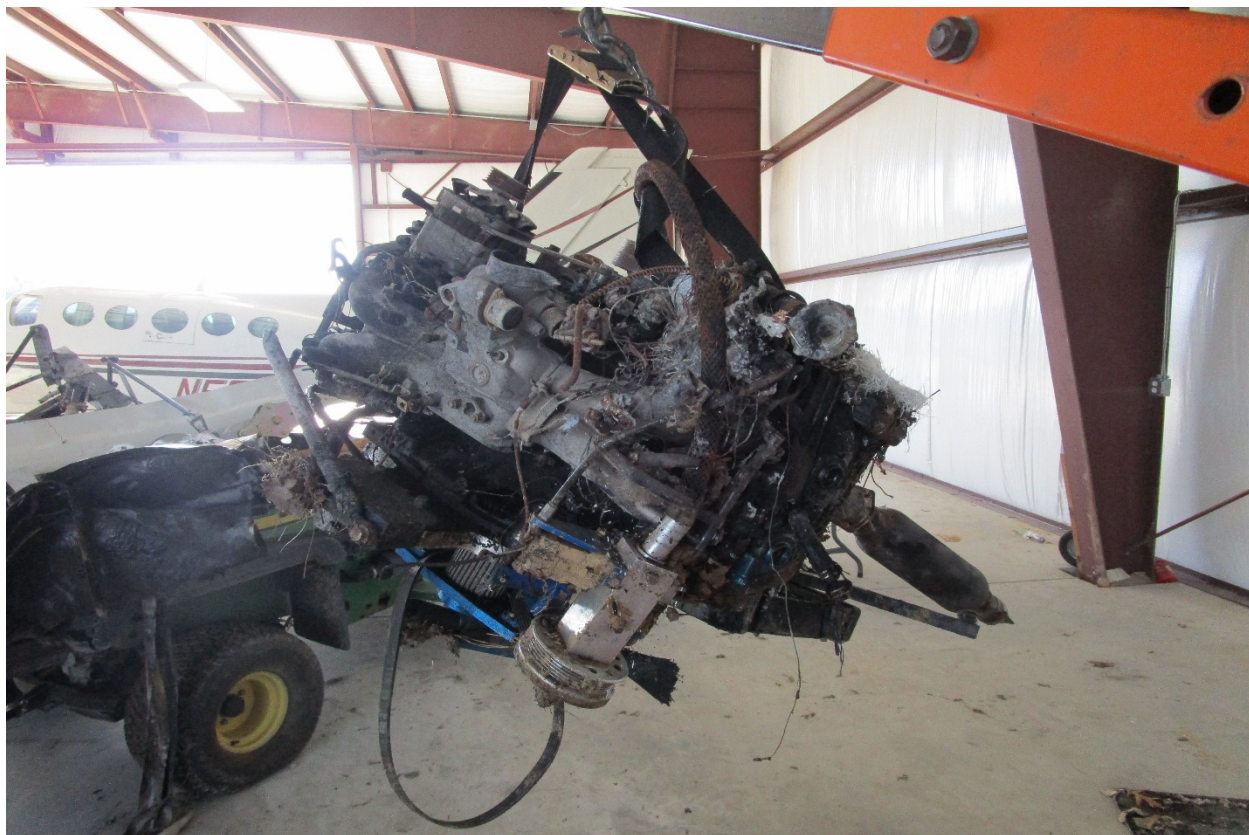
Right side of the engine.

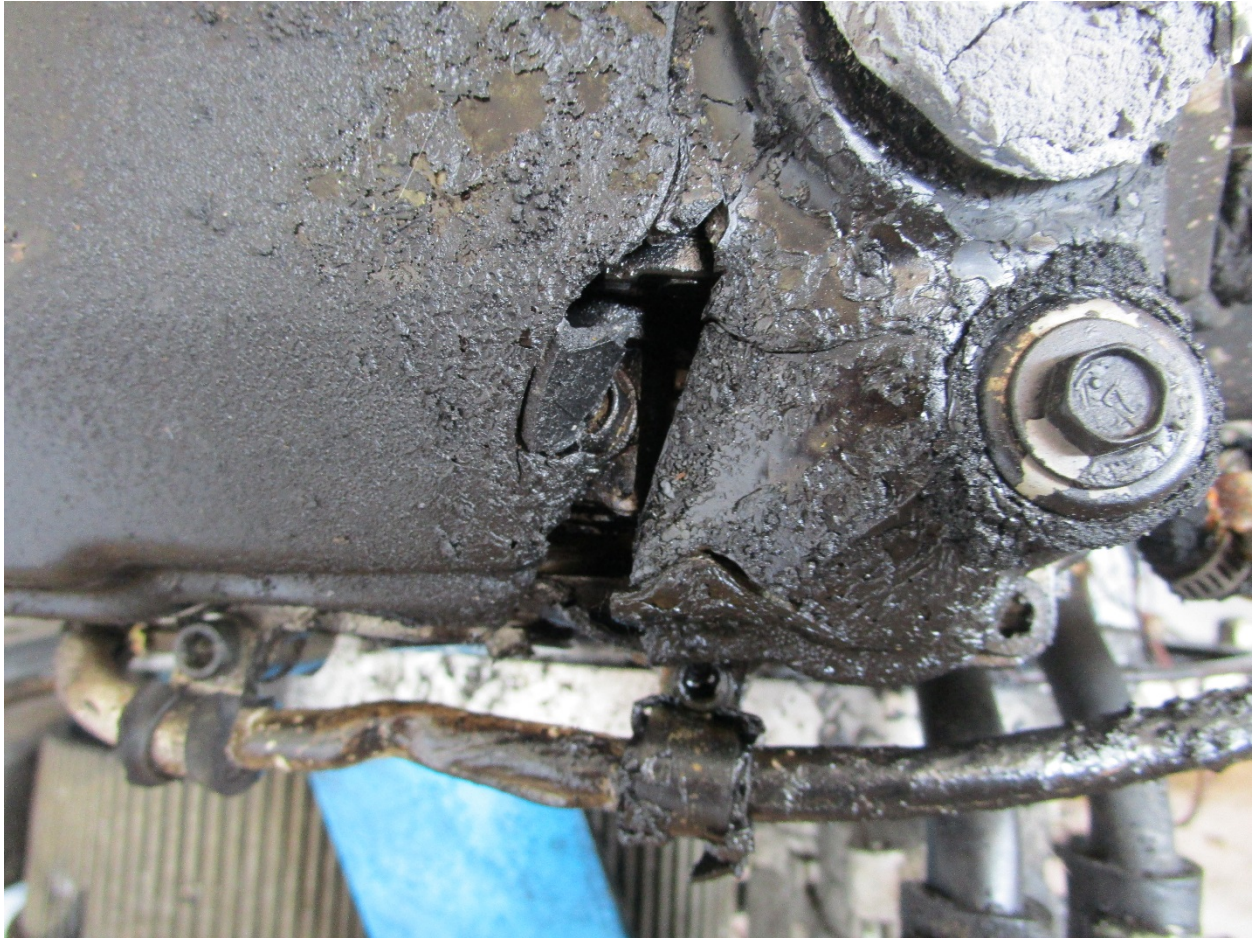
Left hand valve cover, spark plug wires melted completely away due to post crash fire. Near the lower right corner, the valve cover was punctured inward, possibly due to crash/post-crash damage. It is suspected that the damage is not consistent with a valve train malfunction due to the metal being pushed inward rather than outward.

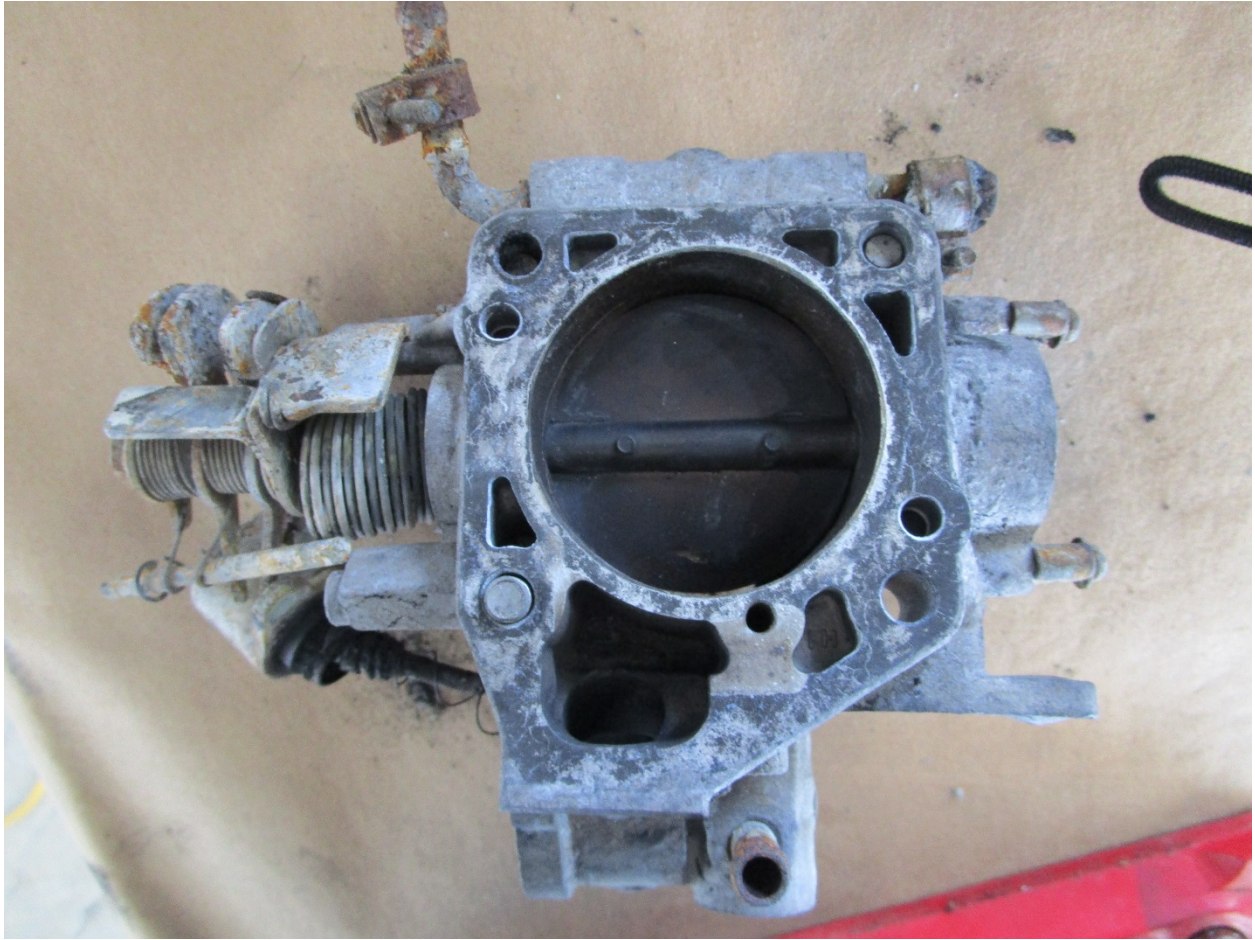
Throttle body removed from engine, bottom view. Of note is the fire damage to the metal.

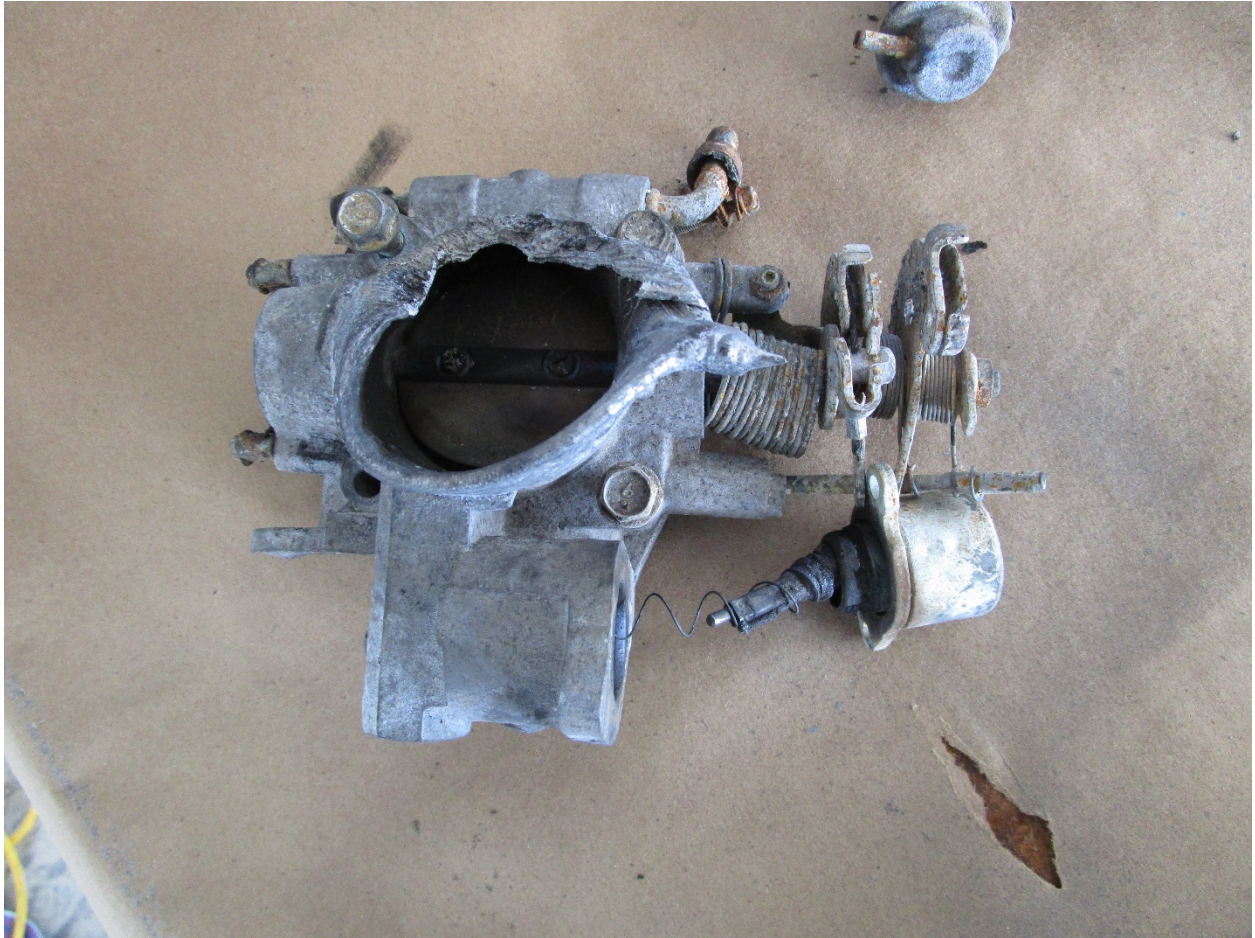
Throttle body from the top looking down, crash damage evident. The component to the lower right is believed to be a choke solenoid.

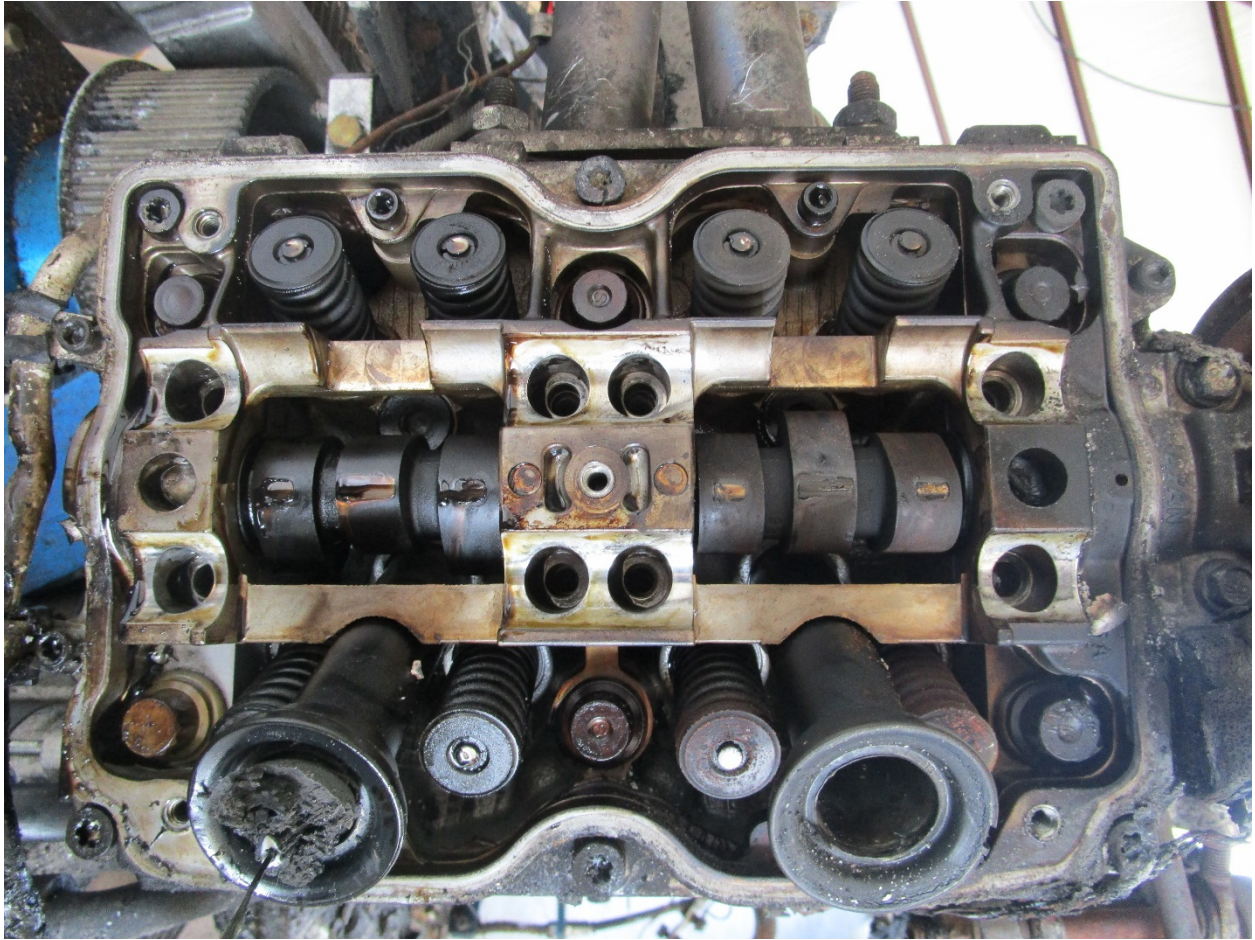
Same side with the valve rollers, lifters removed. Cam in center, rollers all functioned smoothly, and cam lobes showed normal wear.

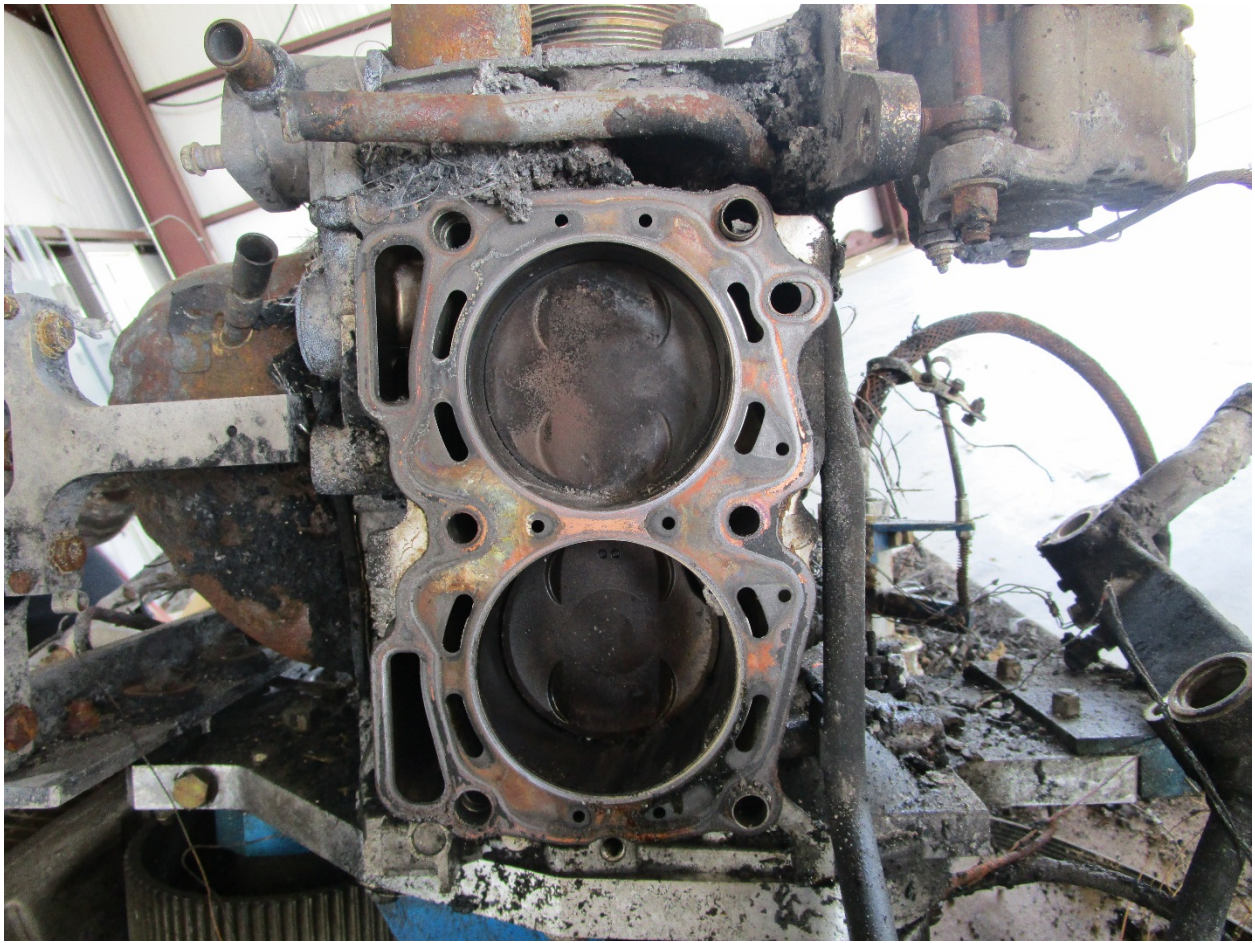
Left cylinder bank with the head removed, head gasket intact with no abnormalities noted. Cylinder sleeves were smooth with no scoring, piston heads showed normal wear, the marks on the piston heads were machined in, and should not be mistaken for valve slap. Debris in the cylinders occurred during disassembly.

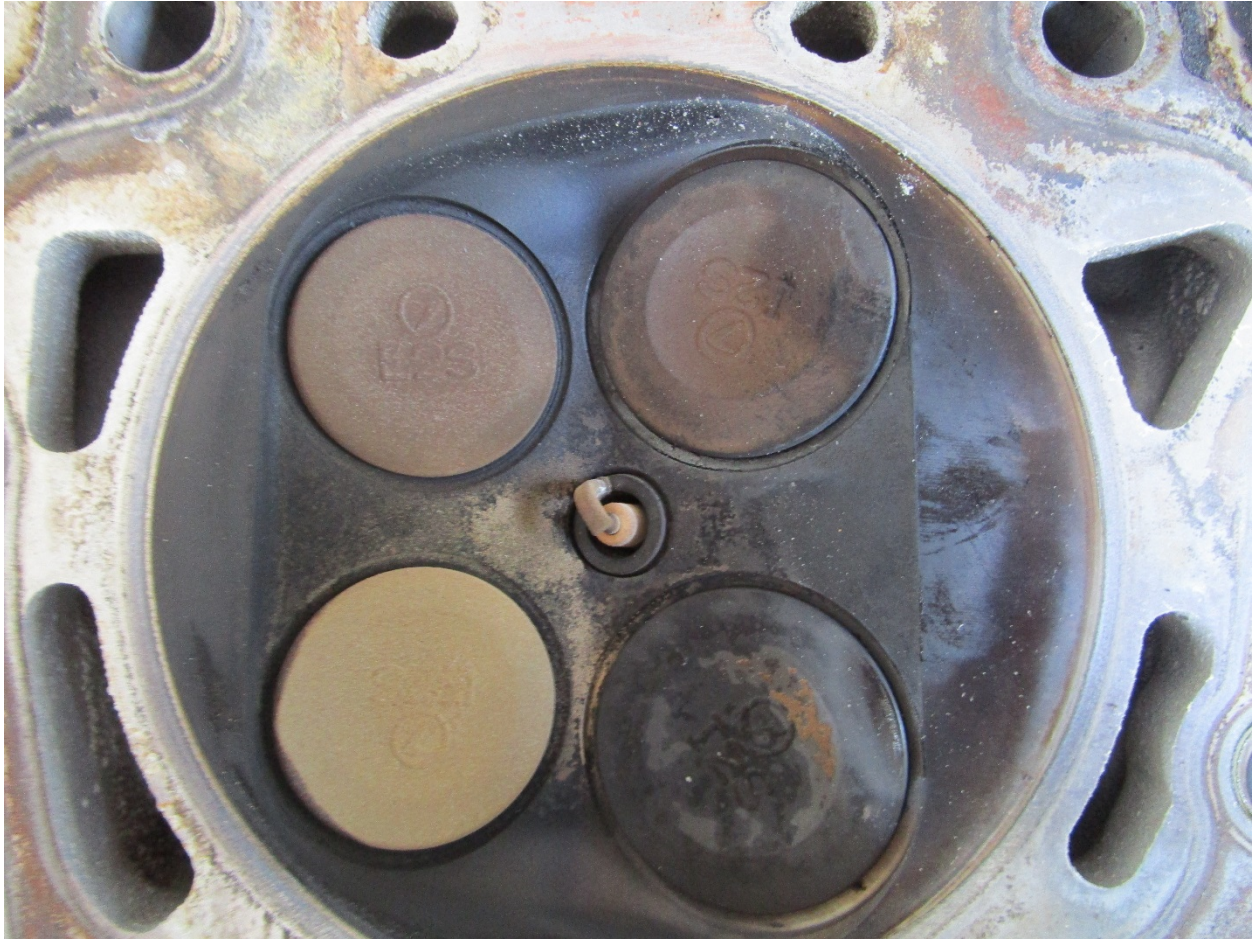
Valves from the forward right cylinder indicated normal wear, opened and closed with normal resistance, spark plug tip in the middle showed normal wear.

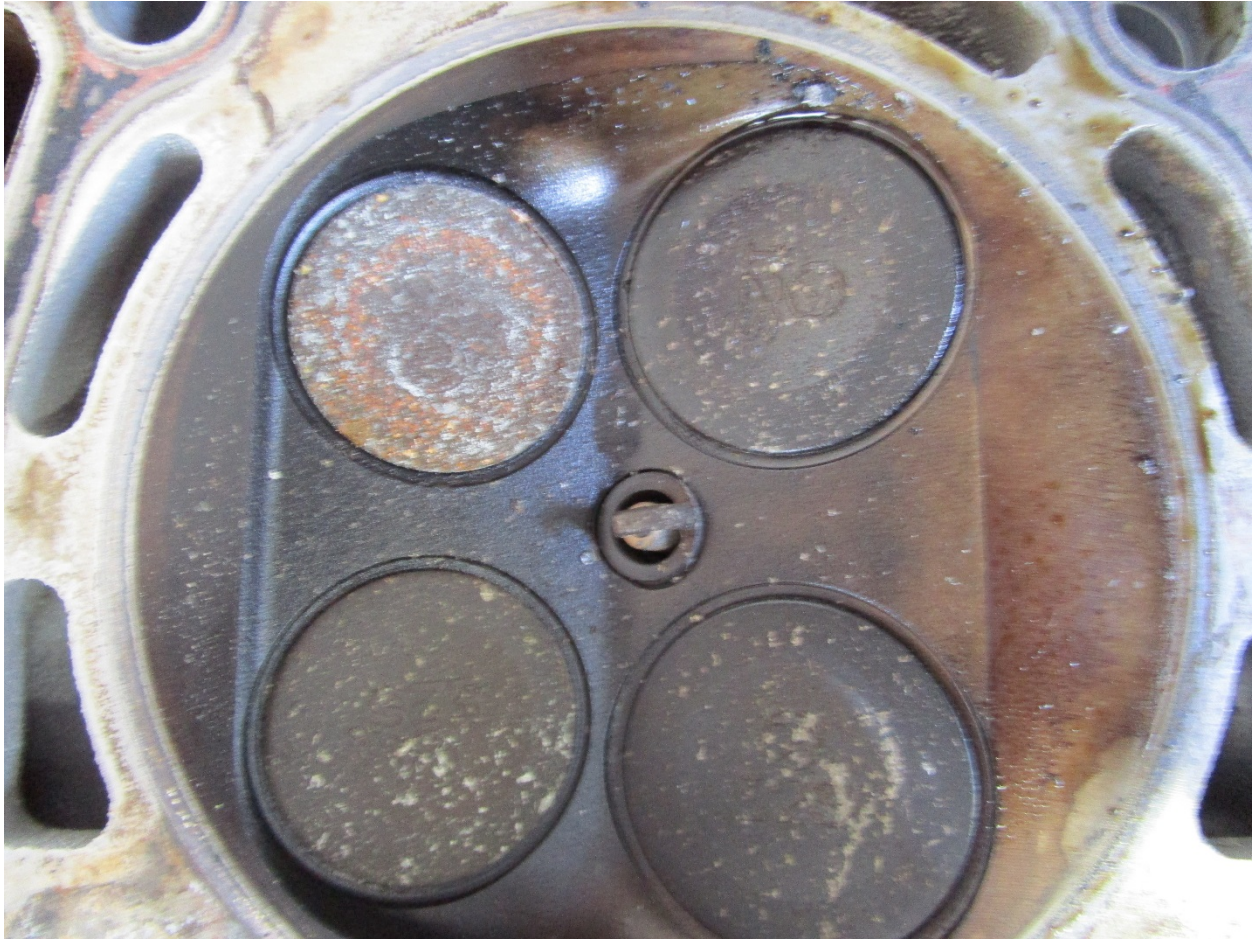
Cylinder head from the right rear cylinder, again indicated normal wear and spark plug tip showed no abnormalities.

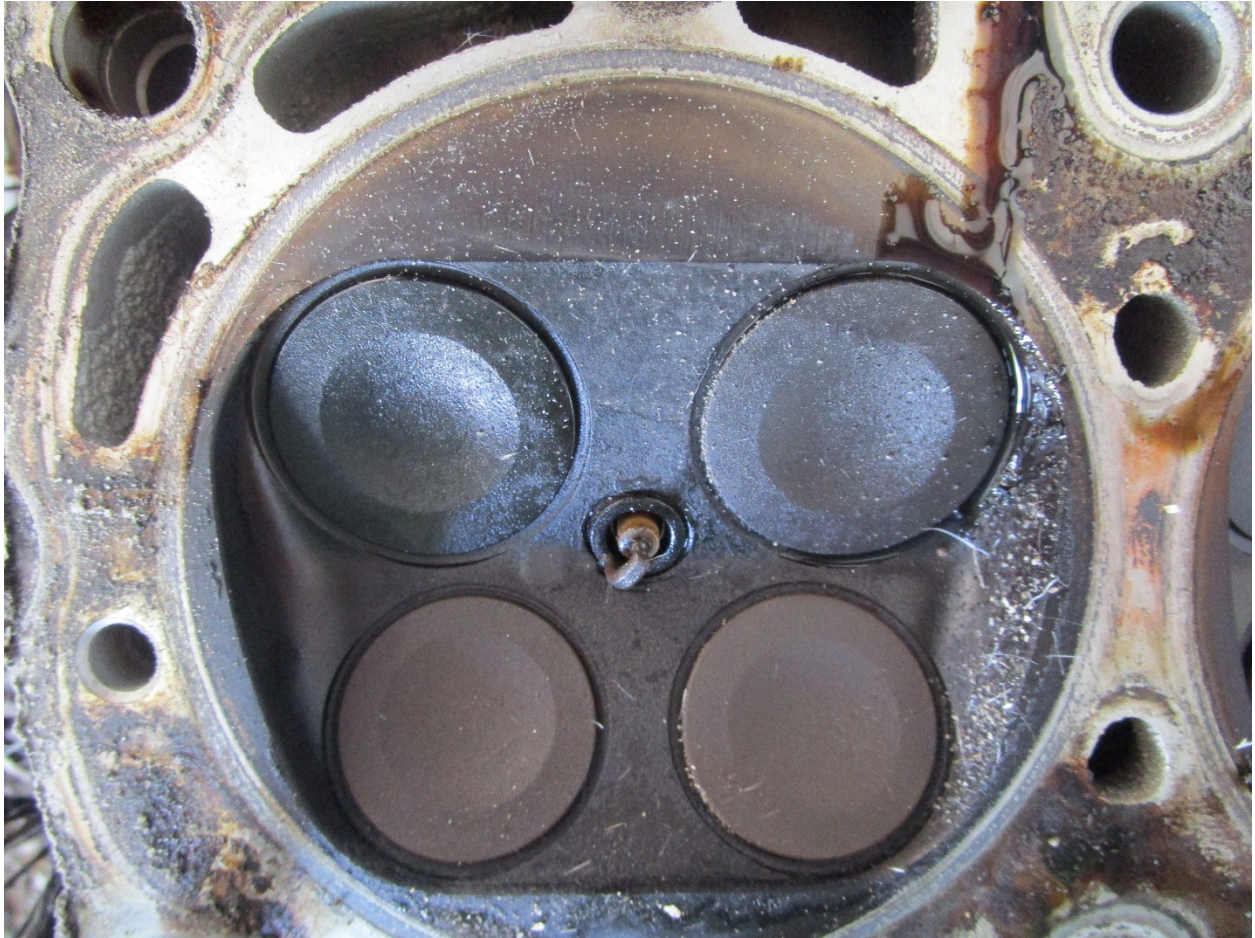
Right front cylinder head/valves/spark plug tip. All showed no abnormalities.

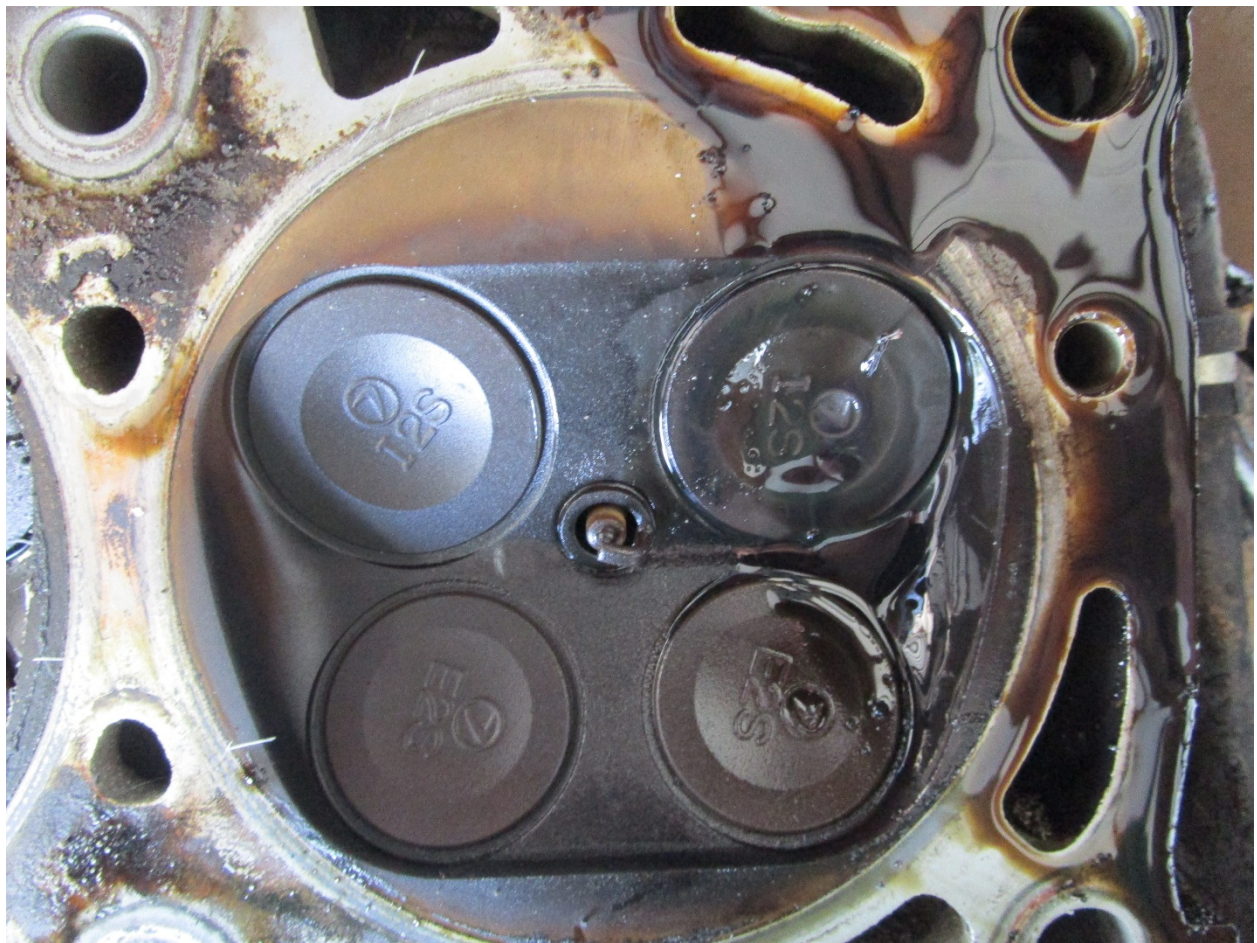
Right rear cylinder head, no abnormalities noted.

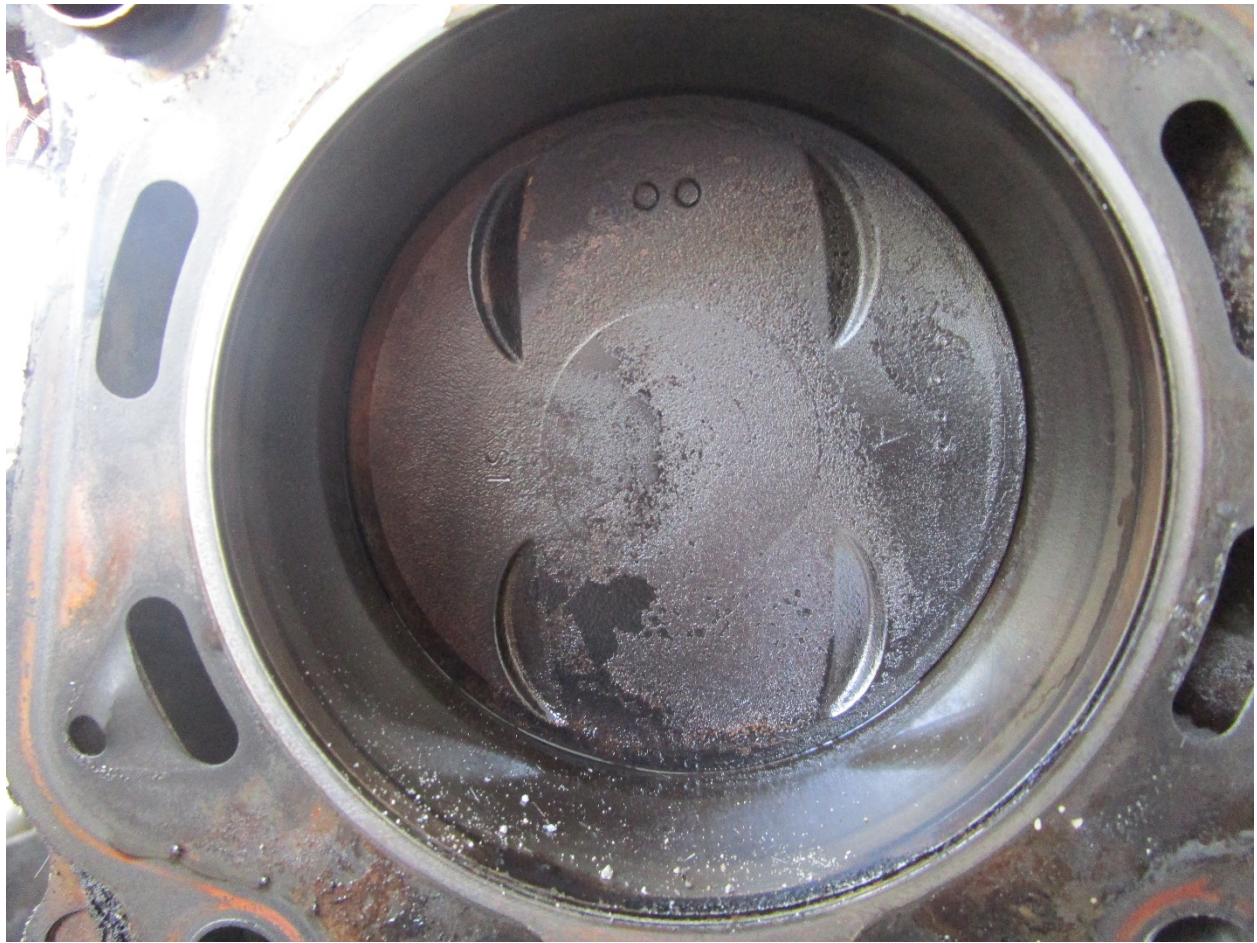
Right front cylinder/piston, again debris was introduced during disassembly.

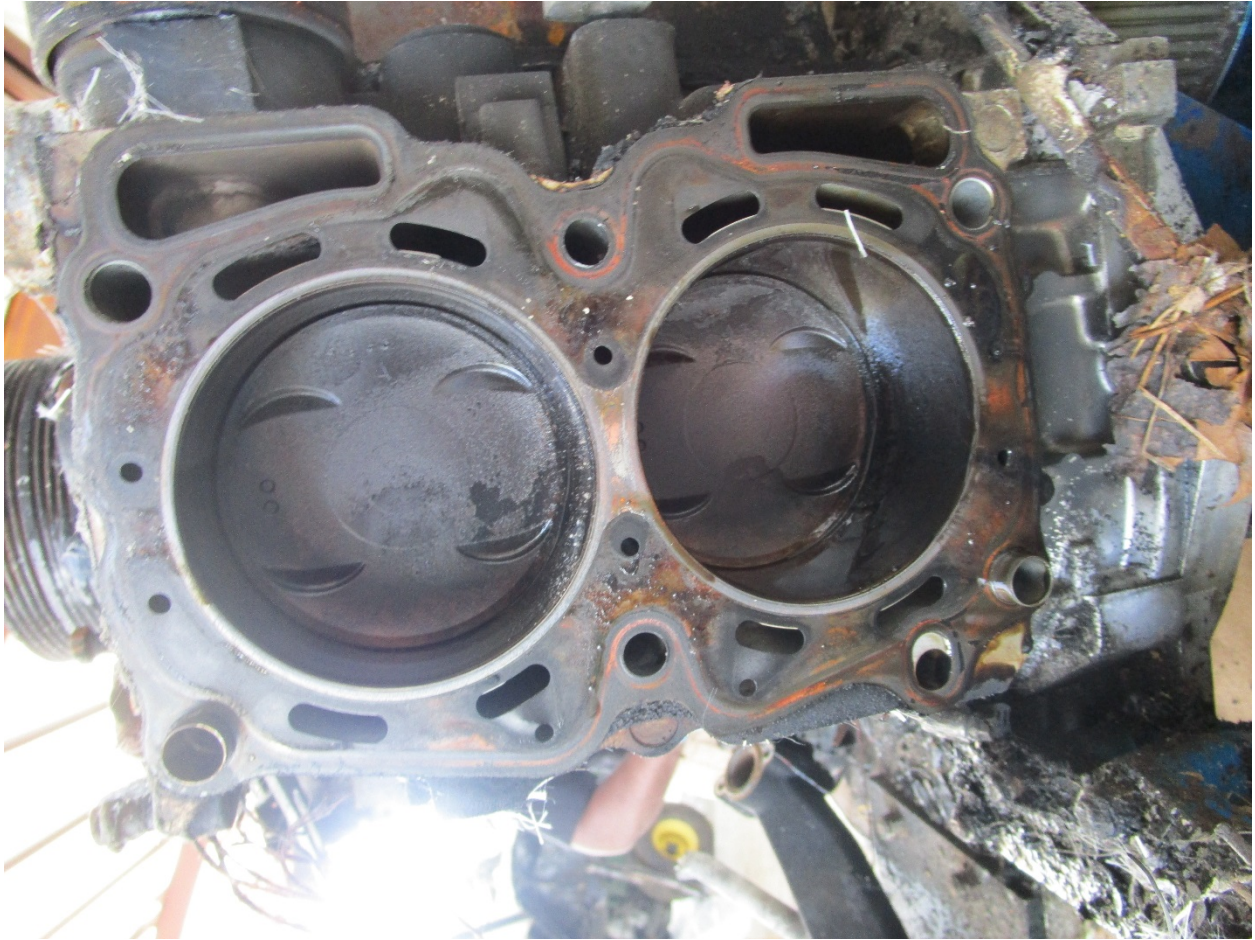
Right head gasket showed no breaks.

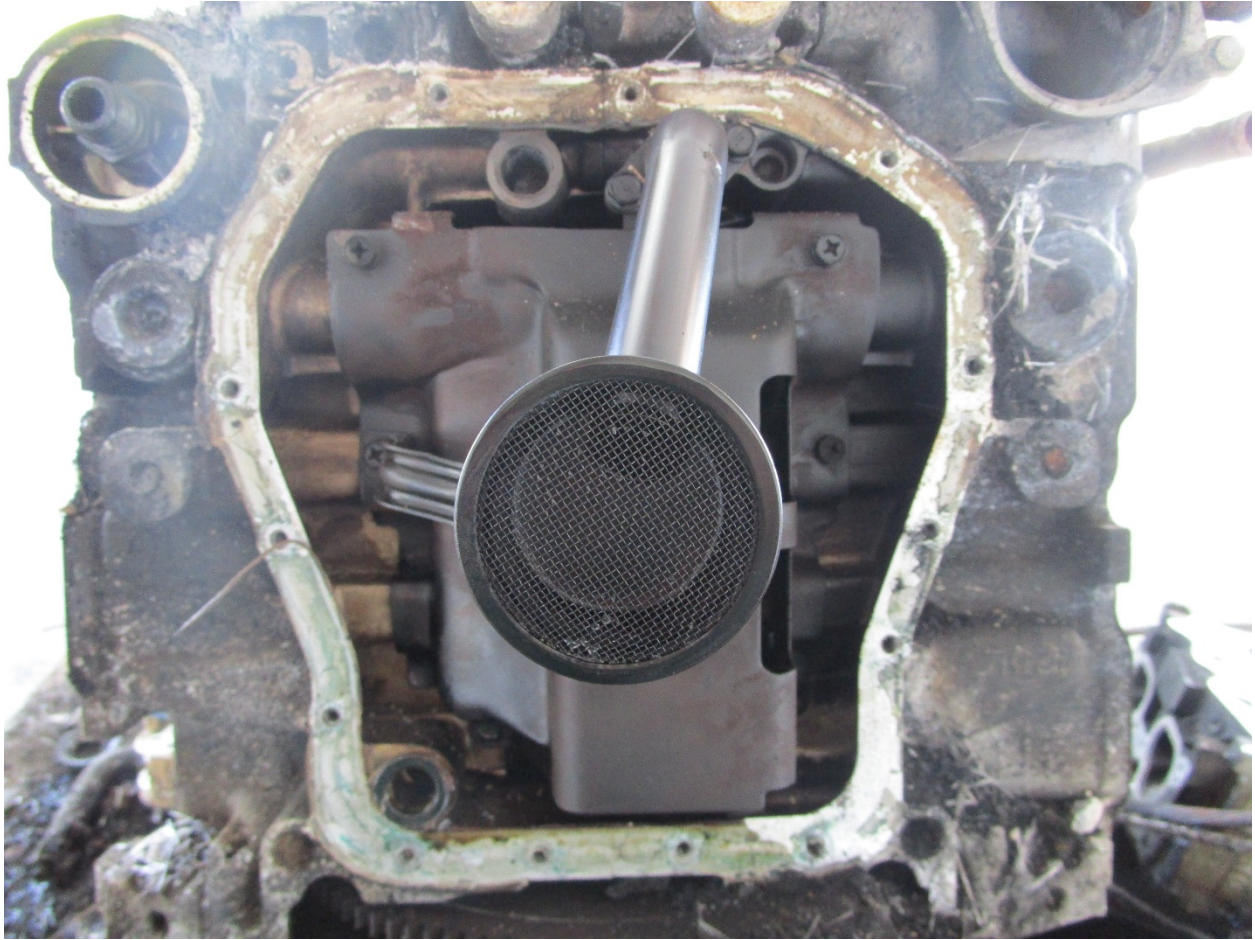
Bottom of engine with oil pan removed. The screen is at the bottom of the oil pick-up tube. No metal or other debris noted in the bottom of the oil pan.

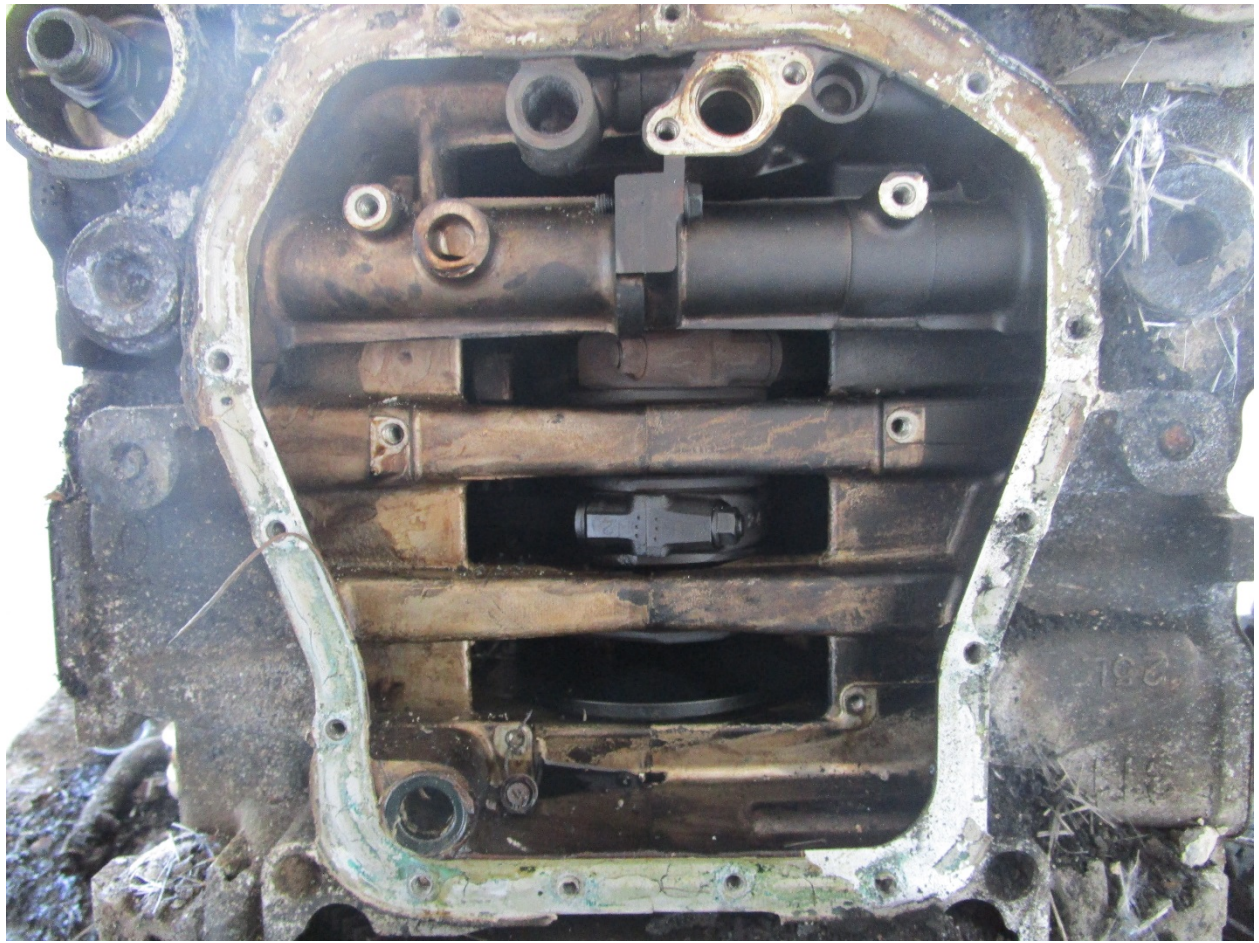
Bottom of engine showing the #2 through #4 connecting rods/crank shaft. Nothing abnormal noted.

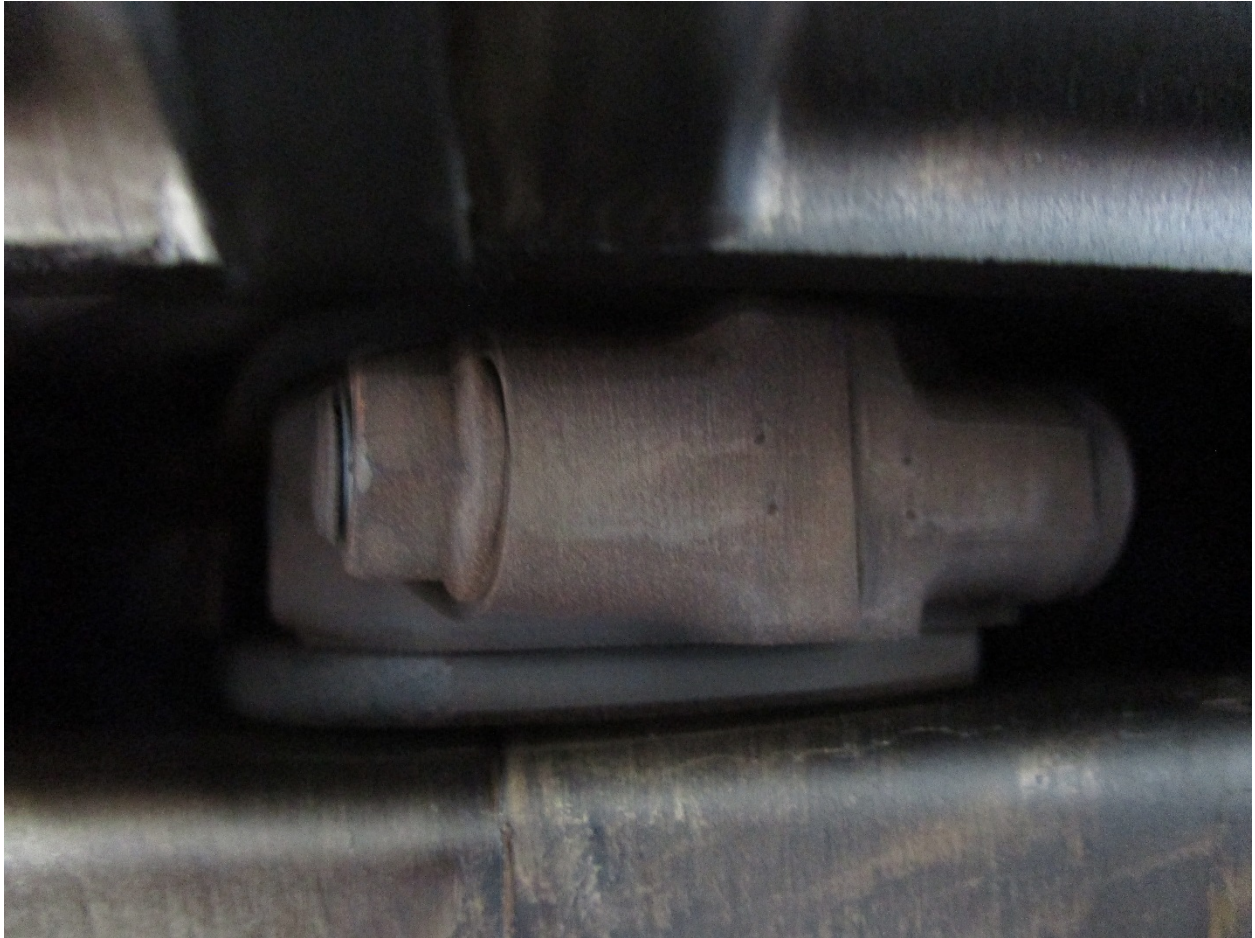
#2 connecting rod. The #1 connecting rod was hidden from view, but when accessories were removed from the front of the engine, the crank shaft rotated freely and all pistons moved in order. Continuity positively established through the engine.

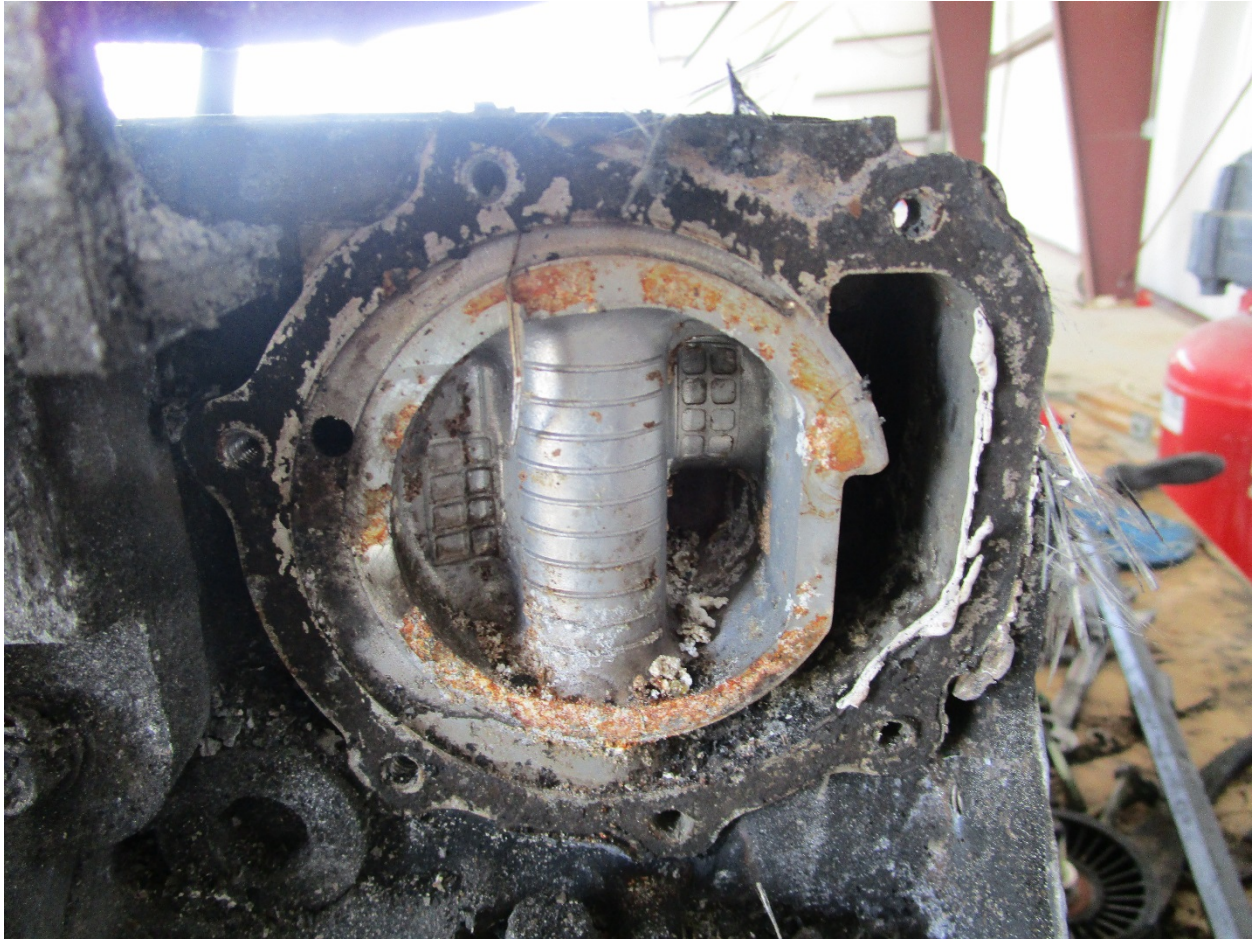
Water pump housing on the front of the engine, debris introduced during disassembly.
