Inspector Statement from Allan Crabbe FAA IIC, Jackson MS. FSDO

On May 1<sup>st</sup> 2018, Inspector Crabbe traveled to Hernando, MS with Inspector Albert McCray to witness an engine disassembly. The engine was recovered from the wreckage of N481ZK, an Experimental/Amateur Built Gyrocopter. The aircraft was built from a kit, titled Sparrow Hawk. The engine examined was a converted automobile engine, a Subaru 4 opposing cylinder engine, liquid cooled, and modified with a fixed pitch “pusher” propeller in the rear of the engine. The first four pictures are the “four corners of the engine for reference –

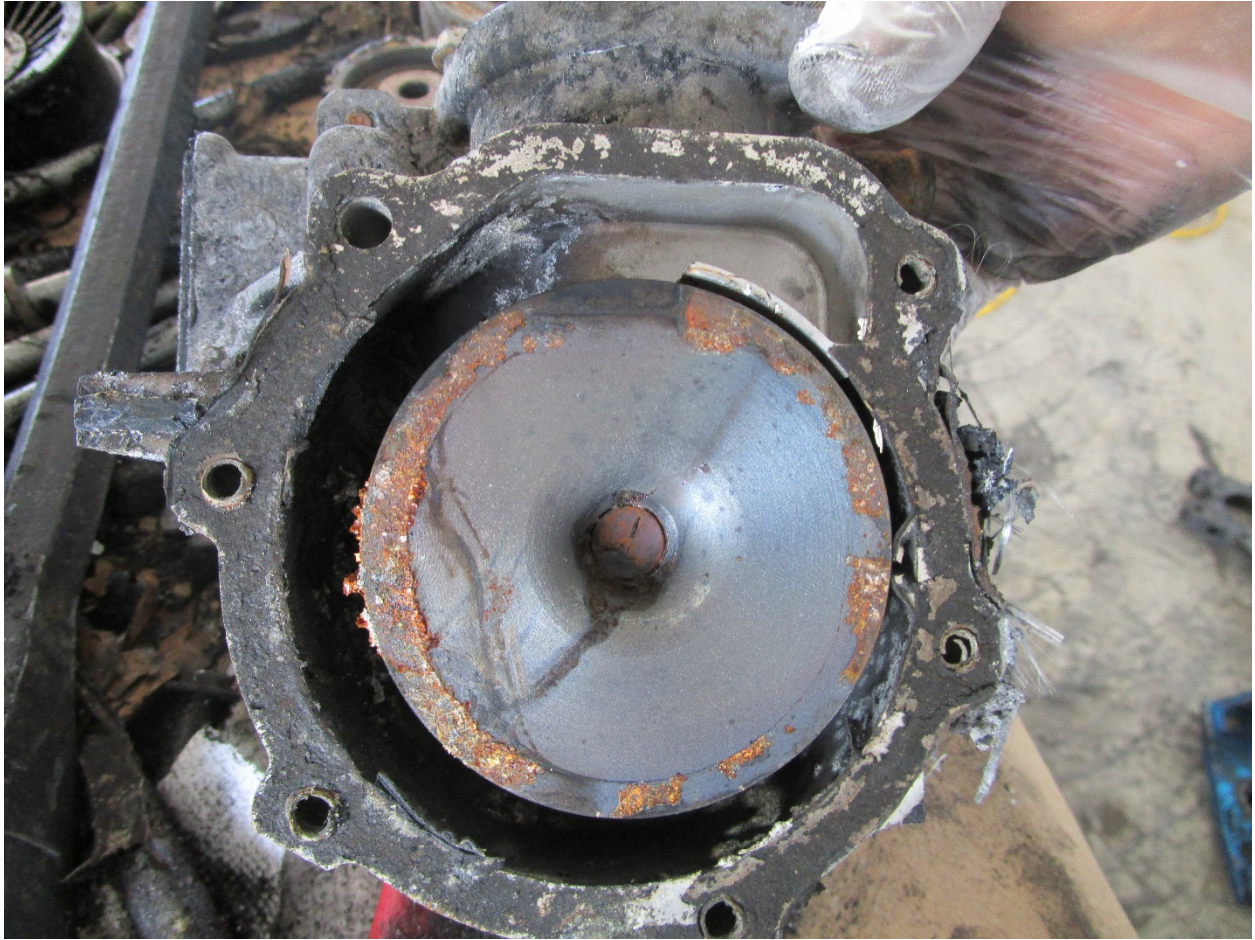
Water pump assembly, would not rotate due to corrosion and damage from crash.

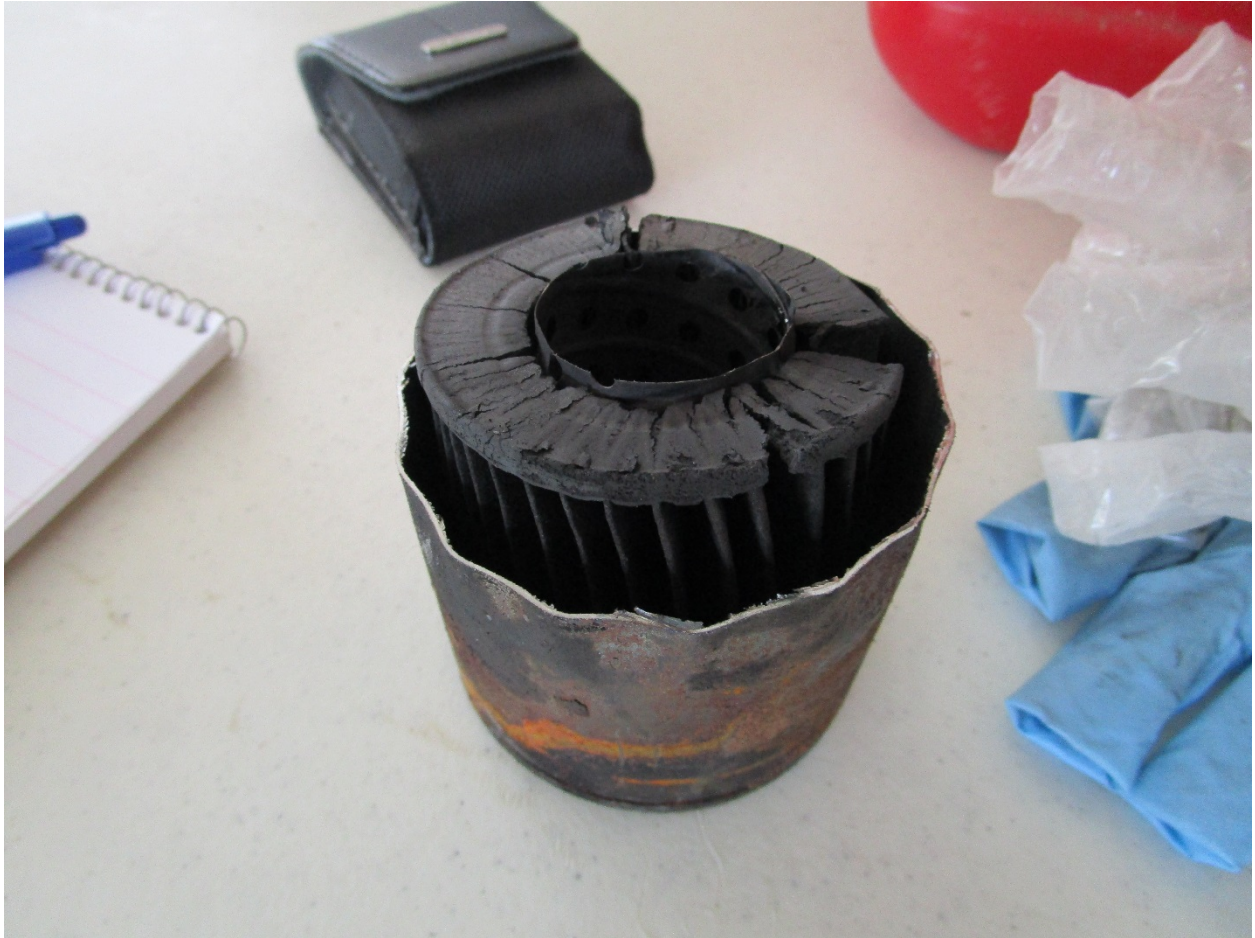
Oil filter cut open, heat damaged due to post crash fire.

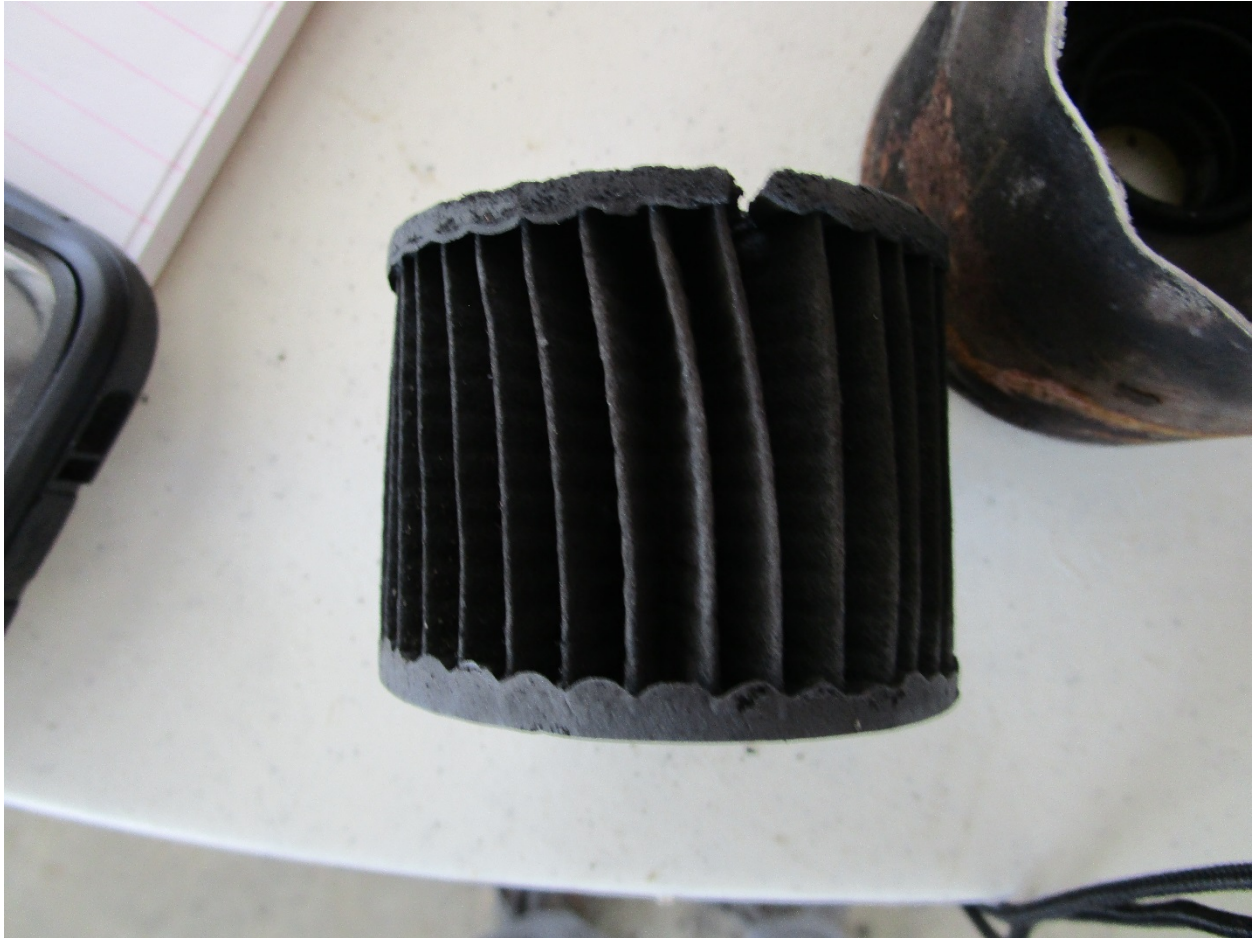
Oil filter element brittle from heat due to post crash fire. No metal found in filter.

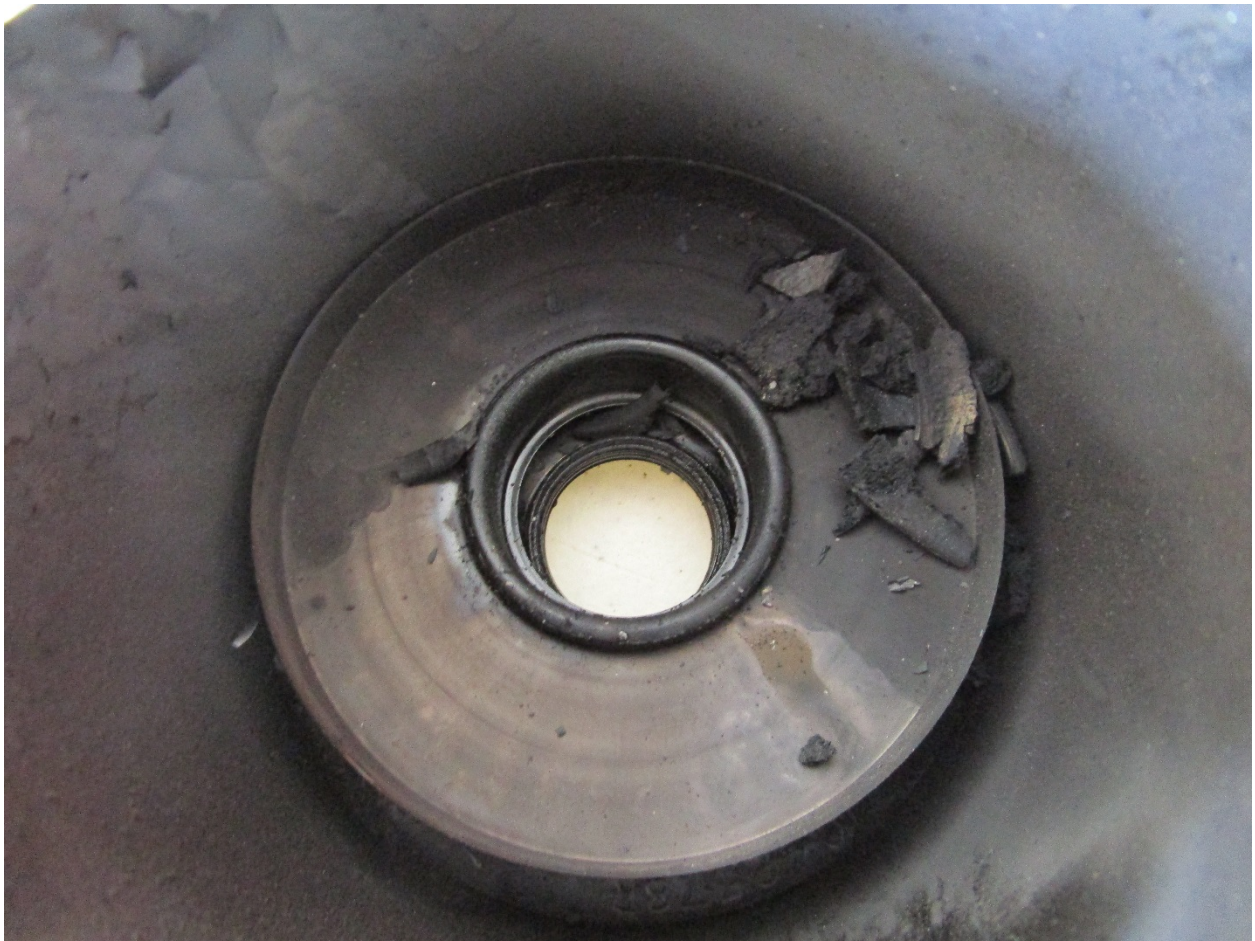
Inside of oil filter housing, debris from brittle oil filter element.

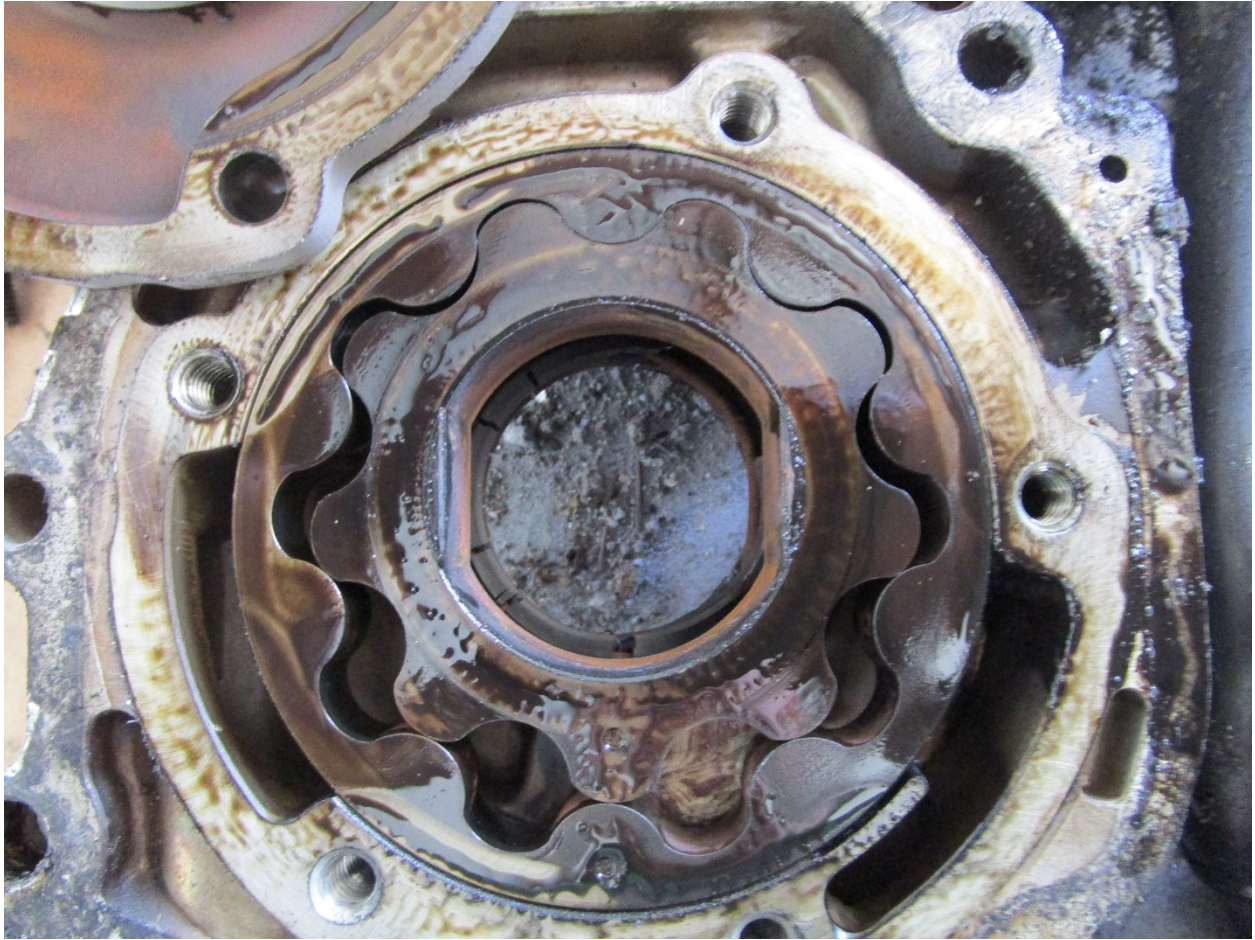
Oil pump and element, no scarring or burring noted. Appeared normal.
